Petaluma Fire Station No. 1

Historic Structure Evaluation and Project Narrative

Historic SPAR Study Session

June 2024

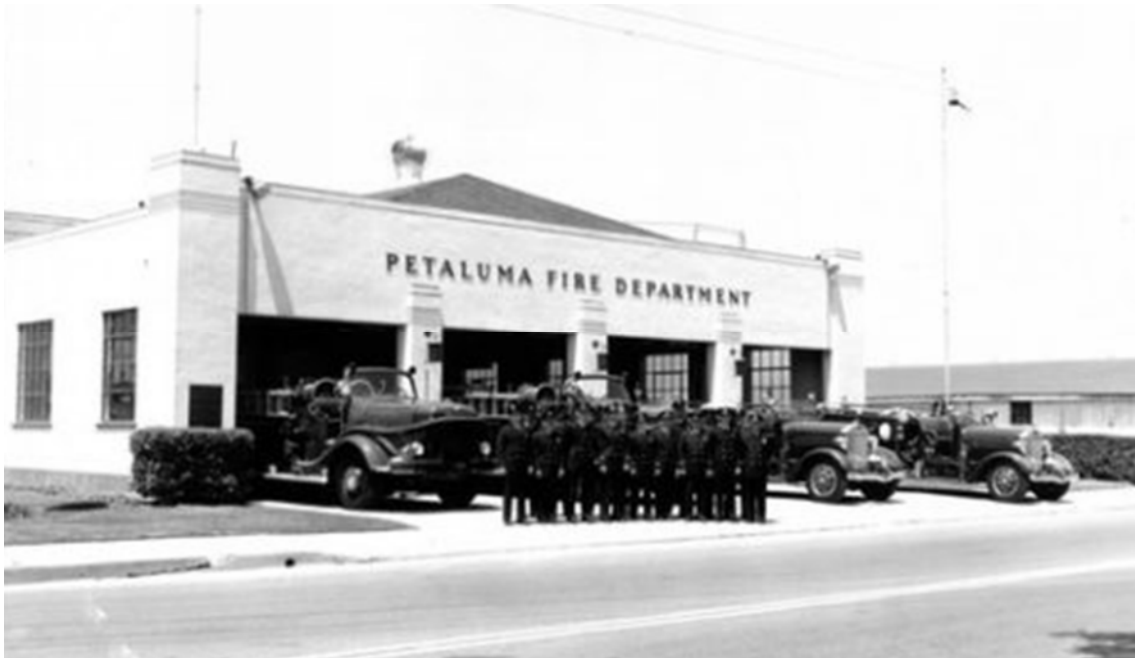
Source: Petaluma Fire Department

The original station is of one and two-story construction with a central multi-story bell tower. The one-story portion of the building housed fire apparatus. The two-story provided for 24-hour fire personnel living quarters. An outdoor plaza was located at the corner of D and 2nd Street. The main building entrance was from this plaza area. The original building is primarily a wood framed structure. Steel trusses span the four original apparatus bays. Exterior building finish throughout is painted plaster with a dash texture. Exterior windows are steel frame with single-pane glazing. Original apparatus bay doors were constructed of wood and glass, but in 1970 replaced with aluminum bay doors which differed in appearance.

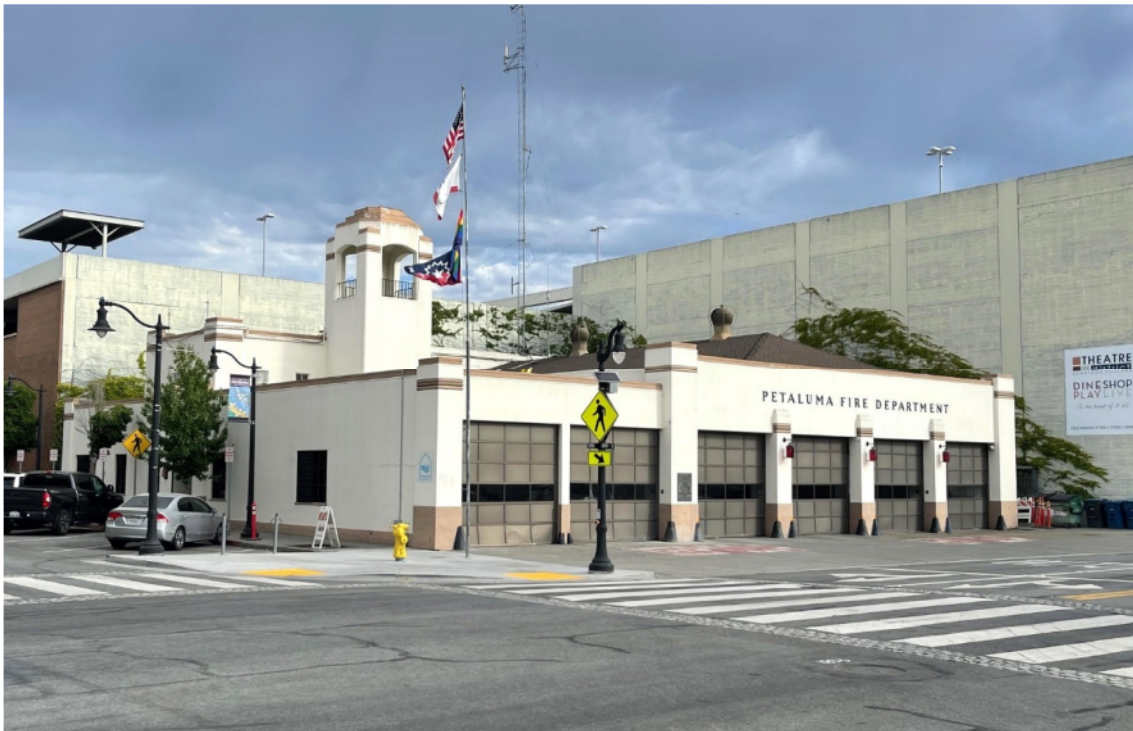
Source: Petaluma Fire Department

Lieb & Quaresma Architects were retained by the City to add this 2,052 square foot addition for housing two apparatus bays and several offices. At that time, this station became the headquarters for the entire Petaluma Fire Department. Original plans of the building addition are not available. This building addition is a wood framed structure with an exterior building finish throughout of painted plaster with a sand trowel texture. All exterior windows in the addition are aluminum frame with single-pane glazing. The main building entrance is constructed of aluminum storefront system. Replaced apparatus bay doors are constructed of aluminum and glass. Roof covering is a combination of single-ply membrane and asphalt shingles.

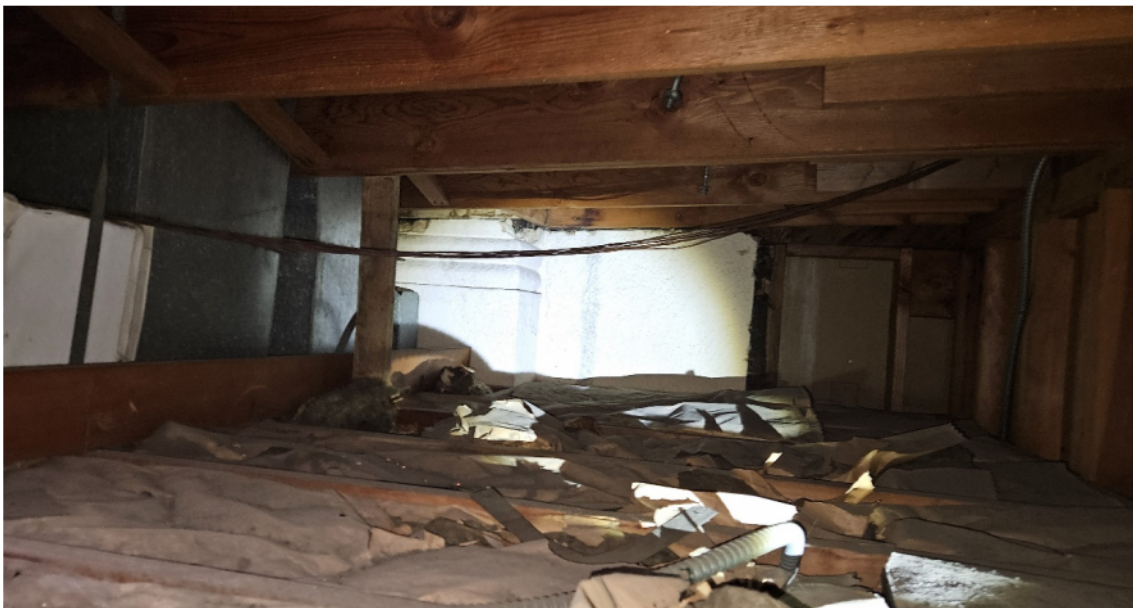
View of original 1938 construction from within ceiling plenum of 1970's addition. Source: Report Author

From the above photo, it appears the original plaster was stripped from the building to allow a wood ledger to be bolted to the 1938 building. Remaining plaster indicates that the building was painted white at the time of the 1970's addition. The pre-1970's photos of FS1 also suggest that the building was painted white with black accents.

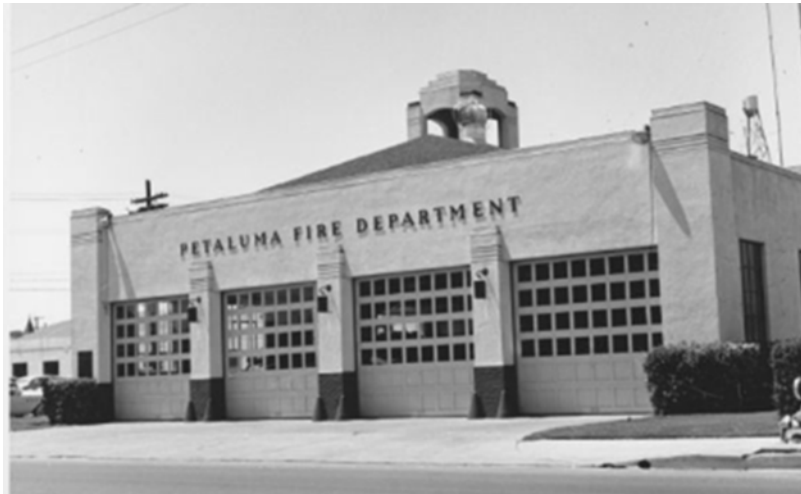
Source: Petaluma Fire Department

- Original 1938 Station massing including the prominent bell tower. The bell tower stands at +43'-6" above finished floor and can be observed for several blocks away. The bell tower is key to the building's original architecture.
- Original four apparatus bay door locations, door size, and proportions of divided-lites. Although the apparatus bay doors have been replaced, their replacement did not account for the proportion and scale of the individual lites within each apparatus bay door. The

apparatus bay doors are considered significant due to their dominant East elevation exposure to D Street, a major arterial corridor.

- The 1970's addition also replaced the existing 1938 apparatus bay doors with dark-bronze aluminum doors. Although it was presumably unreasonable to specify wood as a replacement material for apparatus bay doors at the time, the scale and configuration of these doors was also altered from the original 1938 design. The current apparatus bay doors are considered as non-contributing elements.

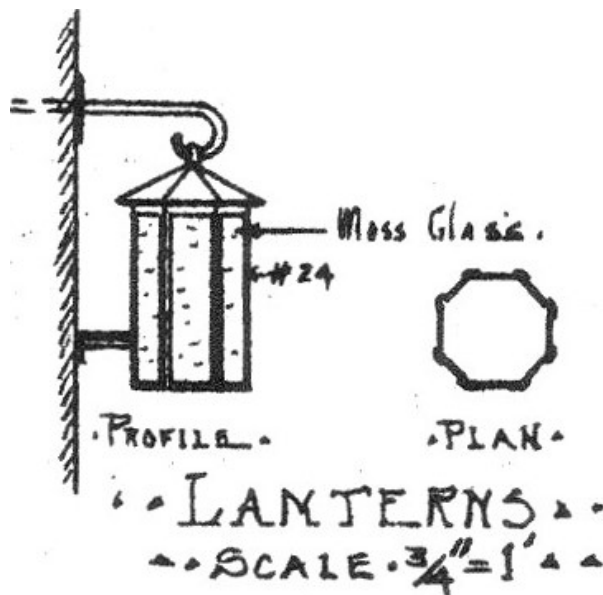
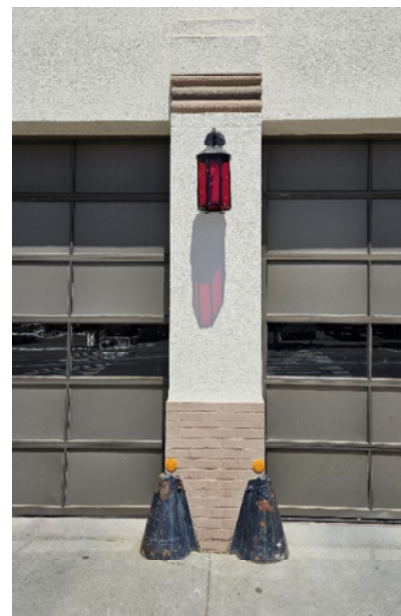
- Original apparatus bay exterior wall-mounted lanterns (lights). Three (3) lanterns on the East elevation, and 1 relocated lantern on the South elevation are distinctive due to their size, black wrought iron frame and red moss glass infill. These lanterns were detailed on the original 1938 plans by Brainard Jones. All 4 lanterns are still in operation.

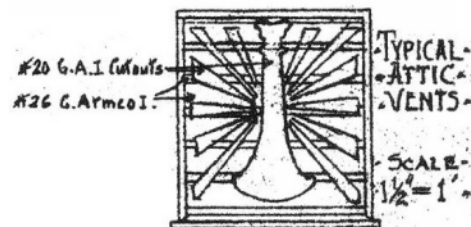
- Eight original decorative steel attic vents. One (1) attic vent on the South elevation, 6 attic vents on the West elevation, and 1 attic vent on the North elevation are distinctive due to their wrought iron design. These attic vents were detailed on the original 1938 plans by Brainard Jones. All of these existing attic vents are still in operation. These attic vents would have been labeled as significant if they were more prominent in appearance to the public or public way.

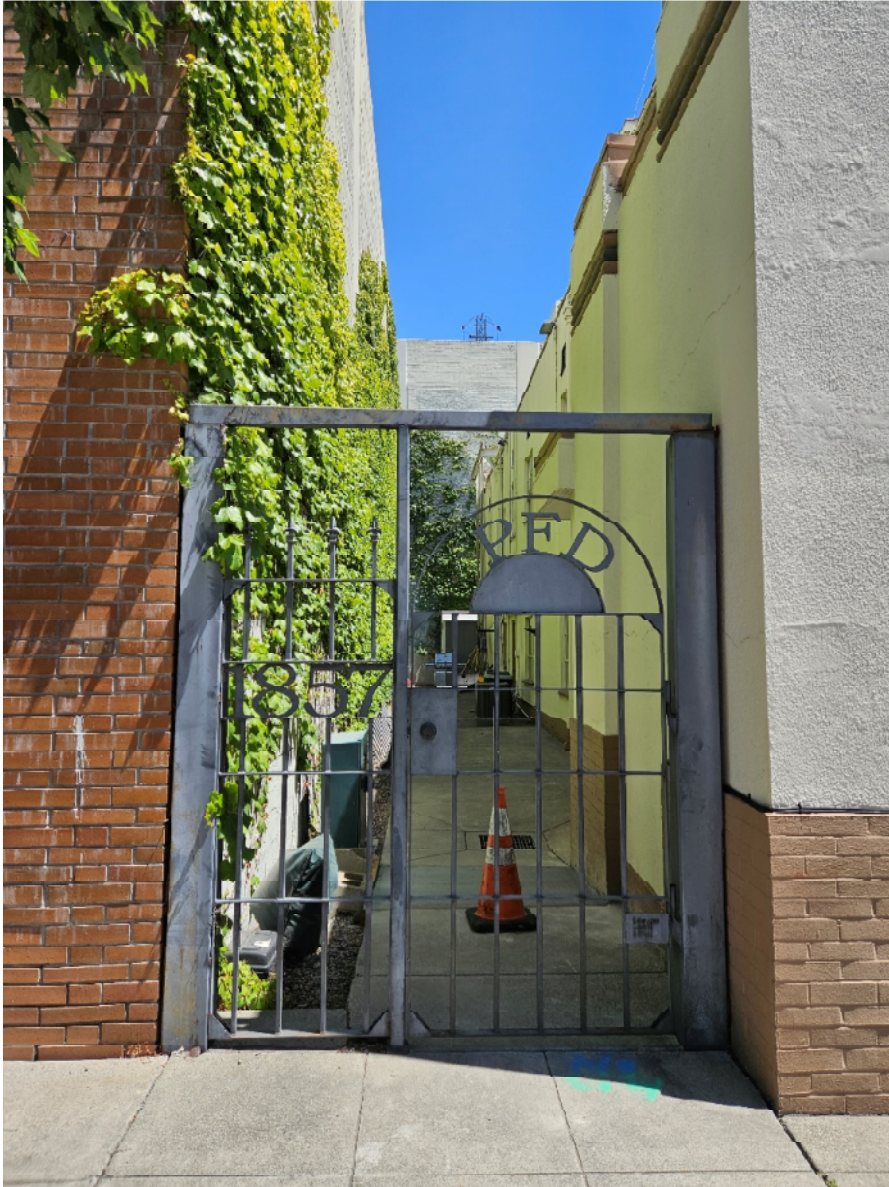
Limited view of West Side Yard from Public Way - Source: Report Author

- After construction of the Theatre District Parking Structure, several non-contributing elements or building modifications were added to Petaluma FS1. All of these elements either face or are located in the West and North side yards between FS1 and the tall parking structure wall. These elements include 1) replacement of exit doors and windows with hollow metal doors and frames, 2) addition of apparatus bay exhaust systems including fans and ducts, 3) addition of a ground-mounted emergency generator, and 4) the installation of two free-standing storage containers. None of the elements face the public way.

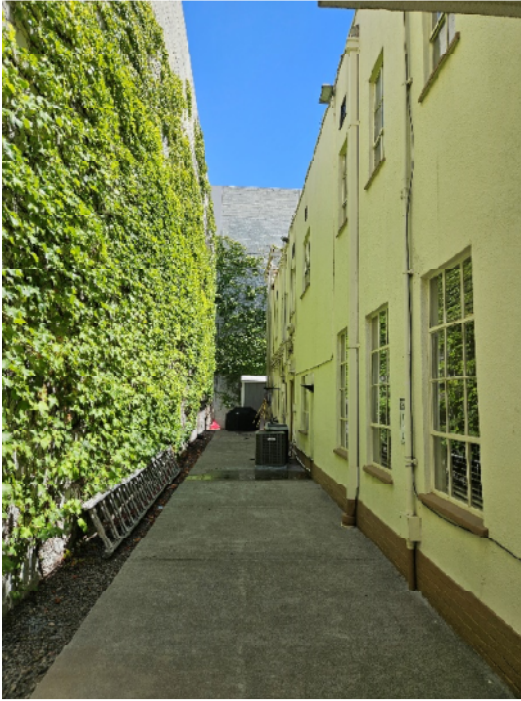
Interior view of West Side Yard – Source: Report Author

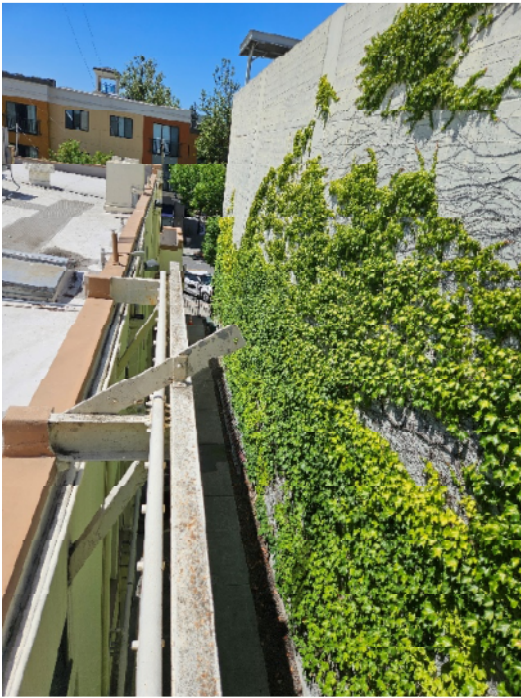
Overhead View of West Side Yard – Source: Report Author

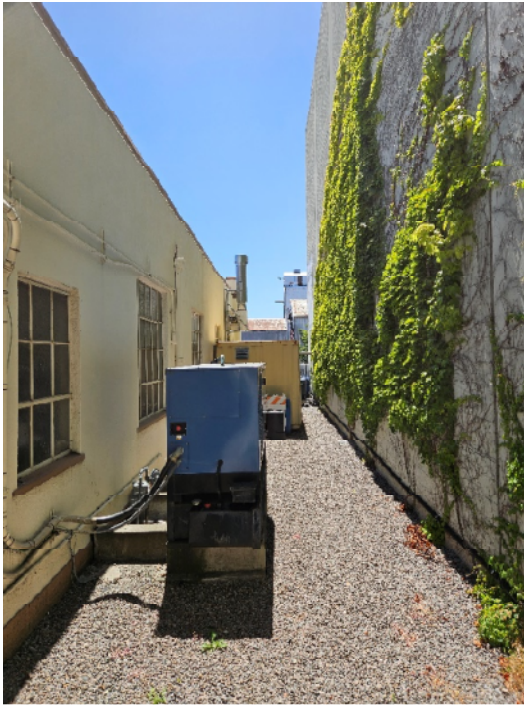
Limited view of North Side Yard – Source: Report Author

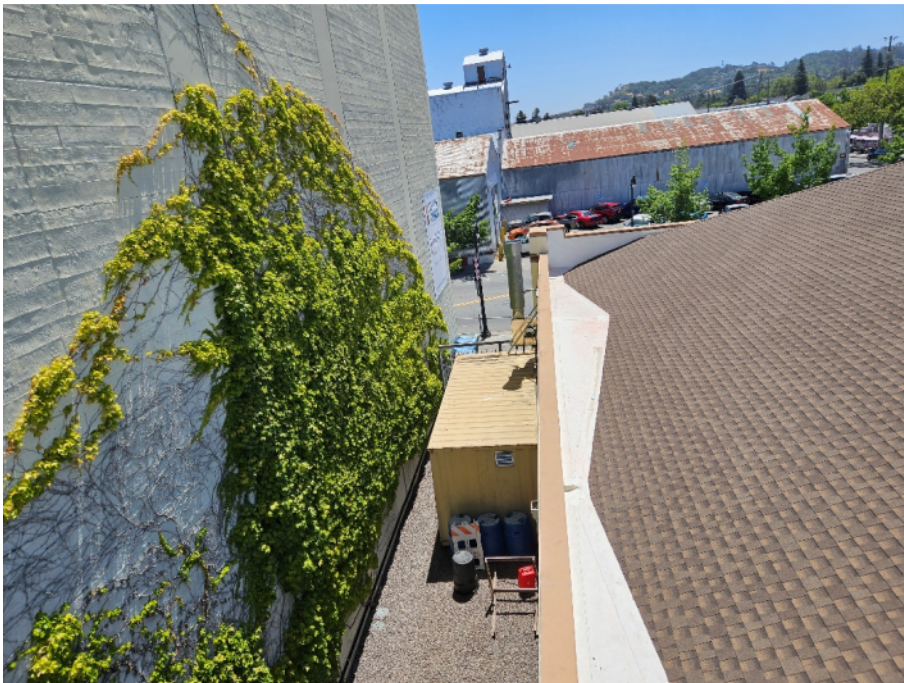
Overhead View of North Side Yard – Source: Report Author

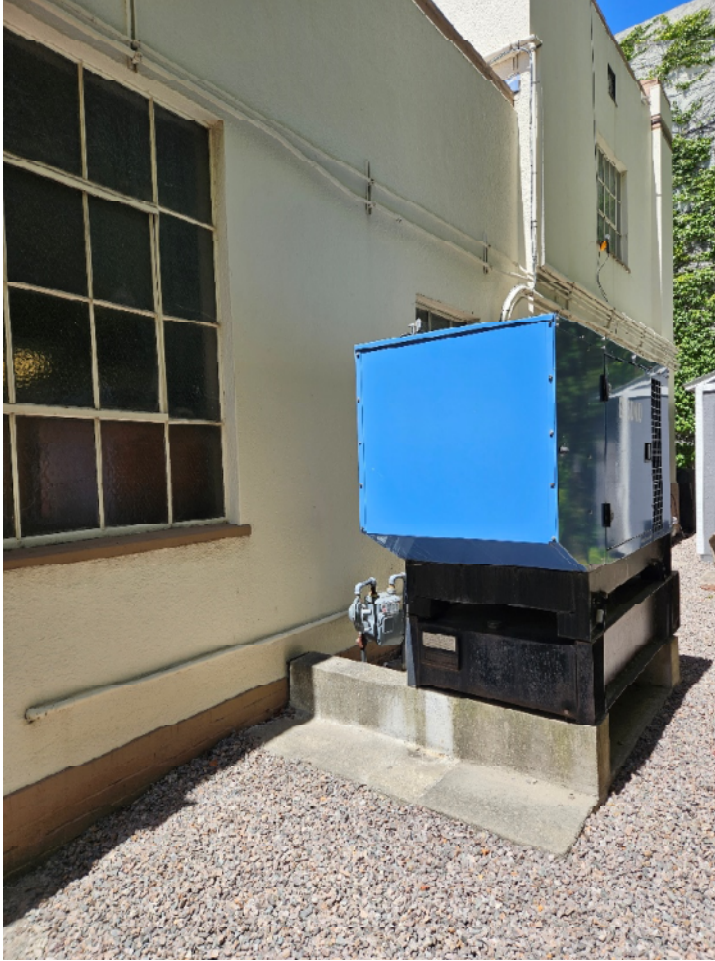
*North side yard emergency generator. Air compressor to be located adjacent to generator
Source: Report Author*

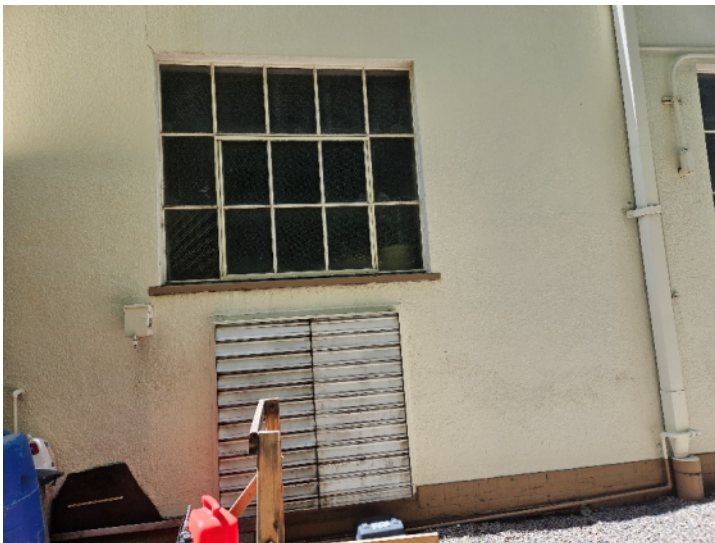
View of window and grille to be replaced with man door and grille – Source: Report Author

Impact: One exterior North elevation existing window with a thru-wall exhaust fan grille would be replaced with a conventional hollow metal man door and frame with an adjacent exhaust fan grille. The elimination of this window modifies the original construction. However, this proposed building elevation revision face the North property line (tall blank concrete wall of parking structure) and does not face the public way.

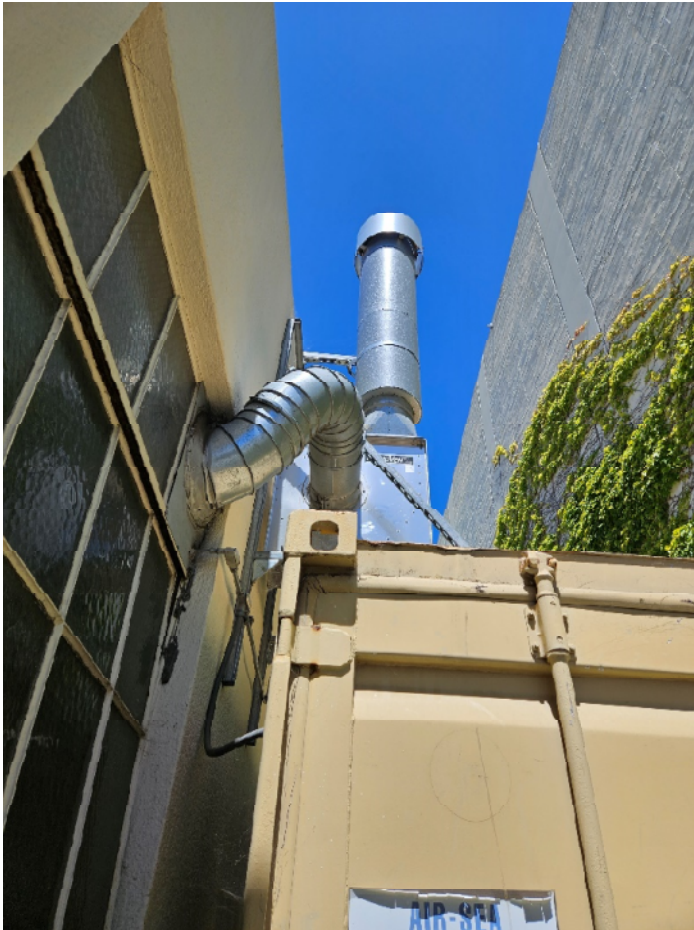
View of North Side Yard exhaust fan and ductwork as seen from the Public Way – Source: Report Author

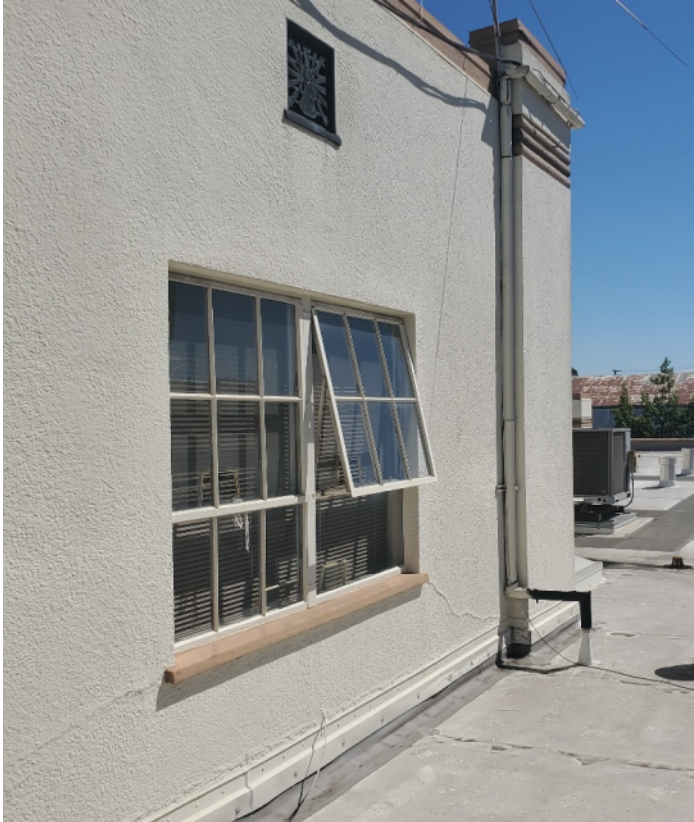
*View of second floor South facing windows requiring replacement to meet exiting requirements
Source: Report Author*

Impact: The configuration of the sleeping quarters shall require the South facing second floor window to change its building exiting operation from non-code compliant awning operation to code compliant casement operation. The same is the case for the two windows within the Battalion Chiefs sleeping quarters whereas these windows need revision from awning to casement operation. Changing window operation on second floor windows for egress purposes modifies the original construction, however the impact is insignificant.

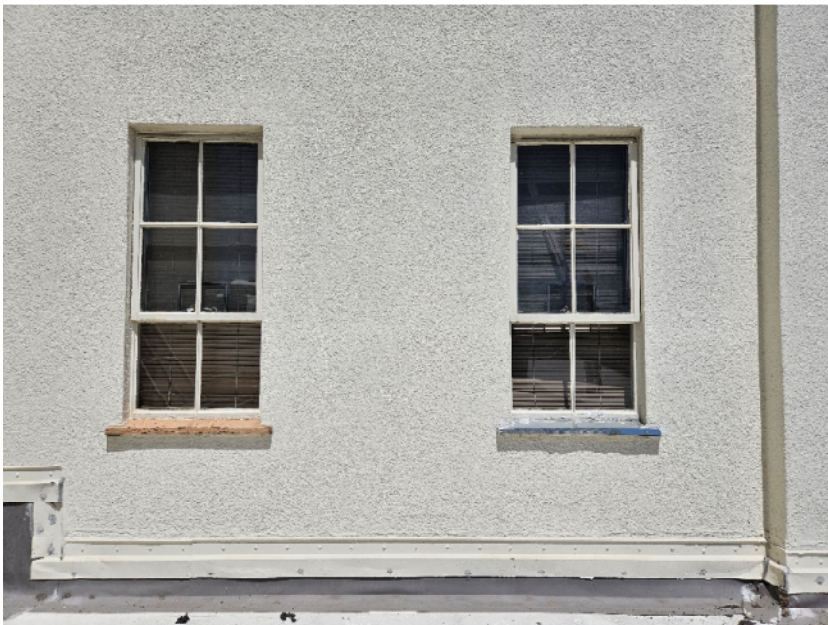
*View of second floor East facing windows scheduled for replacement. Note degraded window sills
Source: Report Author*

Impact: As previously noted, the current exterior windows are a mixture of steel frames and aluminum frames with full or simulated divided-lites. The current windows have several issues including 1) Degraded frames and hardware, 2) poor performing single-pane glazing, and 3) improper window configuration for code-required emergence egress. The objective of new replacement windows is to 1) maintain all existing opening sizes, 2) replicate the size, spacing, and proportions of the divided-lites, and 3) provide energy efficient and code compliant window systems throughout the building. Replacing all exterior windows modifies the original construction but maintains all of the visual features of the windows, particularly those facing the public way along 2nd Street.

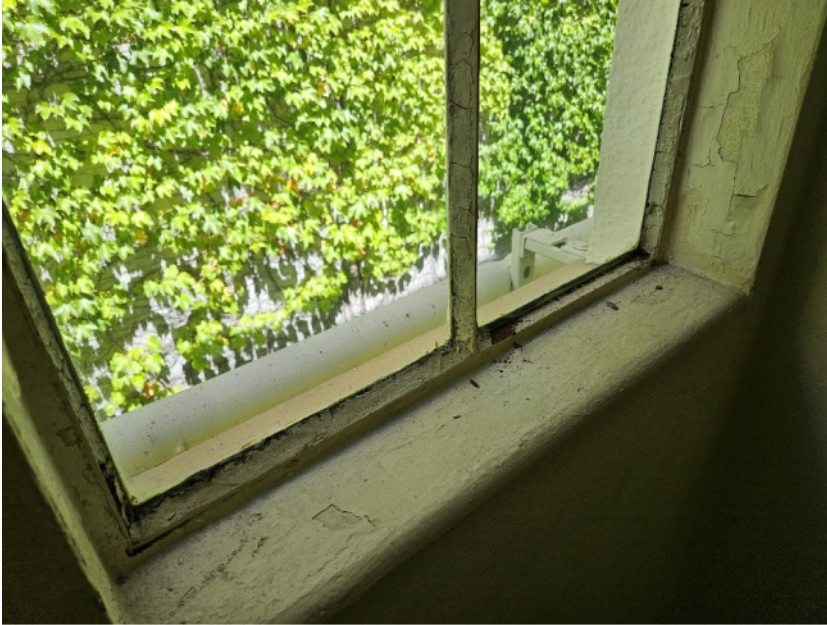
Interior view of degraded West facing windows – Source: Report Author

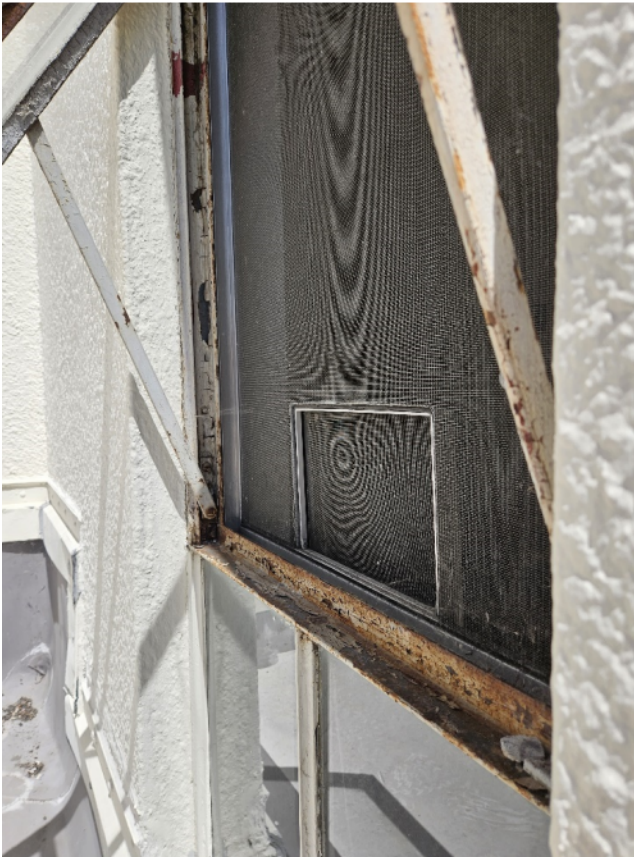
Exterior view of degraded South facing windows – Source: Report Author

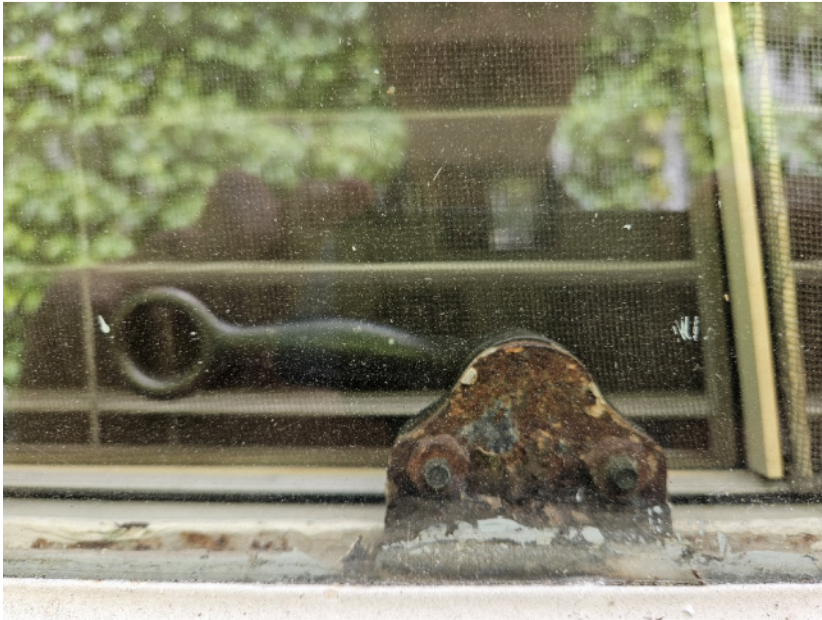
View of degraded window hardware – Source: Report Author

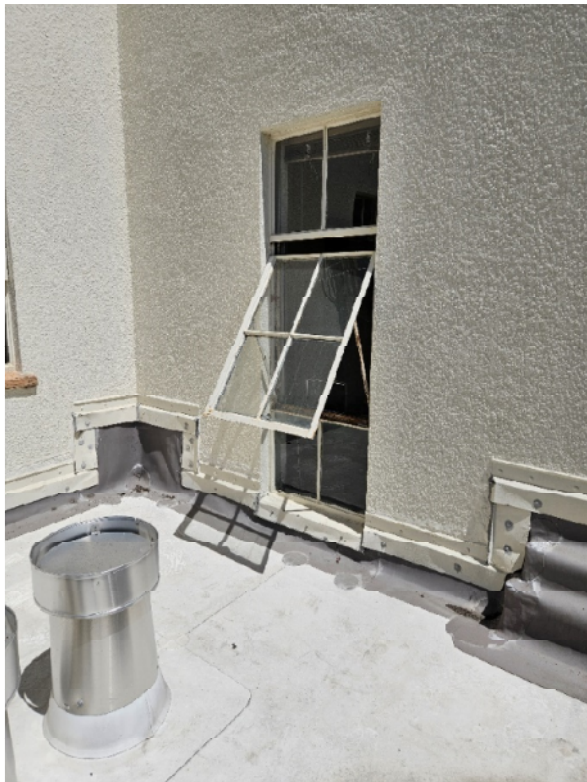
*View of second floor South facing window requiring replacement to meet exiting requirements
Source: Report Author*

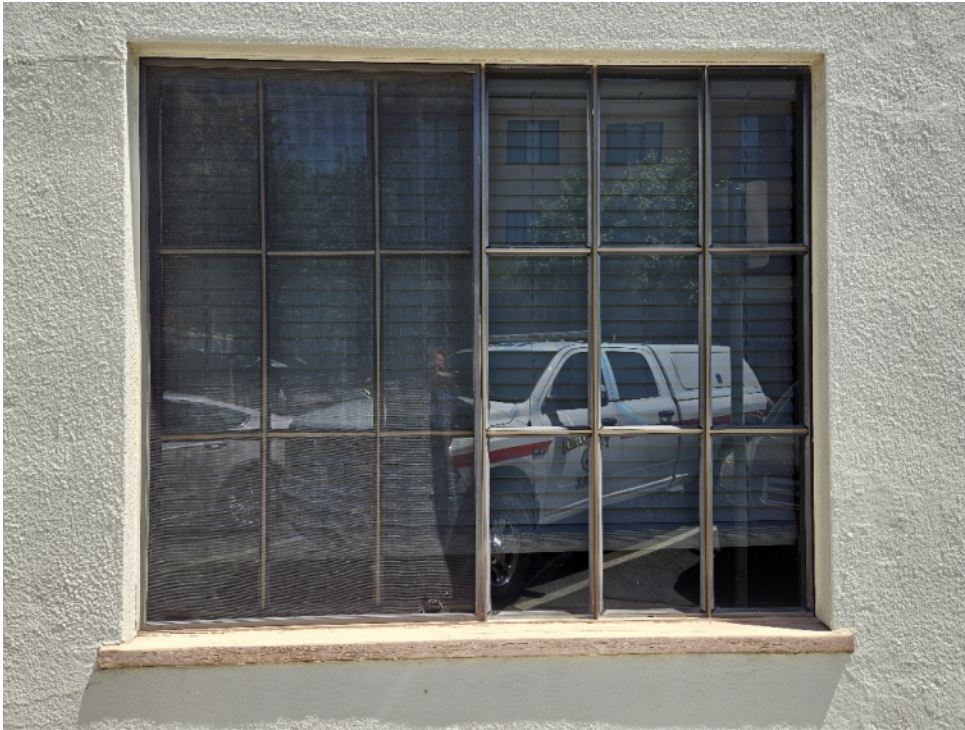
View of first floor South elevation 1970's aluminum window along Public Way – Source: Report Author

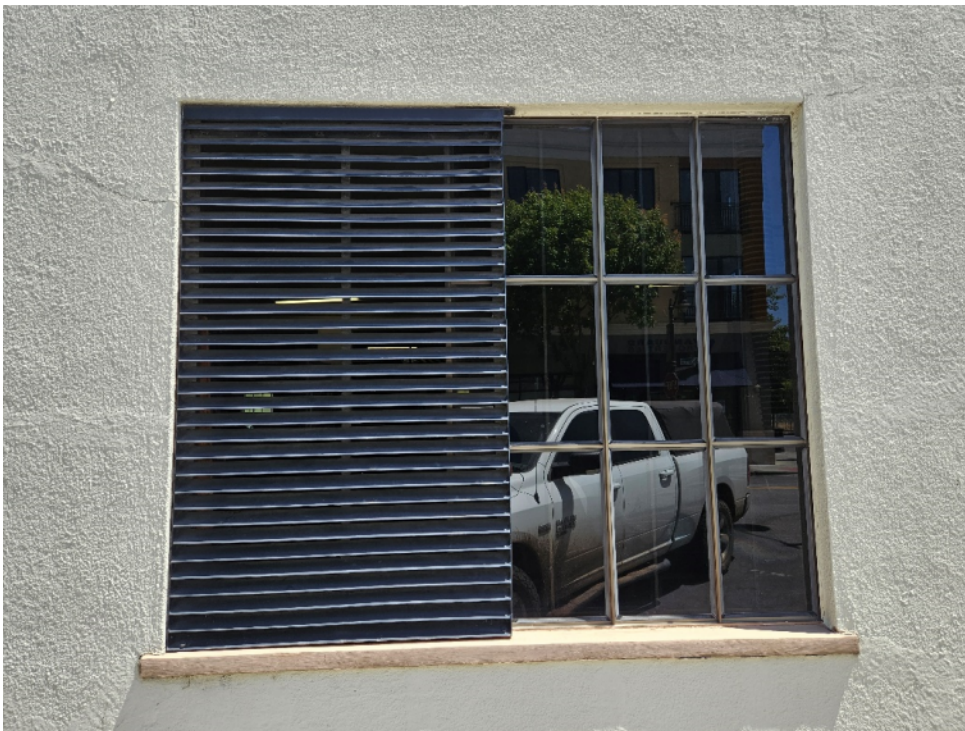
View of first floor South elevation 1970's aluminum window and steel exhaust grille – Source: Report Author

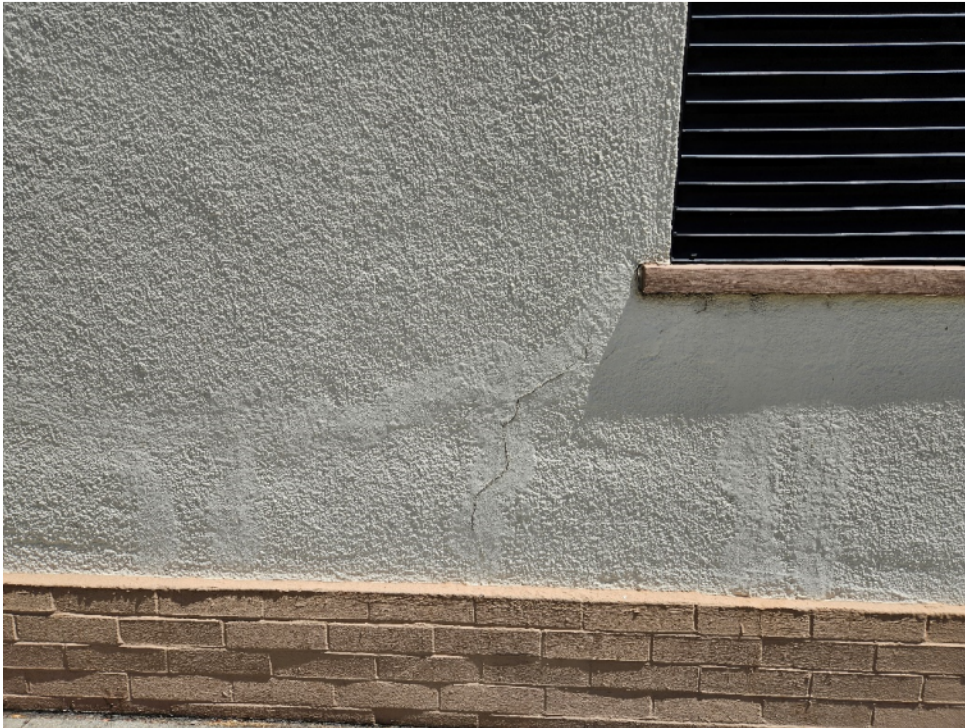
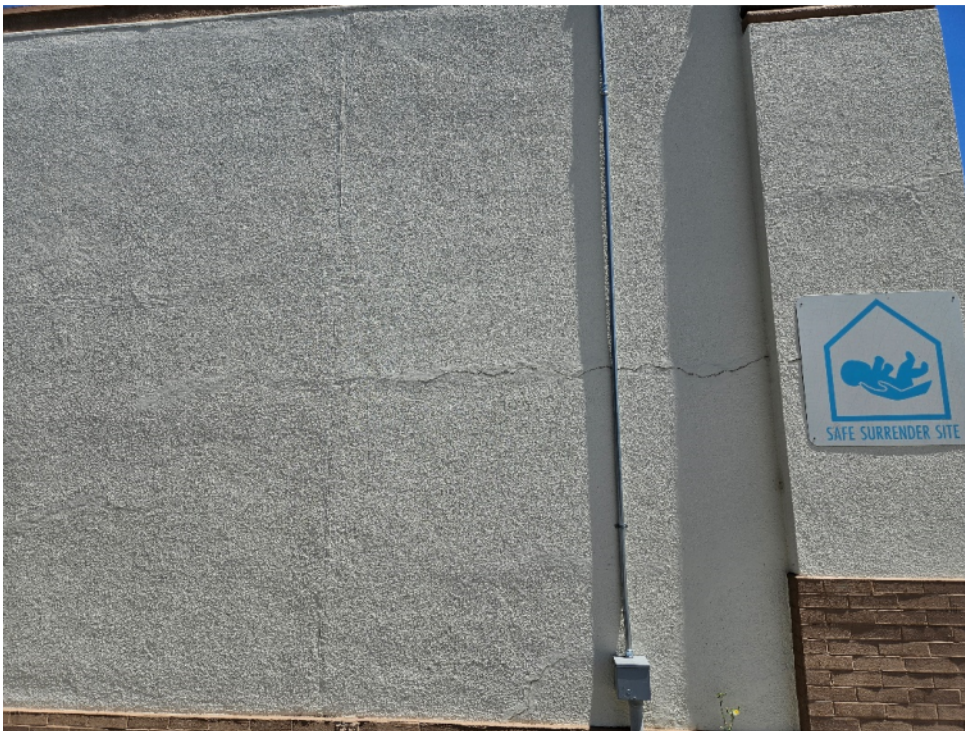
View of South elevation plaster cracks – Source: Report Author

7. Replacement or restoration of 1970's addition exterior plaster.
Impact: Replacing existing plaster with new plaster of the same texture or finish does not modify the original construction and therefore has no impact on the exterior of the building.

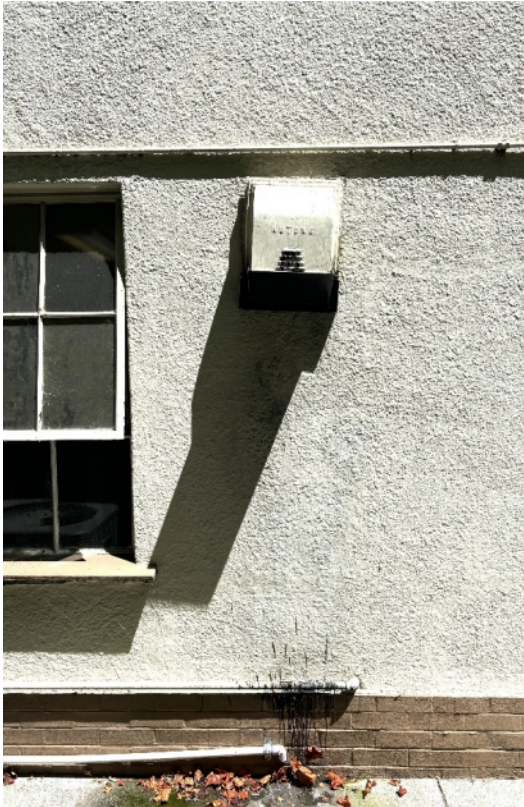
View of West elevation original 1938 kitchen exhaust hood with grease stains – Source: Report Author

Impact: A new exhaust fan servicing the existing kitchen exhaust hood shall be required to replace a current, non-code compliant wall-mounted exhaust fan from the original 1938 construction. This new exhaust fan will be either be wall-mounted or ducted to the roof. This new exhaust fan faces the West property line (tall blank concrete wall of parking structure) and do not face the public way. The new exhaust fan modifies the original construction.

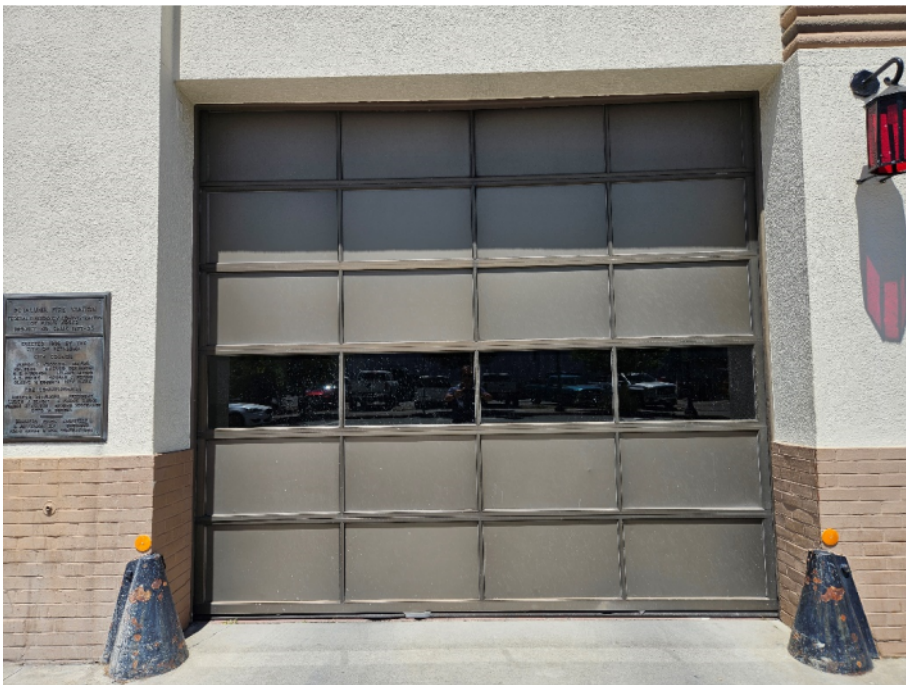
View of East elevation aluminum apparatus bay doors to be replaced – Source: Report Author

Impact: The four original apparatus bay doors, replaced during the 1970’s remodel, will be restored to their original size, proportion, and appearance. This shall be accomplished with custom fabricated aluminum frame doors that employ 6 horizontal sectional panels with eight divided-lite within each panel. This layout or configuration would visually match that of the original 1938 wood apparatus bay doors while maintaining critical fire department operations.

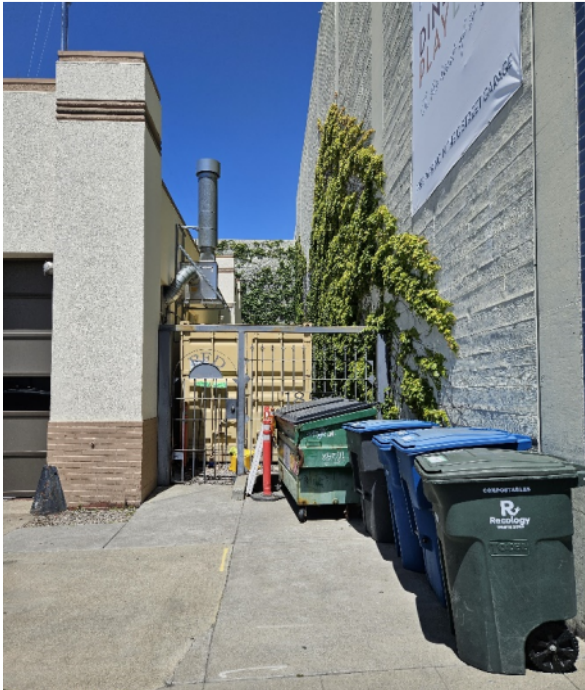
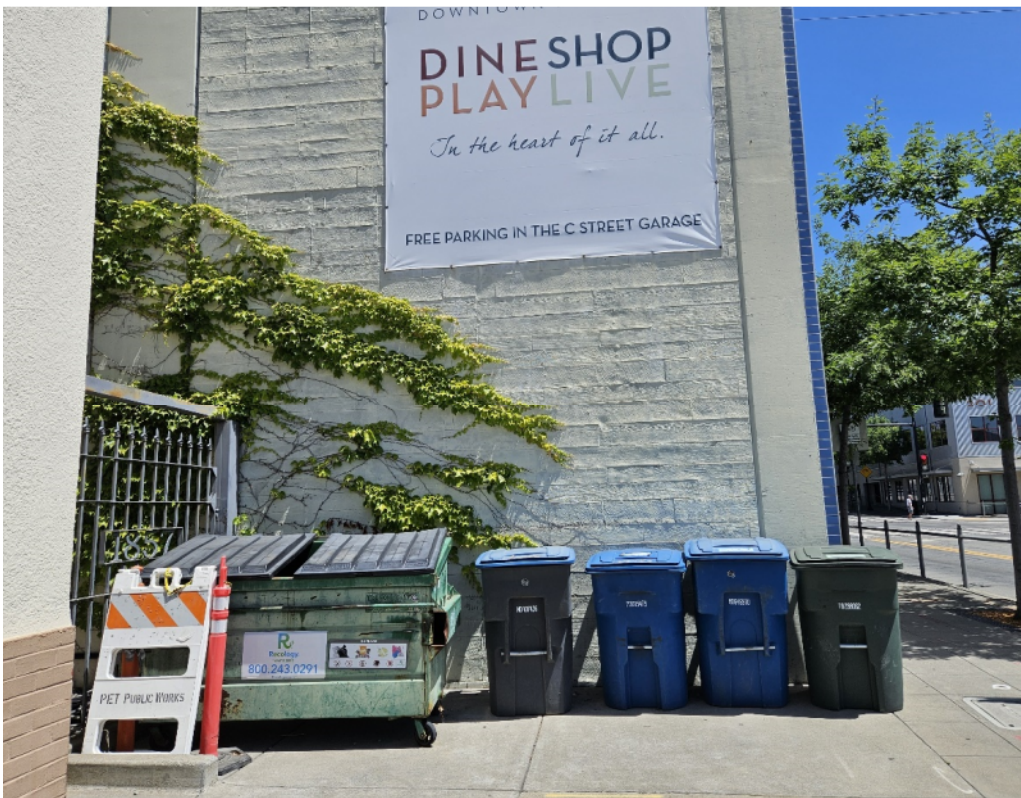
Current trash storage facing D street public way – Source: Report Author

9. New trash enclosure at Northeast corner of property.
Impact: The current existing condition stores trash bins along the North property line directly adjacent to and in full view from the D Street public way. A new trash enclosure is proposed for this location designed per Appendix B SPAR Design Guidelines with modifications necessary to meet existing site conditions and appearance of the PWA Moderne architectural style. Site analysis has concluded that this is the only viable location onsite for such an enclosure. Although this does impact the property, the result of enclosing the trash bins and hidden from public view is deemed as a significant improvement from the current condition.
