# **PHASE I ENVIRONMENTAL SITE ASSESSMENT**

**INDUSTRIAL PROPERTY**

**890 N. McDOWELL BOULEVARD & 320 CORONA STREET  
PETALUMA, CALIFORNIA 94954**

**Issue Date: February 15, 2017**

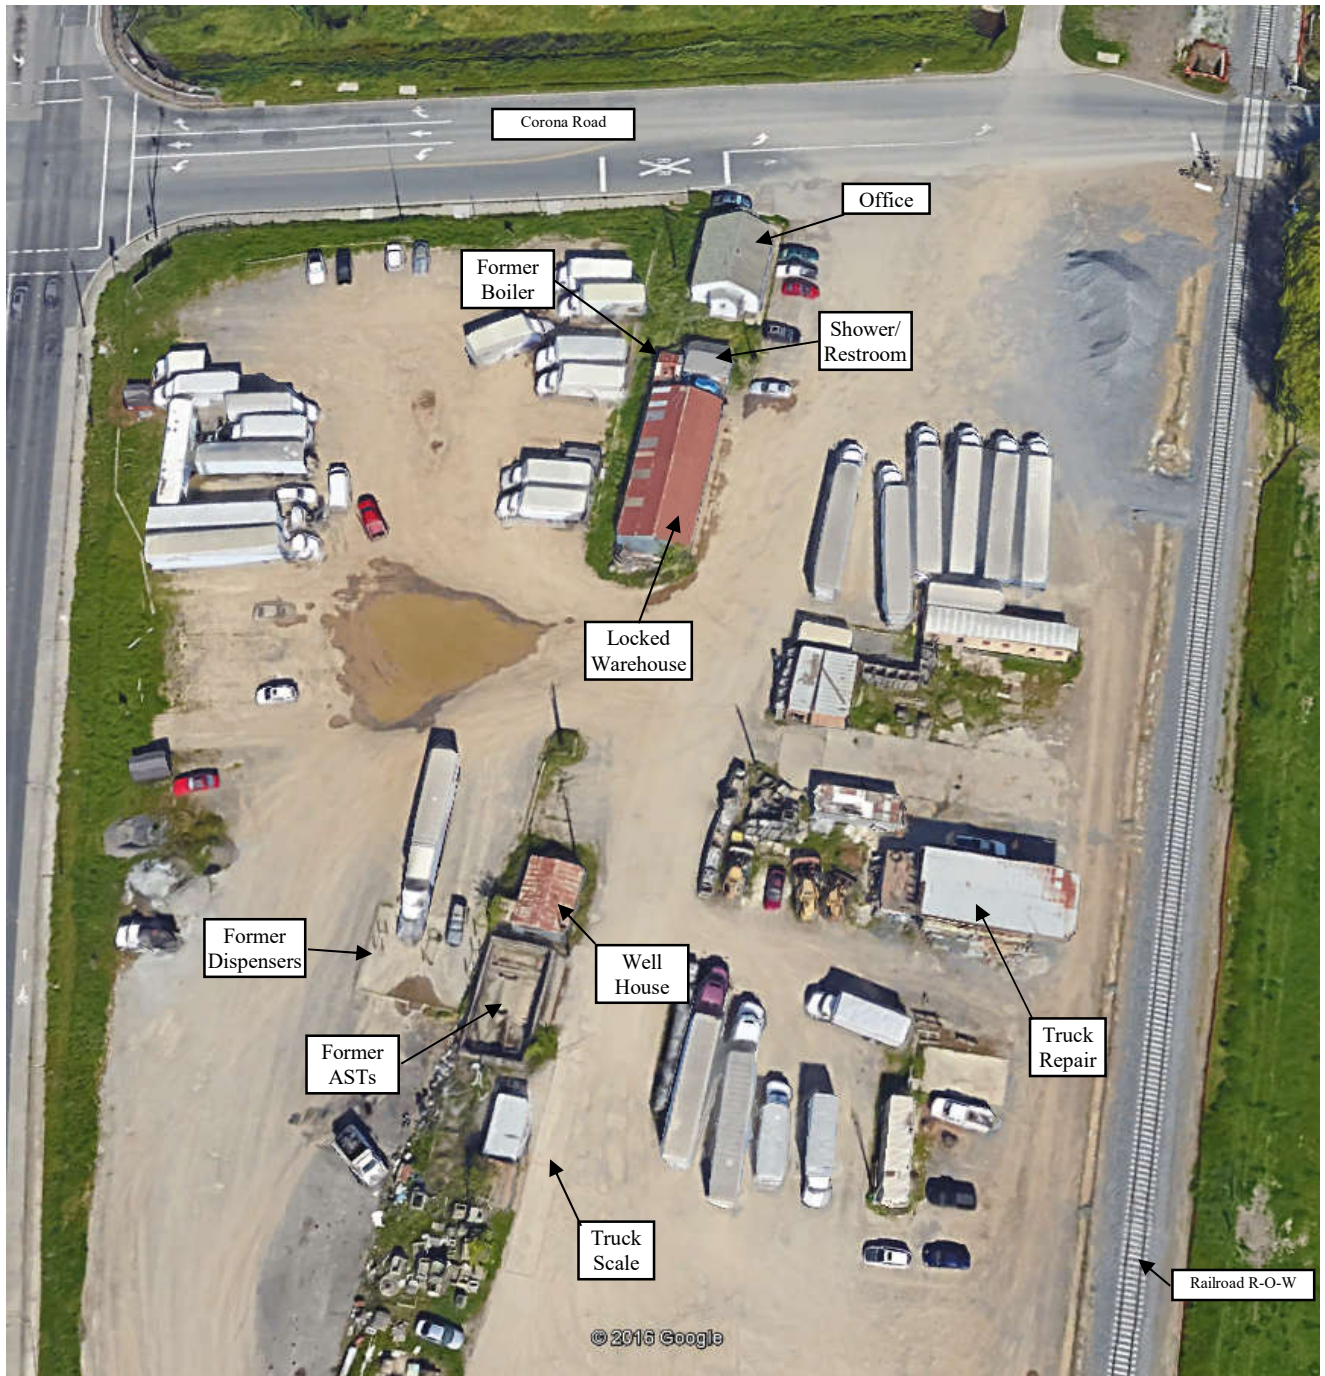
5

Site Map – Northern Portion

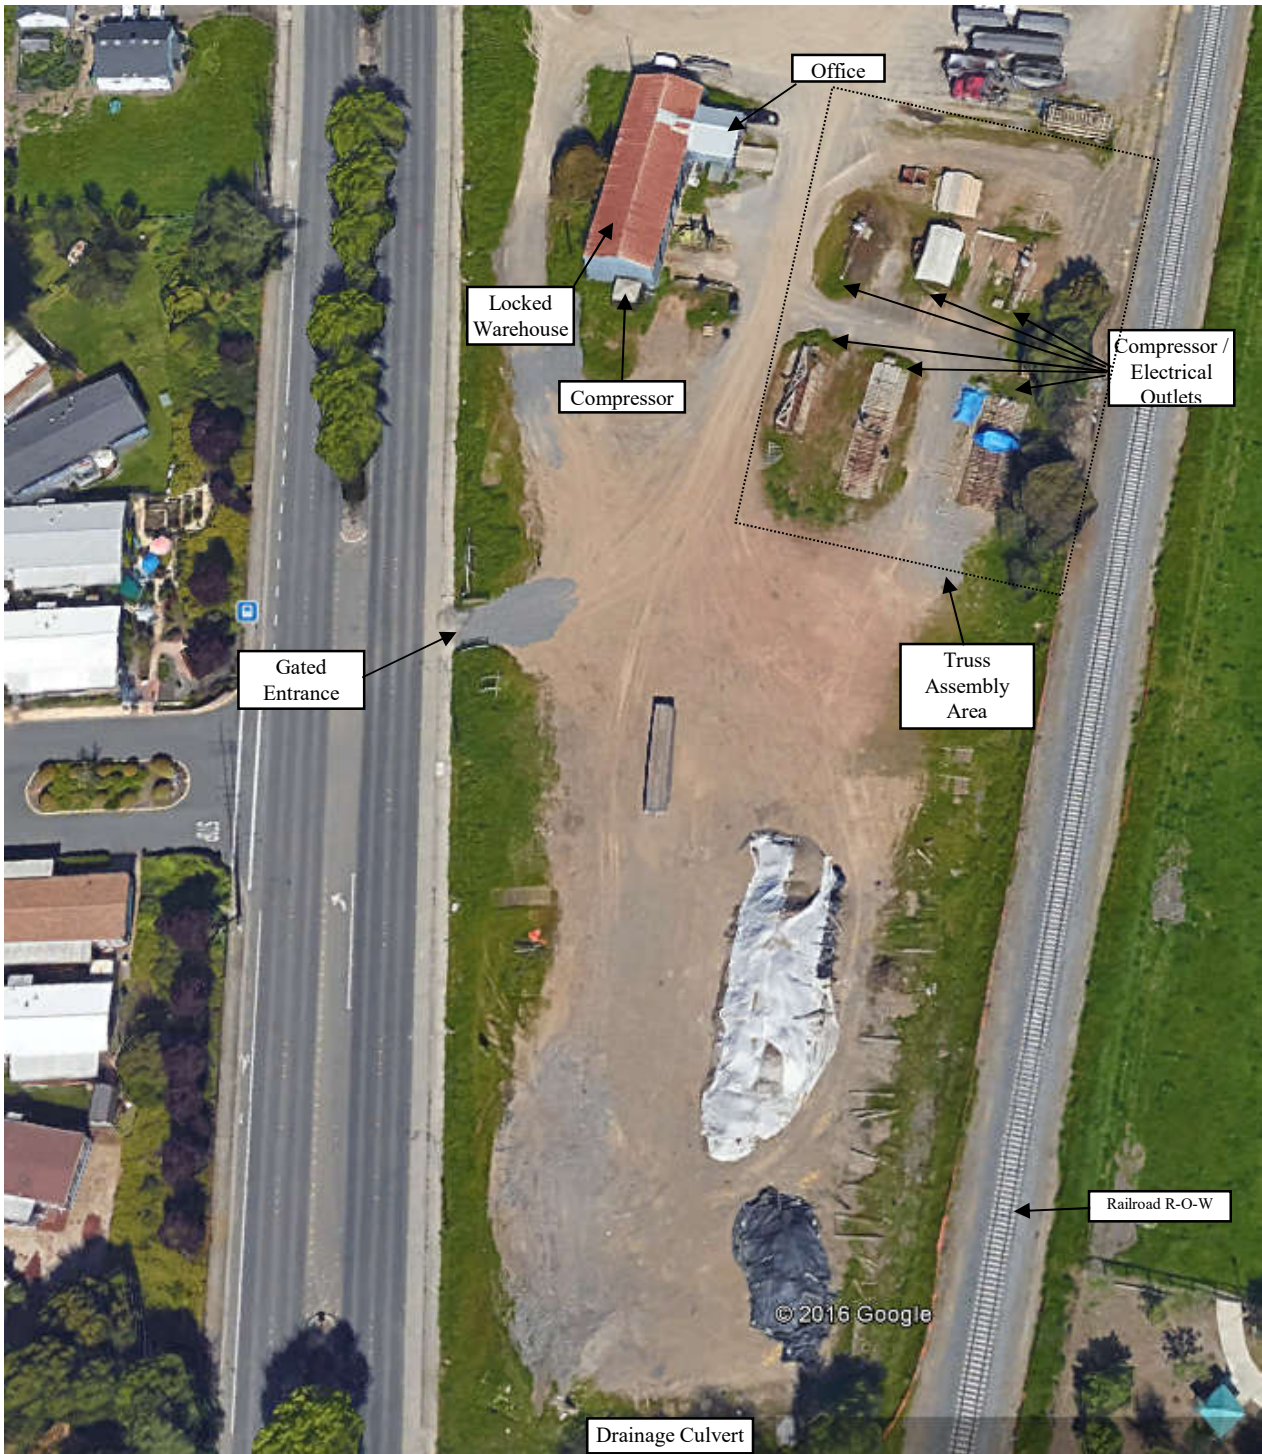
6

Site Map – Southern Portion

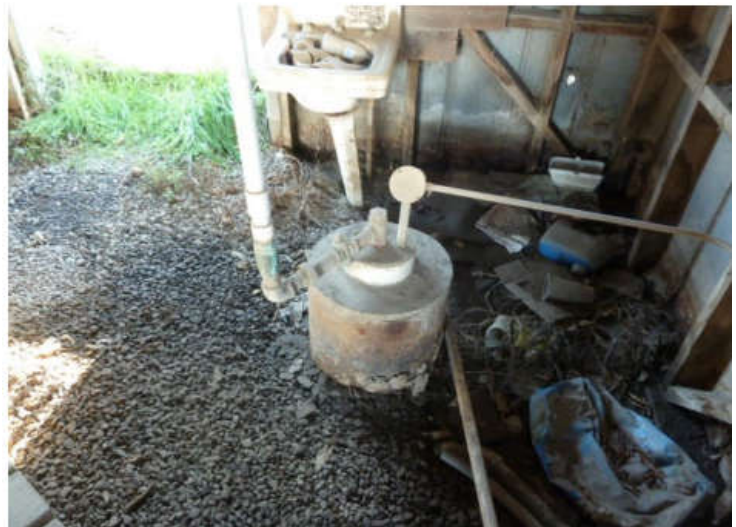
Photo #20:  
Groundwater well within well  
house shed

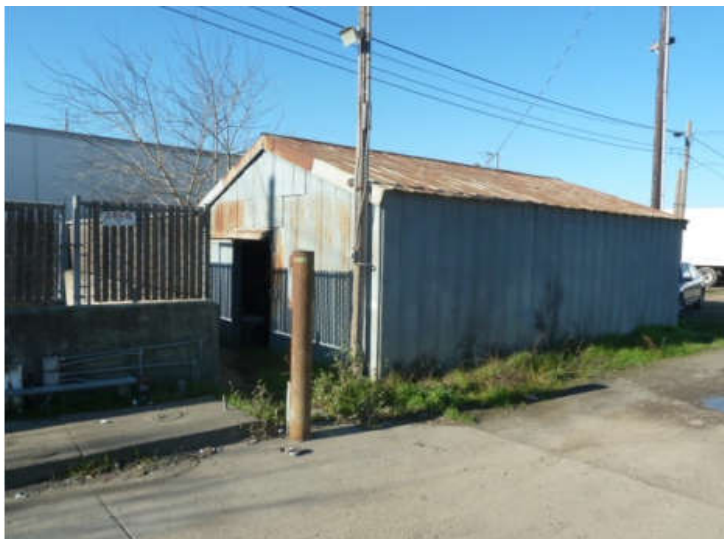
Photo #21:  
Well house shed (right) and former  
AST storage areas (left); noted  
former dispenser piping in front of  
AST concrete berm

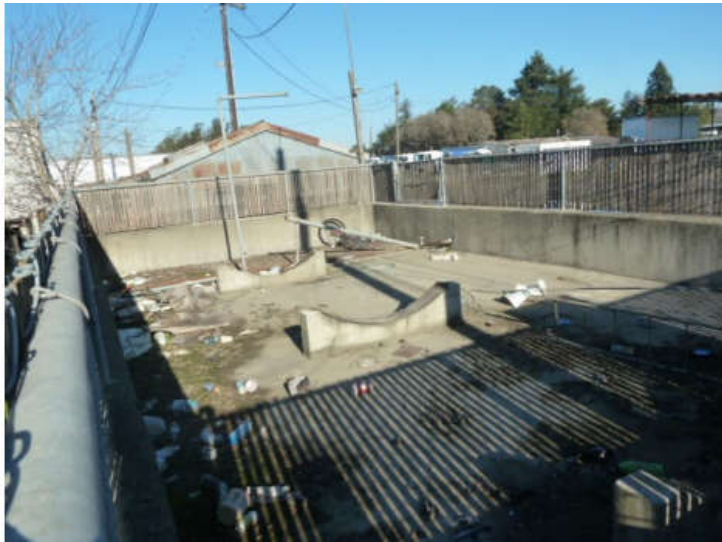
Photo #22:  
Interior of former AST  
storage area

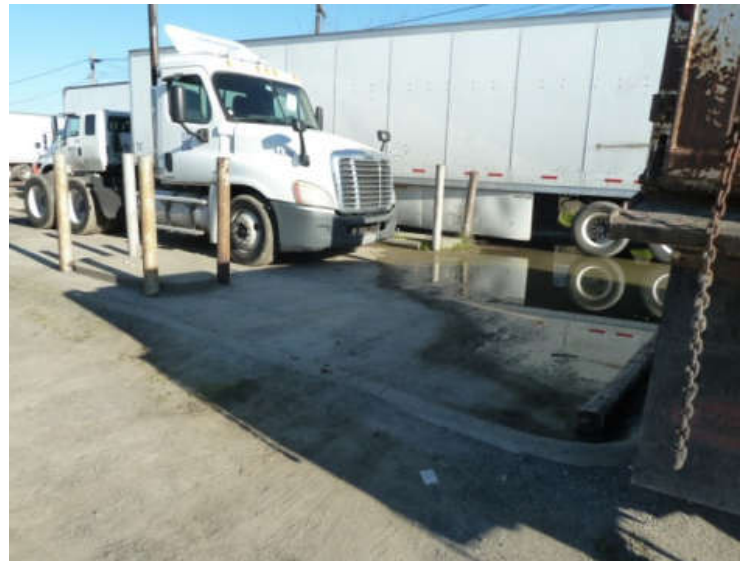
Photo #23:  
Former pump islands  
on south side of ASTs

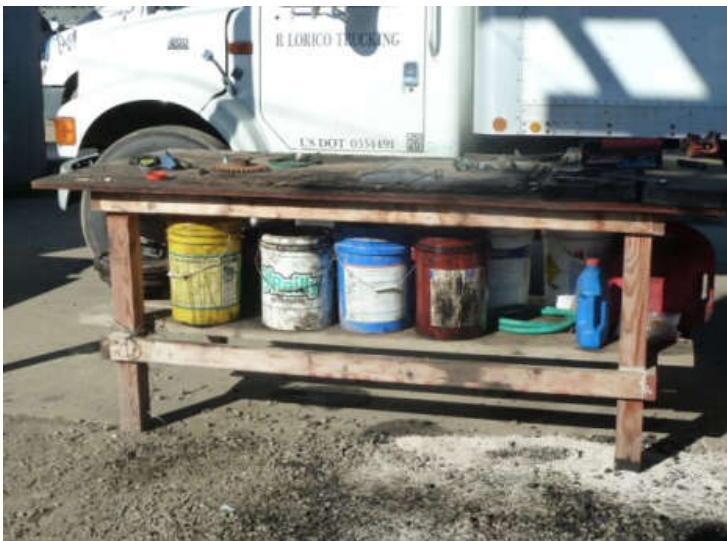
Photo #38:  
Covered truck repair  
area

- ◆ The property has been used for trucking related business which included truck maintenance, painting and sandblasting since at least the early 1980s. Recent truck repair operations have occurred at the subject property that has resulted in surficial staining with heavy petroleum hydrocarbons. This is a recognized environmental condition.

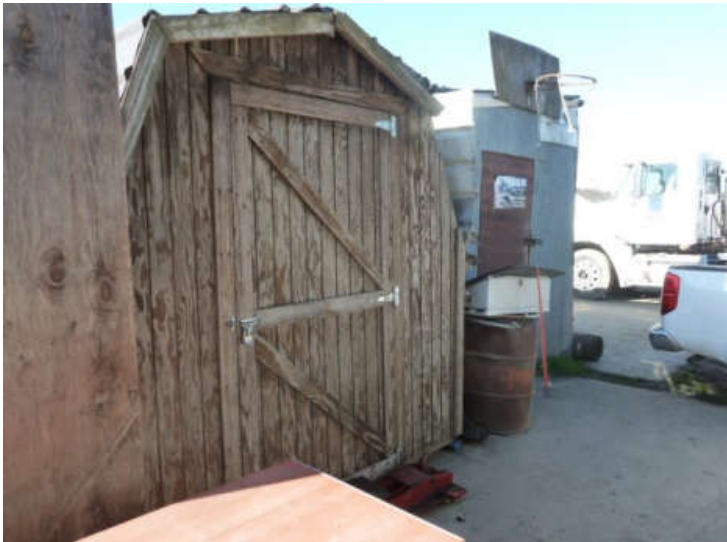
Photo #39:  
Stored petroleum products  
and surface staining

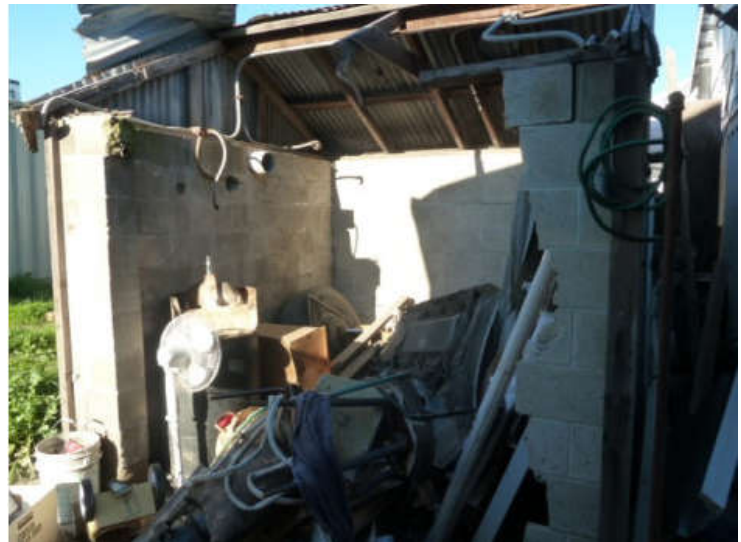
Photo #43:  
Storage container with hazardous materials (AST with Urea Liquor (diesel exhaust fluid), and other petroleum products
