**RE: Historic Resource Evaluation
109 Ellis
Petaluma, CA 94952**

109 Ellis Street Historic Resource Evaluation

City of Petaluma, CA
May 1, 2018

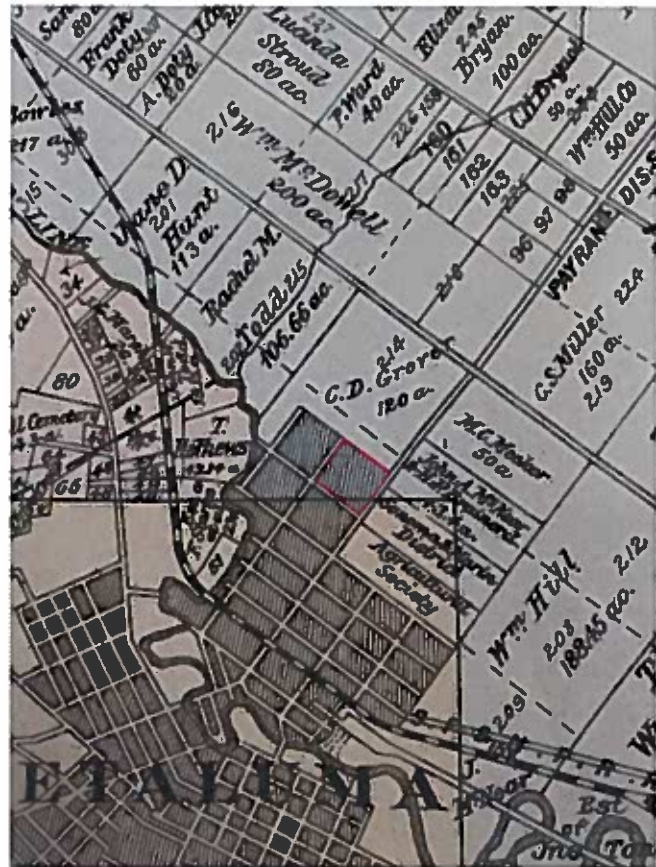
Figure 2. 1898 County Atlas Map, Reynolds and Proctor- Note location of 109 Ellis outlined in Red.

included in the City limits, with the remainder in the Vallejo Township; the boundary passed diagonally across the southeast portion of the lot, although not shown in Figure 1, it is depicted in the 1898 County Atlas, Map shown in Figure 2, below.

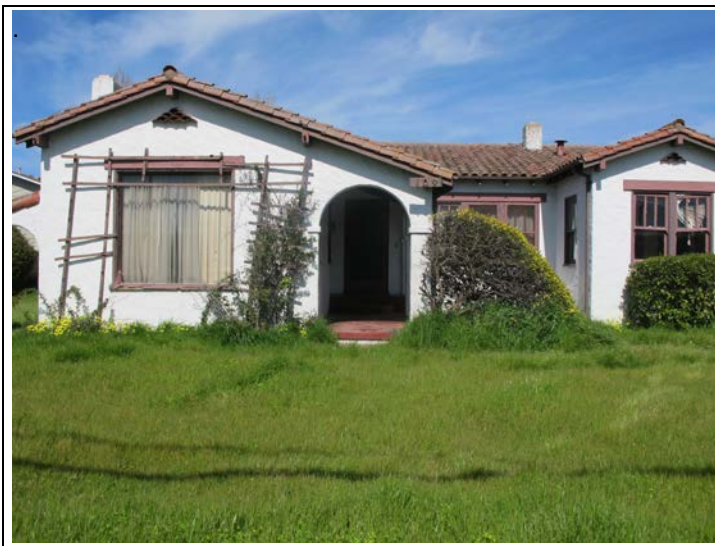
The property is comprised of a 0.68 acre rectangular lot located in East Petaluma and exhibiting frontage on Ellis Street. The northern extents (rear) of the property abuts Washington creek. The property includes three residential building, One Spanish Eclectic residence and two other vernacular residential buildings and two structures: a two-car garage and former tank house.

P5b. Description of Photo: (view, date, accession #) northeast view March 29, 2018.

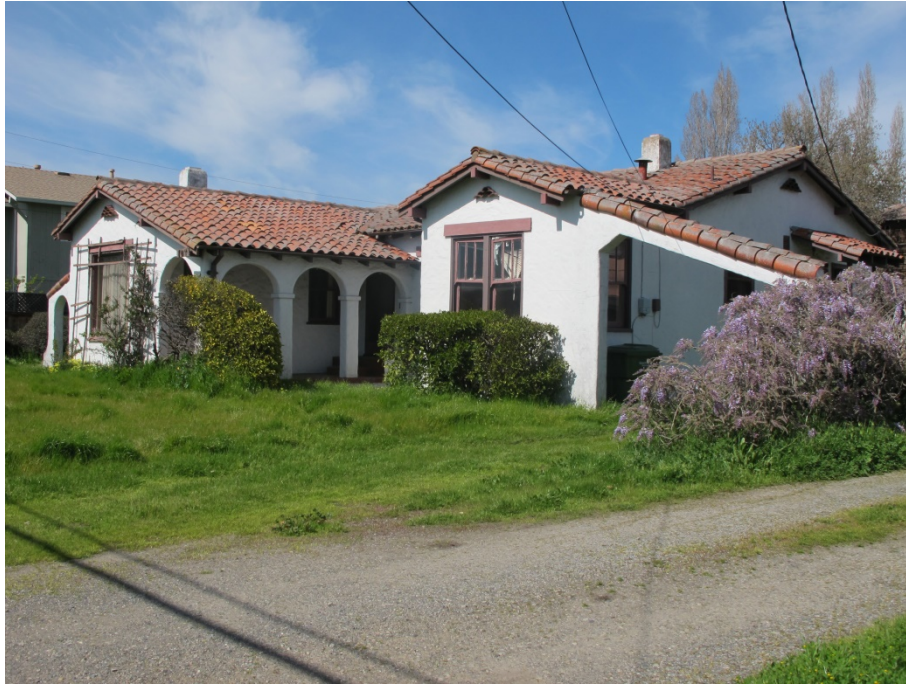
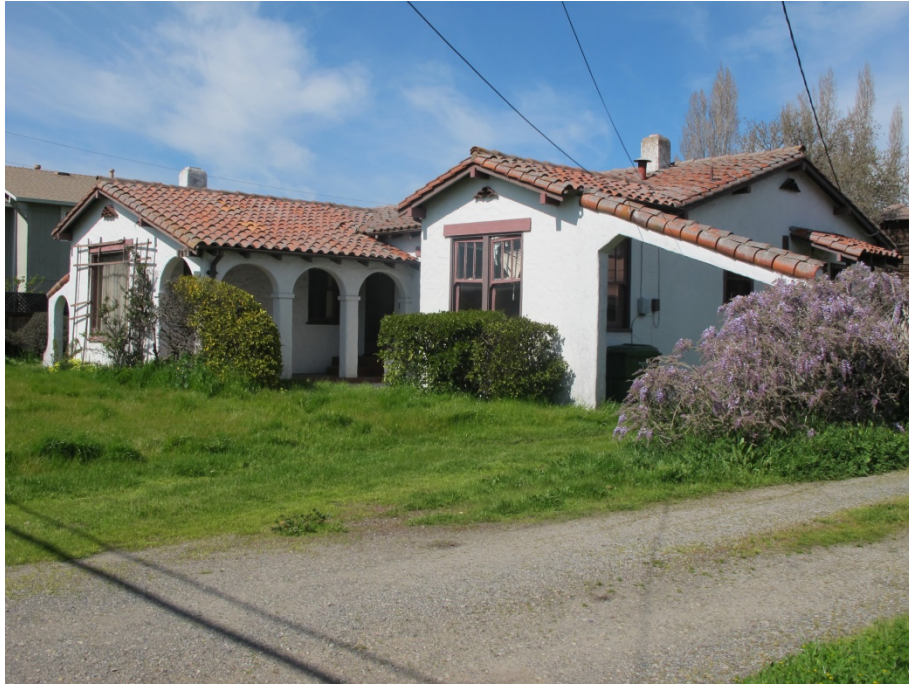
Figure 1 Building A - Looking North

Building A: This is a residence, constructed c.1935, and located at the front most portion of the lot. The building is a one-story, single-family residence constructed in the Spanish Eclectic style. It is a modified L-shape plan with muted Spanish Eclectic detailing. Set atop a slab foundation, the residence features white stucco walls and features an arched, arcuated portico defining the primary entry. The residence is punctuated with a large picture window at front L, and elsewhere, features single, paired, and ribbon one over one, double hung windows. In several of the windows, the upper sash features a series of three vertical muntins form three equally sized lights. The residence is capped by a low-pitched cross gable roof with minimal eave overhang and featuring exposed rafters. The roof features regularly laid American Spanish tiles.

Building A (the Spanish Eclectic house), exhibits some restrained Spanish eclectic detailing; but is not a strong or particularly notable example of this type and therefore would not be considered historically significant purely based on architectural merit. The remaining buildings and structures are of simple vernacular construction and Buildings B and C exist as a haphazard construction of additions and have been substantially altered. Structure 2, the tank house is a utilitarian, vernacular structure likely dating to the property’s early operation as agricultural land. While the tank house is valuable to interpreting the former use of the property, it is not architecturally or artistically significant in its own right or when considered relative to other tank houses throughout Northern California.

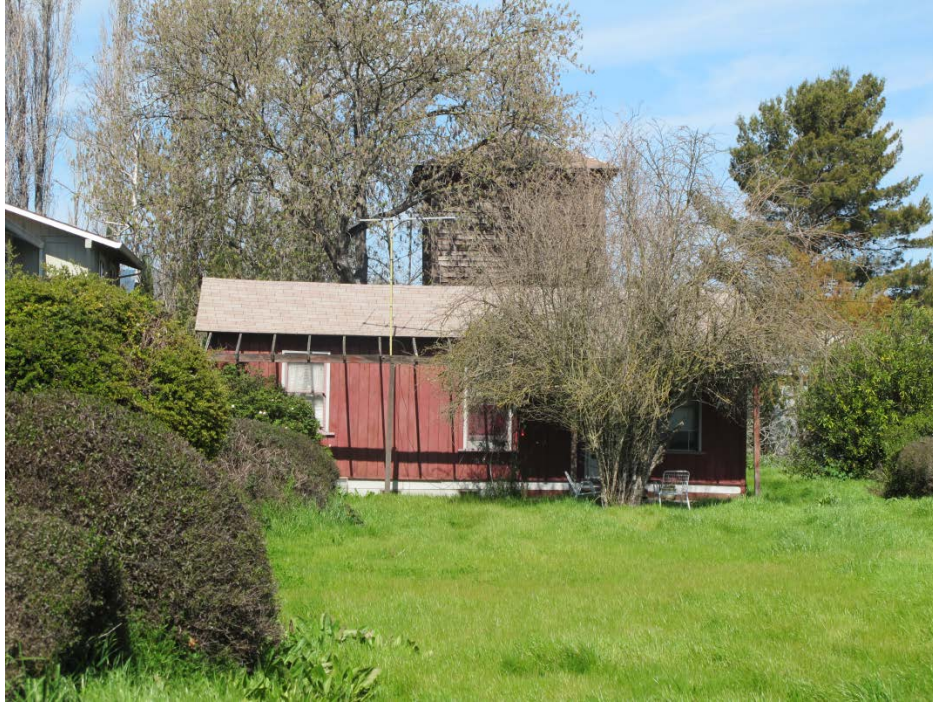
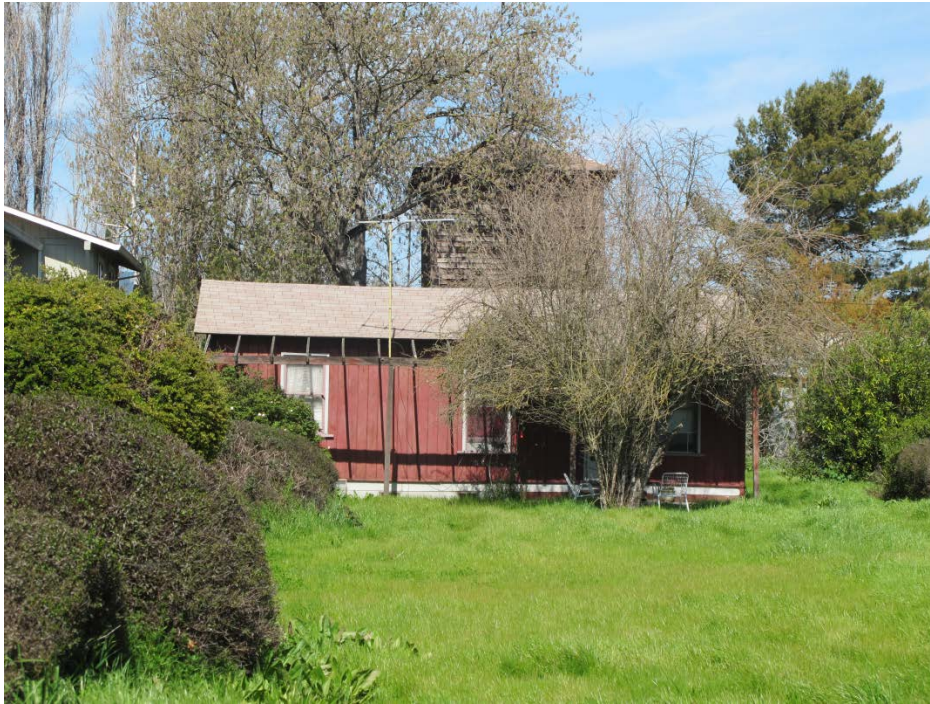
Figure 3 Building B- Looking Northeast

Building B. A vernacular massed plan, side-gabled, family residence. The residence features a full width, shed roof porch. Interestingly, the rearward expansion and broken roofline makes it look more reminiscent of the types predecessor, a hall and parlor type house. This building was substantially altered with additional wings added over the years.

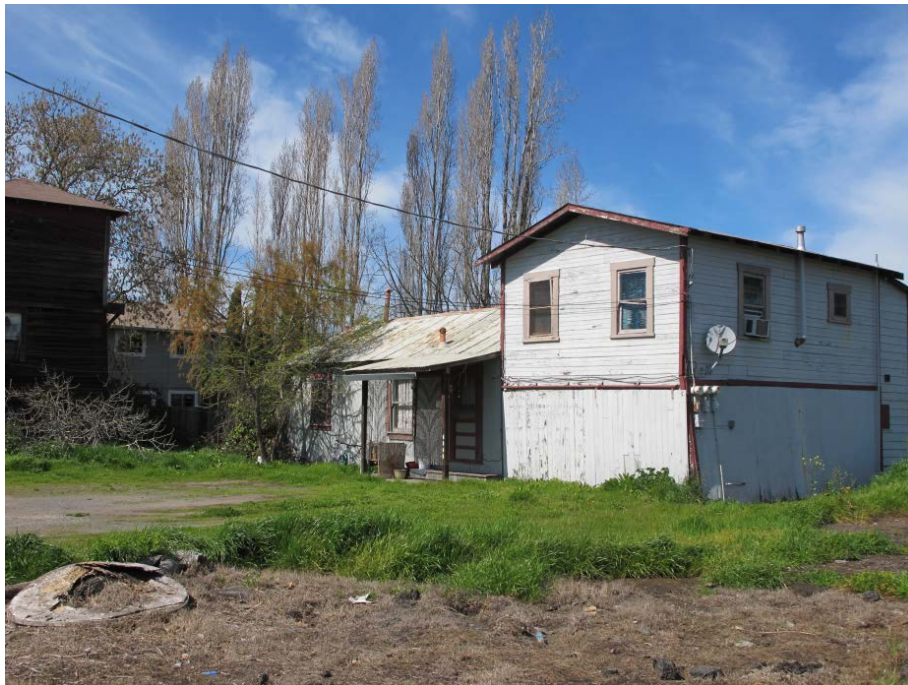
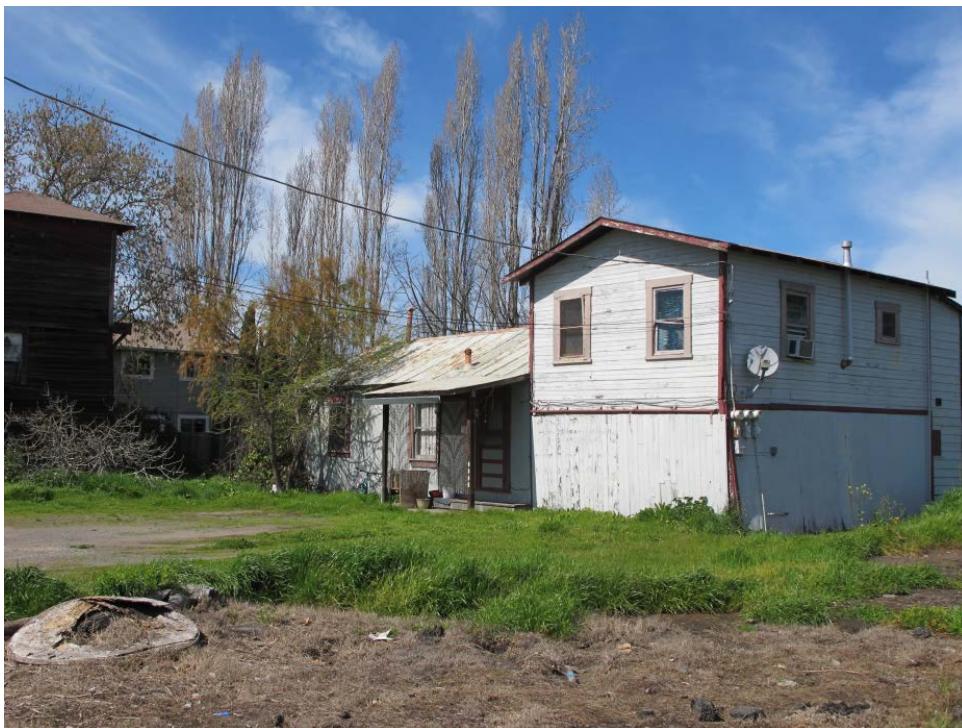
Figure 4 Building C- Looking North

Building C. Like Building B, the rearmost building on the lot has been substantially altered. What appears to be the original building was two stories and of a very simple vernacular construction with horizontal wood siding and simple double hung windows and capped with a gabled roof. Based on the original agricultural use of the property, it may have at some point, operated as a bunkhouse that served the property, but little information is available to confirm that. It is; however, likely that it served as some sort of accessory structure prior to its current residential use.

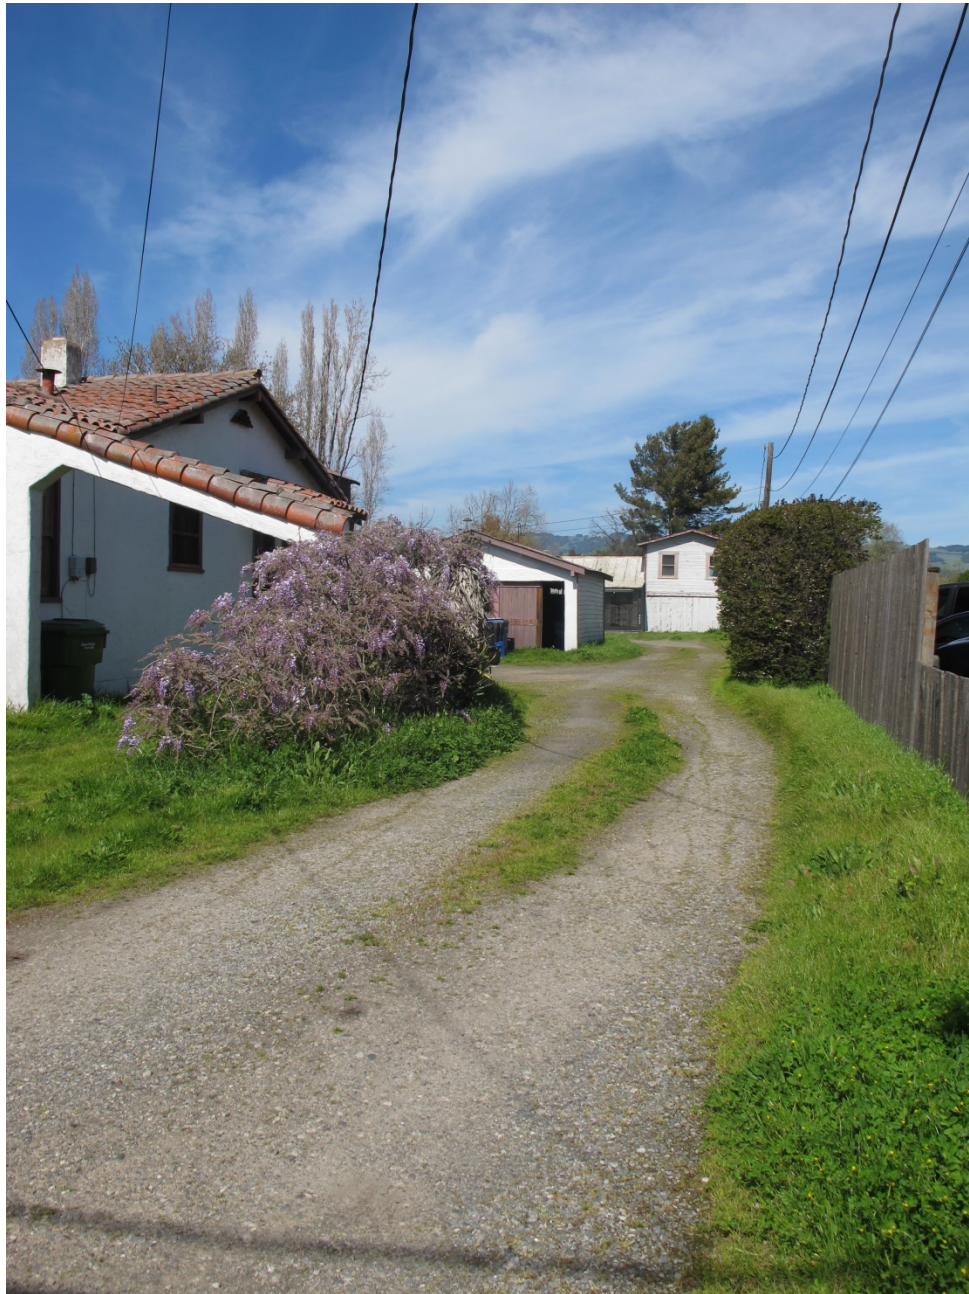
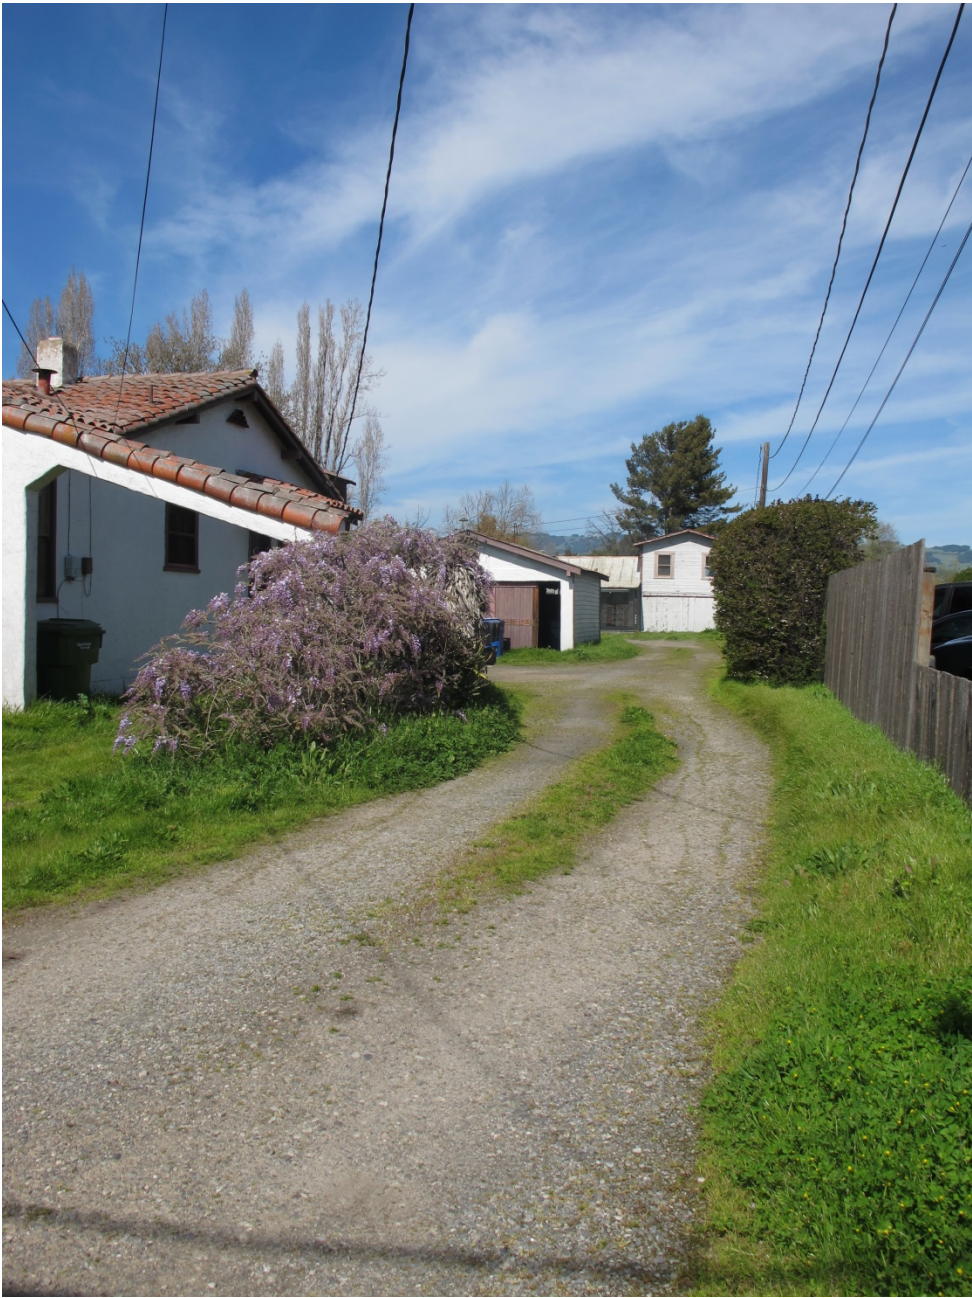
Figure 5 Structure 1 (garage)- Looking North

Structure 1. (Two-car garage). A Hollywood style driveway leads to a simple wood/stucco two-car garage with a gabled roof featuring asphalt shingles and wooden shed doors.

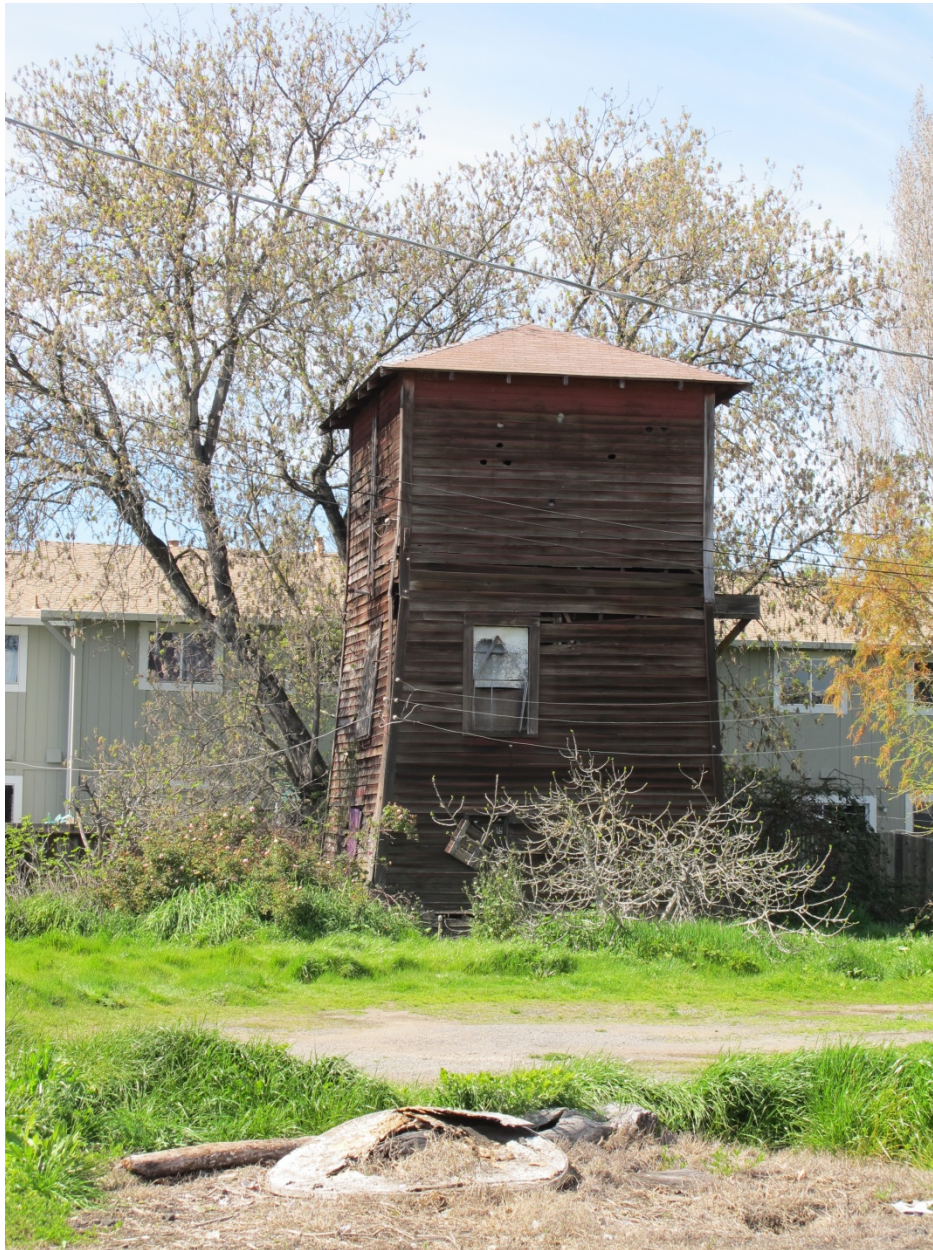
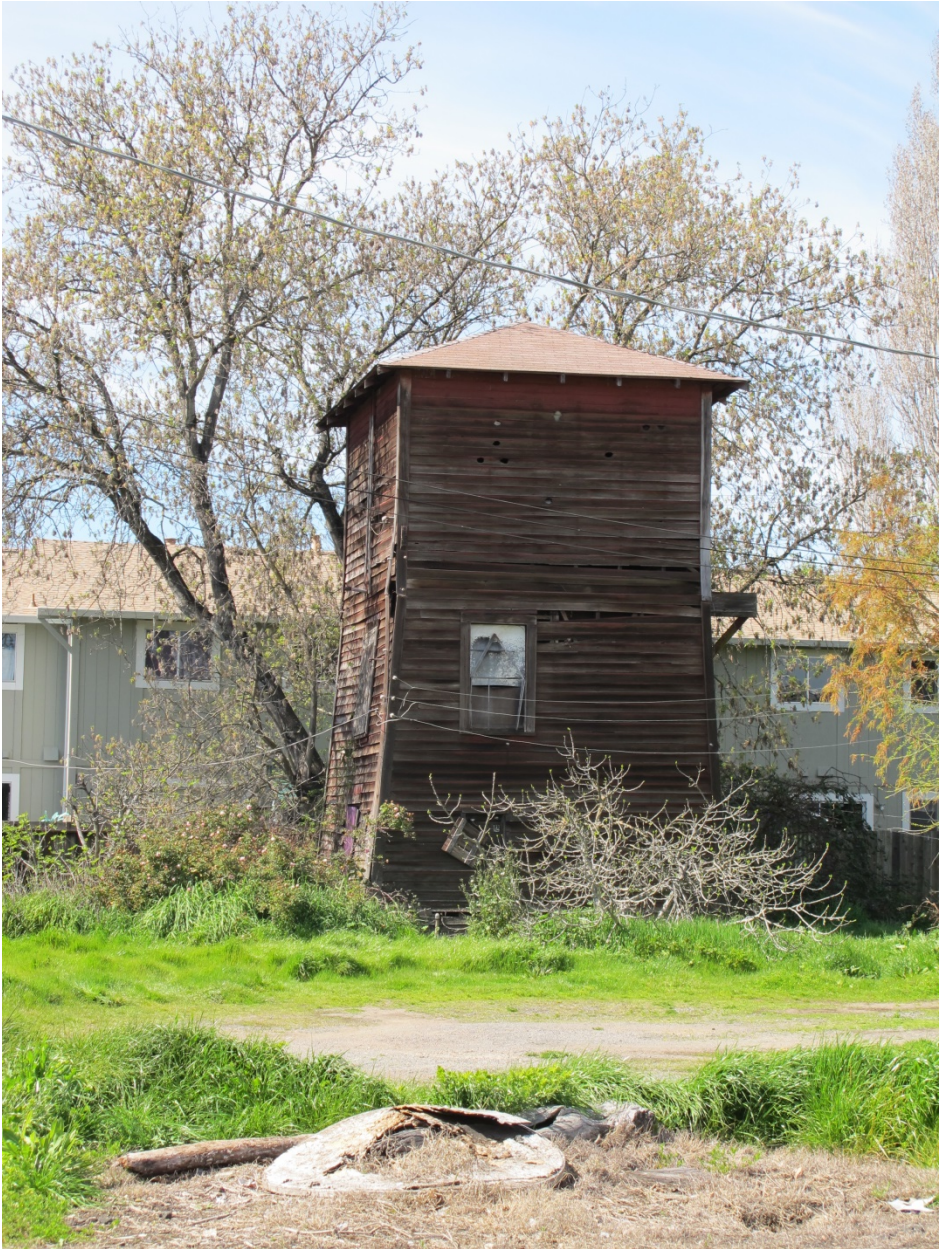
Figure 6 Structure 2 (tank house)- Looking Northwest

Structure 2. (Tank House). This structure is a former tank house - sided in horizontal redwood siding, the tank room features vertical sides with the supporting tower (the lower-half of the tank house) featuring slightly sloping sides. This type of tank house is vernacular and of the kind often seen in Northern California. Typical storage tanks held 5,000 gallons of water and rose about 20 feet above ground. The condition of the tank house is impaired; but it remains largely intact with the exception that it is missing its original windmill.
