PHASE I ENVIRONMENTAL SITE ASSESSMENT PER ASTM E1527-13

109 Ellis Street (APN 007-361-003)
Petaluma, California 94952
Sonoma County

Date: December 18, 2018

TTC Job No.: 2889.01

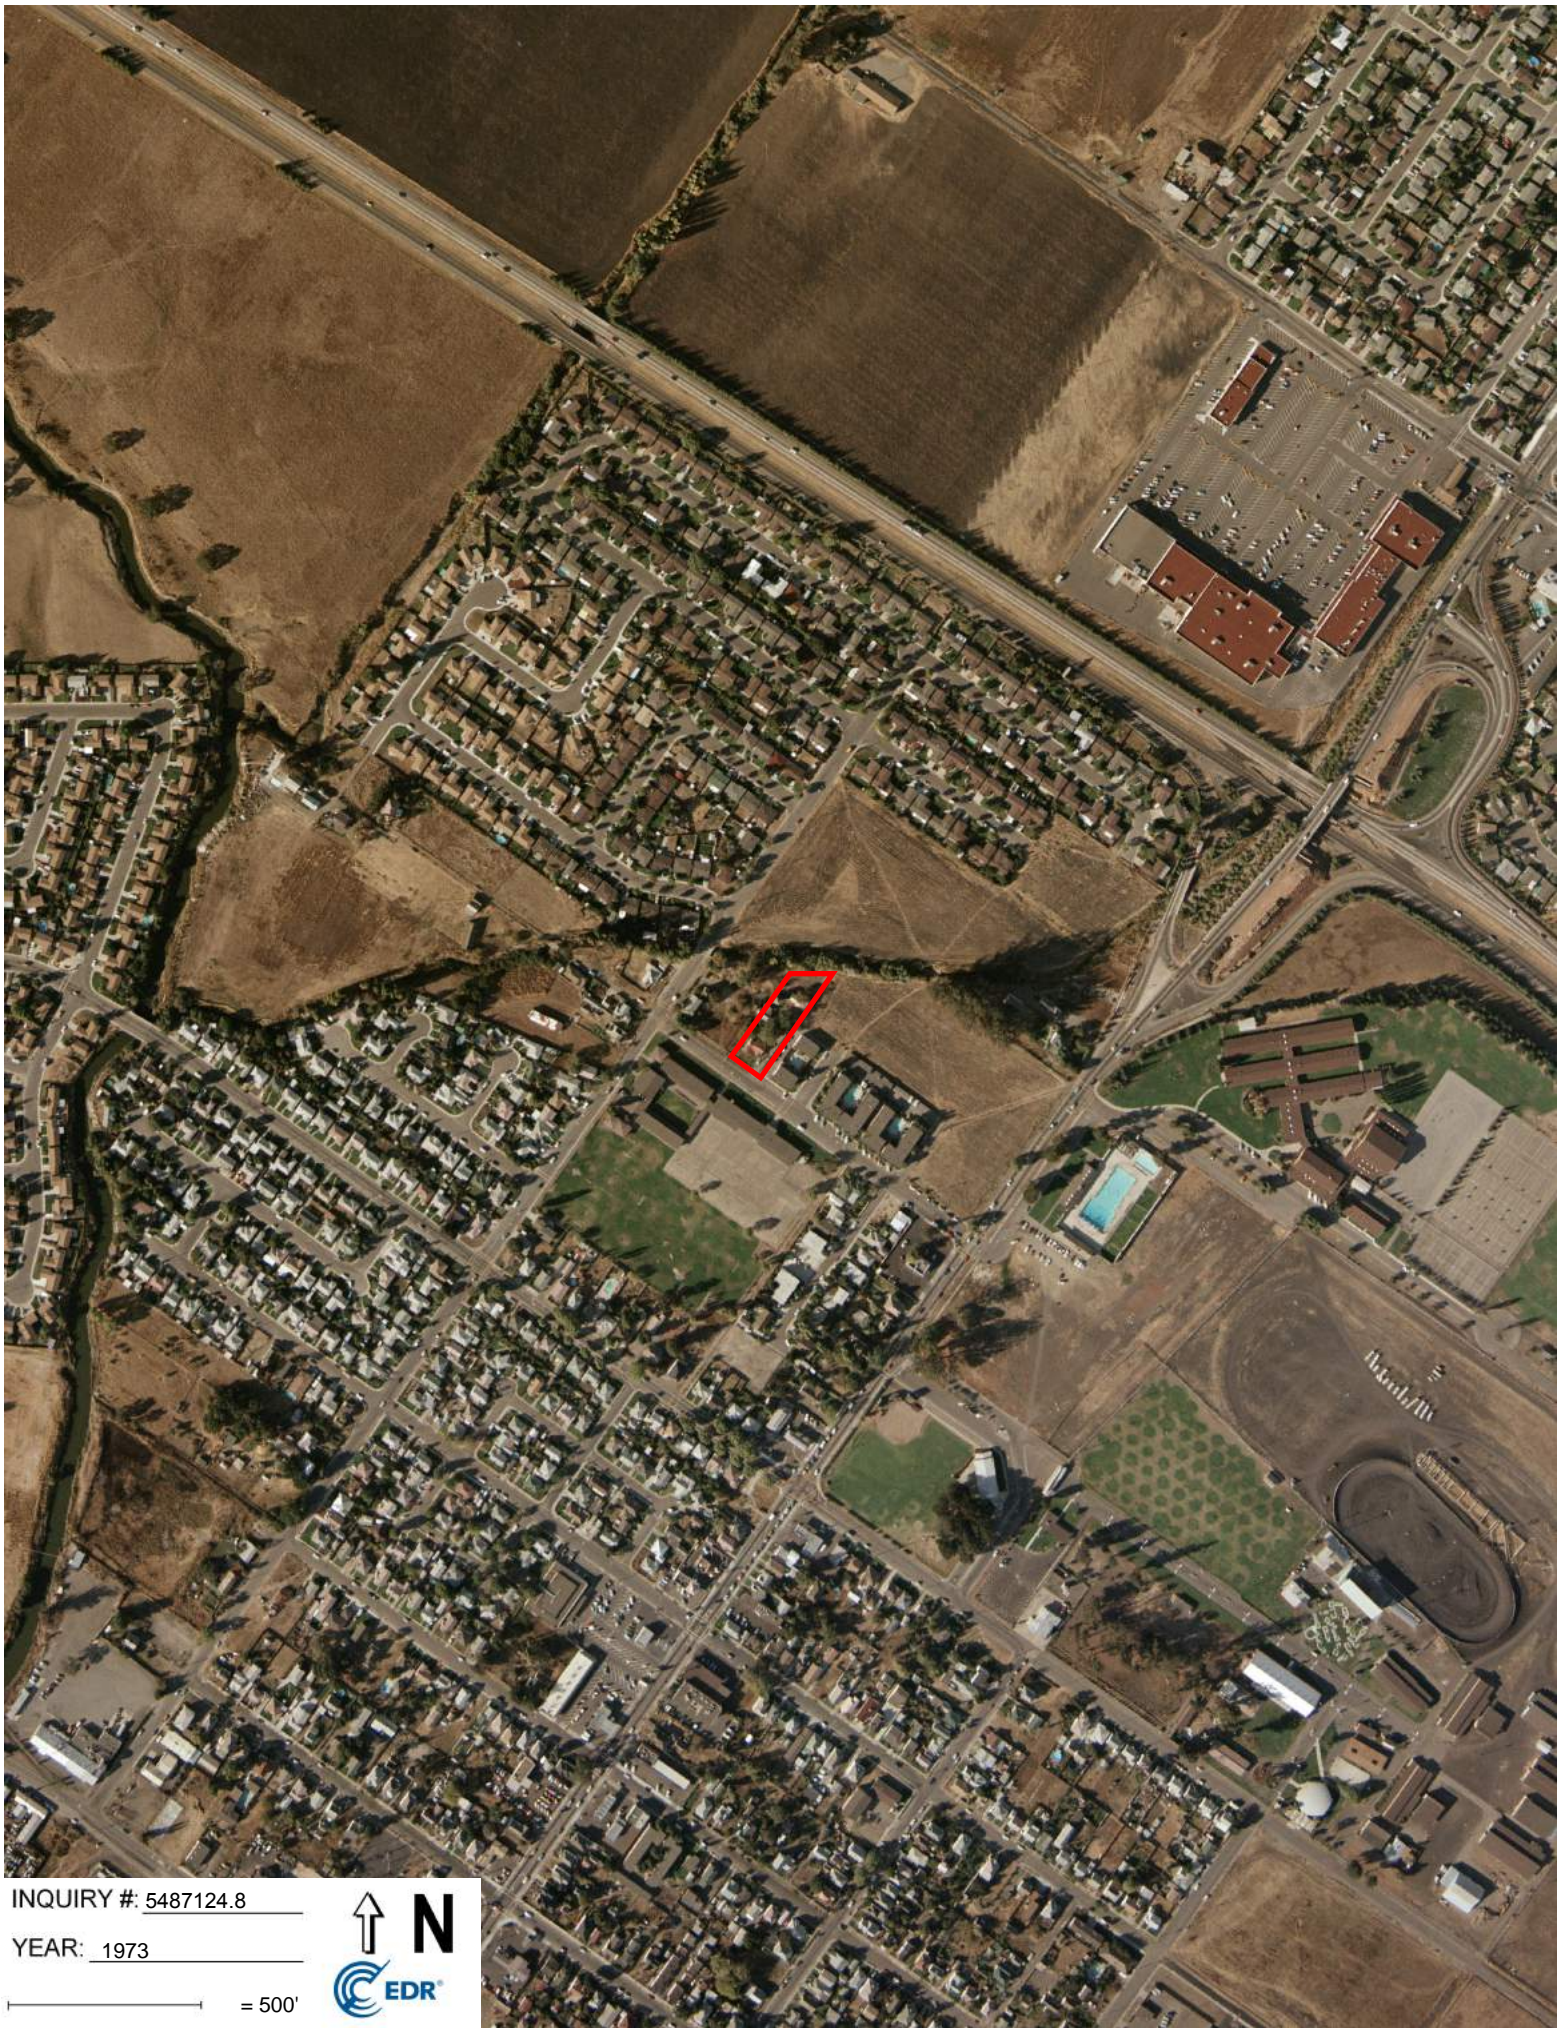
YEAR: 1973

The Study Site and adjacent parcels remain essentially the same as the 1973 air photo, with the exception of the apartment buildings on the western adjacent parcel, observed during the December 13, 2018 site visit, are now present.

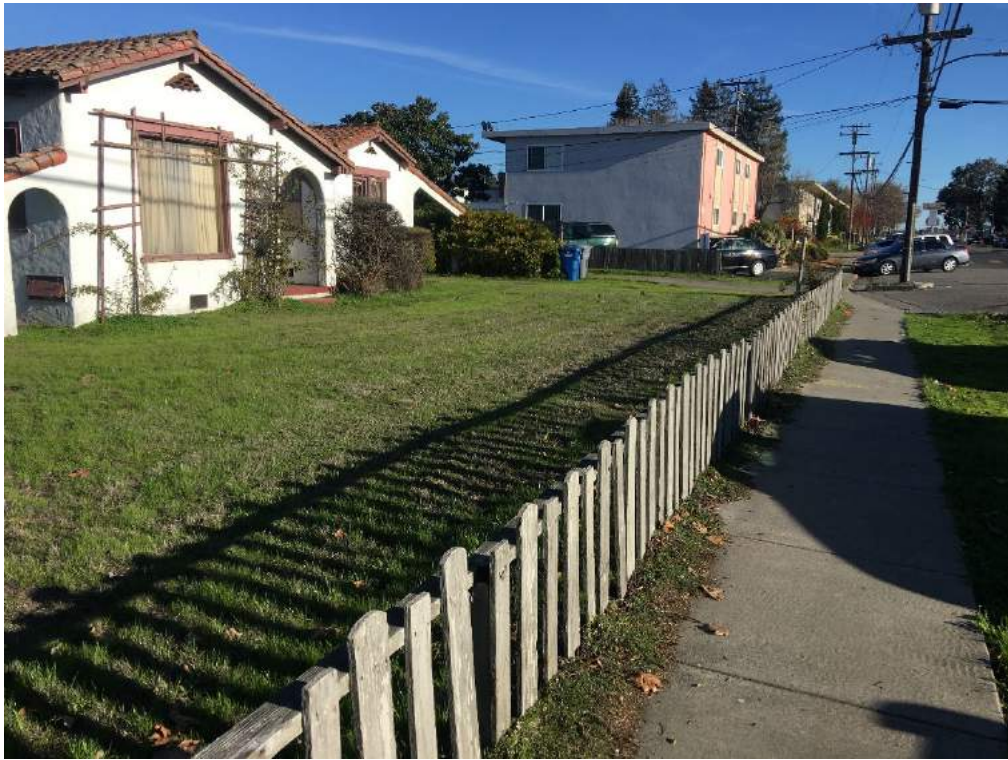
Taken from the southwest corner of the Study Site looking east. The main house can be seen on the left. The apartment at 901 Ellis Street, adjacent parcel to the east is seen in the background. A portion of Ellis Street is seen in the right background.

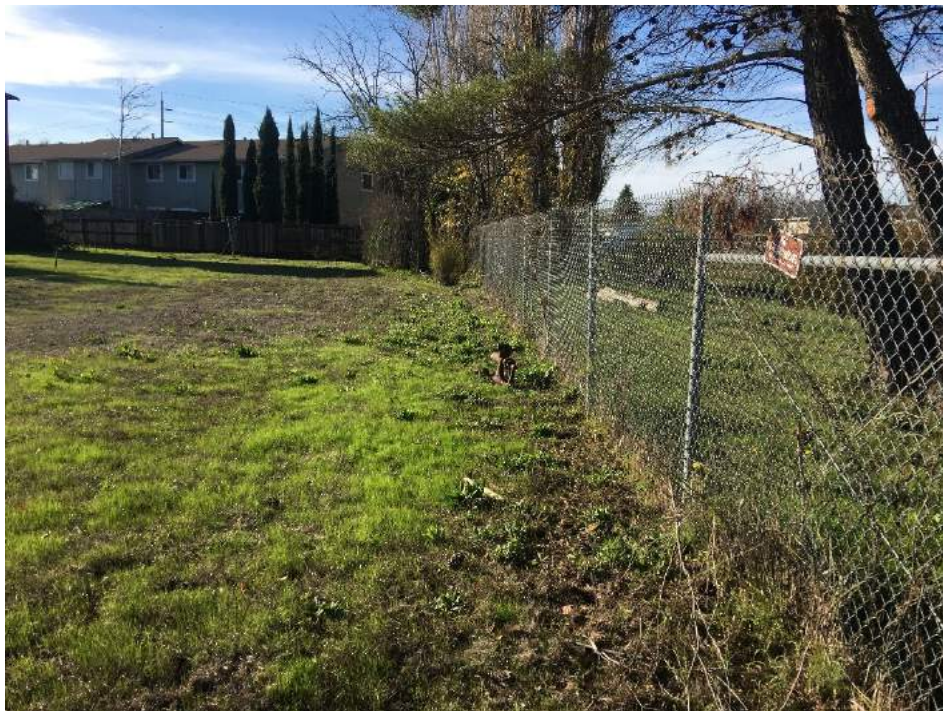
The northeast corner of the Study Site looking west. Washington Creek, adjacent parcel to the north, is seen on the right.

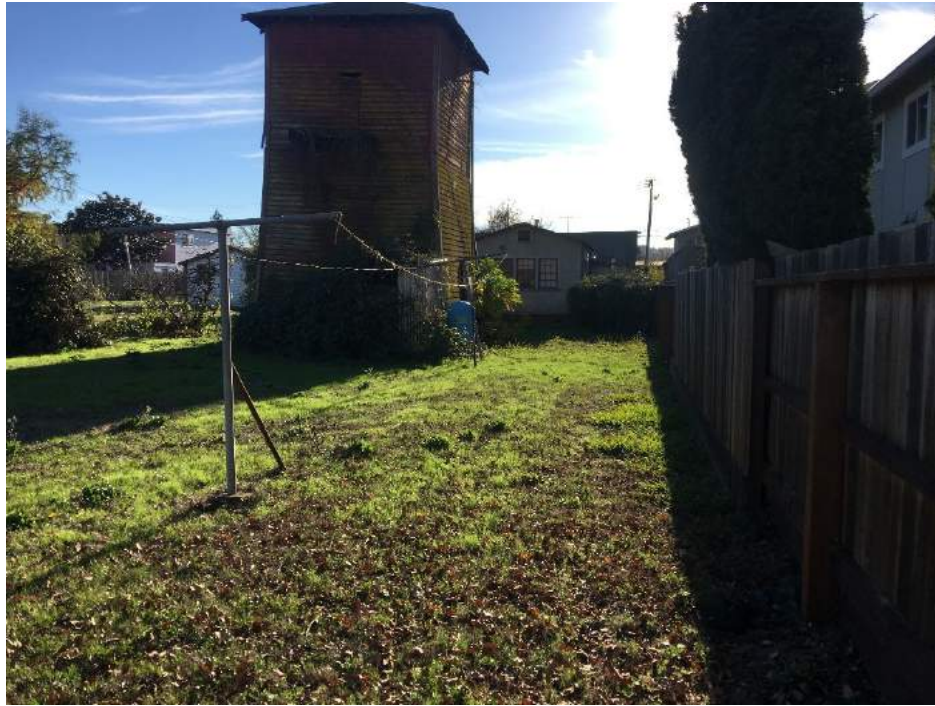
The northwest corner of the Study Site looking southwest. The apartments on 101 Ellis Street, adjacent parcel to the west, are seen on the left.

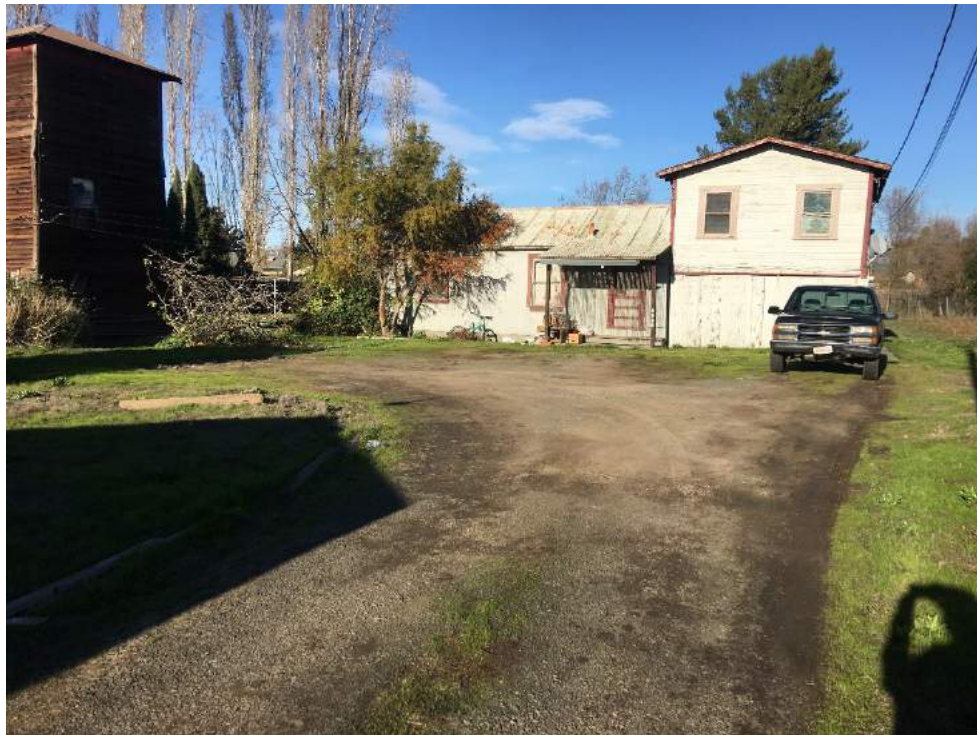
The common driveway for all the rental houses on the property is seen in the center. The open, undeveloped lot adjacent to the east of the northern portion of the Study Site, is seen in the far right background.
