PROPOSED ROAD WIDENING AND FILL
 ALONG LAKEVILLE HIGHWAY AND
 WETLAND MITIGATION ALONG
 ADOBE CREEK.

LAKENVILLE
 HIGHWAY
 (STATE ROUTE 118)
 WIDENING PROJECT
 IN THE
 CITY OF PETALUMA
 PLAN VIEW
 AREA 7

CITY OF PETALUMA
STANDARD
PLANS

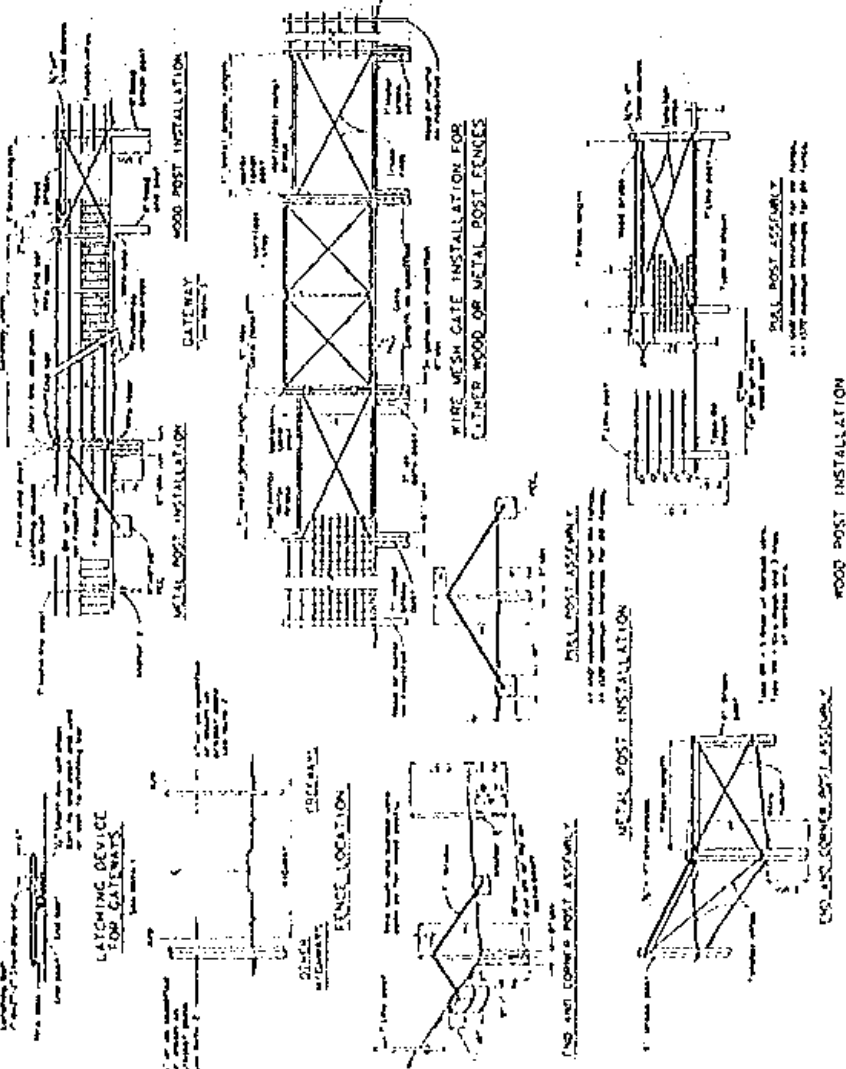
STATE OF CALIFORNIA
 DEPARTMENT OF HIGHWAYS
BARBED WIRE AND WIRE MESH FENCES
 1/4" SCALE
 AB6

1. Posts and rails and bar should be treated with preservative and galvanized.
2. Posts should be 3" or 4" diameter depending on material and/or length to the fence. Posts to support gates should be 4" or 6" diameter.
3. Posts to be used when specified in the contract specifications.
4. Posts should be set in concrete or masonry.
5. Posts should be set in concrete or masonry.

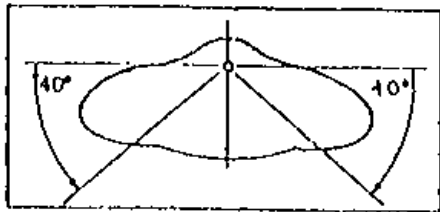
TYPE 3
SIDE MOUNTING
Standard for Collector and Major Streets unless
noted otherwise

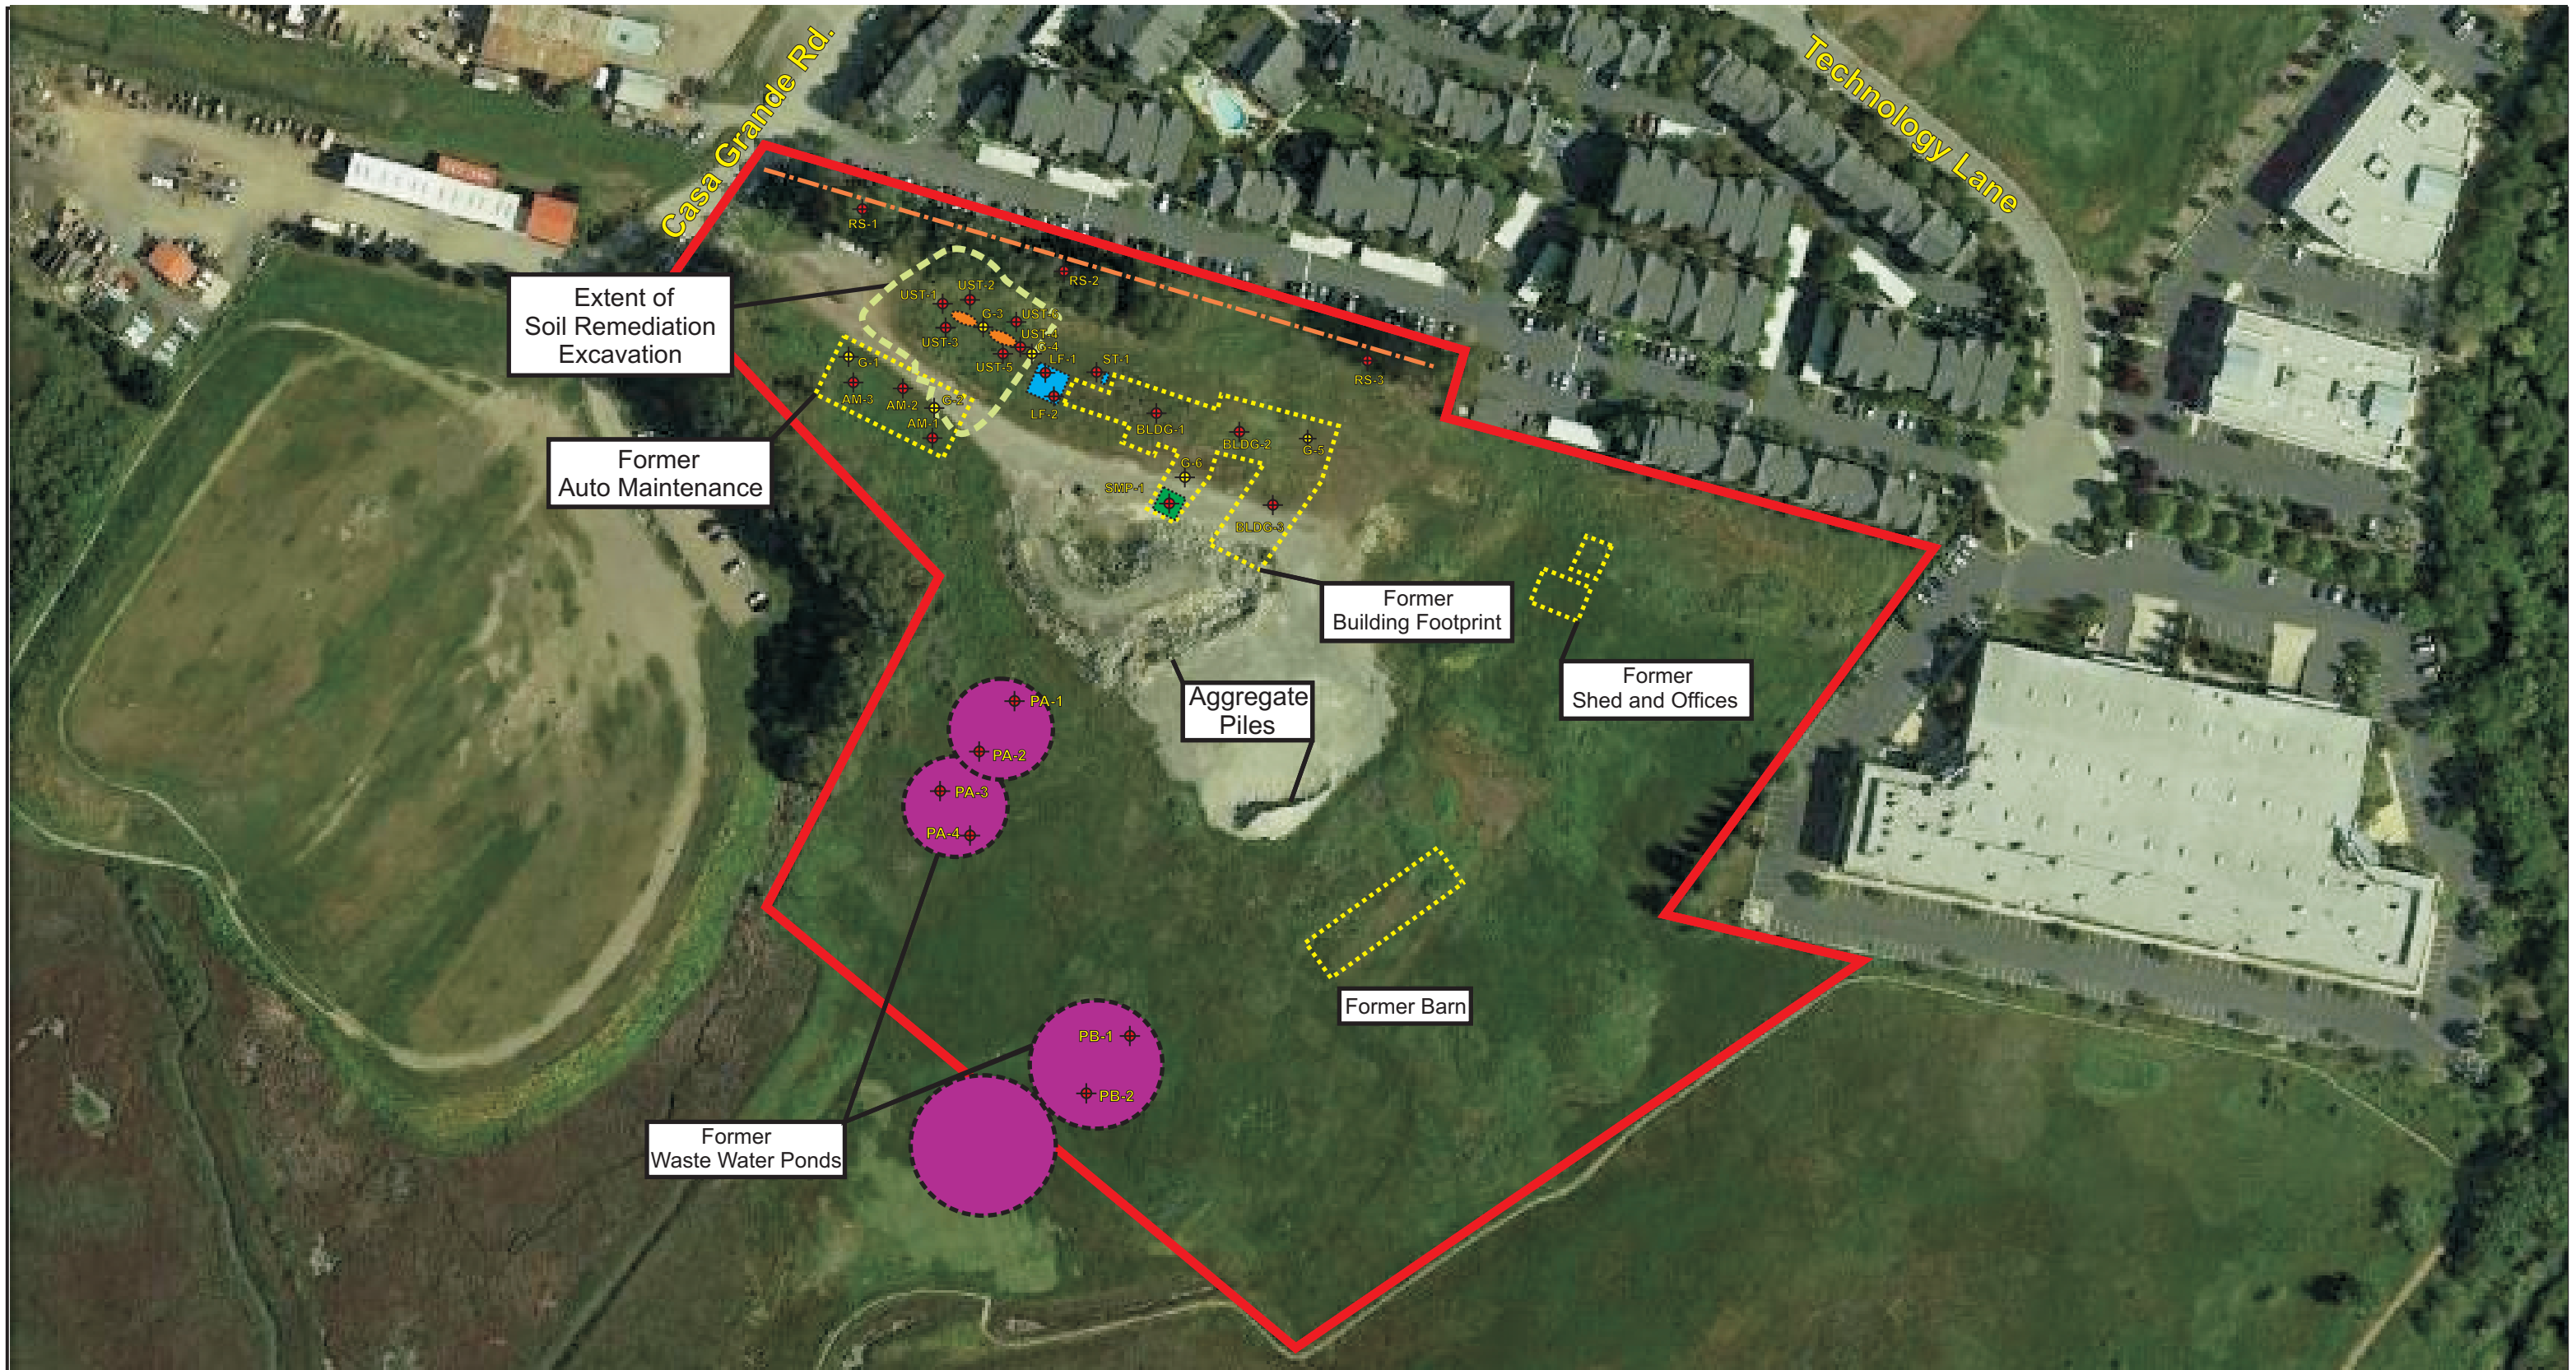
AEI CONSULTANTS 2500 CAMINO DIABLO, WALNUT CREEK, CALIFORNIA	
BORING LOCATIONS	
2592 Lakeville Highway Petaluma, California	FIGURE 2 Project No. 327703

LEGEND			
	Approximate Property Boundary		AEI Soil Boring Locations
	Former Railroad Spur		AEI Soil Gas Well Locations
	Former Structures		Approximate Extent of 2002 Remedial Excavation Source: Site Plan-Darling International, Inc. (Figure 2) MFG, Inc. Project No. 030070, 11/08/2006
	Former Sump		Former USTs
	Former Septic System Leach Field		Former Septic Tanks Area
	Former Wastewater Ponds
