City of Petaluma, California CORPORATION YARD TANK DEMO - PHASE 2 840 HOPPER ST.

Daily Inspection Report

Paint Samples for Demolition of Existing Structures.

Historic Resource Evaluation - FINAL

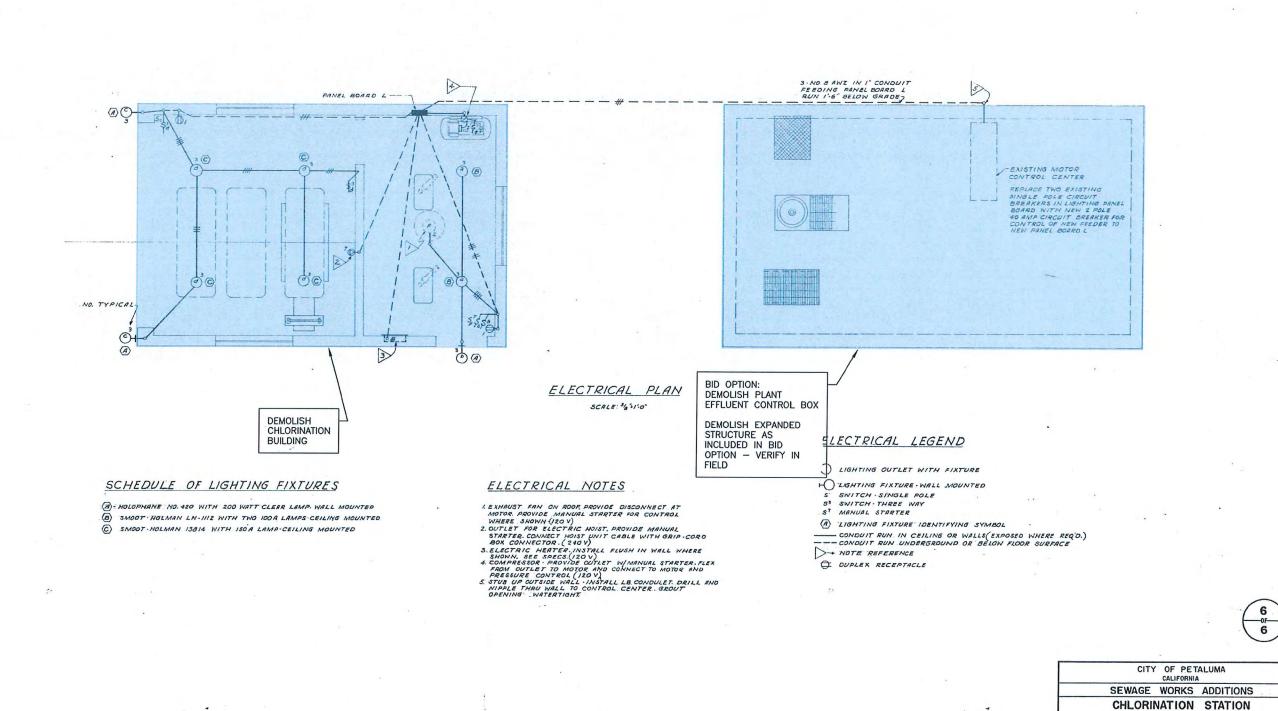
ELECTRICAL LAYOUT AND DETAILS

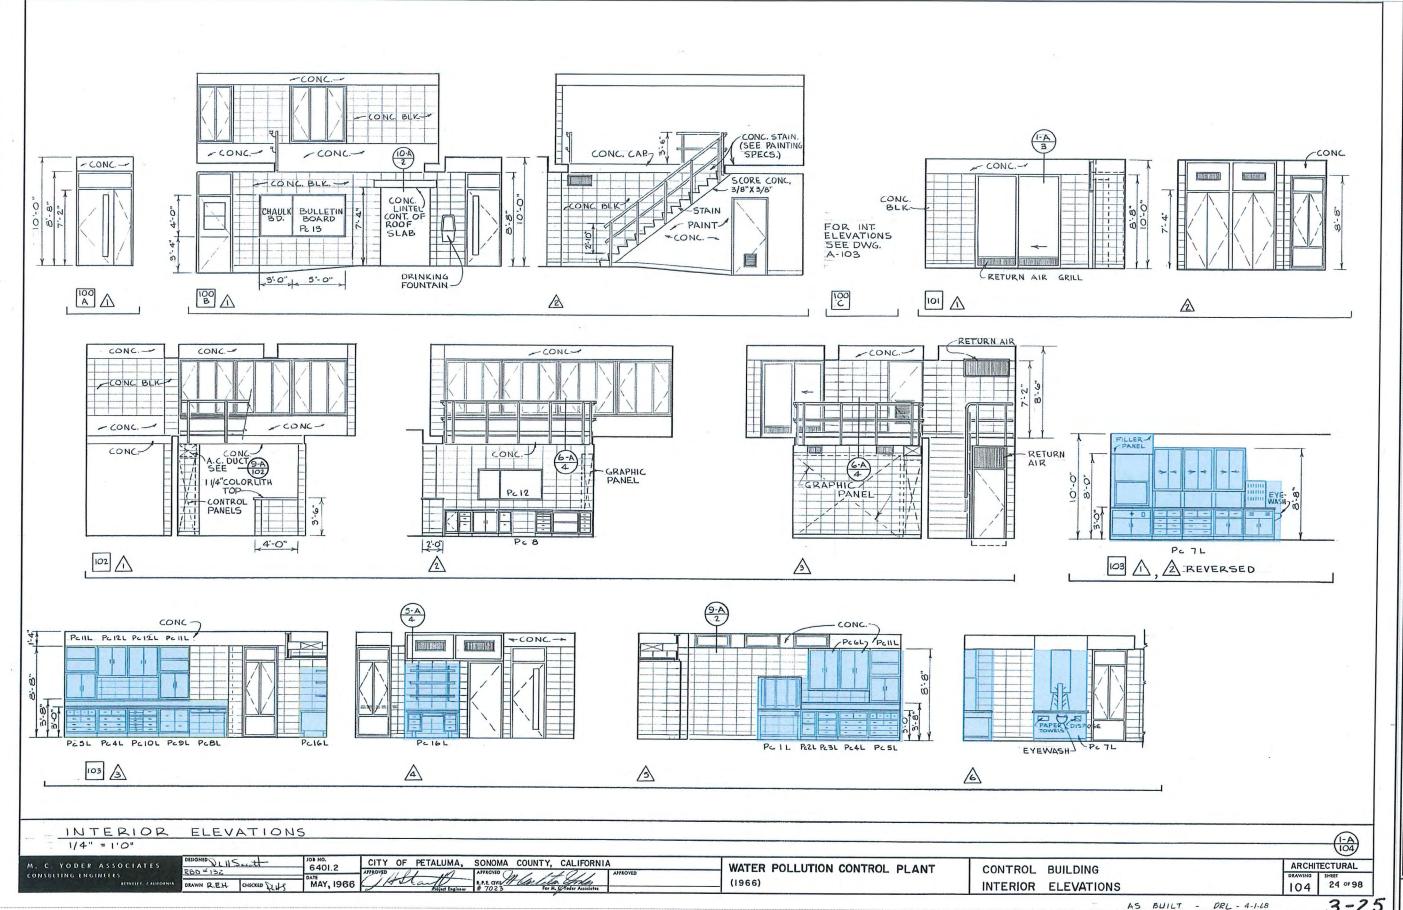
SHEET C 15

BLDG & LAB INTERIOR ELEVATIONS

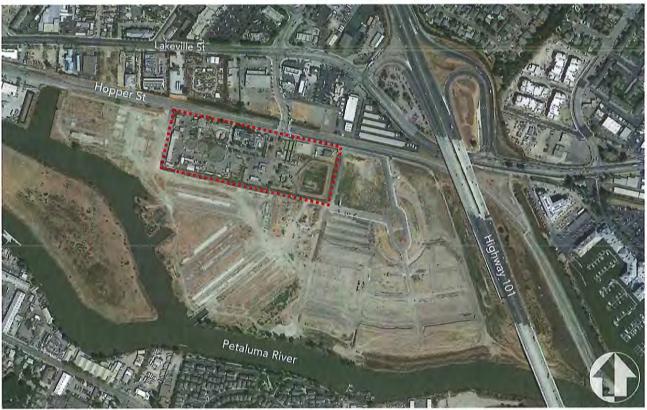
Figure 1. The Hopper Street Corporation Yard, outlined in red (Google Earth, imagery date September 2018).

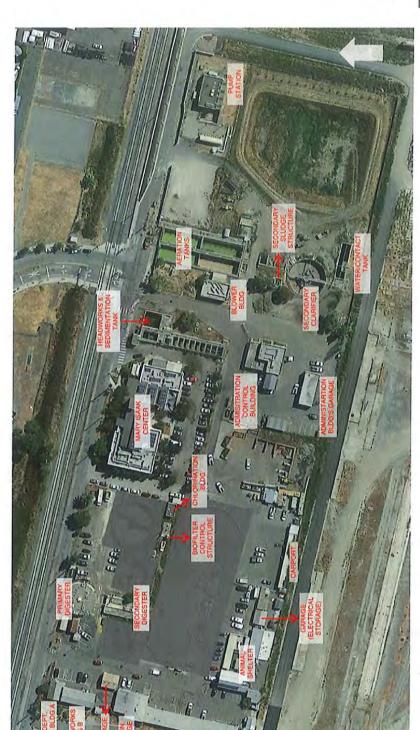
Figure 2. The overall site plan of the corporation yard (revised from Google Earth, imagery date September 2018).

Note: All infrastructure overlaid in gray have been removed and replaced with an asphalt surface lot that postdates the aerial image.

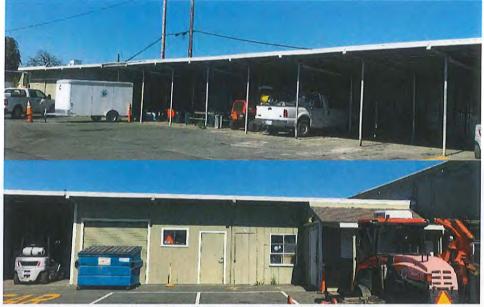
Figures 7 and 8. Corporation Yard structure.

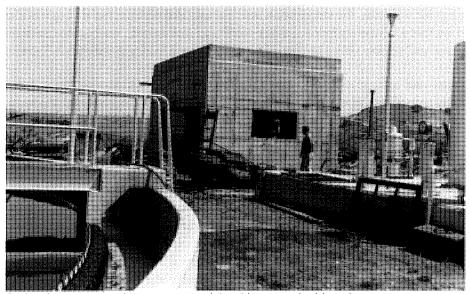
Figure 23. The final sedimentation tank (not extant) and the chlorination building during construction, ca. 1954 (Sonoma County Library Digital Collections).

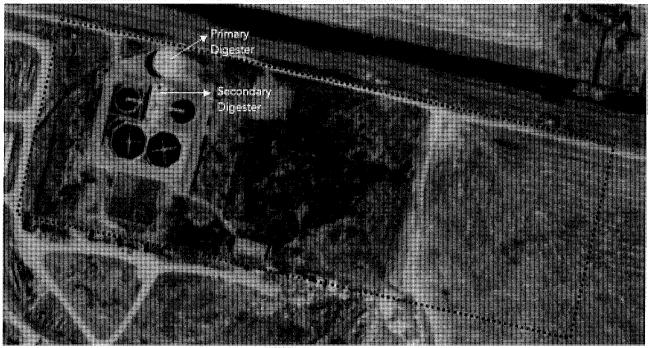
Figure 26. The 1952 aerial photograph; the structures that are still extant are labeled (Historic Aerials by NETR Online).

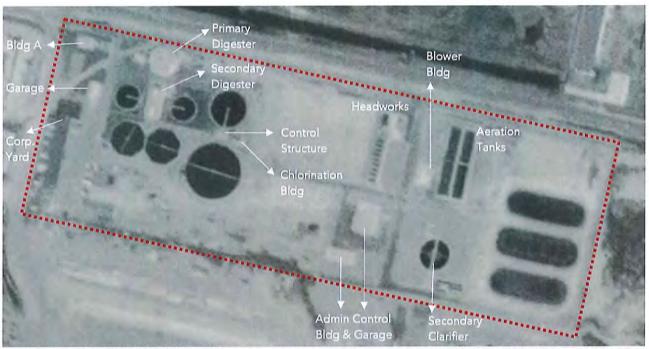
Figure 27. The 1968 aerial photograph; the structures that are still extant are labeled (Historic Aerials by NETR Online).

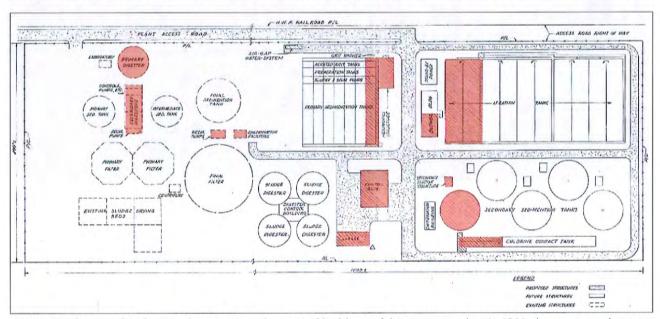
Figure 28. The site plan showing the existing and proposed buildings of the treatment plant in 1966; the structures that are still extant are highlighted in red (M. C. Yoder Associates, 1966).

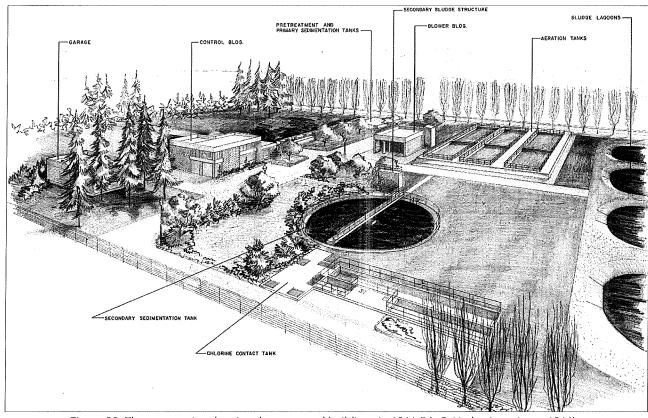
Figure 29. The perspective showing the proposed buildings in 1966 (M. C. Yoder Associates, 1966).
