Introductory Note Fairgrounds Environmental Conditions – July 2022

Petaluma Fairgrounds Environmental Site Analysis completed by Edd Clark & Associates

Phase I Environmental Assessment Report (EC&A, 2020)

Phase II Subsurface Investigation Report (EC&A, 2022)

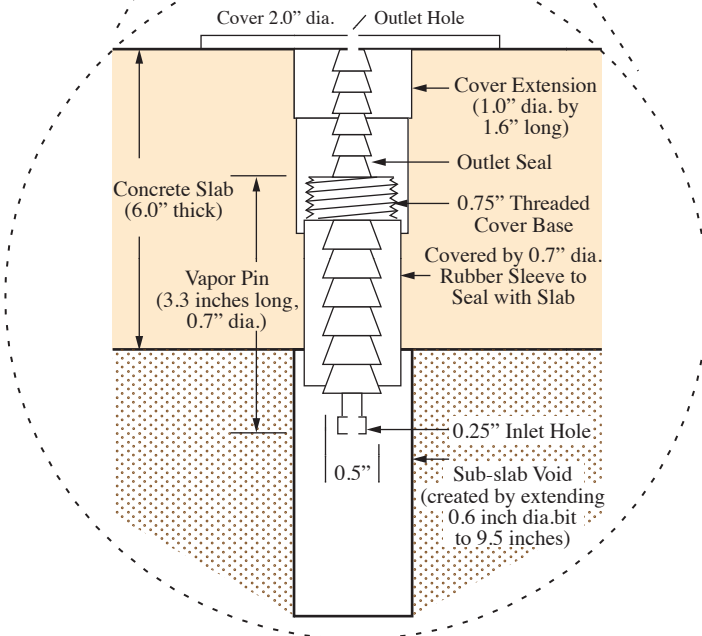
DETAIL--Blowup of Vapor Pin Installation

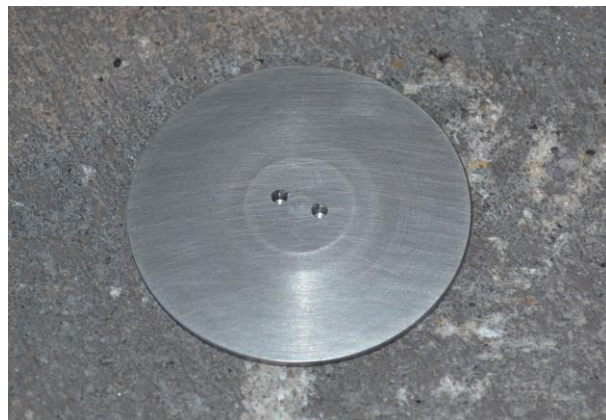
Figure 4. [Secure Cover](#) Installed

- 7) For flush mount installations, cover the vapor pin with a flush mount cover, using either the plastic cover or the optional stainless-steel Secure Cover (Figure 4).

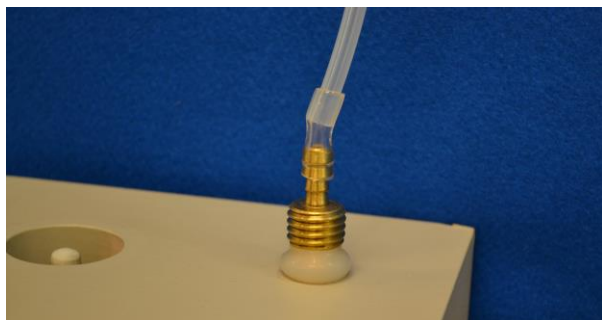
Figure 5. VAPOR PIN® sampling device sample connection

piece of Tygon™ tubing to join the VAPOR PIN® sampling device with the Nylaflow tubing (Figure 5). Put the Nylaflow tubing as close to the VAPOR PIN® sampling device as possible to minimize contact between soil gas and Tygon™ tubing.

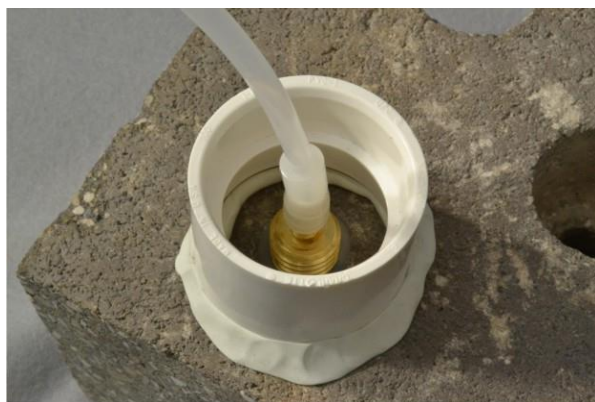
Figure 6. Water dam used for leak detection

10) Conduct leak tests in accordance with applicable guidance. If the method of leak testing is not specified, an alternative can be the use of a water dam and vacuum pump, as described in SOP Leak Testing the VAPOR PIN® sampling device via Mechanical Means (Figure 6). For flush-mount installations, distilled water can be poured directly into the 1 1/2 inch (38mm) hole.

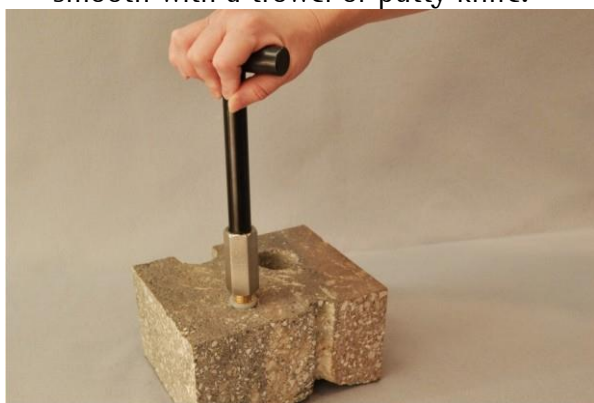
Figure 7. Removing the VAPOR PIN® sampling device

- 1) Remove the protective cap, and thread the installation/extraction tool onto the barrel of the VAPOR PIN® sampling device (Figure 7). Turn the tool clockwise continuously, don't stop turning, the VAPOR PIN® sampling device will feed into the bottom of the installation/extraction tool and will extract from the hole like a wine cork, DO NOT PULL.
- 2) Fill the void with hydraulic cement and smooth with a trowel or putty knife.
