Johnston Residence – 523 B St.

EXISTING CONDITIONS:

CURRENT SITE PHOTOGRAPHS:

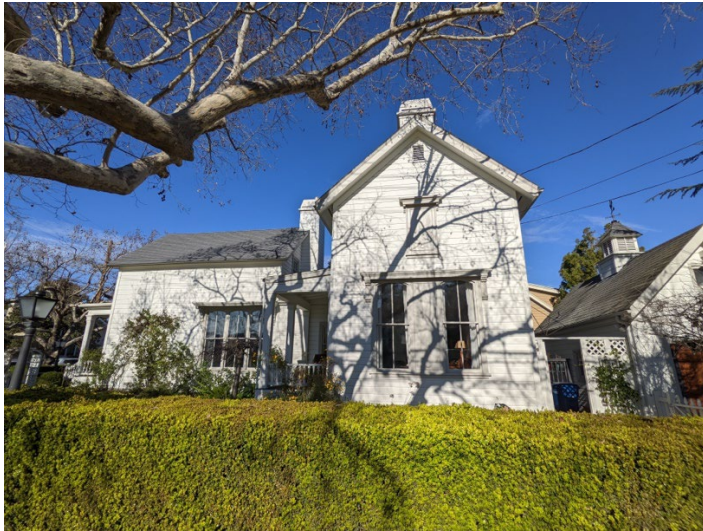
South Elevation. This photo shows the 1992 addition which includes the porch between the two sets of windows. The two windows in the addition are original to the 1860 construction and were removed from the north elevation before it was demolished. (see page 6)

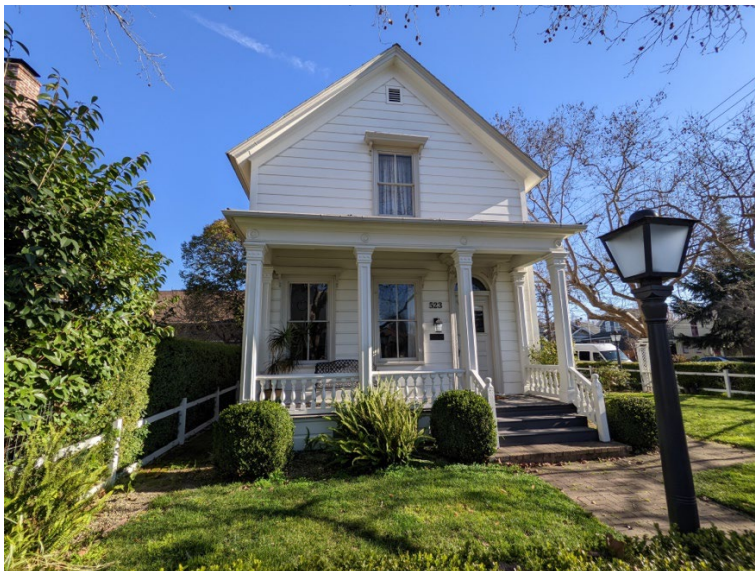
West Elevation on B St. This original facade will not be affected except for the replacement of non-functional windows with identical reproductions.

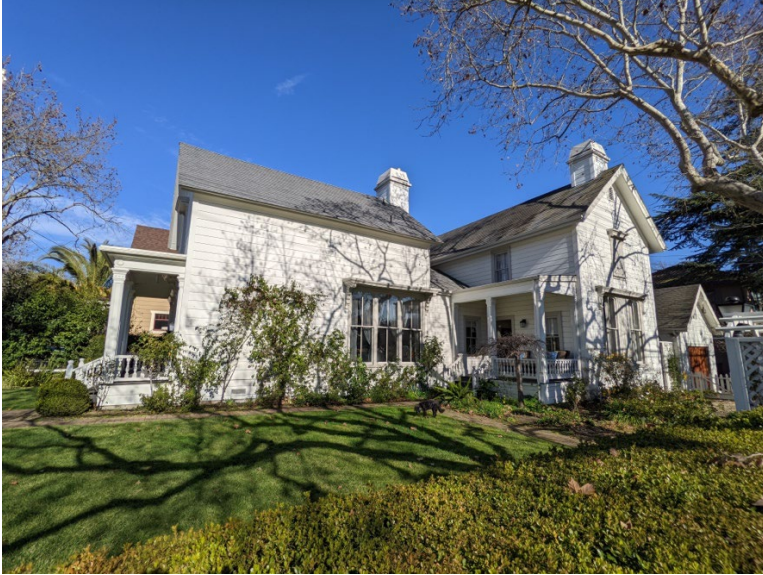
View from the southwest. From this angle the original construction from 1860 ends at the right-hand edge of the triple window.

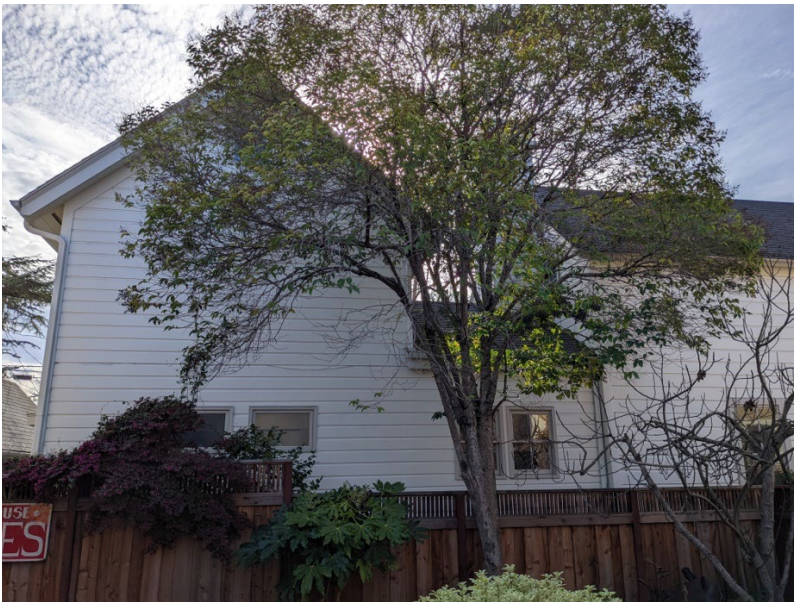
North elevation (from neighbor's yard). The 1992 addition begins at the drainpipe to the right of the single-hung windows behind the tree and includes everything to the left edge of the photo.

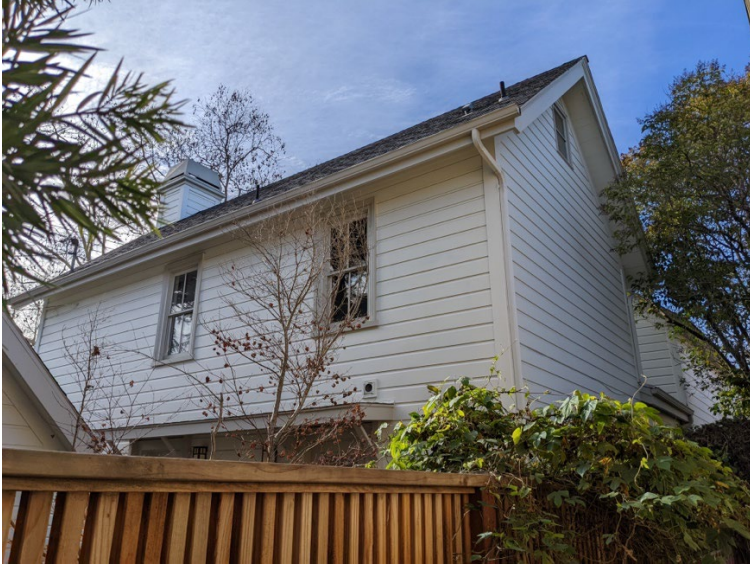
View of the 1992 addition from the northeast.

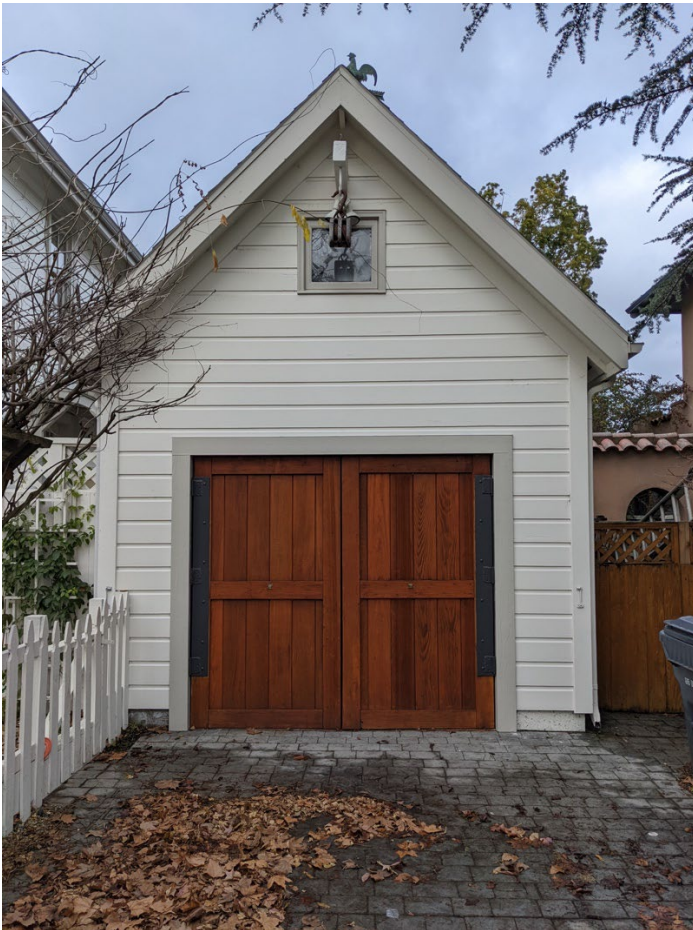
Garage is part of the 1992 addition.

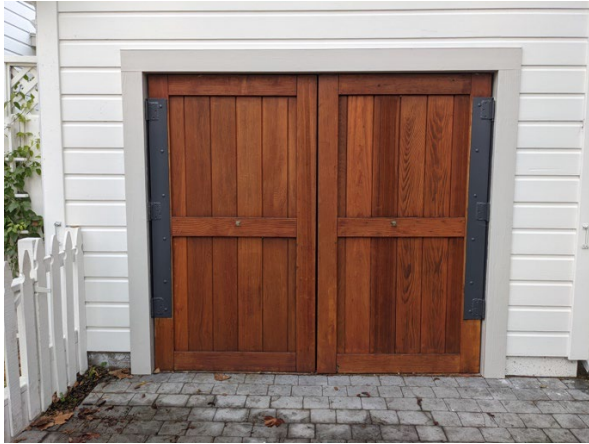
After widening, the garage doors will retain the existing hinge system

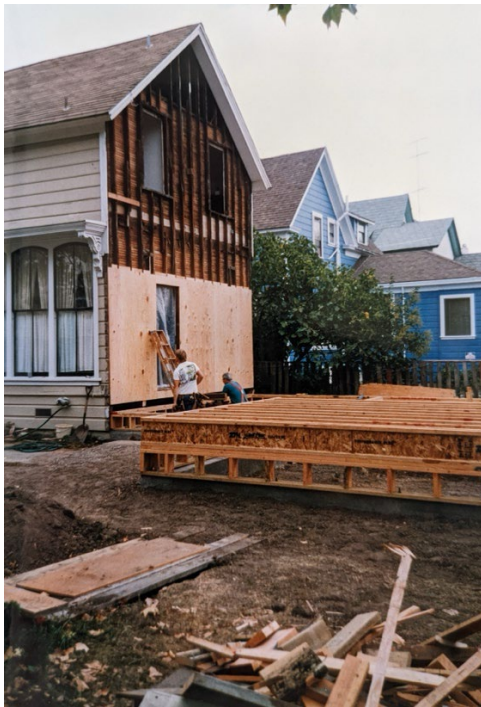
The above photo shows the 1992 addition in progress. The porch is yet to be built in this picture. At the peak of this original roof is where the unnecessary chimney was added.

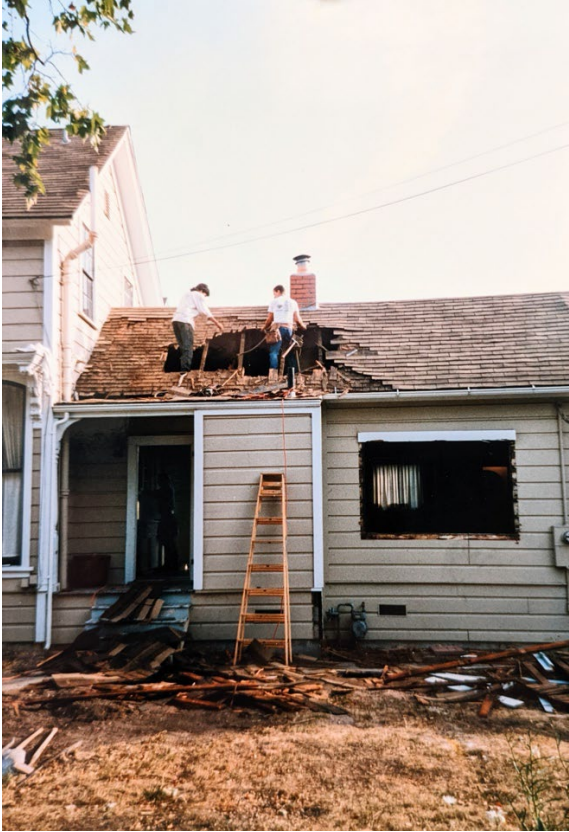
This photo shows the demolition of the eastern end of the house. Although this was an earlier addition, this part of the house included the original kitchen.

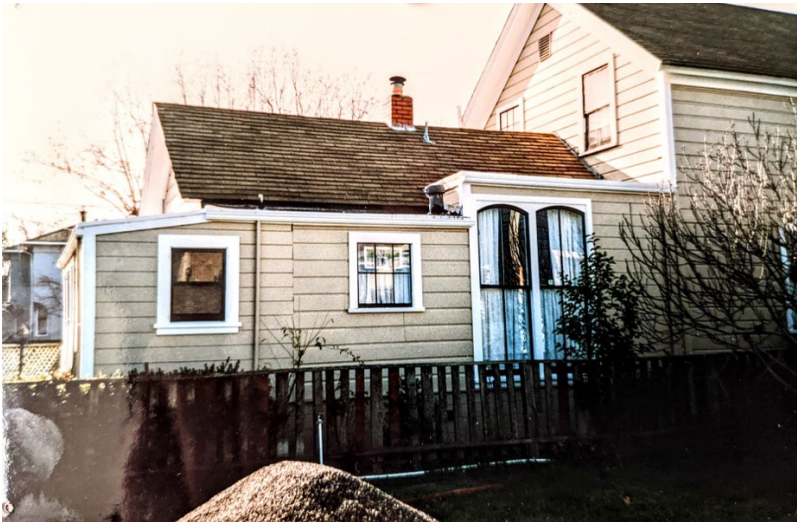
These two original windows on the north elevation were removed, separated and relocated on the south elevation.

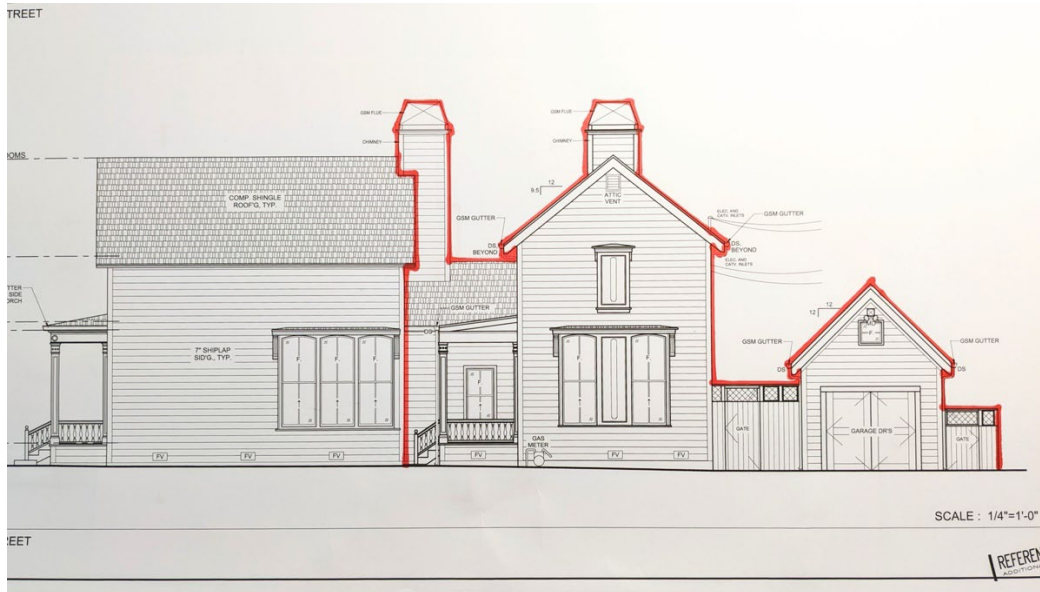
Existing South Elevation. Red line indicates 1992 addition

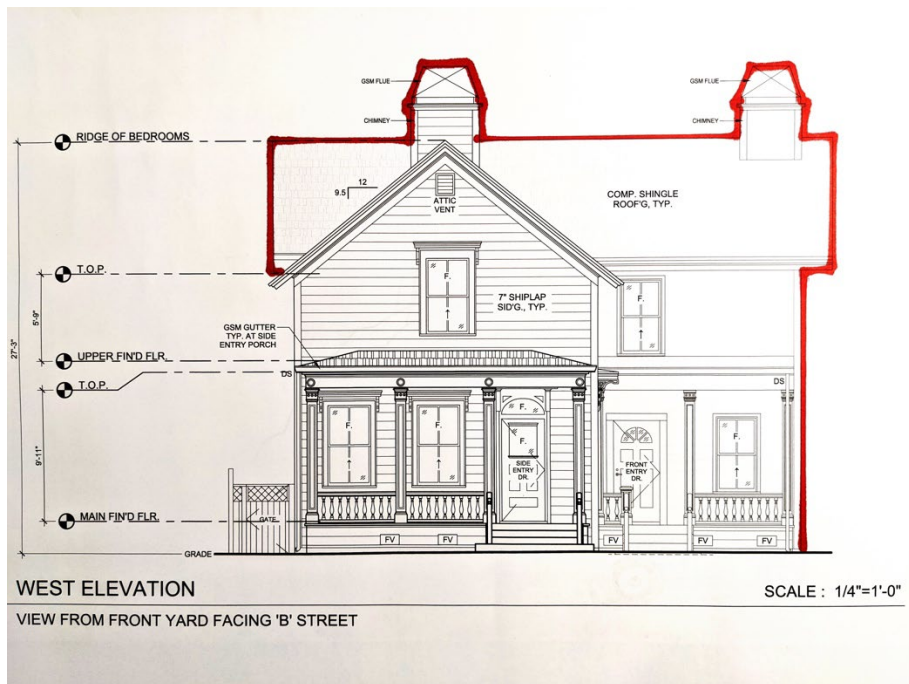
West Elevation (fronting B St) Red line indicates 1992 addition.

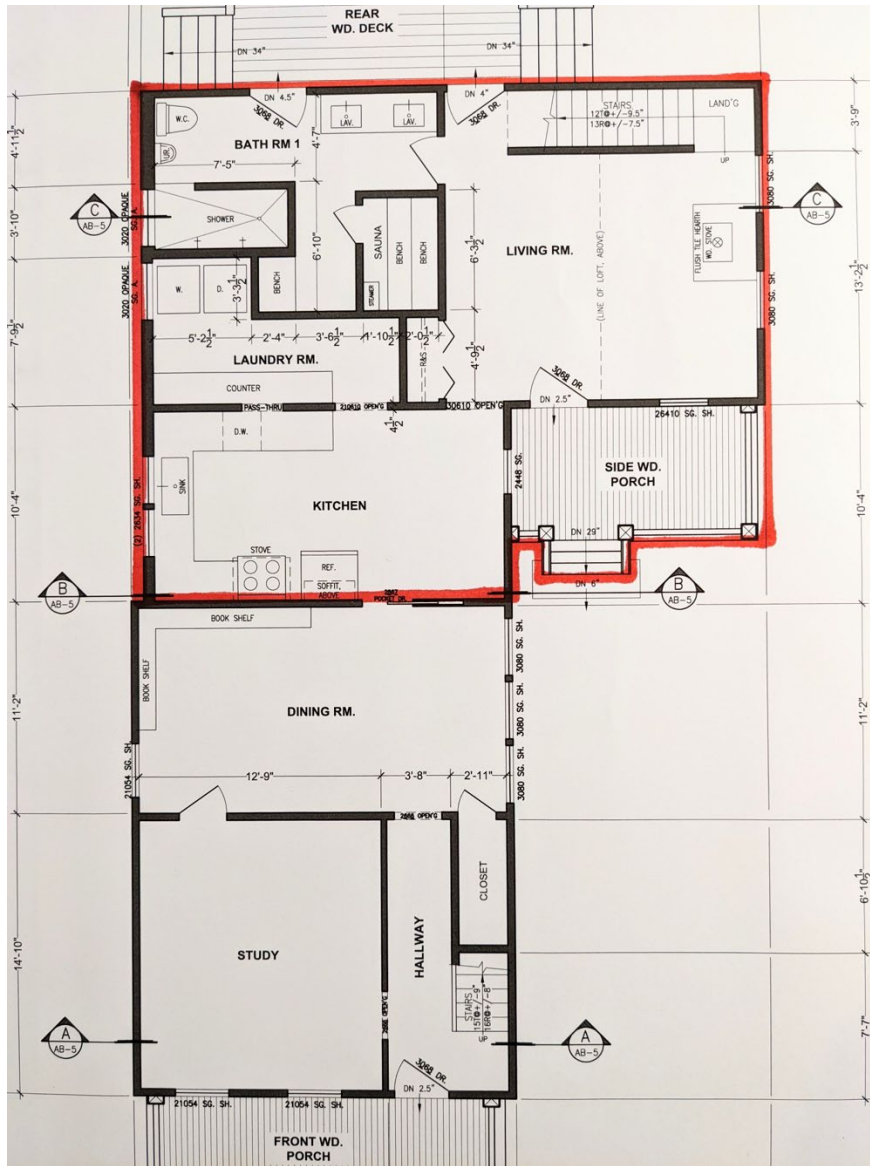
Existing Plan View. Red line indicates 1992 addition.

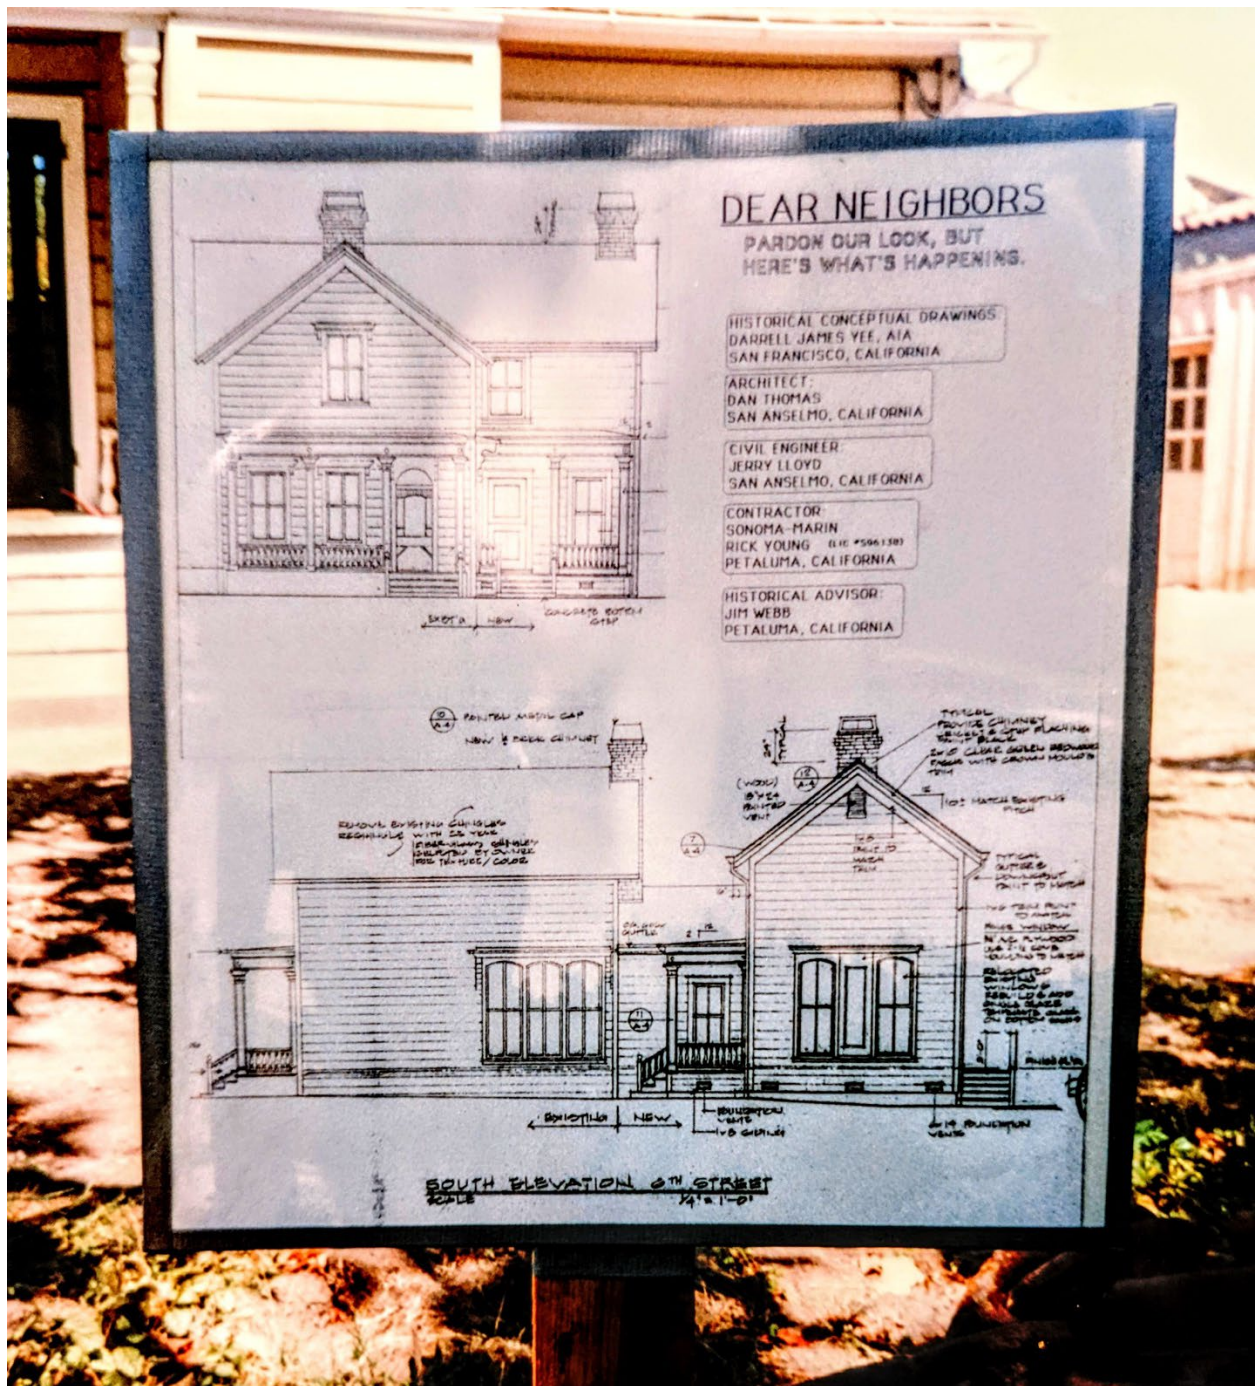
Signboard posted during the 1992 construction. Note that the proposal featured authentic chimneys that were not constructed. The brick-faced chimneys are more in line with what we're proposing.
