October 8, 2021  
updated 12/7/2022

## **PROJECT NARRATIVE for 301 PETALUMA BOULEVARD NORTH**

by Gregory Poloynis, AIA

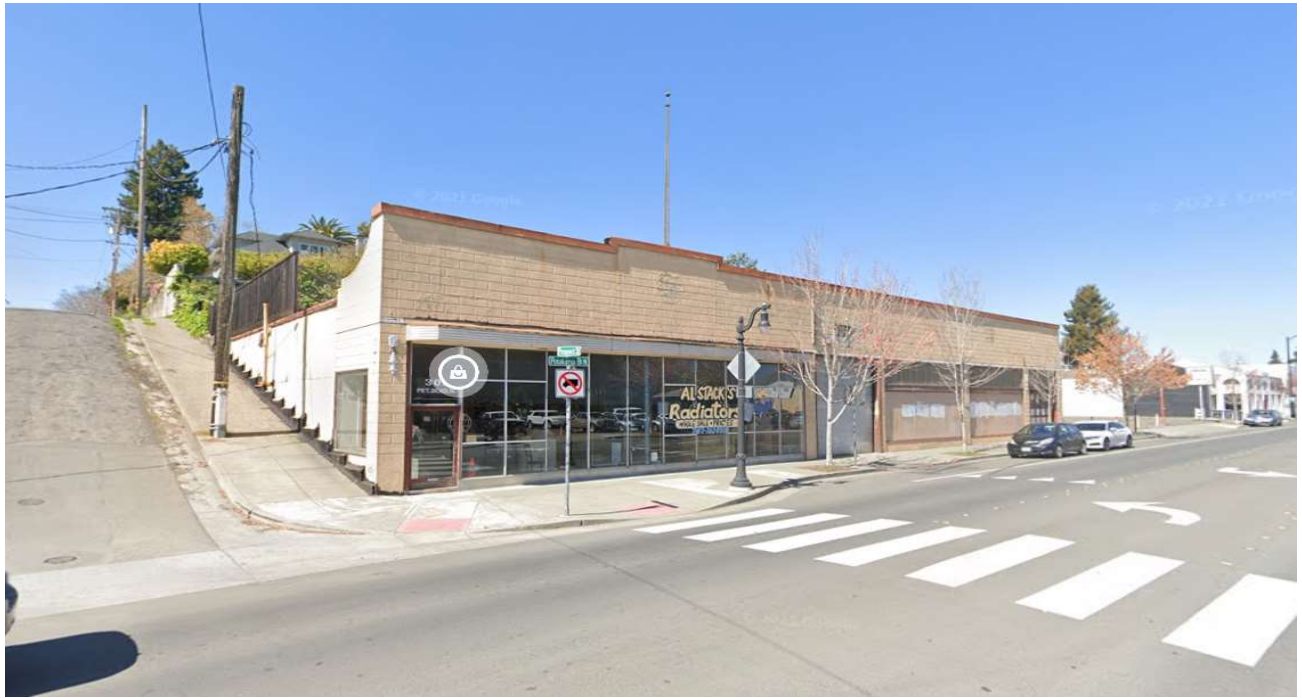
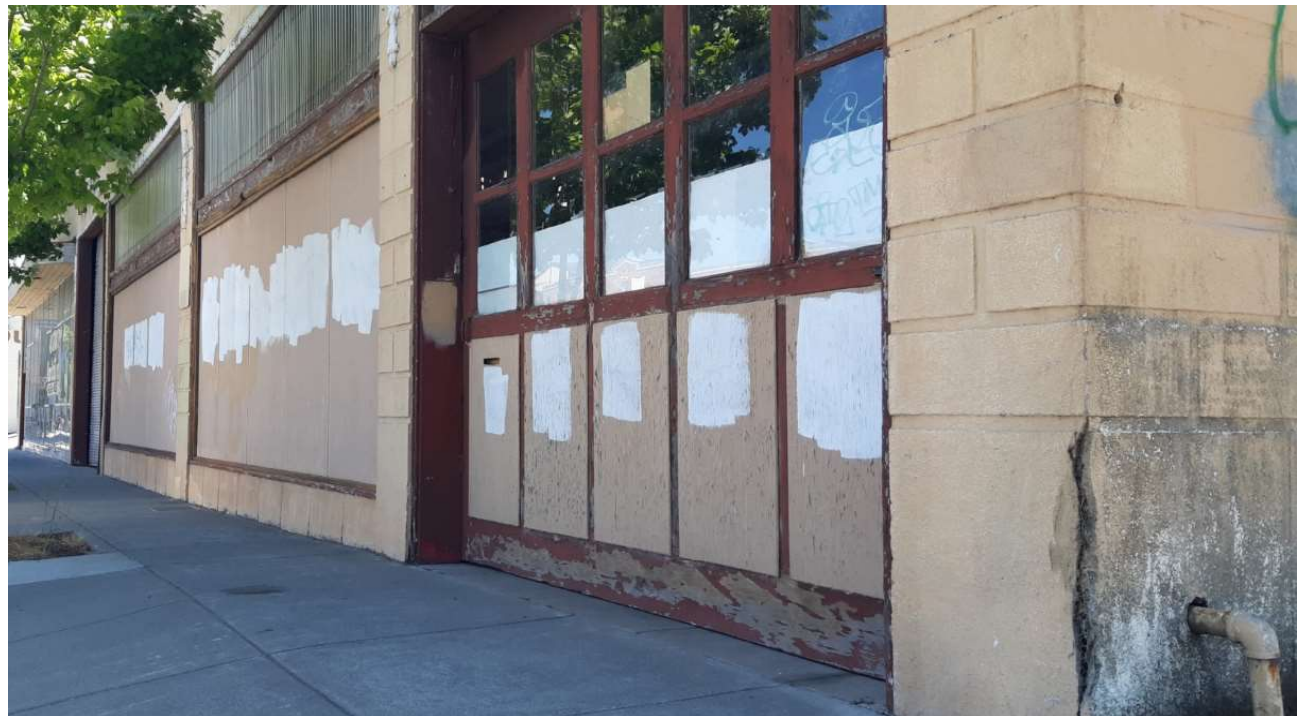
Views of East frontage wall along Petaluma Blvd. North

The existing east frontage facade is a plaster/stucco system, one inch thick and styled to resemble brickwork. This plaster system extends around the corners of the front facade for about 10' at the north and south walls. A parapet wraps around the south, east and north walls to conceal the existing built-up roofing system. The plaster has separated from the substrate in spots, and needs to be reattached. Proposed work includes repairing the existing finish to match in kind with the existing design, pattern and color.

The east frontage wall also has a large storefront system that is set on a wood curb. The existing 2' deep architecturally-significant canopy above the storefront is to remain, but shows signs of weathering and needs maintenance. The storefront has minor buckling and the wood curb is failing in numerous places due to dry-rot. The Owner's intent is to repair the existing storefront system in kind, to match the existing style and finish of the existing, and replace the dry-rotted storefront support curb. There would be minor modifications to the storefront for accessible entry and egress at the retail space.

Adjacent to the east facade storefront are two existing tall 12' wide garage doors with a plain plaster wall clerestory windows between the two. A portion of the wall between the two garage doors would be structurally upgraded from the interior. There would also be two new accessible entrances adjacent to the garage doors for building code egress requirements.

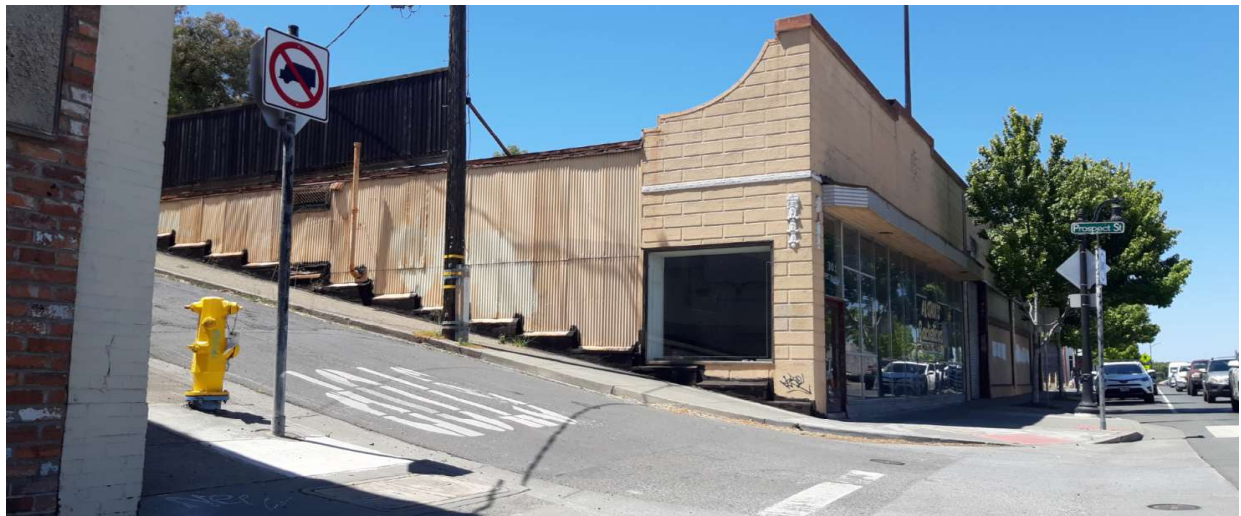
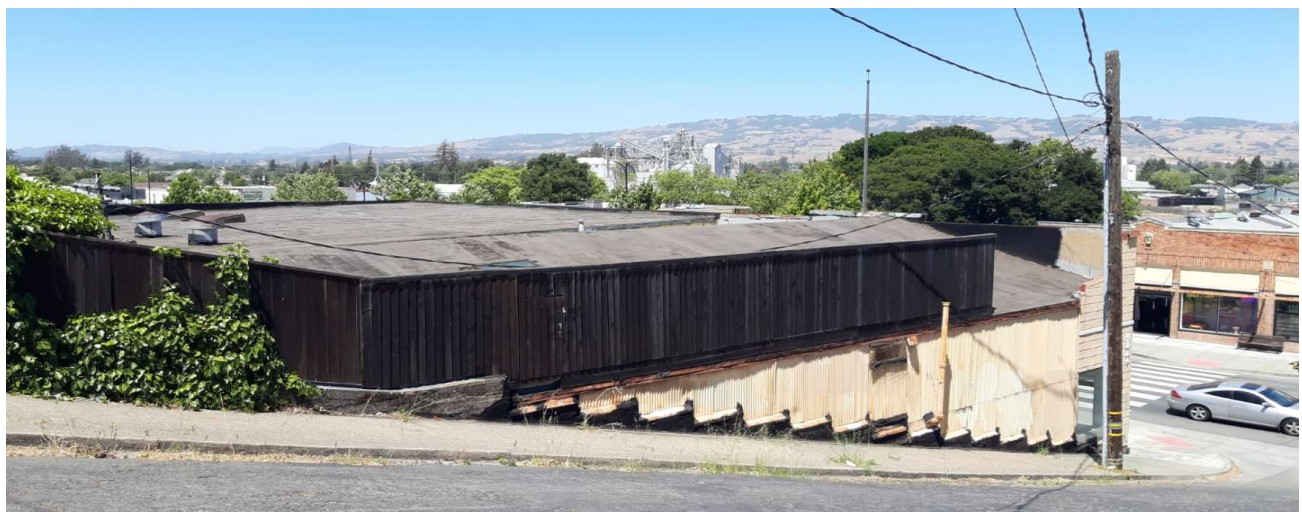
## South Wall at Prospect Street

The South Wall of the building is mostly a thick concrete retaining wall along the property line of Prospect Street. Atop the retaining wall is wood framing with corrugated metal panels attached directly to the wall studs. A wood security fence sits atop the building wall, blocking access onto the roof from the high end of Prospect Street.

The exterior corrugated metal is weathered in locations and has no structural sheathing. Project work would include removing the metal panels, installing new structural sheathing and a weather barrier, and reinstalling the existing metal panels, or replacing panels to match the existing.

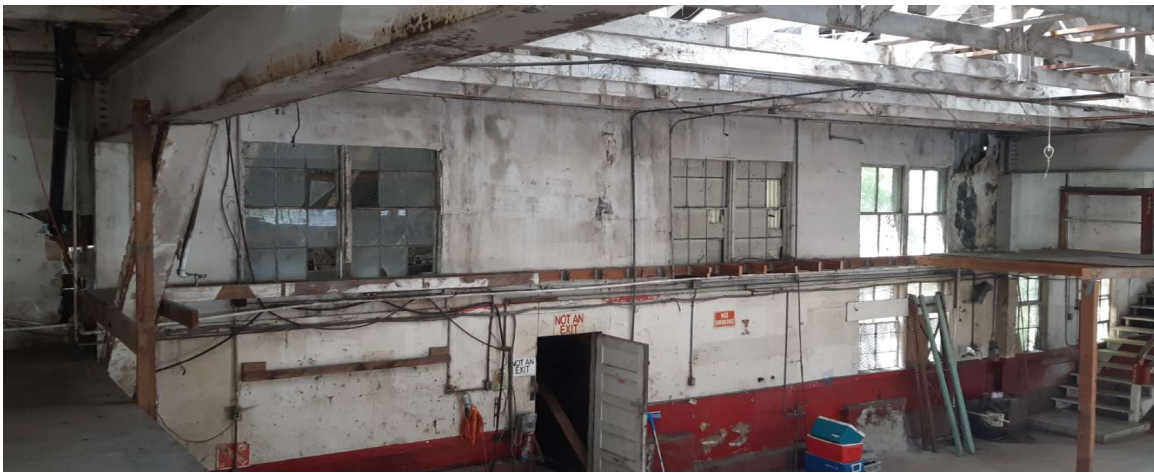
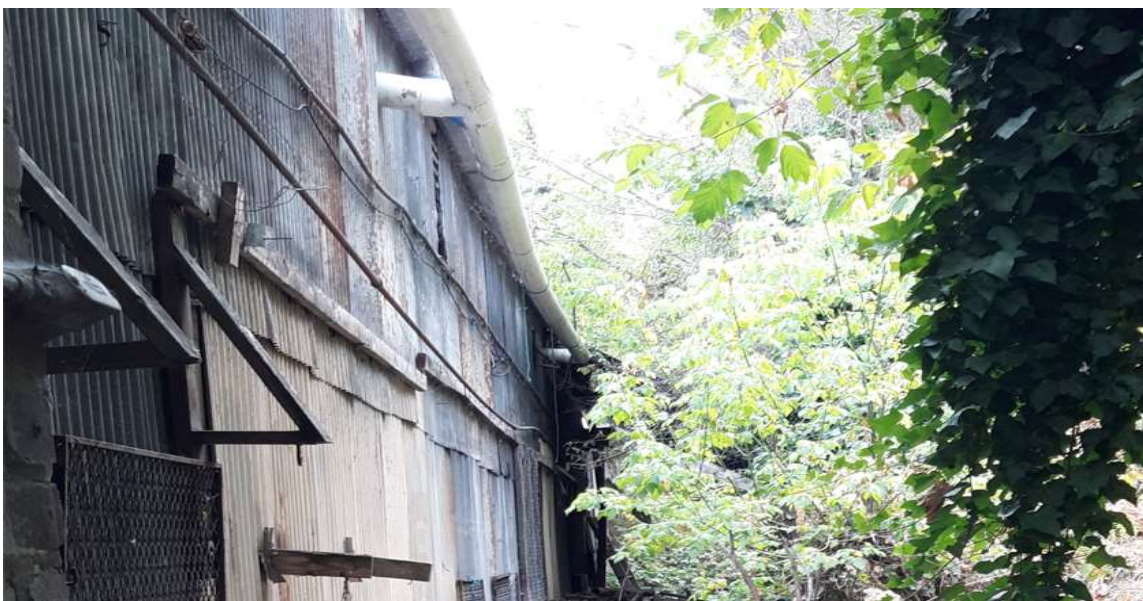
West Wall, not visible from any of the adjacent streets or right-of-ways

The existing west wall is a tall wood-framed wall with a corrugated metal siding. The wall runs parallel with the roof trusses. There is no existing structural sheathing, and the framing is widely-spaced and has weathered in places. There are large existing windows, many of which are broken with weathered frames.

The entire west wall shows signs of weathering, and is intended to be re-framed along the same line as the existing, to incorporate structural upgrades. The corrugated metal siding would be reattached or replaced in-kind over structural sheathing and a water-resistant underlayment. Panels would be replaced as necessary to match the existing paneling. The windows would be replaced to match the size and basic styling of the existing windows.

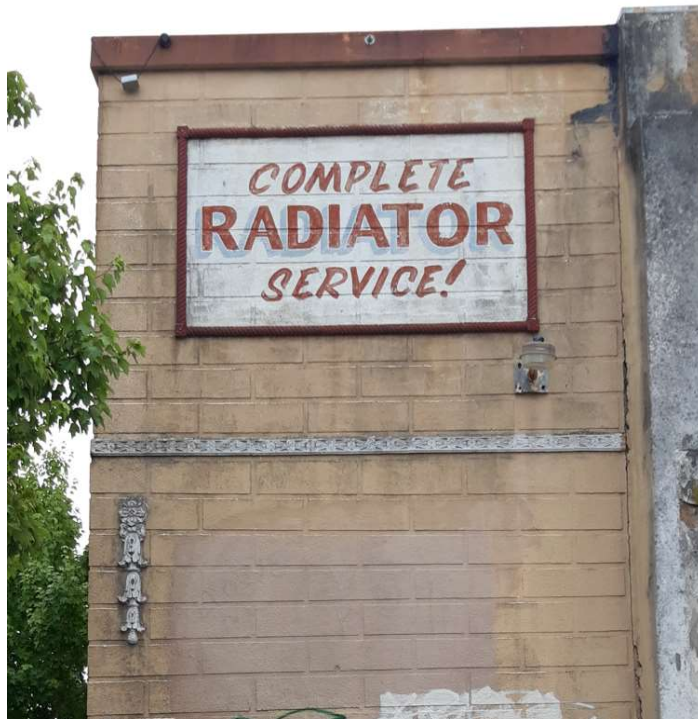
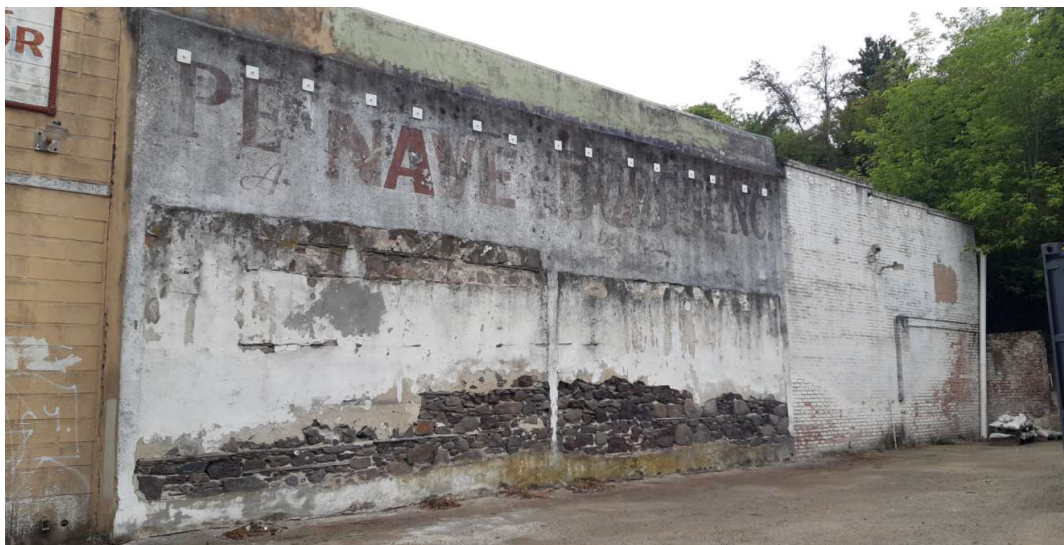
North Wall, adjacent to the Parking lot

The North wall is mostly masonry with some signage areas. These walls appear to be largely intact, and would only require minor clean-up and maintenance work. Lighting would need to be repaired, along with some signage considerations. A large garage door is proposed at the northwest corner of the north wall, due to traffic considerations along along Petaluma Blvd. North, and loading activities using the garage doors along the busy frontage road. The Owner has built this using preliminary engineering information, on their own volition. It is understood that planning and building department review will determine if this is acceptable.

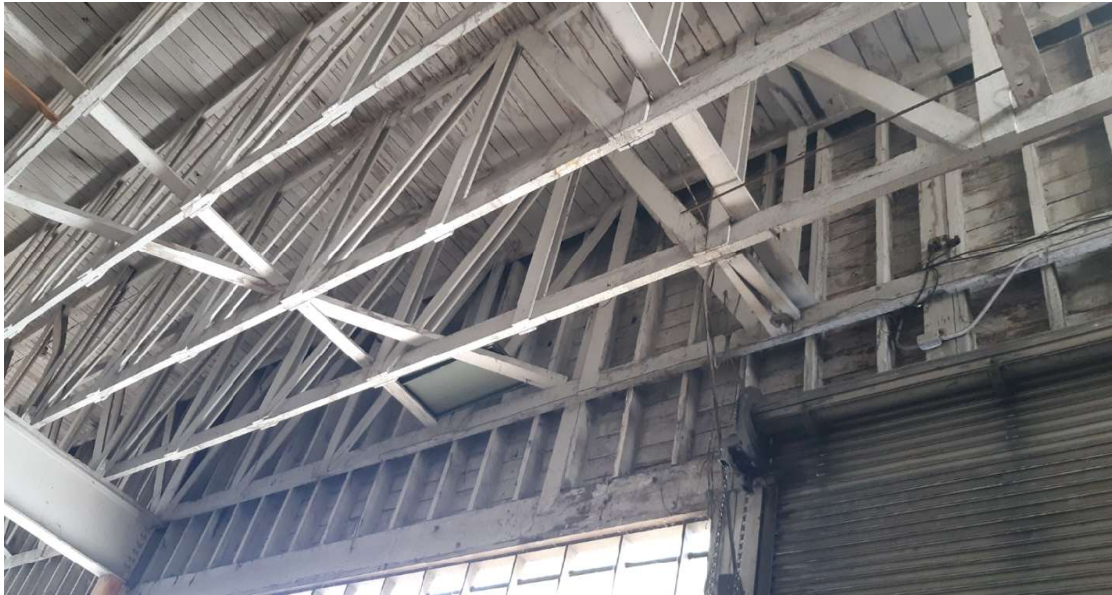
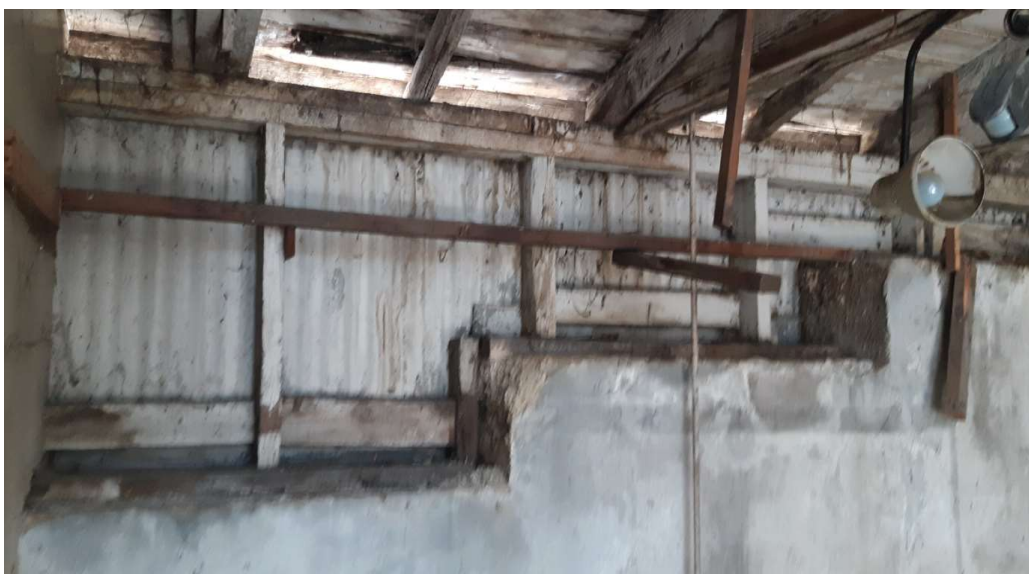
## Roof

The existing roof trusses span between the north and south walls, with existing steel beam support lines. The trusses do not rest on the west or east walls. The goal is for them to be preserved along with the 2x6 roof decking, with maintenance and repair work as necessary. There are some dry-rot conditions mostly at the south retaining wall, along Prospect Street, where the retaining wall and street rise above the roof plate, which need to be repaired.

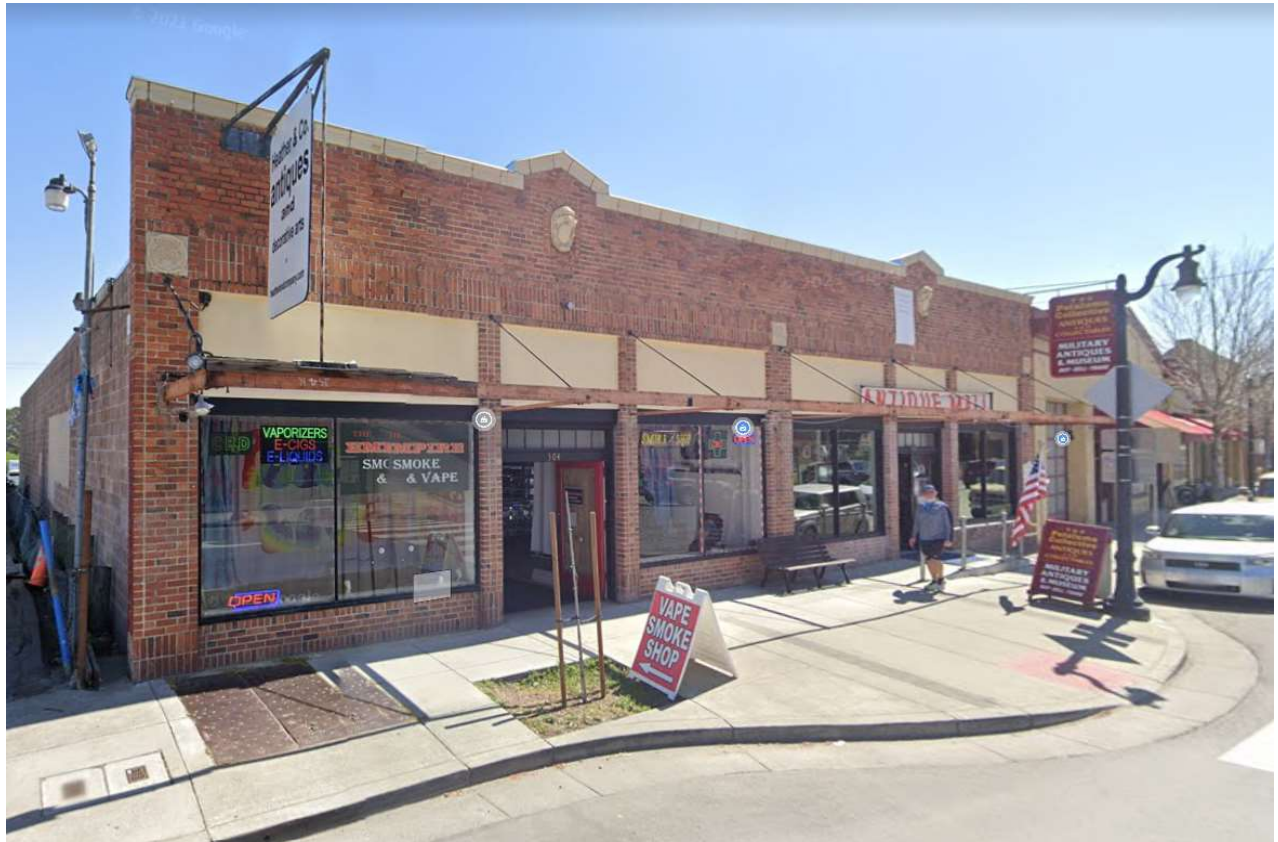
Existing Doorway at 304 Petaluma Blvd. North, directly across the boulevard from Project Building:

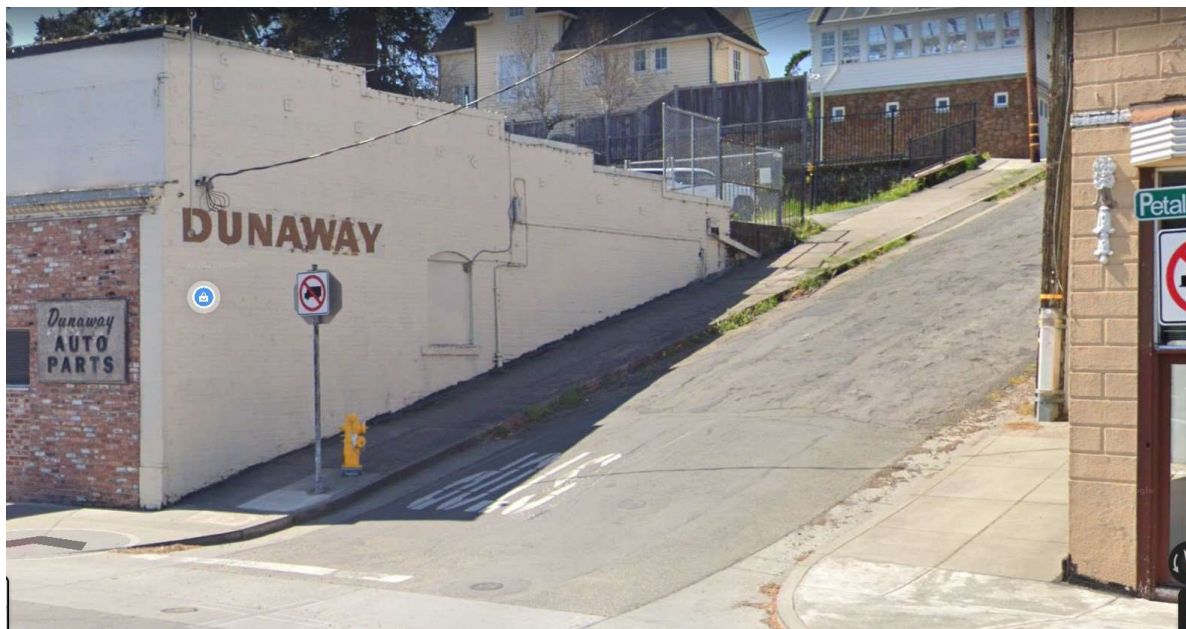
Existing Doorway in side of building at, directly across the street from Project Building:

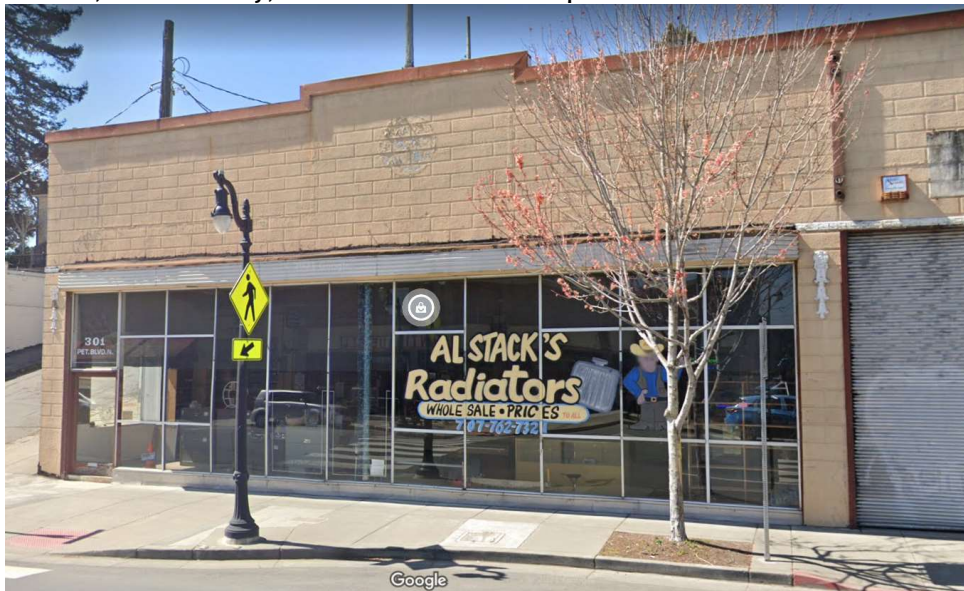
- STOREFRONT SYSTEM
  - Repair existing storefront in kind, to match existing profile and pattern .
  - Finish to match existing Clear Anodized system throughout
  - Mullion Pattern to match existing, except where new accessible alcove Entry door is provided
  - Glazing to be replaced in kind as needed for repairs.
- EXTERIOR FAUX-BRICK PLASTER FACADE
  - Clean, Prep and repaint to match existing color
  - Any patching or replacing of failing sections of the existing plaster will be installed to blend in and match the texture and pattern of the existing adjacent plaster.
- EXTERIOR PLASTER ORNAMENTATION
  - Preserve existing and repair in place.
  - Alternate, if necessary, install a cast-stone replica of ornamentation
