Historic Resource Evaluation (HRE)
515 B Street, Petaluma,
Sonoma County, California
(APN 008-103-003-000)

Prepared for:
Scott Landry
Studio 101 Designs
scott@studio101designs.com
(707) 778-0101

Prepared by:
Alice P. Duffee, Historic Preservation Planner
APD Preservation LLC
January 2023

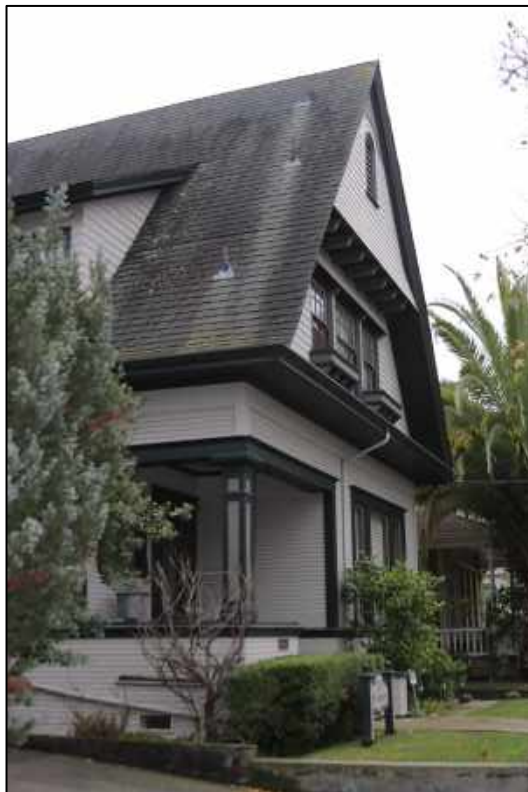
Figure 6: West elevation, porch, northwest corner

A concrete path leads from the sidewalk, up two steps, past a decorative pressed concrete wall to the front porch that is sheltered under the northwest corner of the building. Wood steps lead to the wood floored porch, which is enclosed with a half wall. A paneled, square post with molded trim, base and capital supports the corner of the porch (see figures 1, 9 and 7). The front door is off-centered under the porch and has a wood door with a large single pane of glass sheltered behind a decorative screen door. The frame is wide board trim with a molded lintel and base. This trim pattern is repeated on all windows in the front section of the house. A wood sash, awning type window with diamond shaped panes is centered in the wall to the north of the door.

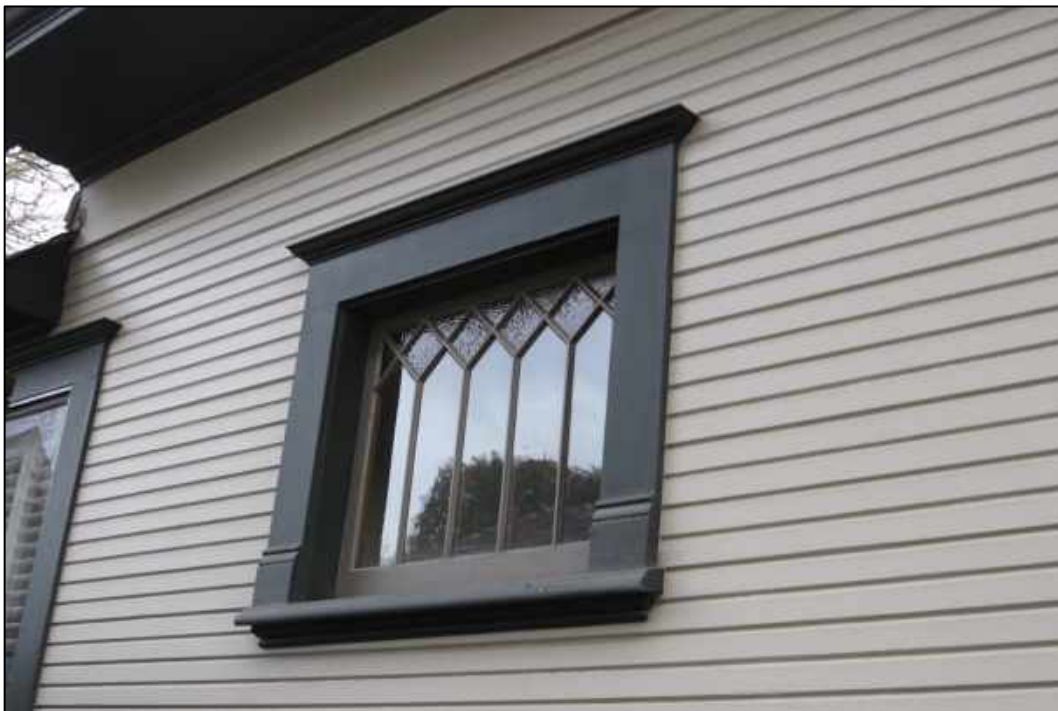
Figure 16: North elevation, diamond pane window

On the north elevation, a large shed-roof dormer with three windows (wood sash, six-over-one, double-hung with ogee lugs) is roughly centered on the main block of the house (see figure 11). On the lower level there is a decorative window with the diamond pane pattern to match the front window. A series of other wood sash windows are placed at irregular intervals along the elevation as dictated by interior spaces (see figure 15). The smaller window at the far eastern end of the elevation appears to have replaced a larger window, based on well concealed patches in the siding (see figure 12).

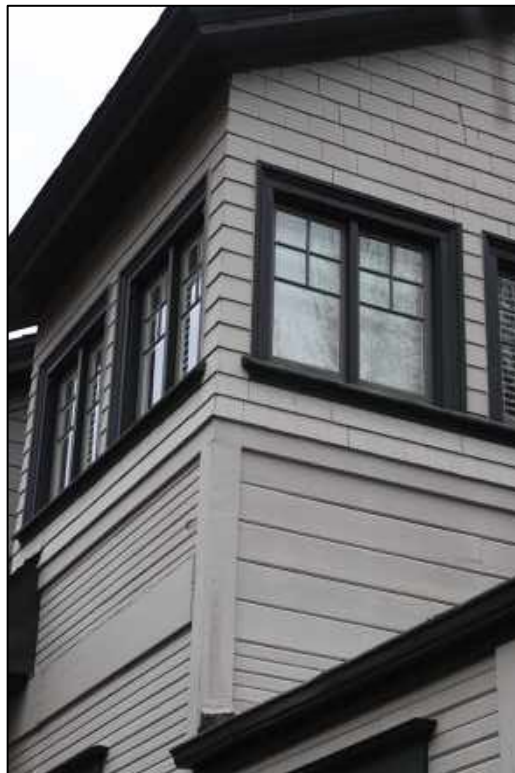
Figure 22: East elevation, upper windows at southeast corner

At the rear of the house, there are several wings and additions of varying heights and scale (see figure 19). A two-story wing extends off the southeast corner of the main block of the house and has sets of four-over-one, wood sash windows on both the east and south elevations (see figure 22). This two-story wing intersects with an older gable-roofed, one-and-one-half story wing that is offset from the northeast corner of the main block (see figure 20). A shed-roof wing extends across the majority of this gable-roofed wing; a smaller shed roof section fills in the space between the two-story wing, the one-and-one-half story wing and the shed roof wing. The lower level windows are modern, aluminum and vinyl sliding units set in simple wood frames (see figures 27 and 28). A modern, multi-lite glass door is sheltered at the south end of the shed roof wing/porch (see figure 29). A modern wood deck with ramp leads to the small back yard.

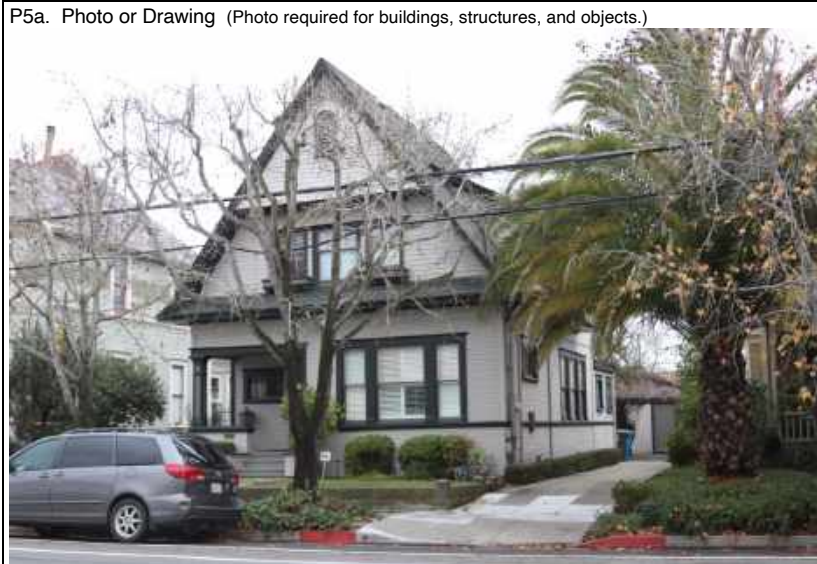
***P3a. Description:** (Describe resource and its major elements. Include design, materials, condition, alterations, size, setting, and boundaries)
 The 1.5-story, gable-facing house has a rectangular mass and sits on a slab concrete foundation. The steeply pitched gable roof of the front block flares at the eaves, is covered with modern composition shingles and has a molded cornice and boxed eaves. A pent eave extends across the front. At the peak, the upper wall overhangs the lower wall and is supported on carved brackets. An arched vent with wood louvers is at the gable peak. The ground level of the main block has narrow, V-groove wood siding on the front and sides; the upper levels have painted wood shingles. The main block has a wide frieze, belt course and water course. A front porch is sheltered under the NW corner. Wood steps lead to the wood floored porch that is enclosed with a half wall. A paneled, square post with molded trim, base and capital supports the corner of the porch. The front door is off-centered in the porch and has a wood door with a large single pane of glass sheltered behind a decorative screen door. The frame is wide board trim with a molded lintel and base. This trim pattern is repeated on all windows in the front section of the house. A wood sash window with diamond shaped panes is centered in the porch wall. At the ground level of the front, 3 windows (wood sash, 1-over-1, double-hung, ogee lugs) are framed as a single unit. At the upper level, 3 multi-lite-over-one windows are grouped together under a shallow hood with brackets. The side windows have decorative window boxes with heavy molding and shaped brackets. On the north, a shed-roof dormer with 3 windows (wood sash, 6-over-1, double-hung, ogee lugs) is roughly centered on the main block. On the lower level there a diamond pane window. Other wood sash windows are placed at irregular intervals. The south of the main block has a shed-roof dormer with 3 wood-sash, multi-lite-over-one, double-hung windows. At the ground level there are a variety of diamond pane windows and 1-over-1, double-hung and single pane awning windows set at irregular intervals. At the rear, there are several heavily modified wings and additions of varying heights and scale.

P5b. Description of Photo: (View, date, accession #)
1/6/23, W Elevation (SW corner)

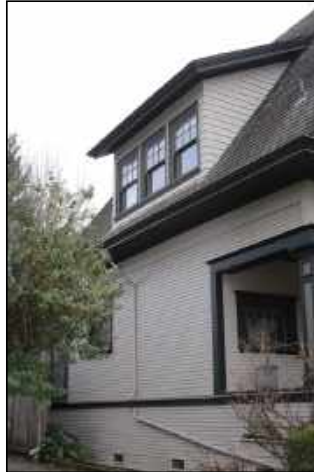
North elevation, NW corner

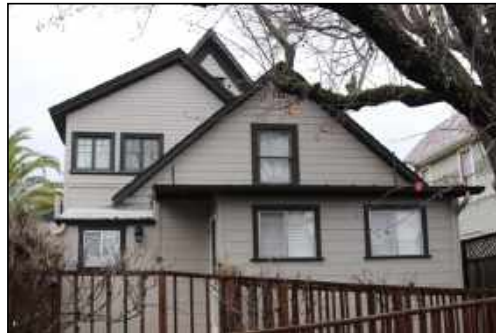
East elevation (rear)

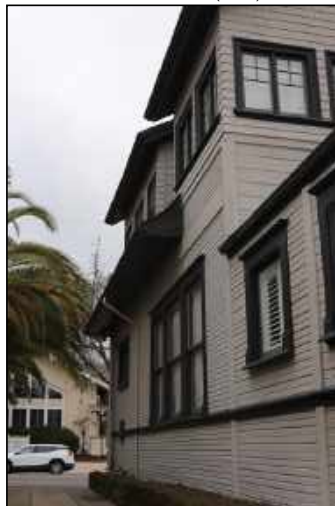
South elevation (looking west)
