**PHASE I ENVIRONMENTAL SITE ASSESSMENT
PETALUMA RIVERFRONT PROPERTY
PETALUMA, CALIFORNIA**

Petaluma Riverfront, LLC
c/o Basin Street Properties
210 First Street, Suite 100
Petaluma, California

IRIS ENVIRONMENTAL
1438 Webster Street, Suite 302
Oakland, California

October 23, 2013
Project No. 13-994A

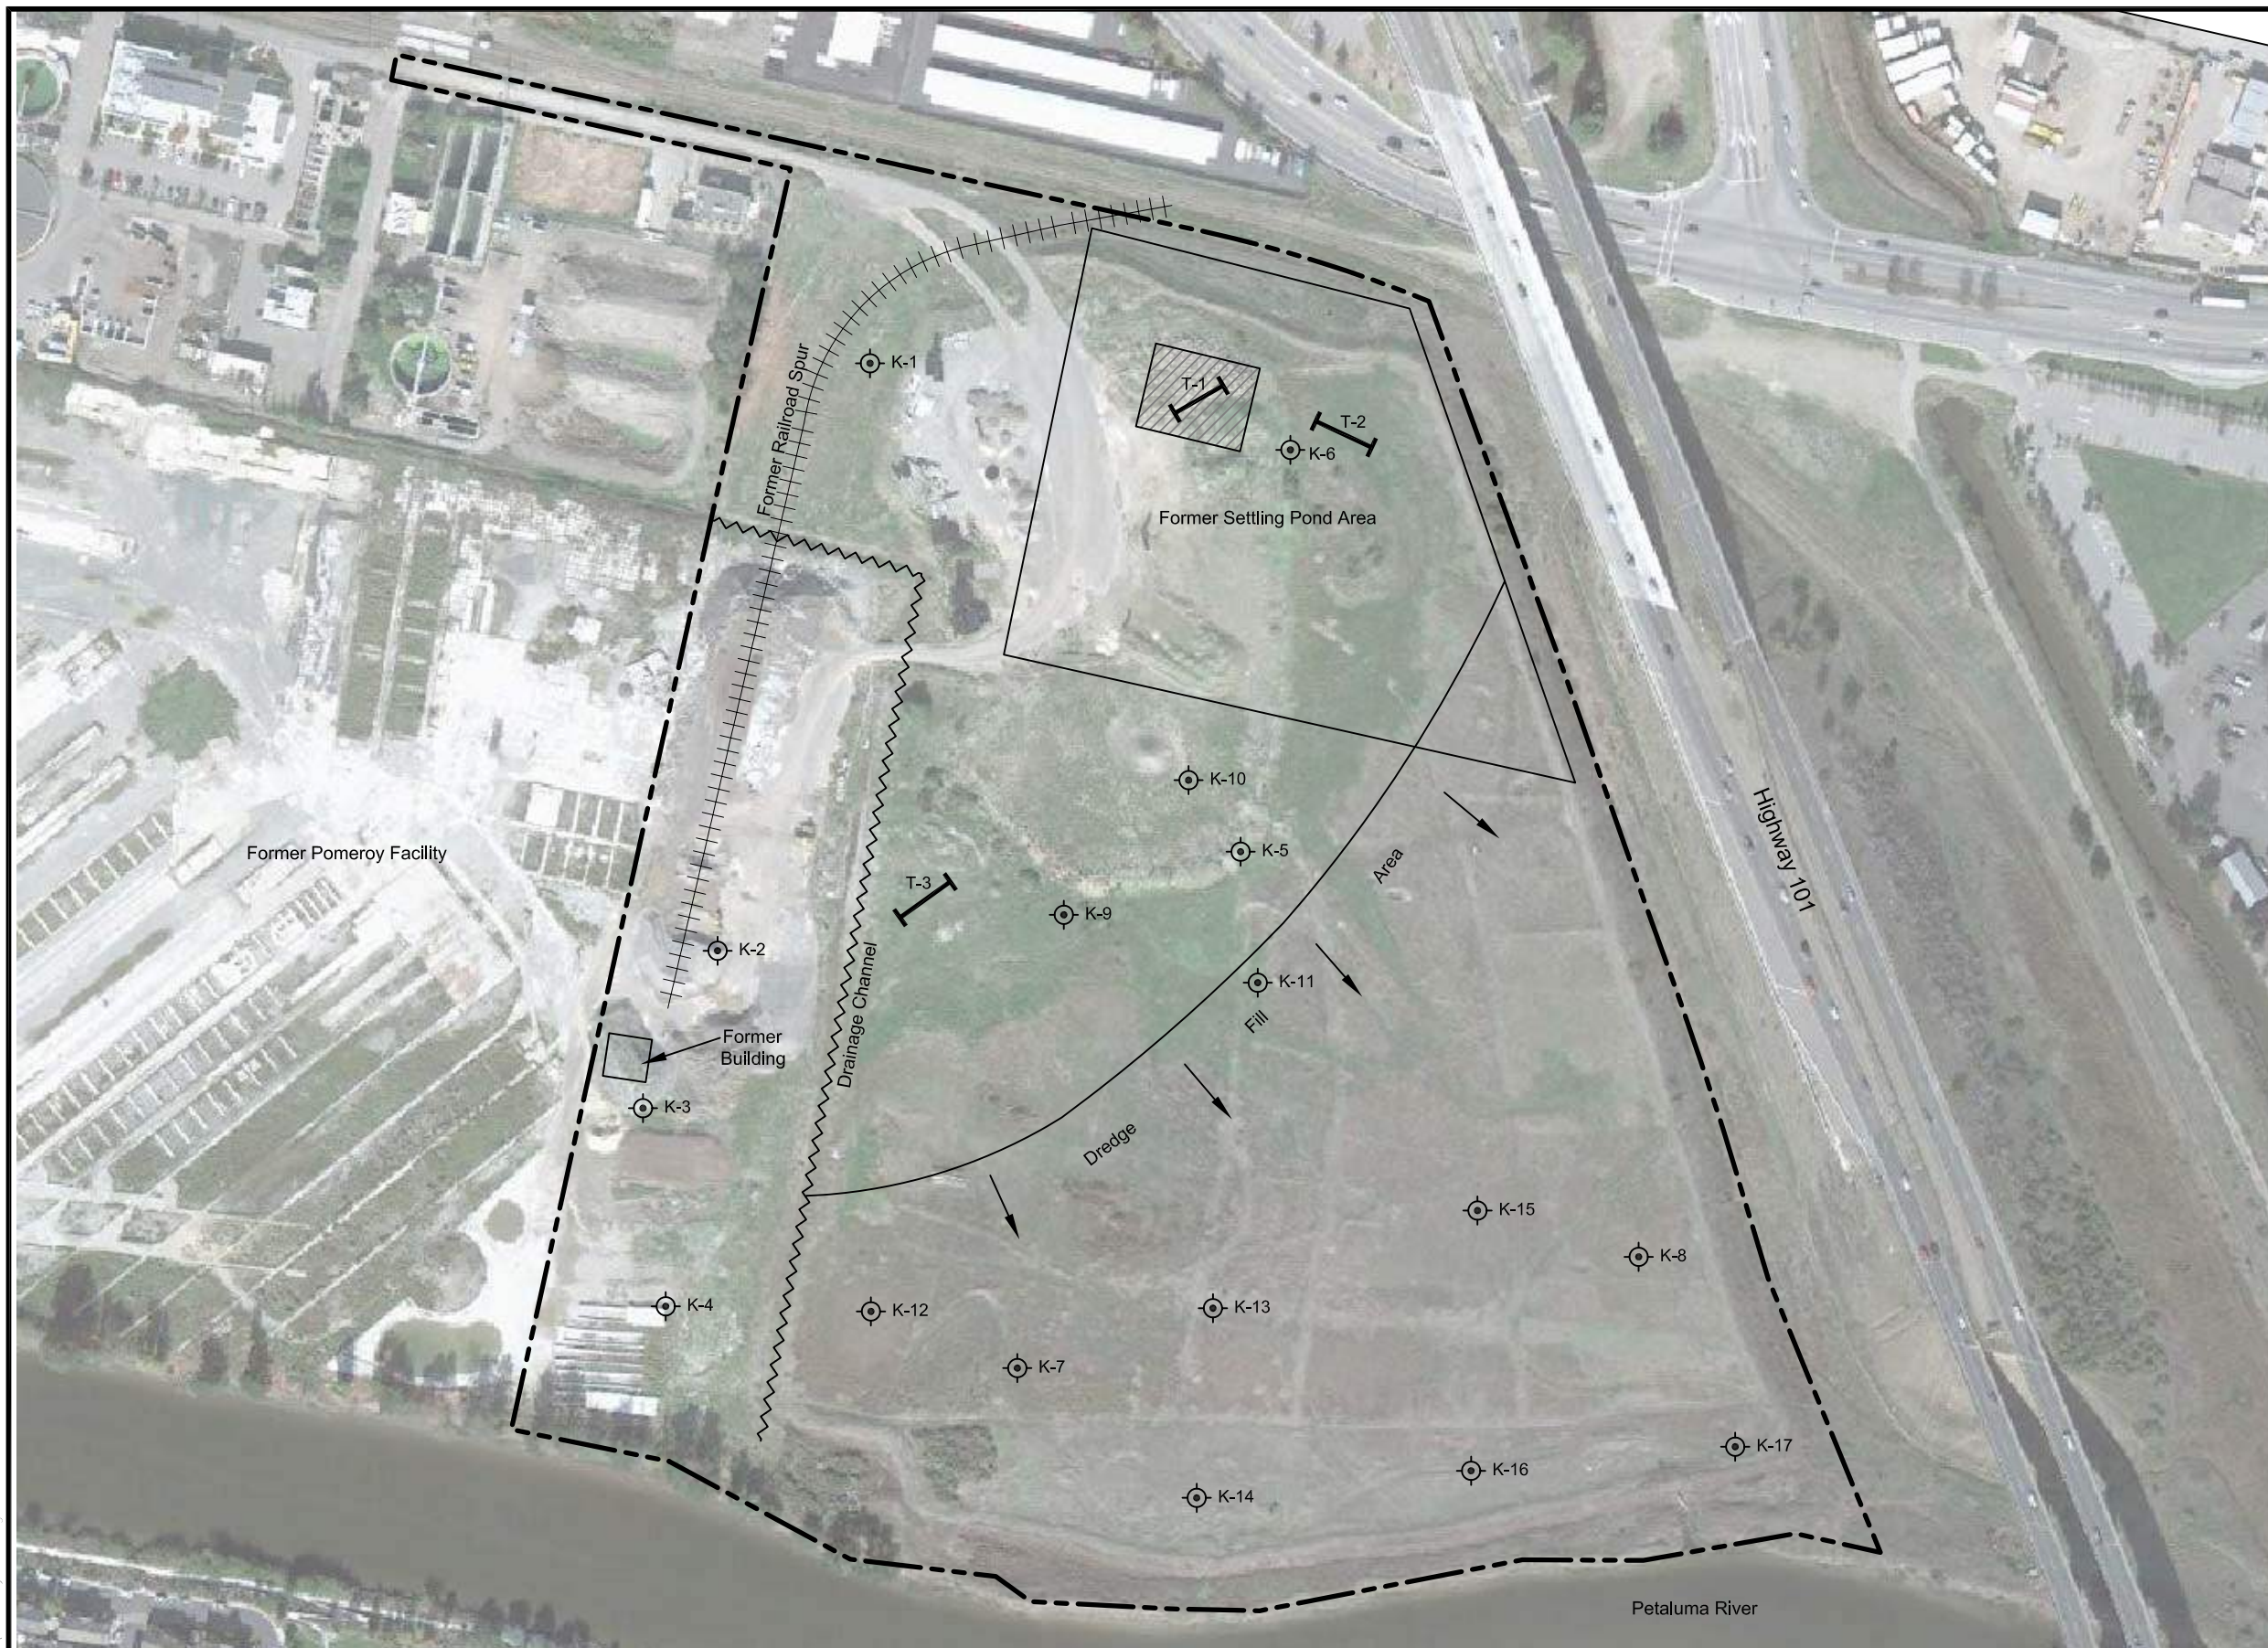
- Explanation**
- Approximate property boundary
 - Soil boring location
 - Exploratory trench location
 - Soil from Pomeroy Facility

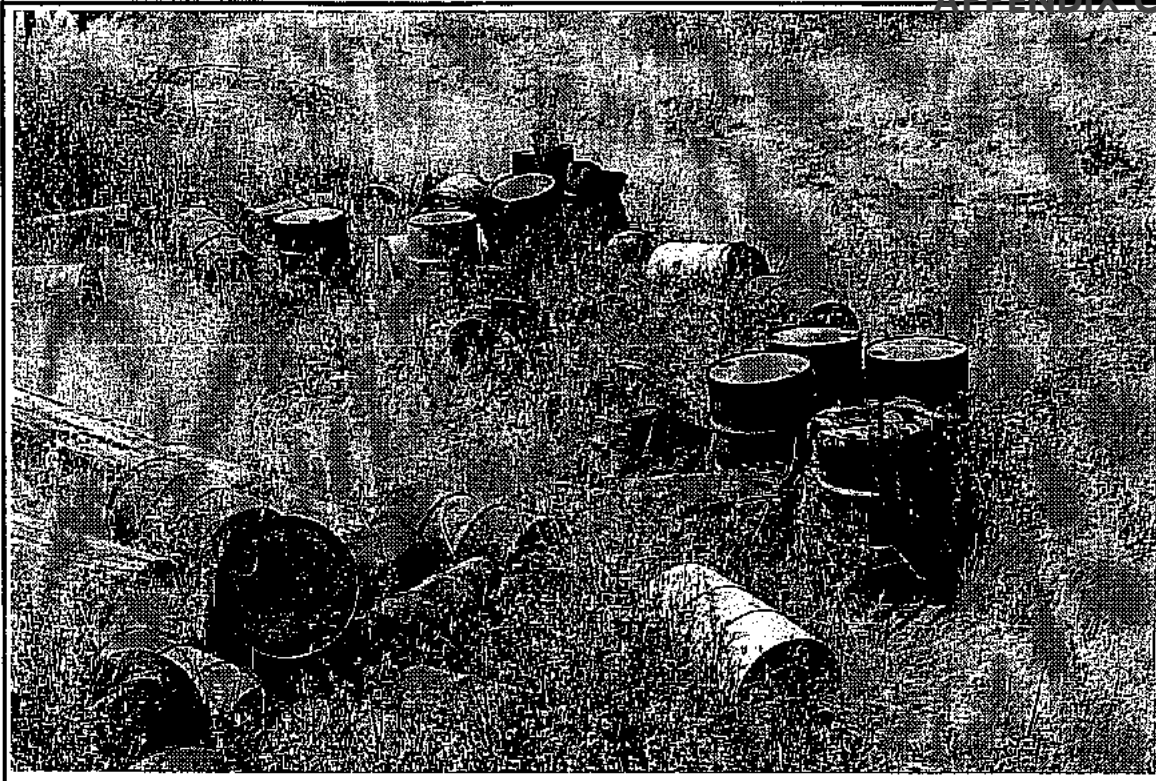
Photo 1: Empty and partially full drums, oils and possibly other liquids. Located in open field east of debris area.

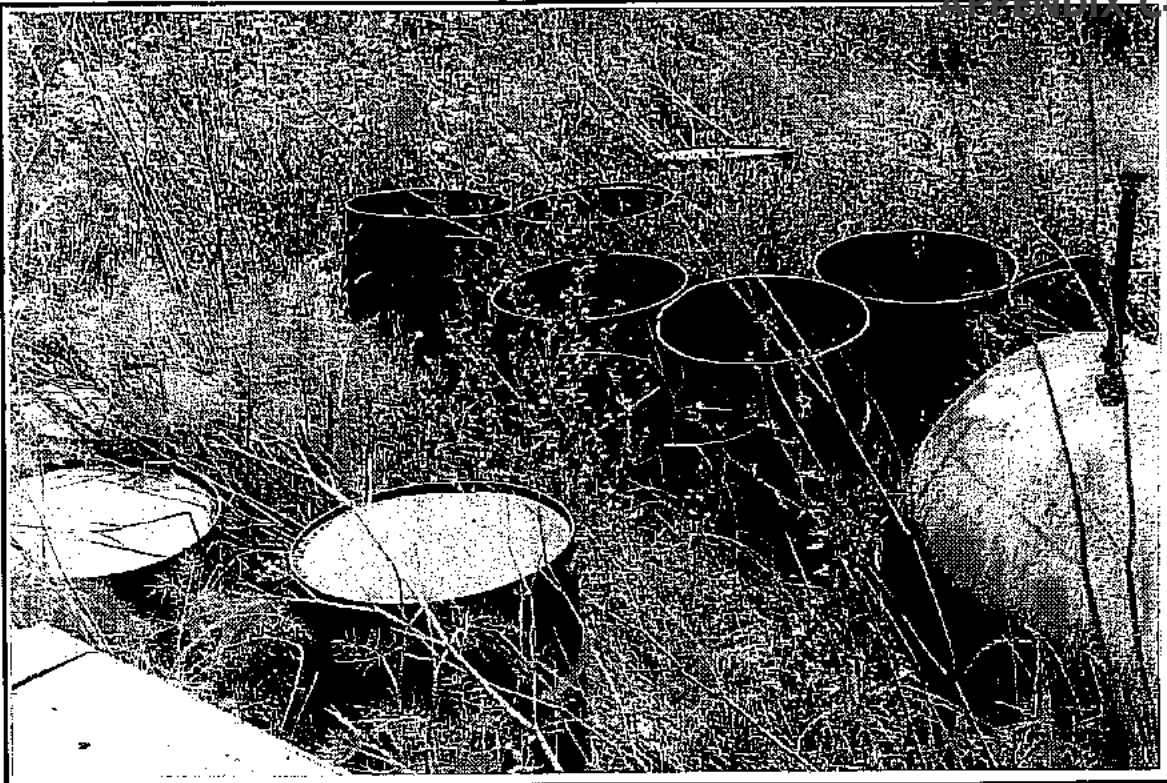
Photo 3: Partial drum quantity (some empty, some partially full of some liquid) near southern portion of debris area.

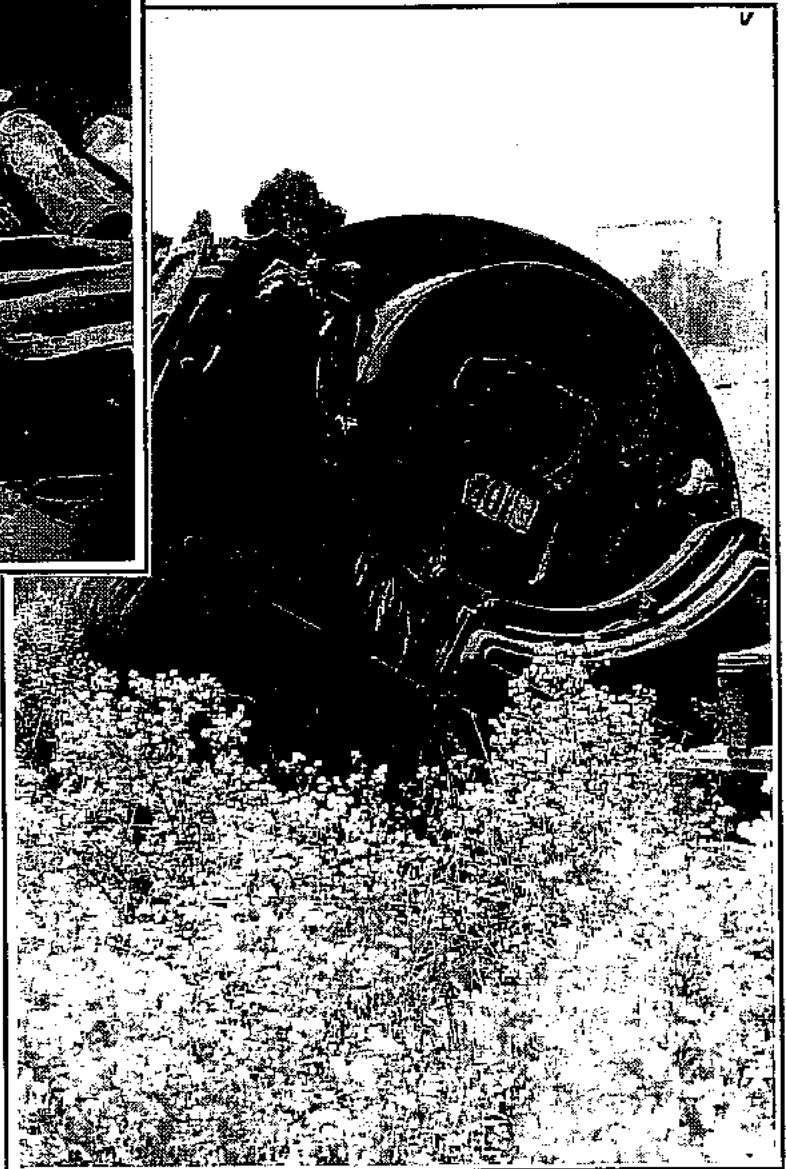
Photo 8: Old boiler deposited in debris area appears to contain friable asbestos liner.
