February 23, 2015 (Revised March 10, 2015)

PHASE I ENVIRONMENTAL SITE ASSESSMENT

898 Lincoln Avenue
898 Lincoln Avenue
San Rafael, Marin County, California 94901

AEI Project No. 339046

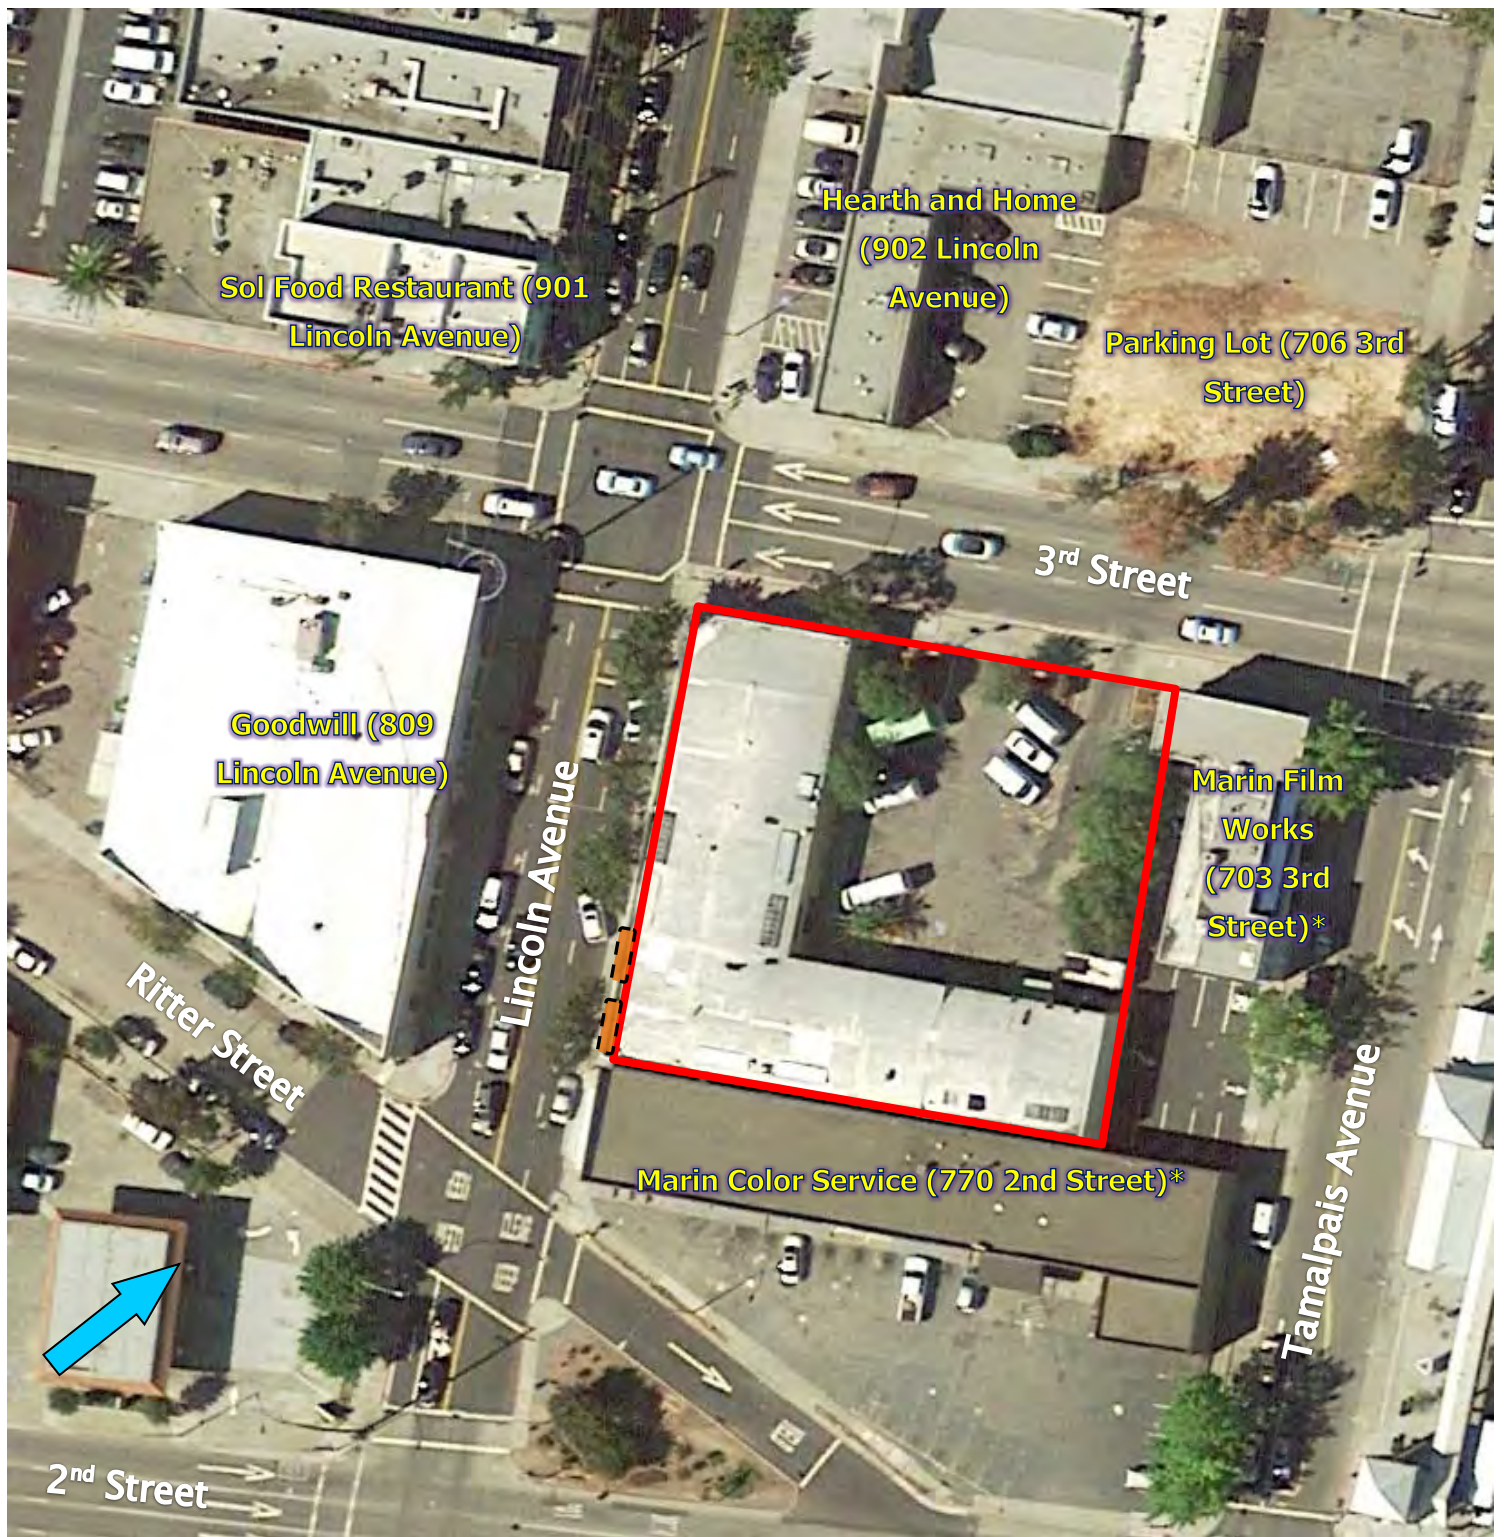
- Legend**
- Former UST  
 - Groundwater Flow Direction  
 - Approximate Property Boundary  
 - Listed in Environmental Database Report *

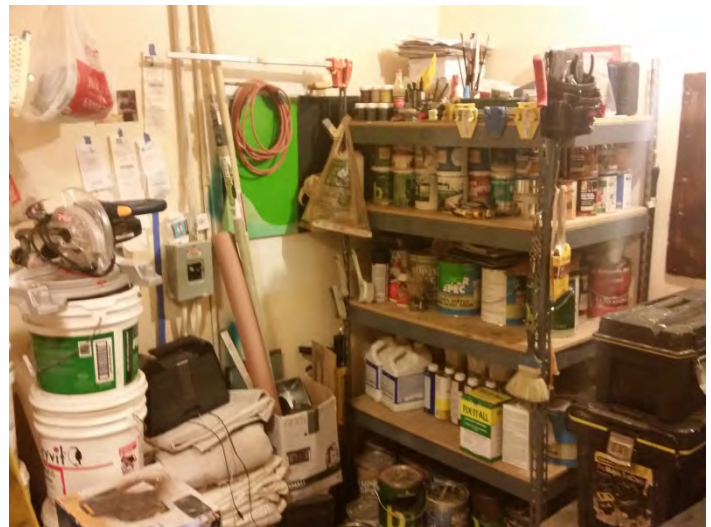
12. Storage room with paints, janitorial chemicals, and property maintenance supplies in the Sol Food partition (upstairs mezzanine storage area)

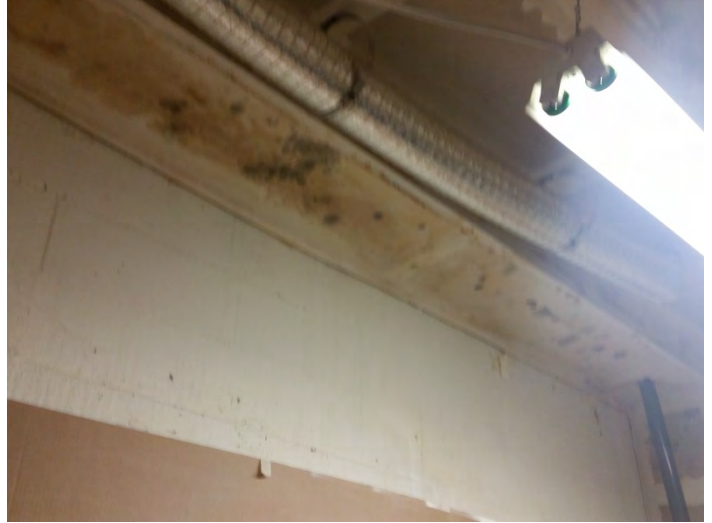
14. Mold on ceiling drywall inside of the paint room

- AEI observed interior areas of the subject property building in order to identify the presence/absence of visible mold (fungal) growth. During the on-site reconnaissance, obvious visible signs of mold growth or conditions conducive for mold growth (water damage) were observed in the spray paint room. Based upon the amount of fungal growth observed, AEI recommends that remediation clean-up of visible mold be conducted by appropriate personnel (typically maintenance personnel for de minimis quantities <10 square feet) within the affected areas, which should include but not be limited to: (1) remediation/cleanup using a mild bleach solution or mold cleaning solution and utilizing appropriate personal protective equipment (PPE) and engineering controls, and (2) disposal of all mold affected building materials that may not be cleaned, as well as used disposable PPE, in sealed plastic bags. Repairs to correct the source of the water intrusion and damage in the impacted area should also be performed where applicable. In addition, in order to assist on-site staff with proper methods of mold growth evaluation and remediation, as well as proper training for on-site maintenance personnel, it would be prudent for the property owner to implement a Mold/Moisture Plan (MMP).

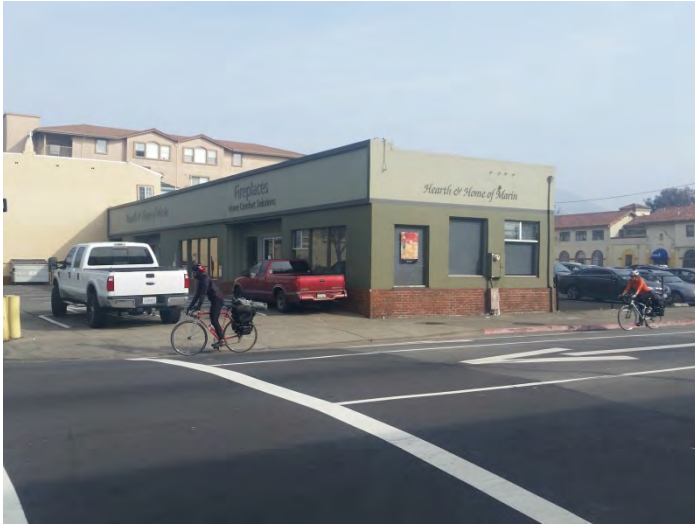
17. 3rd Street followed by the northern adjacent property not listed in the regulatory database, but previously a gas/auto repair station (refer to Section 3.3)

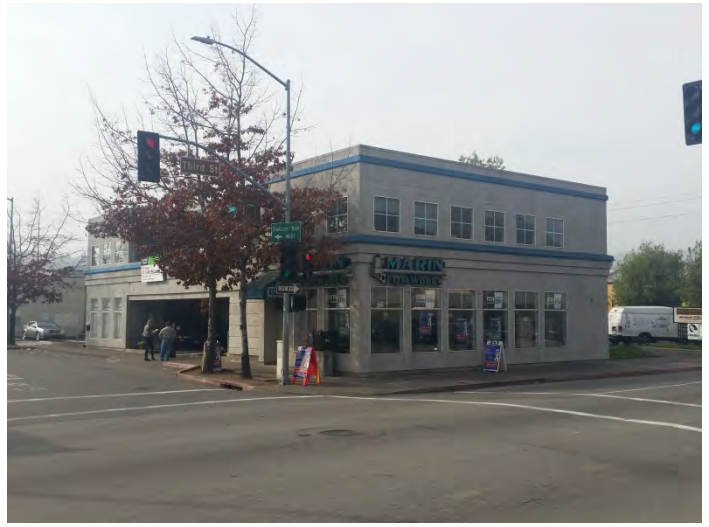
18. Intersection of 3rd Street and Tamalpais Avenue followed by the eastern adjacent Marin Film Works noted in the regulatory database (refer to Section 5.1)

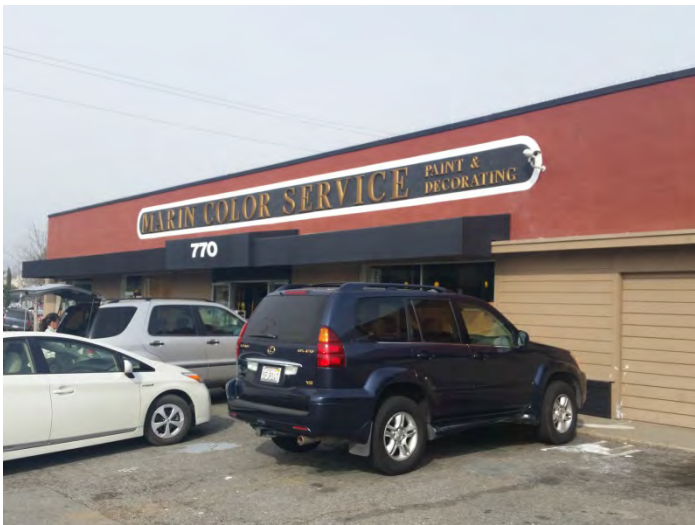
19. Southern adjacent Marin Color Service (770 2nd Street) formerly a gas station and noted in the regulatory database (refer to Section 5.1)
