# Appendix A- Plans and Sections

**THIRD STREET REHABILITATION PROJECT  
EXISTING CONDITION**

**THIRD STREET REHABILITATION PROJECT**  
**PROPOSED IMPROVEMENTS: WEST STREET TO LINCOLN AVENUE**  
**OPTION A**  
 MARIN COUNTY

# **Appendix B- Existing Site Context, Uses and Conditions**

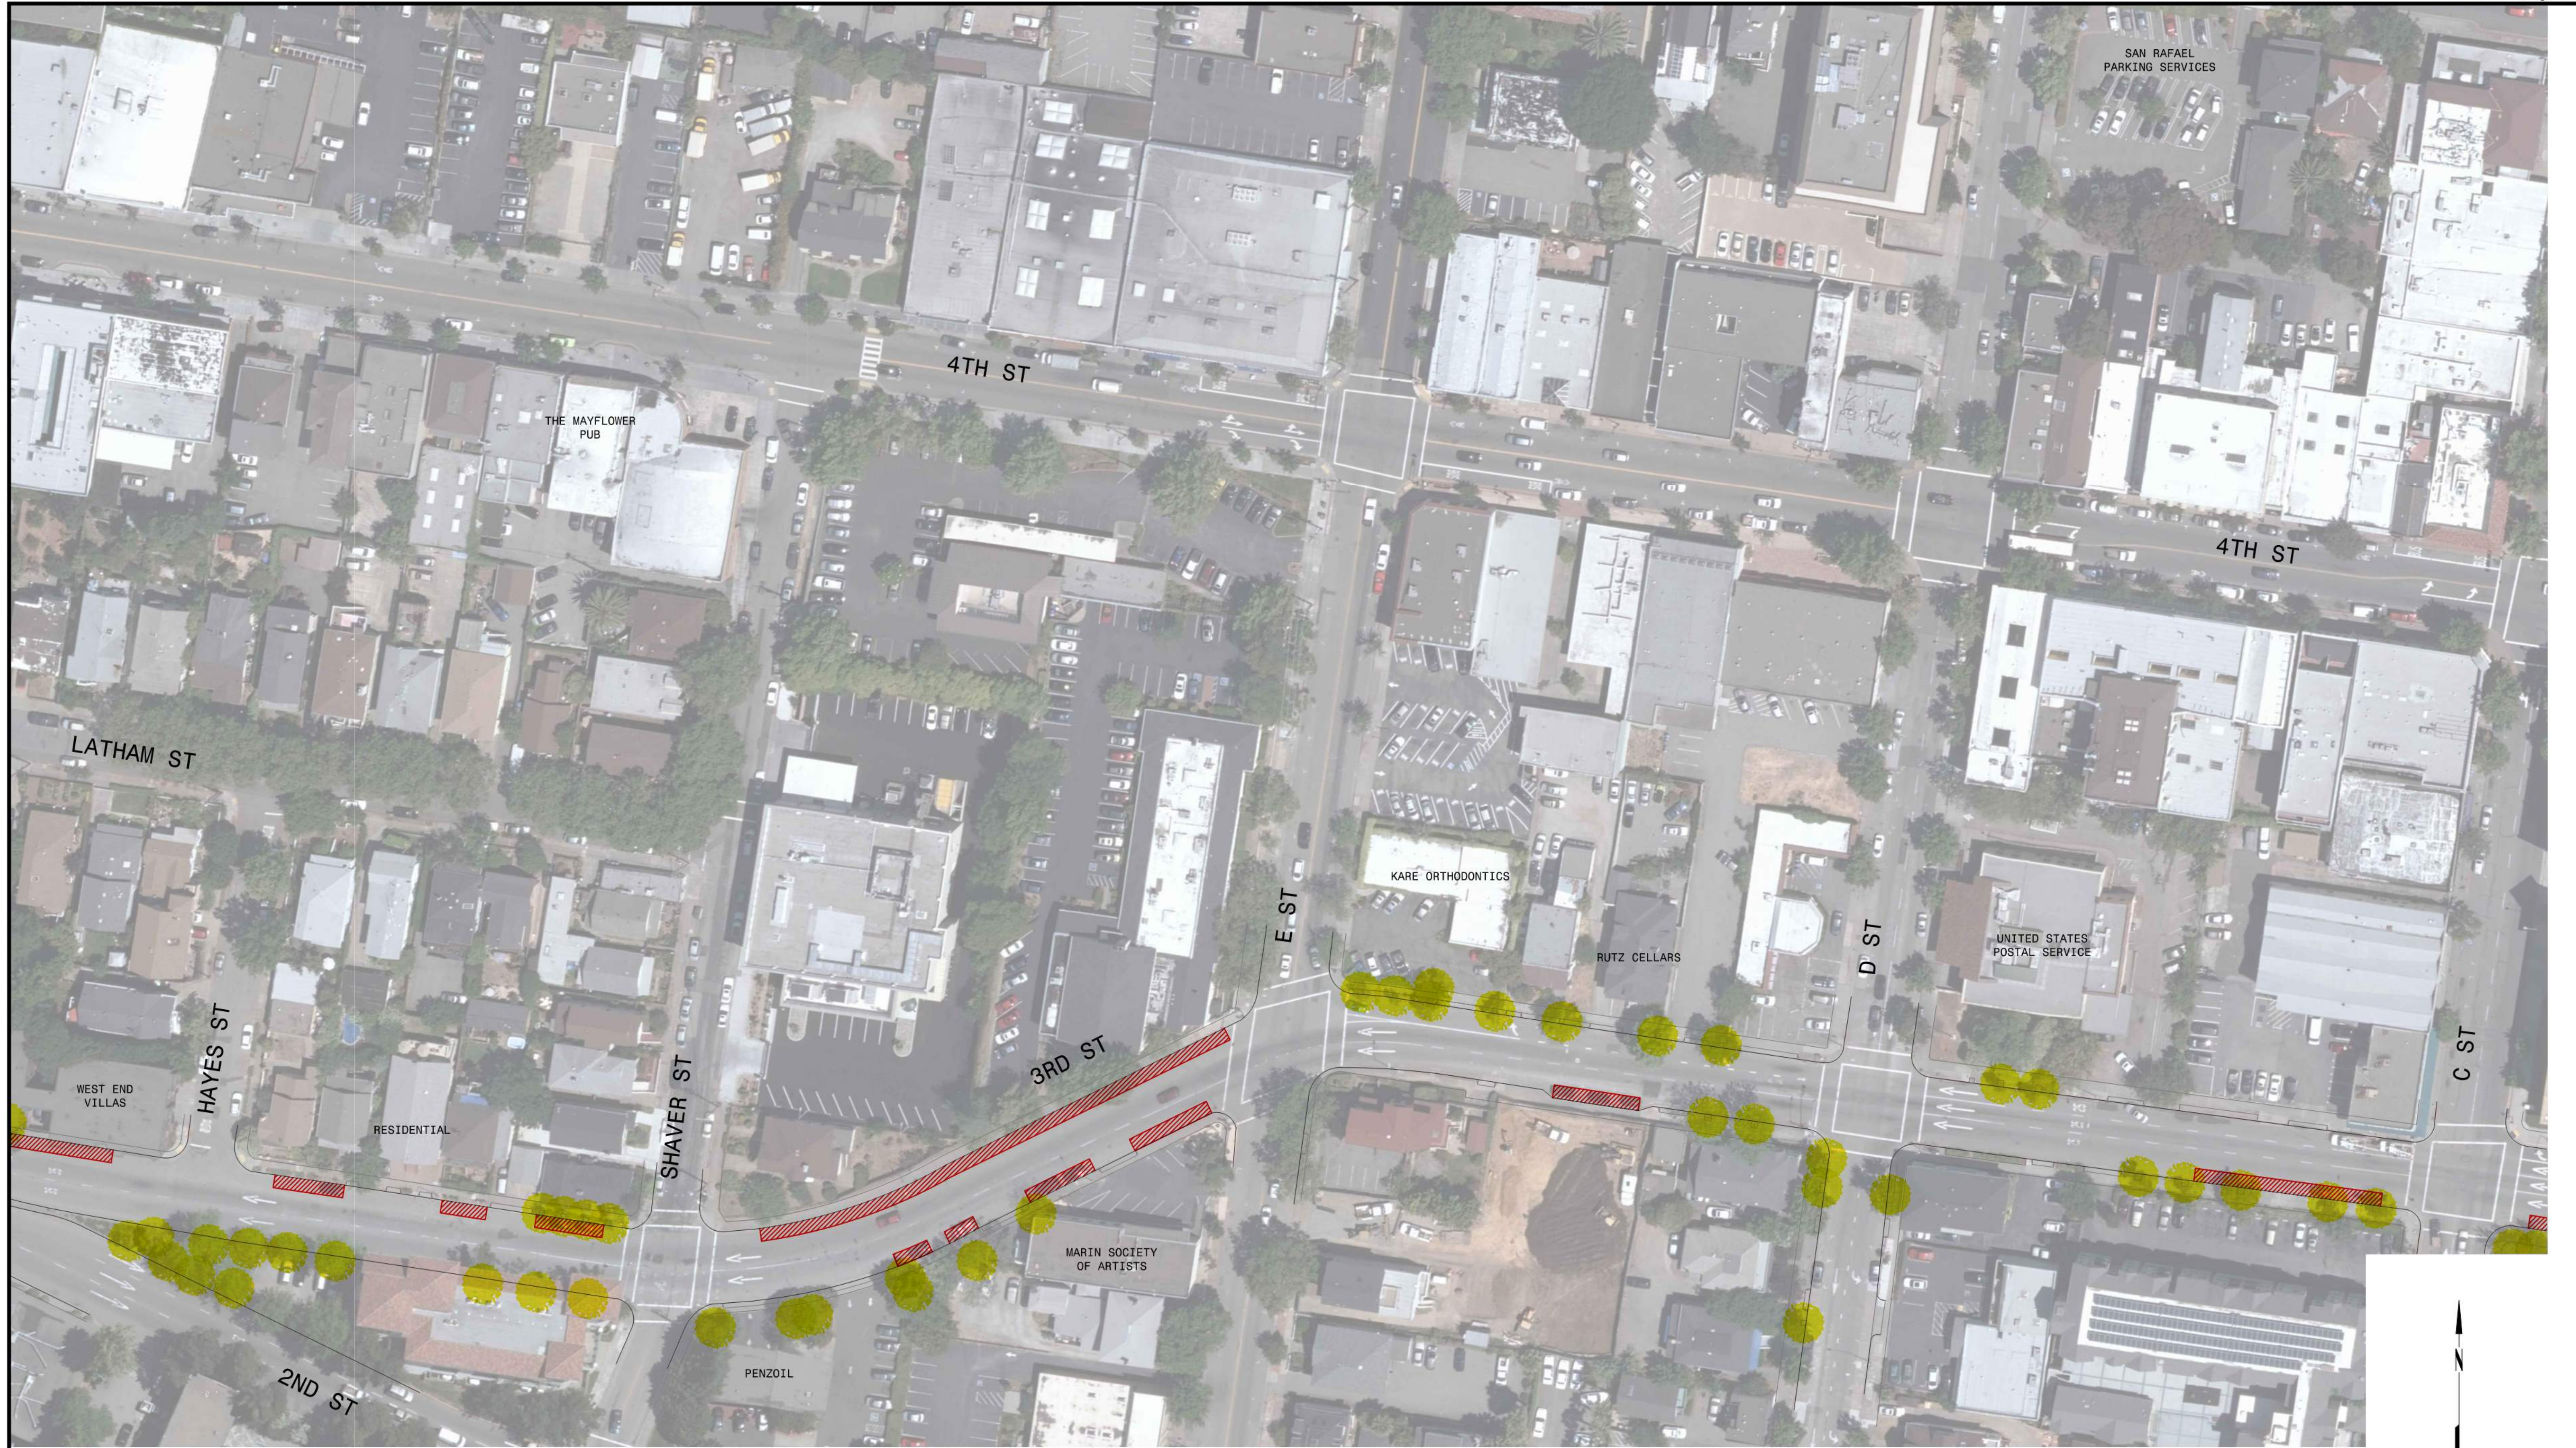
Date 05/25/18	Drawing Number:
Scale AS SHOWN	<b>EXHIBIT 02 OF 04</b>
Design	
Drawn BL	
Approved AM	
Job No 175017

**THIRD STREET REHABILITATION PROJECT  
EXISTING CONDITION**

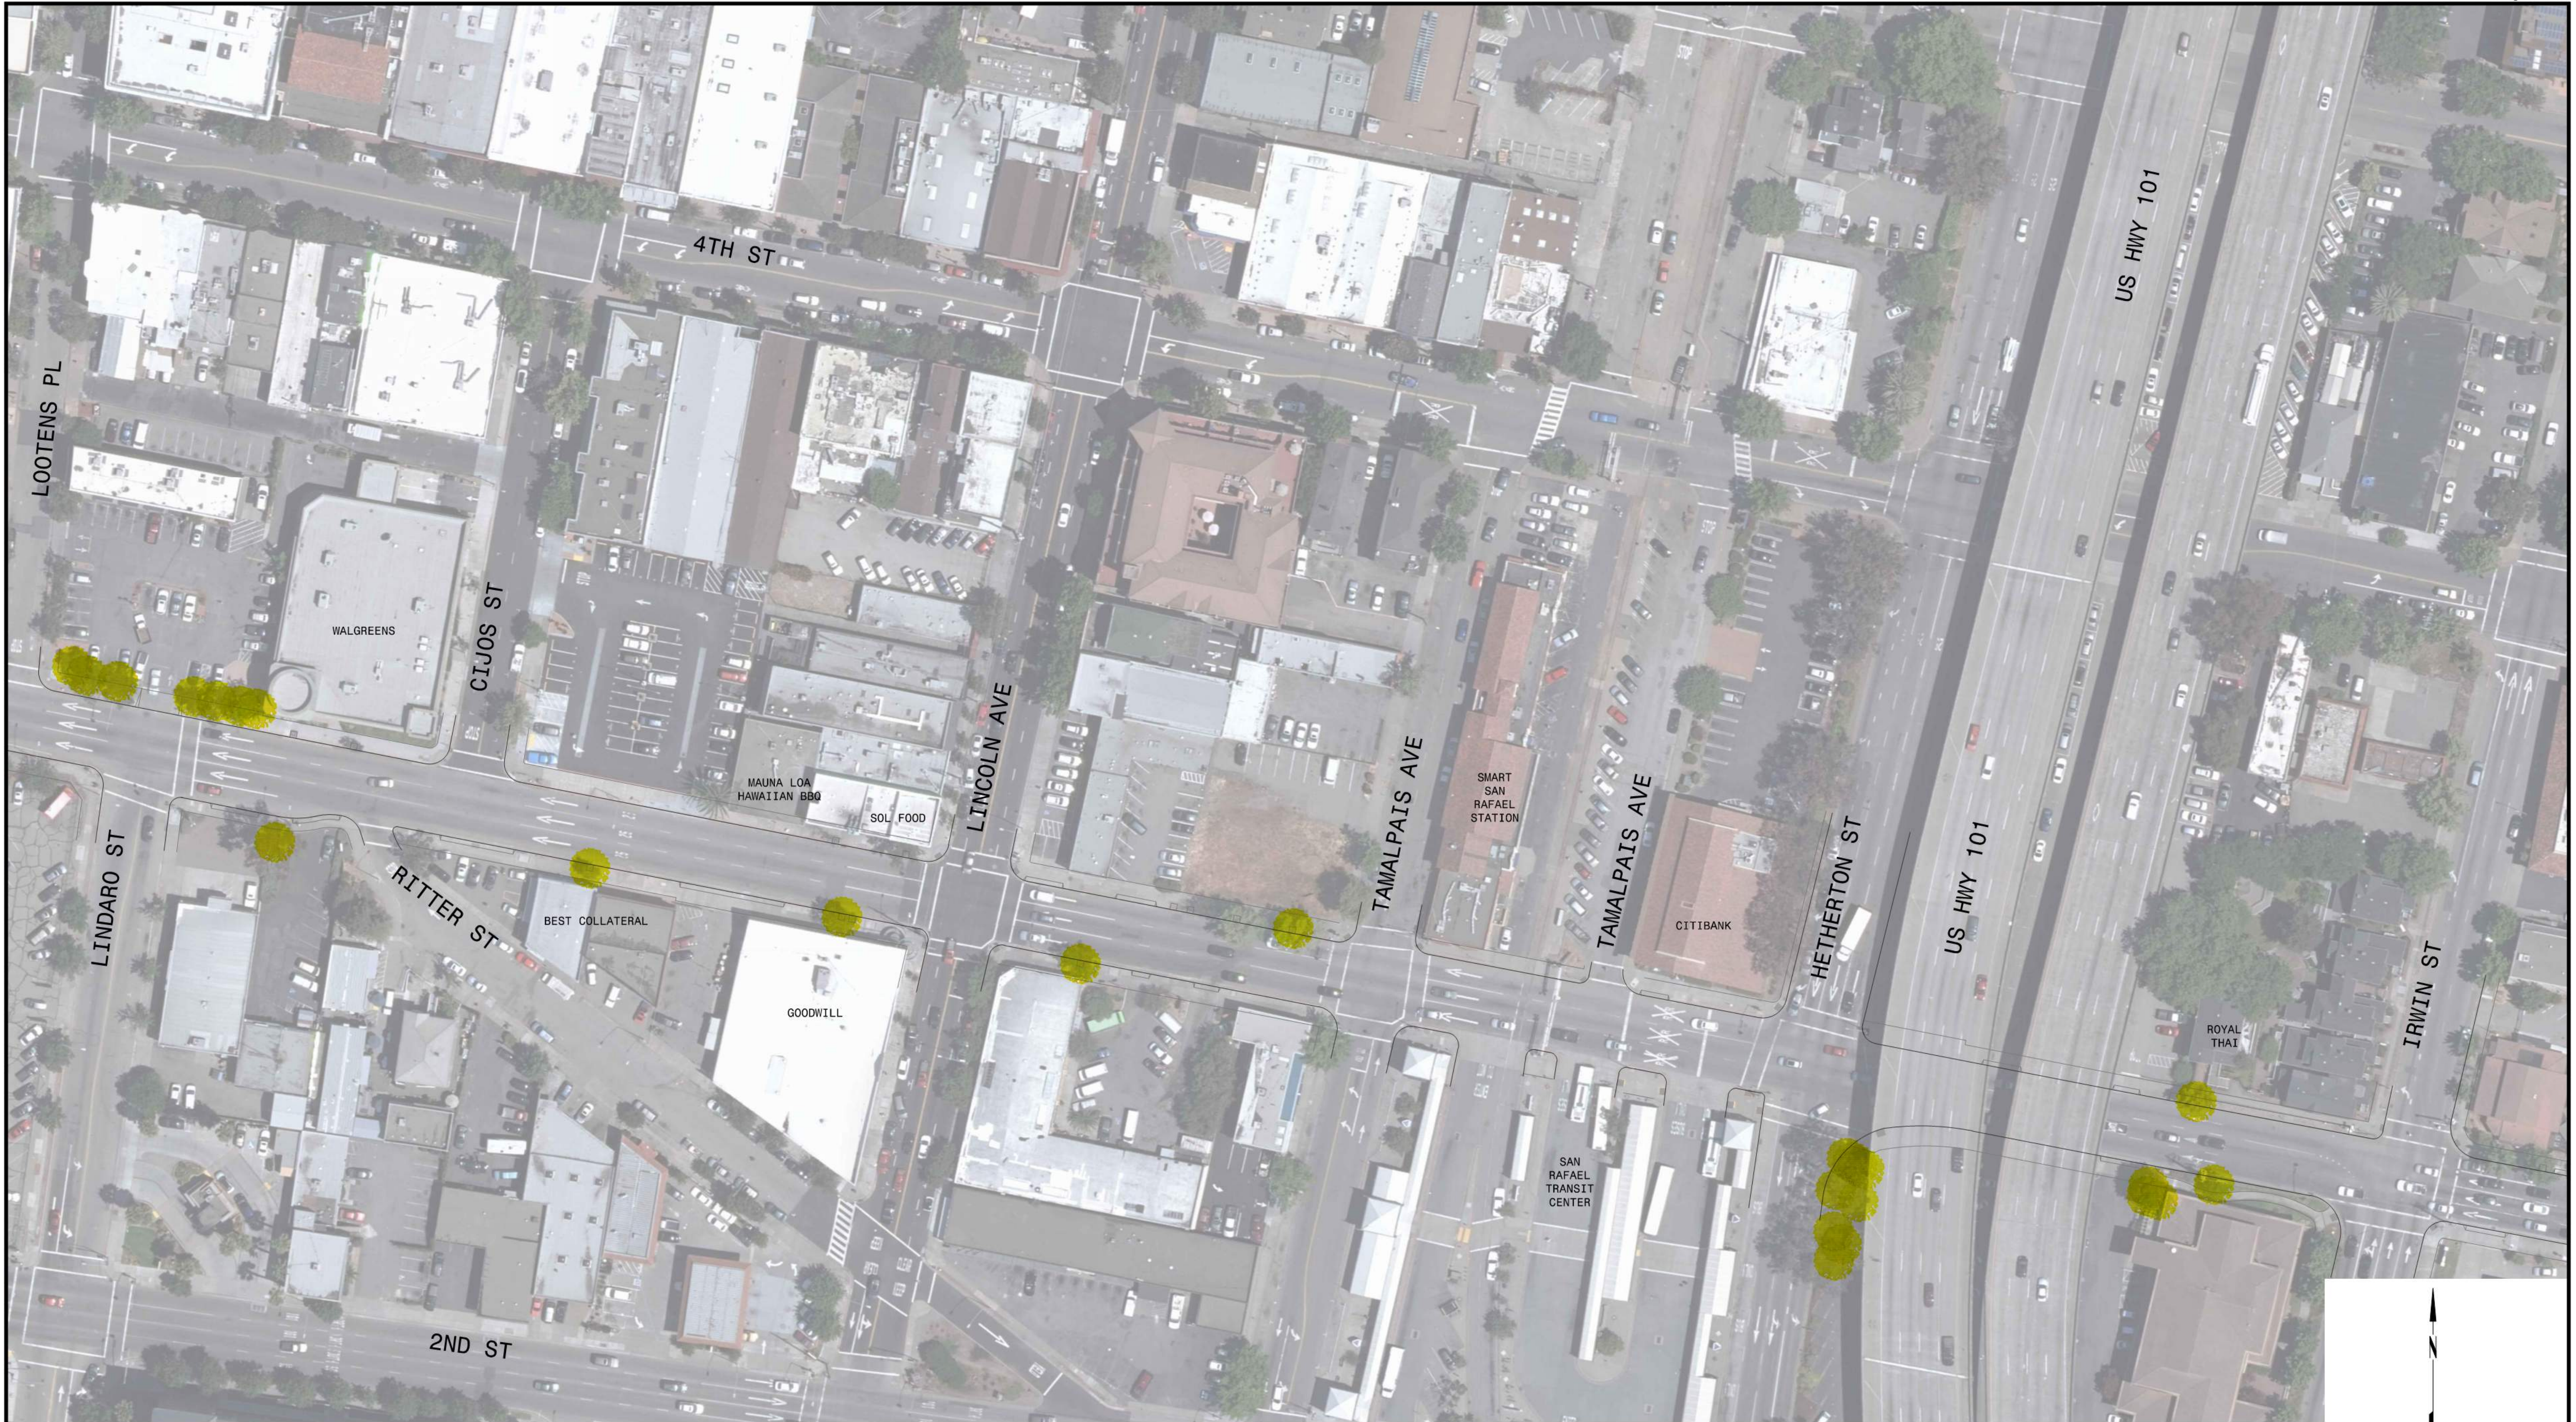
SAN RAFAEL	MARIN COUNTY	CALIFORNIA	Date 05/25/18	Drawing Number:
			Scale AS SHOWN	<b>EXHIBIT 04 OF 04</b>
			Design	
			Drawn BL	
			Approved AM	
			Job No 175017

**THIRD STREET REHABILITATION PROJECT  
EXISTING CONDITION**

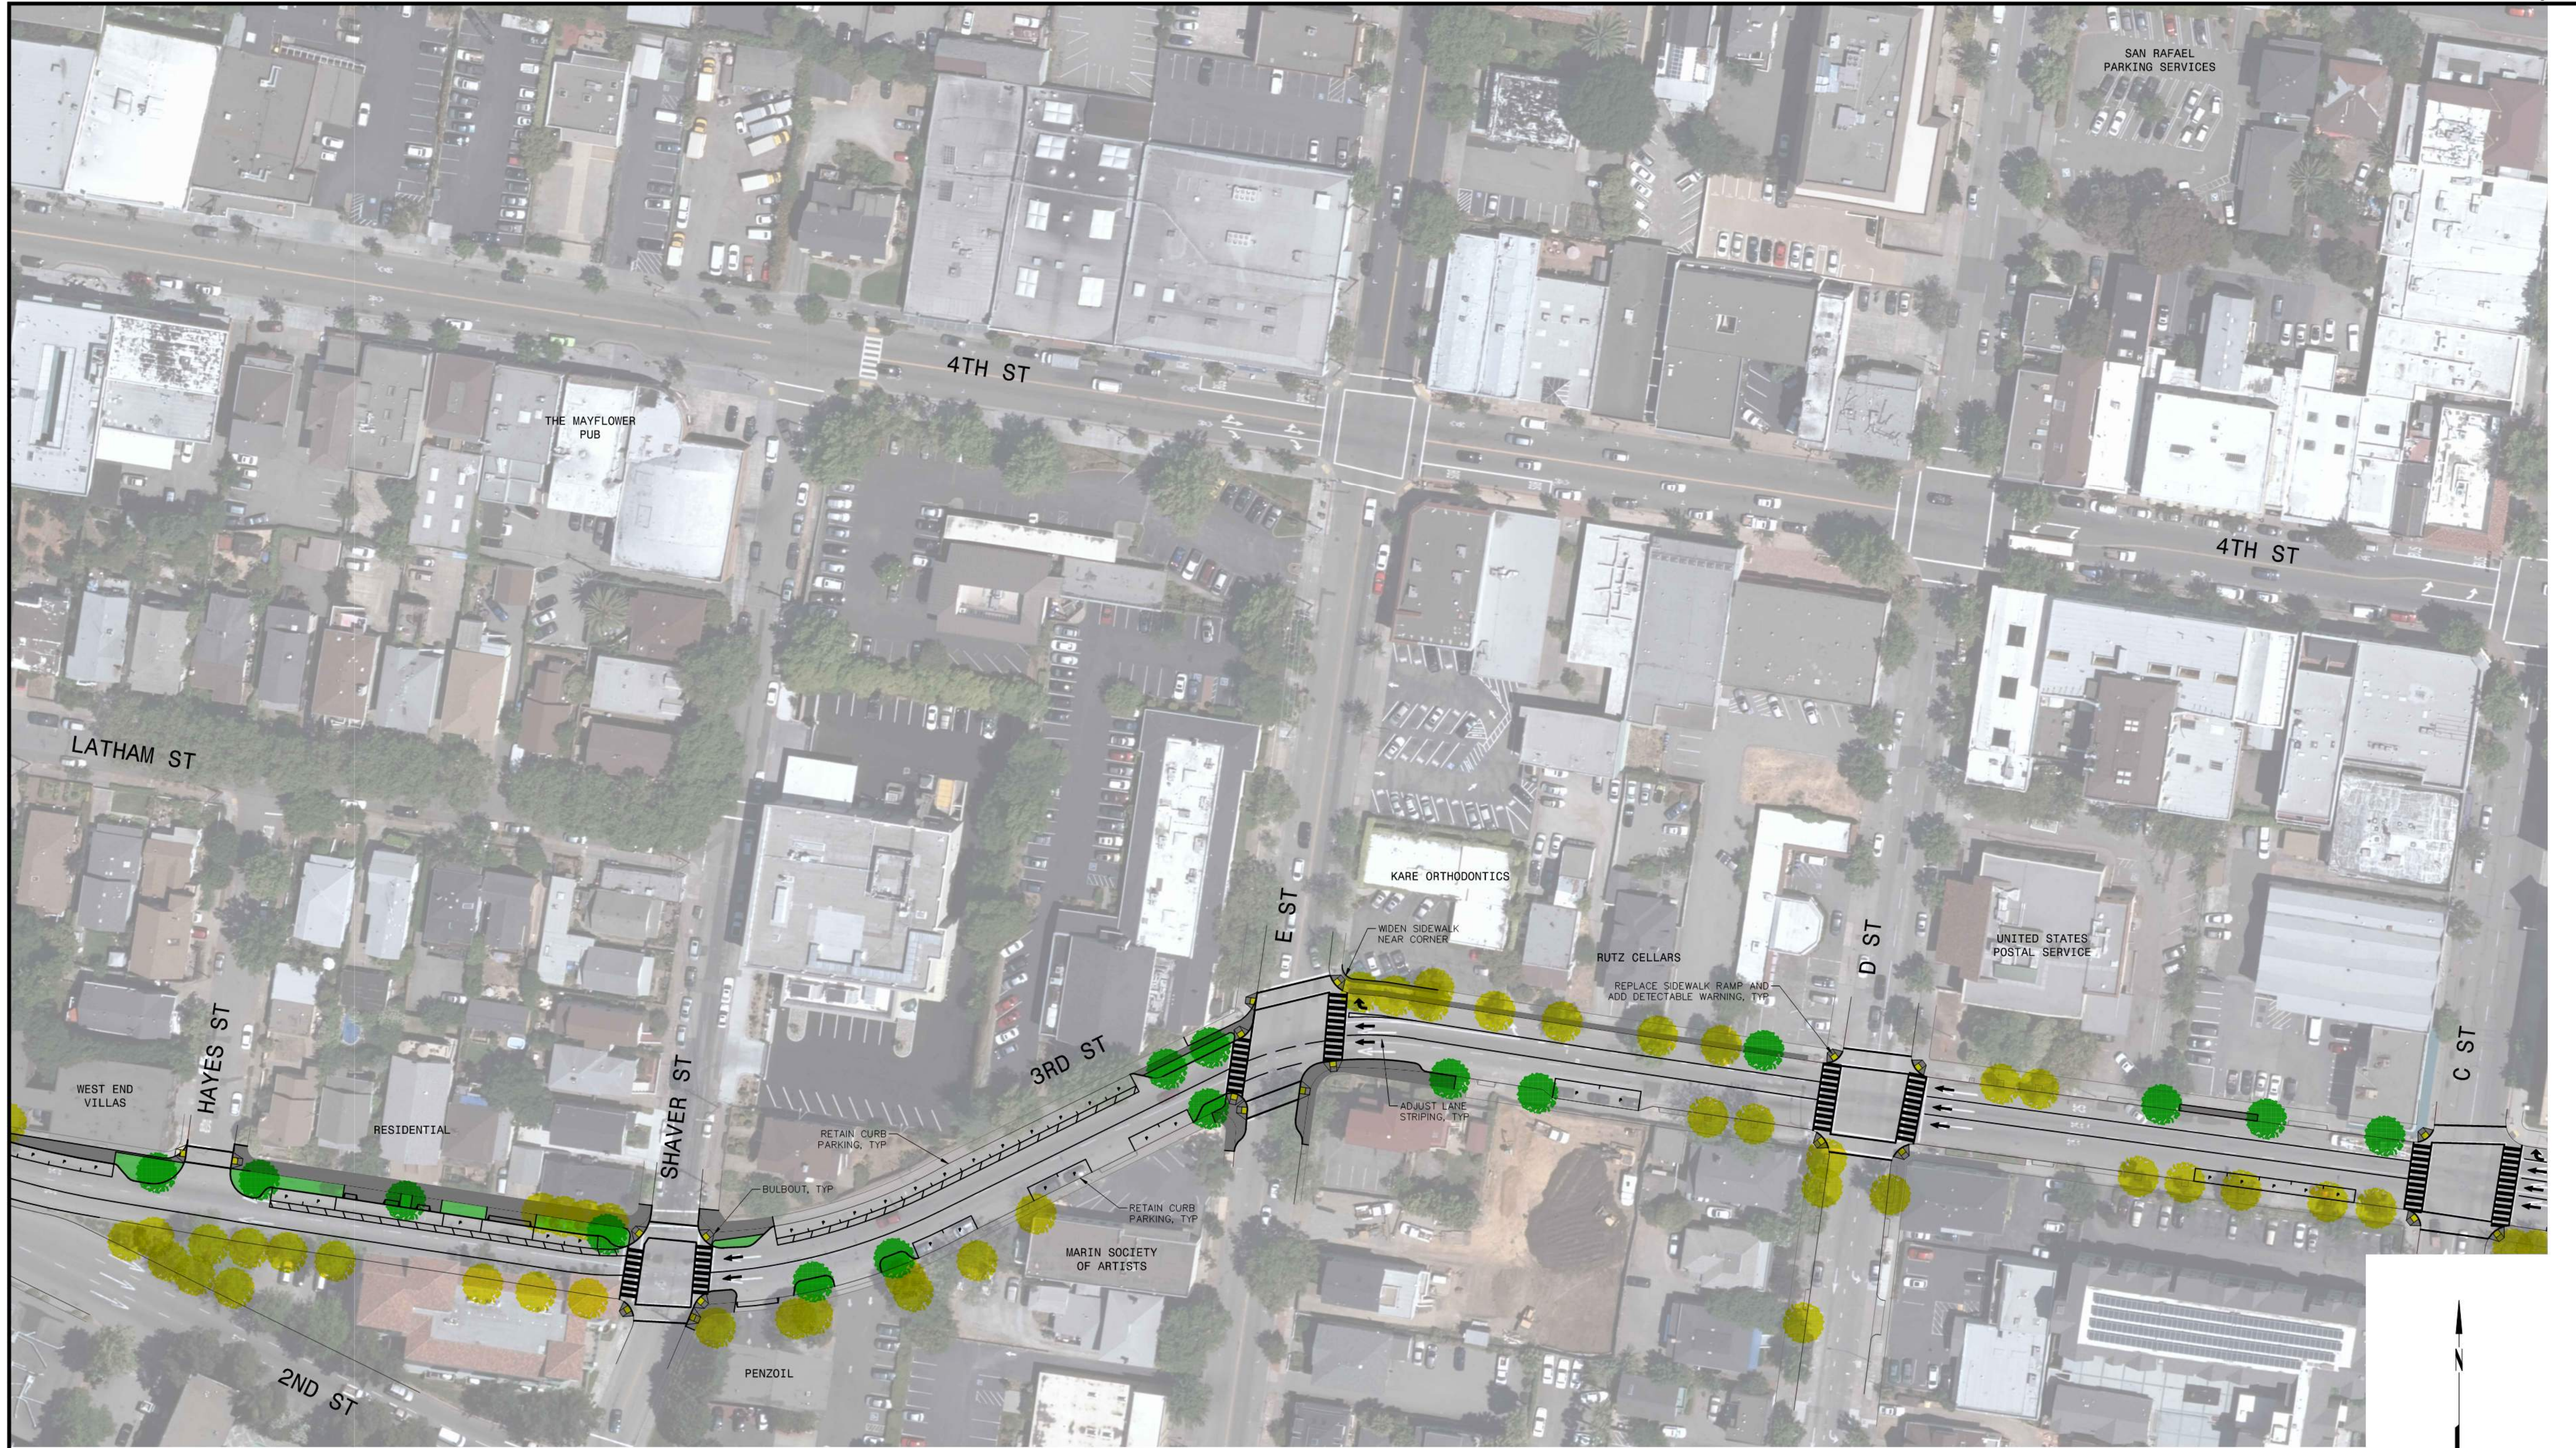
Date 12/07/18	Drawing Number:
Scale AS SHOWN	<b>EXHIBIT</b> <b>02 OF 05</b>
Design	
Drawn BL	
Approved AM	
Job No 175017

**THIRD STREET REHABILITATION PROJECT**  
**PROPOSED IMPROVEMENTS: WEST STREET TO LINCOLN AVENUE**

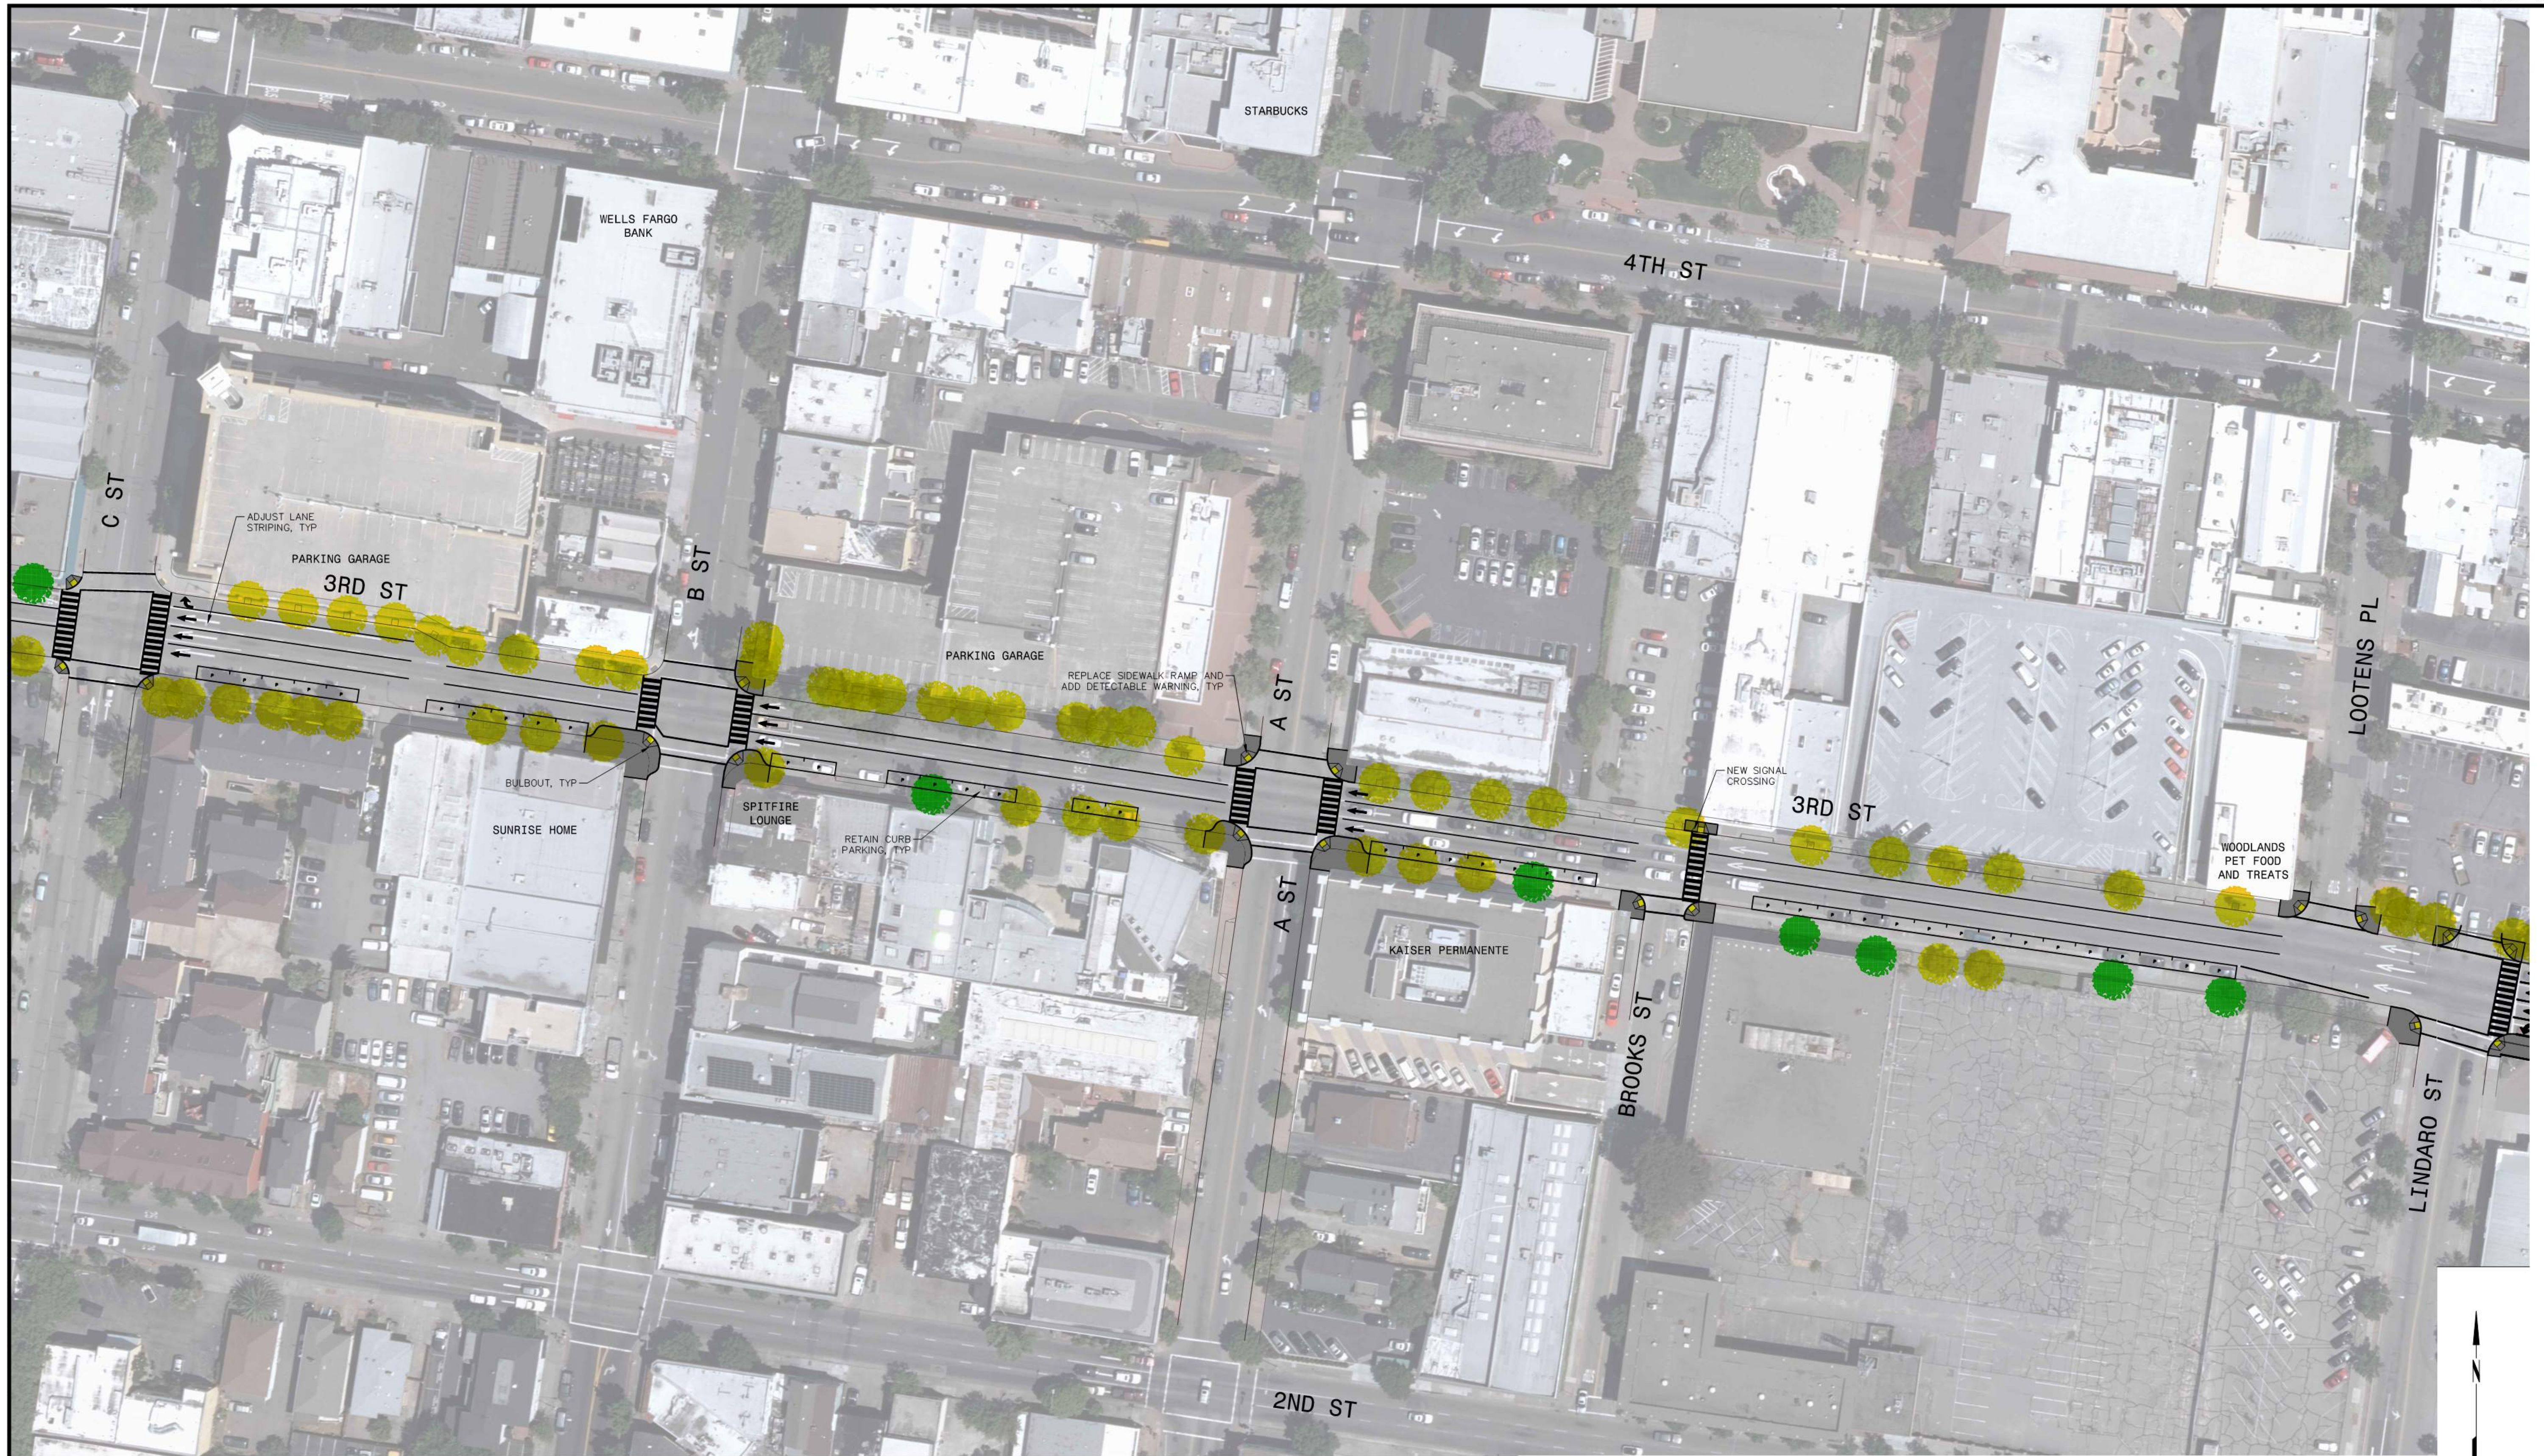
Drawing Number:  
**EXHIBIT**  
**03 OF 05**

**THIRD STREET REHABILITATION PROJECT  
PROPOSED IMPROVEMENTS: WEST STREET TO LINCOLN AVENUE**

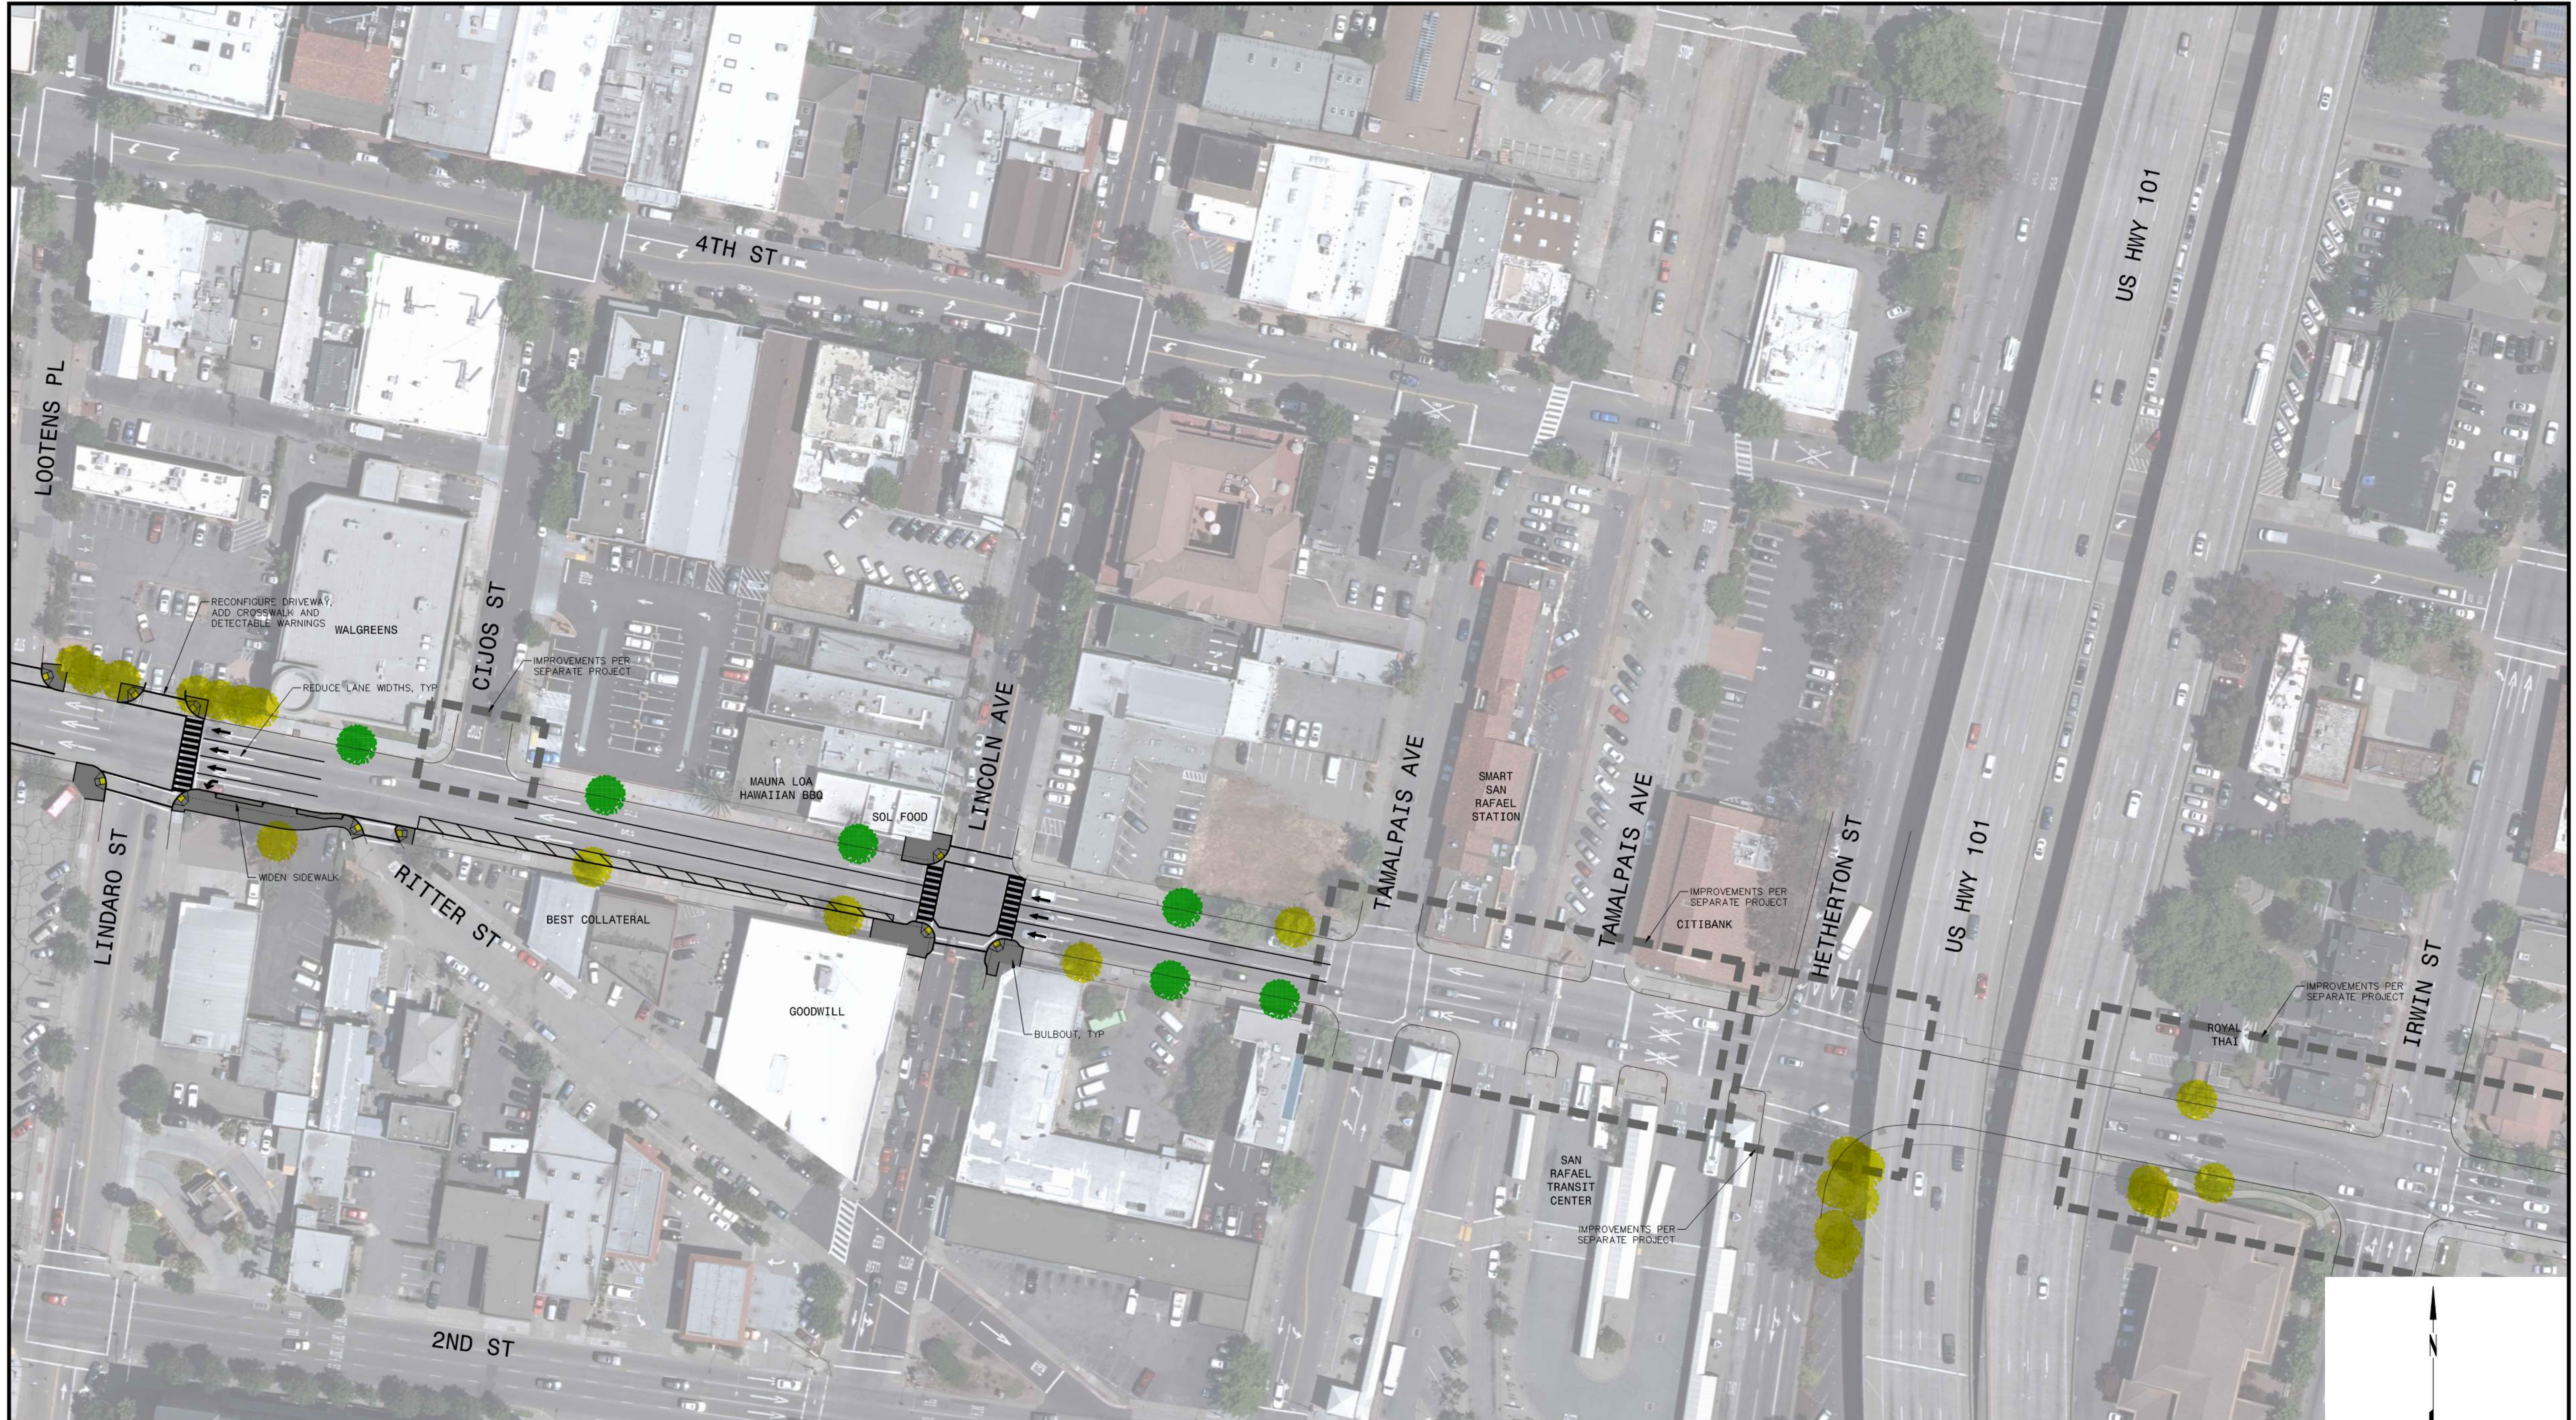
Date 12/07/18	Drawing Number:
Scale AS SHOWN	<b>EXHIBIT</b> <b>04 OF 05</b>
Design	
Drawn BL	
Approved AM	
Job No 175017

**THIRD STREET REHABILITATION PROJECT**  
**PROPOSED IMPROVEMENTS: WEST STREET TO LINCOLN AVENUE**

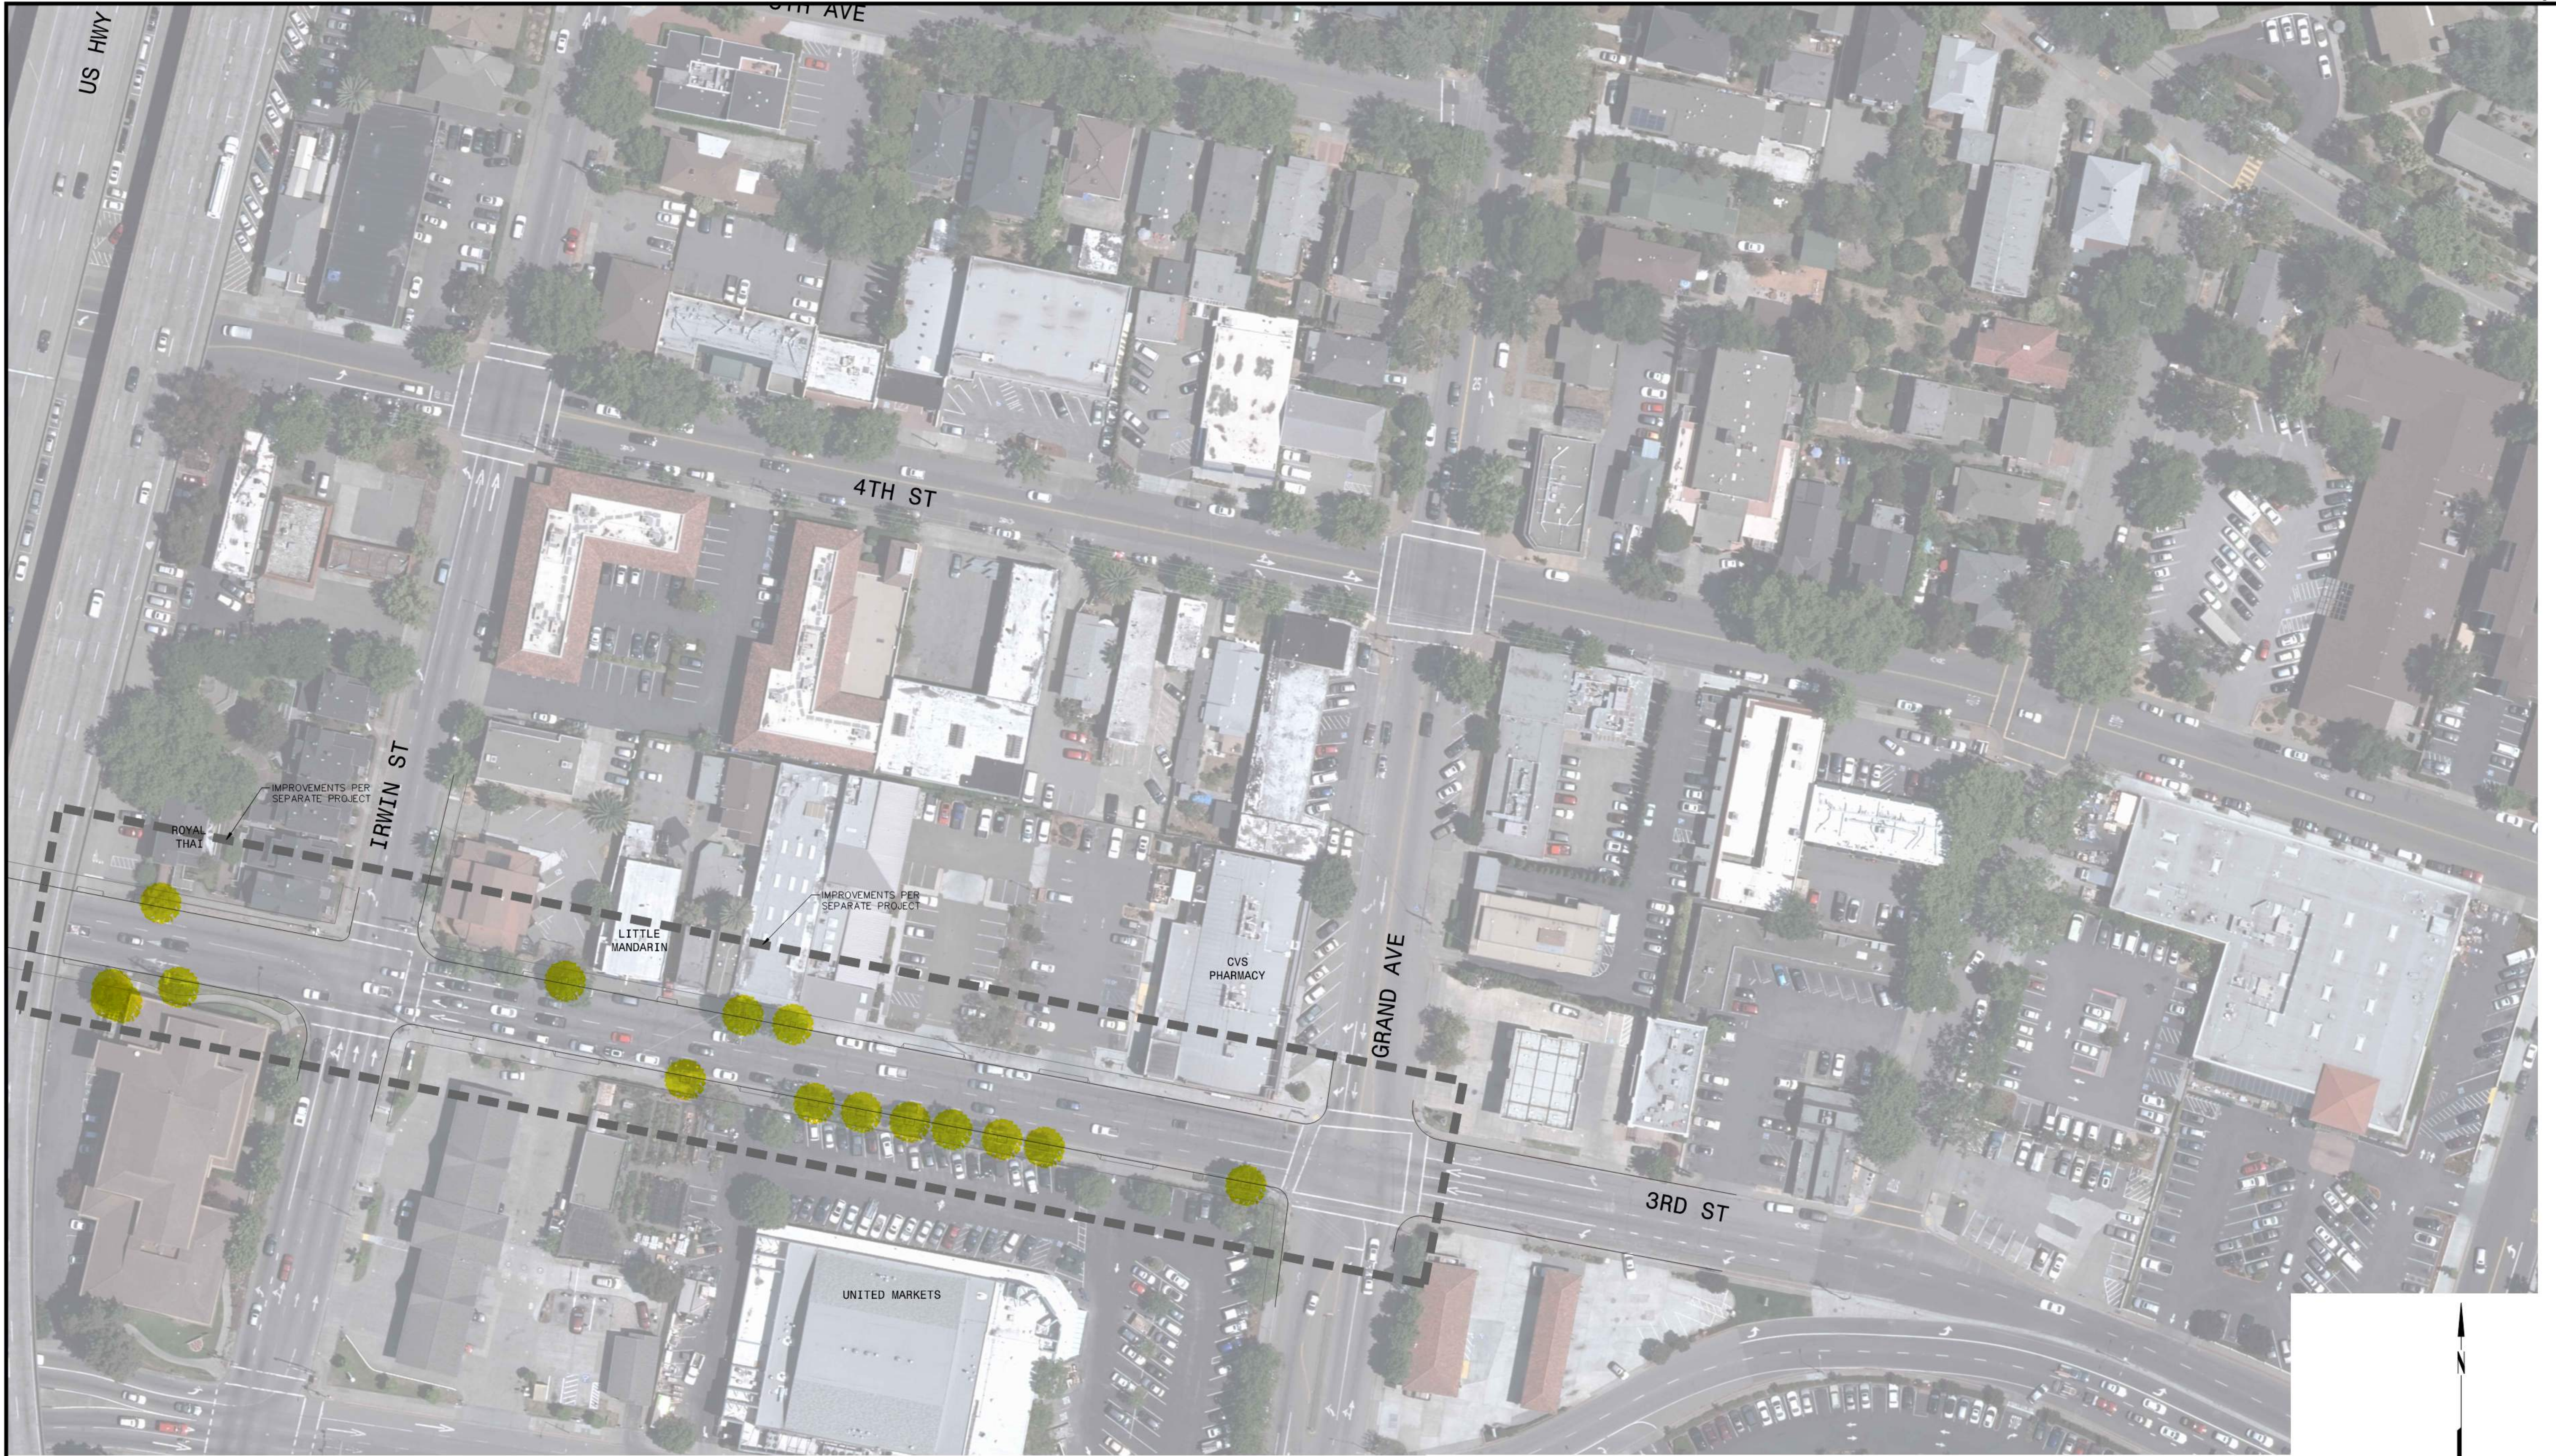
Date 12/07/18	Drawing Number:
Scale AS SHOWN	<b>EXHIBIT 05 OF 05</b>
Design	
Drawn BL	
Approved AM	
Job No 175017

**THIRD STREET REHABILITATION PROJECT  
PROPOSED IMPROVEMENTS: WEST STREET TO LINCOLN AVENUE**
