# Appendix A- Plans and Sections

**THIRD STREET REHABILITATION PROJECT  
EXISTING CONDITION**

**THIRD STREET REHABILITATION PROJECT**  
**PROPOSED IMPROVEMENTS: WEST STREET TO LINCOLN AVENUE**  
**OPTION A**  
 MARIN COUNTY

# **Appendix B- Existing Site Context, Uses and Conditions**

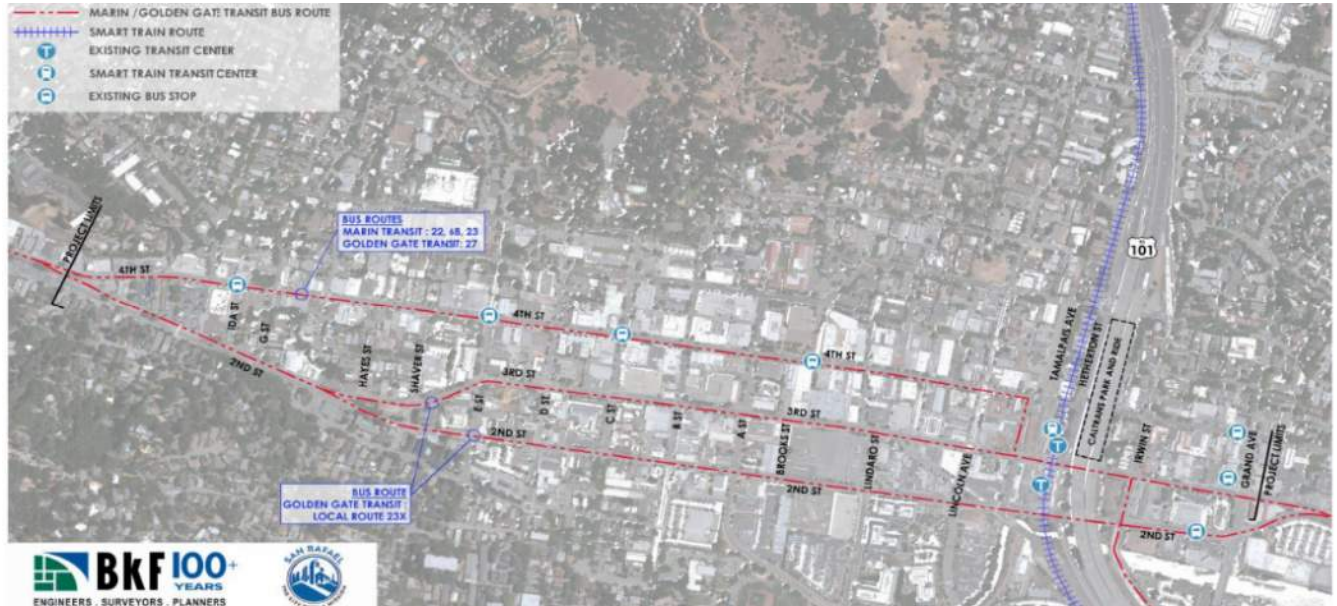
Figure B5: Transit Use

Golden Gate transit and Marin Transit operate bus routes down Third Street with stops at Grand Avenue and the Bettini Center. The local bus route that serves the downtown businesses is located on Fourth Street. Refer to Figure 5 for corridor related bus routes.

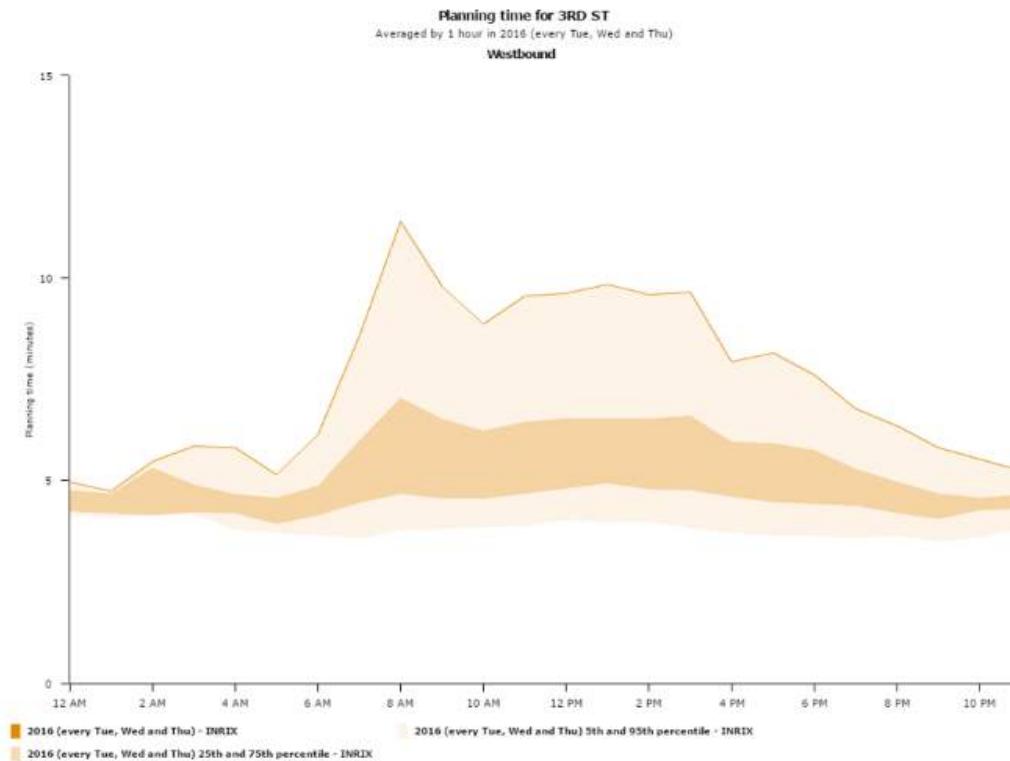
Figure C1: Vehicle Congestion

The average daily traffic on Third Street varies along the length of the corridor between 19,200 and 24,700 daily vehicles. Peak period vehicle congestion is summarized in Table 1. Traffic delay is typically described in terms of Level of Service (LOS). LOS is a qualitative measure of several factors on traffic operating conditions, including speed and travel time. In both the AM and PM peak periods, Third Street's LOS is C between Fourth Street and US 101, corresponding to an average travel speed of 17-19 mph. Currently the corridor is typically congested on weekdays between the hours of 7:00 AM and 4:00 PM with the highest congestion occurring at 8:00 AM.

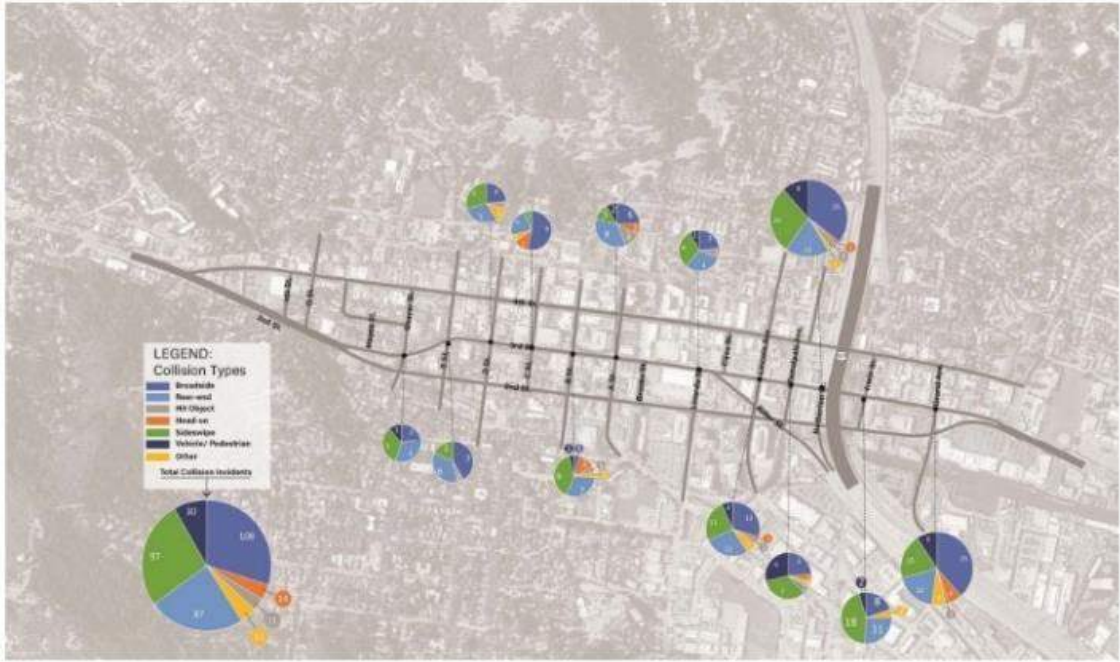
Figure C3: Collision Types

According to the Statewide Integrated Traffic Records System, there were 362 reported collisions along the Third Street study area between 2011 and 2016. One hundred twenty of the reported collisions were injury collisions. Walking and bicycling collisions represent 11 percent and 2 percent of collisions along the study area, respectively. The 2018 San Rafael Bicycle and Pedestrian Master Plan, 2018 Update identifies Third Street as the corridor with the greatest occurrence of pedestrian-involved collisions per mile in San Rafael, with 55 pedestrian collisions between 2009 and 2016. Third Street was also identified as having the most pedestrian collisions per individual intersection in San Rafael, specifically with the intersections in the transit zone (pedestrian collisions measured between 2009 and 2016).

Figure 9 shows the distribution of all collisions (vehicle, bicycle and pedestrian) throughout the study area with the three highest collision intersections being Third Street and Hetherton Street, Third Street and Grand Avenue, and Third Street and Lincoln Avenue. The most common type of collisions in the study area are broadside collisions, which account for 30% of all collisions, and sideswipe collisions, which account for 27% of all collisions. Both the Hetherton Avenue and Grand Avenue intersections are part of a separate study by the City.

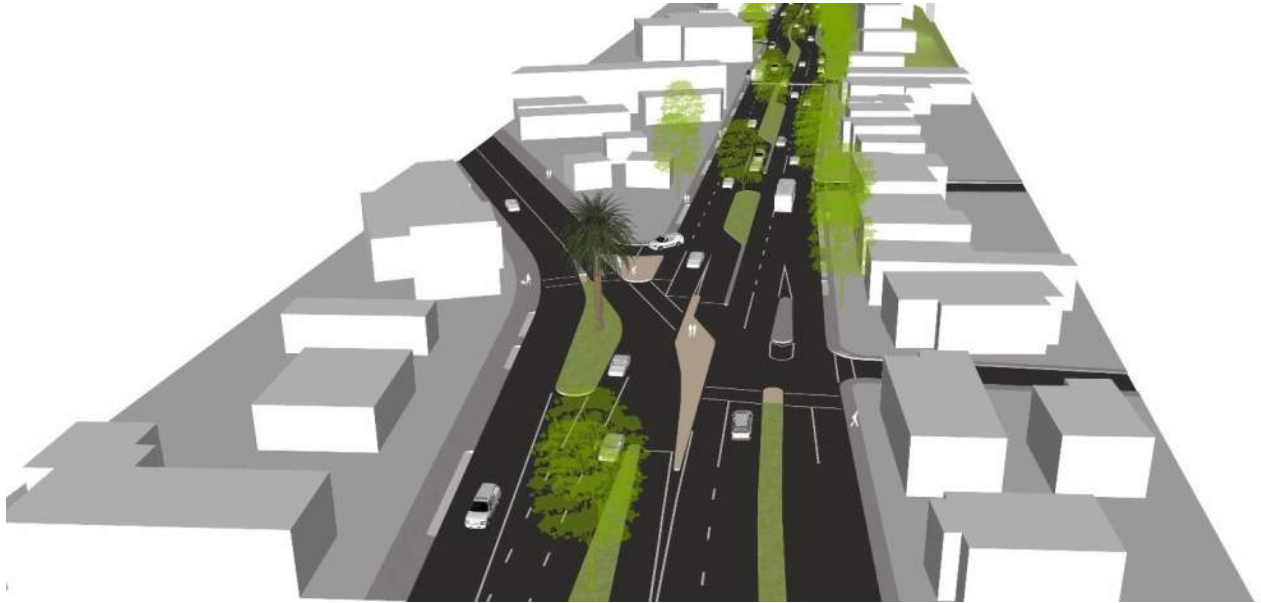
Figure D1: Fourth Street Intersection Existing Rendering

The project study team began to analyze the Fourth Street Intersection and came up with a few potential renderings for squaring off the intersection. After further discussions with the city and community, this intersection was removed from the scope due to schedule of additional analysis including traffic study and right of way mapping and acquisition, and funding.

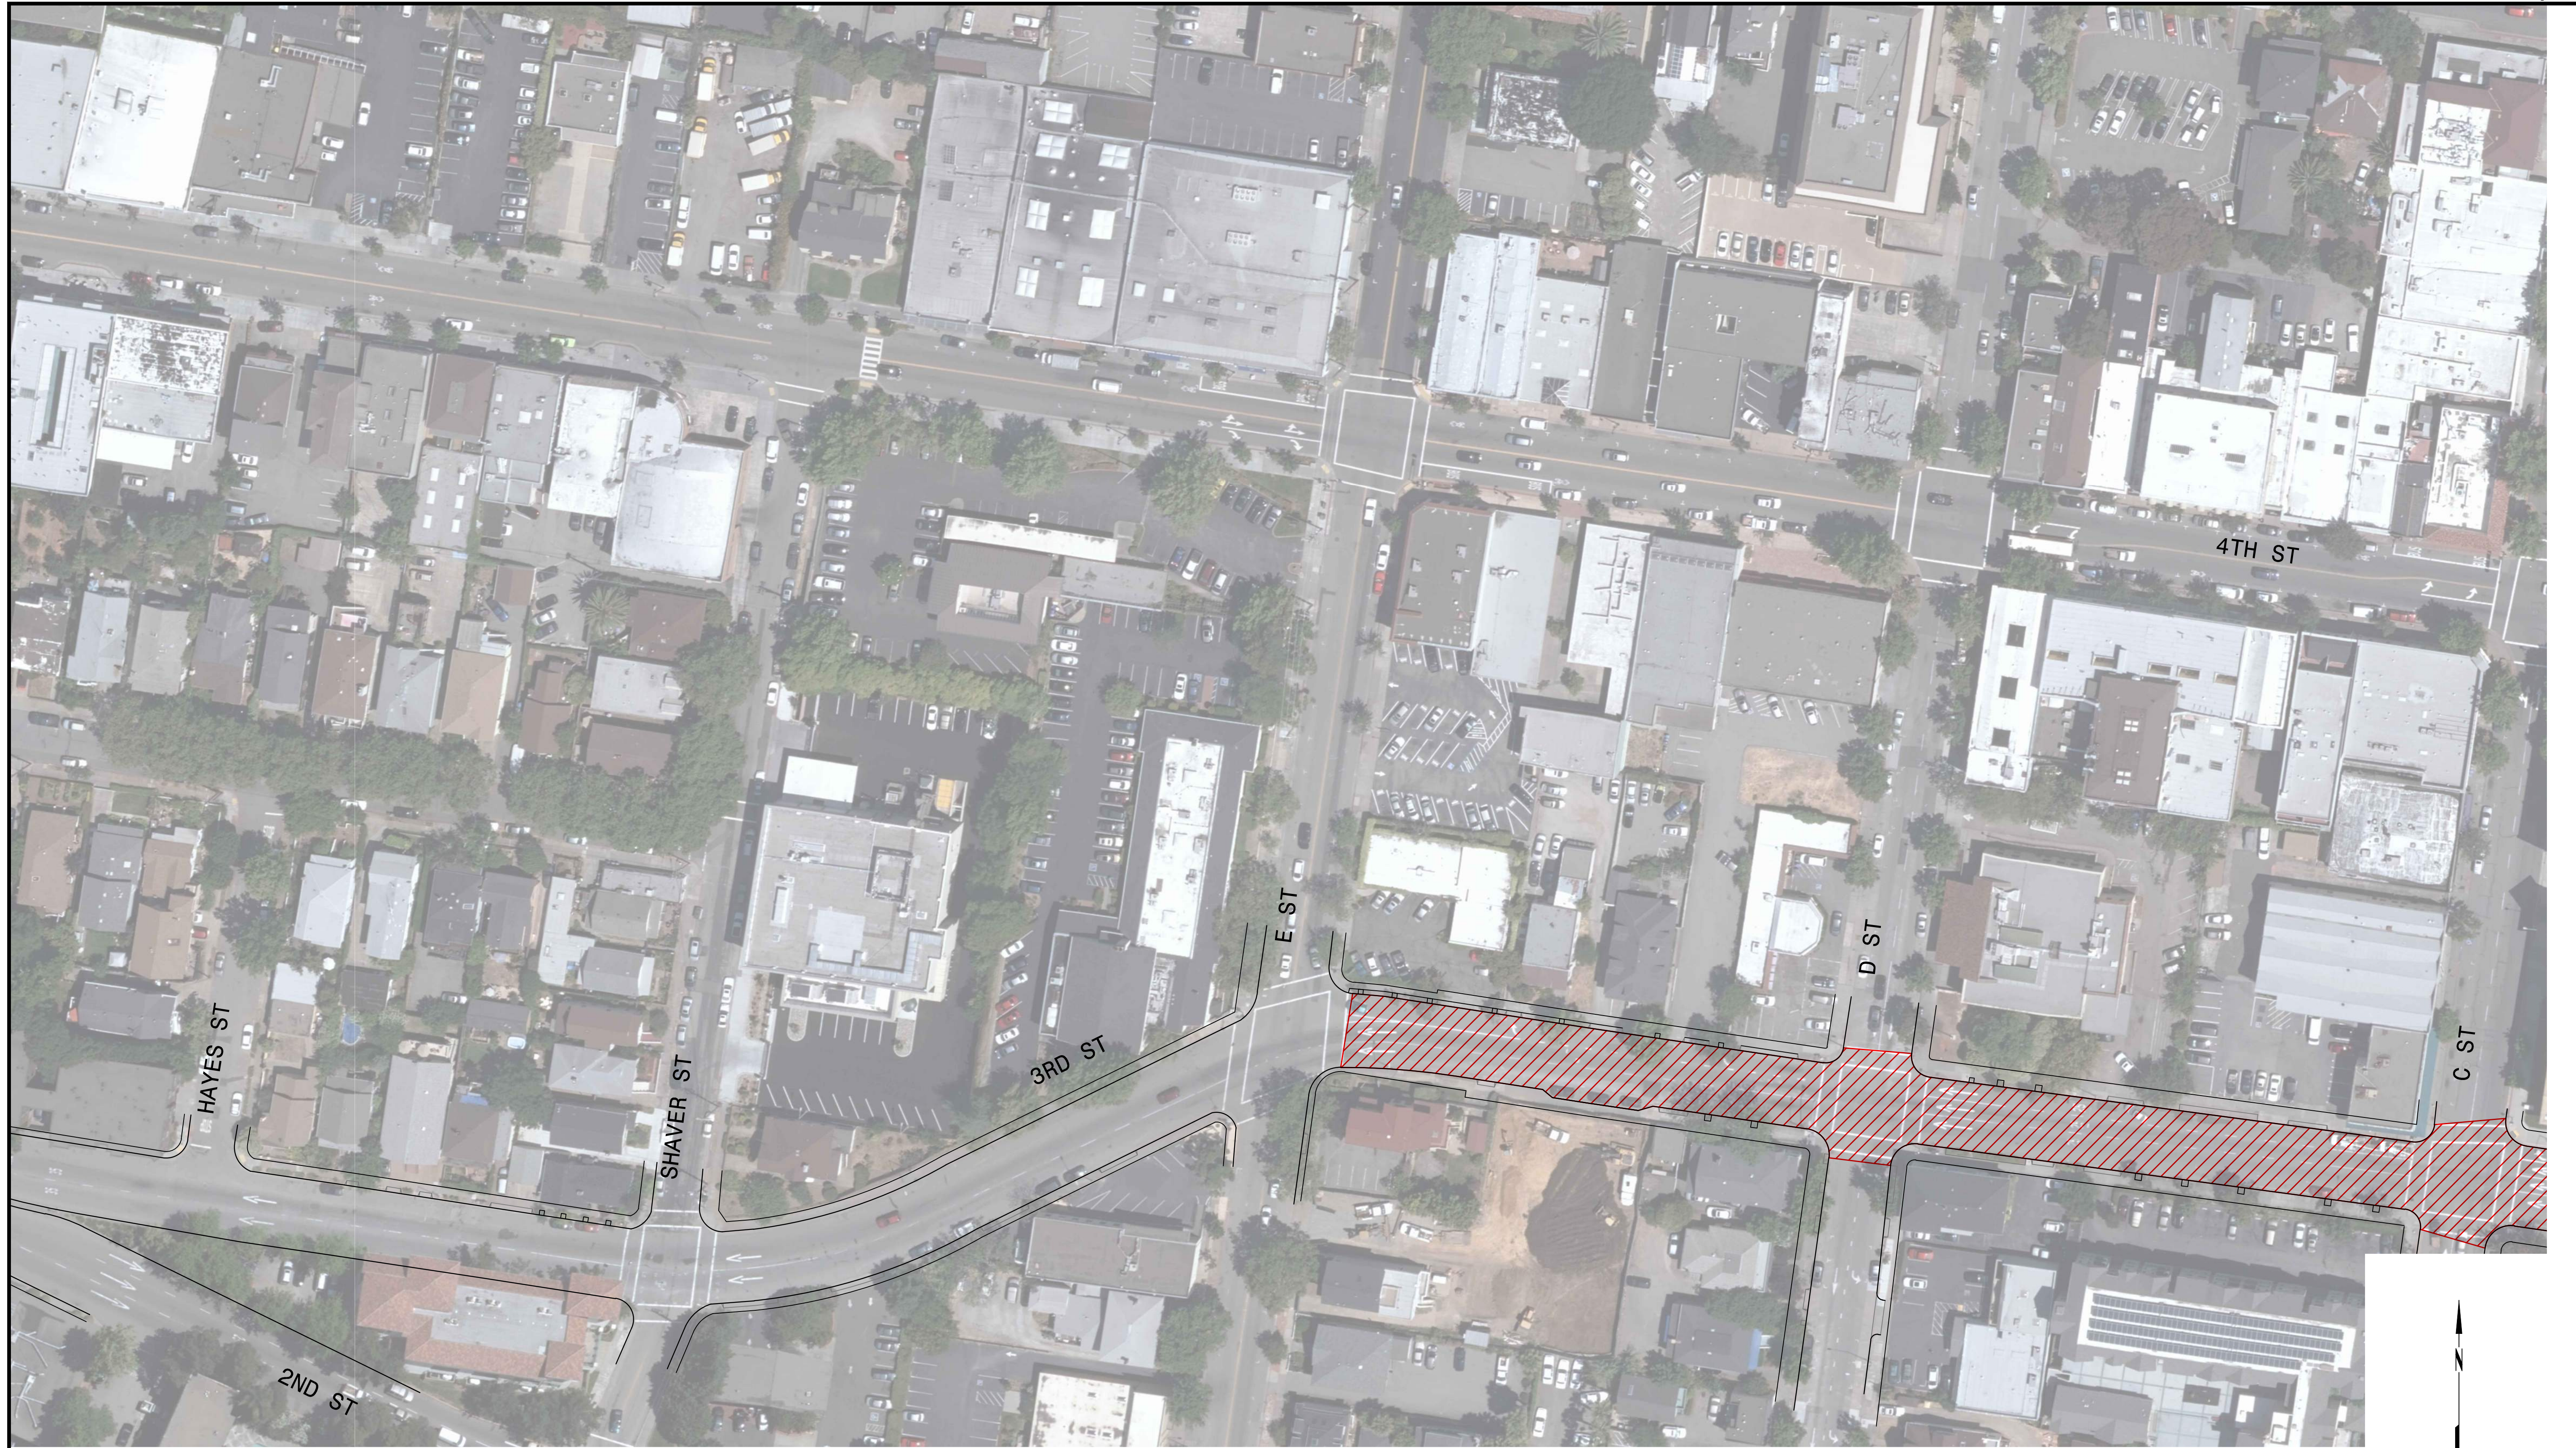
**THIRD STREET REHABILITATION PROJECT  
CROSS SLOPE REDUCTION OPPORTUNITY MAP**

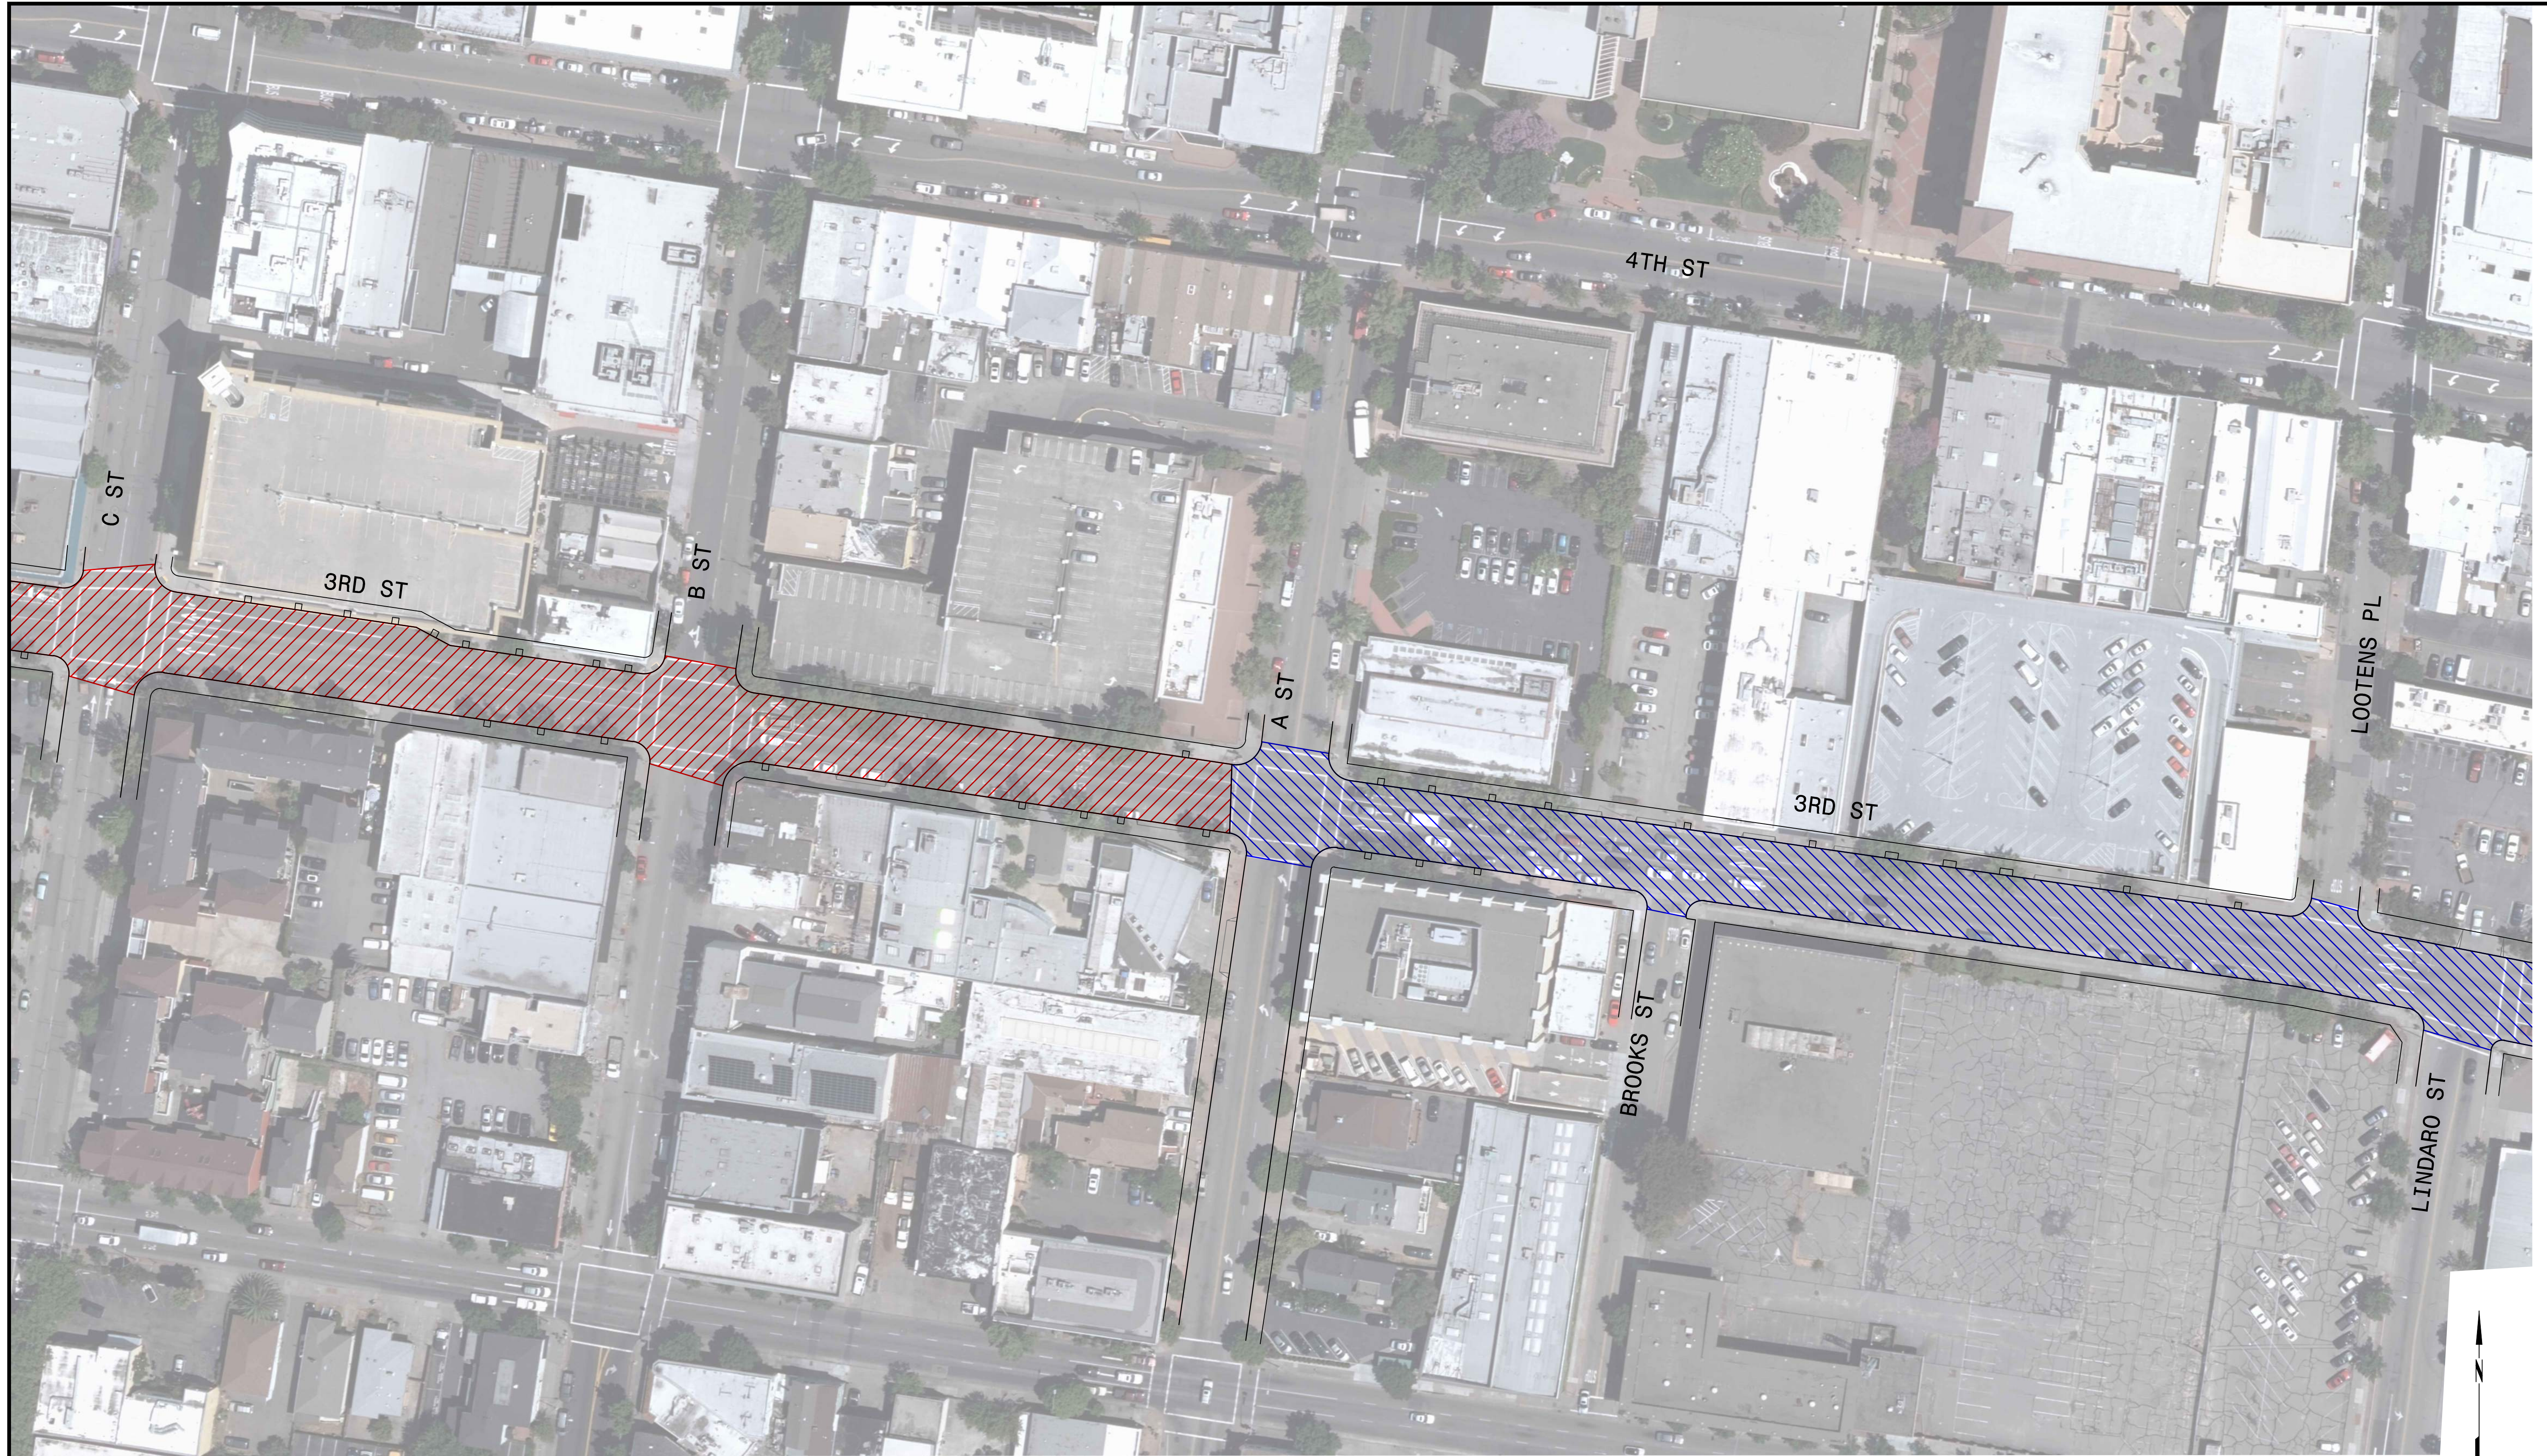
**THIRD STREET REHABILITATION PROJECT  
 CROSS SLOPE REDUCTION OPPORTUNITY MAP**

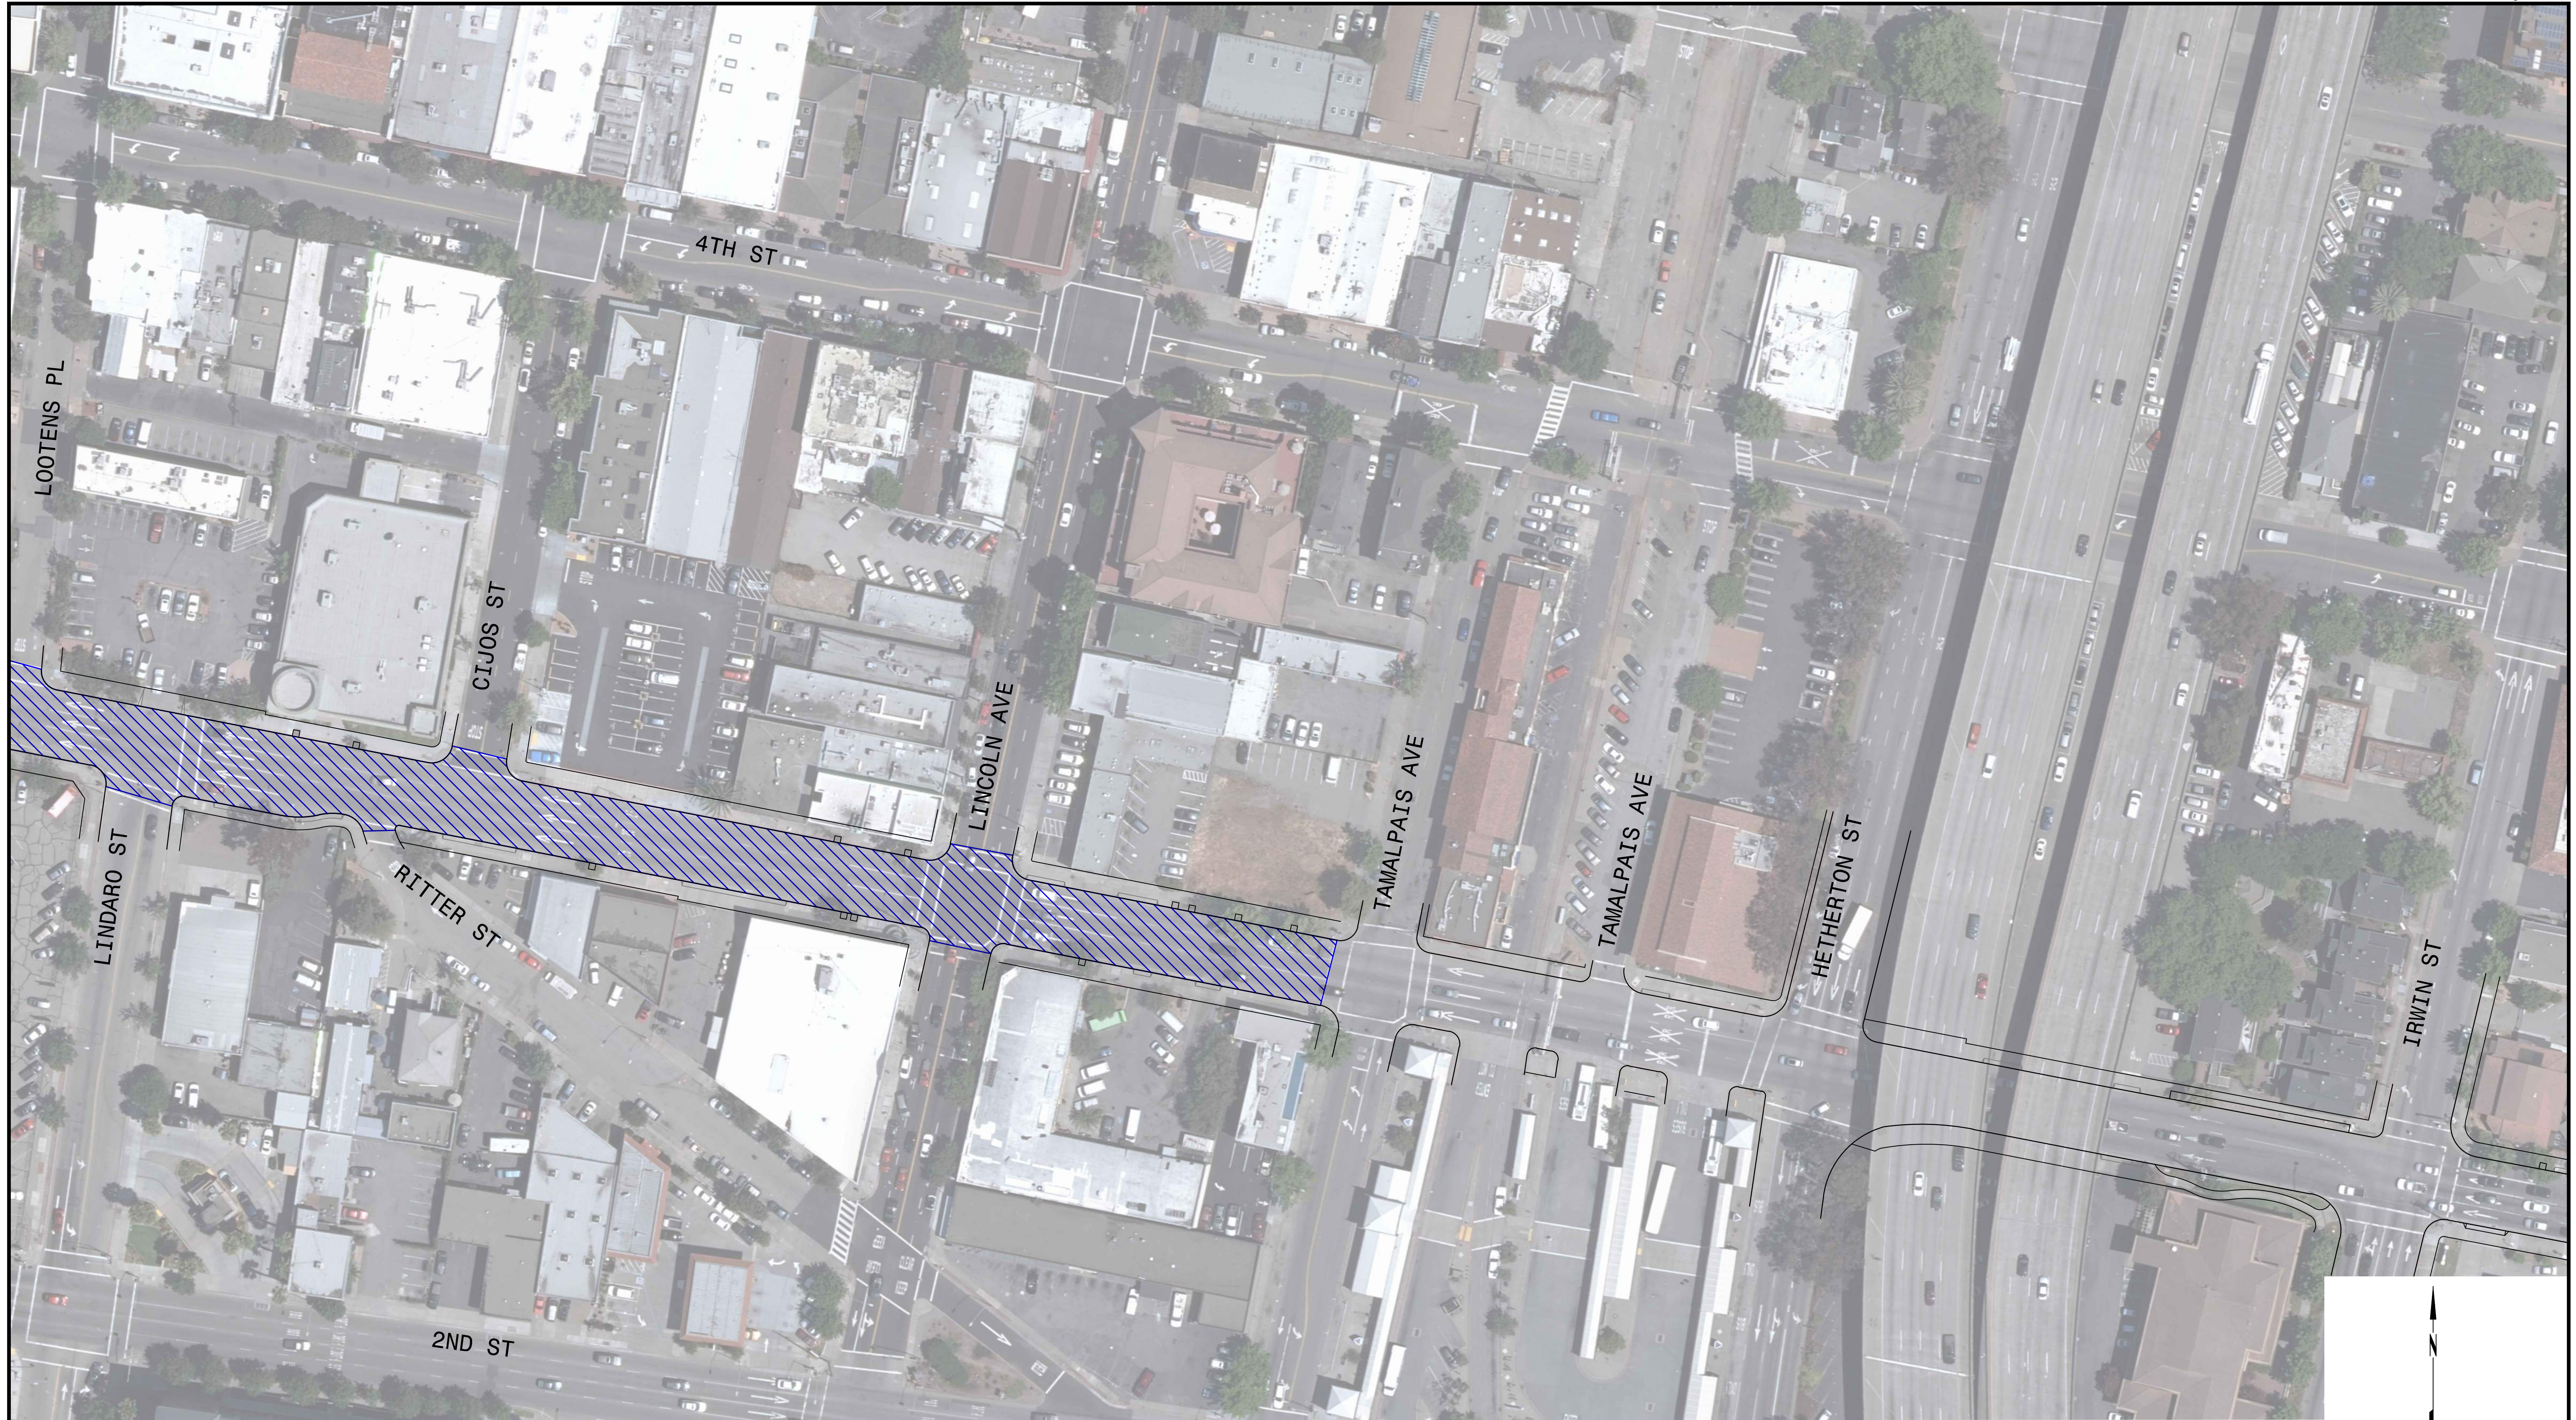
**THIRD STREET REHABILITATION PROJECT  
CROSS SLOPE REDUCTION OPPORTUNITY MAP**
