Downtown San Rafael Precise Plan Historic Resources Inventory Summary Report

December 2020

[Revised May 2021](#)

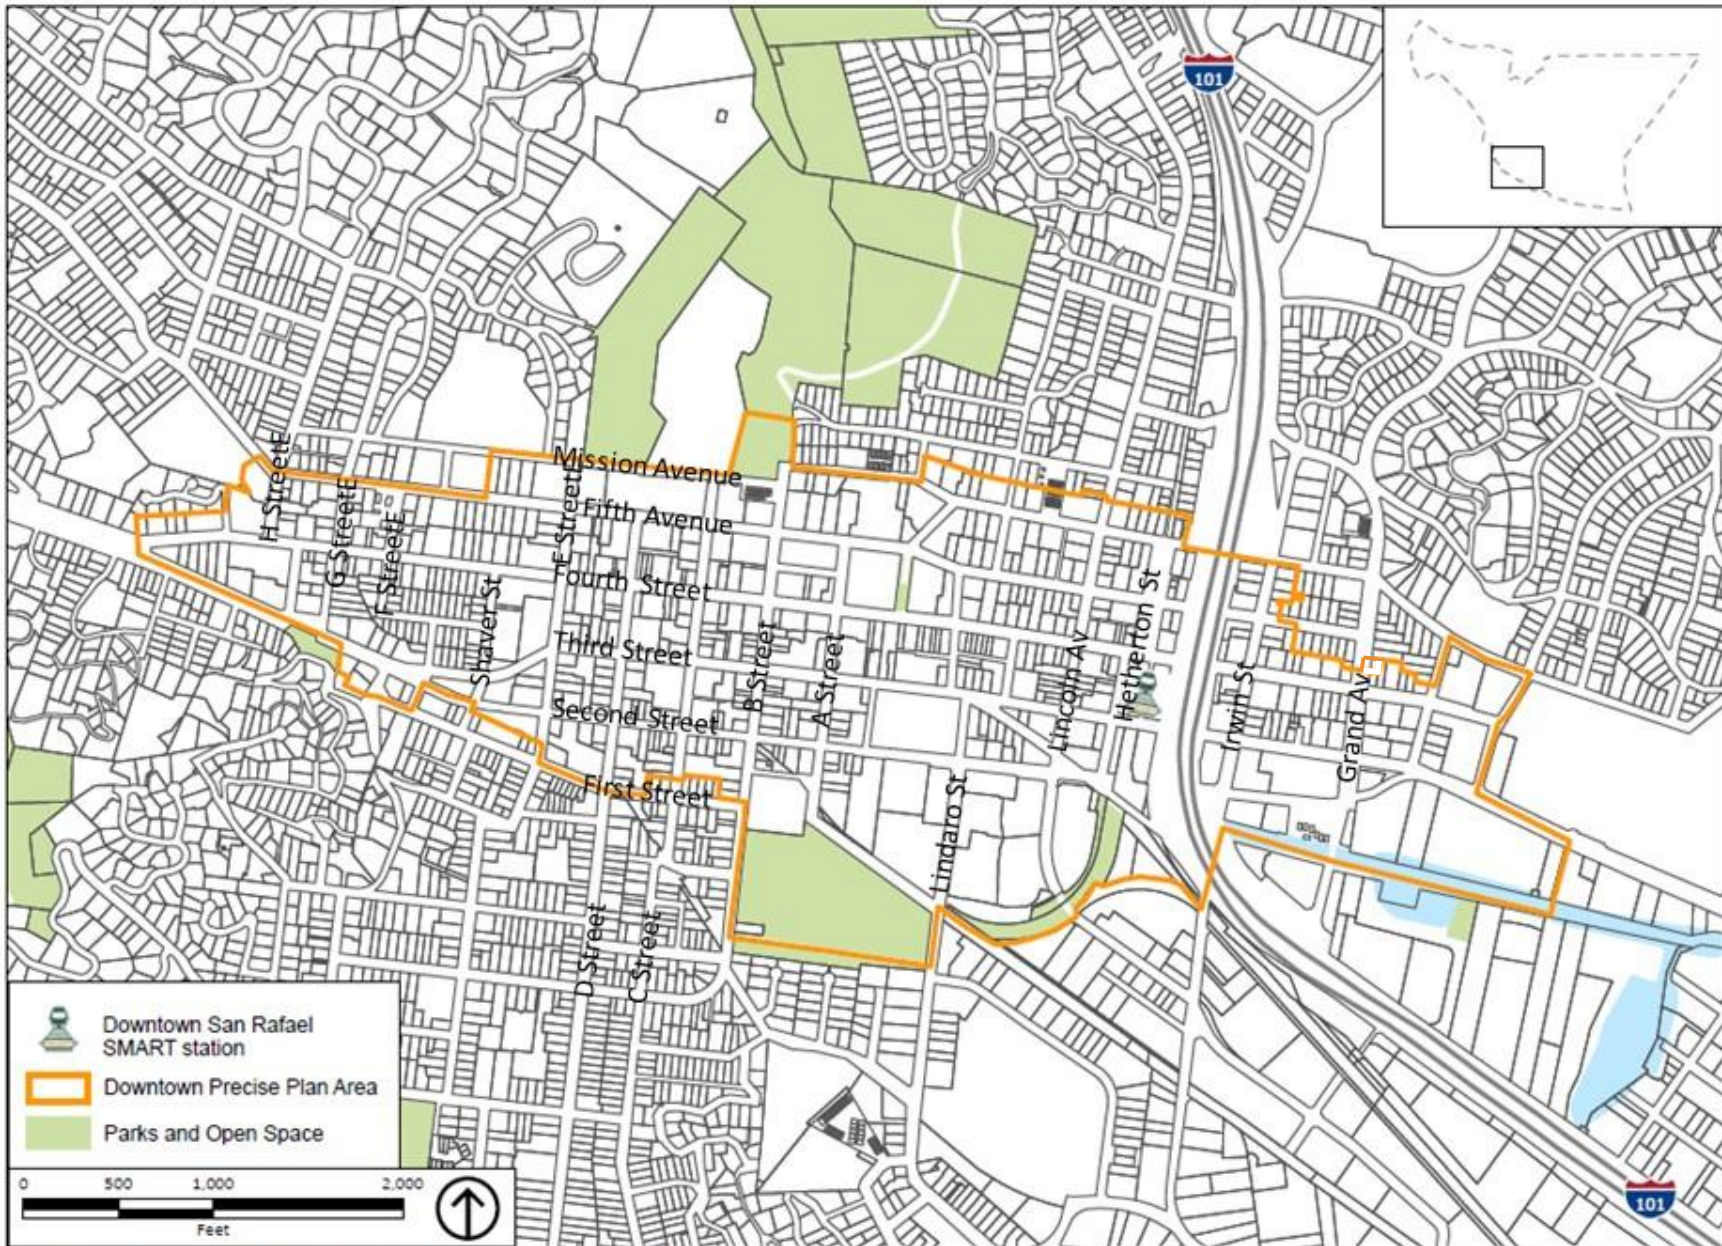
Figure 1-1
Downtown Precise Plan Boundary

Figure 1-1 shows the Downtown Precise Plan Boundary. Figure 1-2 shows the areas that were excluded from the 2019-2020 field survey. Some of the excluded areas contain historic resources but are not expected to experience significant changes during the time horizon of the

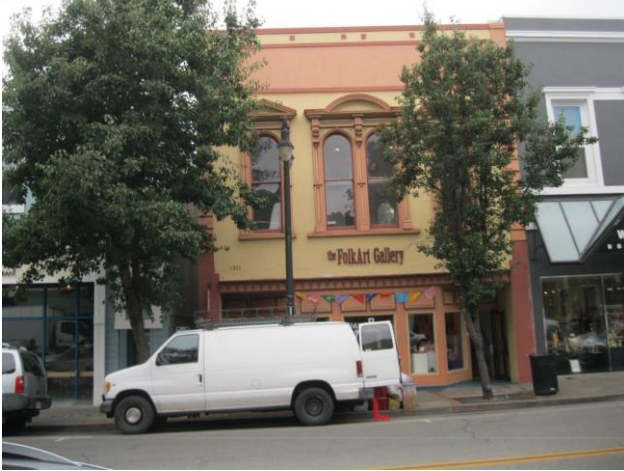
The oldest standing example of a commercial Italianate structure in San Rafael is at 1321 Fourth Street. Originally built in 1871 to house a business for local banker Upton Gordon, the building continued to be used for banking purposes through the early decades of the 20th century.³⁰ The building has gone through several renovations but retains Italianate detailing in the pedimented arched windows and decorative quoins.

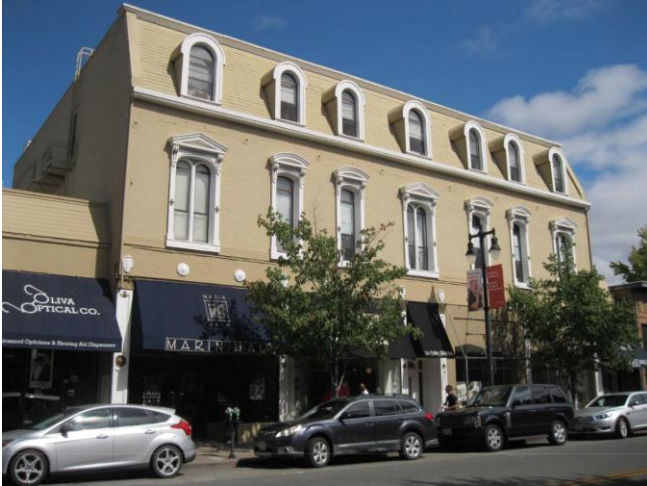
Originally known as the Mahon House, the building at 1330 Fourth Street first appears on the 1879 Sanborn Fire Insurance Map of San Rafael. The first-ground floor of the building has continuously been occupied with commercial space, with apartments or hotel rooms on the second at the upper floor.³⁴

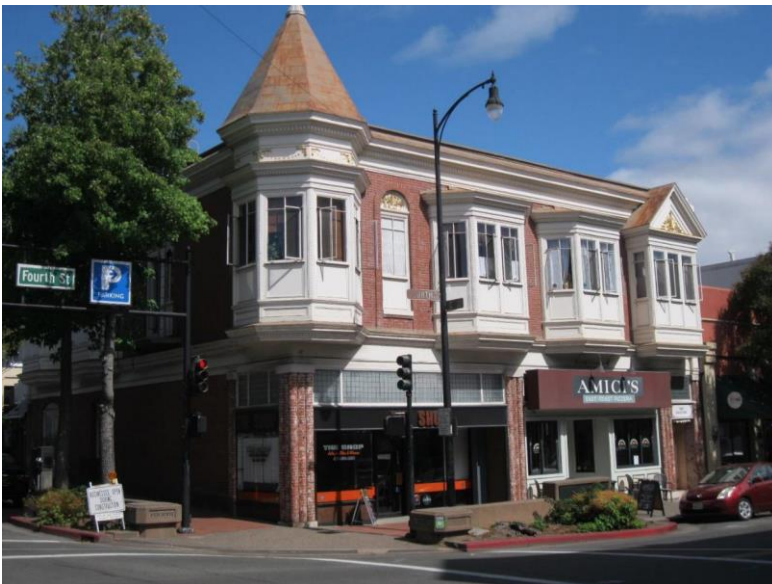
French-born tailor and local proprietor Louis Peter built 1240 Fourth Street to operate his dry goods business, opened in 1893. As a prominent commercial anchor on Fourth Street.

The most notable example of Queen Anne commercial style can be seen at 844-48 B Street (1890), and at 1240 Fourth Street (1893). Both buildings feature corner towers, cantilevered bay windows, and decorative cornices.

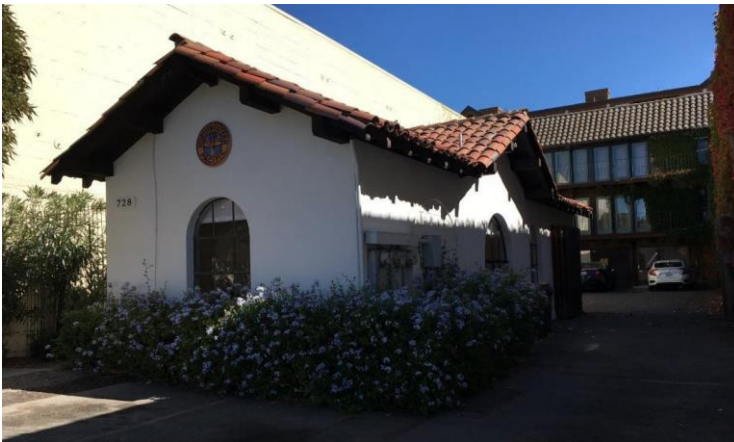
The station originally stood behind the Flatiron building at Second and B Street, but was moved to its current location [at A Street](#) in 1930 (720 [728] A Street).

While means of transportation were rapidly changing in the early 20th century, the need for rail stations persisted. The Spanish Colonial/Mission Revival “B Street Station” was constructed to replace an older structure in 1928. This era also saw the replacement of the [1890-1884](#) railroad shed structure at Tamalpais Avenue with a Spanish Colonial/Mission Revival station in 1929. The station was designed by architect Frederick H. Meyer, who is credited with designing many “Mission Revival” stations throughout Marin County. The station has been significantly altered, but still stands in its original location.

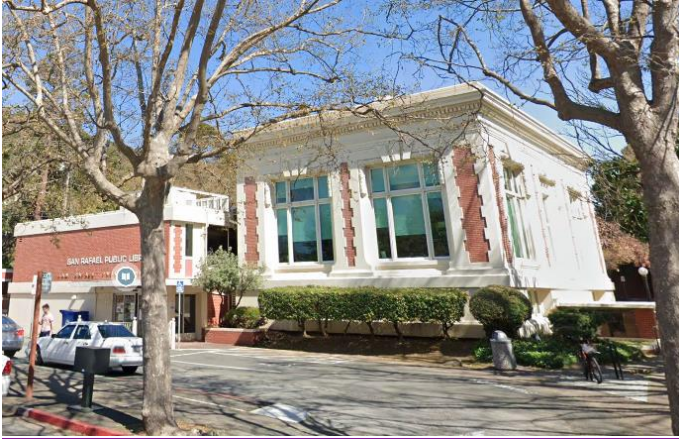
View of the original library structure and details and modern additions. (2019)

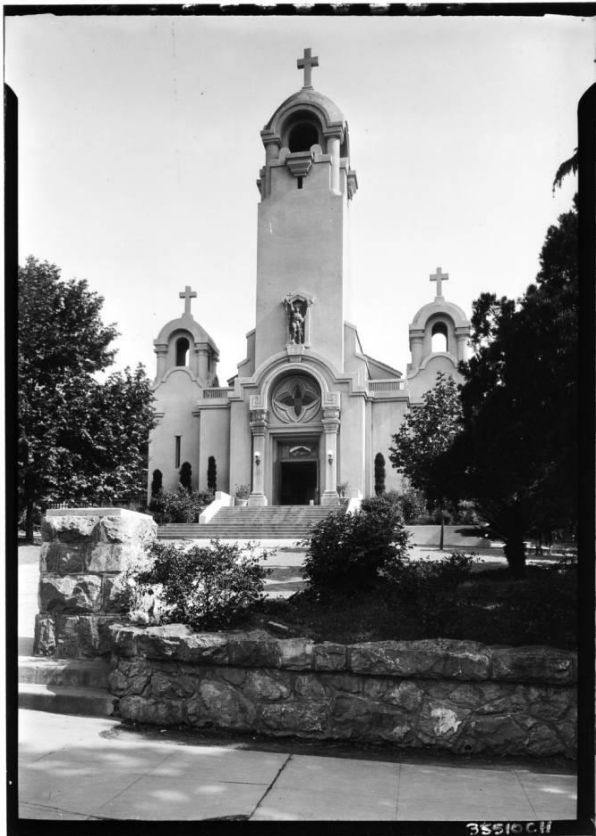
A principal example of Spanish Colonial Revival architecture in San Rafael is the Church of Saint Raphael / Mission San Rafael Arcángel. The buildings standing today were designed from research and findings by the Marin County Historical society to replicate the original Mission buildings as closely as possible. With financing from the Hearst Foundation, the structures were completed by 1949.⁵⁶ (California Historical Society Collection, 1860-1960, University of Southern California Digital Library)

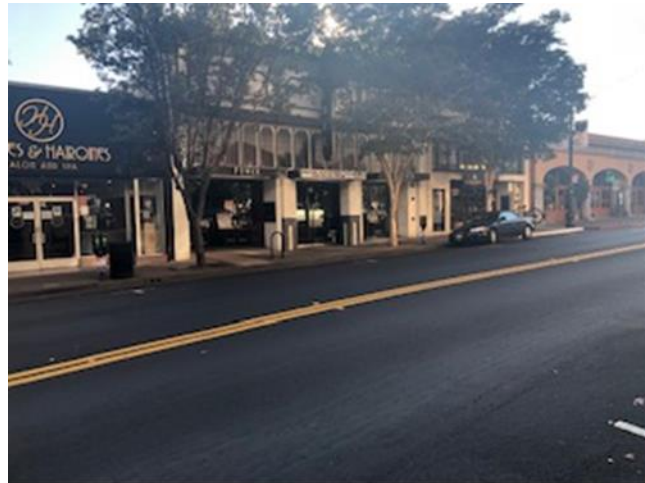
In the early 1980's, the RDA administered a very informal incentive program that offered advice to property owners and businesses on storefront improvements. The primary goal of the program was to seek business compliance with the City's sign ordinance but to also offer design advice on storefront design and restoration. While most of storefront improvements that were implemented involved new signage, awning additions and painting, some property owners opted to restore their storefronts to near original design. One example is 919 Fourth Street.

919 Fourth Street with restored transom and glass/upper storefront

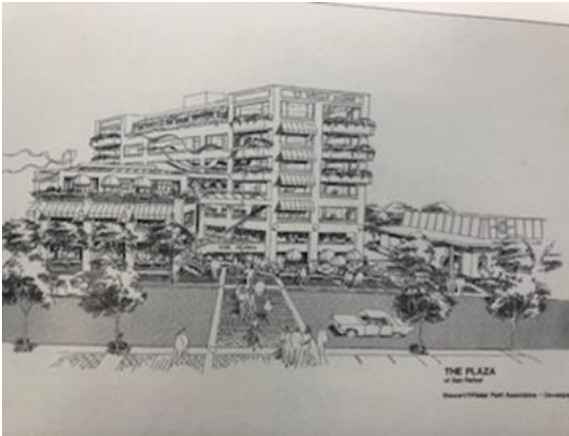
The initially preferred concept design called for placing a seven-story building stepping back from Fourth & A Streets but it was deemed too imposing (schematic below). Ultimately, the City opted to approve a more conventional building design with the building offering two levels of retail below two levels of office (built project below). The two levels of retail offered by this design was an attractive incentive, but the split-level storefront has been marginally successful.

Original Redevelopment Proposal – Fourth and A Streets

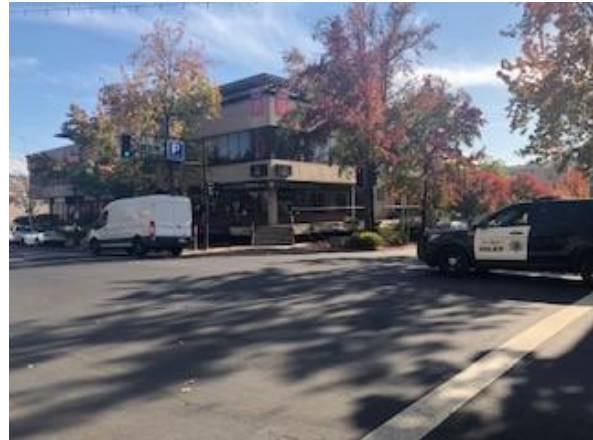
Built project at Fourth and A Streets

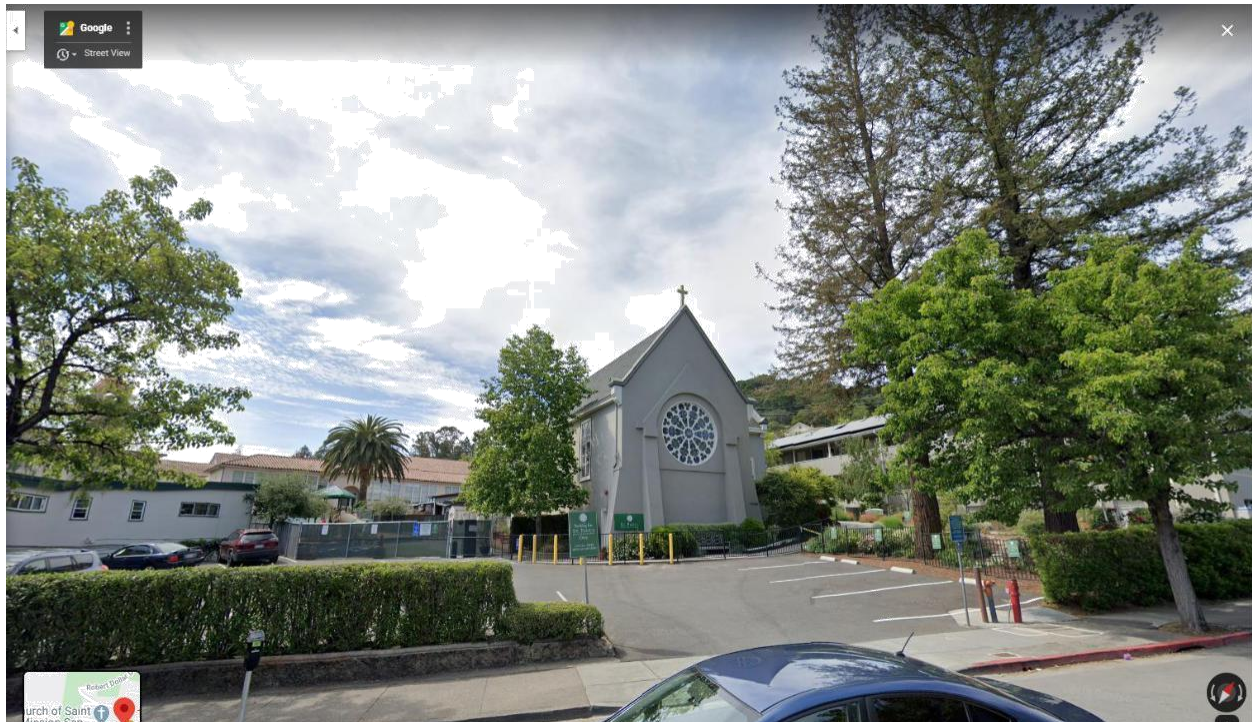
Address/code	1123 Court Street	DB
APN	011-213-18	
Building Name	St Paul's Episcopal Church	
Year Built	1927 (church website), 1920 (DIJ 1949, Sanborn Maps)	
Original Use	Religious	
Architectural Style	Gothic Revival / Classical Revival	
Architect/Builder	WA Boyd, Contractor	
Description	The church sanctuary building is rectangular in plan with a steeply pitched gabled roof. It is connected to other church buildings to form a U-shaped compound building. The sanctuary has a rose window on the south elevation and pointed arch stained glass on the sides. It is clad in smooth stucco (may be reinforced concrete construction) with decorative buttresses. The main entrance is in a projecting volume near the east corner of the north elevation and features a pointed arch doorway under a pedimented gable.	
Integrity	Unknown. Building was moved from 4th and E	
Significance	Unlikely to be eligible, requires more study, entrance apparently altered Probably not eligible for State or National listing, but eligible for local listing.

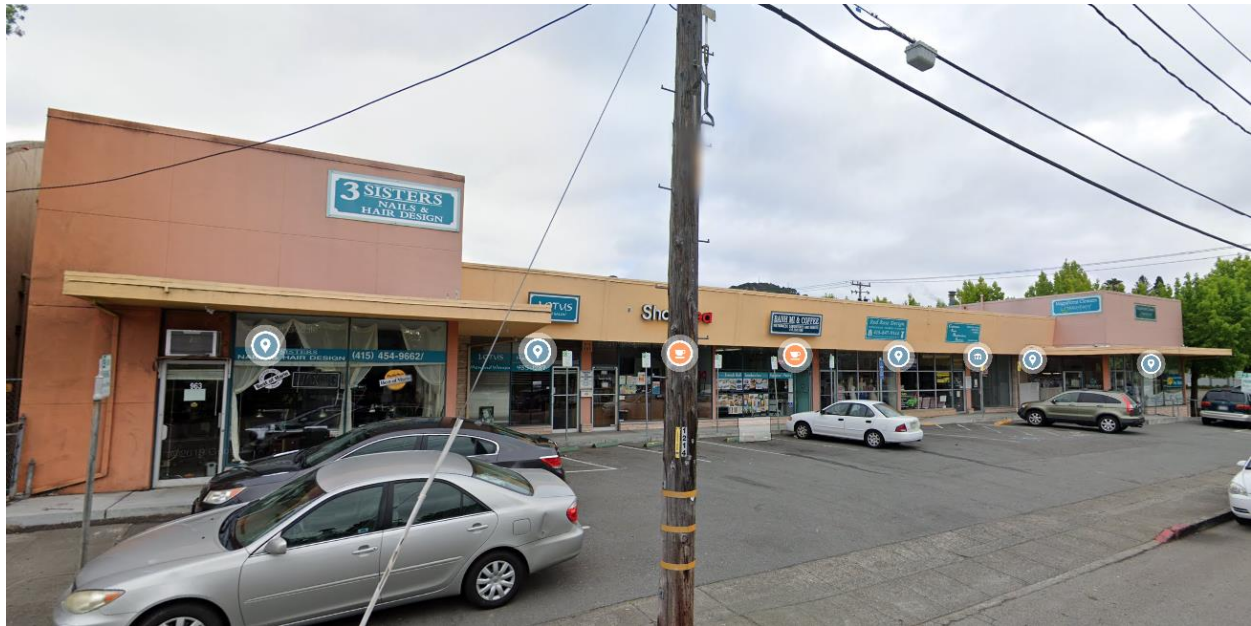
Address/code	963-977 Grand Av	D
APN	014-123-10	
Building Name		
Year Built	1956	
Original Use		
Architectural Style		
Architect/Builder		
Description	The one-story building has a flat roof and long, narrow U-shaped plan. The building is an early example of a strip shopping center with parking in front of the building. There is a slit-face rock bulkhead, as well as vertical strips at both ends of the long recessed volume. Elsewhere, the building is clad in smooth stucco. Large storefronts line the main façade. The projecting volumes at either end have higher roofs than the rest of the building and flat awnings above the storefront windows. Heavy soffits above storefronts on the recessed volume are canted.	
Integrity	Appears to retain integrity	
Significance	Lacks architectural distinction, not eligible as landmark or contributor	
Notes

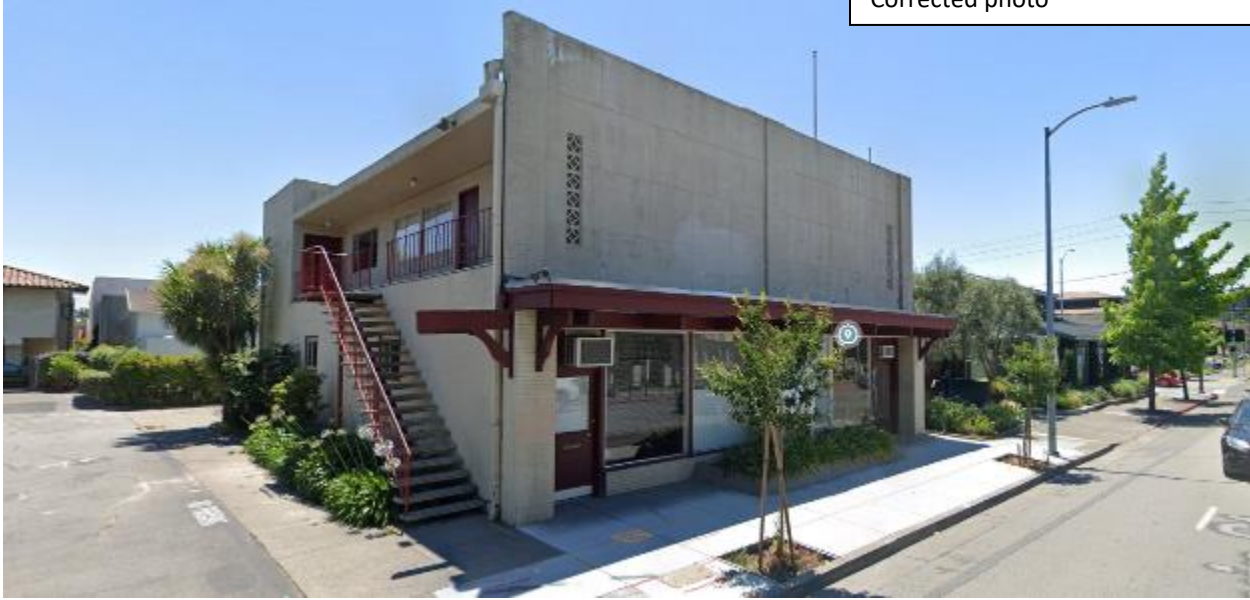
Address/code	914 Irwin Street	ED
APN	014-123-21	
Building Name		
Year Built	1907	
Original Use		
Architectural Style		
Architect/Builder		
Description	The two-story building has a rectangular plan and flat roof. There is brick at the corners, down the center, and at the main façade bulkhead, and the building is otherwise clad in textured stucco; the second-floor parapet of the main façade is concrete with a pattern of large squares. There are two storefronts with partially glazed doors and large windows. A small, flat wooden awning with exposed rafters and decorative knee braces shelters the first floor.	
Integrity	Integrity appears impaired	
Significance	Not significant at any level, hybrid 1905/1960s building

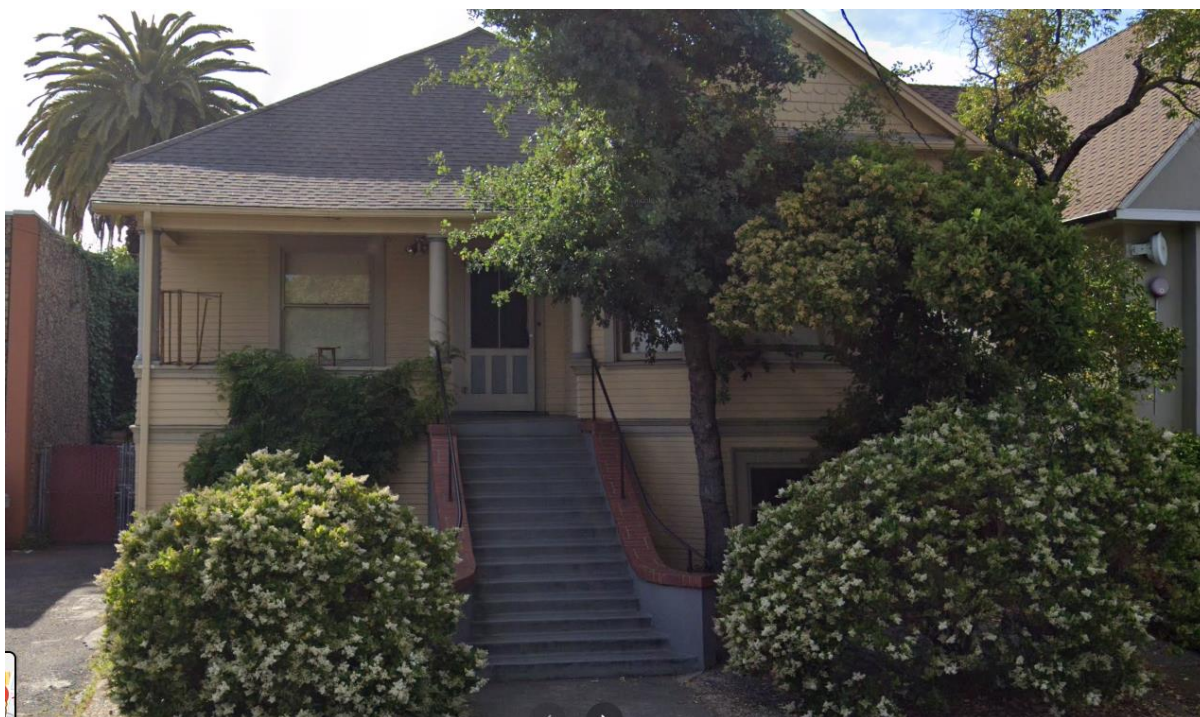
Address/code	1011 Irwin Street		B
APN	014-085-10		
Building Name			
Year Built	1907		
Original Use	Residential		
Architectural Style			
Architect/Builder			
Description	The two-story building has a rectangular plan and hipped roof with small gables on the main façade and one side. Under the gable on the front is a projecting volume with a second-floor bay window; next to the volume is the second-floor partial-width projecting porch. The building is clad in a wood clapboard and decorative shingles at gable ends.		
Integrity	Retains Integrity		
Significance	Good example of hipped roof cottage, eligible as contributor		
Notes

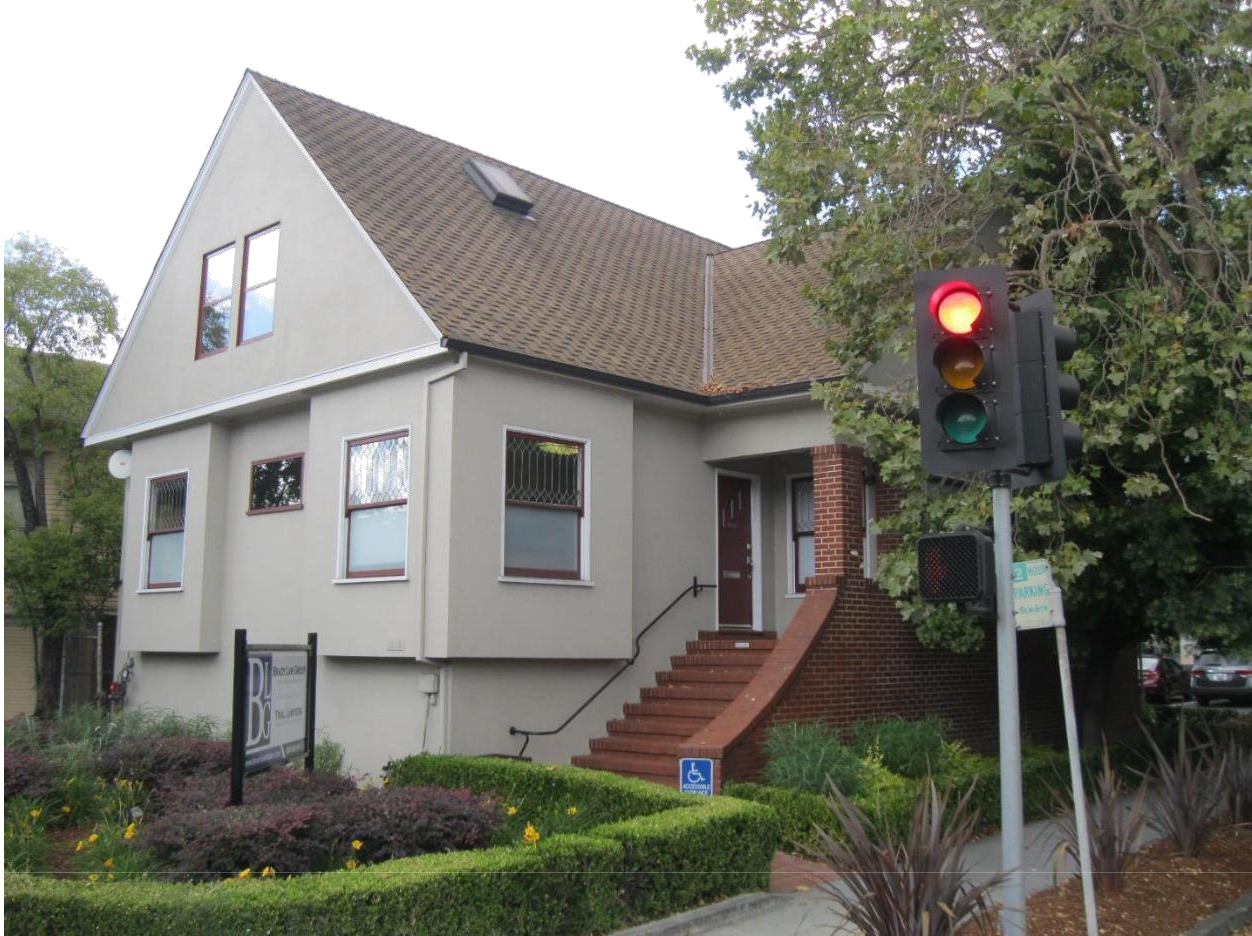
Address/code	1015 Irwin Street	ED
APN	014-085-11	
Building Name		
Year Built	c1900	
Original Use	Residence	
Architectural Style		
Architect/Builder		
Description	The one-and-a-half story building has a rectangular plan and cross-gabled roof. It has a raised elevation and a small integral entry porch accessed via brick steps. The main façade is also clad in brick on the first floor, and the rest of the building is clad in smooth stucco. A side elevation has a staircase to access rear entrances on both floors.	
Integrity	Appears to lack integrity, stucco, brick	
Significance	Not eligible at any level, lacks integrity	
Notes

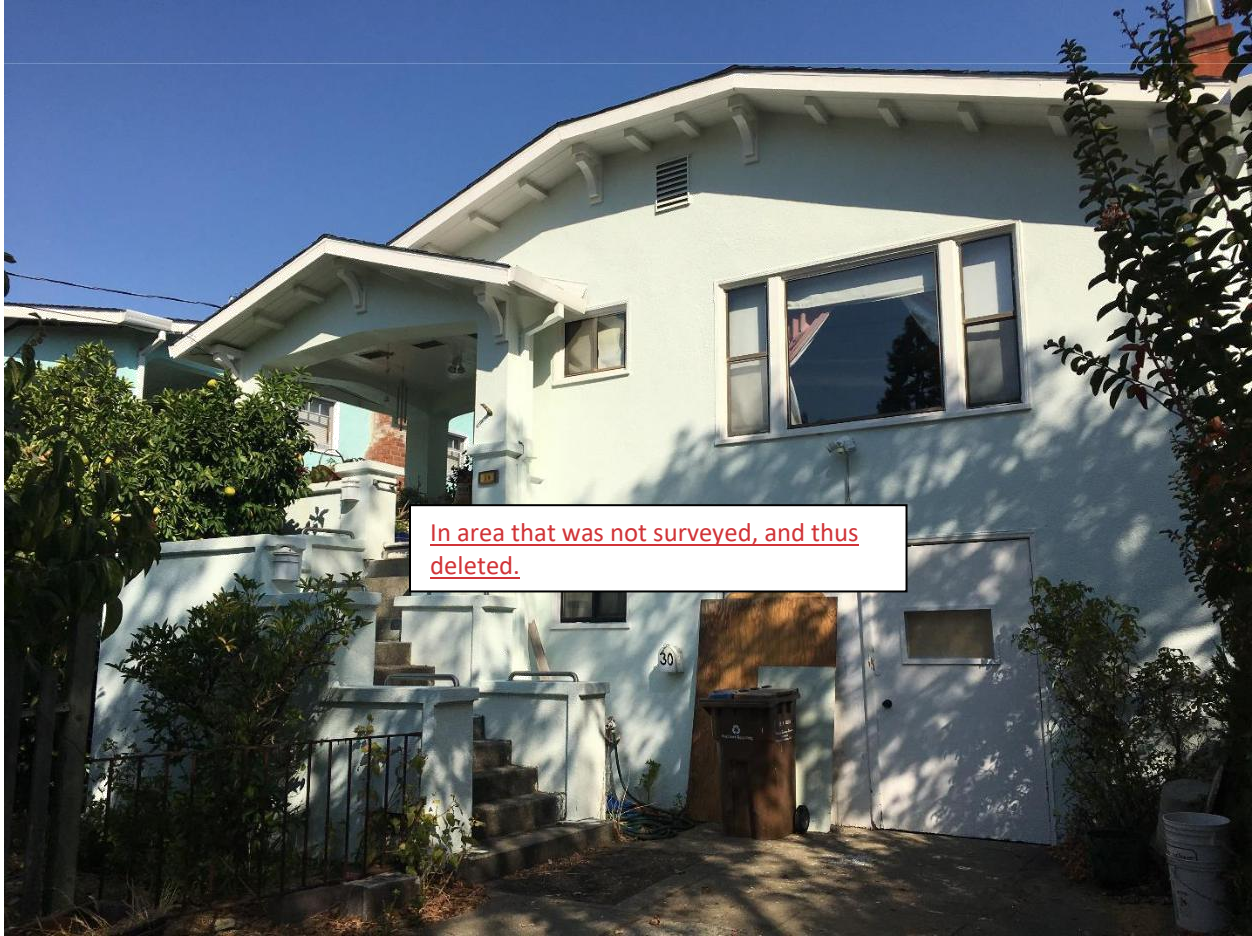
Address/code	30 Latham Street		B
APN	011-242-22		
Building Name			
Year Built	1928		
Original Use	Residential		
Architectural Style			
Architect/Builder			
Description	The two-story house has a roughly rectangular plan. The second-story entrance is sheltered under a partial-width integral porch with its own, slightly projecting gable. The entrance faces into the side of the building. There is a garage on the first floor opposite the porch on the main façade. The building is clad in smooth stucco.		
Integrity	Retains integrity		
Significance	Good example of craftsman architecture, district contributor		
Notes

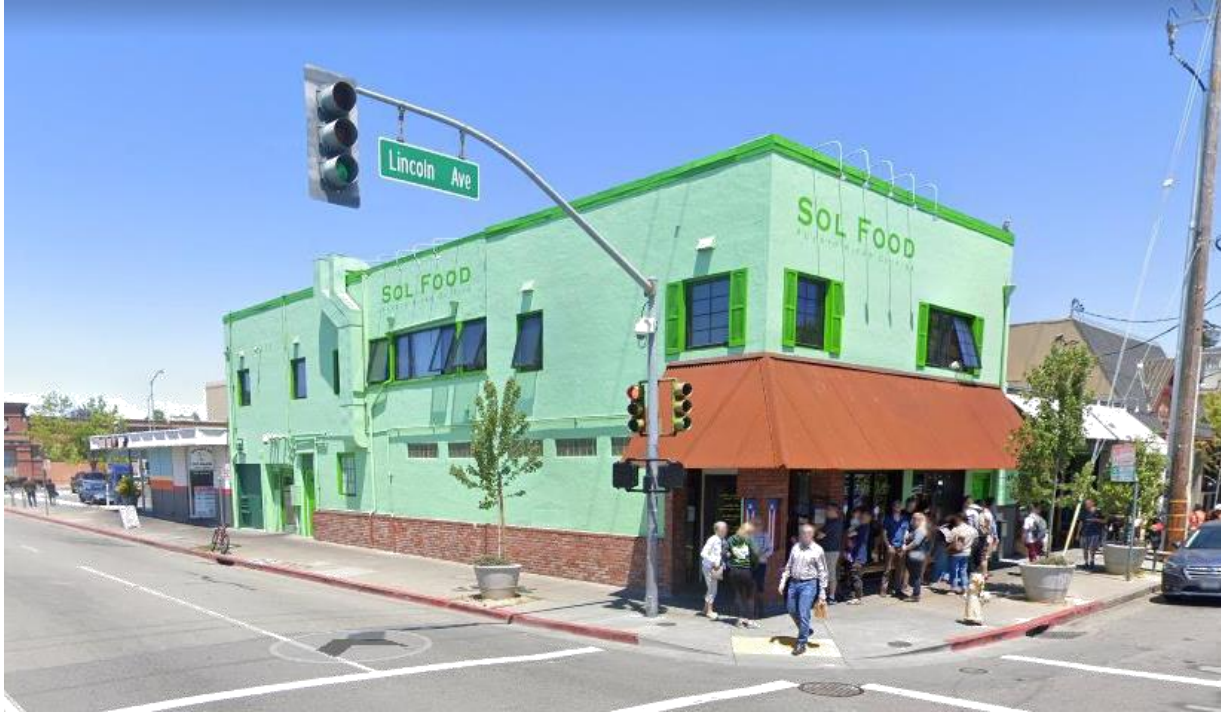
Address	901 Lincoln Avenue / 806 3rd St		ED
APN	011-273-12		
Building Name			
Year Built	c1920		
Original Use			
Architectural Style			
Architect/Builder			
Description	The two-story building has a flat roof and a rectangular plan. There is a recessed entrance in the corner and floor-to-ceiling windows along most of the first story of one façade. Windows on the second floor have wooden shutters. The first floor also features a corrugated metal awning with a wide brick support above the façade with windows. The other street-facing façade has a low strip of brick at the bottom; otherwise, the building is clad in smooth stucco.		
Integrity	Appears to lack integrity, no visible 1920s fabric		
Significance	Not eligible		
Notes

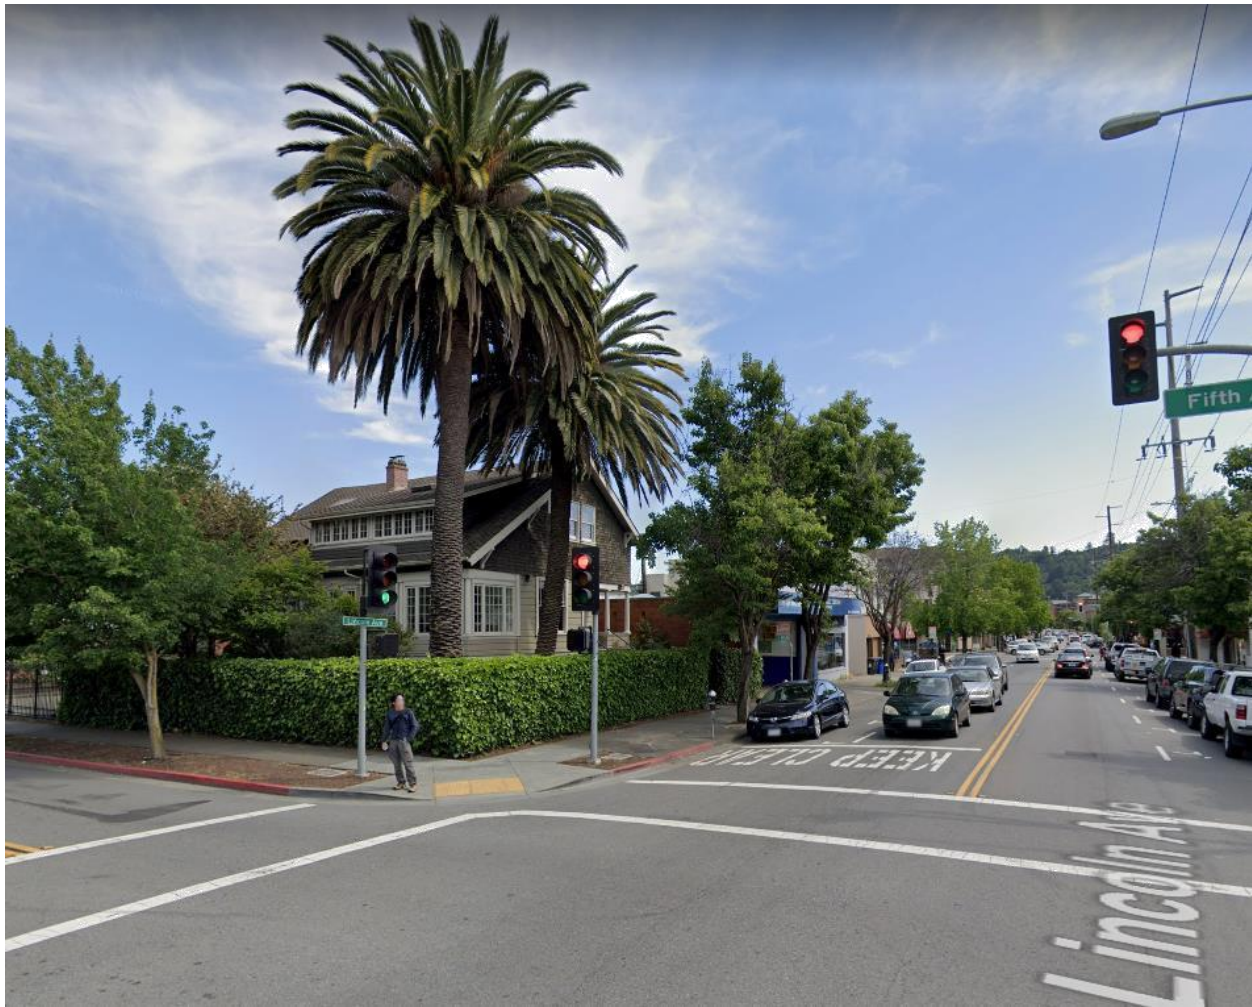
Address	1016 Lincoln Avenue	7N	€ B
APN	011-227-01		
Building Name			
Year Built	c1889-1891		
Original Use			
Architectural Style			
Architect/Builder			
Description	The one-and-a-half story building has a roughly rectangular plan and a gabled roof. It is surrounded by a high, vine-covered fence. It has a raised foundation and a partial-width integral porch. There is a long dormer window on the side façade of the corner building. The first floor is clad in wide horizontal board siding and the second floor is clad in wood shingle.		
Integrity	Appears to retain integrity, more study needed		
Significance	Potential district contributor, <u>see note below individually eligible at any level</u>		
Notes	<u>Was the Grateful Dead headquarters until the death of Jerry Garcia.</u>

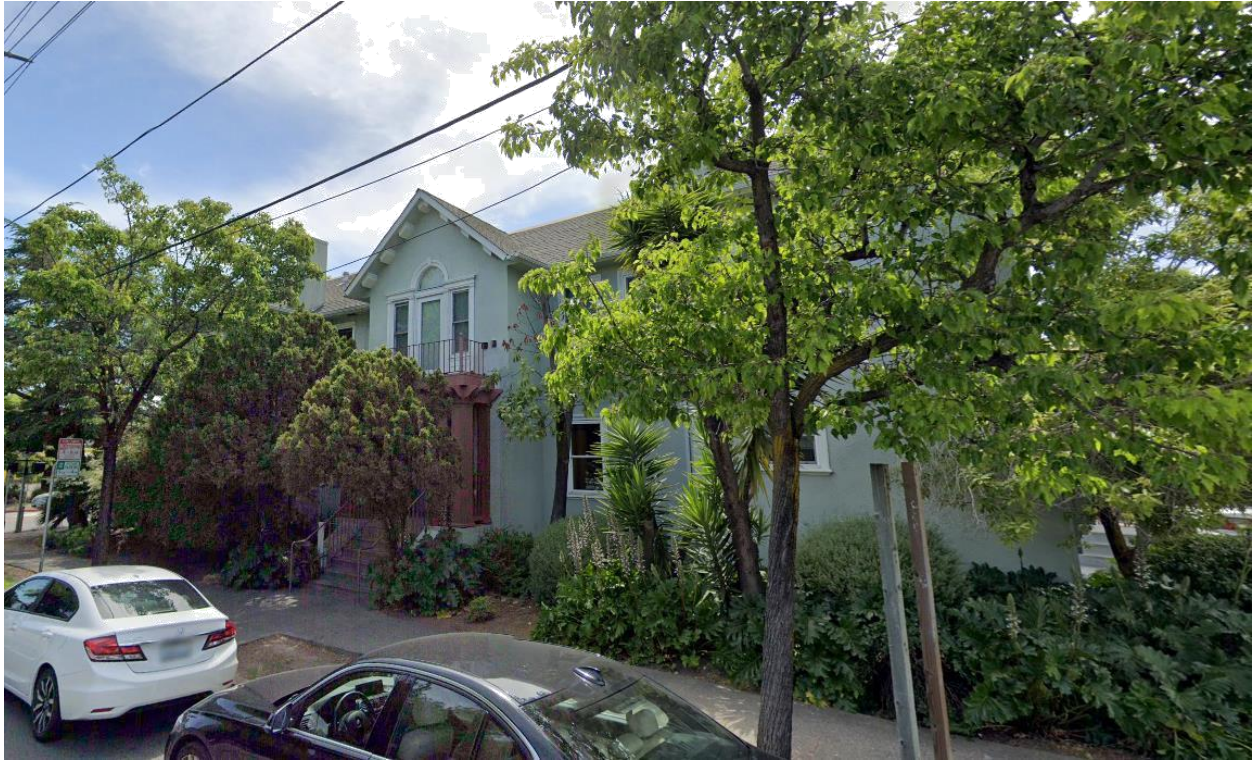
Address	1103 Lincoln Avenue	D
APN	011-225-04	
Building Name		
Year Built	c1900	
Original Use		
Architectural Style		
Architect/Builder		
Description	The two-story building has a roughly rectangular plan and a composition shingle mansard roof. There are three small projecting volumes on the main façade. The central volume has a gabled roof, a second-floor balcony, and a recessed entrance accessed by concrete steps on the first floor. The two volumes flanking it are hipped. The building is clad in smooth stucco.	
Integrity	Integrity appears impaired	
Significance	Probably Not eligible	
Notes

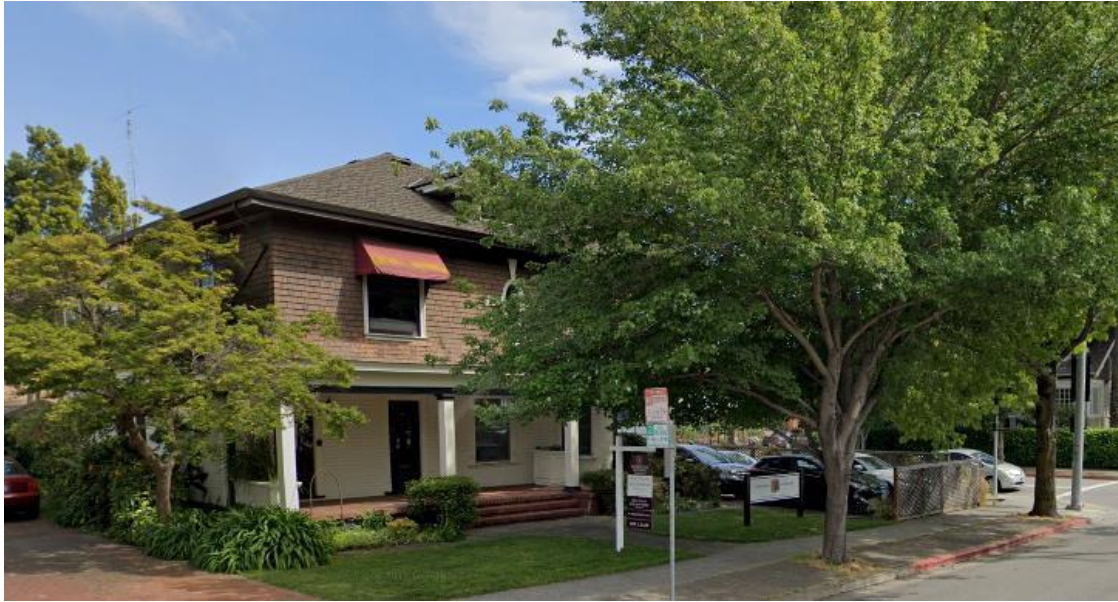
Address	1104 Lincoln Avenue	7N	B
APN	011-226-07		
Building Name	San Rafael House		
Year Built	1906		
Original Use			
Architectural Style	American Foursquare		
Architect/Builder			
Description	The two-story building has a roughly square plan and a hipped composition shingle roof. There is a full-width integral porch with wide brick steps on the main façade and a dormer window in the center. There are cloth awnings on the windows. The first floor is clad in narrow horizontal board siding and the second floor is clad in shingle.		
Integrity	Retains Integrity		
Significance	Potential district contributor, not individually eligible at any level		
Notes

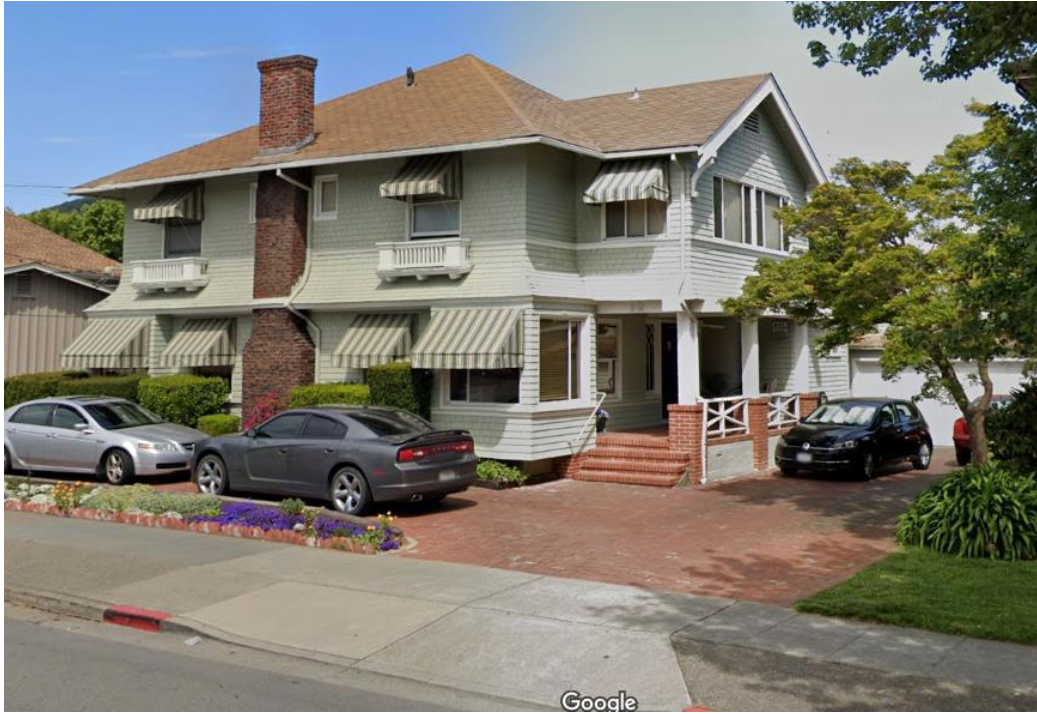
Address	1110 Lincoln Avenue	5S2	B
APN	011-226-08		
Building Name			
Year Built	1907		
Original Use			
Architectural Style	Craftsman		
Architect/Builder			
Description	<p>The two-story building has a roughly square plan and a gable-on-hip composition shingle roof. There is a deep one-story integral porch at one end of the main façade, running along part of a side façade. It is accessed by a set of brick steps, with a brick floor and brick around the bottoms of the porch supports. The main entrance faces into the side of the building. Some original double hung wood sash windows have been replaced. There is a large brick chimney at the center. The walls flare at the bottom of the second floor. The building is clad in in shingle.</p>		
Integrity	Retains sufficient Integrity for district contributor despite window replacement		
Significance	Eligible as district contributor		
Notes

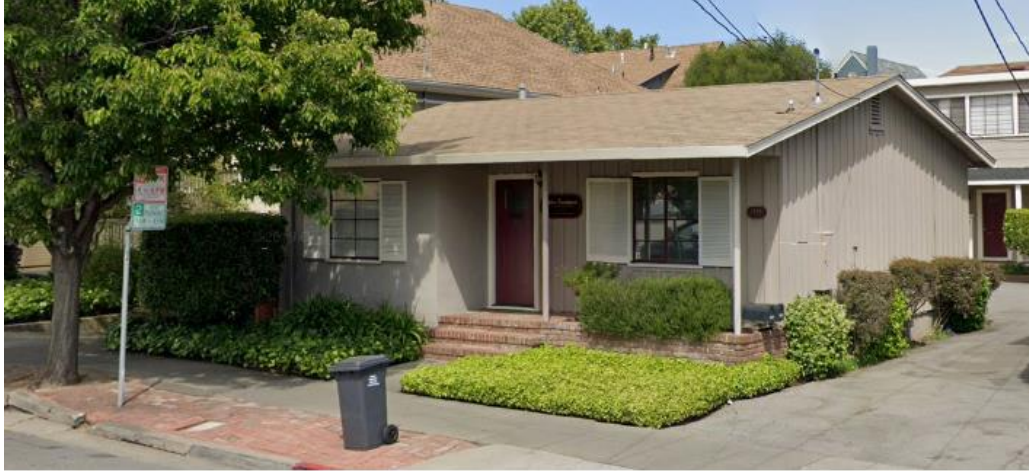
Address	1116 Lincoln Avenue	<u>ED</u>
APN	011-226-13	
Building Name		
Year Built	1953	
Original Use	Residential	
Architectural Style		
Architect/Builder		
Description	The one-story building has a roughly square plan and gabled roof. The entrance is centered on the main façade at one end of a partial-width integral porch with a brick floor, steps, and planter. Windows are eight-light with large wooden shutters. The building is clad in board-and-batten.	
Integrity	Integrity appears impaired	
Significance	Not eligible, lacks significance.	
Notes

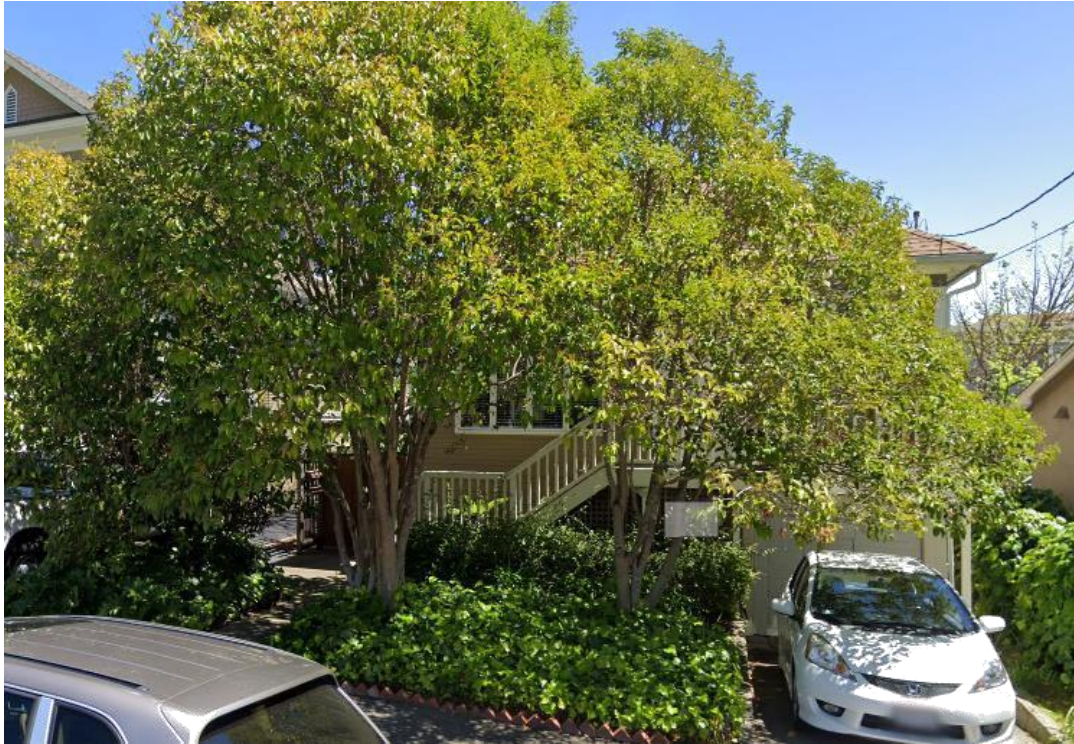
Address	1118 Lincoln Ave	C
APN	011-226-10	
Building Name		
Year Built	c1903	
Original Use	Residential	
Architectural Style		
Architect/Builder		
Description	The two-story building has a hipped composition shingle roof and rectangular plan. The second-floor main entrance is accessed by a side-facing staircase that runs along the length of the main façade. There is a metal roll-up garage door underneath the staircase on the first floor. The building is clad in both narrow and wide horizontal board siding.	
Integrity	Integrity appears impaired; visibility limited more study needed	
Significance	May be eligible as district contributor	
Notes

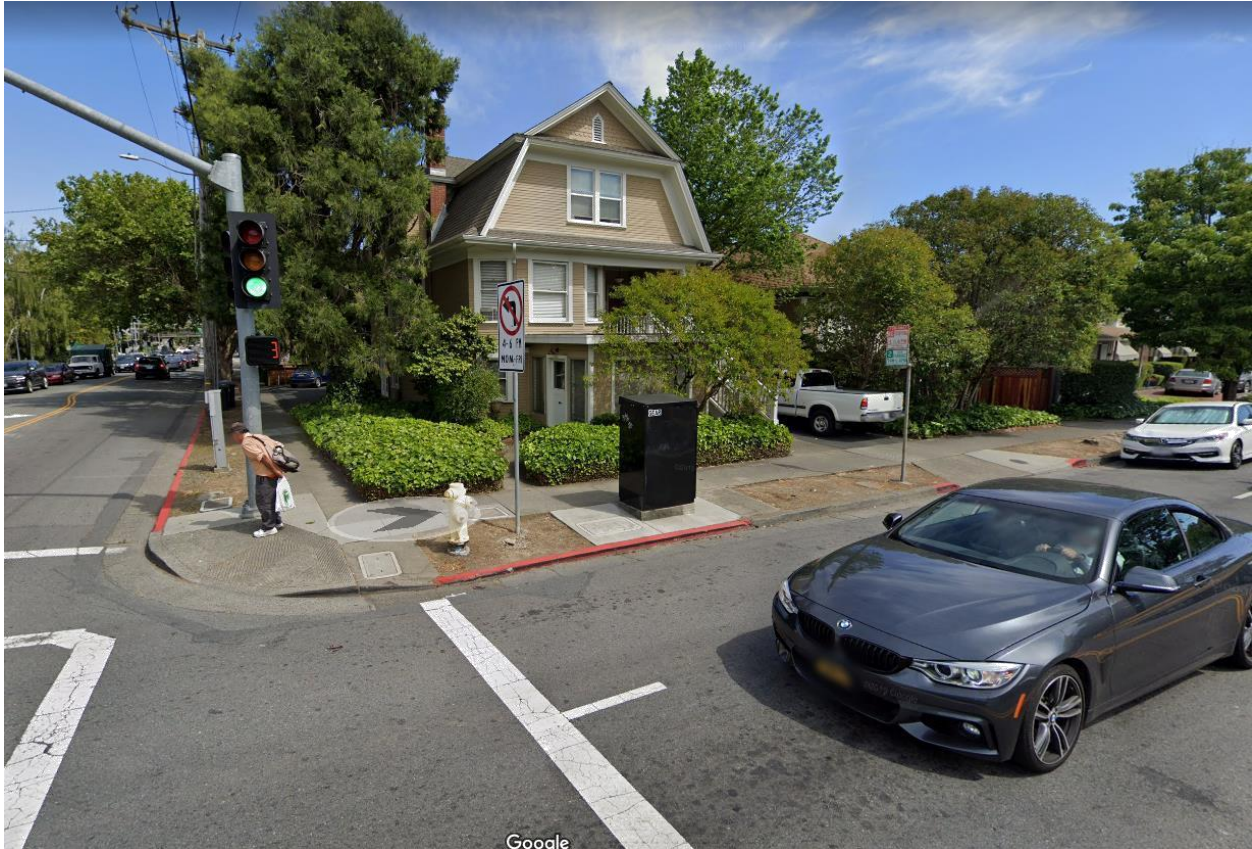
Address	1120 Lincoln Avenue	(likely B)
APN	011-226-01	
Building Name		
Year Built	1903	
Original Use	Residential	
Architectural Style		
Architect/Builder		
Description	The three-story building has a roughly rectangular plan and a gambrel roof. There are entrances on every façade. Of the two façades that face the street (the building is on a corner lot), one has a second-floor entrance sheltered by a partial-width integral porch. There is also a projecting one-story addition on this façade with its own entrance. Another has a glazed pair of double doors on the first floor. The building is clad in narrow horizontal board siding, with the exception of the addition, which is clad in wide horizontal board siding.	
Integrity	Retains Integrity despite addition, some replacement windows	
Significance	Eligible as district contributor	
Notes	<u>Building may have been raised to add garage</u>
