Downtown San Rafael Precise Plan Historic Resources Inventory Summary Report

December 2020

[Revised May 2021](#)

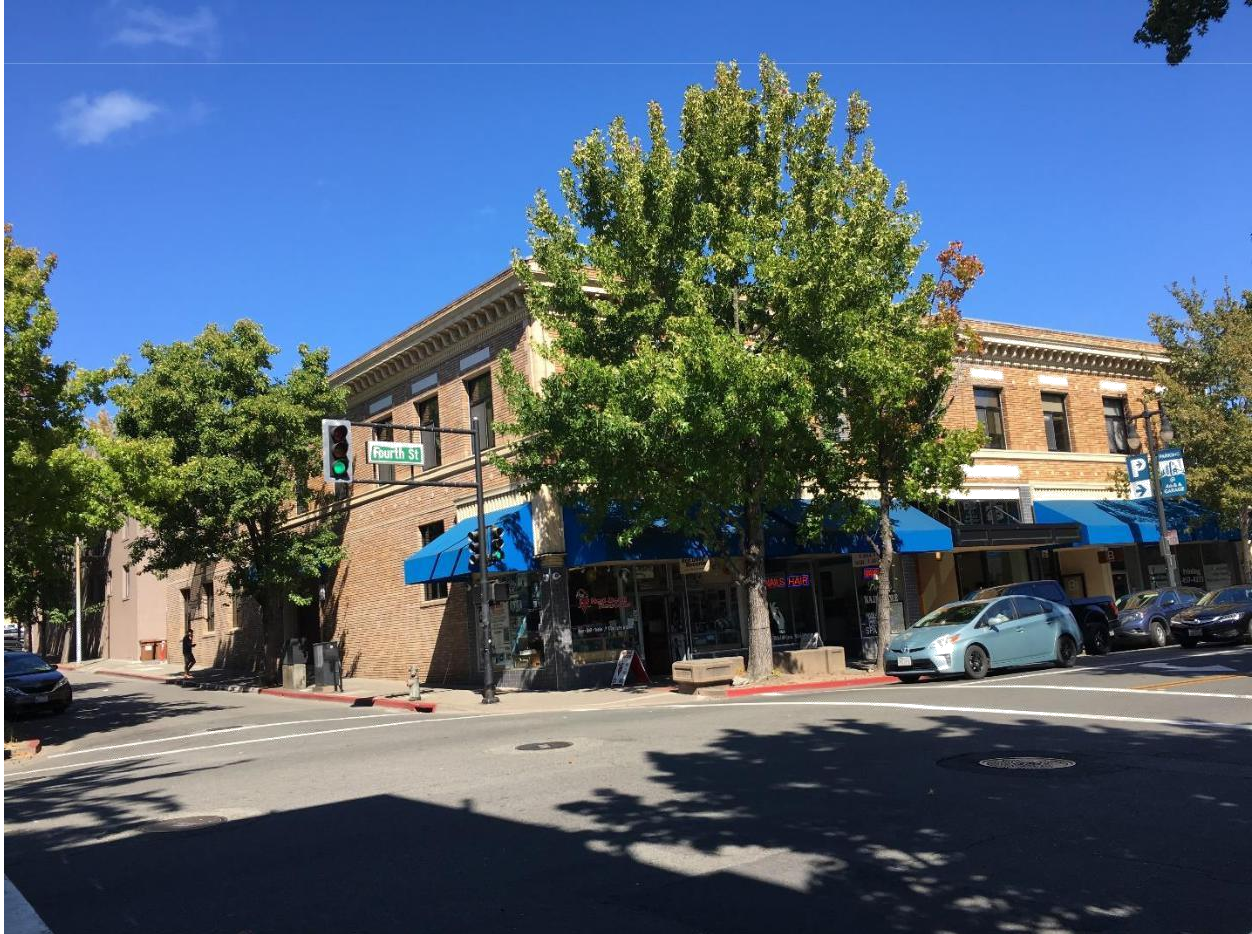
Address/code	<u>1010 Lootens/</u> 882-884 Fourth Street (1010 Lootens)	7N	BA
APN	011-224-18		
Building Name	Masonic Building		
Year Built	1910 (spreadsheet)		
Original Use	Lodge/Storefront Commercial		
Architectural Style	Classical Revival		
Architect/Builder			
Description	The lodge/commercial building is two story and rectangular in plan with a flat roof. The building is clad in brick and has facades on Fourth and Lootens. The heavy cornice features decorative brackets and dentil moulding, there is also decorative moulding separating upper and lower floors. Storefronts and doors have been replaced, and original transoms are covered except over the <u>recent</u> central entrance on Fourth Street leading to the lodge rooms.		
Integrity	Retains sufficient integrity for listing as district contributor despite replacement windows and storefronts.		
Significance	Eligible as district contributor <u>and potential local</u> , lacks integrity for landmark <u>status</u>

Notes	<u>4th Street entrance is relatively new.</u>

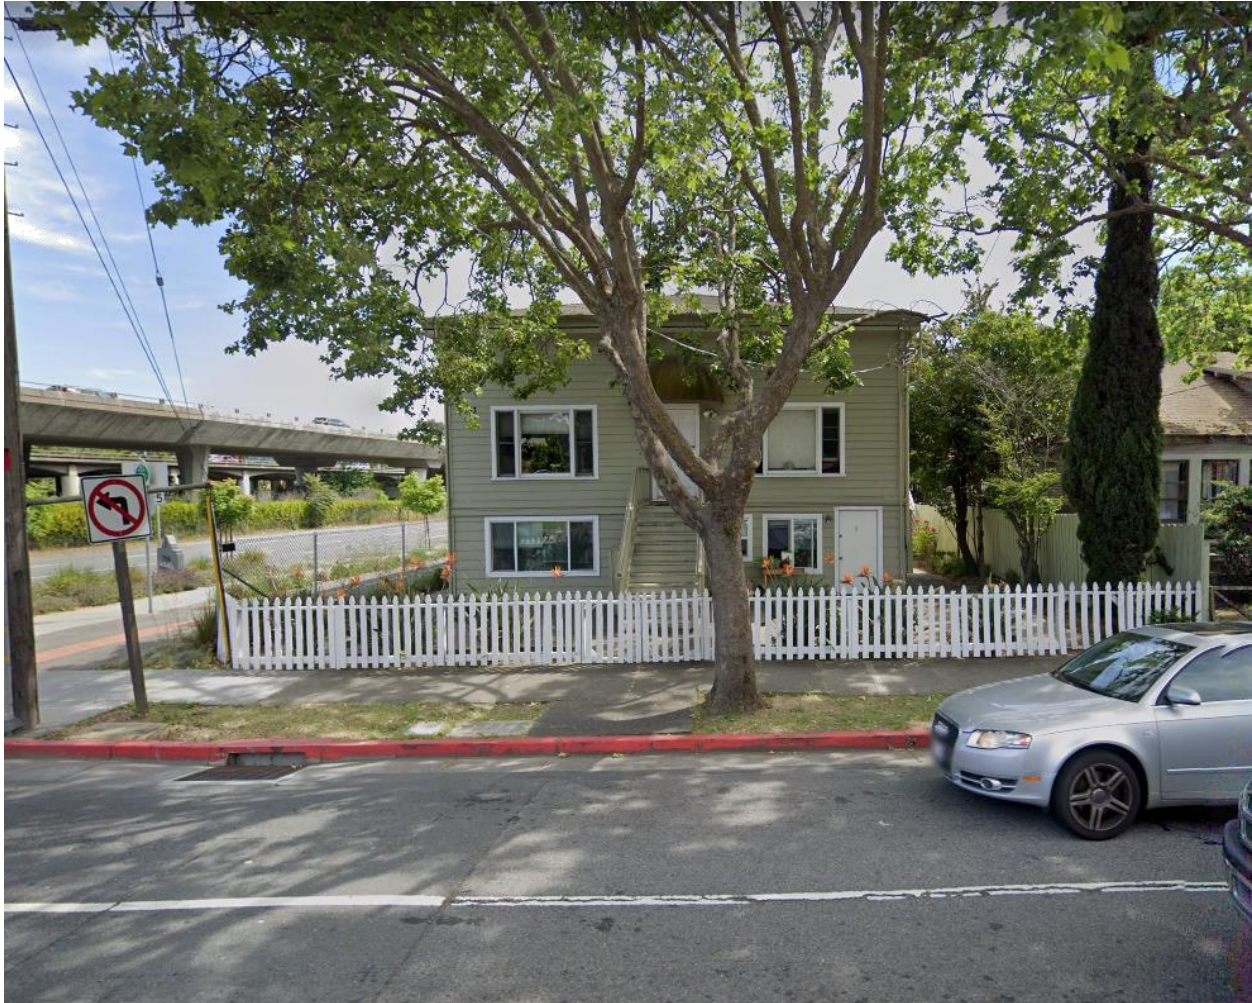
Address	633 Mission Avenue	E D
APN	014-081-02	
Building Name		
Year Built	Pre-1894	
Original Use	Residential	
Architectural Style		
Architect/Builder		
Description	The two-story building has a rectangular plan and low-pitch hipped composition shingle roof. There are multiple entrances on the main façade, one on the first floor and one on the second floor, accessed by a wooden staircase and sheltered under an awning. The building is clad in horizontal board siding.	
Integrity	Appears to lack integrity	
Significance	Not eligible	
Notes

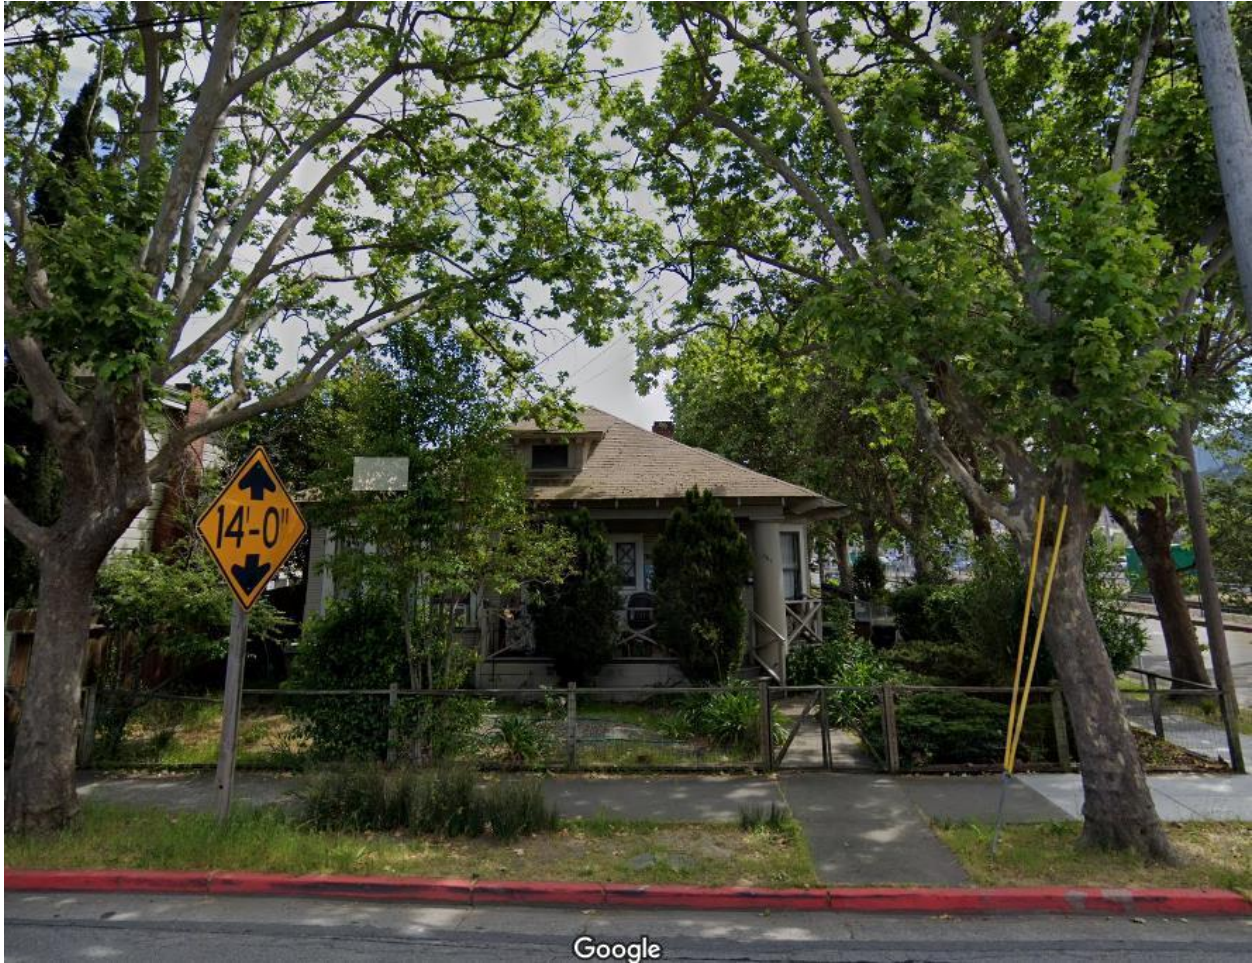
Address	637 Mission Avenue	B
APN	011-081-01	
Building Name		
Year Built	1904	
Original Use	Residential	
Architectural Style	Craftsman	
Architect/Builder		
Description	The one-story building has a roughly rectangular plan and hipped composition shingle roof with exposed rafter tails. There is a shed dormer on the main façade as well as a partial-width integral porch with one massive column. The building has large, wide double-hung wood sash windows and is clad in a combination of narrow and wide horizontal board siding.	
Integrity	Appears to retain integrity	
Significance	Excellent small example of craftsman architecture, Potential local district contributor and individual landmark.	
Notes

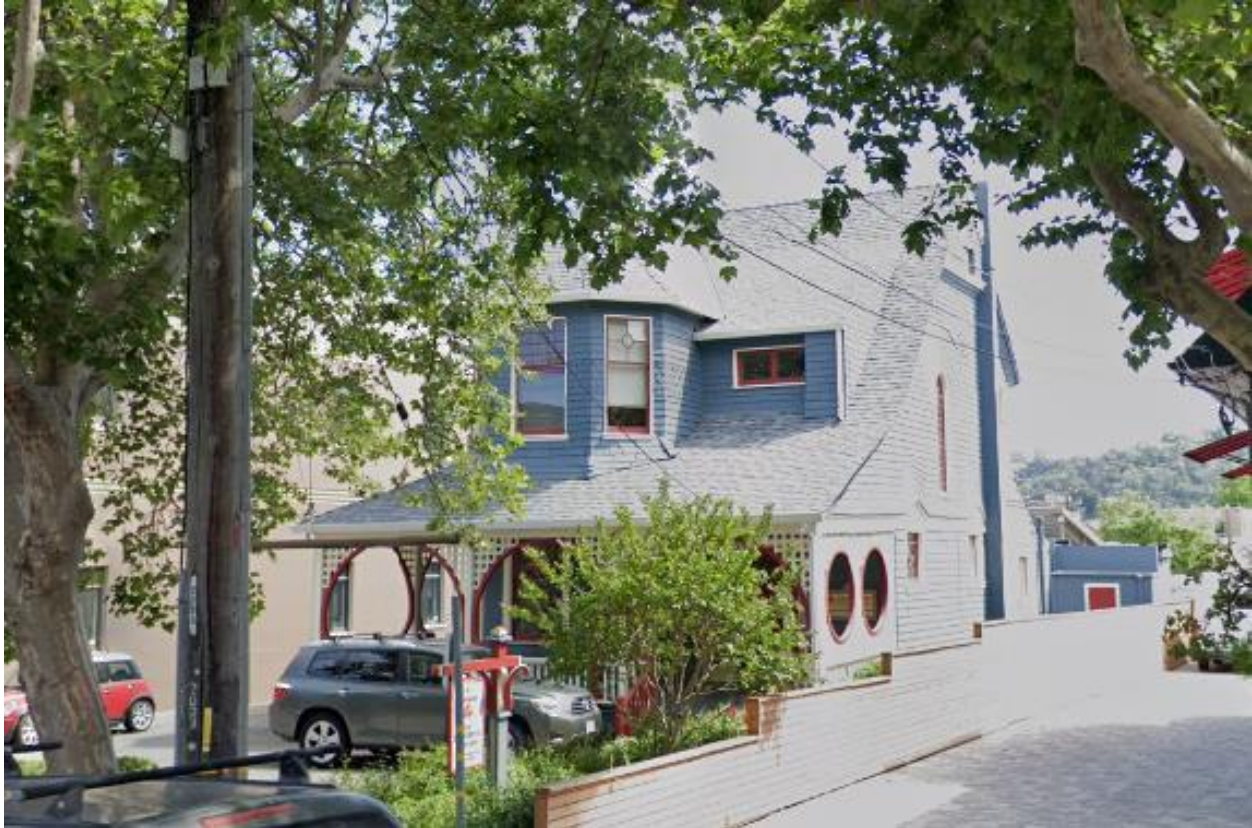
Address	705 Mission Avenue	7N	A
APN	011-226-03		
Building Name	NWP Station Master's House		
Year Built	c1900		
Original Use	Residential		
Architectural Style	Shingle		
Architect/Builder			
Description	The one-and-a-half-story building has a roughly rectangular plan. It has a hip-on-dual-pitched-gable roof. It has a full-width integral porch with rounded openings on all sides. Double hung wood sash windows have various decorative configurations. It is clad in shingle, with several decorative strips of straight-lined fishscale on the second-floor projecting volume.		
Integrity	Appears to retain integrity		
Significance	Good example of rare style, Eligible as landmark and district contributor		
Notes

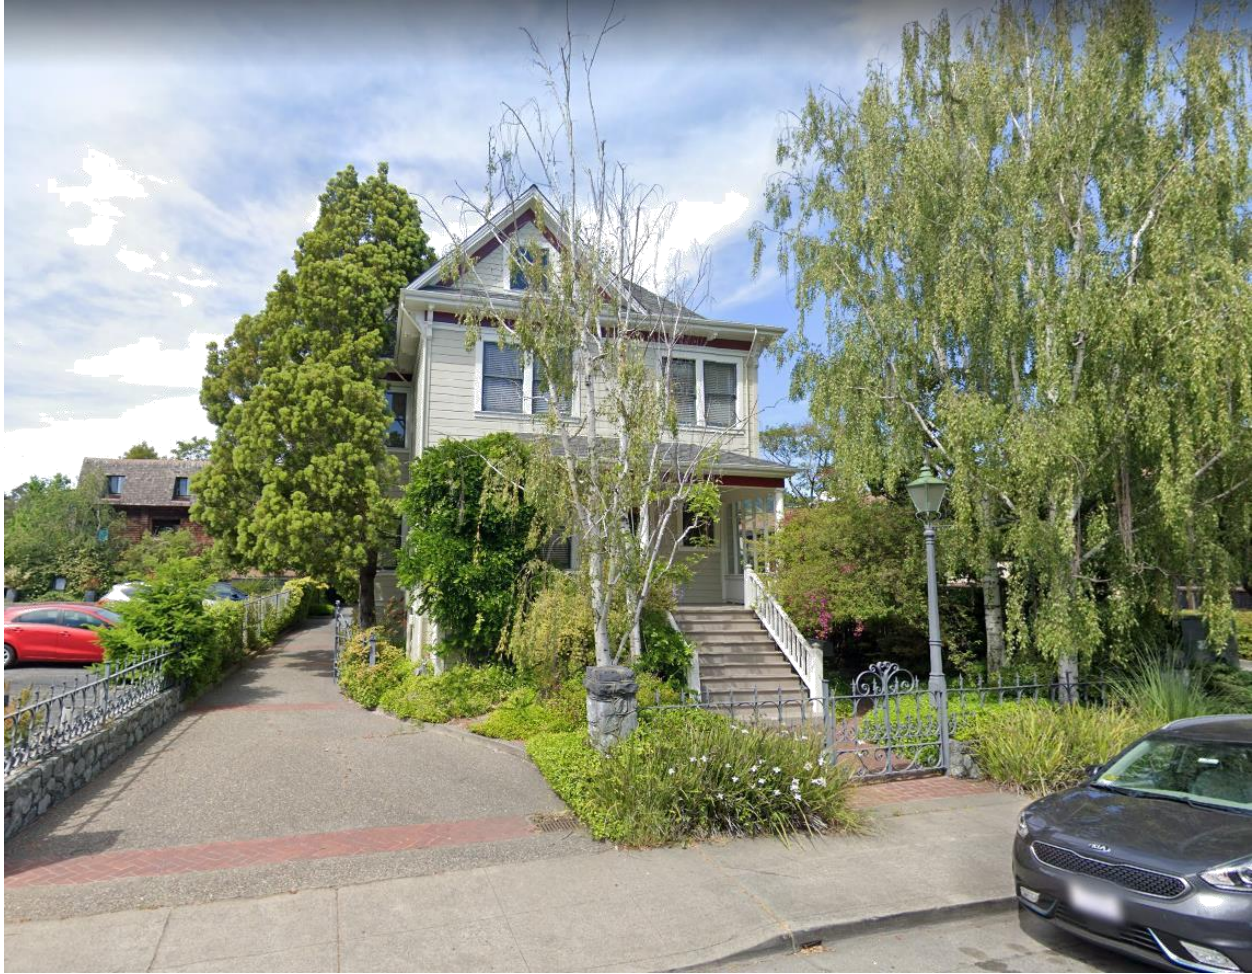
Address	710 Mission Avenue	A
APN	011-186-10	
Building Name		
Year Built	c1900	
Original Use	Residential	
Architectural Style	Queen Anne	
Architect/Builder		
Description	<p>The two-and-a-half story building has a gable-on-hip composition shingle roof with decorative brackets at the cornice and a roughly rectangular plan. It has a raised elevation and a full-width one-story projecting front porch with at the center that is screened on the sides. The entrance is centered and recessed. The building is clad in horizontal board siding, with a combination of shingle and fishscale on the attic-floor gable. It has wide double-hung wood sash windows, many of them in pairs.</p>	
Integrity	Appears to retain integrity	
Significance	Eligible as individual landmark and district contributor	
Notes	<u>Converted to offices</u>

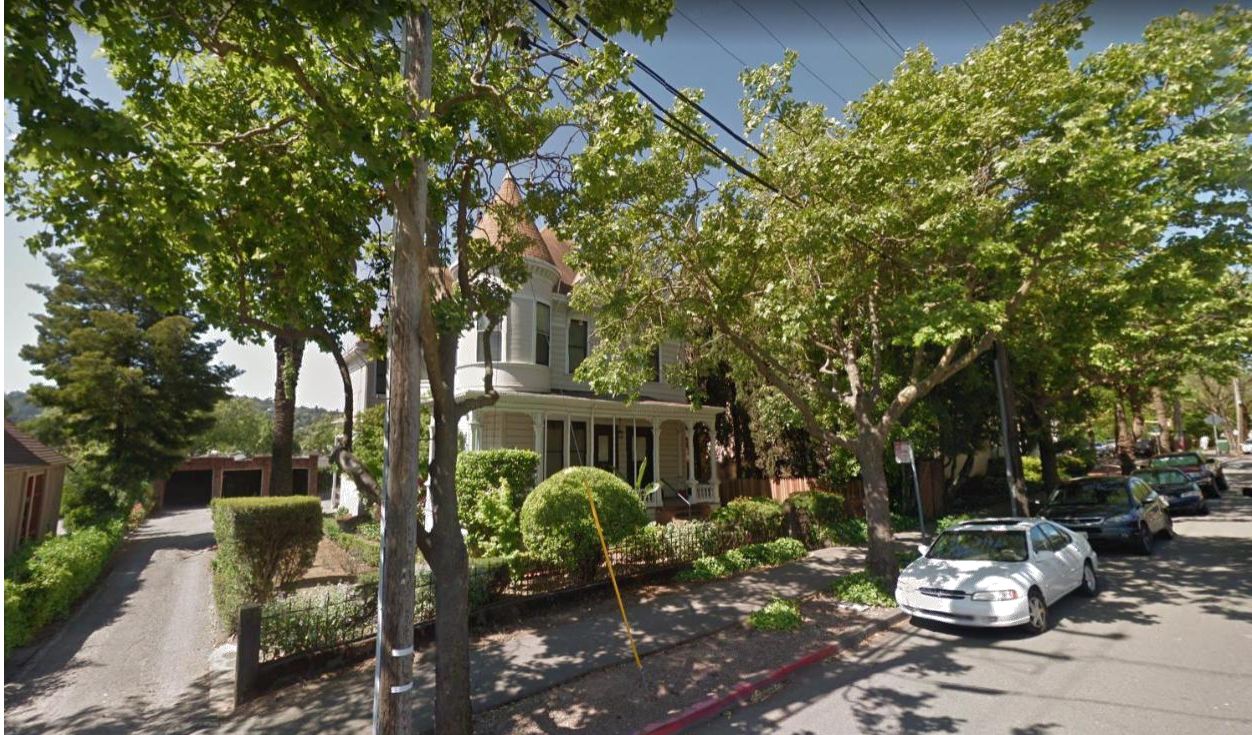
Address	823-25 Mission Avenue	3S	A
APN	011-223-02		
Building Name			
Year Built	Pre-1887		
Original Use	Residential		
Architectural Style	Queen Anne		
Architect/Builder			
Description	The two-story building has a roughly rectangular plan and a gable-on-hip composition shingle roof with a round, pointed tower in one front corner. There is a projecting full-width porch on the first floor that extends wider than the house at one side. The building is clad in horizontal wood siding. Queen Anne decorative features include brackets at the tower cornice, ornate window casings, and square porch columns with capital and scrolled brackets.		
Integrity	retains integrity		
Significance	Excellent example of high style Queen Anne architecture, landmark and contributor		
Notes

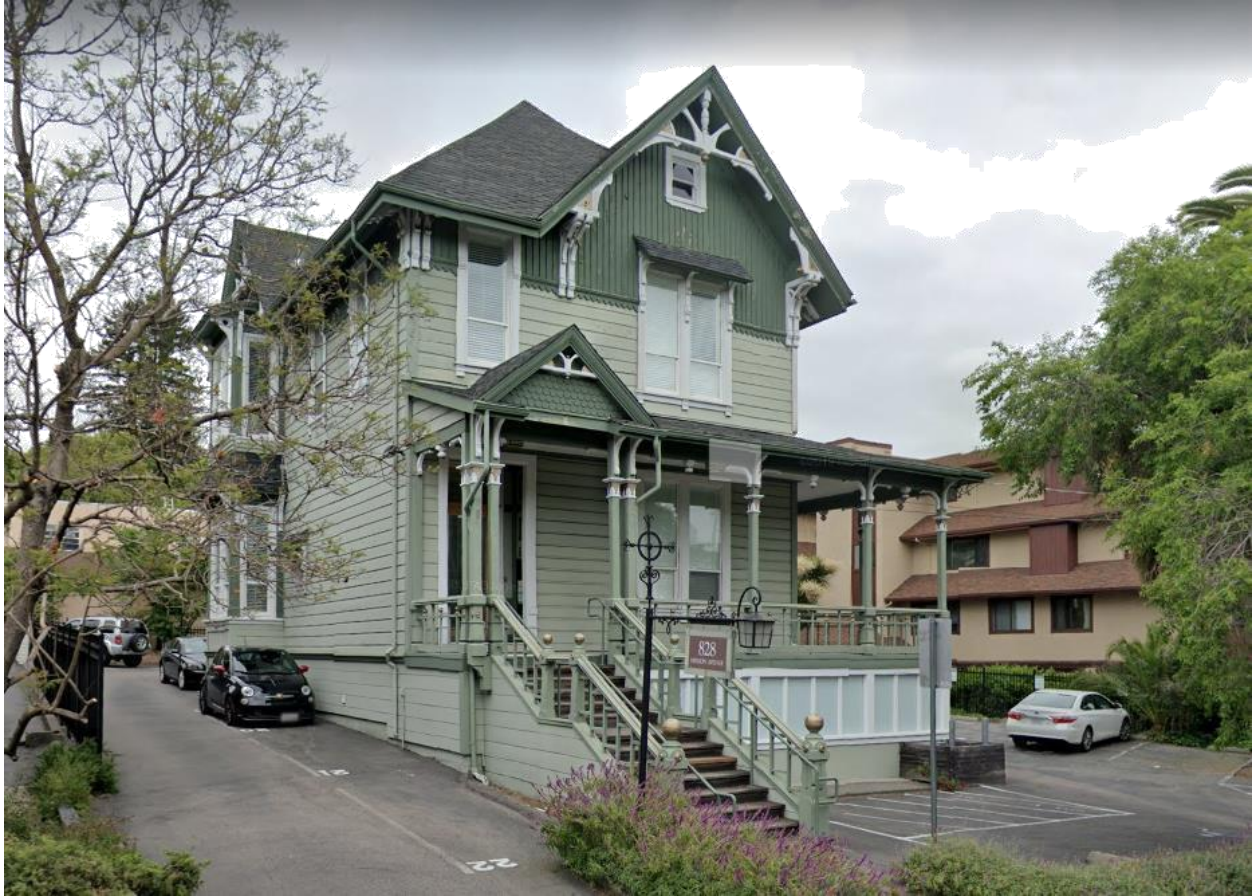
Address	828 Mission Avenue	A
APN	011-184-10	
Building Name		
Year Built	Pre-1887	
Original Use	Residential	
Architectural Style	Stick	
Architect/Builder		
Description	The two-story building has a roughly rectangular plan and a parking lot to one side. The gable-on-hip composition shingle roof features decorative triangular brackets at the corners and gable trusses. There is a projecting full-width wraparound porch on the first floor of the main façade and a side façade, with a small gable on the one-story projecting porch roof above the corner main entrance. The building, sited on a slope, has a raised foundation toward the front, and a set of stairs lead directly to the main entrance. The building is clad in horizontal board siding with narrow vertical board siding on the gable faces.	
Integrity	retains integrity	
Significance	Eligible as landmark and contributor	
Notes	<u>Mayor McCarthy residence</u>

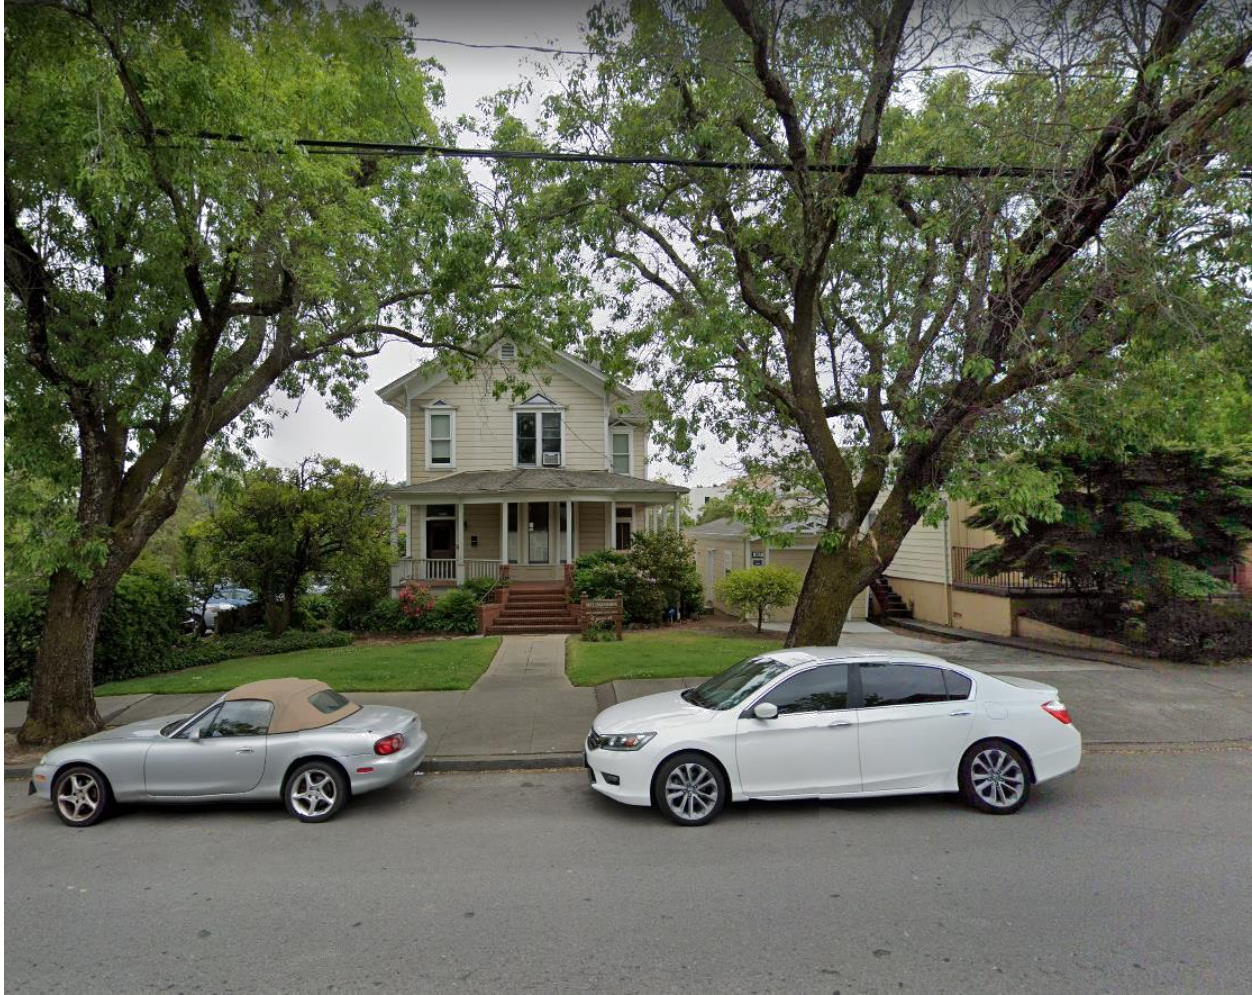
Address	907 Mission Avenue	7N	A-
APN	011-221-03		
Building Name	<u>Cheda House</u>		
Year Built	c1900 <u>(moved here from the Cheda Block (SE of 4th and A))</u>		
Original Use	Residential		
Architectural Style	Folk Victorian		
Architect/Builder			
Description	<p>The two-story building has a roughly rectangular plan. The cross-gabled composition shingle roof features decorative triangular knee braces at the corners. There is a projecting full-width wraparound porch on the first floor of the main façade and side, with entrances at either end and a bay window. It is accessed by a set of brick steps. The building has tall, narrow double-hung wood sash windows, and those on the second floor feature decorative wood pediments. The building is clad in horizontal board siding. There is a small detached garage next to the building with matching cladding and a low-pitch gabled roof with a gable truss above the garage door.</p>

Integrity	Appears to retain integrity		
Significance	Eligible as landmark and contributor		
Notes

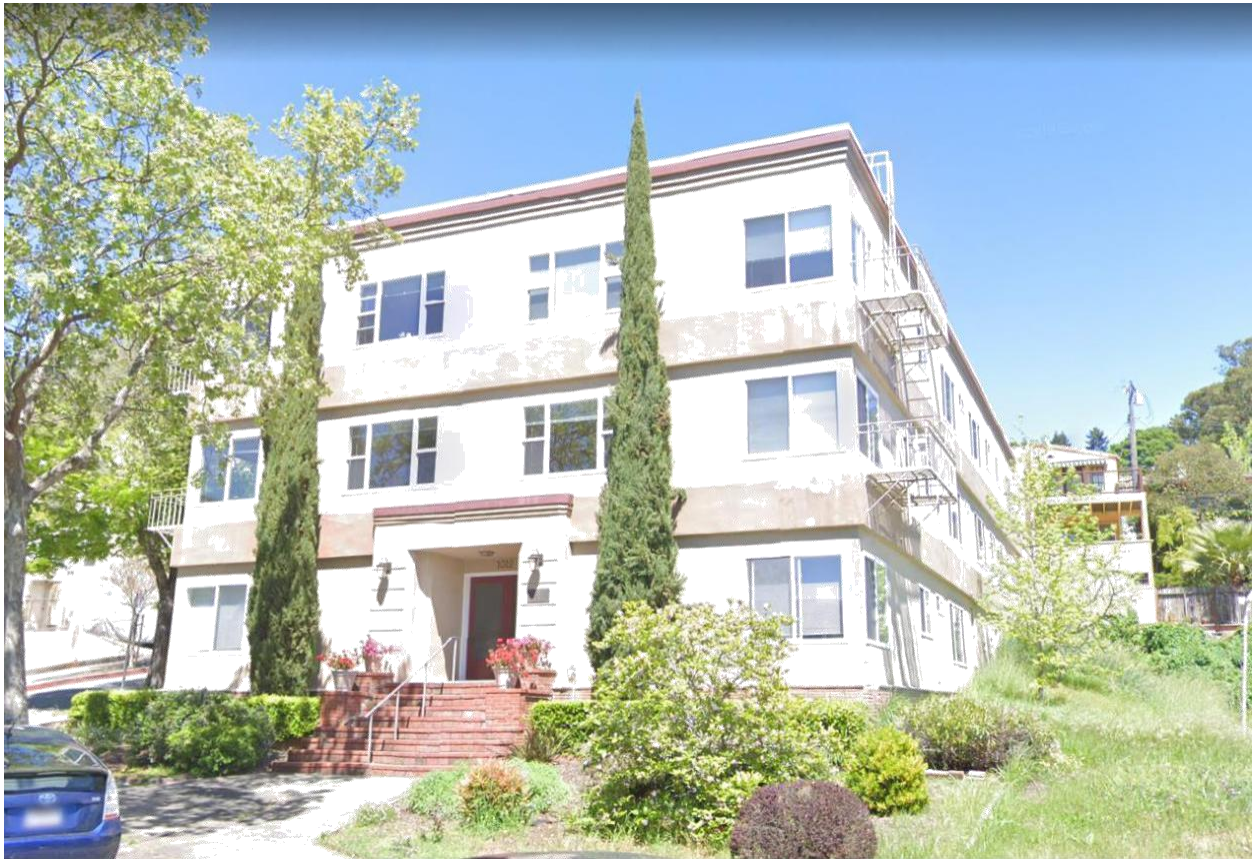
Address	1012 Mission Ave	ED
APN	011-174-11	
Building Name		
Year Built	1949	
Original Use	Residential Apartment Building	
Architectural Style	Streamline Moderne	
Architect/Builder		
Description	The three-story building has a rectangular plan with an open courtyard in the center and a flat roof. There is a large parking lot to one side of the building. Located on a slope, the building is only two stories at the back. The recessed front entrance is accessed by a set of brick steps at the center of the main façade. Windows are fitted with various types of replacement sash.	
Integrity	Appears to lack integrity	
Significance	Unlikely to be significant	
Notes

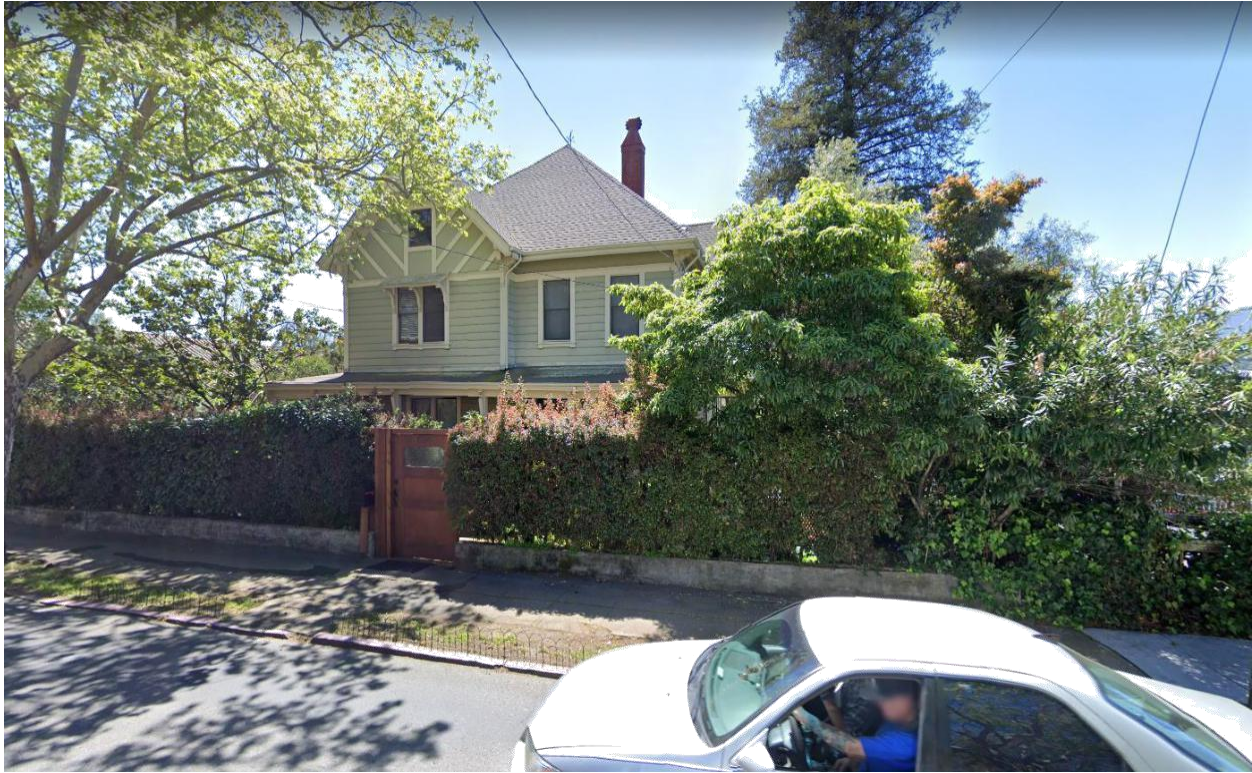
Address	1135 Mission Av	(likely B) A
APN	011-213-04	
Building Name	DeCourtieux House	
Year Built	1893	
Original Use	Residential	
Architectural Style	Stick	
Architect/Builder		
Description	The two-and-a-half-story building has a roughly rectangular plan and combination cross-gabled and hipped roof. While the first floor is mostly obscured behind a tall hedge, the building appears to have a full-width integral porch with a slightly projecting roof on the main façade. There is a variety of cladding, including horizontal channel board siding and half-timbering on the gable faces.	
Integrity	Appears to retain integrity	
Significance	Potential local district contributor. <u>Initially rated as ,—not individually eligible but changed to an individual resource during public review.</u>	
Notes

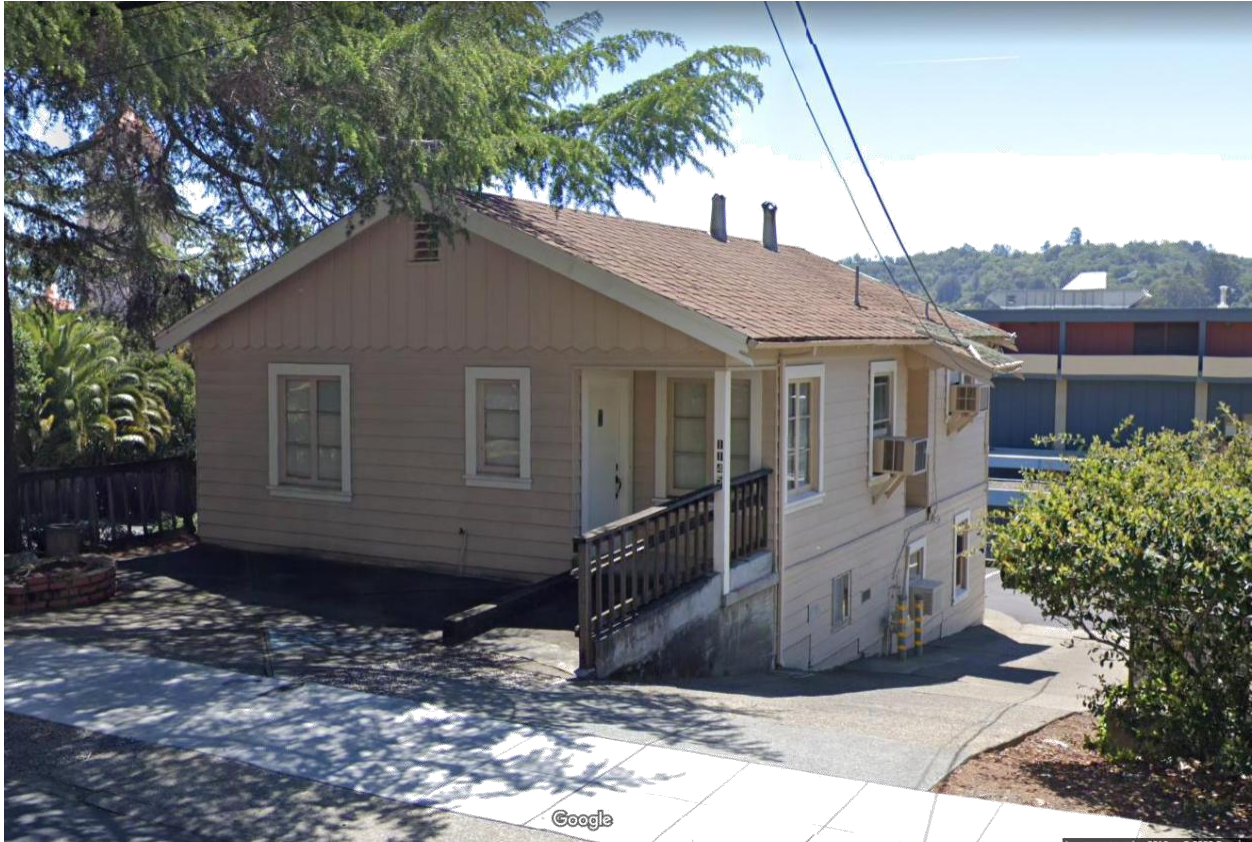
Address	1145 Mission Av	(likely E)D
APN	011-186-11	
Building Name		
Year Built	1937 (spreadsheet)	
Original Use	Residential	
Architectural Style	Minimal Traditional	
Architect/Builder		
Description	The one-story building has a rectangular plan and gabled composition shingle roof with exposed rafter tails. Sited on ground that slopes downward from the front, the building has a second, lower floor at the back. There is a small, partial-width integral porch, and a ramp with a wooden railing on one side leads up to it. The main entrance faces into the side of the building from the porch. The building is clad in a variety of wood board siding, both vertical and horizontal.	
Integrity	Integrity appears impaired; ramp has been added	
Significance	Not eligible, architecture not significant	
Notes

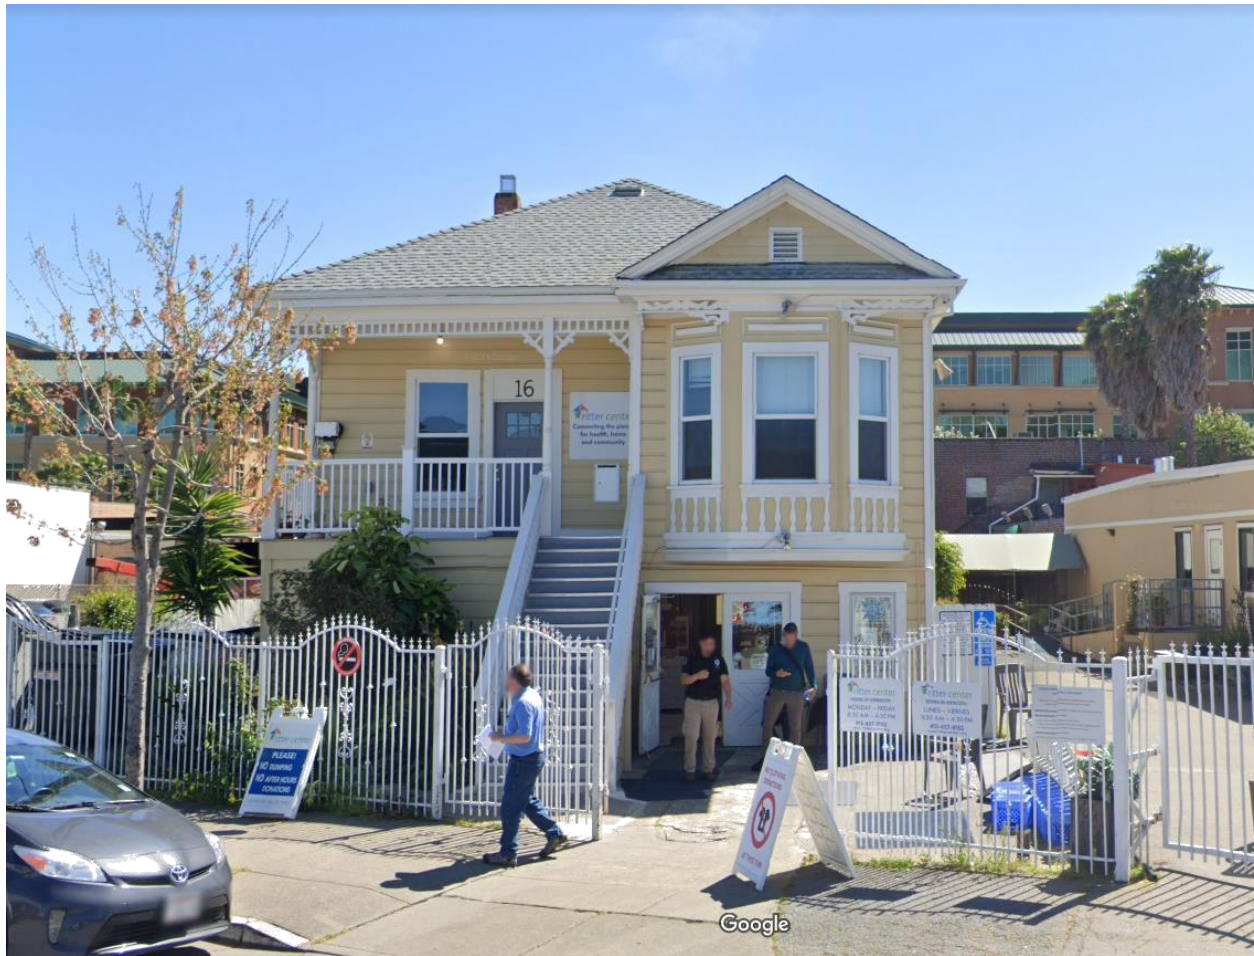
Address	16 Ritter Street	(likely E) C
APN	011-272-04	
Building Name		
Year Built	1911 (spreadsheet)	
Original Use	Residential	
Architectural Style	Queen Anne Cottage	
Architect/Builder		
Description	The two-story building has a rectangular plan and a gable-on-hip composition shingle roof. There are two entrances on the main façade: a set of double doors on the first floor, and an entrance sheltered by a partial-width integral porch on the second floor. There is a bay window above the first-floor entrance. The building is clad in horizontal drop siding. The building has vinyl windows, a replacement door, replacement porch balustrade, and may have been raised.	
Integrity	Integrity appears impaired; windows replaced, door altered	
Significance	Not eligible, lacks integrity Initially rated poorly but may require additional evaluation.	
Notes	The last of a row of modest homes considered for inclusion in 1978.

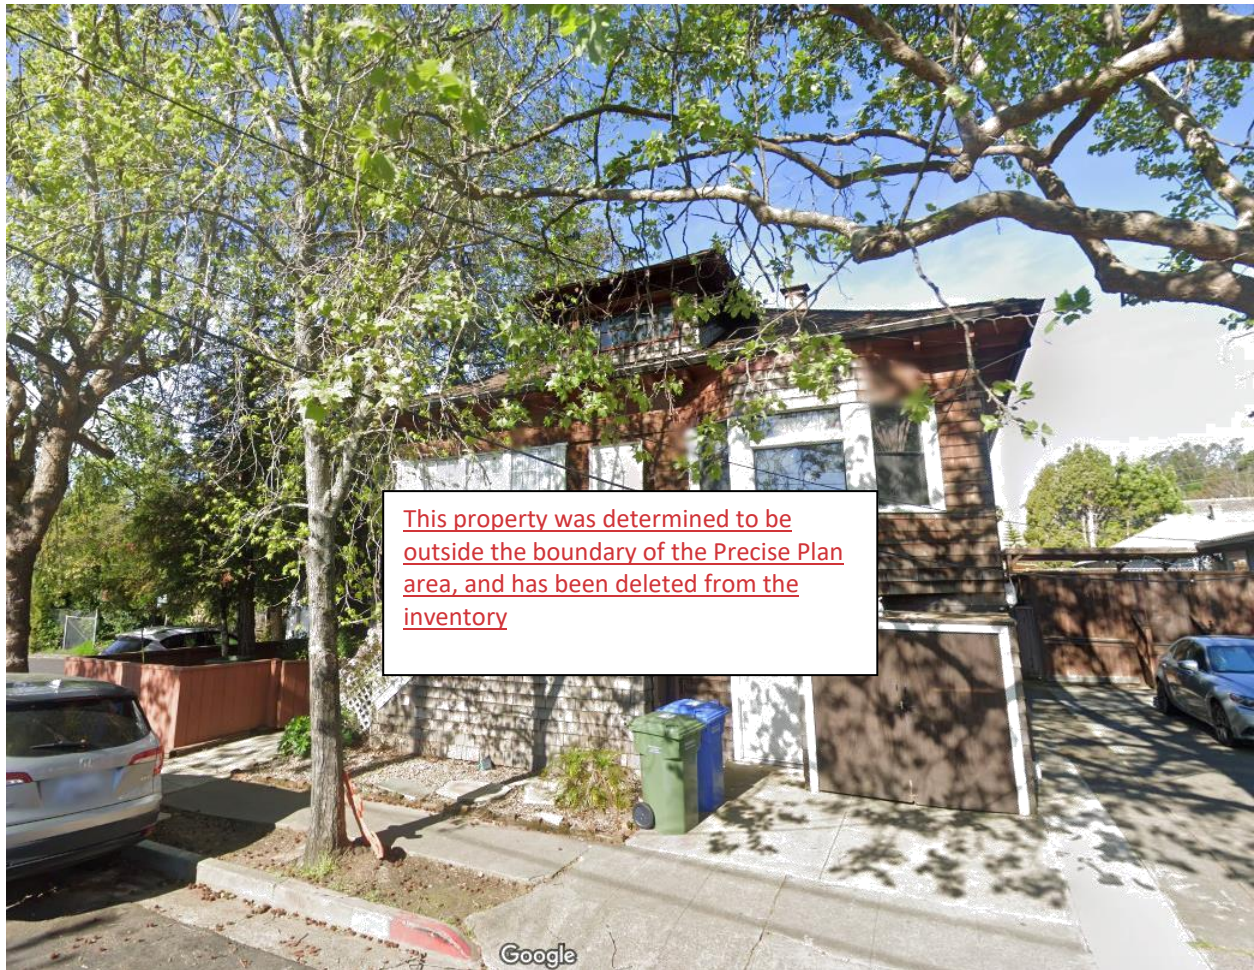
This property was determined to be outside the boundary of the Precise Plan area, and has been deleted from the inventory

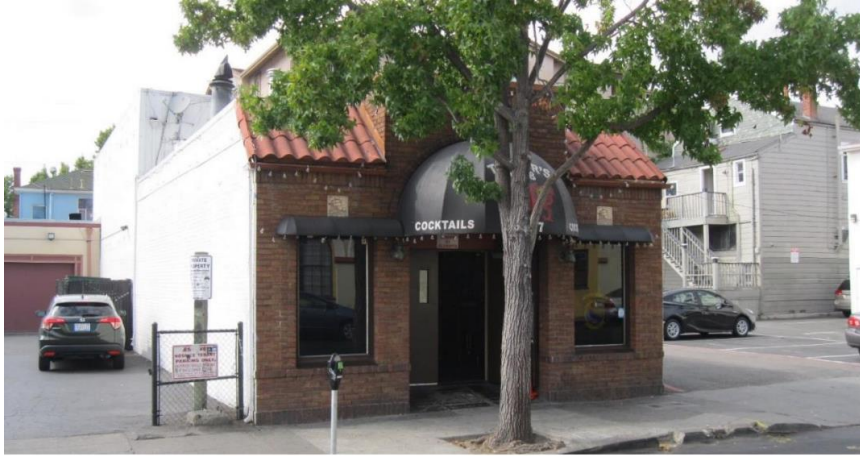
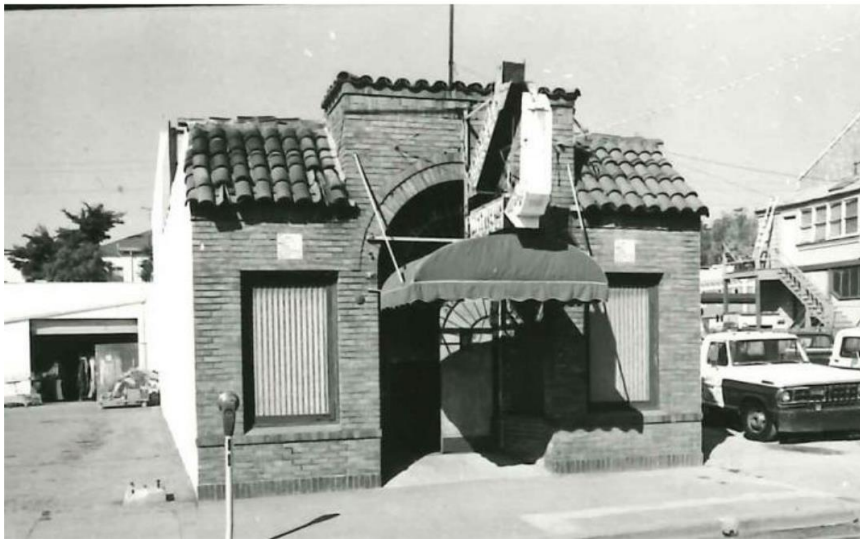
Address	927 Tamalpais Av	3S	B
APN	011-275-04		
Building Name	Barrel House		
Year Built	c1925 (spreadsheet)		
Original Use	<u>Taxi office and/or ferry ticket office</u>		
Architectural Style			
Architect/Builder			
Description	The narrow rectangular building is one story at the front and two stories toward the back. It has a flat roof and is clad in brick with some vertical board siding on the second story. The brick is unpainted on the main façade. The main façade also features a slanted tile roof on either side of the partial-width parapet that shelters the arched main entrance. There are large decorative tiles over the small storefront windows. <u>The façade and single story portion is the principal resource.</u>		
Integrity	Retains integrity, see 1970s photo above		
Significance	Eligible as district contributor, lacks significance for landmark status		
Notes

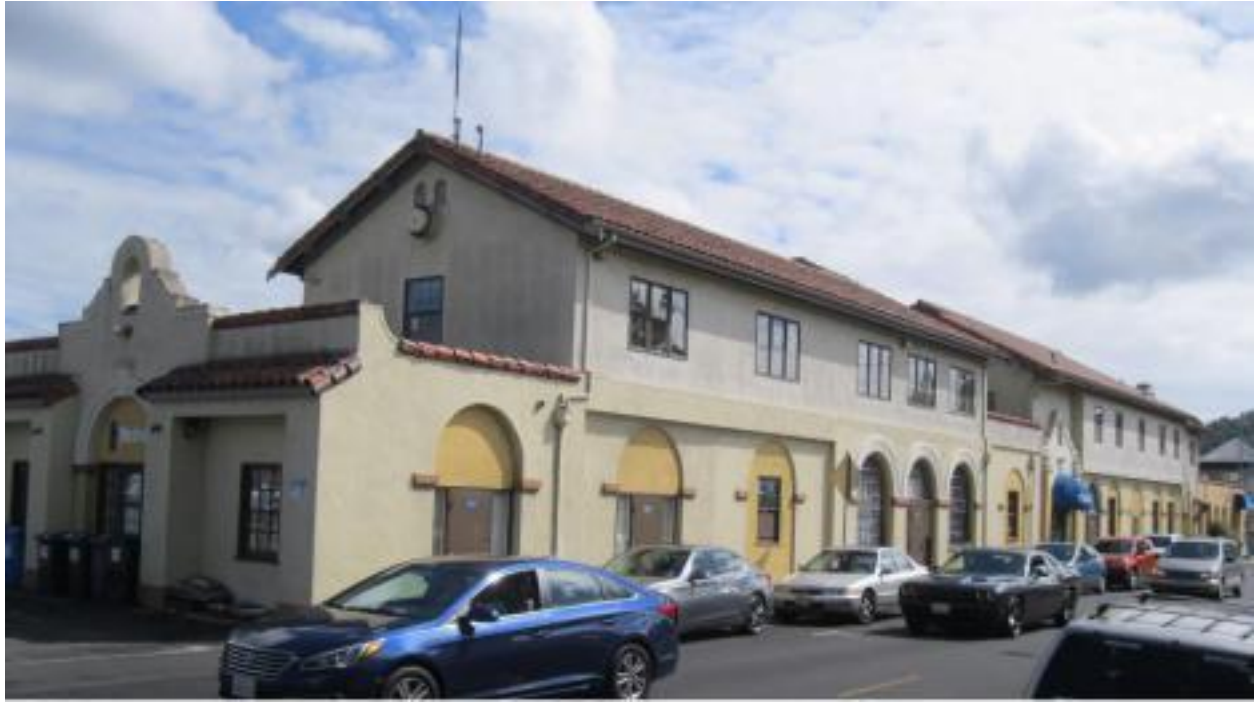
Address	930 Tamalpais Av	3S	<u>EC</u>
APN	011-277-01		
Building Name	Northwest <u>ern</u> Pacific Railroad Depot		
Year Built	c1929 (spreadsheet)		
Original Use	Railroad Depot		
Architectural Style	<u>Spanish?</u> Mission Revival		
Architect/Builder	<u>Frederick H Meyer, AIA</u>		
Description	The two-story linear building runs along the railroad tracks next to Tamalpais Avenue. It is clad in smooth stucco and has a gabled tile roof. Windows are varied, but all have multiple small lights; most are wide vertical eight-over-eight light windows. A series of arches in shallow relief along the main façade have windows or doors in them. There are a number of entrances on the main façade, but the main entrance is located under a cloth awning and large decorative arch.		
Integrity	Appears to retain integrity, more study needed, 2 nd story addition		
Significance	<u>Likely significant, currently being separately evaluated for individual NRHP nomination Initially assigned "C" rating, but subsequently added to potential eastern historic district. Will require further evaluation.</u>

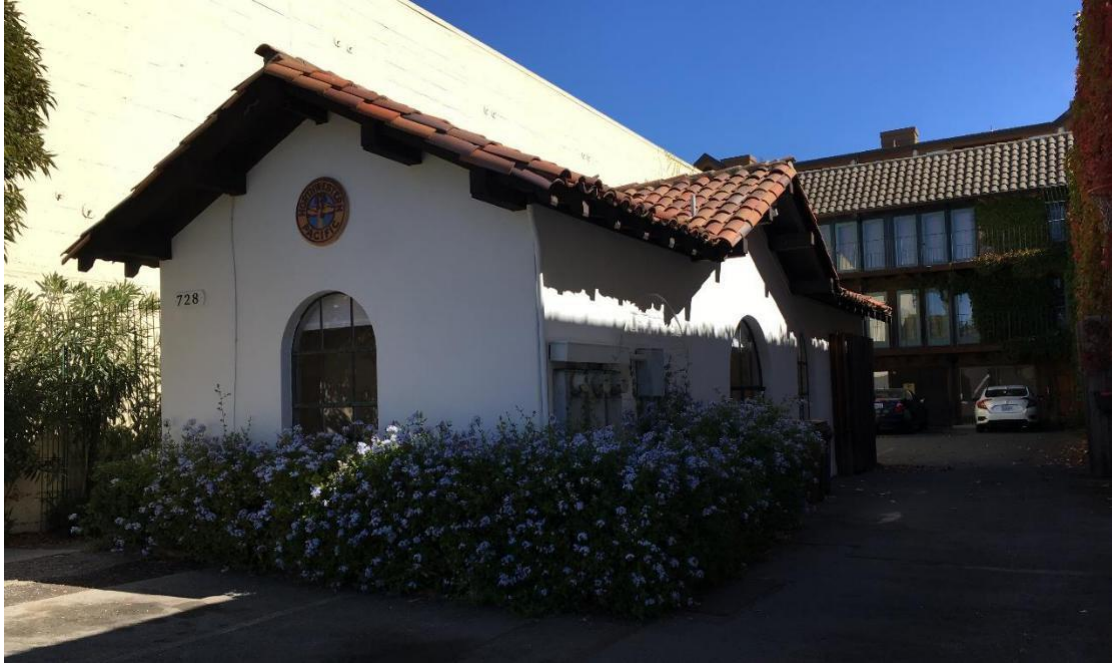
Address/code	7280 A Street (728 A Street)	7N	A
APN	013-012-05		
Building Name	Northwestern Pacific Railroad Station		
Year Built	19 30 29 (https://annetkent.kontribune.com/articles/5656), c1960 moved		
Original Use	Railroad station		
Architectural Style	Spanish Revival		
Architect/Builder			
Description	The diminutive one-story rectangular plan building is set back on its parcel in a neighborhood of taller buildings sited immediately adjacent to the sidewalk. It has a cross-gabled Tile roof with exposed purlins and rafter tails. Cladding is smooth plaster stucco. Large arched windows are fitted with multi-light steel sash. There is a decorative medallion with the railroad logo at the gable end.		
Integrity	Retains integrity despite being moved		
Significance	Individually eligible under A and C, also local contributor		
Notes	<i>This is not the original Depot location, building was appears to have been moved to site from original B St location when Safeway was developed in early 1960s. <u>Apartments in back are 720 A Street.</u></i>

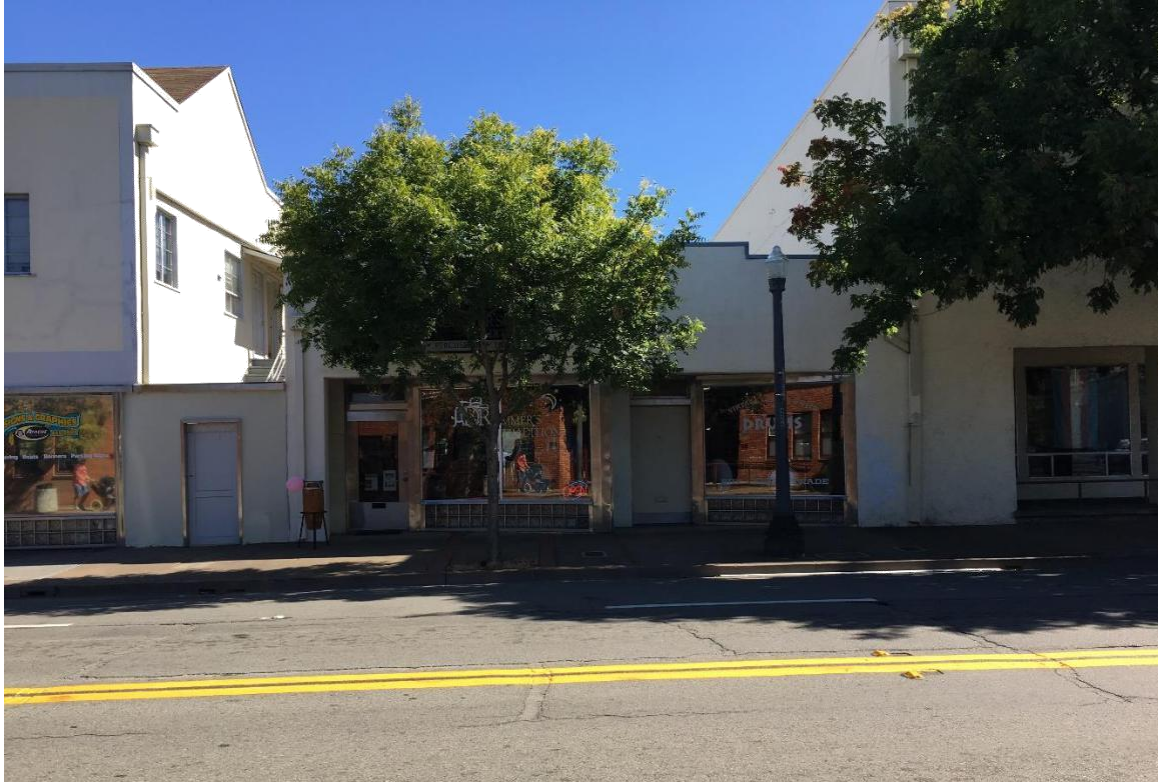
Address/code	740 A Street		<u>BD</u>
APN	013-012-20		
Building Name	A Drummer's Tradition (drum store)		
Year Built	1948		
Original Use	Retail		
Architectural Style	Midcentury Modern		
Architect/Builder			
Description	<p>The one-story commercial building is rectangular in plan with its main façade immediately adjacent to the sidewalk. It has a simple stepped parapet and two storefronts with entrances left of display windows. Storefronts slant outward from recessed doors creating a zig-zag façade. The building has glass block bulkheads and metal window and door trim. Cladding is stucco. There is a small wood-clad volume at the rear of the main building with a shed roof.</p>		
Integrity	Appears to retain integrity, may have been altered 1950s		
Significance	<p>Potential local district contributor if a sufficient concentration of postwar commercial resources is present, not individually eligible at any level. <u>Initially rated "B" in the 2019 Survey. Because this structure is not in an eligible district and is not eligible as an individual resource, its final rating is D.</u></p>

Notes	<p><i>Bulkhead and trim match the adjacent building to the north (742-744 A), probably both were remodeled in the 1950s as other details differ. Both buildings should probably be included or not included in potential district</i></p>
