Downtown San Rafael Precise Plan Historic Resources Inventory Summary Report

December 2020

[Revised May 2021](#)

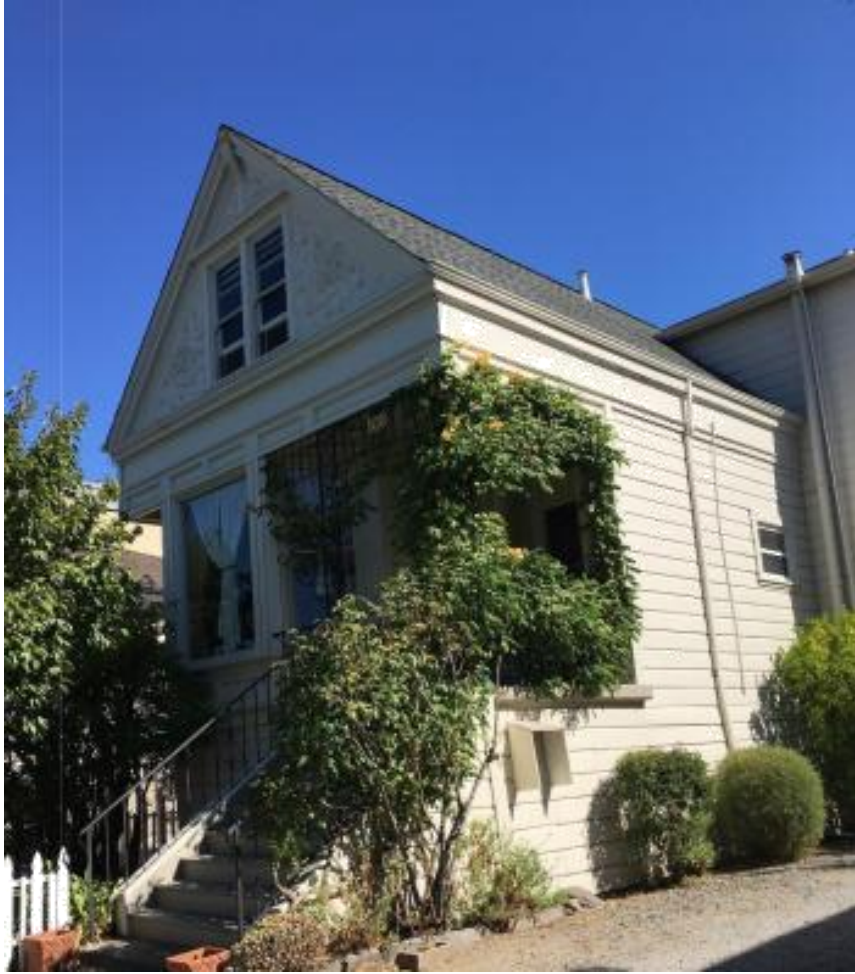
Address/code	808 A Street		B
APN	011-264-07		
Building Name			
Year Built	C1890 (Sanborn Maps)		
Original Use	Residence		
Architectural Style	Queen Anne Cottage		
Architect/Builder			
Description	The 1.5 story house has a roughly rectangular plan and a raised basement. It has a steeply pitched front-gabled roof. It is clad in drop wood siding and has a combination of double-hung wood sash and replacement windows. Decorative features include ornamental scrolls at the main façade gable end and a paneled frieze. Porch supports and balustrade are wrought iron.		
Integrity	Retains integrity despite replacement of some windows and original wood porch details		
Significance	Local district contributor, not individually eligible for architecture due to alterations		
Notes

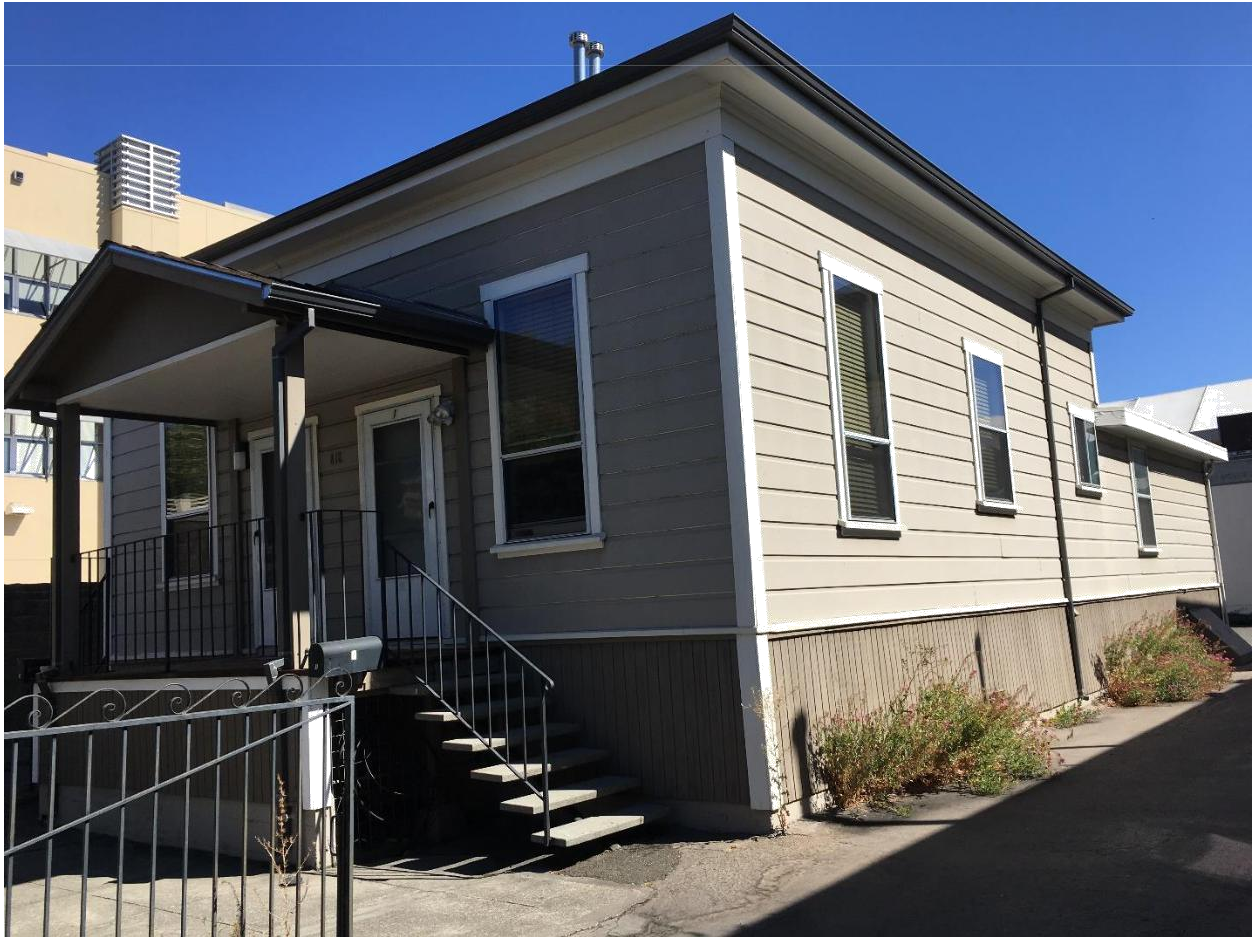
Address/code	812 A Street	ED
APN	011-264-08	
Building Name		
Year Built	Before 1887 (Sanborn Maps)	
Original Use	Multi-family Residence	
Architectural Style	Folk Victorian Duplex	
Architect/Builder		
Description	The one story duplex has a rectangular plan and a slightly raised basement. Its front wing has a steeply pyramidal roof; the rear of the building has a lower shed roof. Front doors are side by side in the symmetrical main façade. The building is clad in drop wood siding with vertical groove plywood at the basement level and has vinyl replacement windows. A partial width projecting porch has a low pitch gabled roof, concrete steps with open risers, and a balustrade are wrought iron. The building lacks decorative features	
Integrity	Lacks integrity due to replacement of windows and original full-width porch, basement siding, and installation of inappropriate porch steps and balustrade	
Significance	Not eligible under any criterion due to loss of integrity

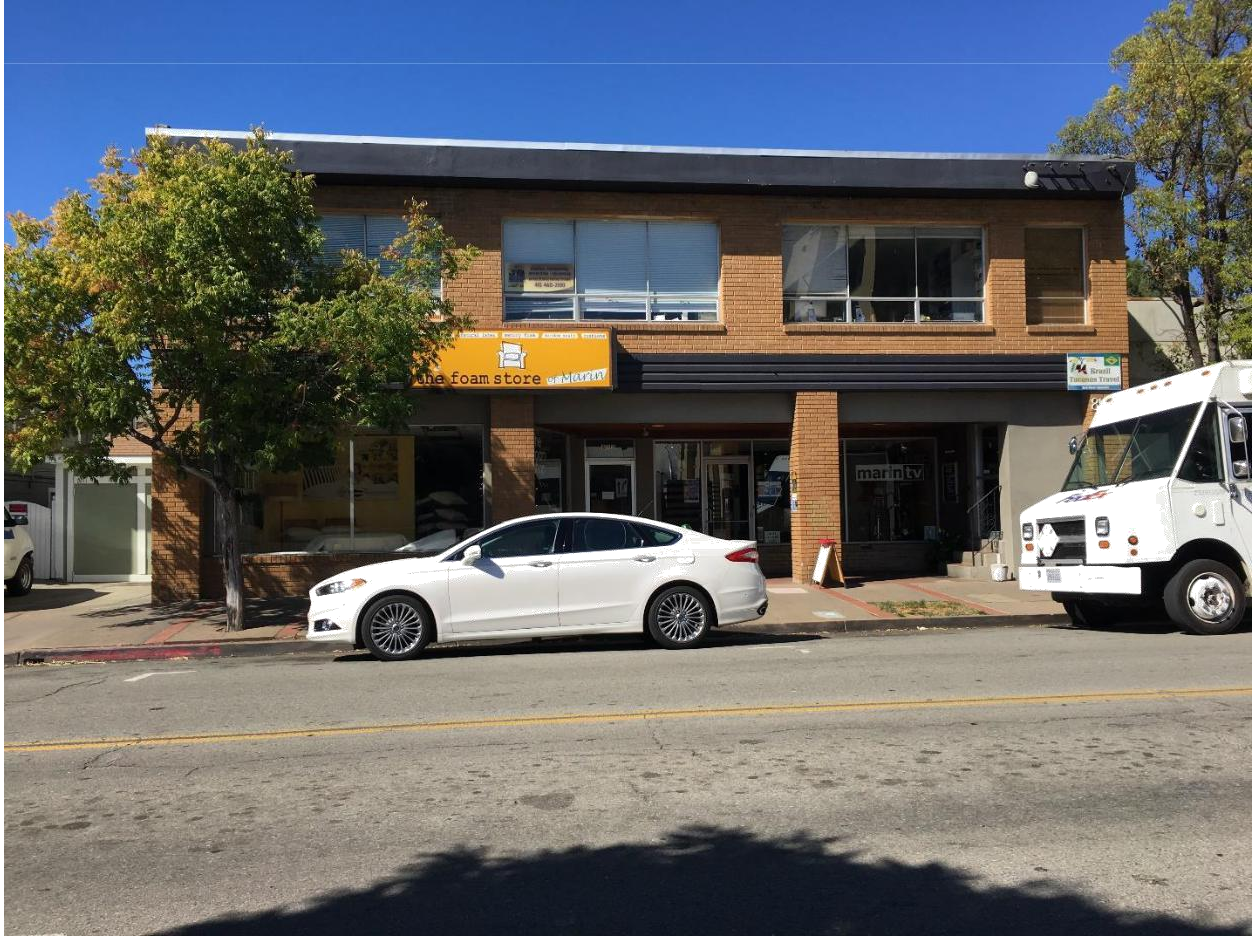
Address/code	813 A Street	BC
APN	011-262-06	
Building Name	Foam Store	
Year Built	1951 (Sanborn Maps, aerials)	
Original Use	Commercial	
Architectural Style	Midcentury Modern	
Architect/Builder		
Description	<p>The two story commercial building has a rectangular plan with storefronts on the ground floor and offices above. It has a flat roof with a heavy soffit on the upper floor. It is clad in brick with small areas of stucco. Upstairs windows are three-part steel casement. Decorative grooved moulding separates upper and lower stories. The storefront in the south third of the building is adjacent to the sidewalk, while the north end storefront and entrances are recessed behind heavy brick pillars and are fitted with contemporary replacement aluminum frame doors and windows.</p>	
Integrity	Retains integrity despite storefront replacement.	
Significance	<p>Potential local district contributor if a sufficient concentration of postwar commercial resources is present, not individually eligible at any level. <u>Initially rated as "B" but requires further evaluation.</u></p>

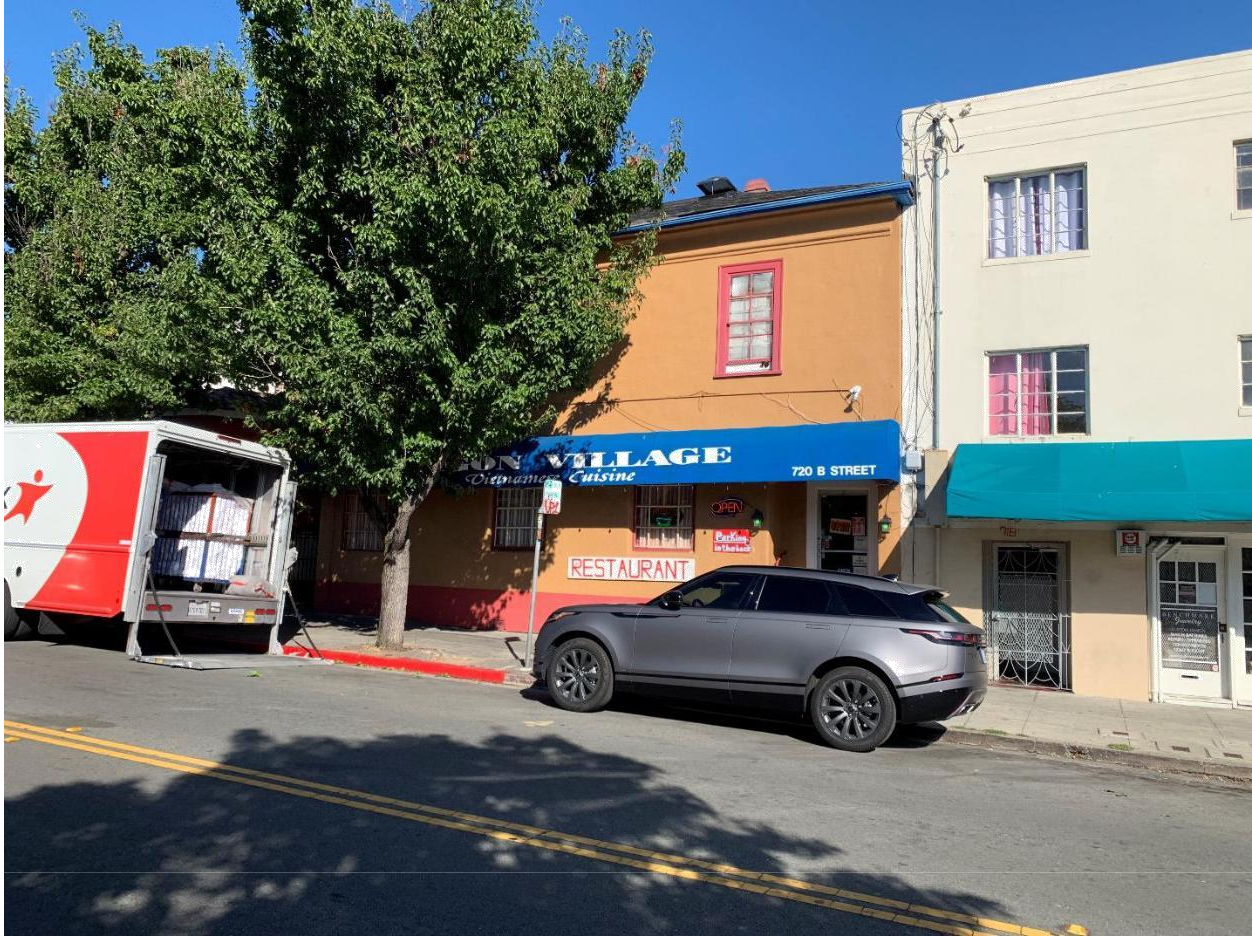
Address/code	720 B Street	CA
APN	013-011-02	
Building Name	Saigon Village Restaurant, Historic San Rafael Hotel House restaurant/saloon/lodging (now Saigon Village)	
Year Built	Before 1887 (Sanborn Maps)	
Original Use	Saloon/restaurant with rooms for railroad workers hotel upstairs	
Architectural Style	American Foursquare	
Architect/Builder		
Description	The two story residential-style building has a triangular plan to conform to the railroad tracks to its northeast. It features a medium pitch hipped roof in front with a flat-roofed addition at the rear. Cladding is stucco, windows are a combination of double-hung wood sash and fixed multi-light. The entrance is fitted with a fully-glazed aluminum frame commercial-style door. There are commercial buildings immediately adjacent to its side elevations.	
Integrity	Current appearance probably c1905, door modern, requires more study	
Significance	Potential local district contributor as extant nineteenth century restaurant/hotel. <u>Conforms to former RR alignment.</u> Not eligible for its architecture.

Notes	<u>Good candidate for restoration incentives.</u>

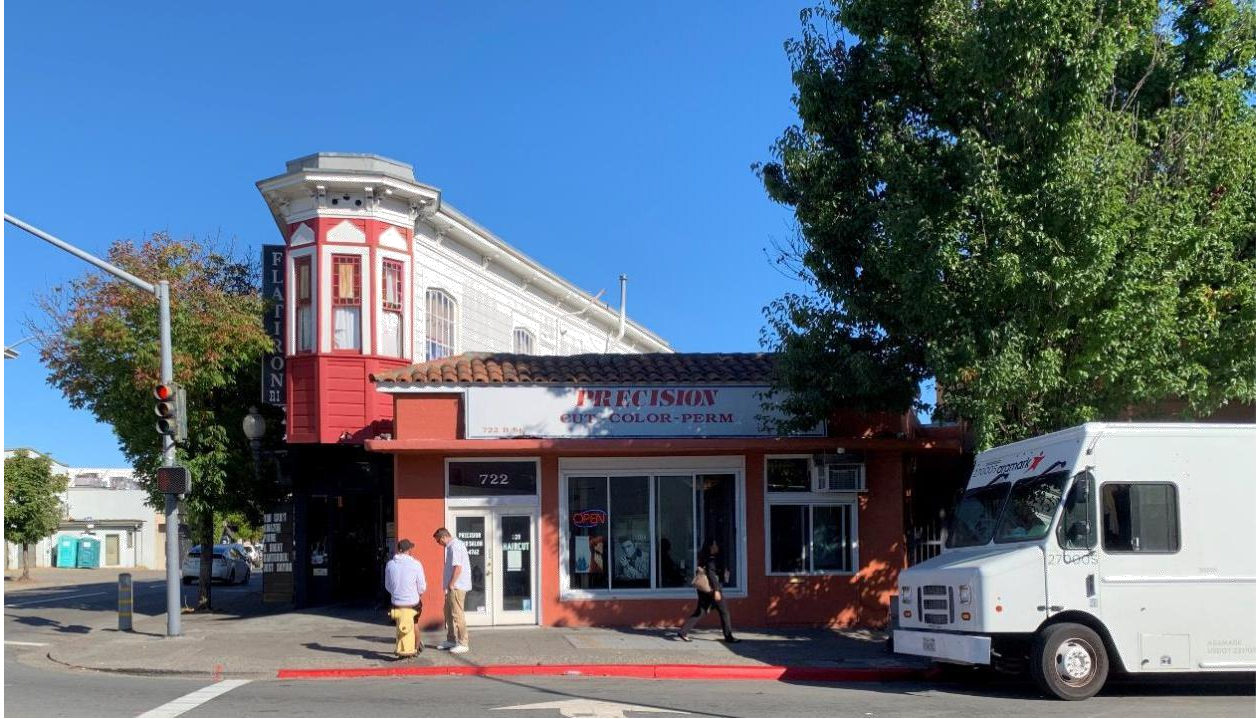
Address/code	724 B Street	7N	A
APN	013-011-05		
Building Name	Flatiron Building		
Year Built	1883		
Original Use	Saloon/residential <u>(rooms for rent)</u>		
Architectural Style	Queen Anne Commercial		
Architect/Builder			
Description	<p>The two story commercial building has a triangular plan with a bar and grill on the ground floor and apartments above. It has a flat roof and cornice elaborated with ornamental brackets and frieze. It is clad in drop wood siding and has double-hung wood sash windows. Its northwest corner features a highly decorative projecting bay above the main entrance which features decorative spandrel panels above multi-light stained-glass windows. Windows and doorways on the north elevation feature pedimented hoods. Entrances are fitted with wood-frame French doors, and there is a historic painted beer sign.</p>		
Integrity	Retains integrity, only doors appear to have been altered

Significance	Individually NRHP eligible under C and potentially A, also local contributor		
Notes	<p><i>Designated as Local Landmark in 1982, decorative features may have been added during the nineteenth century based on historic photographs. <u>Building was stucco when surveyed in 1978. Beer sign was discovered after stucco was removed following a fire.</u></i></p>

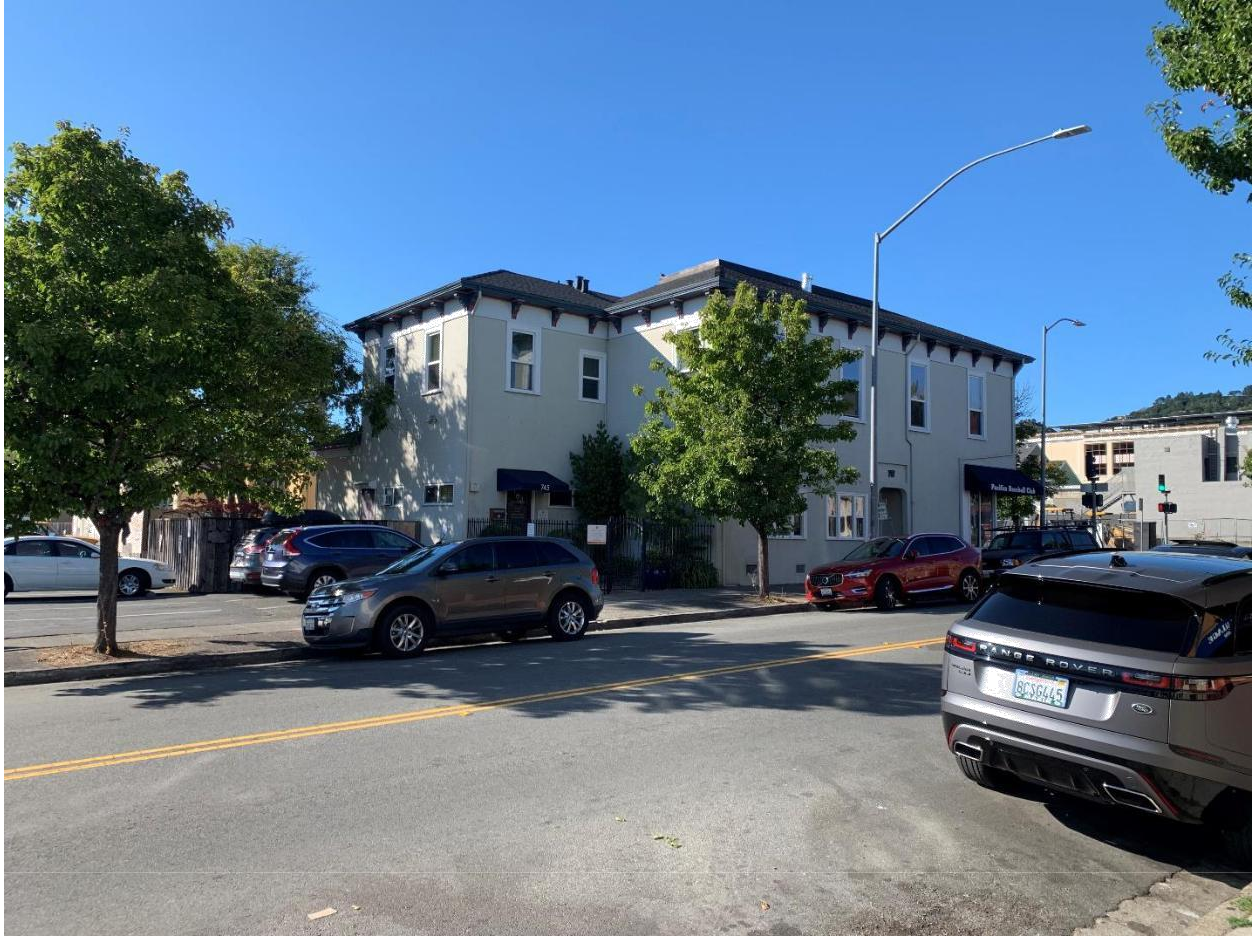
Address/code	747 B Street /1201 Second Street	N/A	DC
APN	013-011-056		
Building Name	Cosmopolitan Hotel		
Year Built	Before 1887 (Sanborn Maps)		
Original Use	Hotel		
Architectural Style			
Architect/Builder			
Description	The two story hotel building has an irregular plan with moderate pitch hipped roof and ornamental brackets at the cornice. Cladding is stucco and the building has vinyl replacement windows. There is a small wood frame storefront at its northwest corner. The balance of the lower north elevation lacks fenestration.		
Integrity	Does not appear to retain integrity, more study needed but stucco, windows, storefront, blank wall all appear to be alterations. <u>Initially rated "D" but changed to "C" during public review</u>		
Significance	Unlikely to be eligible, lack of integrity		
Notes	<u>Property was mistakenly shown as 901 B in the 1978 Survey</u>

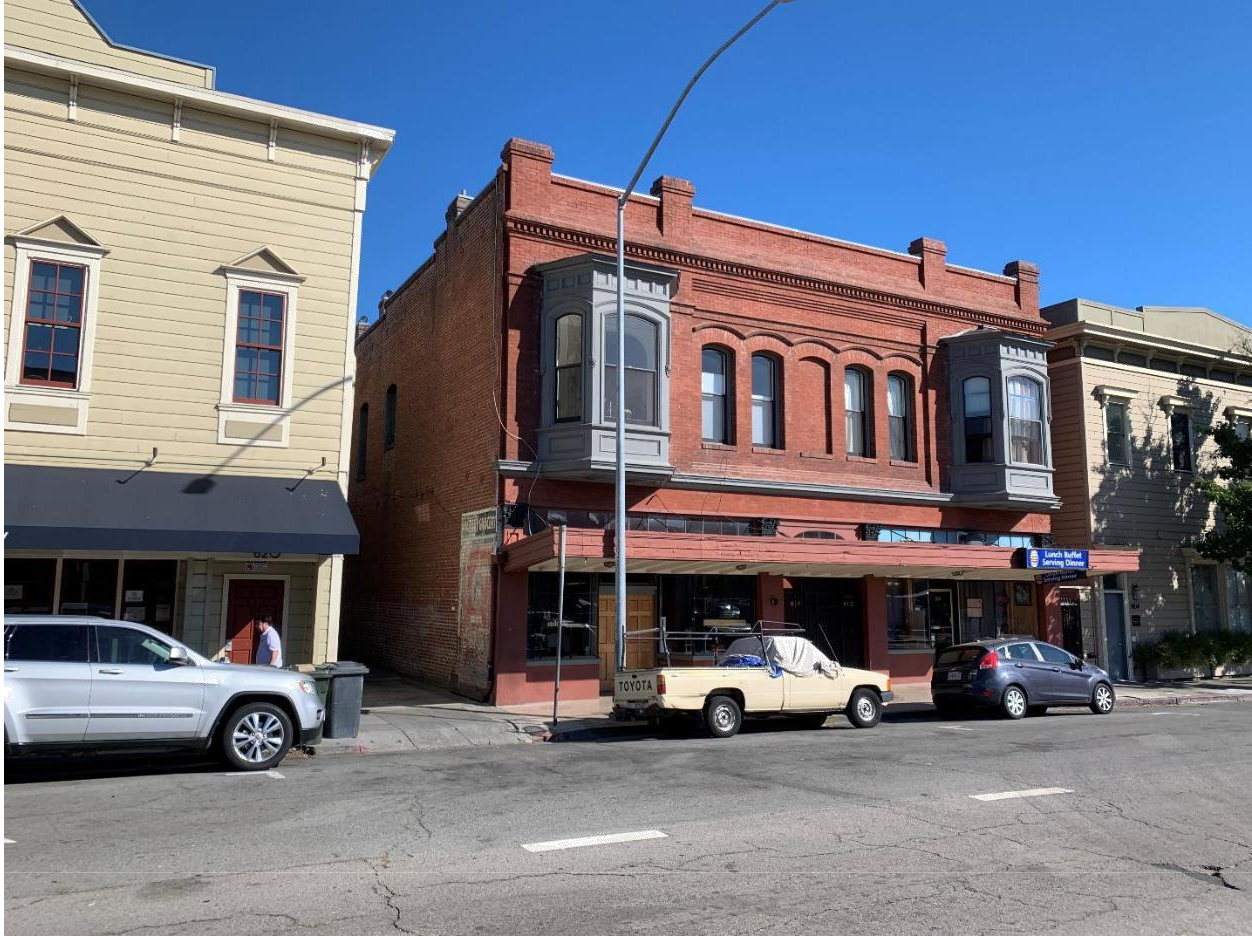
Address/code	810-814 B Street	3S	A
APN	01011-262-14		
Building Name	World Wide Antiques/Victory Grocery		
Year Built	Before 1894 (Sanborn Maps)		
Original Use	Retail storefront		
Architectural Style			
Architect/Builder			
Description	<p>The two story commercial building has a rectangular plan with flat roof and parapet. Cladding is brick with ornamental features including dentil moulding, upper floor pilasters, and window hoods also executed in brick. Two projecting wood upstairs bays have decorative frieze and window hoods. Window openings are arched and fitted with wood sash. Ground floor pilasters have Corinthian capitals flanking multiple light transoms above storefronts. A metal awning projects from the façade just below the capitals. Bulkheads and pilasters have been stuccoed below the awning. Ground floor doors are residential-type paneled wood doors on the north and a contemporary aluminum frame glazed door on the south.</p>

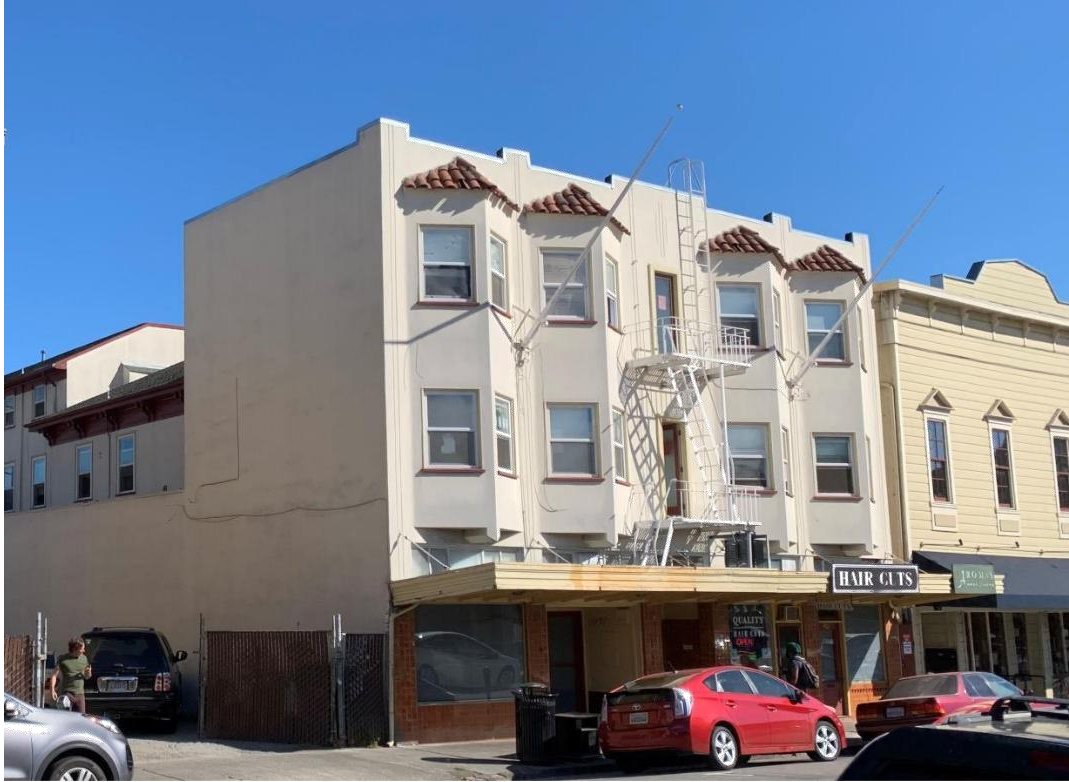
Address/code	826-832 B Street (830 B St)	5S2	C
APN	01011-262-16		
Building Name	Albion House, Hotel Carmel		
Year Built	1887 Albion Hotel, 2 story, smaller footprint; 1894 Cypress Villa Hotel, expanded footprint; 1907/1924 unchanged; 1950-1930 Hotel Carmel current footprint (Sanborn Maps) c1930 current façade (spreadsheet)		
Original Use	Retail storefront/hotel		
Architectural Style			
Architect/Builder			
Description	The <u>original 1887 building stands in the middle and the 1894 rear addition (probably the Cypress Villa Hotel) reflects the same style. The three story street-facing</u> building is rectangular in plan with a lower-height volumes at the rear. Its main façade is immediately adjacent to the sidewalk. The roof is flat with a shaped parapet. Four slanted bays project from the upper stories; each is topped with a tile roof. Fenestration consists of vinyl replacement windows. There is a fire escape with exits at the center of the façade. A metal awning <u>in front of below</u> multiple-light transoms shades the ground floor storefronts. Upper floors are stuccoed while the ground floor is clad in tile. Storefront entrances, one of which is recessed, are fitted with partially glazed paneled wood doors.

Integrity	May retain integrity to c1930 façade, more research needed		
Significance	Potential local contributor, not individually eligible		
Notes

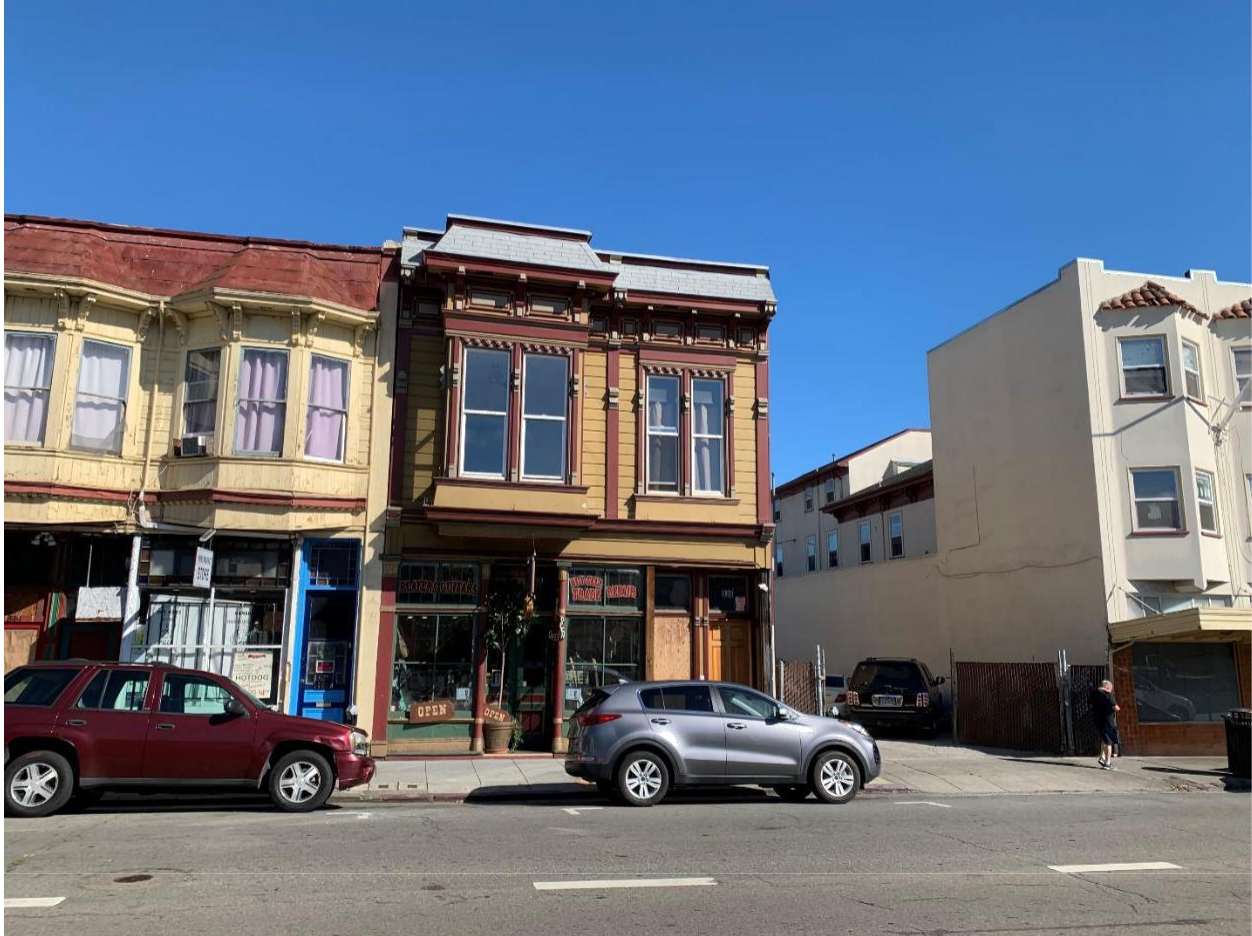
Address/code	8364-840 B Street	3S	A
APN	01011-262-22		
Building Name	Players Guitars		
Year Built	1885 per DPR, c1895 (between 1887-1894 and 1894-1907 Sanborn Maps)		
Original Use	Retail storefront (cobblershoe and boot store)		
Architectural Style	Stick Eastlake		
Architect/Builder			
Description	<p>The two story commercial building is rectangular in plan with a mansard roof. The façade is asymmetrical with has one projecting square bay on the upper floor. Cladding is drop siding. Tall vertical windows separated by stylized pilasters are fitted with vinyl replacement sash. Ornamental features include cornice with decorative brackets and elaborate paneled frieze as well as bird's eye moulding above windows. Rare original storefronts have multiple-light display windows and transoms. There is a set of original double wooden doors flanked by decorative round columns. Doors at the south end of the storefront have been replaced or temporarily boarded up.</p>

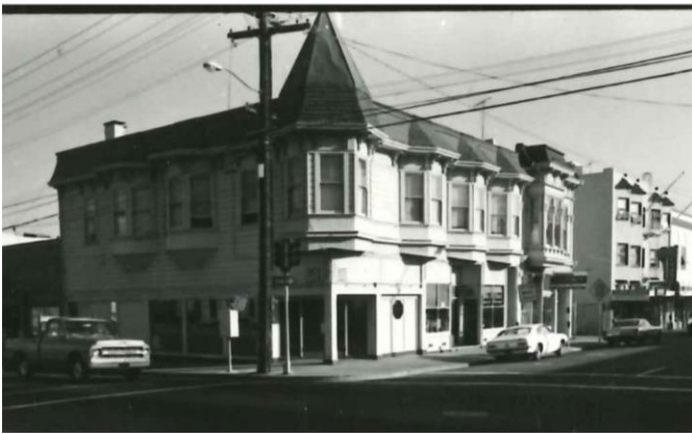
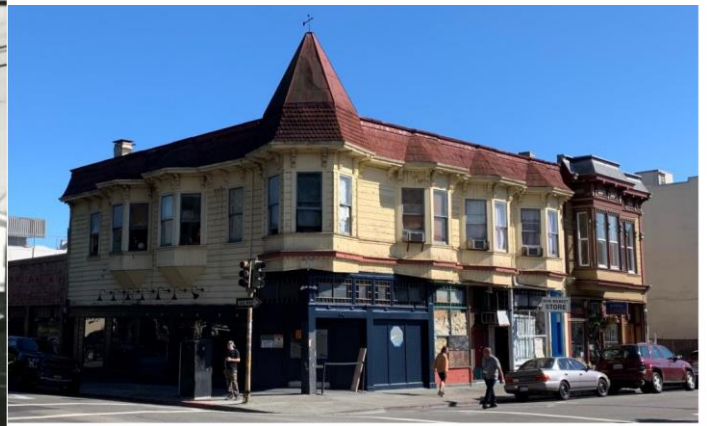
Address/code	844-848 B Street	3S	A
APN	011-262-01		
Building Name	Milani Building		
Year Built	<u>Between 1887 and 1894 (Sanborn Maps) 1890</u>		
Original Use	Retail storefront grocery/saloon, residential upstairs		
Architectural Style	Queen Anne Commercial		
Description	<p>The two story building is rectangular in plan with facades on B and Third Street and a mansard roof with metal tiles. Its focal point is a projecting bay at the corner with peaked hexagonal roof. There are three projecting upper floor bays on the B Street façade and two on Third Street, all are capped with diminutive hipped roofs and feature a cornice with scrolled brackets. Cladding is drop siding with vertical-groove plywood above and below windows. Windows are double-hung wood sash. There are two original storefronts at the south end of the west façade similar to those on 834-840, with multi-light stained glass transoms. The northernmost storefront has been boarded up except for a hexagonal window. An entrance facing the corner is fitted with double partially glazed doors. Storefront bays on Third Street have been modernized with large panes of glass.</p>

Integrity	Retains integrity despite storefront and cladding alterations, well-preserved Victorian-era storefronts (1970s photo above)		
Significance	Eligible as an individual landmark and as contributor		
Notes	<u><i>Began as a grocery. Became a saloon by 1898. Alterations to north storefront are likely to have been performed between 1930 and 1950 and may be historic in their own right.</i></u>

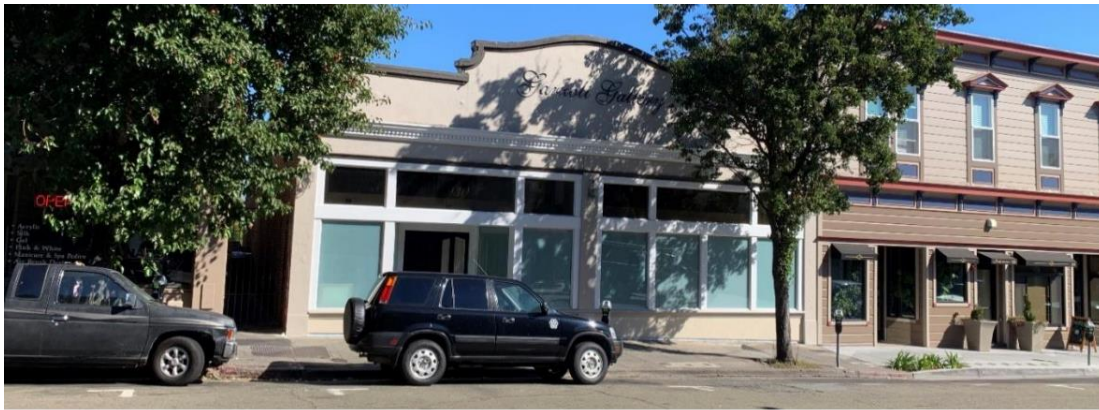
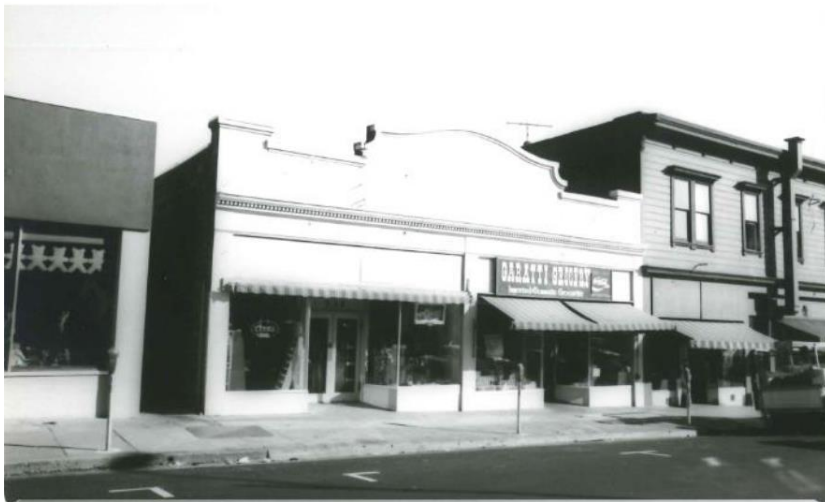
Address/code	926-930 B Street	7N	<u>DB</u>
APN	011-261-13		
Building Name	Garatti Grocery		
Year Built	<u>1914 1912 (spreadsheet)</u>		
Original Use	Retail storefront grocery		
Architectural Style	Mission		
Architect/Builder			
Description	The one story commercial building is rectangular in plan with a decorative shaped parapet and entablature with dentil moulding above the storefront level. Replacement storefronts are divided by heavy wooden moulding. Cladding is stucco. The entrance is fitted with a paneled wooden door.		
Integrity	Lacks integrity, major alterations since 1970s survey (see above)		
Significance	not eligible, combination of modest architecture and integrity problems		
Notes	<u>Originally rated as "D" but revised to "B"</u>

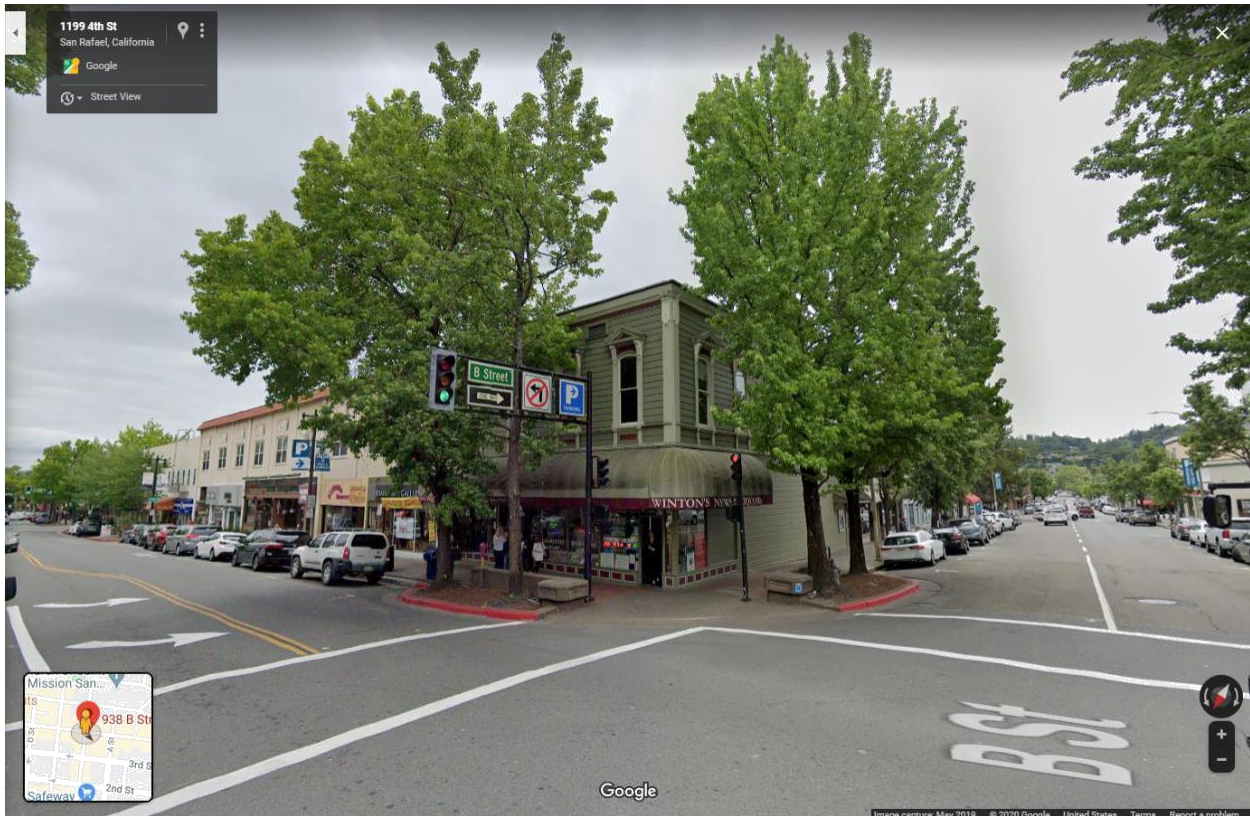
Address/code	938 B Street (1143-49		
	Fourth St)	6X	B+ A
APN	011-261-01		
Building Name	McDermott Building/ <u>Mulberry House</u>		
Year Built	Prior to 1887 (Sanborn Maps)		
Original Use	Retail storefront (grocery)/ <u>apartmentrooms for rent</u>		
Architectural Style	Italianate/ <u>MansardSecond Empire</u>		
Architect/Builder			
Description	The two story commercial/ <u>mixed use apartment</u> -building has a rectangular plan with a flat roof and minimal cornice. There are facades on B and Fourth streets. Cladding is drop wood siding. Upper floor windows are tall double-hung wood sash with decorative pedimented hoods elaborated with brackets and diamond shingles. The ground floor storefronts have paneled frieze bulkheads.		
Integrity	Appears to retain integrity despite some storefront alterations, spreadsheet says cornice removed		
Significance	Eligible as contributor and possibly as individual landmark. <u>Property has been formally designated a local landmark.</u>

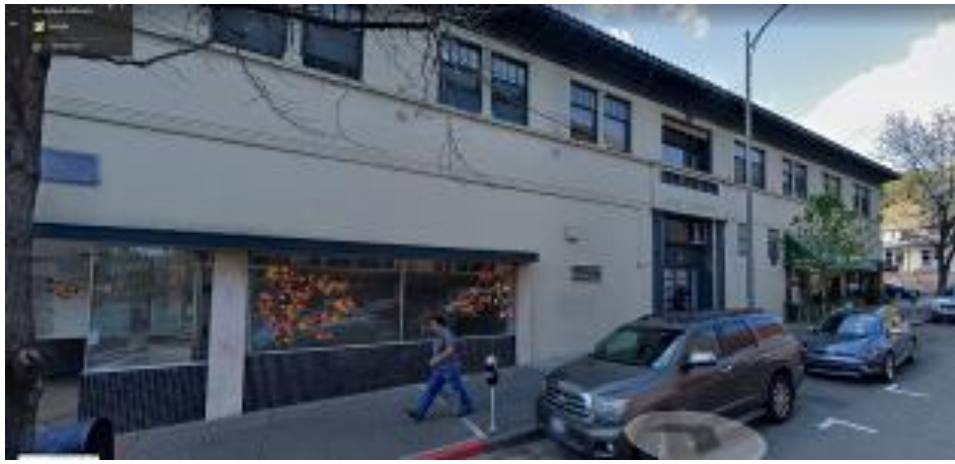
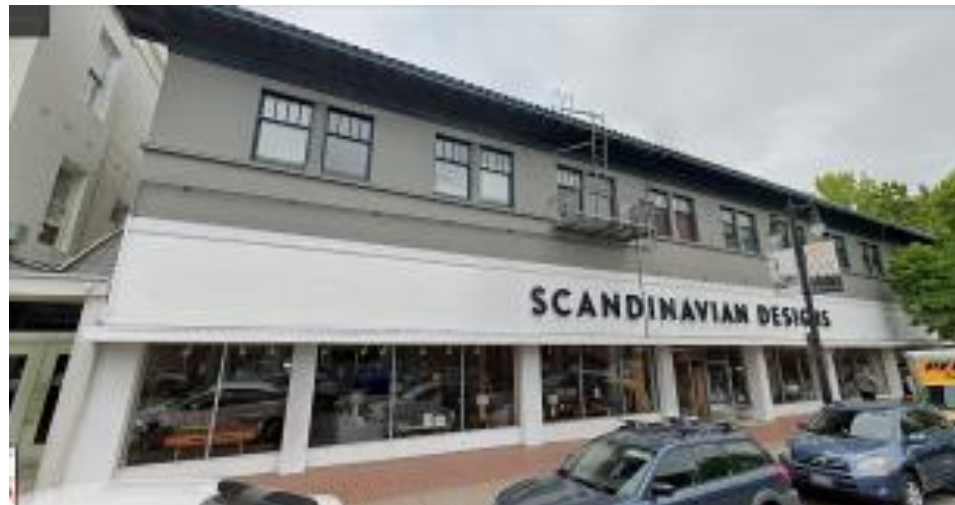
Address/code	1009 B Street (1200-12162 4th)	552	A
APN	011-212-05		
Building Name	Aileen Apartments		
Year Built	1917 1930? (architecture)		
Original Use	Retail storefront / Apartments / Commercial storefronts		
Architectural Style	Spanish Revival		
Architect/Builder			
Description	The two story commercial/apartment building is square in plan with a tiled mansard roof and cornice with decorative rafter tails, dentil moulding, cartouche, and floral frieze. There are facades on B and Fourth streets. Cladding is stucco. Upper floor windows are paired double-hung 4-over-1 wood sash separated by pilasters elaborated with floral motifs. An upstairs balcony feature decorative plaster in floral patterns. The ground floor apartment entrance is flanked by Corinthian columns, topped by a transom, and has double French doors with sidelights. Storefront windows on the ground floor have been somewhat altered

Integrity	Retains integrity despite storefront replacement		
Significance	Eligible as individual landmark and contributor		
Notes

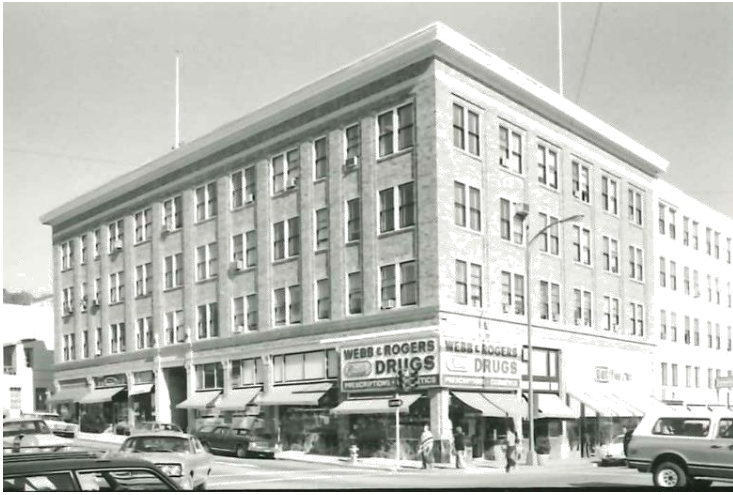
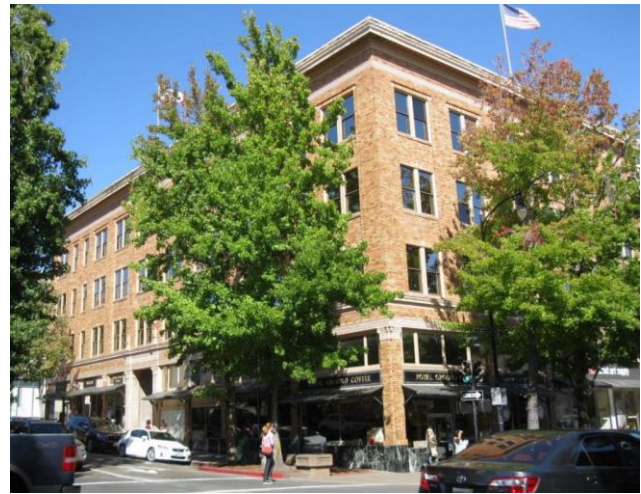
Address/code	1010 B Street (1138-1146 Fourth)	1S	A
APN	011-215-01		
Building Name	Albert Building		
Year Built	c1920 (DPR), 1930 (AnnexPatch Article)		
Original Use	Office/Retail storefronts / apartment		
Architectural Style	ChicagoNeoclassical /Commercial		
Architect/Builder			
Description	<p>The four story office/retail commercial/apartment building has an L-shaped plan with a flat roof and heavy decorative cornice. There are facades on B and Fourth streets. Cladding is brick with terra cotta decorative features and granite bulkheads. Upper floor windows are paired double-hung fitted with replacement windows. An upstairs balcony feature decorative plaster in floral patterns. The ground floor apartment entrance is flanked by Corinthian pilasters elaborated with decorative urns and inscribed with the building name. The door is deeply recessed and fitted with an original bronze door/sidelight/transom assemblage. Storefronts are separated by brick pilasters with terra cotta capitals. Most have original fully glazed wood doors and transoms. Contemporary awnings have been installed on storefronts <u>and help keep the original storefront facades intact.</u></p>

Integrity	Retains integrity despite window replacement and some storefront alterations		
Significance	Eligible as individual landmark and contributor		
Notes	<u>The annex is treated as a separate Fact Sheet, at 1122-1132 4th Street.</u>

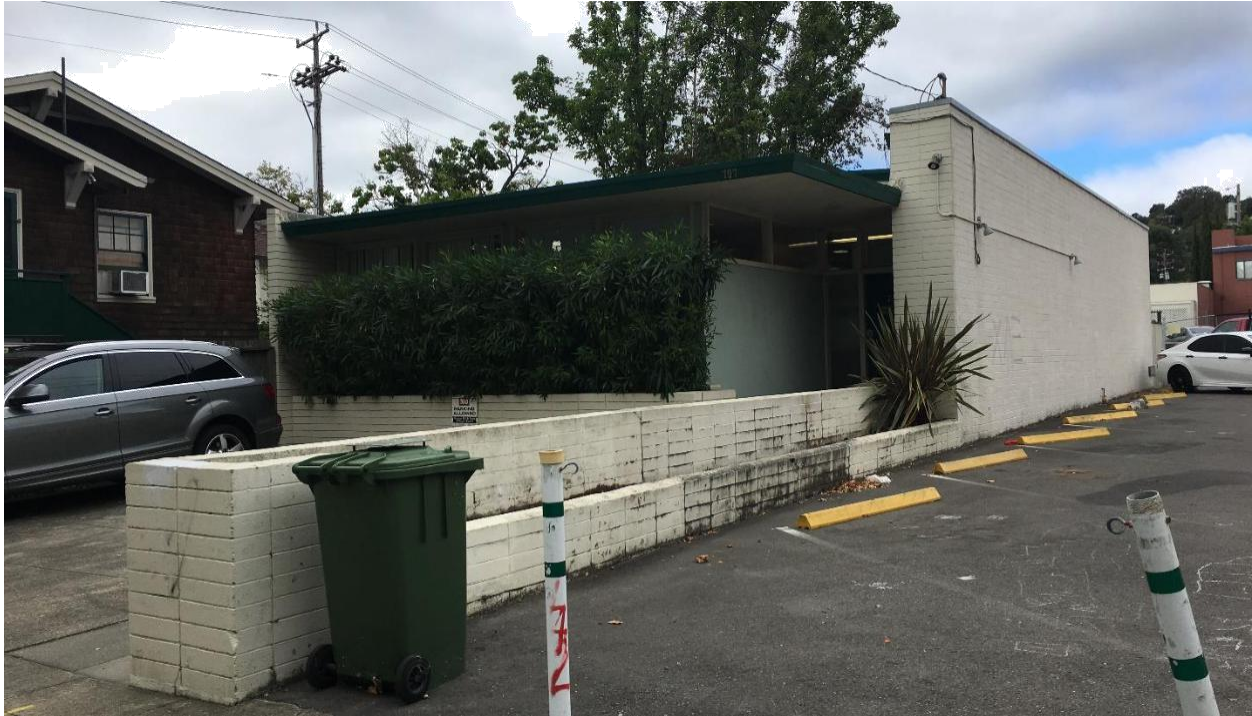
Address/code	707 C Street		A-
APN	012-073-11		
Building Name			
Year Built	1952 (spreadsheet)		
Original Use			
Architectural Style	Midcentury Modern		
Architect/Builder			
Description	The one story commercial building is recessed behind a parking area. It has a rectangular plan with a flat roof that projects over its deeply recessed entry, which is at the south end of its main (east) façade. The building is clad in brick with stucco accents and features clerestory windows on its main façade. There are built-in brick planters in front of the building and along the south property line.		
Integrity	Retains integrity, low visibility because of shrubbery		
Significance	Eligible as contributor and possibly as individual landmark for its Modern architecture		
Notes

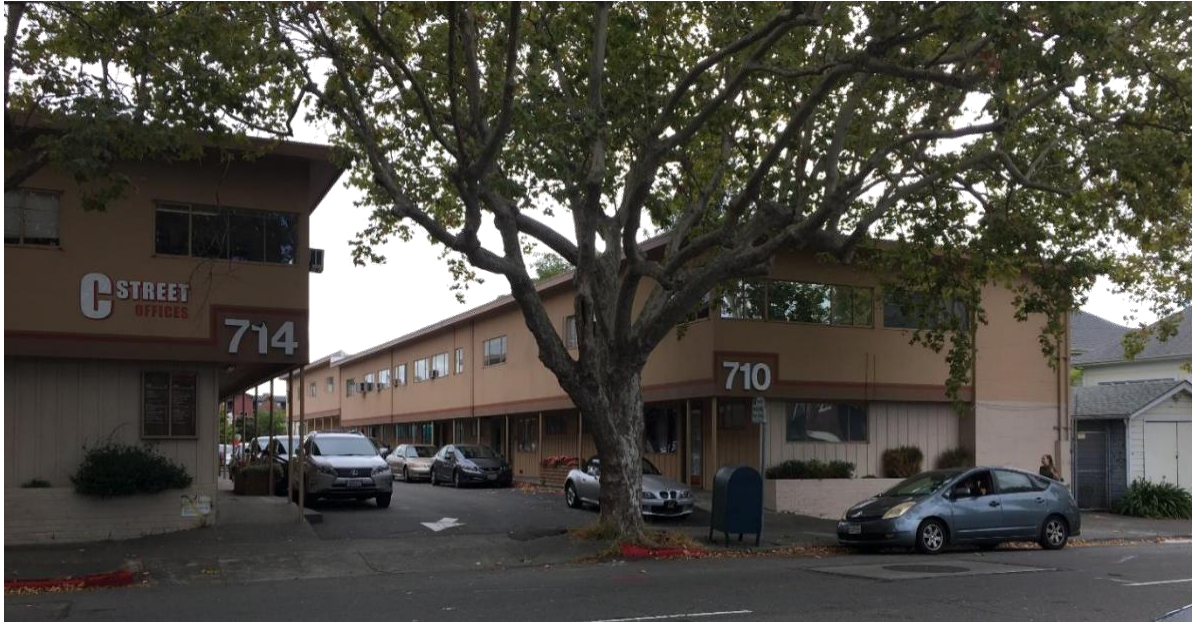
Address/code	710-714 C Street	ED
APN	012-075-17	
Building Name		
Year Built	1954 (spreadsheet)	
Original Use	Apartment <u>(now offices)</u>	
Architectural Style	Midcentury Modern	
Architect/Builder		
Description	The two story apartment building (now used for offices) has two rectangular-plan flat-roofed buildings facing a central courtyard. Cladding is board and batten on the ground floor and stucco above. Windows are narrow frame metal casement. The overhanging second story on the courtyard-facing elevations is supported by plain metal poles and forms a sort of loggia sheltering apartment entrances. There are brick planters along the street-facing (west) elevations.	
Integrity	Retains integrity	
Significance	Not eligible individually or as district contributor	
Notes	<i>Common example of inexpensive midcentury architecture</i>

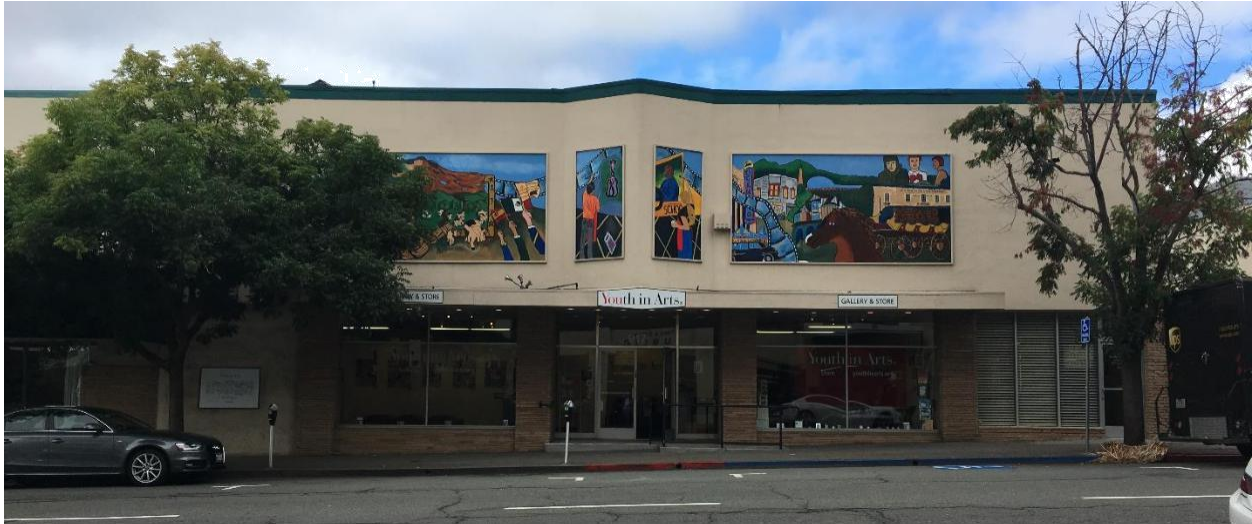
Address/code	917 C Street	ED
APN	011-253-06	
Building Name	Youth in Arts	
Year Built	1880 (spreadsheet) /c1950	
Original Use		
Architectural Style		
Architect/Builder		
Description	<p>The two story commercial building has a rectangular plan and sawtooth roof disguised by a parapet on the main (east) façade. The main façade upper story is stuccoed and lacks fenestration. There is a projecting v-shaped bay centered on the main façade. The ground floor has large aluminum frame storefront windows and split-face rock columns and bulkheads. The entrance has fully glazed aluminum frame double doors with transom and sidelights. Sides and rear elevations have steel sash windows in vertical openings. <u>There is nothing left of the 1880 building façade.</u></p>	
Integrity	Lacks integrity to 1880 construction, not a good example of a 1950s building	
Significance	Not eligible individually or as district contributor

Notes	<p><i>19th century industrial origins of buildings displayed by roof form and side/rear elevations. Partial c1950 façade remodel created an oddly hybrid building that is not a good example of either era. 9017 C St (adjacent south) is a better example of a midcentury commercial building</i></p>

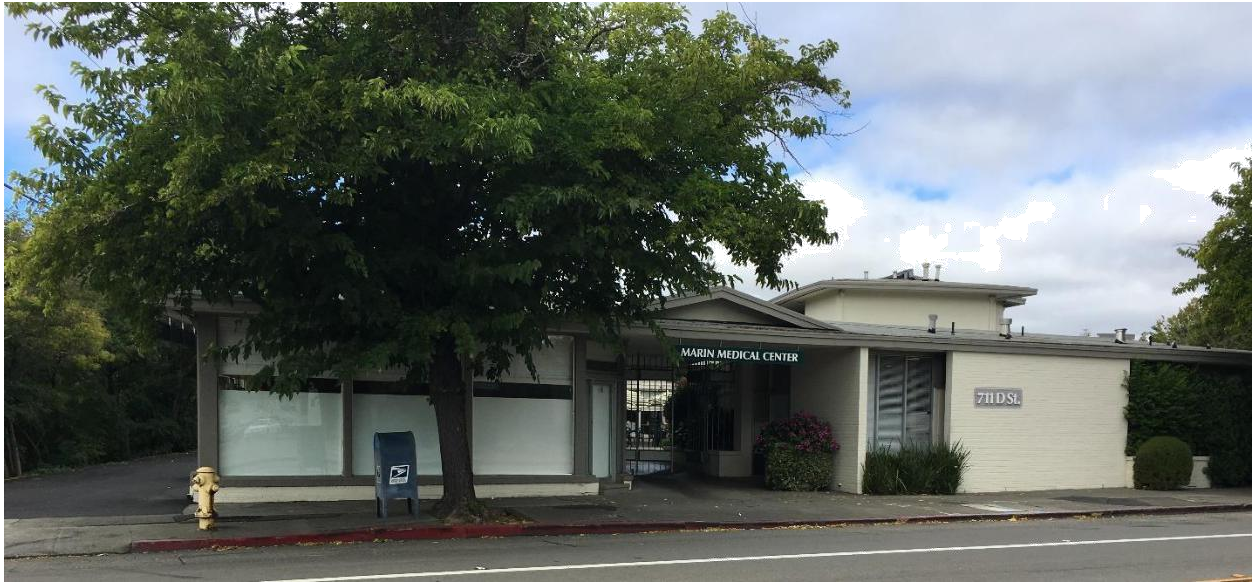
Address/code	711 D Street		C
APN	012-071-17		
Building Name	Marin Medical Center		
Year Built	Before 1952 (aerials)		
Original Use	Commercial		
Architectural Style	Mid-century Modern		
Architect/Builder			
Description	The commercial building is trapezoidal in plan with an interior courtyard and main facades on the east (D Street) and north (parking lot) elevations. The primary roof is flat with a low pitch gable over the courtyard entrance on D Street, which features large expanses of glass and brick cladding. The east façade has wood cladding and clerestory windows. A large second story addition on the east side of the building has low pitch roof and metal casement windows.		
Integrity	Research required to determine date of second story		
Significance	May be district contributor, not individually eligible		
Notes	<i>Second story may have been added within the historic period but does not fit Modernist aesthetic of other building elements. May be important as an early example of auto-oriented commercial architecture. <u>Interior courtyard features a small patio restaurant amenity.</u></i>
