Downtown San Rafael Precise Plan Historic Resources Inventory Summary Report

December 2020

[Revised May 2021](#)

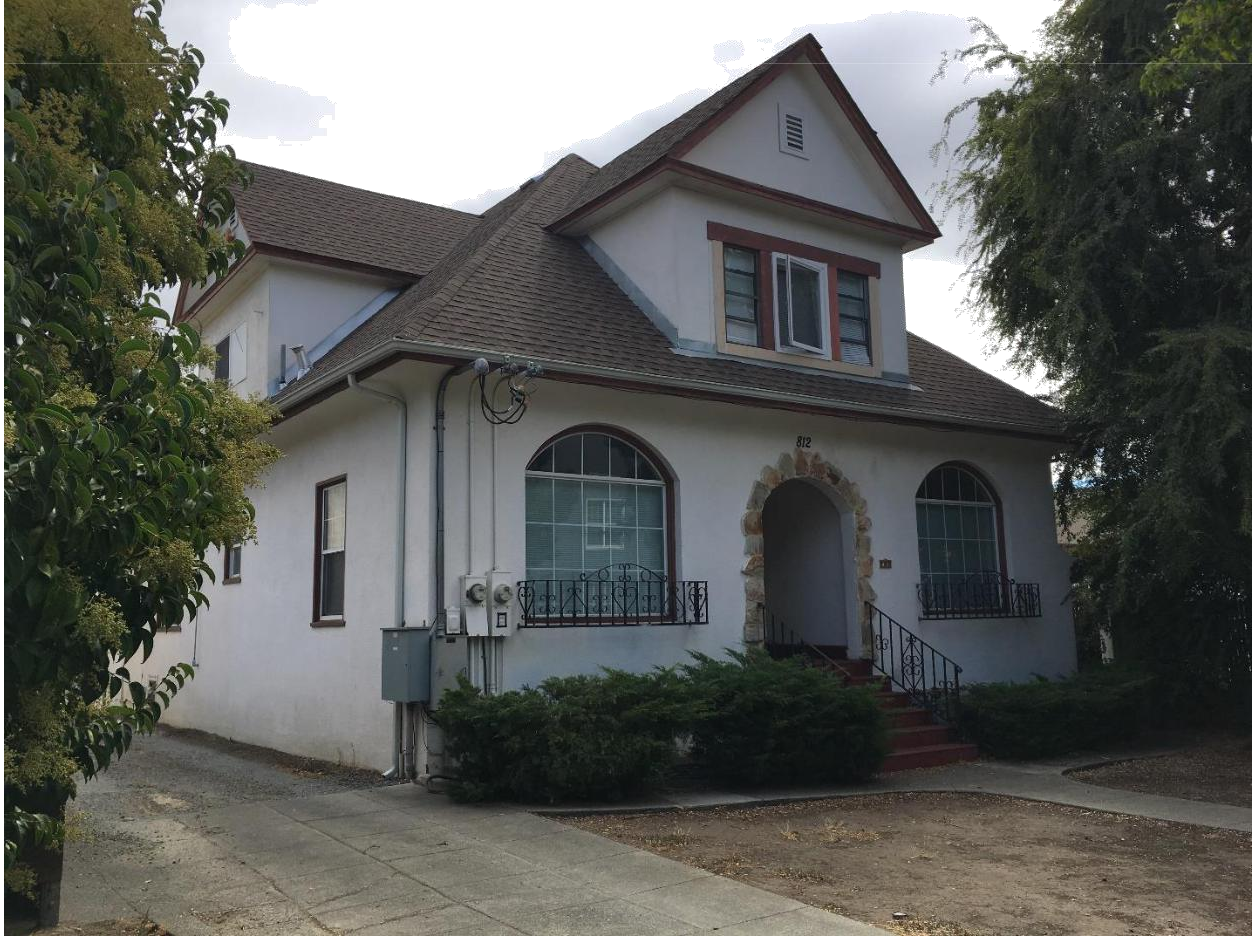
Address/code	812 D Street	ED
APN	011-254-22	
Building Name		
Year Built	1930s (spreadsheet) 1908-1923 (Sanborn Maps) 1906 (real estate ads)	
Original Use	Residential	
Architectural Style	Hip roof cottage (Foursquare)	
Architect/Builder		
Description	The rectangular plan residence is 1.5 stories and exhibits a hybrid appearance with a pyramidal roof, large dormers, and double-hung dormer windows dating from the building's original construction the first decade of the twentieth century. Arched window and door openings, flagstone door surround, and stucco cladding appear to date from a later addition.	
Integrity	Lacks integrity due to stucco, arched windows, etc.	
Significance	Not eligible individually or as contributor	
Notes

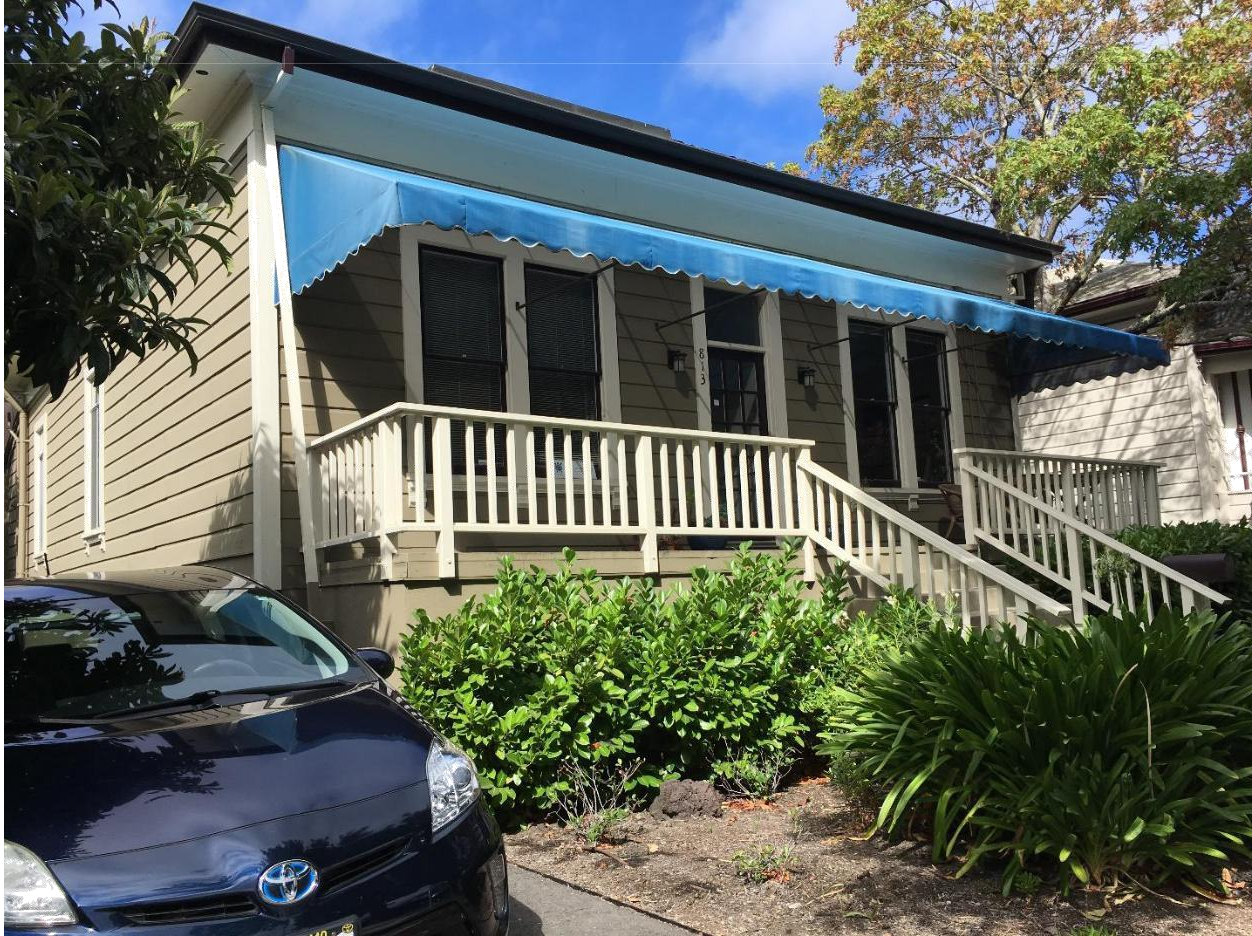
Address/code	813 D Street	C
APN	011-252-06	
Building Name		
Year Built	1882 (spreadsheet)	
Original Use	Residential	
Architectural Style	Folk Victorian	
Architect/Builder		
Description	The rectangular plan residence is single story with a hipped roof. It has a plain cornice with boxed eaves and full-width porch with simple balustrade. A canvas awning, likely a replacement for an original porch roof, shelters the porch. Windows are double hung wood sash and cladding is drop siding. The ground floor sits above a raised basement and is accessed via a wide set of wooden steps.	
Integrity	More research required, porch roof appears to have been removed and there may be additional alterations.	
Significance	Potentially eligible as contributor	
Notes	<i>Good example of a folk house if integrity is present</i>

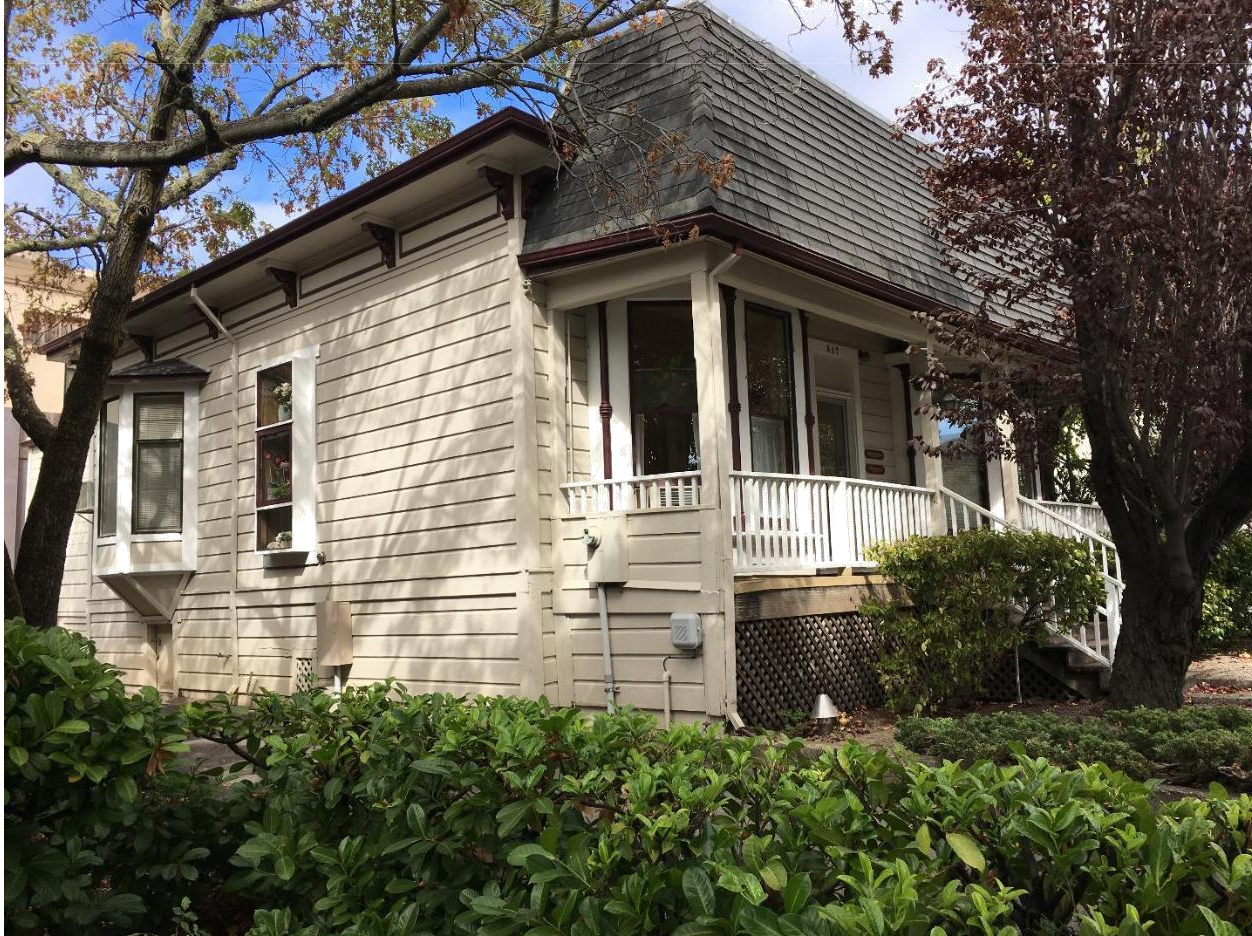
Address/code	817 D Street		C
APN	011-252-05		
Building Name			
Year Built	1884 (spreadsheet)		
Original Use	Residential		
Architectural Style	Folk Victorian		
Architect/Builder			
Description	<p>The rectangular plan residence is single story with a hipped roof. It has a cornice with boxed eaves, ornamental brackets, and paneled frieze. Its full-width porch has a replacement balustrade and an unusual mansard roof. Windows are double hung wood sash with a projecting bay on the main (east) façade. Cladding is drop siding. The ground floor sits above a raised basement and is accessed via a wide set of wooden steps. The front of the house at the basement level is clad in lattice.</p>		
Integrity	More research required, porch appears altered, porch roof may not be original		
Significance	Potentially eligible as contributor		
Notes	<i>Good example of a folk house, appears related to 813 D next door</i>

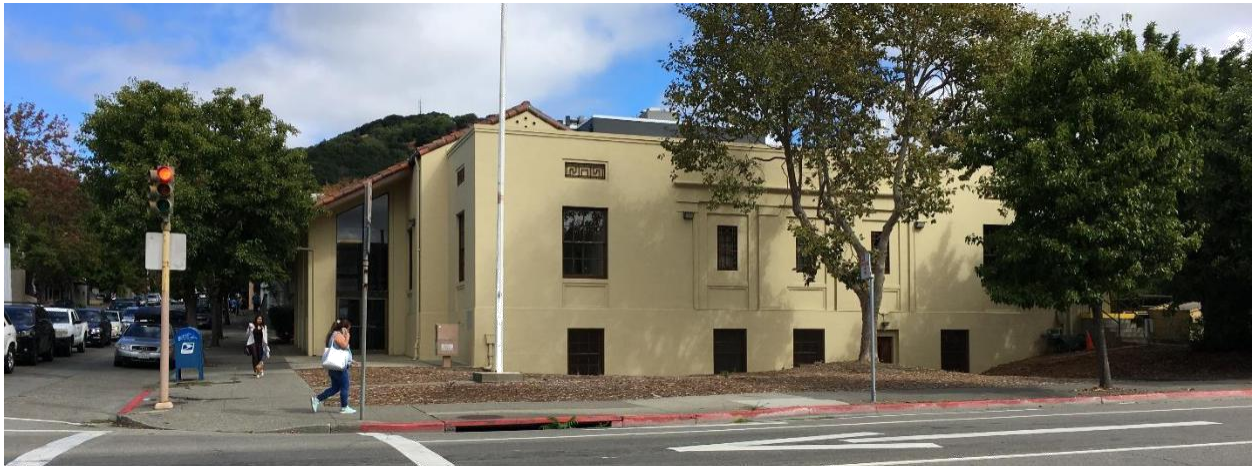
Address/code	910 D Street	<u>E</u><u>C</u>
APN	011-253-09	
Building Name	San Rafael Post Office <u>“Mission Station”</u>	
Year Built	1936	
Original Use	Post office	
Architectural Style		
Architect/Builder		
Description	<u>First federal government building in Marin Co. In the early 1960s the entrance was altered to provide ADA access. The sides and rear of the building remain intact</u>	
Integrity	<u>Lacks integrity Requires further evaluation</u>	
Significance	Not eligible	
Notes	<u>Initially rated as E but upgraded to C in response to public comment. City should contact USPS, Tetra Tech looked at it in 2013 and concluded recommended it lacked integrity due to Modernist addition. It has features of its original Spanish Colonial Revival elements. <u>Could potentially brought back to original design.</u></u>

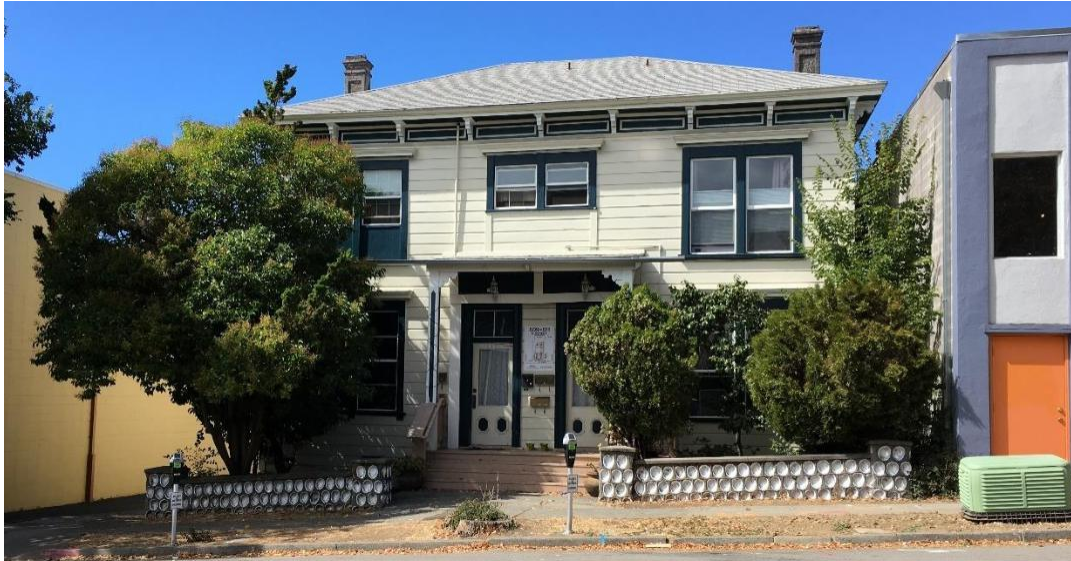
Address/code	809-11 E Street	C
APN	011-246-08	
Building Name		
Year Built	1885 (spreadsheet)	
Original Use	Residence (duplex)	
Architectural Style	Italianate	
Architect/Builder		
Description	<p>The rectangular plan residence is two story with a hipped roof from which two decorative brick chimneys project. It has a cornice with boxed eaves, ornamental brackets, and paneled frieze. Its partial-width porch has a shed roof and square supports elaborated by scrolled brackets. Replacement windows of different types have been fitted into window openings, some of which have been altered. Cladding drop siding. Side-by-side original partially glazed doors with octagonal panels topped with transoms are accessed via a wide set of wooden steps. A low concrete wall enclosing the property is adorned with abalone shells.</p>	
Integrity	Appears to retain sufficient integrity for district contributor status, more study needed.

Significance	Good example of Italianate/vernacular duplex, potentially eligible as district Contributor	
Notes	<i>Appears related to 817 and 813 D, all built around the same time</i>

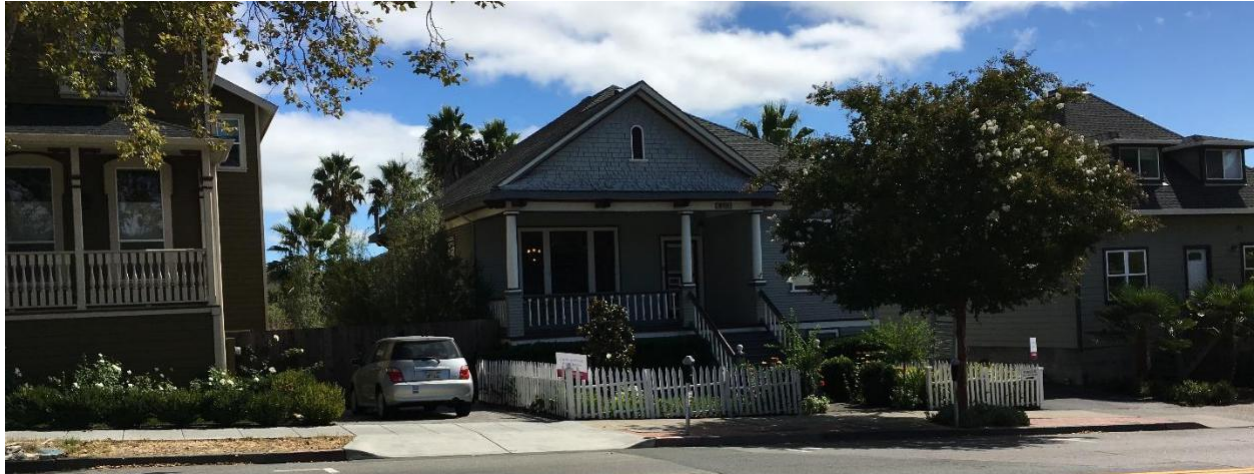
Address/code	810 E Street	A
APN	011-252-14	
Building Name		
Year Built	1910 (spreadsheet)	
Original Use	Residence	
Architectural Style	Hipped roof cottage	
Architect/Builder		
Description	<p>The rectangular plan residence is single story with a hipped roof from with a large gable over the partial-width porch. The gable end has a louvered vent in an arched opening and is clad in shingles. Boxed eaves have decorative shaped rafter tails. Porch supports are Tuscan columns a top a balustrade of narrowly spaced turned balusters. The front door is fitted with a paneled partially glazed wood door and accessed via a set of wooden steps. Windows are double-hung wood with at least one decorative cottage window on the main (east) façade. The main floor sits atop a raised basement</p>	
Integrity	Retains integrity despite possible replacement of balustrade.	
Significance	Excellent example of vernacular hipped roof cottage, eligible landmark and contributor

Notes	<i>Transitional Victorian/craftsman features</i>

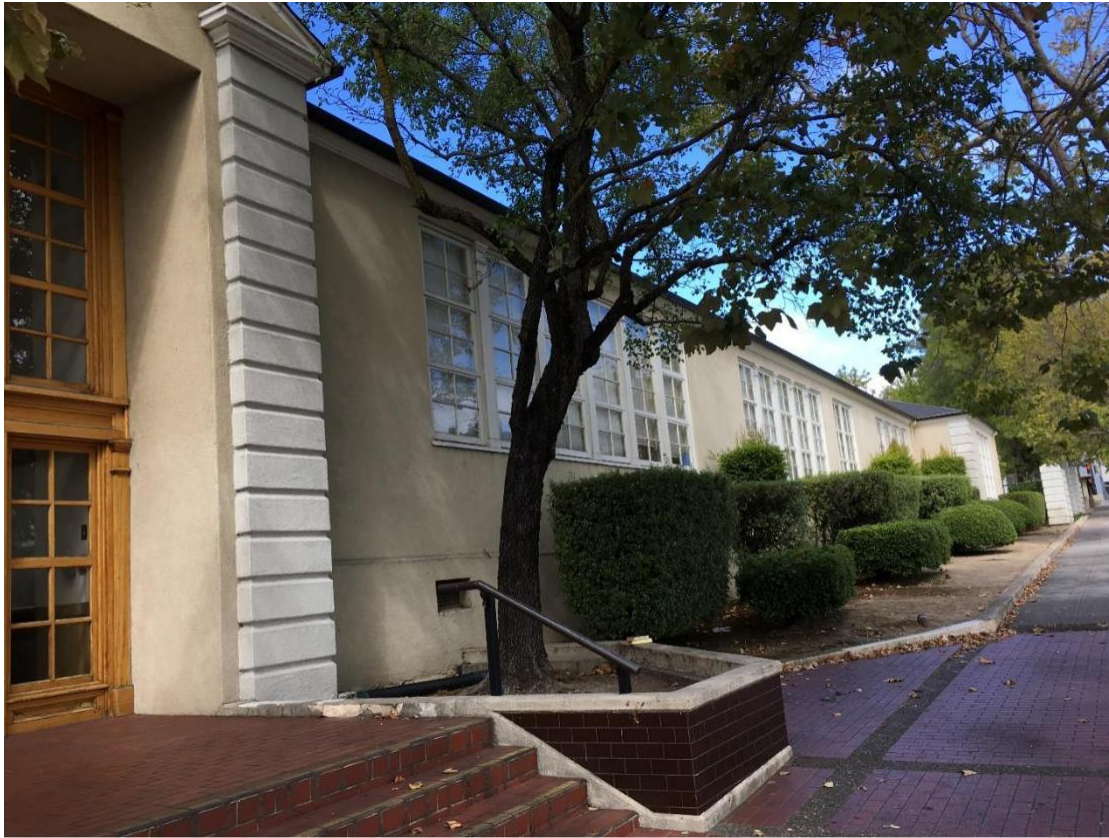
Address/code	901 E Street		C
APN	011-245-27		
Building Name	E Street Grammar School		
Year Built	1932-1946 (aerials)		
Original Use	School		
Architectural Style	Classical/Mediterranean Revival		
Architect/Builder			
Description	The single story building is roughly rectangular in plan with a hipped roof main volume and a smaller gable roof volume at the south. Large windows are fitted with multiple light windows. The main entrance on E Street has an assemblage of wood multiple light doors, sidelights and transoms. There are decorative quins flanking the entrance. Cladding is spray-on stucco. There is a basement at the south end of the building. <u>Recent remodel added wood entry element.</u>		
Integrity	May retain integrity despite modern stucco, more research needed.		
Significance	Good example of a 1930s school building, appears eligible as a contributor, lacks the distinction of an architectural landmark.

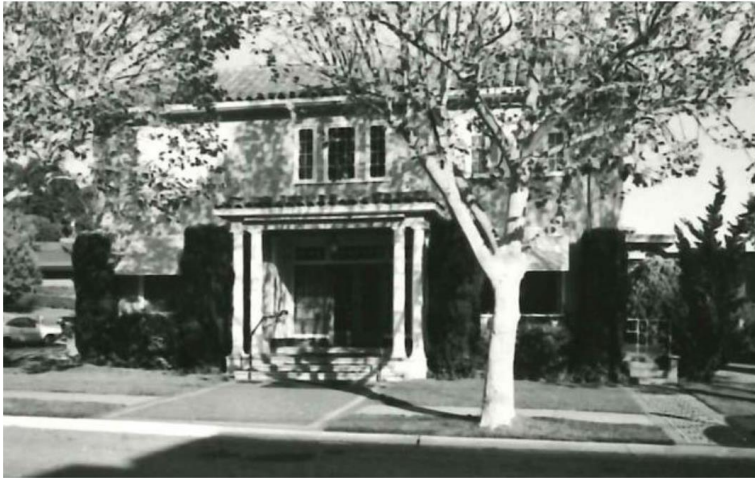
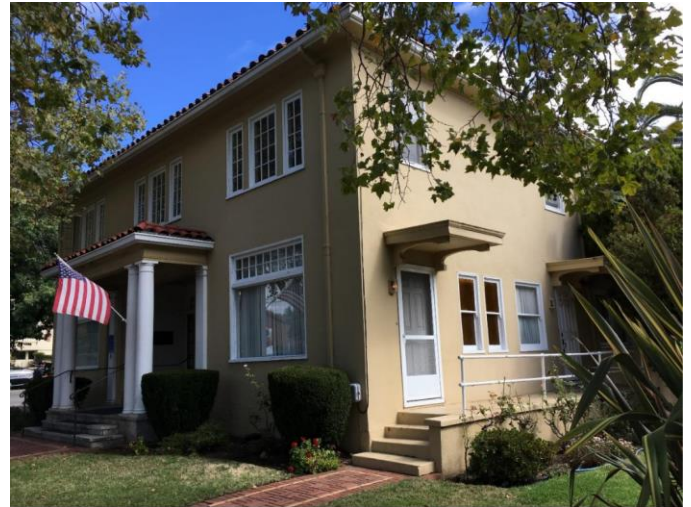
Address/code	1022 E Street	A-
APN	011-204-01	
Building Name	Keaton's funeral Home	
Year Built	1924 (spreadsheet)	
Original Use	Residence	
Architectural Style	Mediterranean Revival with Classical details	
Architect/Builder		
Description	The two story house is roughly rectangular in plan with a tiled mansard roof roof main volume and a smaller gable roof volume at the south. There are similar diminutive roof forms on the projecting porte cochere and partial width front porch, both of which are supported by decorative columns. The recessed entrance is fitted with a wood panel partially glazed door with matching transom and side lights. Porch landing and wide steps are granite. The porte cochere is partially infilled. Cladding is smooth stucco. Windows are double hung wood sash with various sizes and configurations.	
Integrity	Retains integrity despite porte cochere alterations (see 1970s photo)	
Significance	Good example of a Mediterranean Revival house, eligible as a contributor and may also qualify as an individual landmark.

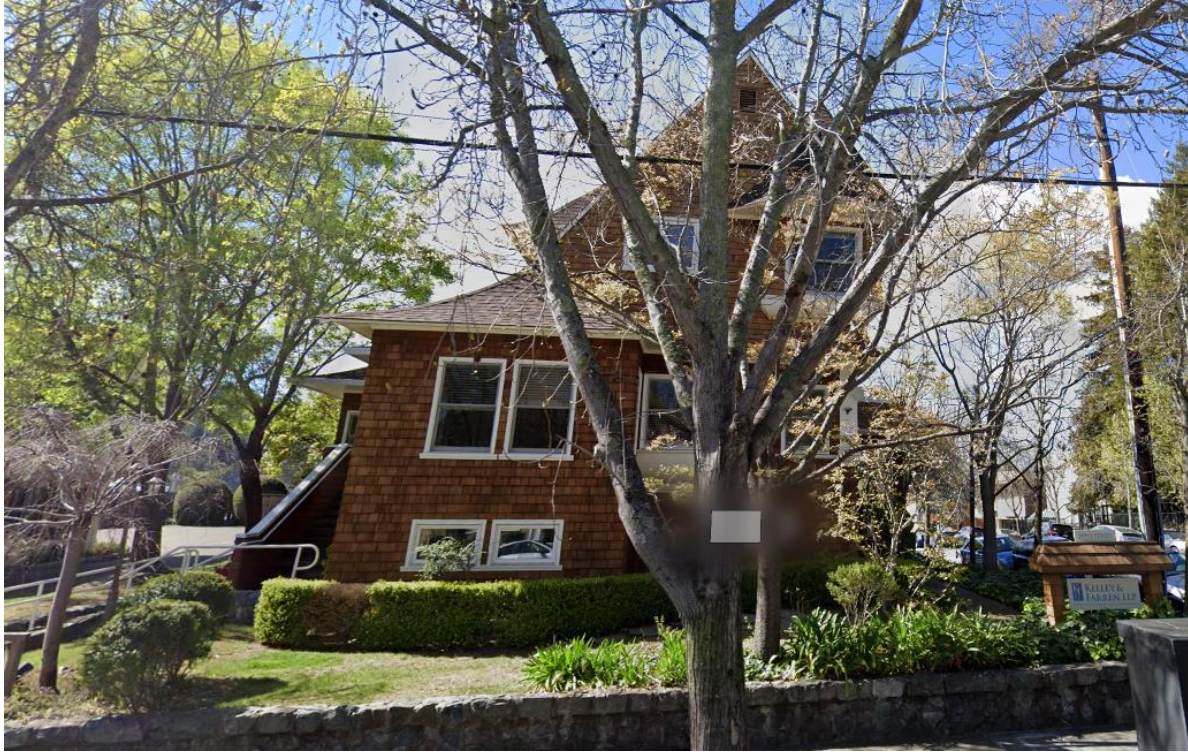
Address	1099 E Street		B
APN	011-202-06		
Building Name	Schlosser-Cole Residence		
Year Built	<u>1895</u>		
Original Use	Residential		
Architectural Style			
Architect/Builder			
Description	The three-story building has a roughly rectangular plan and steeply pitched composition shingle gable-on-hip roof. It is clad in wood shingle. There is an integral porch on the main façade and several other entrances around the building. The building has wide double-hung wood sash windows. There is a small tower with a pointed roof at the corner of the building above the porch.		
Integrity	Appears to retain integrity		
Significance	Potential district contributor, not individually eligible at any level		
Notes	Registered local landmark

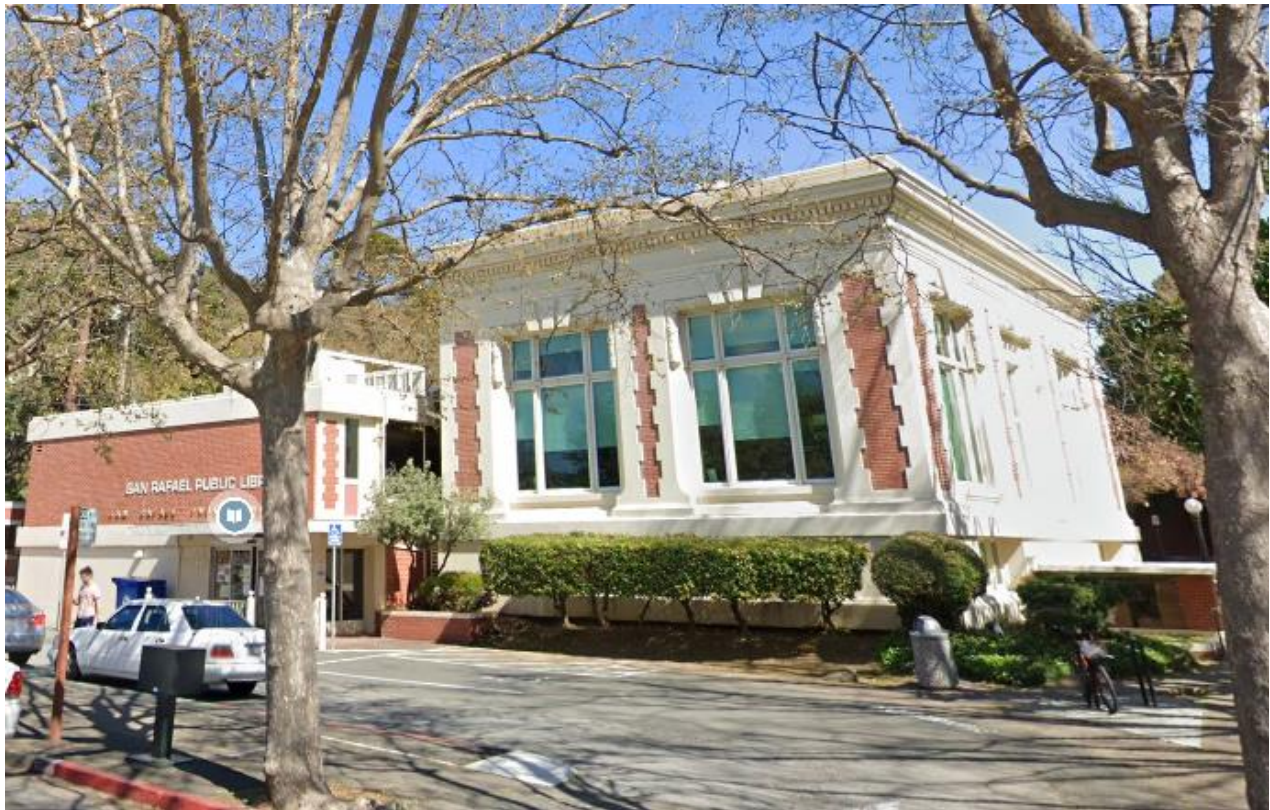
Address	1100 E Street	3S	A
APN	011-203-01		
Building Name	San Rafael Public Library		
Year Built	<u>1909</u>		
Original Use	Library		
Architectural Style			
Architect/Builder			
Description	<p>The large T-shaped building occupies the entire west end of the block it sits on, surrounded by landscaping and parking lots as well as streets on three sides. The building is composed of multiple volumes of different sizes and eras. The taller older volume is clad in brick and stucco and has large windows. This volume features a number of decorative details, including dentil molding, quoins flanking the windows as well as at the corners, and large keystones on the windows. The newer volume is longer and shorter. It is clad in stucco and brick. On its main façade, the automatic sliding glass door entrance is located in a corner; the upper half of the façade is clad in brick, and the lower features subtle dentil molding in a more subdued echo of the older volume. The rear façade is clad almost entirely in brick. On the volume's other façades, windows alternate with brick-and-stucco patterns that mimic the older volume's quoins.</p>

Integrity	60s addition in notably different style, but sympathetic and both the addition and original building look to have good integrity		
Significance	Eligible as landmark and contributor		
Notes

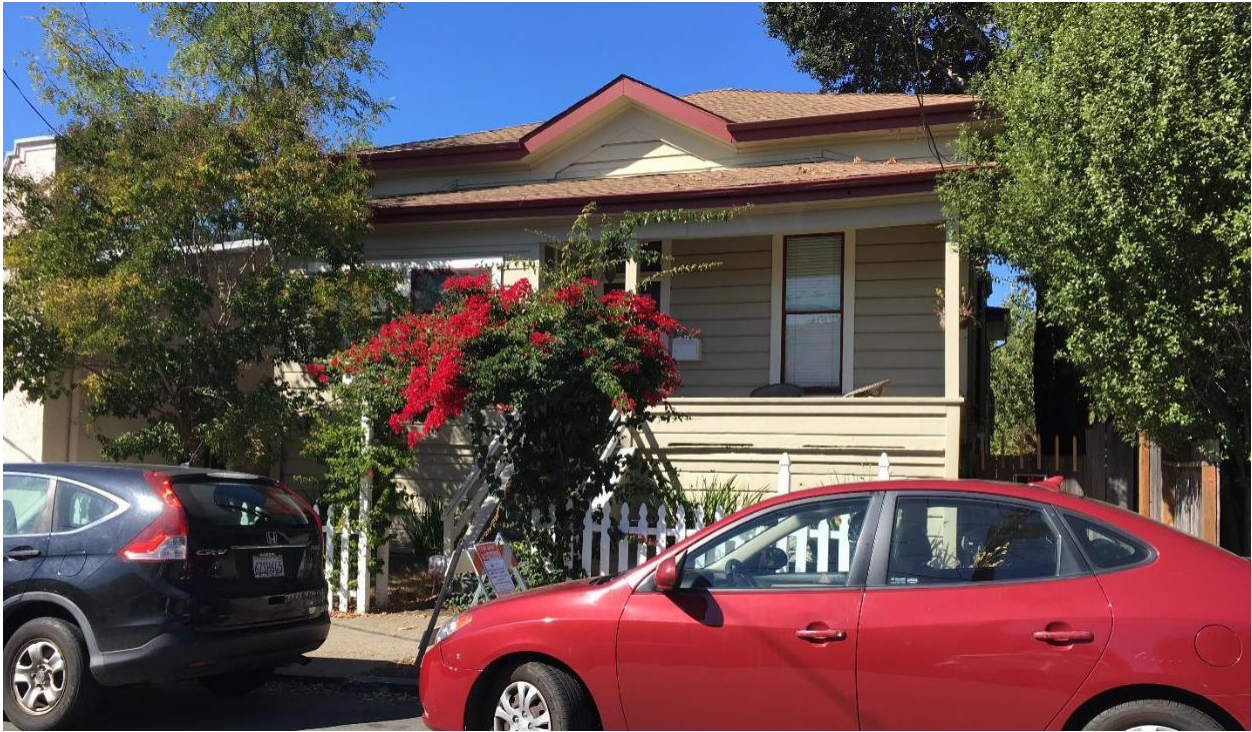
Address/code	105 F Street	ED
APN	011-194-06	
Building Name		
Year Built	1893 (spreadsheet)	
Original Use	Residence	
Architectural Style	Folk Victorian	
Architect/ Builder		
Description	The single story house is roughly rectangular in plan with a gable on hip roof and full width porch under its own hipped roof. It is clad in drop siding and has tall window openings fitted with replacement windows. The south end of the porch has been enclosed.	
Integrity	Lacks integrity, odd roof form may be alteration, enclosed porch	
Significance	Not eligible	
Notes

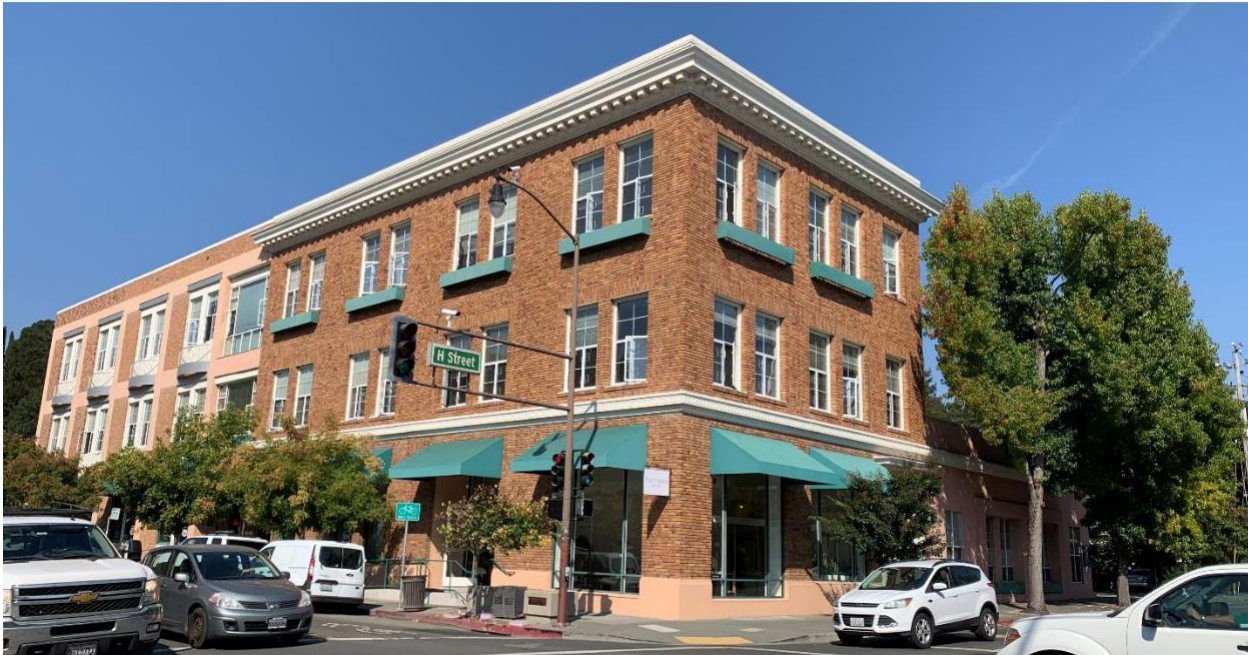
Address/code	1 H Street 1820 4th		DC
APN	010-291-69		
Building Name			
Year Built	c1950		
Original Use	<u>Pacific Telephone and Telegraph</u>		
Architectural Style			
Architect/Builder			
Description	The parcel encompasses three adjoining buildings with three façades that face onto streets and a parking lot alongside the back. It has a flat roof. The three-story portion, which forms a roughly T-shaped layout, is clad in a combination of brick and smooth stucco, with dentil molding at the roof and molding between the first and second stories. Windows on the main first floor, the main façade of which runs along an entire block, are large storefronts and have cloth awnings. There are railings outside of some of the third-floor windows. On either side of the building are one-story additions, both of which are entirely clad in smooth stucco.		
Integrity	Nineteenth century building at corner lacks integrity

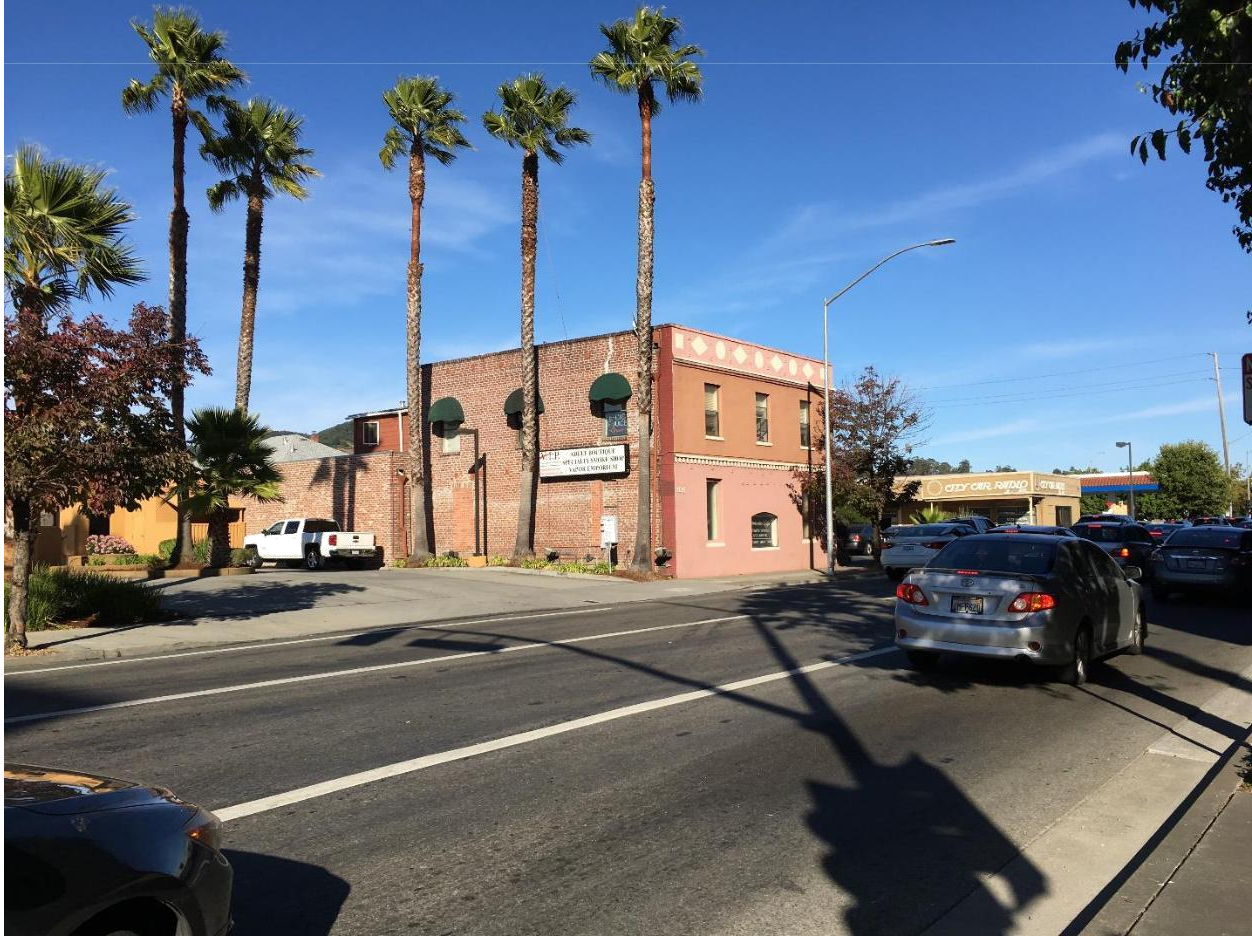
Address	826 Second Street	(likely E) C
APN	011-272-10	
Building Name		
Year Built	<u>1895-1905</u>	
Original Use	<u>Possibly the Lombard Hotel</u>	
Architectural Style		
Architect/Builder		
Description	The building has a flat roof and roughly rectangular plan. It is two stories at the front with a one-story portion and a lower one-story addition at the back. It is clad in brick, with stucco on the main façade and addition. There is dentil molding above the first floor on the main façade. There is brick trim around the roof of the two-story volume as well as brick sills on the second-floor windows. Windows are varied and feature rounded cloth awnings on the sides of the building, as does a door into the lower volume. There are also two garage doors towards the back of the building, and the addition has an entrance as well.	
Integrity	Lacks Integrity	
Significance	Not eligible, nineteenth century commercial heavily altered on main facade

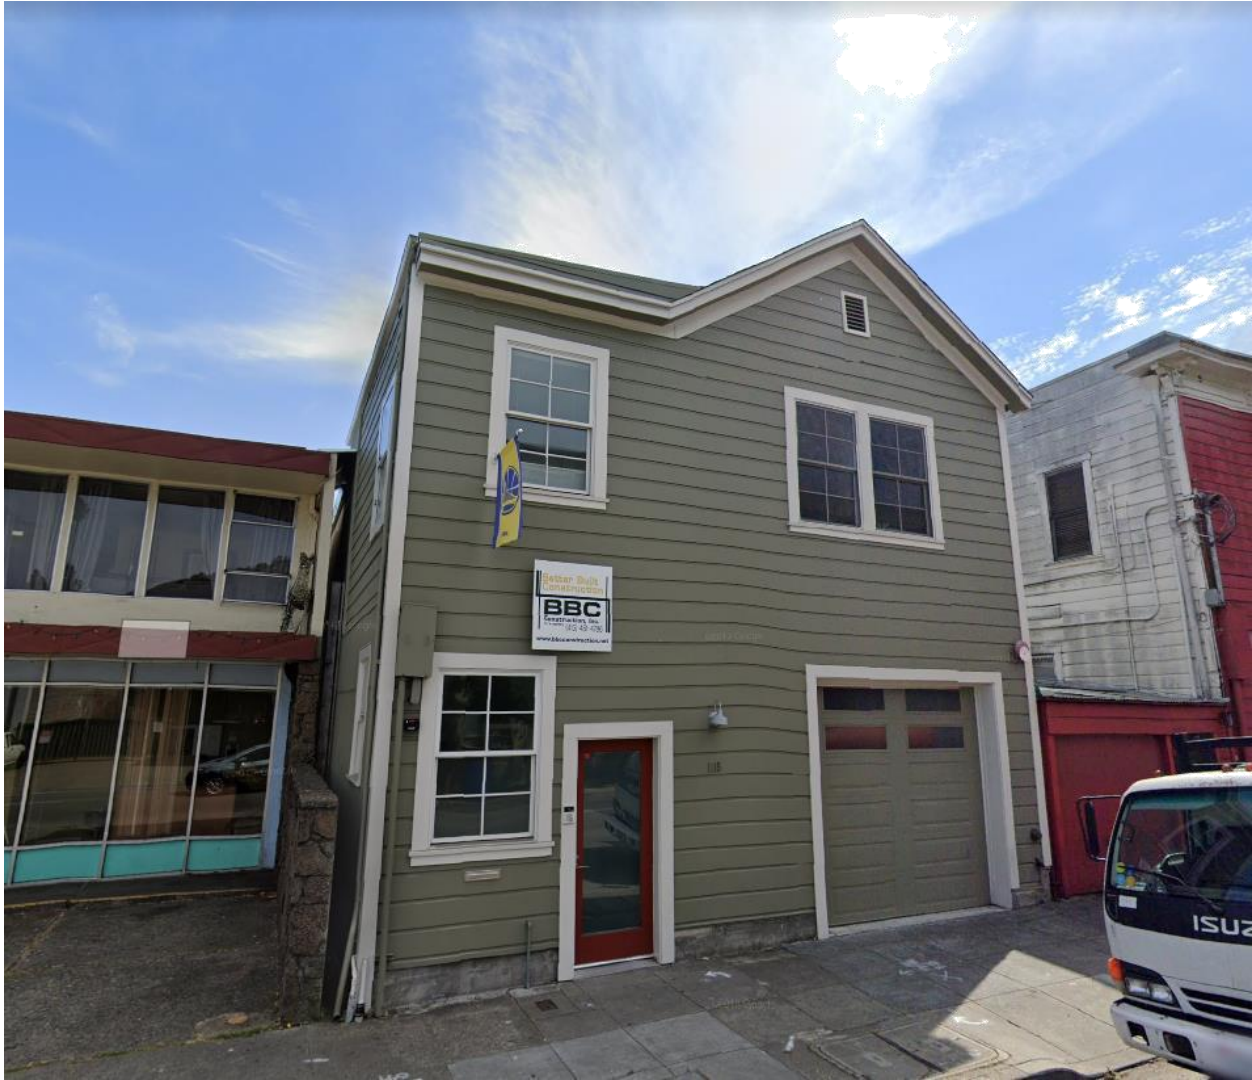
Address	1115 Second Street	7N	ED
APN	013-011-06		
Building Name	Mackey Frames		
Year Built	1875 (spreadsheet)		
Original Use	Residential		
Architectural Style			
Architect/Builder			
Description	The two-story building has a combination shed and gabled roof and a rectangular plan. It is clad in horizontal drop siding. There is a glazed door and a metal roll-up garage door on the main façade. Windows are hung vinyl sash		
Integrity	Appears to lack integrity		
Significance	Not eligible, lack of significance and integrity		
Notes	<u>A request to change the rating from D to C was considered. The building was re-evaluated and determined ineligible.</u>

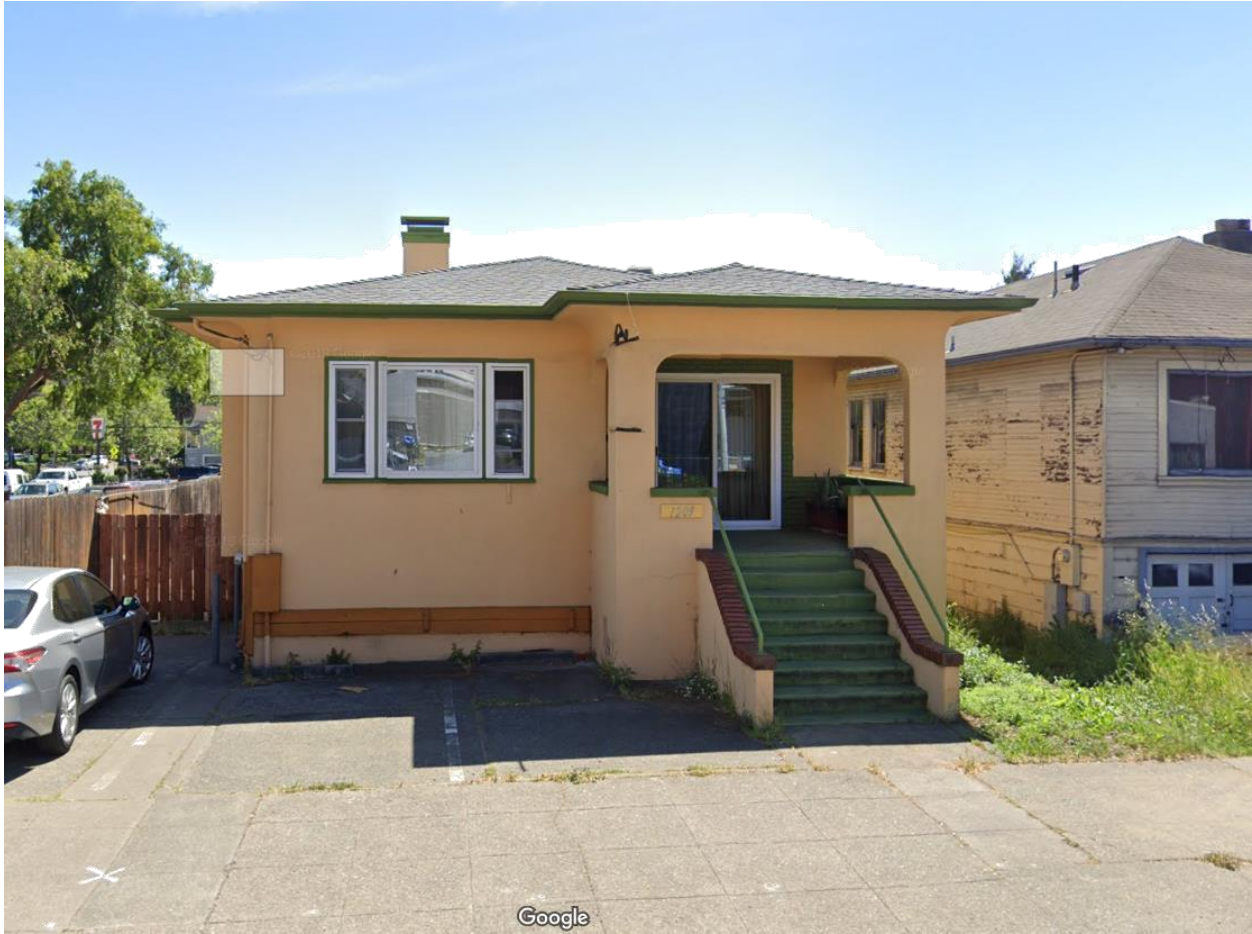
Address	1209 Second Street	ED
APN	12-075-05	
Building Name		
Year Built	1924 (spreadsheet)	
Original Use	Residential	
Architectural Style	Craftsman	
Architect/Builder		
Description	The one-story building has a raised foundation and an L-shaped plan that includes a projecting partial-width porch. It has a hipped composition shingle roof. There are two doors accessed via the raised porch: one sliding double glass door that faces the street, and one partially glazed single wooden door that faces to the side. The building is clad in stucco with vertical board siding near the bottom on the side façades.	
Integrity	Appears to lack integrity, replacement windows, sliding glass door	
Significance	Not eligible, lacks significance and integrity	
Notes

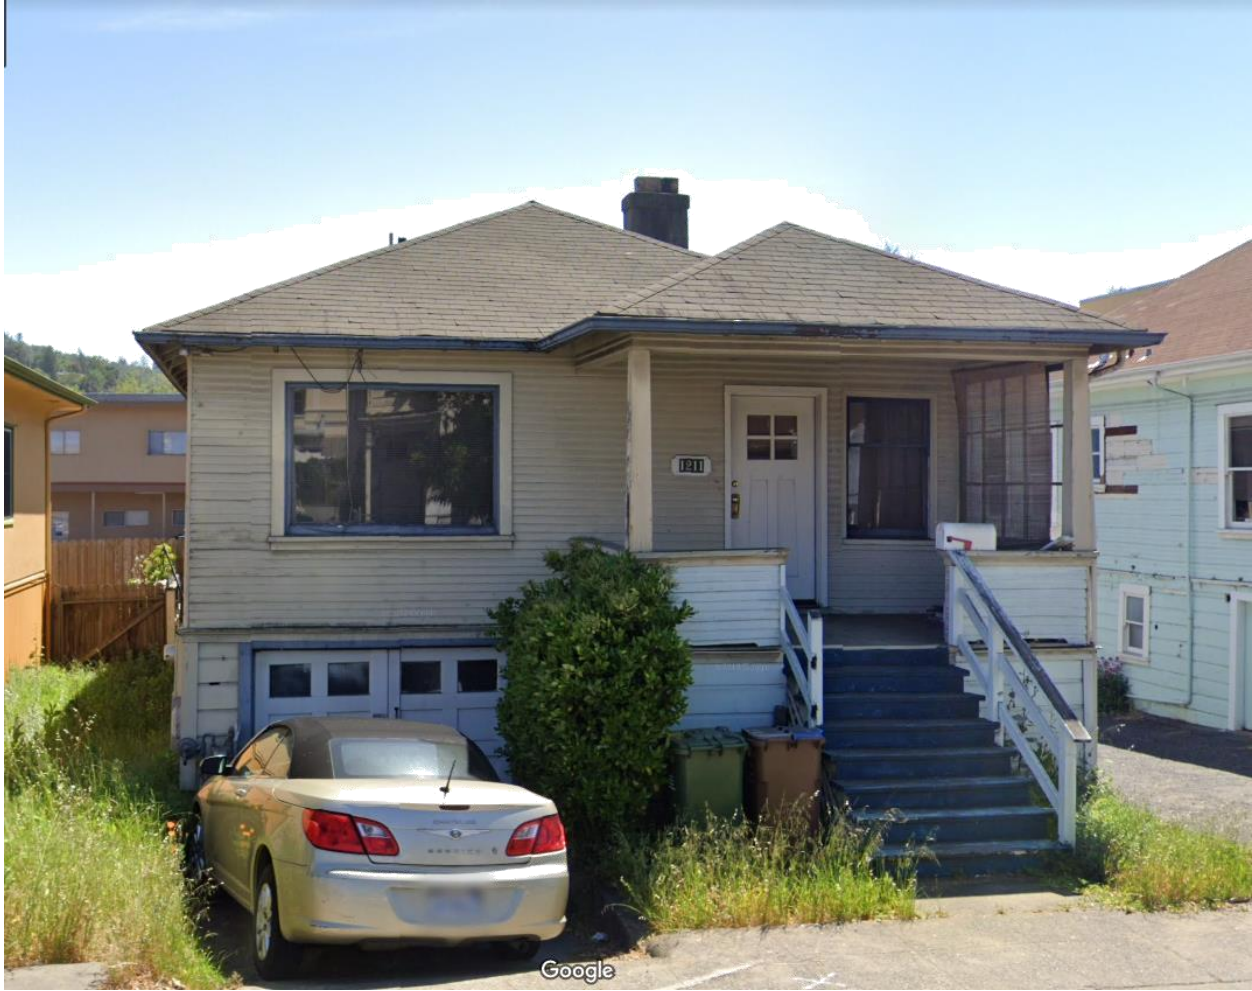
Address	1211 Second Street	C
APN	012-075-04	
Building Name		
Year Built	1920 (spreadsheet)	
Original Use	Residential	
Architectural Style	Hipped roof cottage	
Architect/Builder		
Description	The two-story building has an L-shaped plan that includes a projecting partial-width porch screened on one side. It has a hipped composition shingle roof The main entrance is on the second floor. The building is clad in a horizontal board siding in a variety of widths. There is a garage on the lower floor of the main façade.	
Integrity	Appears to retain integrity, more study needed, condition poor	
Significance	Potential local district contributor, not eligible as landmark	
Notes

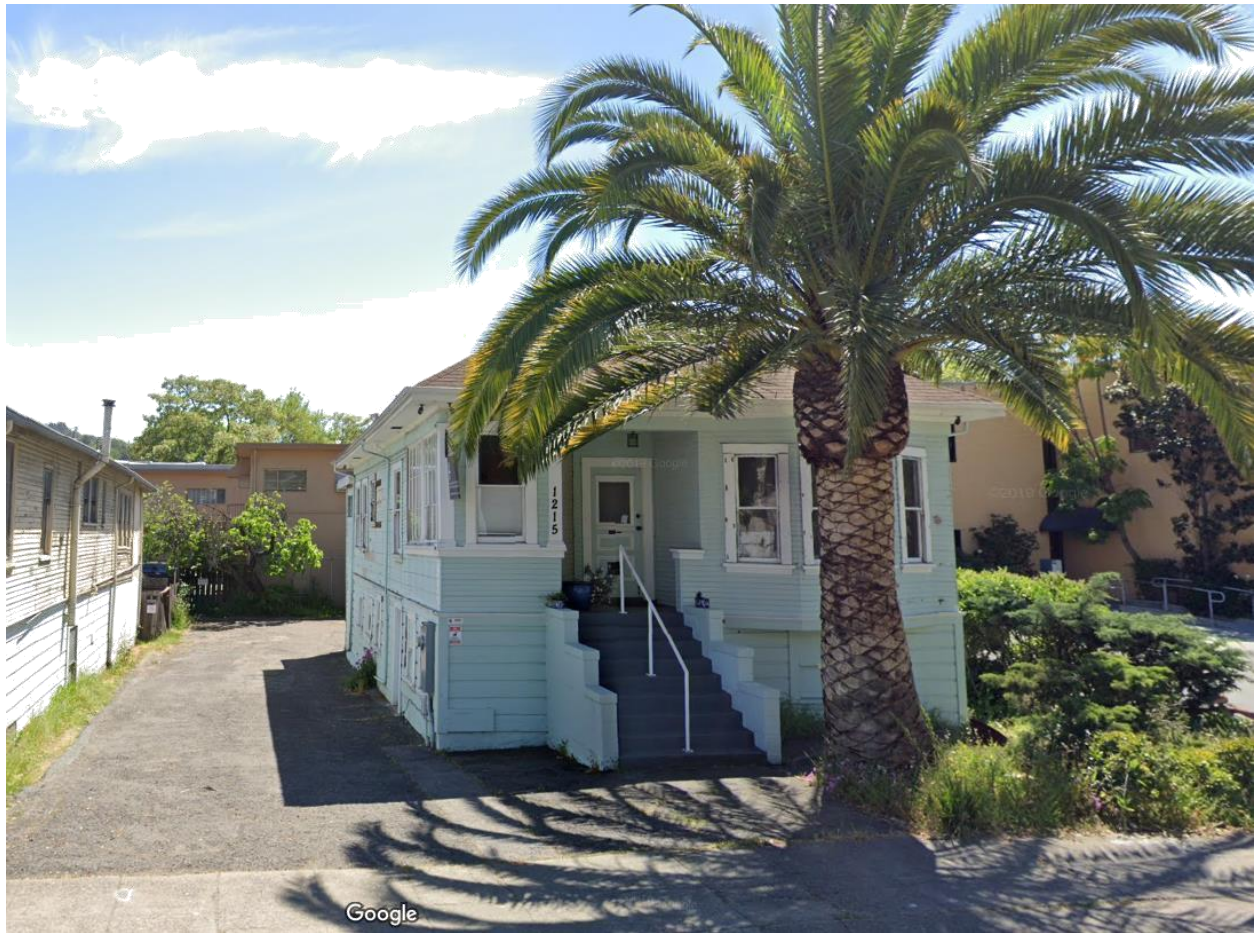
Address	1215 Second Street	B
APN	012-075-03	
Building Name		
Year Built	1916 (spreadsheet)	
Original Use	Residential	
Architectural Style	Hipped roof cottage	
Architect/Builder		
Description	The two-story building has rectangular plan and composition shingle hipped roof and has a parking lot behind it. The second-story main entrance is sheltered under a partial-width integral porch, with a bay window on one side. The building is clad in multiple widths of horizontal board siding. It has original double hung wood sash and partially glazed wood paneled door.	
Integrity	Retains Integrity	
Significance	Potential local district contributor, not individually eligible at any level	
Notes

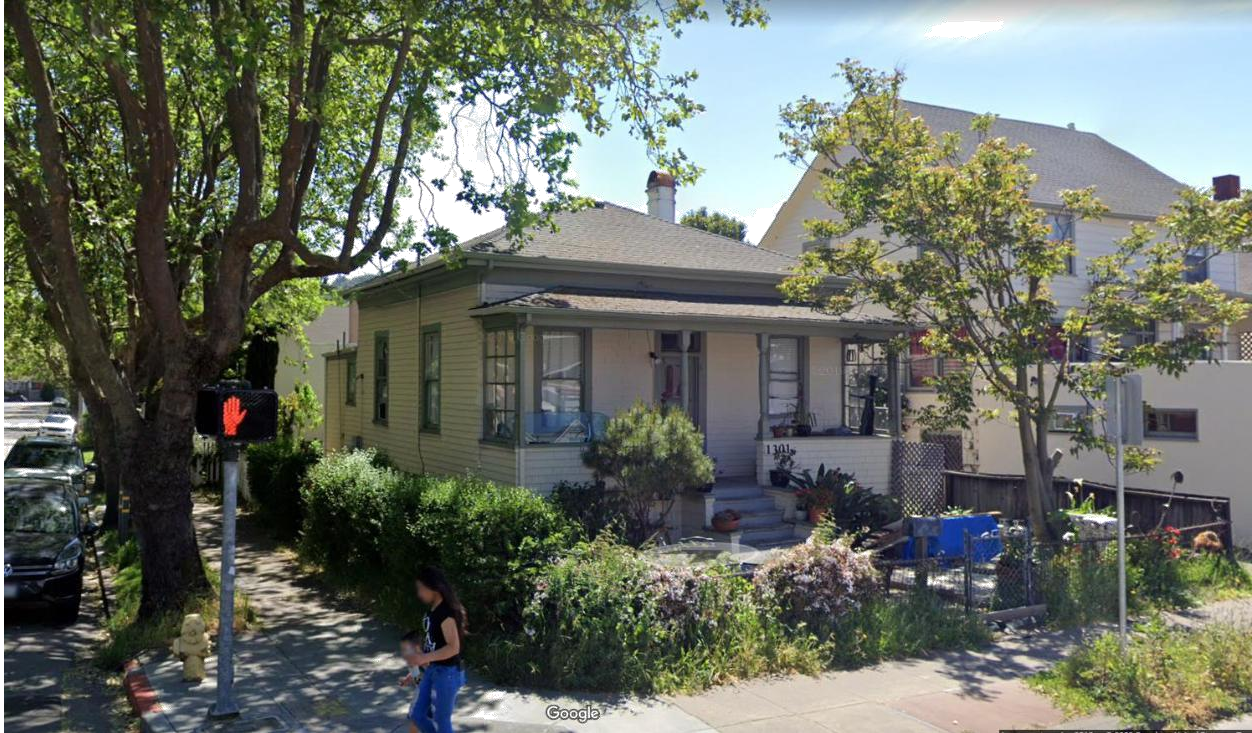
Address	1301 Second Street	B+
APN	012-073-07	
Building Name		
Year Built	1907 (spreadsheet)	
Original Use	Residential	
Architectural Style	Hipped roof cottage	
Architect/Builder		
Description	The one-story building has a raised foundation, a roughly rectangular plan, and a composition shingle hipped roof. A volume at the rear of the building is lower than the main roof. The main entrance is centered on the main façade and sheltered under a full-width projecting porch, screened on both sides with decorative turned posts. The building is clad in wood shingle. It has original double hung wood sash and partially glazed wood paneled door.	
Integrity	Appears to retain integrity	
Significance	Contributor and potentially landmark eligible, very good example of hipped roof cottage with excellent integrity	
Notes
