Downtown San Rafael Precise Plan Historic Resources Inventory Summary Report

December 2020

[Revised May 2021](#)

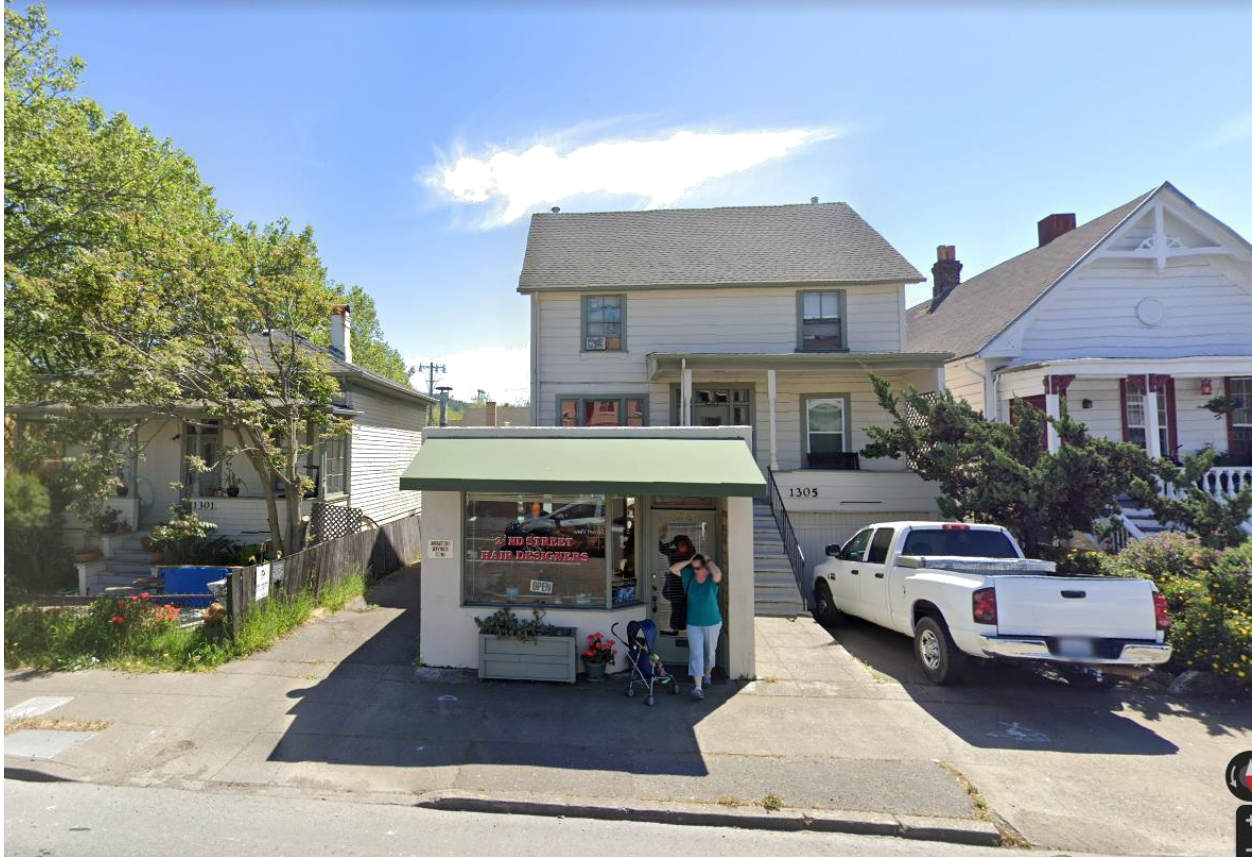
Address	1305 Second Street	ED
APN	012-073-06	
Building Name		
Year Built	1887 (spreadsheet)	
Original Use	Residential	
Architectural Style	Folk Victorian	
Architect/Builder		
Description	The original building has a roughly square plan and a notably distinct addition projects forward on the main façade. The original volume is three stories tall with a gabled composition shingle roof. The main entrance is sheltered under a partial-width projecting porch with a flat roof. The volume is clad in horizontal channel board siding. On the first floor is a vertical board wooden garage door. The addition is one story; it rises to about halfway up the original volume's second floor, running next to the front staircase, under one of the porch supports, which is abbreviated to make space for it, and up to one side of the original volume's main entrance. The addition has its own entrance and large plate glass window on its main façade. It is clad in smooth stucco.

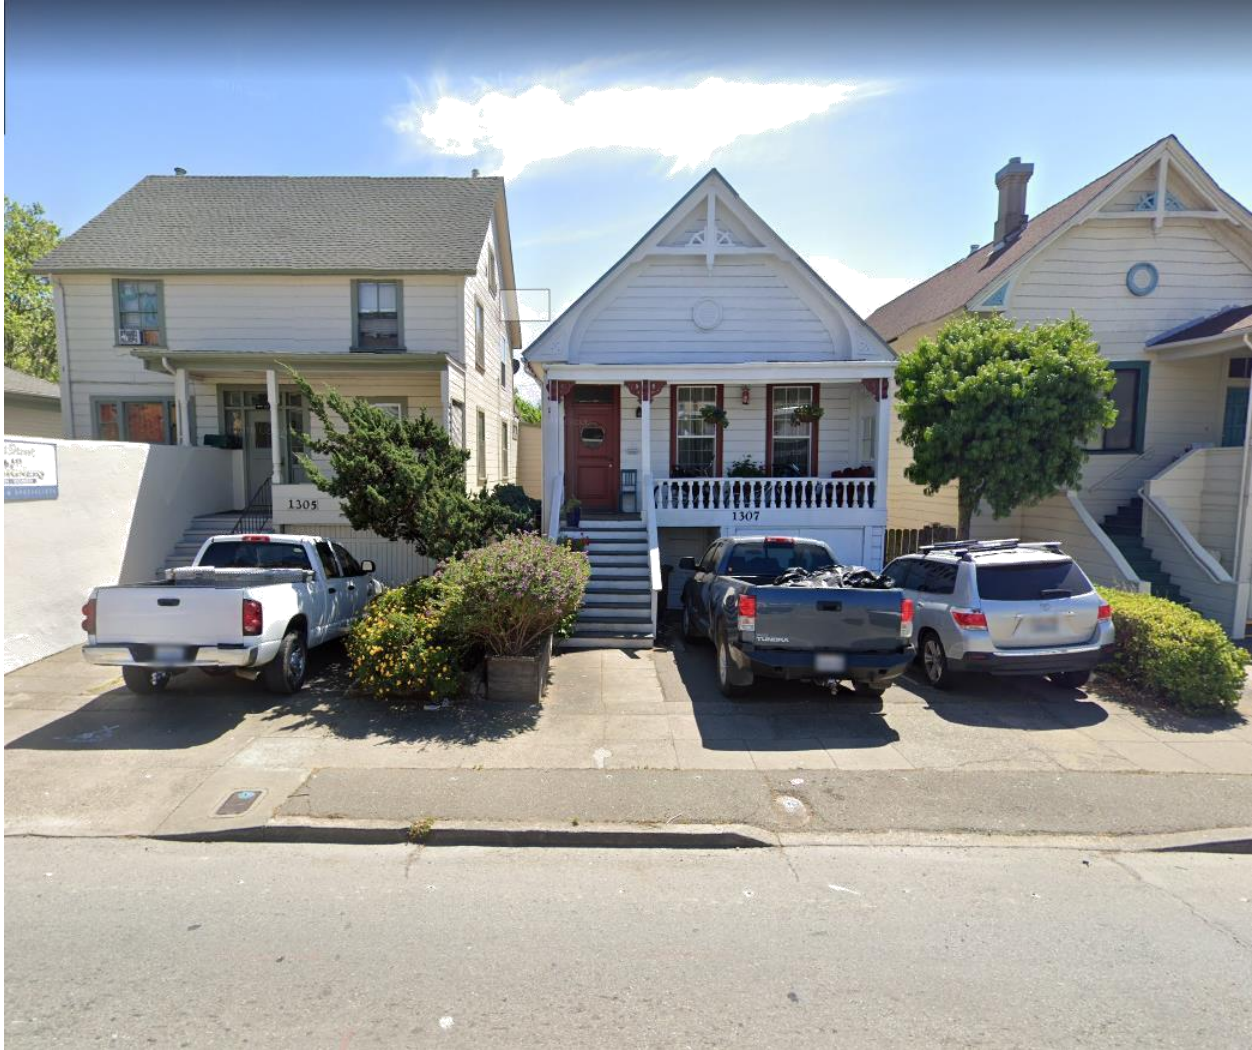
Address	1307 Second Street	5S2	B
APN	012-073-05		
Building Name			
Year Built	1905 (spreadsheet)		
Original Use	Residential		
Architectural Style	Stick/Vernacular		
Architect/Builder			
Description	The long rectangular building is two-story and has a gabled composition shingle roof with decorative gable bracket details. The second-story entrance is sheltered under a full-width integral porch. There is a garage with a wooden door on the first floor of the main façade. The building is clad in horizontal channel board siding.		
Integrity	Retains Integrity despite replacement windows		
Significance	Potential district contributor, lacks integrity required for landmark		
Notes

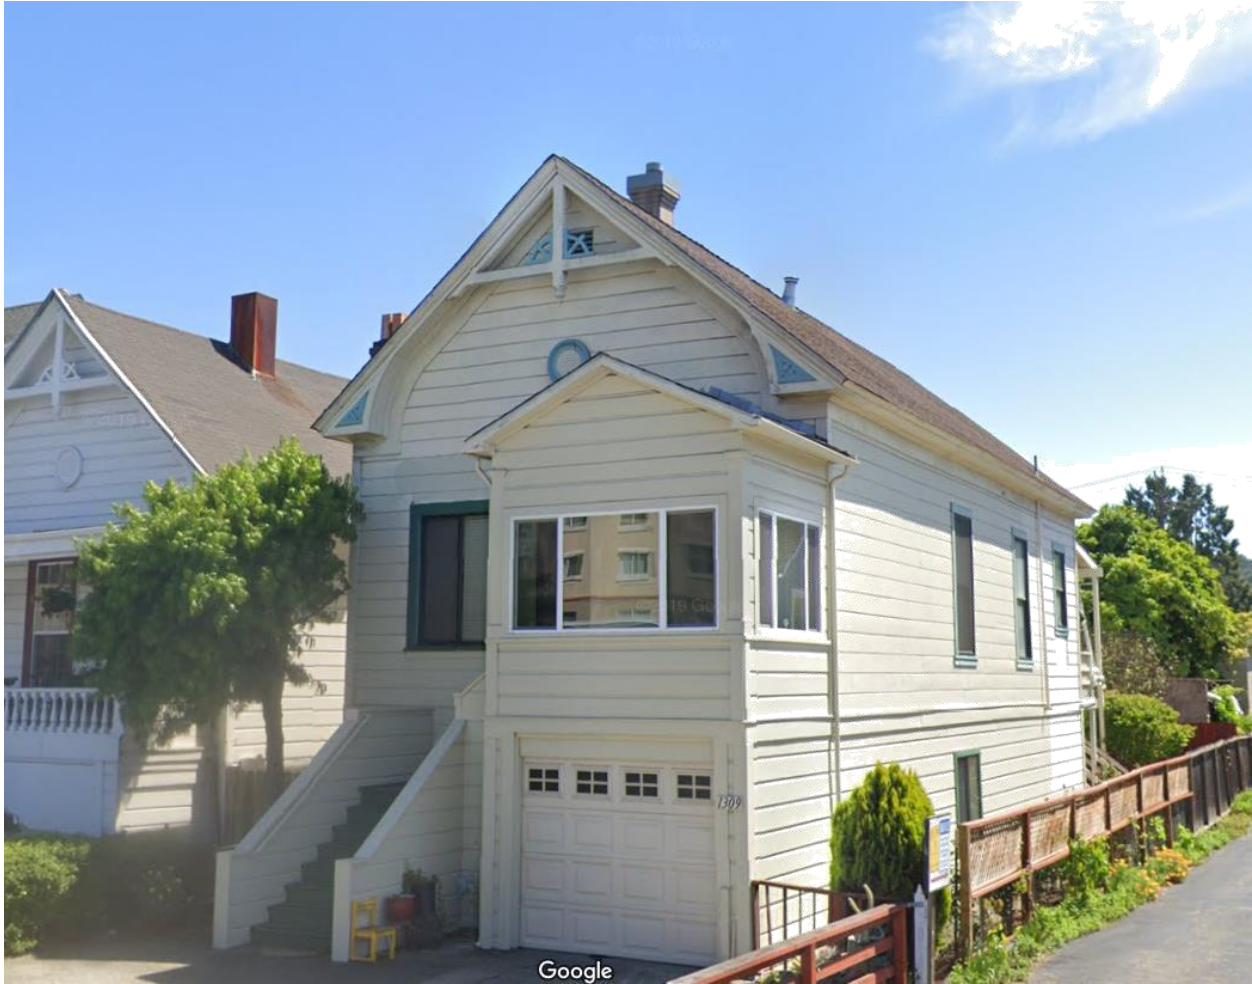
Address	1309 Second Street	ED
APN	012-073-04	
Building Name		
Year Built	1900 (spreadsheet)	
Original Use	Residential	
Architectural Style	Victorian	
Architect/Builder		
Description	The long rectangular building is two-story and has a gabled composition shingle roof with decorative gable bracket details. The second-story entrance is sheltered under a partial-width projecting gabled porch, accessed by a staircase from the side and above the metal roll-up garage door. The building is clad in horizontal board siding.	
Integrity	Lacks Integrity, replacement windows and porch	
Significance	Not eligible, lack of integrity	
Notes

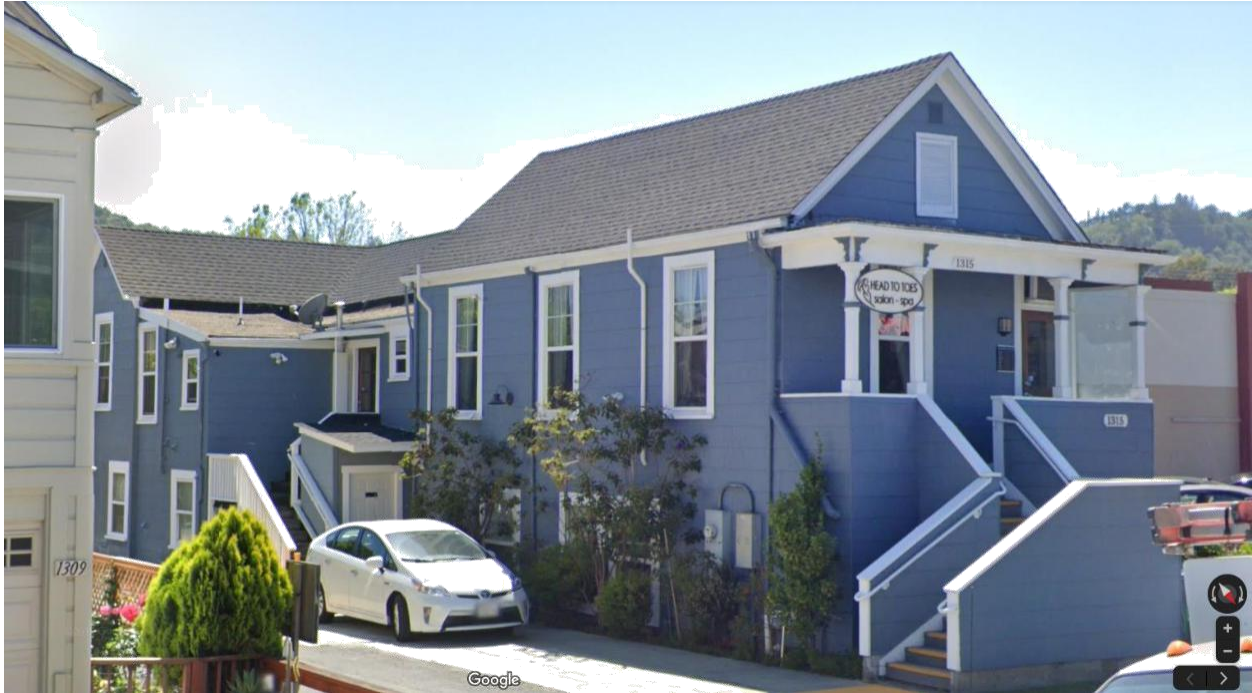
Address	1315 Second Street	E D
APN	012-073-03	
Building Name		
Year Built	c1900 (spreadsheet)	
Original Use	Residential	
Architectural Style	Folk Victorian	
Architect/Builder		
Description	The long, L-shaped two-story building has a gabled composition shingle roof. It is clad in horizontal board siding. The building has a second-floor entrance, sheltered under a projecting full-width porch accessed by a staircase on the main façade.	
Integrity	Lacks Integrity impaired, replacement windows, raised	
Significance	Ineligible, lack of integrity	
Notes

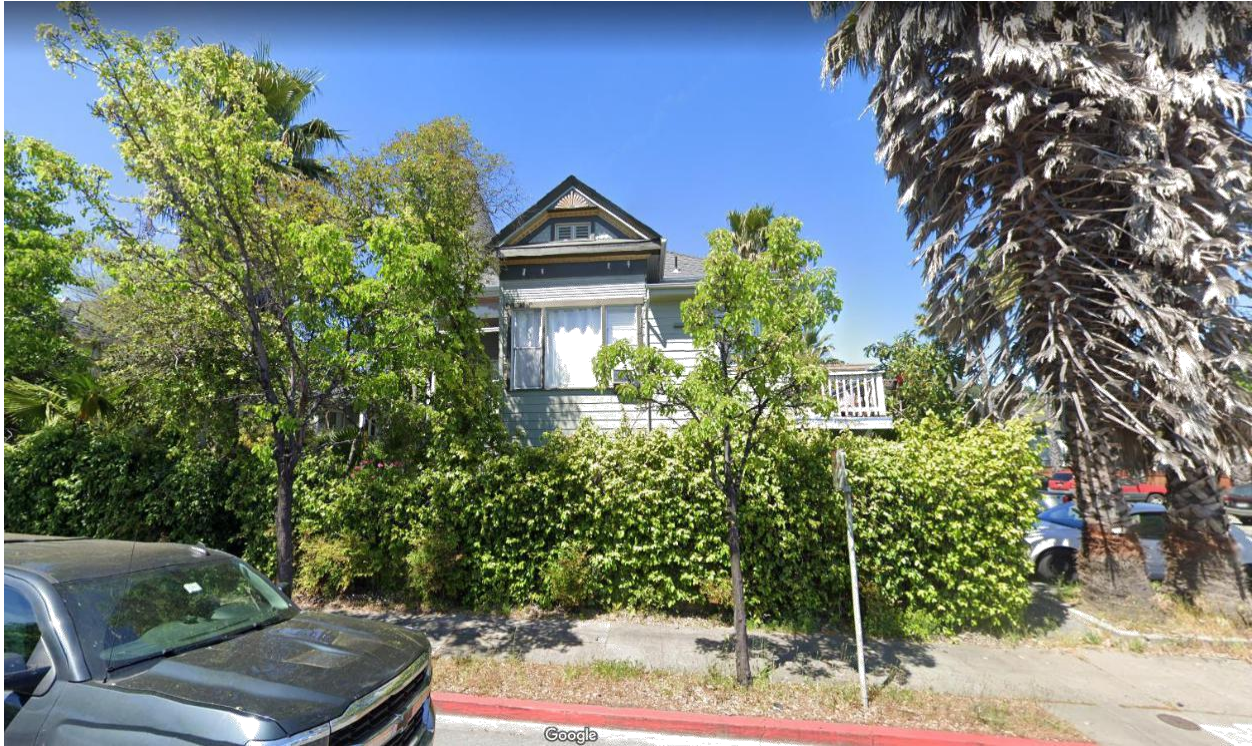
Address	1416-1420 Second St	7N	<u>ED</u>
APN	011-252-11		
Building Name			
Year Built	1895 (spreadsheet)		
Original Use	Residential		
Architectural Style	Queen Anne		
Architect/Builder			
Description	The roughly rectangular two-story building is located behind a high wall overgrown with vines, and there is considerable vegetation on the parcel. There is a parking lot to one side of the building, and the second-story entrance and deck are located near the back of the building on the façade that faces the parking lot rather than the façade facing the street. The building has a gabled composition shingle roof as well as a round room in one corner with a pointed roof.		
Integrity	Lacks Integrity, replacement windows and stairs/deck		
Significance	Not eligible, lacks integrity		
Notes	<u>Presents opportunities for improvement</u>

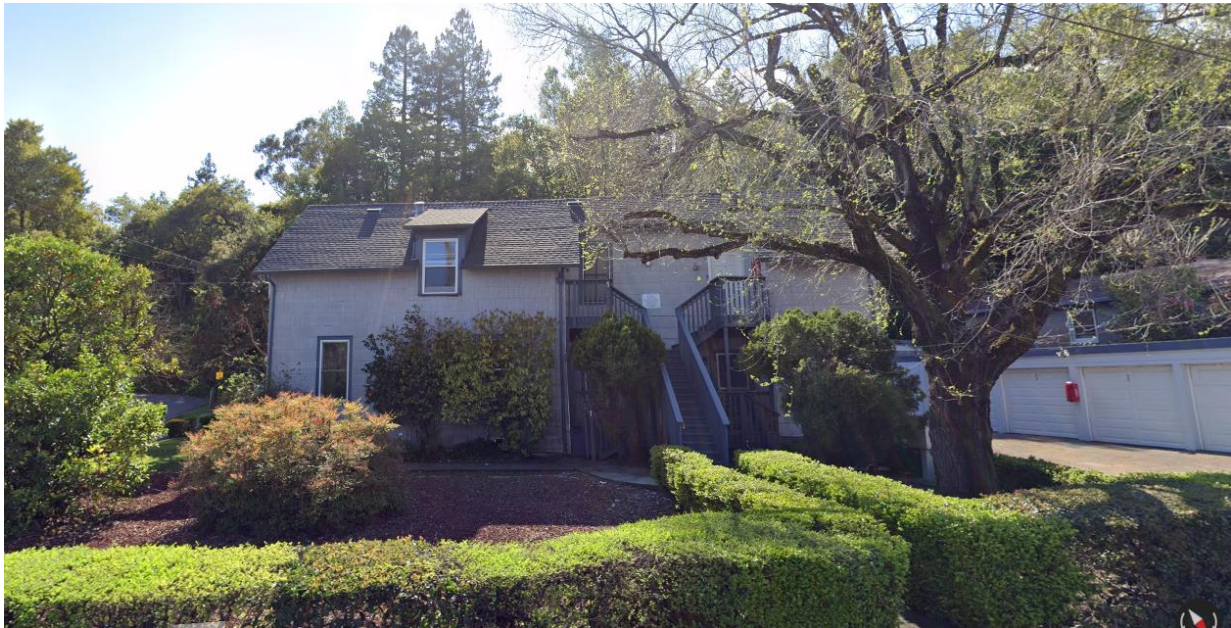
Address/code	455 First St /1621 Second St/ 455 First St		<u>ED</u>
APN	012-054-02		
Building Name			
Year Built	1950 (spreadsheet), appears to be c1900 house converted to multi-unit		
Original Use	Residential		
Architectural Style			
Architect/Builder			
Description	The single story building has a roughly rectangular plan and steeply pitched gabled roof with shed dormers. It is clad cement shingle and has replacement windows in vertical openings. The north elevation has been remodeled into apartments with an exterior staircase to the second floor		
Integrity	Lacks integrity		
Significance	Not eligible as landmark or contributor		
Notes

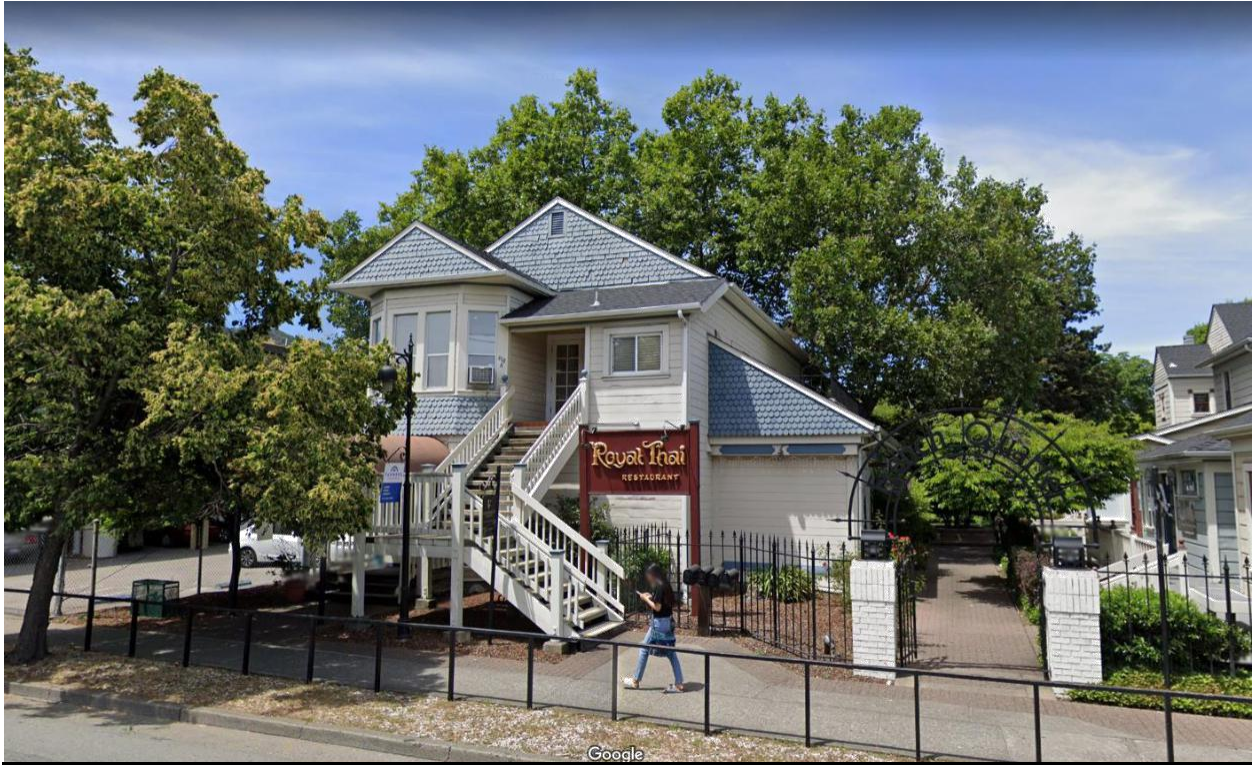
Address	610 Third Street	ED
APN	014-122-14	
Building Name	French Quarter	
Year Built	[spreadsheet gives implausible date of 1970] Bldg shown was relocated to the site c.1970.	
Original Use	Residential	
Architectural Style	Queen Anne	
Architect/Builder		
Description	The two-story rectangular building has a gabled composition shingle roof. There are two entrances located on the main façade. An entrance on the first floor under a bay window is sheltered by a cloth awning. The other entrance, located on the second floor, is accessed by a wooden staircase and sheltered under a partial-width integral porch. The building is clad in a combination of horizontal board and fishscale shingle siding. Appears to have been raised, shed roof addition	
Integrity	Integrity impaired by windows, staircase, enclosed porch, shed addition	
Significance	Not eligible, lacks integrity	
Notes	<u>Structure is located in the French Quarter Historic District. This district also includes 901, 903, 905, 907-9, and 911 Irwin, which are on their original sites and more significant resources. A Fact Sheet for the other buildings has not been prepared.</u>

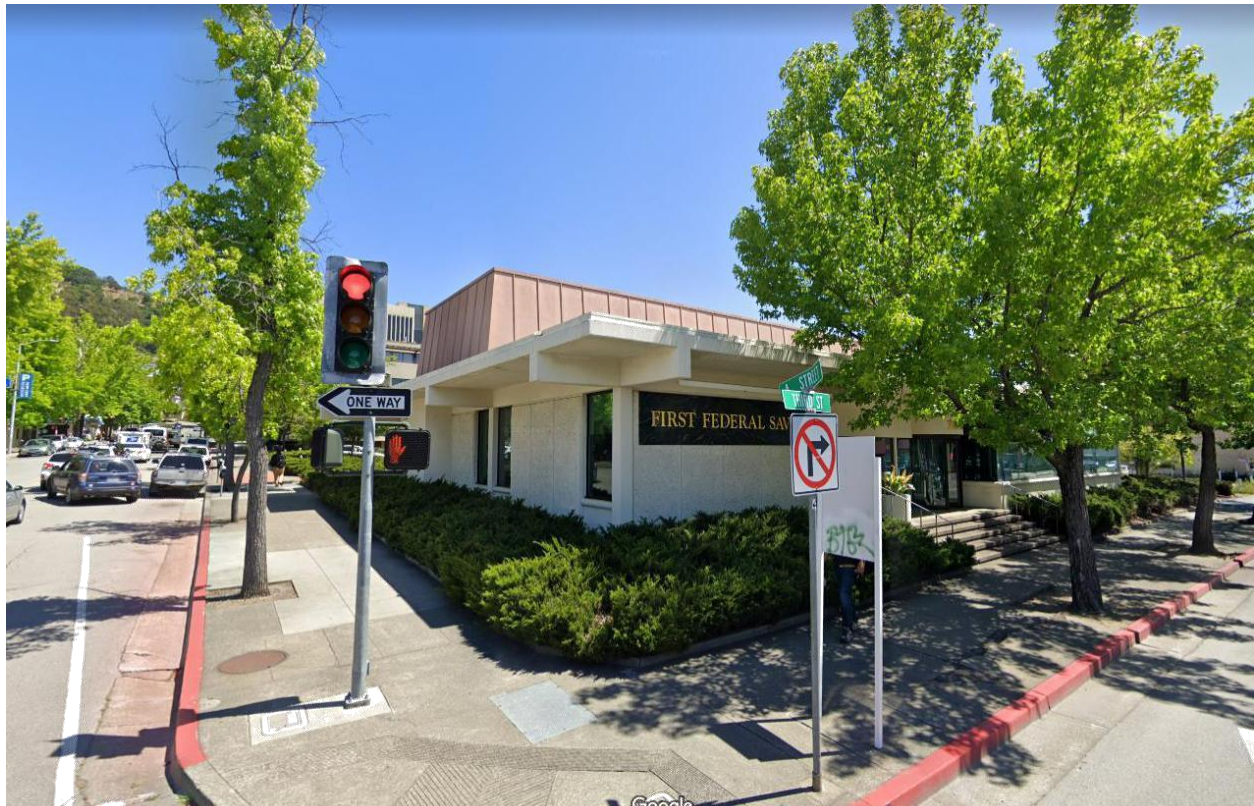
Address	1030 Third Street	A
APN	011-263-21	
Building Name	<u>Wells Fargo (now First Federal Savings and Loan)</u>	
Year Built	1963 (spreadsheet)	
Original Use	Commercial (<u>banking</u>)	
Architectural Style	Modern	
Architect/Builder	John Carl Warnecke (DIJ 11/23/1962)	
Description	The one-story rectangular building occupies a corner lot, surrounded on its other two sides by a driveway and parking lot. The building has a flat concrete roof with wide eaves and a penthouse with slanted sides. It is clad in panels of rough stucco, which are interspersed with tall vertical windows. There are also long horizontal stretches of window on multiple façade. The main entrance is a revolving door accessed by a set of wide, low concrete steps; there are multiple other entrances.	
Integrity	Appears to retain integrity, further study needed	
Significance	Probable eligible as landmark, designed by John Carl War <u>neckemecke</u>

Notes	<u>Supplemental evaluation performed during public review confirmed the building is eligible for the NRHP as an example of Modern Commercial Architecture and the work of a Master.</u>

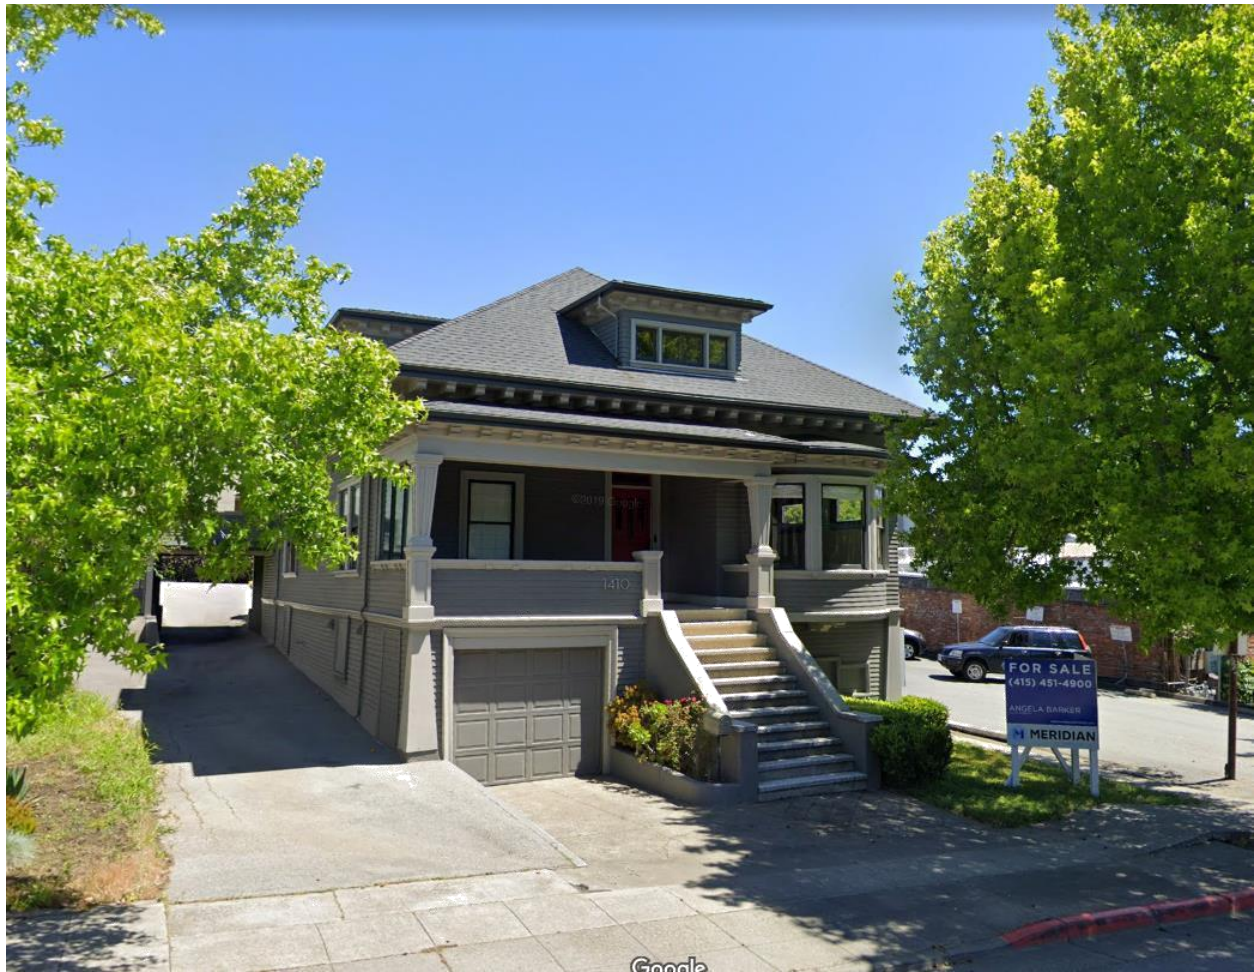
Address	1410 Third Street	A
APN	011-251-09	
Building Name		
Year Built	1916 (spreadsheet)	
Original Use	Residential	
Architectural Style	Foursquare/Craftsman	
Architect/Builder		
Description	The two-story rectangular building has a hipped composition shingle roof with hipped dormers on three façades. The second-story main entrance is sheltered under a deep partial-width integral porch; next to it is a rounded bay window. Eaves around the roof as well as the porch, the bay window, and the dormers all feature decorative brackets. The building is clad in clapboard siding and has original double hung wood sash windows and partially glazed door. Porch columns are highly decorative	
Integrity	retains integrity	
Significance	Eligible as landmark and district contributor	
Notes

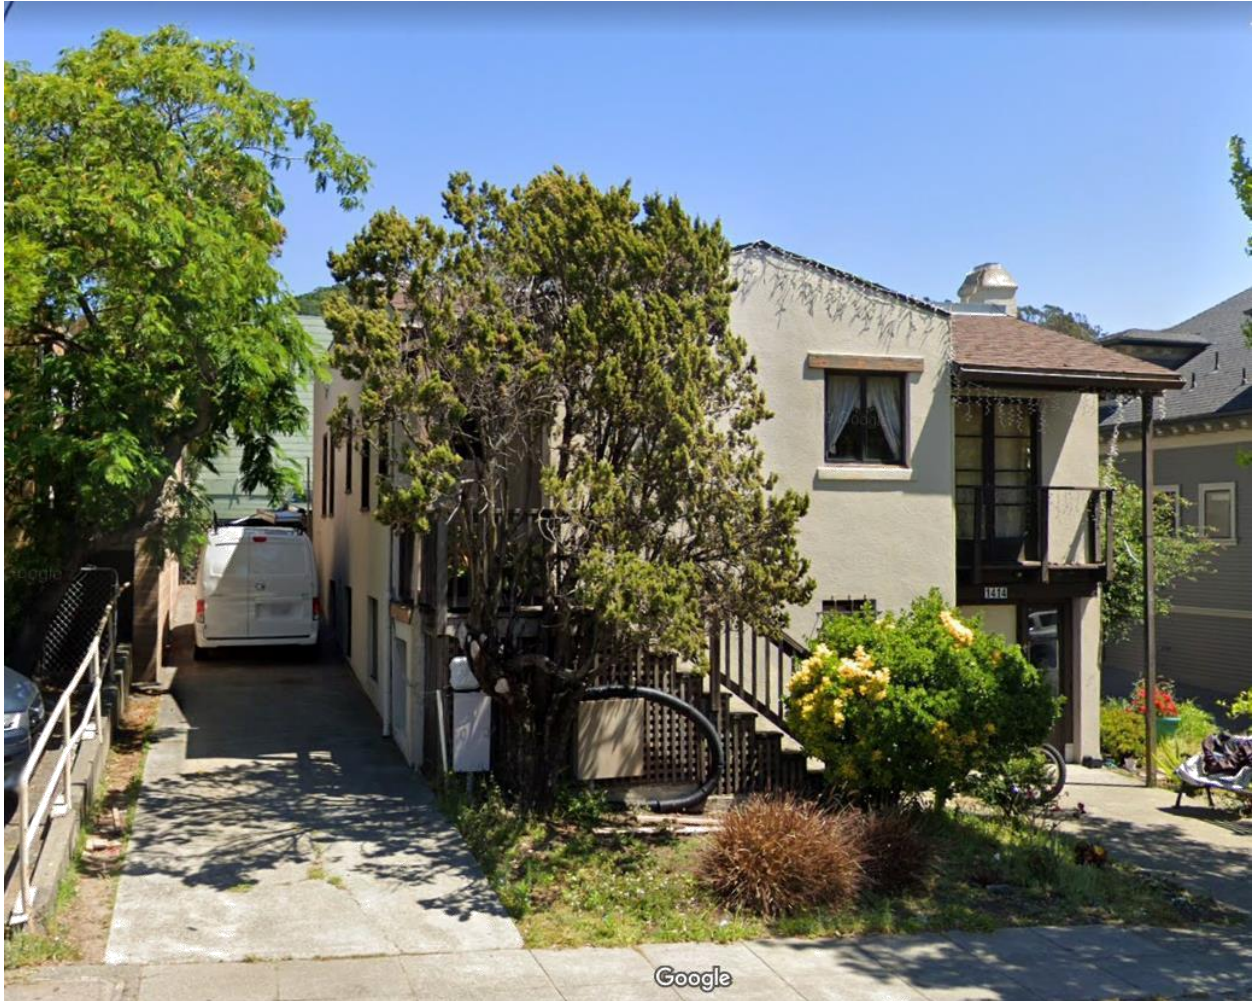
Address	1414 Third Street	DE
APN	011-251-11	
Building Name		
Year Built	1930 (spreadsheet)	
Original Use	Residential	
Architectural Style		
Architect/Builder		
Description	The two-story rectangular-plan building has a cross gable near the main façade, but most of the roof is flat. The building is clad in stucco with varied fenestration. The main façade features a ground-floor entrance as well as a second-floor entrance accessed by a wooden staircase.	
Integrity	Appears to lack integrity	
Significance	Not likely to be significant	
Notes

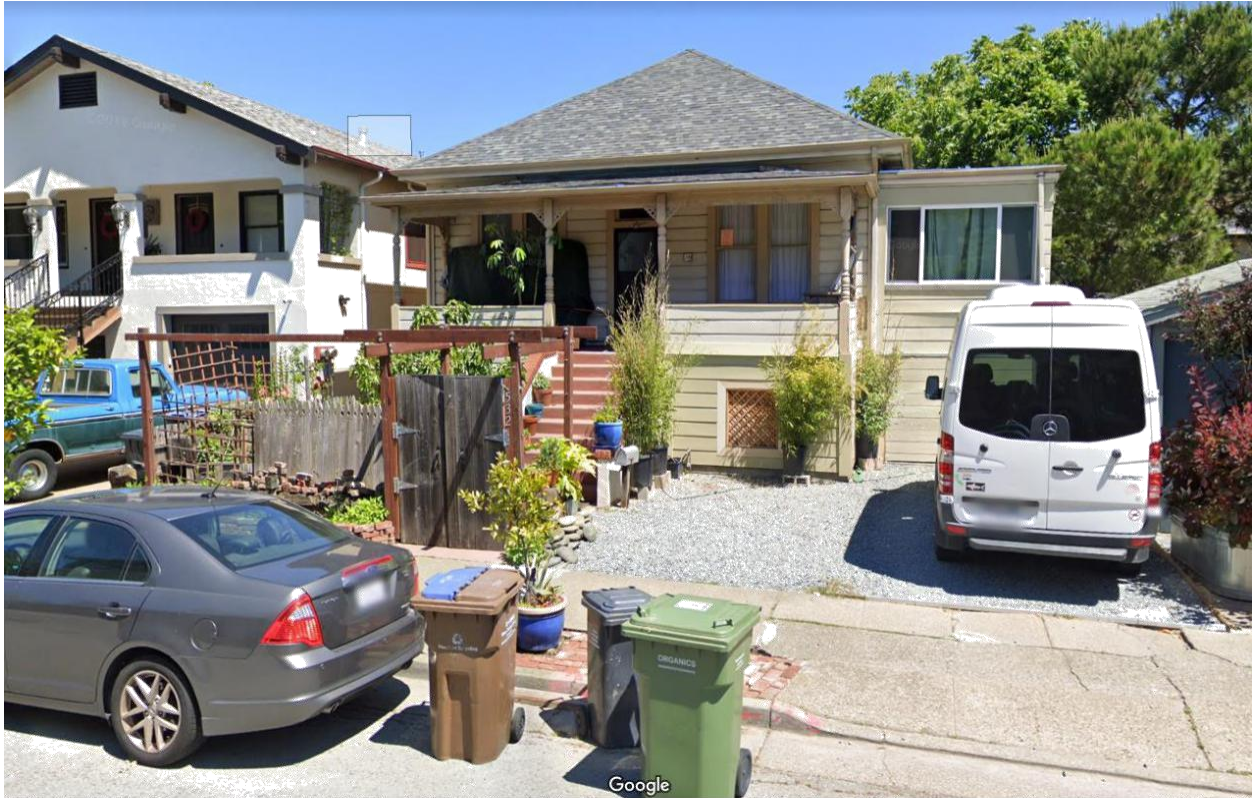
Address	1532 Third Street	B
APN	011-243-11	
Building Name		
Year Built	1900 (spreadsheet)	
Original Use	Residential	
Architectural Style	Hipped Roof Cottage	
Architect/Builder		
Description	The building is one story with a raised foundation and a rectangular plan. It has a hipped composition shingle roof and a projecting full-width porch on the main façade, accessed by a centered set of steps. The porch has decorative turned posts and scrolled brackets. It is clad in horizontal board siding. There is a flat-roofed addition to one side. Windows are double hung wood sash	
Integrity	Retains Integrity despite side addition	
Significance	Eligible as district contributor, not a landmark	
Notes

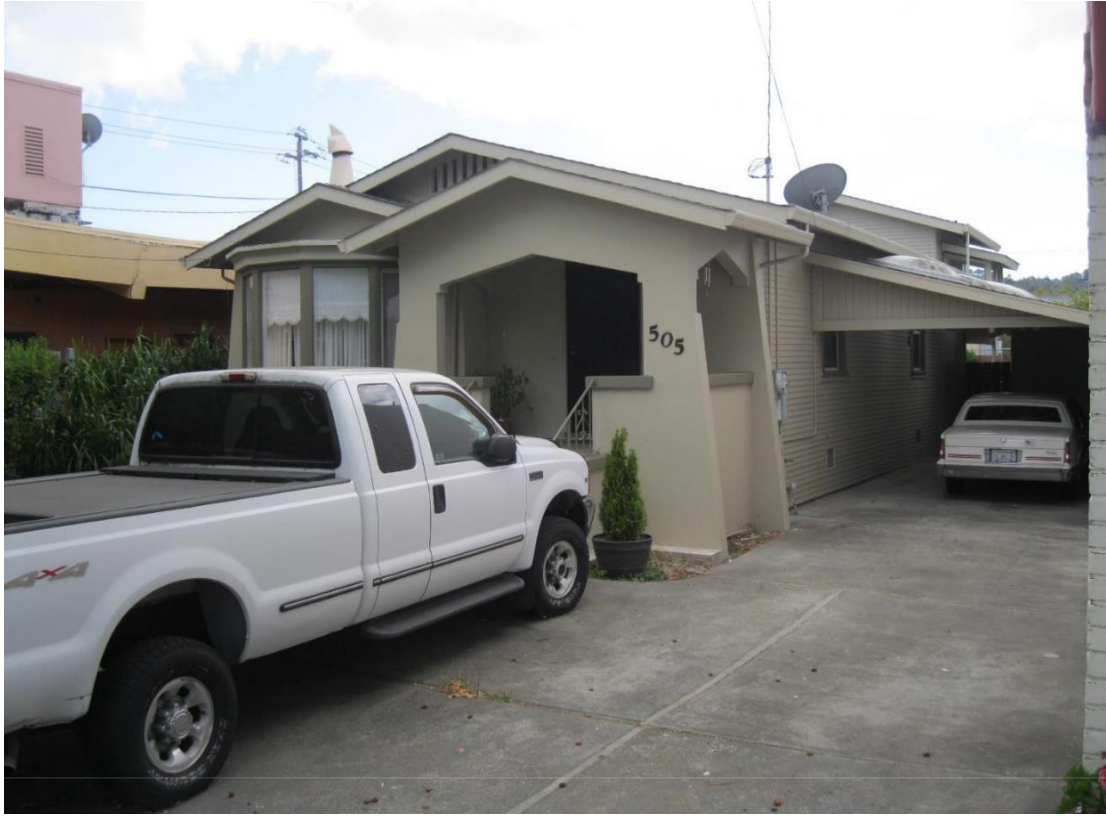
Address/Code	505 Fourth Street	<u>ED</u>
APN	014-123-09	
Building Name	Residence	
Year Built	1924/1930 (spreadsheet),	
Original Use	residential	
Architectural Style	Craftsman	
Architect/Builder		
Description	The single story house has a roughly rectangular plan and medium pitched multi-gabled roof with shed dormers. It is wood clapboard with stucco on the main (north) façade. There is a projecting partial-width porch with battered supports and shaped opening adjacent to a projecting window bay. A shed roof carport projects from the west side of the house.	
Integrity	Lacks integrity, replacement windows, carport, probably stucco over original wood, large neighboring building affects setting	
Significance	Not eligible as landmark or contributor due to marginal significance and lack of integrity	
Notes

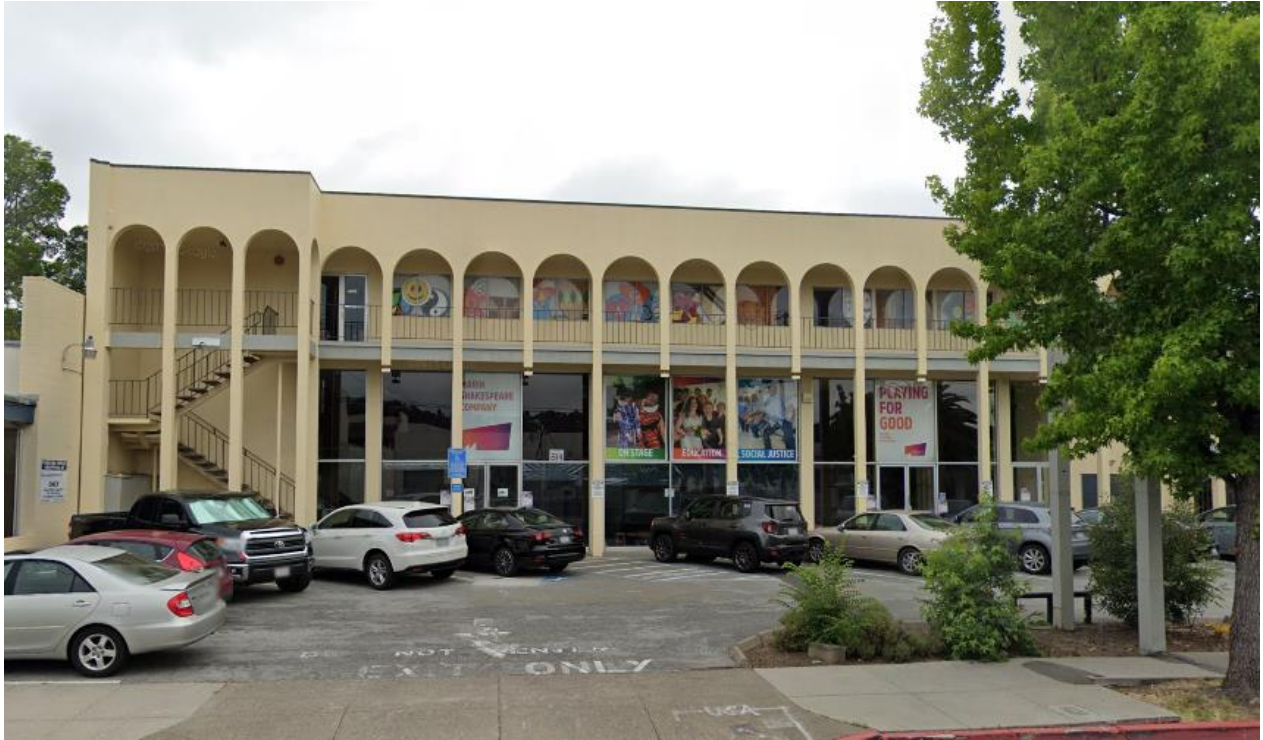
Address	514 Fourth Street	ED
APN	014-086-15	
Building Name		
Year Built		
Original Use	Commercial	
Architectural Style	New Formalism	
Architect/Builder		
Description	The two-story rectangular-plan building has a flat roof and is set back behind a parking lot. The double-height first floor features multiple entrances and large aluminum frame storefronts on the main façade. An exterior staircase projects forward slightly at one corner of the main façade, and an exterior hallway runs along the second floor; both the staircase and hallway are sheltered under a projecting roof with an arcade. There is parking in front of the building	
Integrity	Retains integrity	
Significance	Not eligible, not a significant example of the style	
Notes

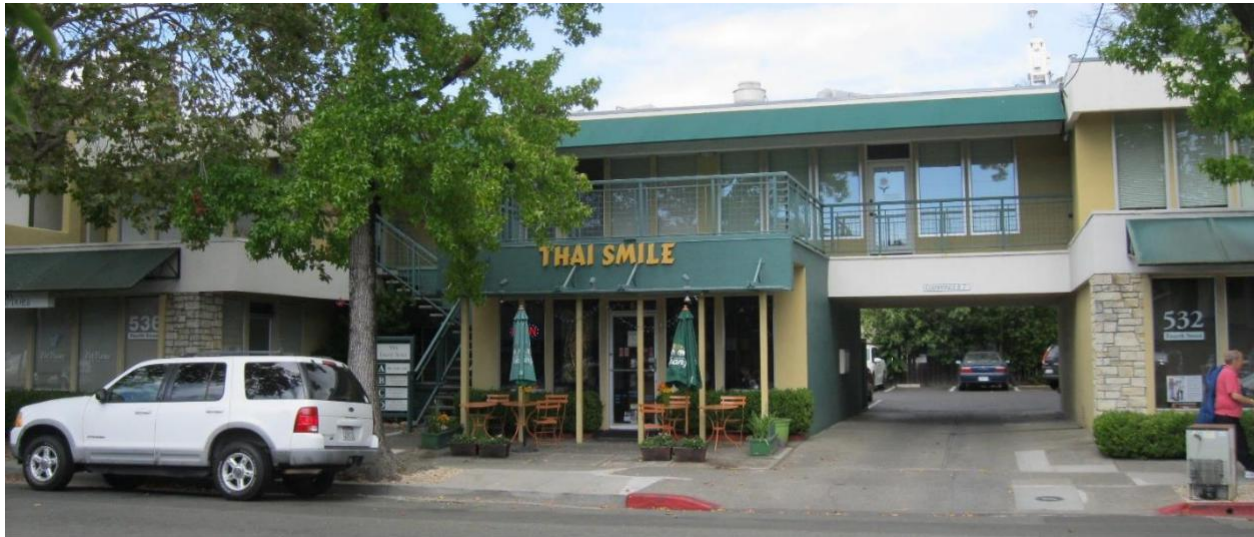
Address/code	532 Fourth Street	ED
APN	014-086-26	
Building Name		
Year Built	1965 (spreadsheet),	
Original Use		
Architectural Style	Midcentury Modern	
Architect/Builder		
Description	The two story storefront commercial building is rectangular in plan with flat roof, ground floor retail, and second floor office space. The two storefronts are separated by a driveway that leads under the second floor to the rear parking lot. Cladding is stucco with manufactured stone on the east storefront. Fixed windows are vertical with aluminum frames and doors are fully glazed aluminum frame.	
Integrity	Probably lacks integrity, stone facing, upstairs balustrade, windows appear to be replacements	
Significance	Not eligible as landmark or contributor due to marginal significance and lack of integrity	
Notes

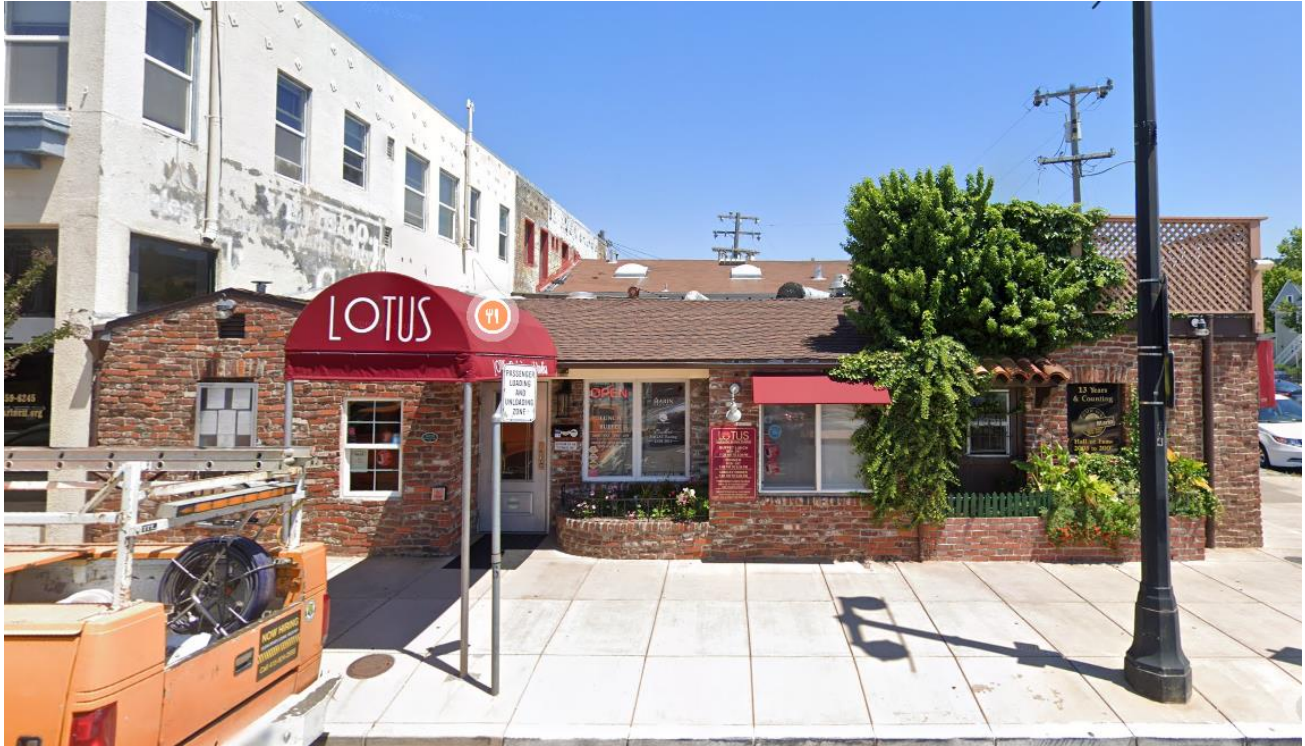
Address	704 Fourth Street	EC
APN	011-227-10	
Building Name	Lotus Restaurant (La Petit Auberge)	
Year Built	c.1920	
Original Use	Commercial	
Architectural Style	Mid-century Storybook	
Architect/Builder		
Description	The rectangular-plan building is located on a corner lot. The roof type is unclear, but there is a front gable located to the side of the main entrance. The roof is composition shingle and there is a tile awning over one window, a cloth awning over another window, and a projecting cloth awning over the main entrance. The building is clad in irregular brick and the main façade features built-in brick planters. Windows are a variety of shapes and sizes.	
Integrity	Integrity appears impaired but the brick is a unique feature that warrants further consideration	
Significance	Not likely to be significant	
Notes

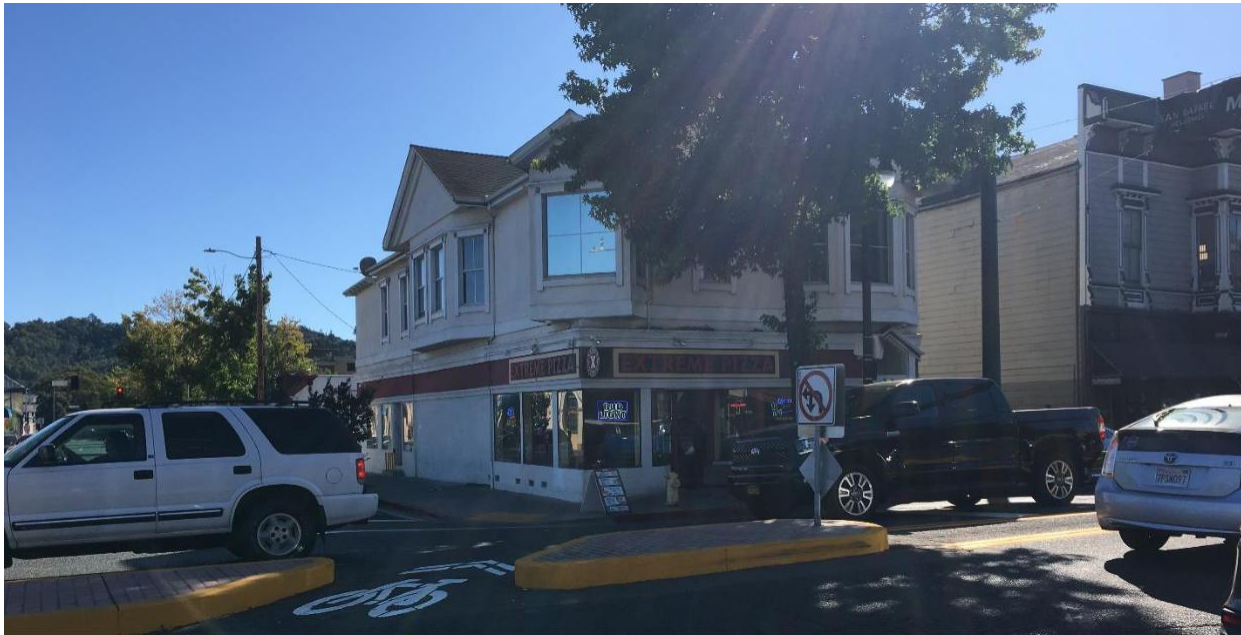
Address/code	705 Fourth Street	ED
APN	011-275-03	
Building Name	National Hotel	
Year Built	1898/1991/2008 (spreadsheet)	
Original Use		
Architectural Style	Queen Anne	
Architect/Builder		
Description	The two story house is roughly rectangular in plan with a gable on hip roof and projecting bays at the north, east, and corner. It is clad in stucco and upper floor windows have been replaced. East and north elevations have been converted to storefront on the ground floor.	
Integrity	Lacks integrity, roof form and decorative window casings are drastically altered only remnants of Original	
Significance	Not eligible as landmark or contributor due to lack of integrity	
Notes

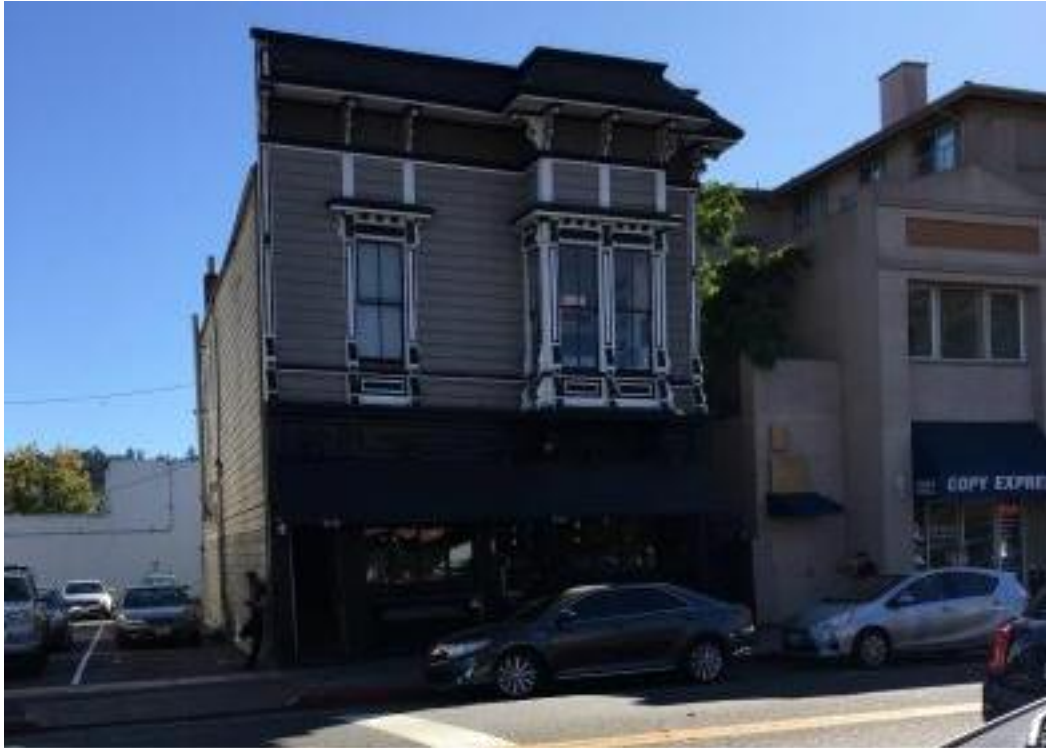
Address/code	709-711 Fourth Street	7N	A
APN	011-275-02		
Building Name			
Year Built	1889 1898 (spreadsheet)		
Original Use	Storefront/residential <u>Saloon/ Proprietor's residence above</u>		
Architectural Style	Italianate		
Architect/Builder			
Description	<p>The two story building is rectangular in plan with ground floor retail and upper floor residential. Its mansard roof has a cornice with elaborate shaped brackets. Upper floor windows are tall two over two double hung wood sash and elaborated with decorative hoods and casings. There is a projecting square bay. Cladding is drop siding. A decorative frieze separates the storefront from the upper floor. An original partially glazed wood panel door at the east end of the main (north) façade leads to a staircase to the second floor. Storefronts and storefront entrance are contemporary.</p>		
Integrity	Retains integrity despite modernization of storefront

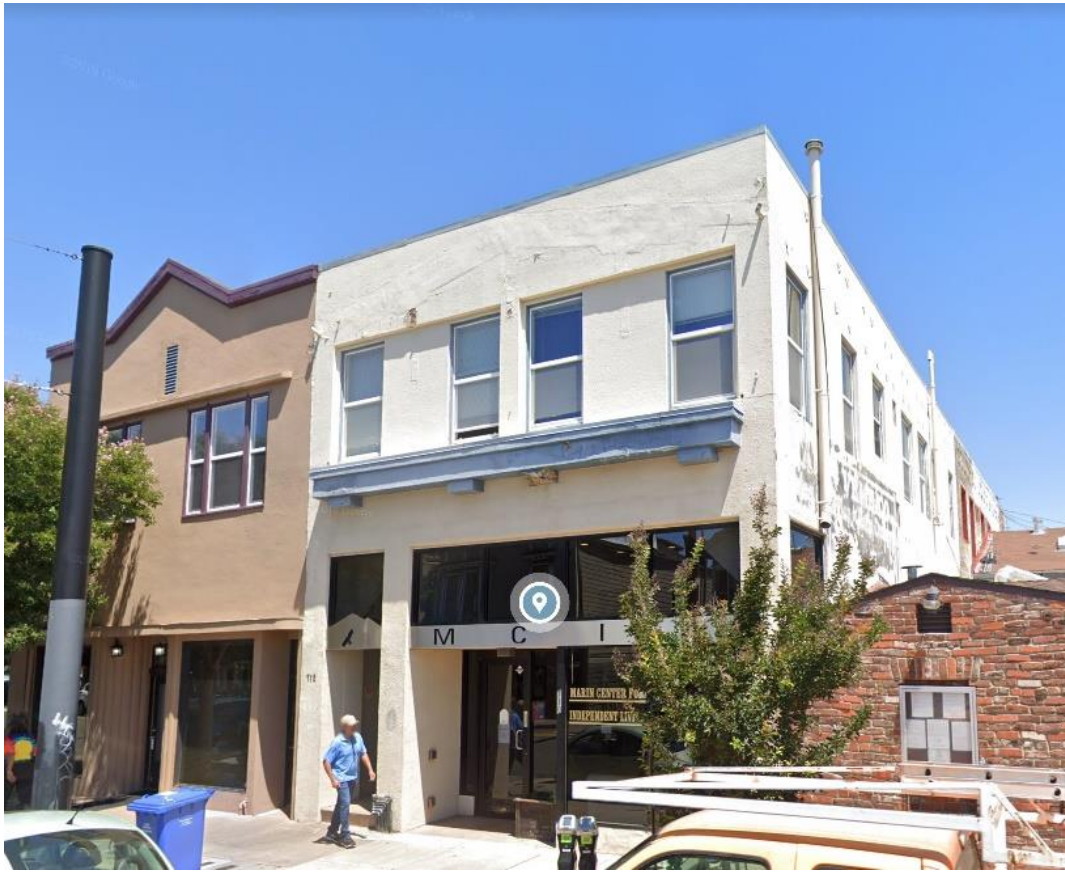
Address/code	710 Fourth Street	<u>E</u> <u>D</u>
APN	011-227-04	
Building Name	Marin Center for Independent Living	
Year Built	1950s? (spreadsheet), c1930 (aerials)	
Original Use	residential	
Architectural Style	Minimal Traditional/Commercial	
Architect/Builder		
Description	Historic aerials suggest that the southwest portion of the building with cross-gabled roof was originally a small house constructed about 1930. Additions were constructed over the decades, resulting in a hybrid building with multiple roof forms and both horizontal and vertical window shapes. Brick cladding is unlikely to be original	
Integrity	Lacks integrity to 1930	
Significance	Not eligible as landmark or contributor, not a recognizable example of a historic style	
Notes

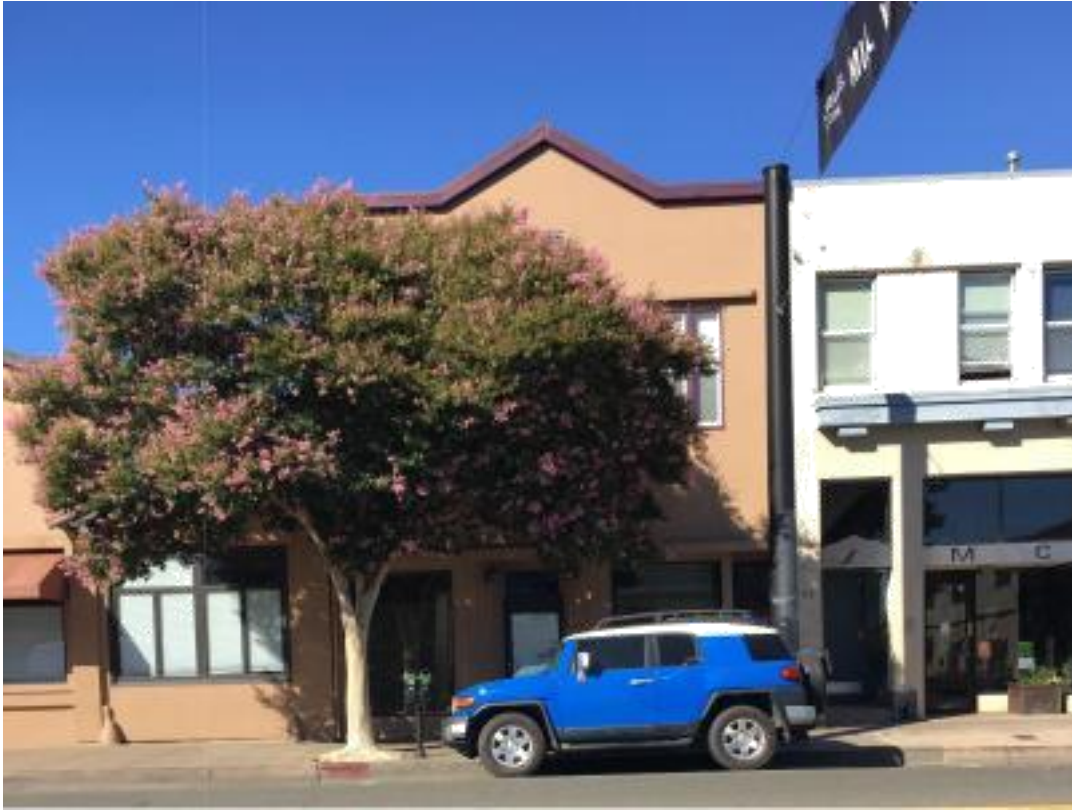
Address/code	716 Fourth Street	ED
APN	011-227-05	
Building Name		
Year Built	1908/1949/1983 (spreadsheet)	
Original Use	Storefront/residential	
Architectural Style		
Architect/Builder		
Description	The two story building is rectangular in plan with ground floor retail and upper floor residential or offices. It is clad in stucco and has a pointed parapet. Tall original window openings on the upper floor are fitted with replacement windows. The ground floor has storefront windows and a rounded streamline modern entrance and awning.	
Integrity	Lacks integrity	
Significance	Hybrid architecture from various eras, not a good example of any historic style, not eligible	
Notes
