Downtown San Rafael Precise Plan Historic Resources Inventory Summary Report

December 2020

[Revised May 2021](#)

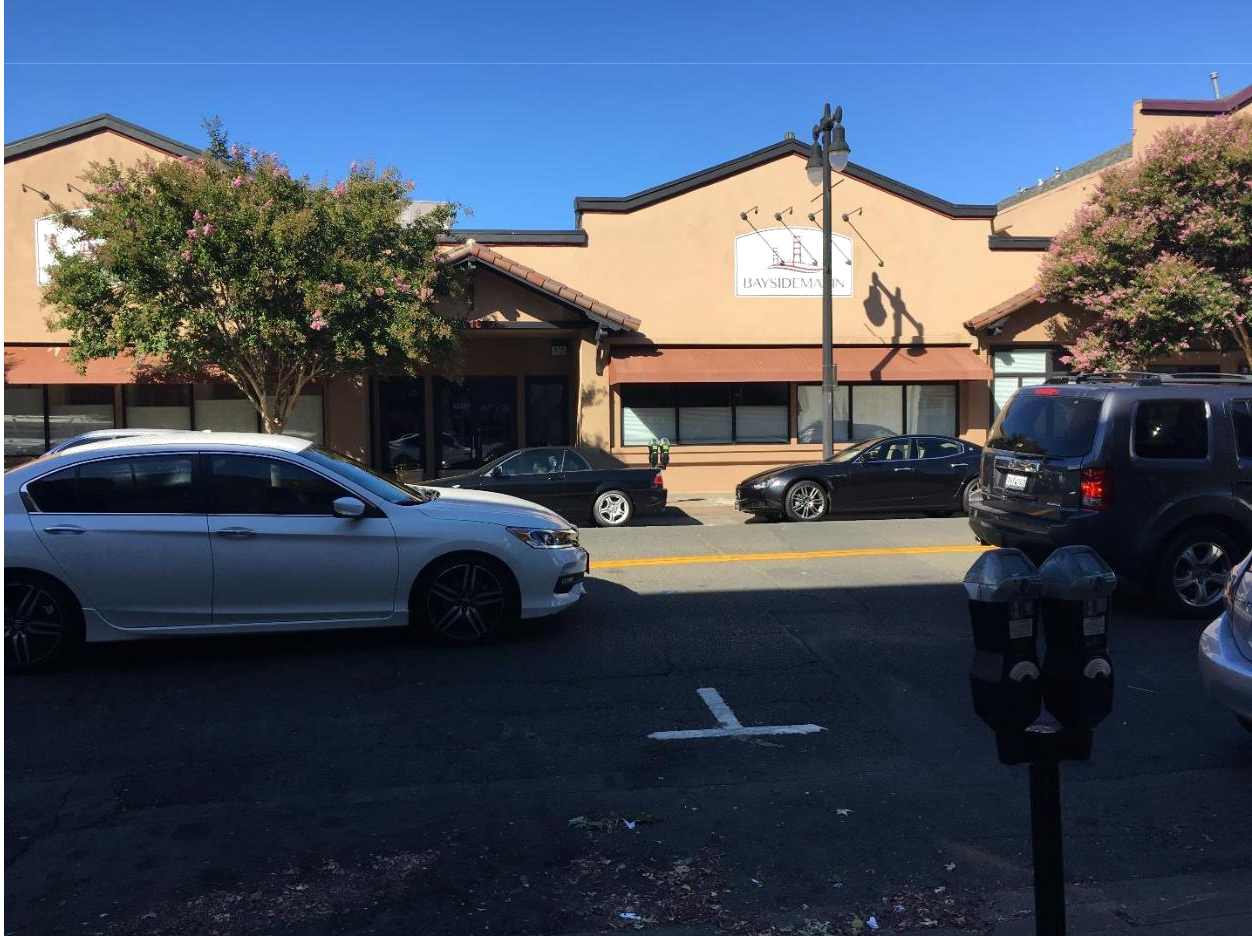
Address/code	718-24 Fourth Street	EC
APN	011-227-06	
Building Name	Bayside Marin	
Year Built	1918 (spreadsheet)	
Original Use	Storefront	
Architectural Style		
Architect/Builder		
Description	The large single story building is rectangular in plan with a tall shaped parapet and divided storefront windows. The projecting entrance has a gabled roof with plastic tile and shaped knee braces. The building is clad in stucco.	
Integrity	<u>Appears to lack sufficient</u> Lacks-integrity <u>to be eligible</u>	
Significance	Not a good example of any historic style, not eligible	
Notes	<u>Originally noted as ineligible. May warrant further study. Used for auto repair until 1970s</u>

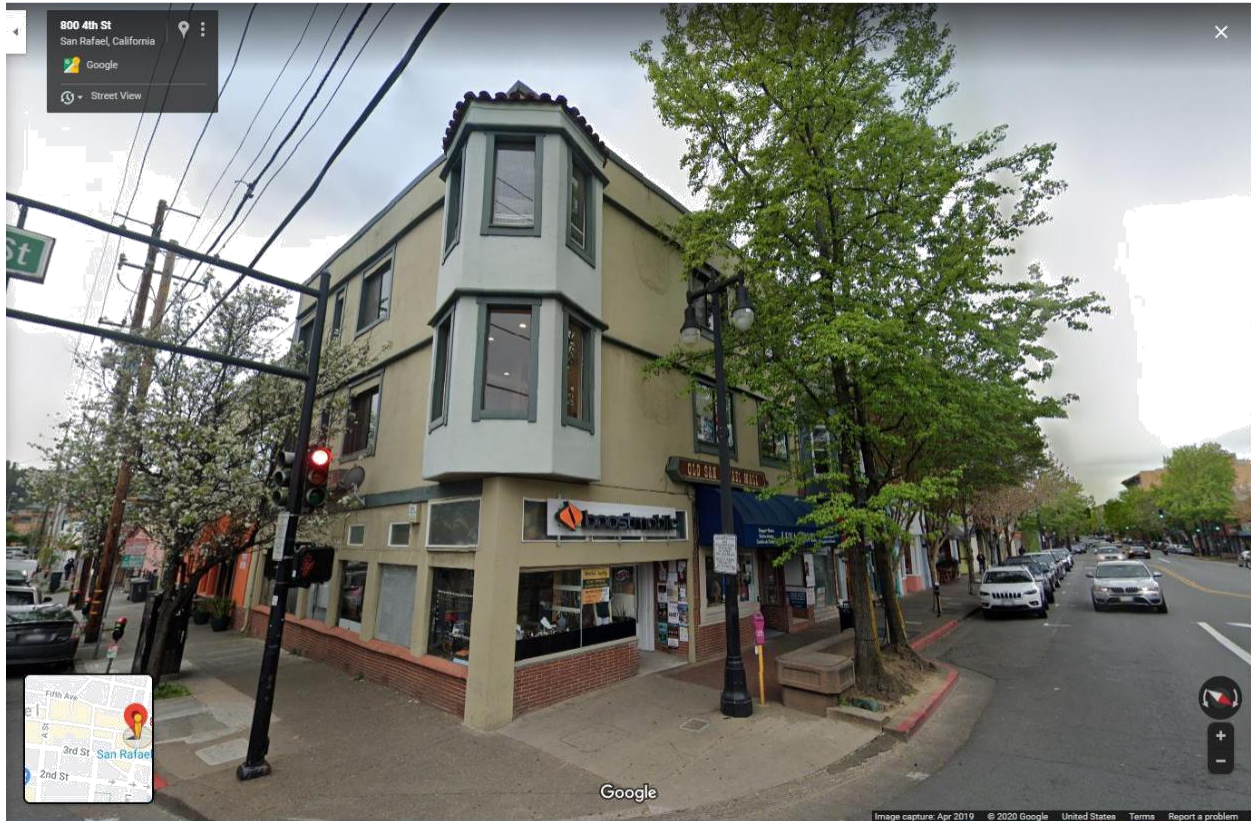
Address/code	801-805 Fourth Street	5S2	<u>ED</u>
APN	011-273-06		
Building Name	Old San Rafael Mall <u>(California/ Union Hotel)</u>		
Year Built	1878 (spreadsheet)		
Original Use	<u>Hotel Storefront</u>		
Architectural Style			
Architect/Builder			
Description	The three story corner commercial building has storefronts on ground floor Fourth St and Lincoln Ave facades with apartments above. The building is clad in stucco with Roman brick bulkheads. Windows have been replaced and most window openings altered. A projecting second and third floor bay at the corner is the only recognizable element of the building's nineteenth century origins.		
Integrity	Lacks integrity		
Significance	Not a good example of any historic style, not eligible		
Notes

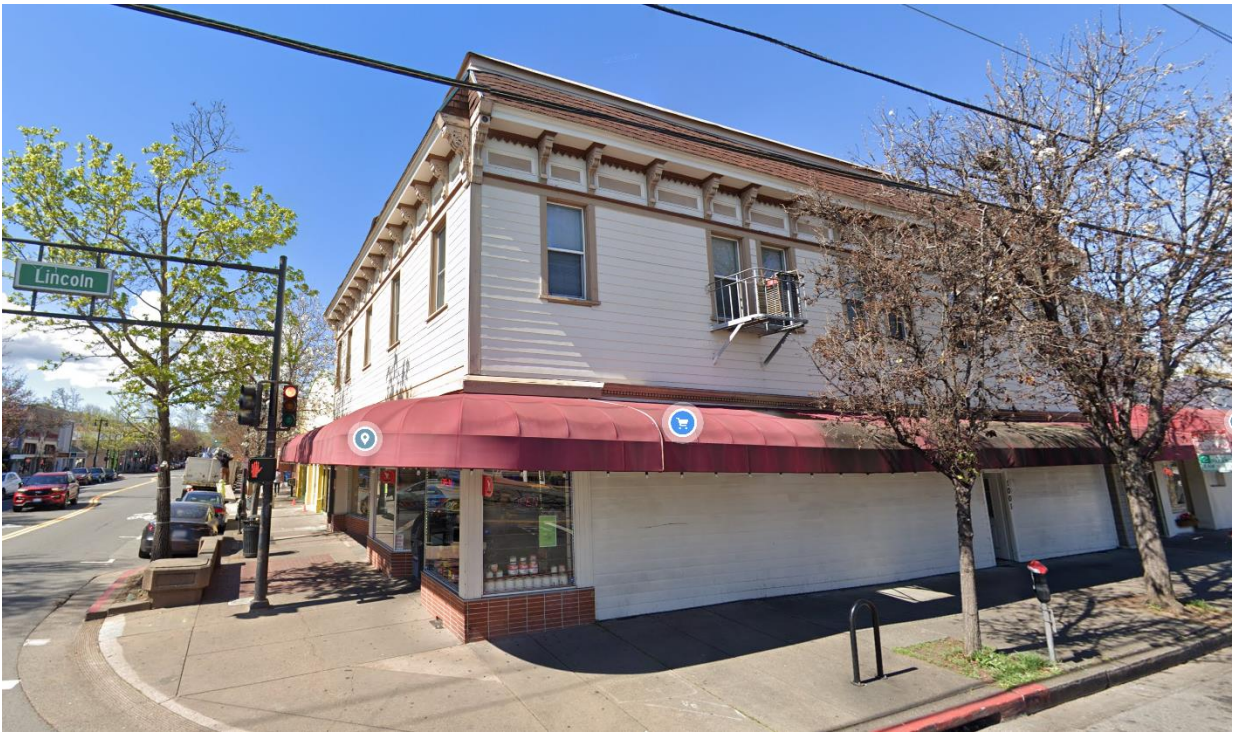
Address	<u>802-06 4th Street/</u> 1001 Lincoln Avenue		B
APN	011-224-10		
Building Name			
Year Built			
Original Use	Commercial		
Architectural Style			
Architect/Builder			
Description	The two-story building has a rectangular plan. The roof consists of two side-by-side composition shingle gables, hidden on both the street-facing sides of the corner lot by a slanted parapet supported by decorative molding and brackets. The main façade contains two first-floor storefronts consisting primarily of large plate-glass windows, with brick bulkheads and narrow vertical board siding between the windows. On the second floor and other façades, the building is clad in horizontal board siding. Upstairs windows have been replaced.		
Integrity	Appears to retain integrity despite window replacements		
Significance	Eligible as district contributor, lacks integrity required for landmark		
Notes	<u>806 is the original entrance to the upper floor, now accessed from Lincoln, a later alteration.</u>

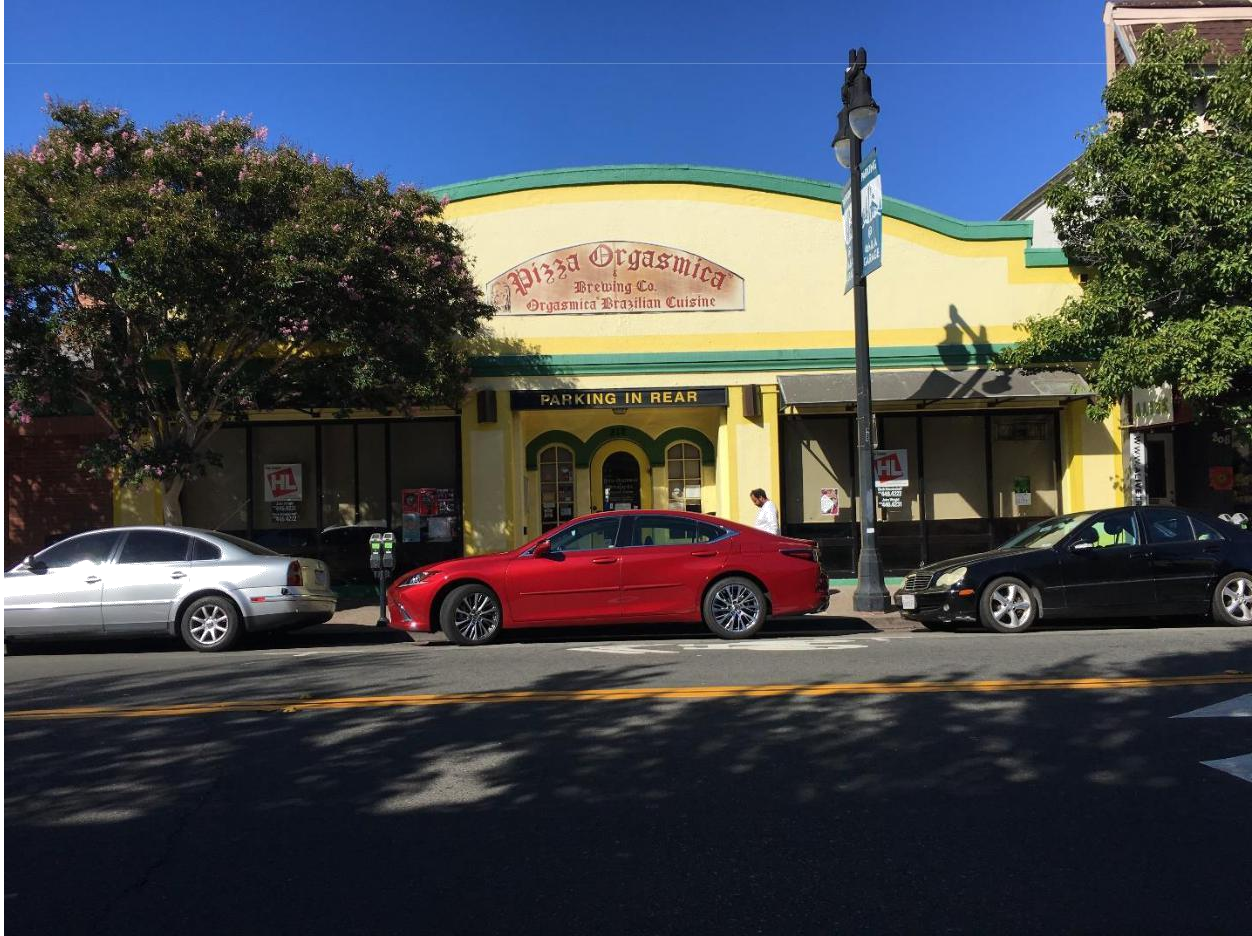
Address/code	812 Fourth Street	5S2	B
APN	011-224-11		
Building Name	Redhill Imports		
Year Built	1920/1950/1971 (spreadsheet)		
Original Use	Commercial <u>Auto repair</u>		
Architectural Style	Mission		
Architect/Builder			
Description	The one story storefront commercial building is rectangular in plan with arched roof and shaped parapet. Its recessed main entrance has an arched door flanked by arched multiple light wood windows. Divided storefront windows are contemporary.		
Integrity	Appears to retain integrity, more research needed		
Significance	Good if modest example of Mission commercial architecture, not a landmark, potentially a district contributor		
Notes	<i>Adjacent building to the east (806) apparent district contributor does not appear on any spreadsheet tab is not in exclusion area</i>

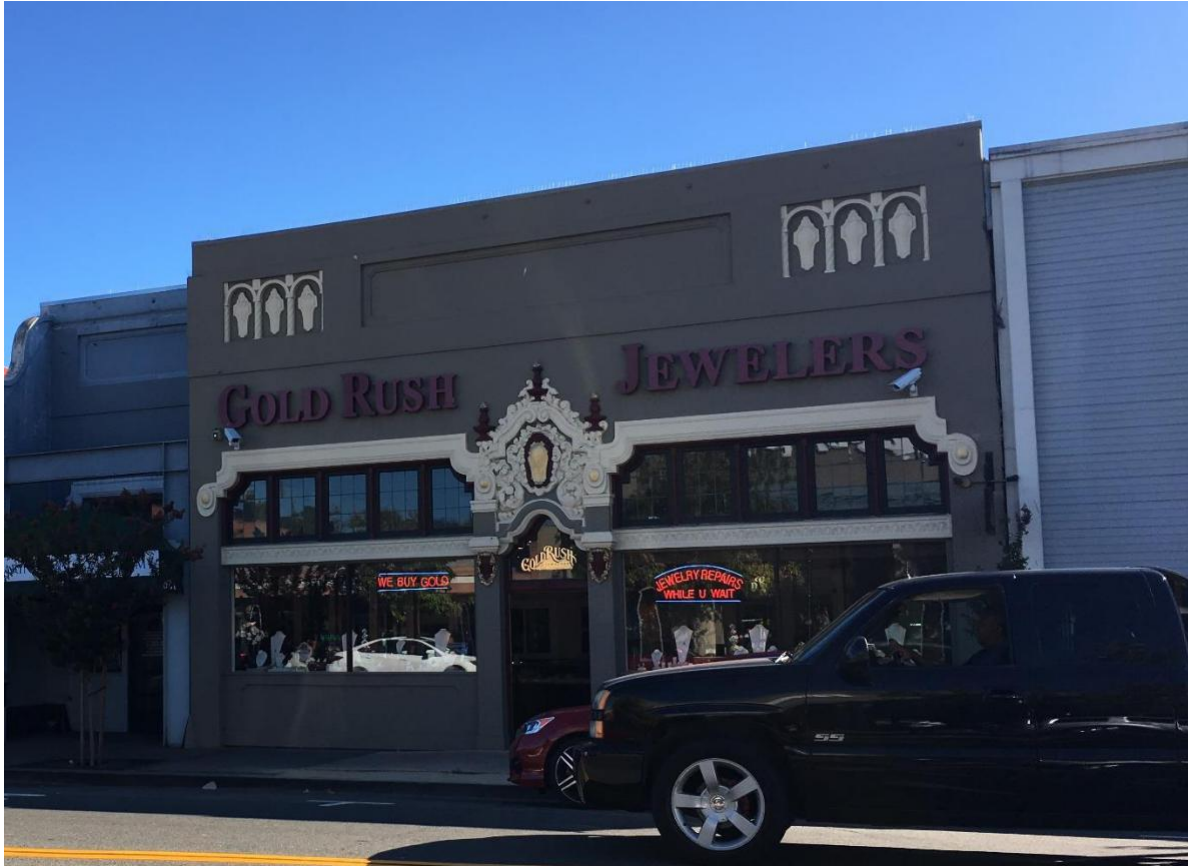
Address/code	827-831 Fourth Street	3S	A
APN	011-273-02		
Building Name	Rafael Florist/Gold Rush Jewelers		
Year Built	Before 1924 (Sanborn Maps)		
Original Use	Commercial (auto showroom)		
Architectural Style	Mission		
Architect/Builder			
Description	<p>The one story storefront commercial building is rectangular in plan with gabled roof concealed by a parapet. The building is stucco with terracotta ornament including cartouche and arch motif at parapet corners. Storefront windows are topped by floral frieze and large multiple light transoms with decorative turned posts and scrolled moulding. The partially glazed wood door is topped by a transom and set in an elaborately shaped arch. A cartouche with ornate floral and candle motifs tops the door. 827 Fourth originally had a vehicle door leading to a repair area behind the showroom and retains scrolled moulding and parapet that matches the primary building.</p>

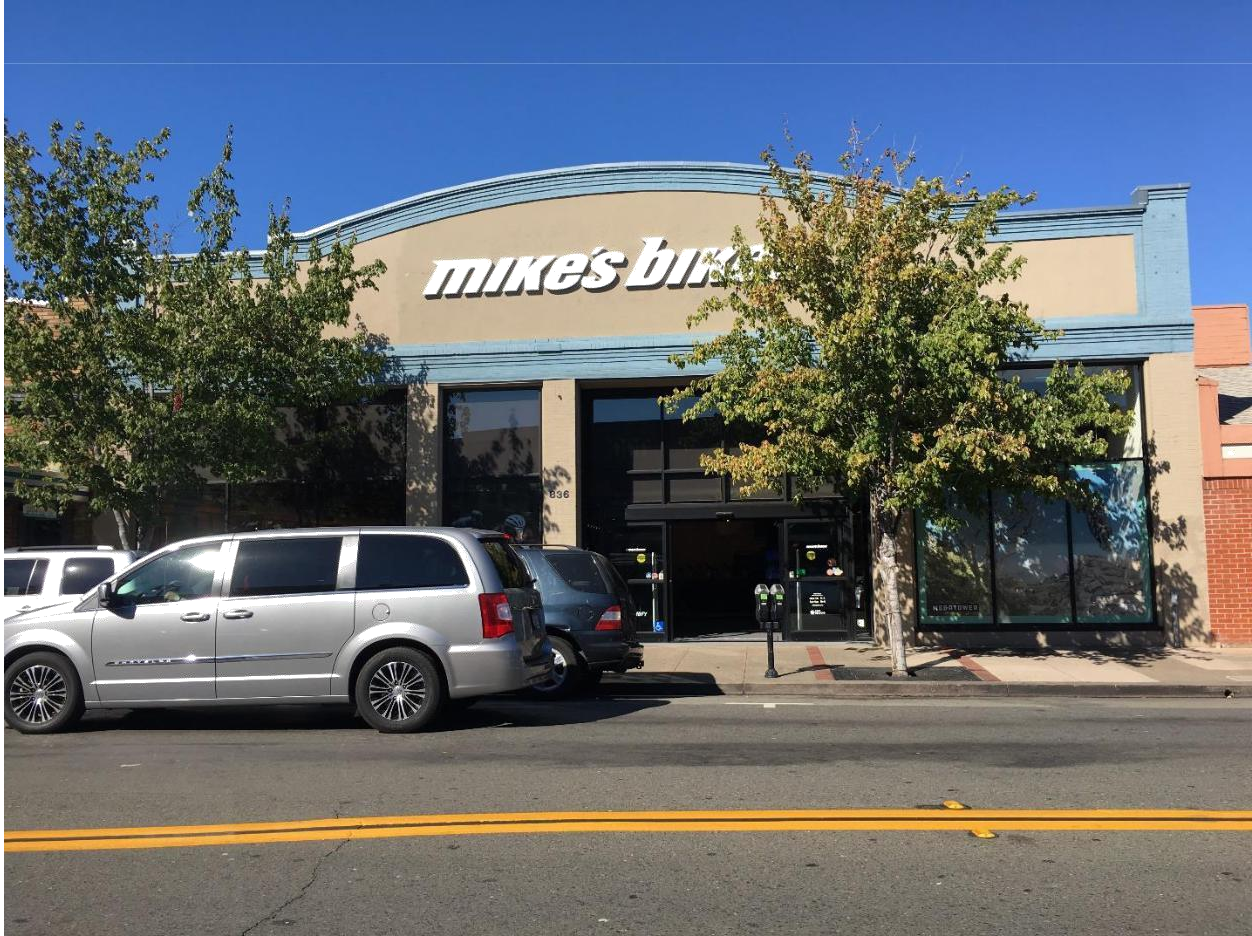
Address/code	836 Fourth Street		B
APN	011-224-13		
Building Name			
Year Built	1924 (spreadsheet, Sanborns)		
Original Use	Commercial , auto showroom		
Architectural Style	Mission		
Architect/Builder			
Description	The single story commercial building is rectangular in plan with a gabled roof hidden by a shaped parapet. The main (south) façade is occupied by large contemporary storefront windows and centered entrance. Cladding is brick with stuccoed areas. Decorative corbelling is also executed in brick.		
Integrity	Retains integrity		
Significance	Good simple example of Mission architecture, potential district contributor		
Notes	<i>Similar to 831 Fifth but better example of the style</i>

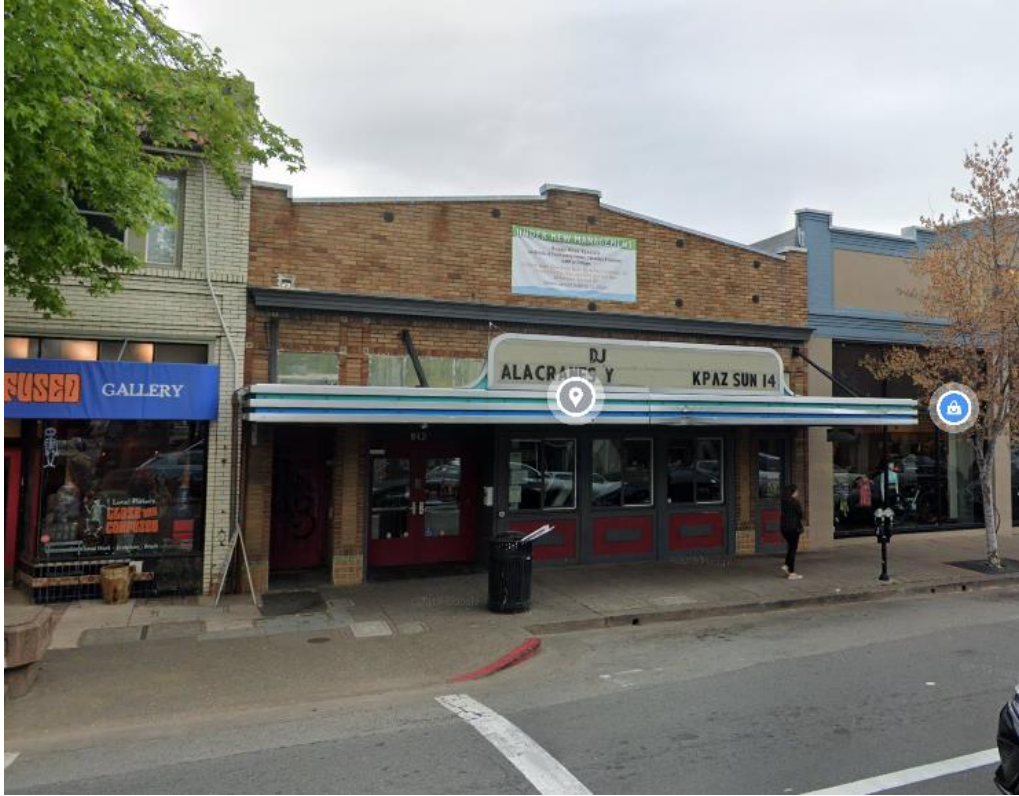
Address/code	842 Fourth Street		B
APN	011-224-14		
Building Name	<u>George's San Rafael Recreation and Pool Hall</u>		
Year Built	1929 (spreadsheet)		
Original Use	Commercial		
Architectural Style	Mission		
Architect/Builder			
Description	The single story commercial building is L-shaped in plan with a flat roof and stepped parapet. The main (south) façade is occupied by small windows above a paneled bulkhead and two entrances at its west end. A metal awning with a small marquee projects from the façade above the storefront level. Transoms above the awning appear to have been partially covered. There is a cornice between transoms and parapet. The building is clad in brick with columns articulated in contrasting color brick and tile column bases		
Integrity	Retains integrity, probable alterations to storefront level are sympathetic		
Significance	Good example of Mission architecture, potential district contributor

Notes	Same parcel as 8462 Fourth

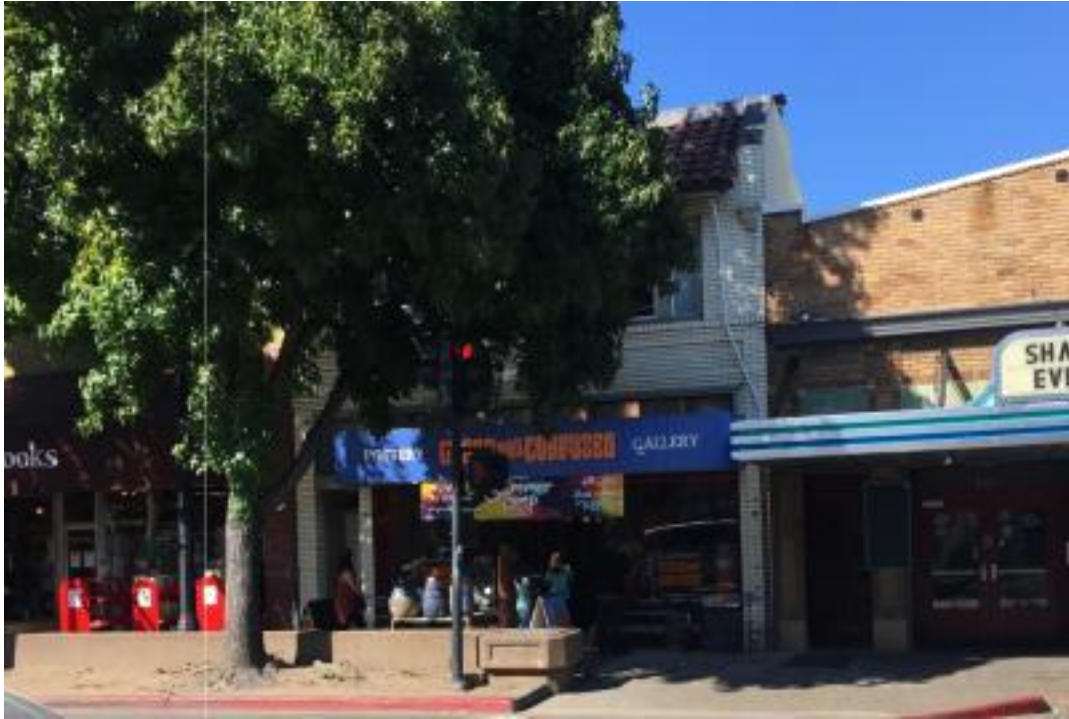
Address/code	846 Fourth Street		B
APN	011-224-14		
Building Name			
Year Built	1908-1924 (Sanborn Maps)		
Original Use	Storefront Commercial		
Architectural Style			
Architect/Builder			
Description	<p>The two story commercial building is rectangular in plan with a flat roof and parapet and decorative tiled shed roof with shaped rafter tails. The main (south) façade is occupied by large contemporary storefront windows and centered entrance. Cladding is glazed brick with decorative tile bulkhead. Decorative frieze separating ground and second stories is also executed in brick. Tripartate upstairs windows are fitted with replacements. The recessed entrance is flanked by slanted storefronts and fitted with a fully glazed wood panel door. There are divided light transoms above the storefront. The entrance to the upstairs is fitted with a replacement door.</p>		
Integrity	Retains integrity		
Significance	Good example early twentieth century commercial storefront, potential district contributor

Notes	Same parcel as 842 Fourth – was <i>“Glazed and Confused” Gallery in 2019</i>

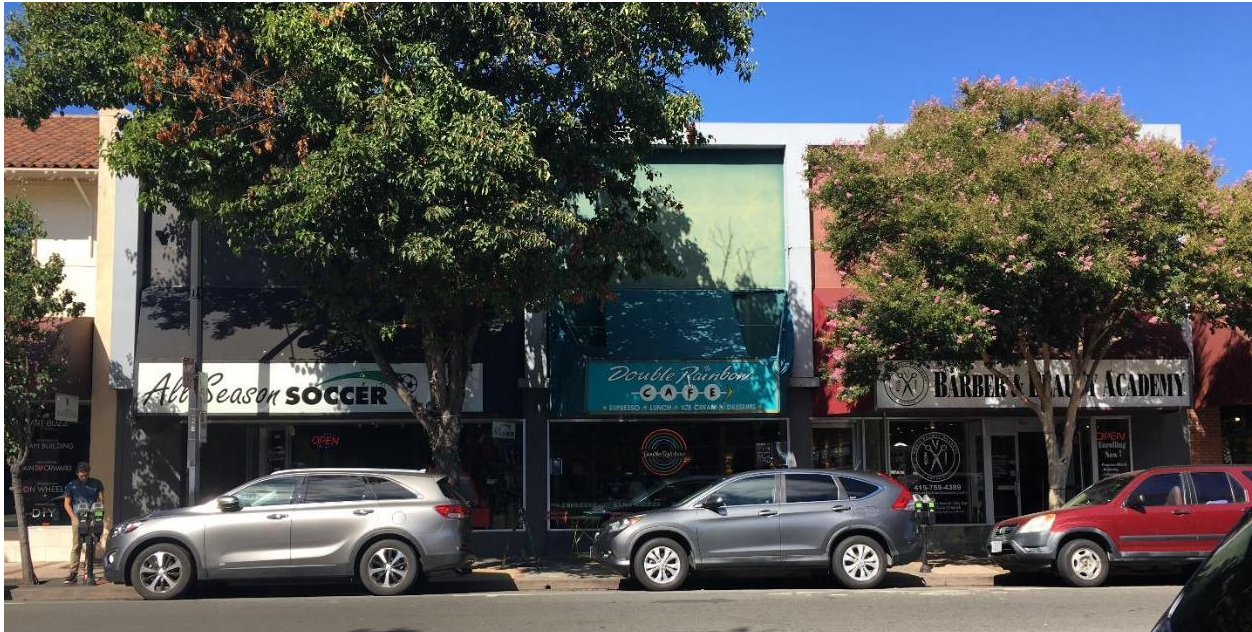
Address/code	866 Fourth Street	5S2	<u>ED</u>
APN	011-224-20		
Building Name			
Year Built	1953 (spreadsheet)		
Original Use	Commercial		
Architectural Style			
Architect/Builder			
Description	The single story commercial building is rectangular in plan with arched roof and flat parapet. Three storefront bays are divided by concrete beams. The building is clad in stucco. Storefront windows and doors are contemporary.		
Integrity	Integrity unknown		
Significance	Not eligible, not a good example of any historic architectural style		
Notes	<u>Rear of building is 835 Fifth Ave and is a contributor, but 4th Street frontage lacks integrity.</u>

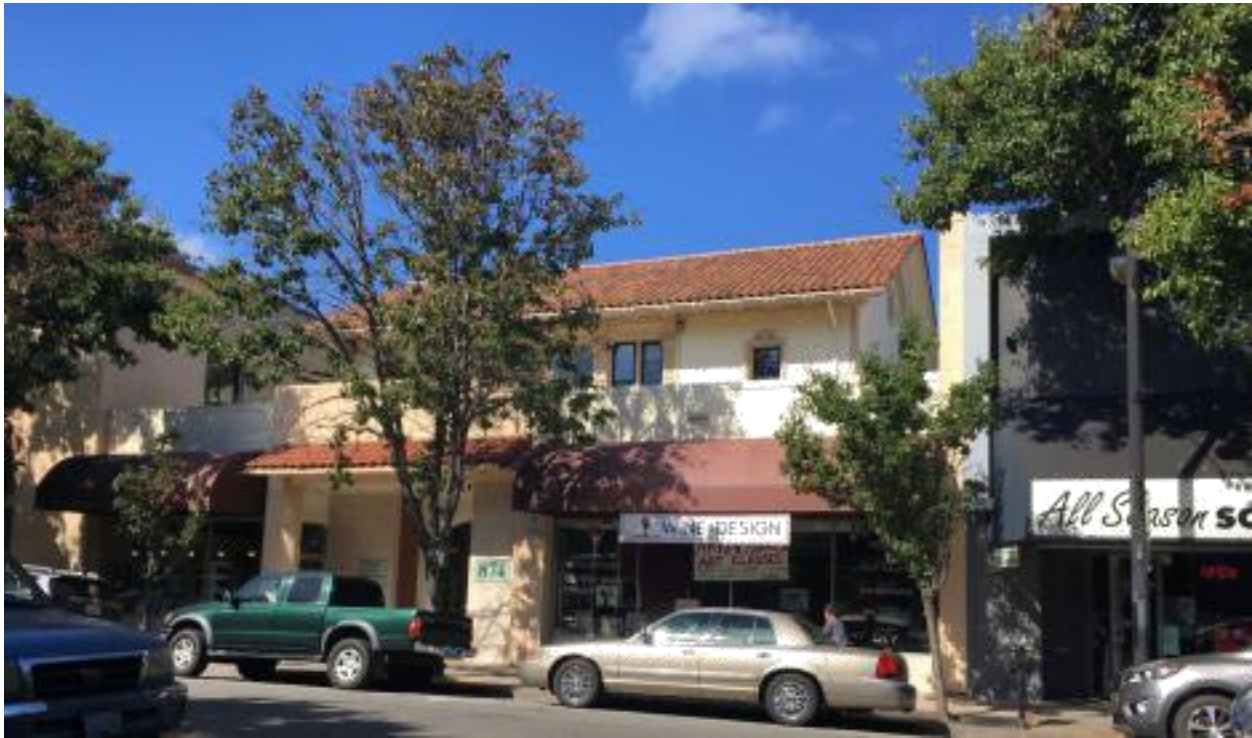
Address/code	874 Fourth Street	EC
APN	011-224-17	
Building Name	Marin Municipal Water Department	
Year Built	1903 (spreadsheet)	
Original Use	Water Department	
Architectural Style	Spanish Revival	
Architect/Builder		
Description	The municipal/commercial building has a two story 1903 municipal building set back on the lot with a single story storefront addition adjacent to the sidewalk. The original building has a side-gabled roof and stucco cladding with highly decorative terra cotta ornament. The storefront is also stucco and has a shed tile roof at the center entrance, but it is contemporary in character.	
Integrity	Lacks Integrity, intrusive main façade addition 1951-1964.	
Significance	Architecturally significant original building ineligible, lack of integrity	
Notes	<u>Although heavily altered, this is a good example of an opportunity for restoration. The building's original attractive façade has been masked by the storefront additions. If restored, it could contribute to the streetscape.</u>

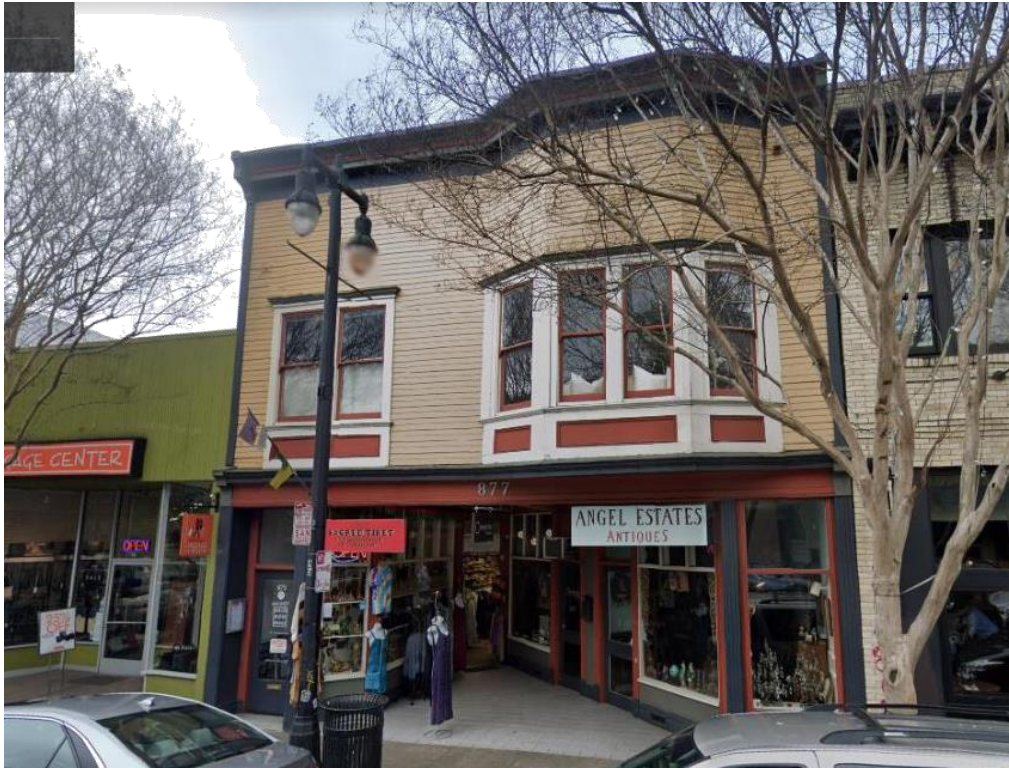
Address/code	875-87781-883 Fourth Street	7N	<u>A</u> <u>B</u>
APN	011-271-043		
Building Name			
Year Built	1905 (DPR)		
Original Use	Storefront Commercial		
Architectural Style			
Architect/Builder			
Description	The commercial building is two story and rectangular in plan with a flat roof and stepped parapet. The building is clad in narrow wood siding with stucco at the ground floor. The cornice features decorative rafter tails and dentil moulding. Projecting upstairs bays have tripartite replacement windows Replacement storefronts are contemporary and not sympathetic.		
Integrity	Retains integrity		
Significance	Eligible as district contributor and landmark		
Notes	<i>881 Fourth right frame, adjacent building 877 Fourth (center frame) appears to be contributor but was eliminated, different building described in initial condition assessment</i>

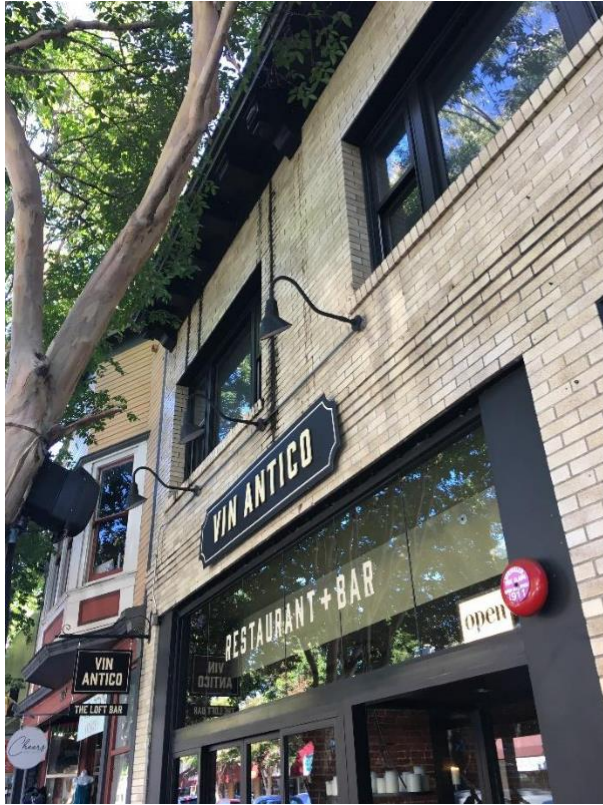
Address/code	881-883885-887 Fourth Street		A
APN	011-271-032		
Building Name			
Year Built	19 0510 /1975 (spreadsheet)		
Original Use	Storefront Commercial		
Architectural Style	<u>Neo-classical</u>		
Architect/Builder			
Description	The commercial building is two story and rectangular in plan with a flat roof. It has a stepped parapet and heavy wood cornice with decorative rafter tails. Tripartite upstairs windows have been fitted with fairly sympathetic replacement windows. The building is clad in brick with mouldings and windows sills also executed in brick. Original obscure transom has been retained above the door to the upstairs. Replacement storefront and doors are sympathetic.		
Integrity	Retains integrity despite replacement window and storefront, appearance similar to 1970s photo		
Significance	Eligible as landmark and contributor		
Notes

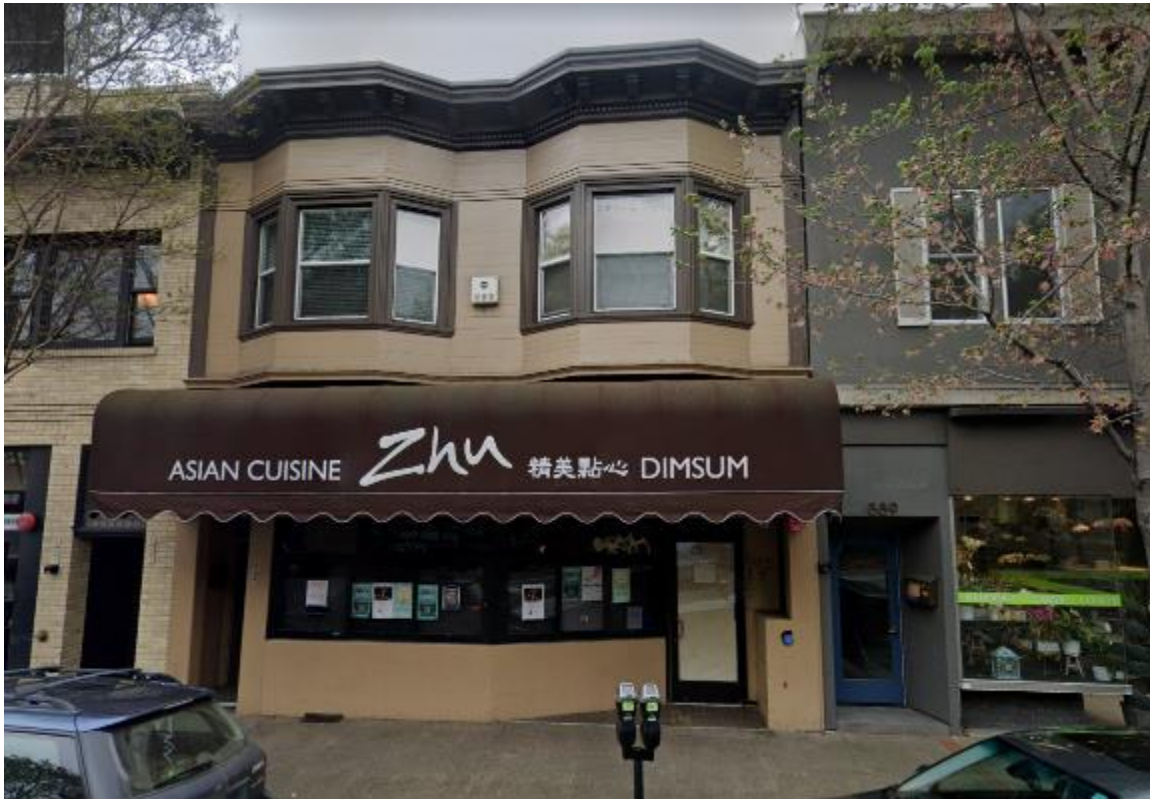
Address/code	885-887 Fourth Street	B
APN	011-271-02	
Building Name		
Year Built	1910/ 1975	
Original Use	Storefront Commercial	
Architectural Style		
Architect/Builder		
Description	<u>The commercial building is two story and rectangular in plan with a flat roof.</u>	
Integrity		
Significance	<u>Contributor, based on 2019 field survey</u>	
Notes	<u>Property was not correctly addressed during field survey and complete Fact Sheet is unavailable. Also identified in 1978 survey.</u>

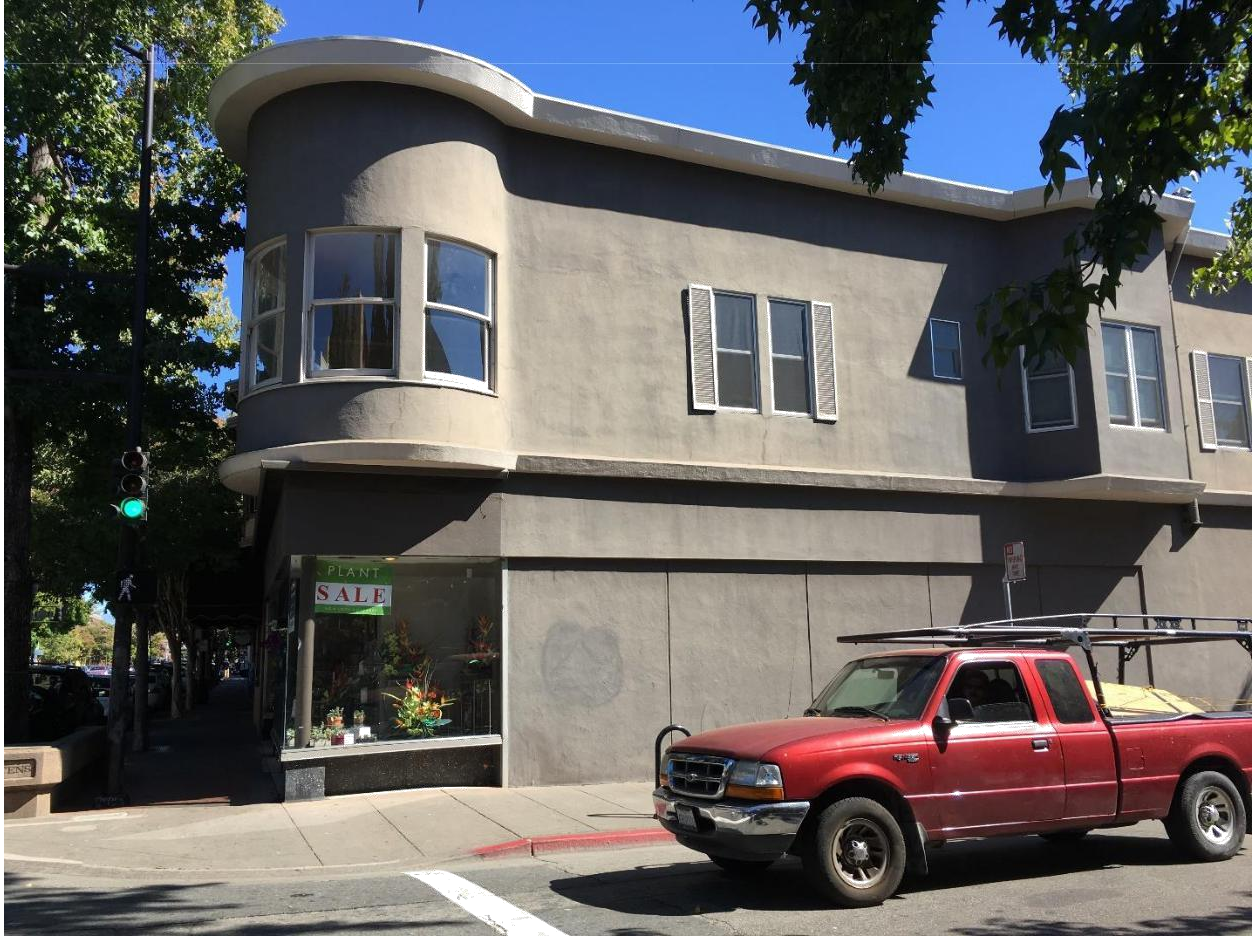
Address/code	889-891 Fourth Street	ED
APN	011-271-01	
Building Name		
Year Built	1908/1956 (spreadsheet)	
Original Use	Storefront Commercial	
Architectural Style		
Architect/Builder		
Description	The commercial building is two story and rectangular in plan with a flat roof and heavy plain cornice. There is a rounded upper bay at the corner and a slanted bay on Lootens. Cladding is stucco. Some upper windows have been replaced and some are double hung wood sash. Terrazzo flooring and storefront configuration suggest it was installed in 1956	
Integrity	Lacks integrity	
Significance	Not a good example of any historic building type, not eligible for listing	
Notes

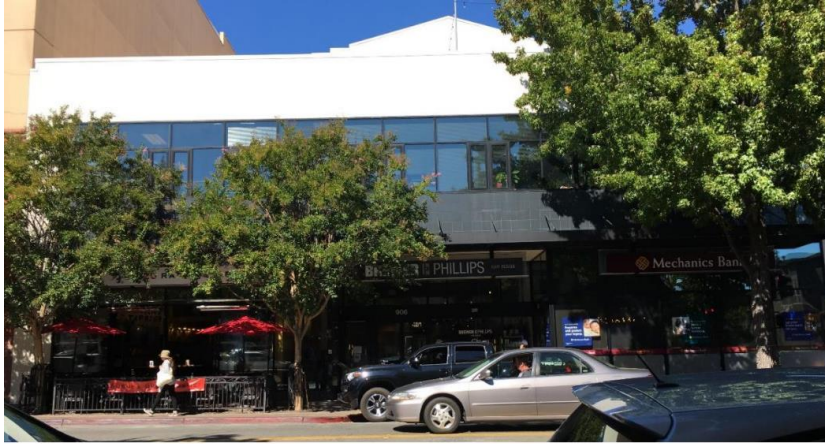
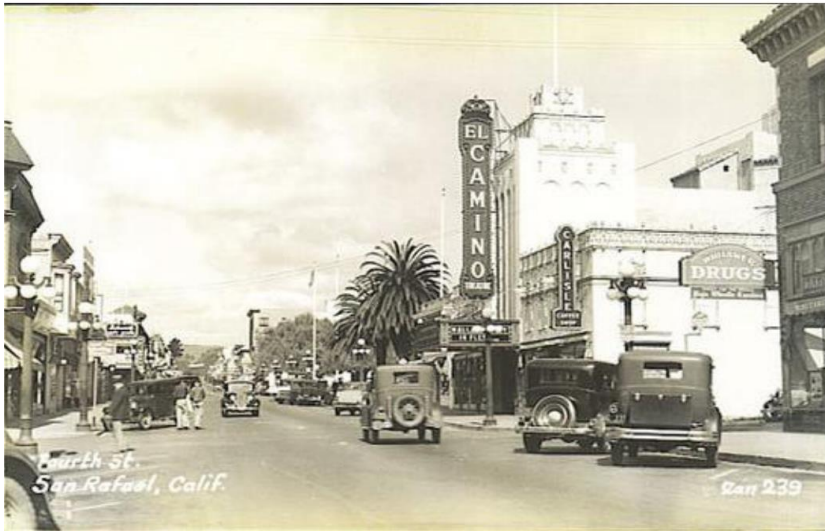
Address/code	900 Fourth Street	ED
APN	011-222-05	
Building Name	El Camino Theatre	
Year Built	1925-30 (Sanborns/aerials)	
Original Use	Cinema	
Architectural Style	Art Deco? <u>High Spanish Colonial</u>	
Architect/Builder		
Description	The large commercial building is two story and rectangular in plan with a flat roof. It is clad in stucco with continuous windows along upper and ground floors on Fourth Street. Some remnants of Art Deco details can be discerned at sides and rear but building is missing ornate tower, marquee, and other character-defining elements	
Integrity	Lacks integrity, does not convey significance	
Significance	Not eligible because of lack of integrity	
Notes

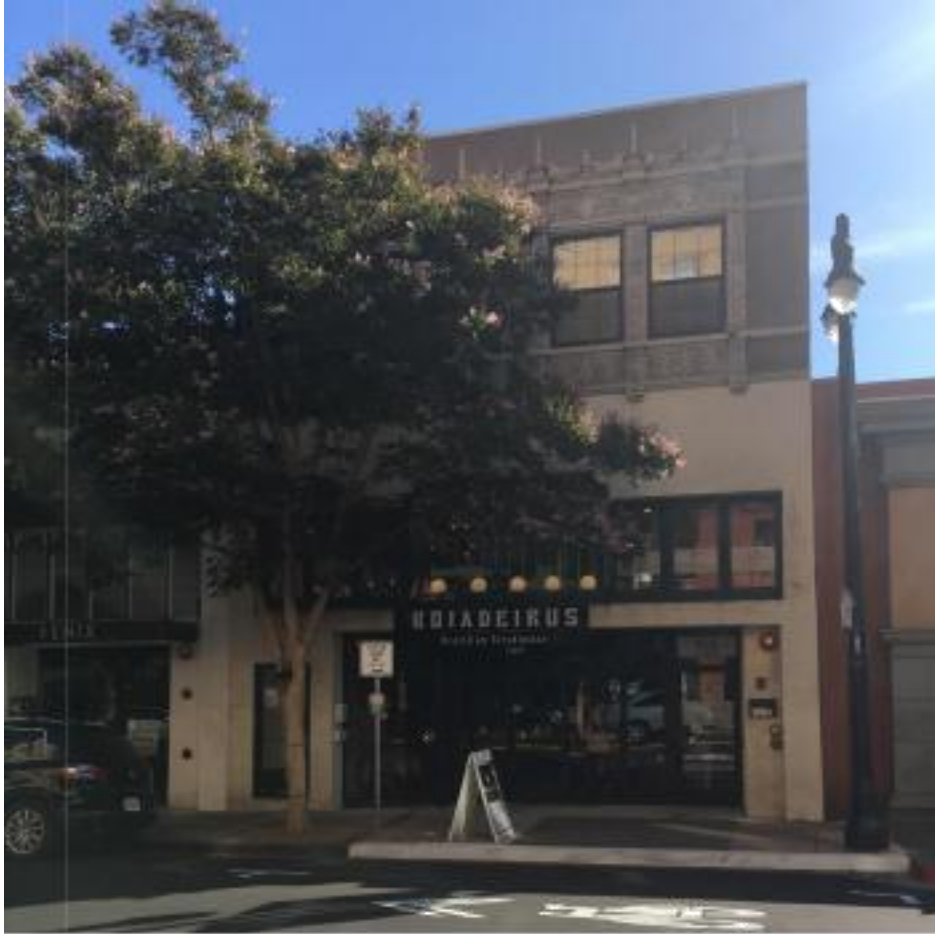
Address/code	925 Fourth Street		B
APN	011-263-07		
Building Name			
Year Built	1928 (spreadsheet)		
Original Use	Storefront Commercial		
Architectural Style			
Architect/Builder			
Description	The commercial building is two story and rectangular in plan with a flat roof. It is clad in stucco and has ornate terracotta decorative surrounds on vertical upstairs windows, which are fitted with vinyl replacement sash. A decorative balconet at the mezzanine level has a shaped opening and is flanked by transom divided by diminutive turned posts. The storefront is contemporary		
Integrity	Retains sufficient integrity to qualify as district contributor but not as landmark		
Significance	Good example of 1920s commercial architecture, eligible as district contributor		
Notes

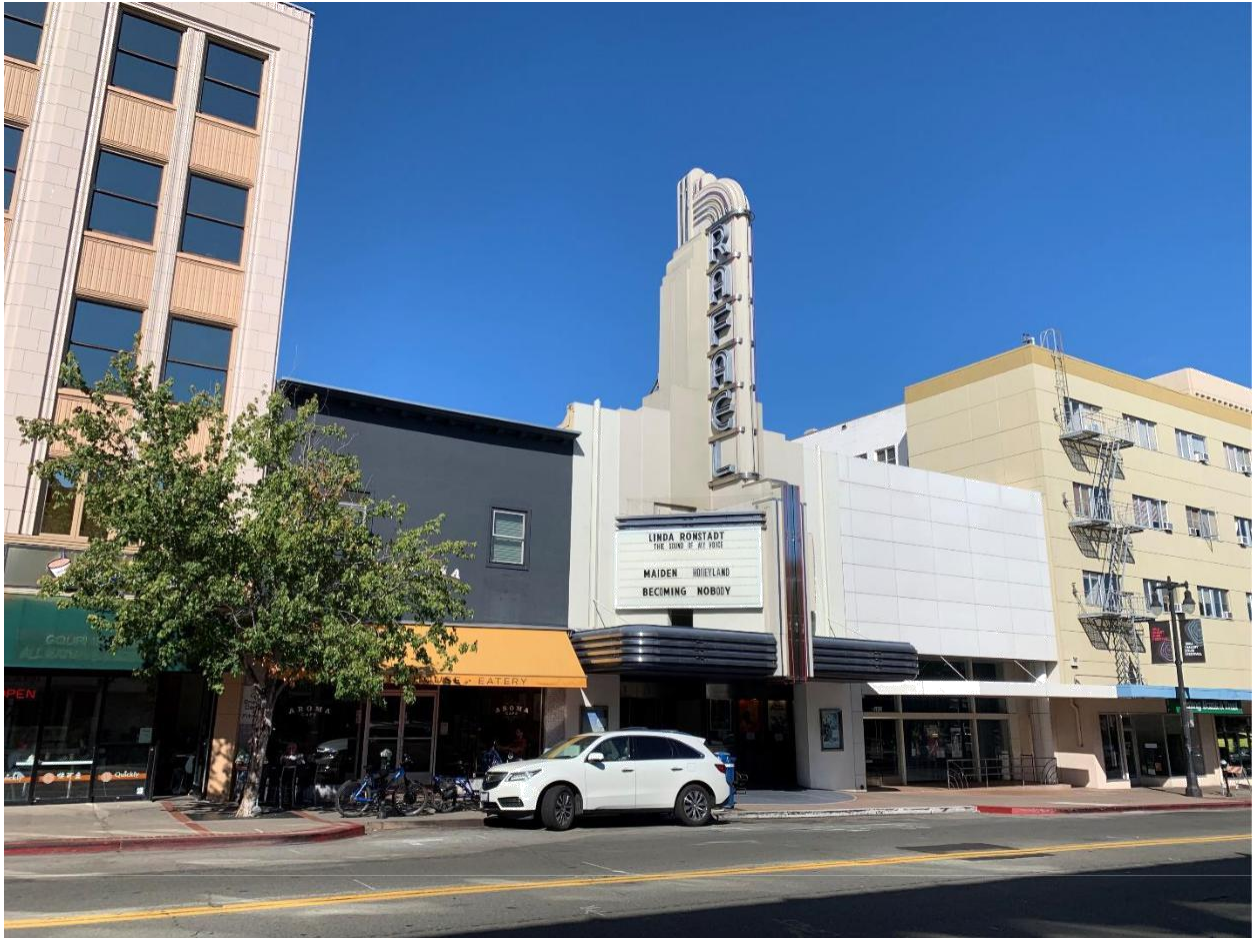
Address/code	1118 Fourth Street	3S	A
APN	011-215-04		
Building Name	Orpheus/Rafael Theatre		
Year Built	1920/1938 (spreadsheet/Cinema Treasures)		
Original Use	Cinema		
Architectural Style	Streamline Moderne		
Architect/Builder			
Description	The small theater building occupies a single parcel. Its façade is dominated by a tall pylon marquee with neon letters spelling “Rafael” and the curved horizontal motif that characterizes Streamline Moderne architecture. The building’s parapet is stepped up to the pylon sign. There is a marquee with streamline neon atop a curved awning with the same motif. The original entrance and ticket booth have been removed and replaced with a recessed contemporary entrance. Original terrazzo sidewalks have been <u>replaced with new terrazzo sidewalks</u> <u>preserved</u> .		
Integrity	Retains integrity despite entrance replacement		
Significance	Good example of 1930s cinema architecture, eligible as landmark and district contributor

Notes	<u>Adj. bldg. to west (now Aroma Café) was an early movie house (the Lyric)</u>

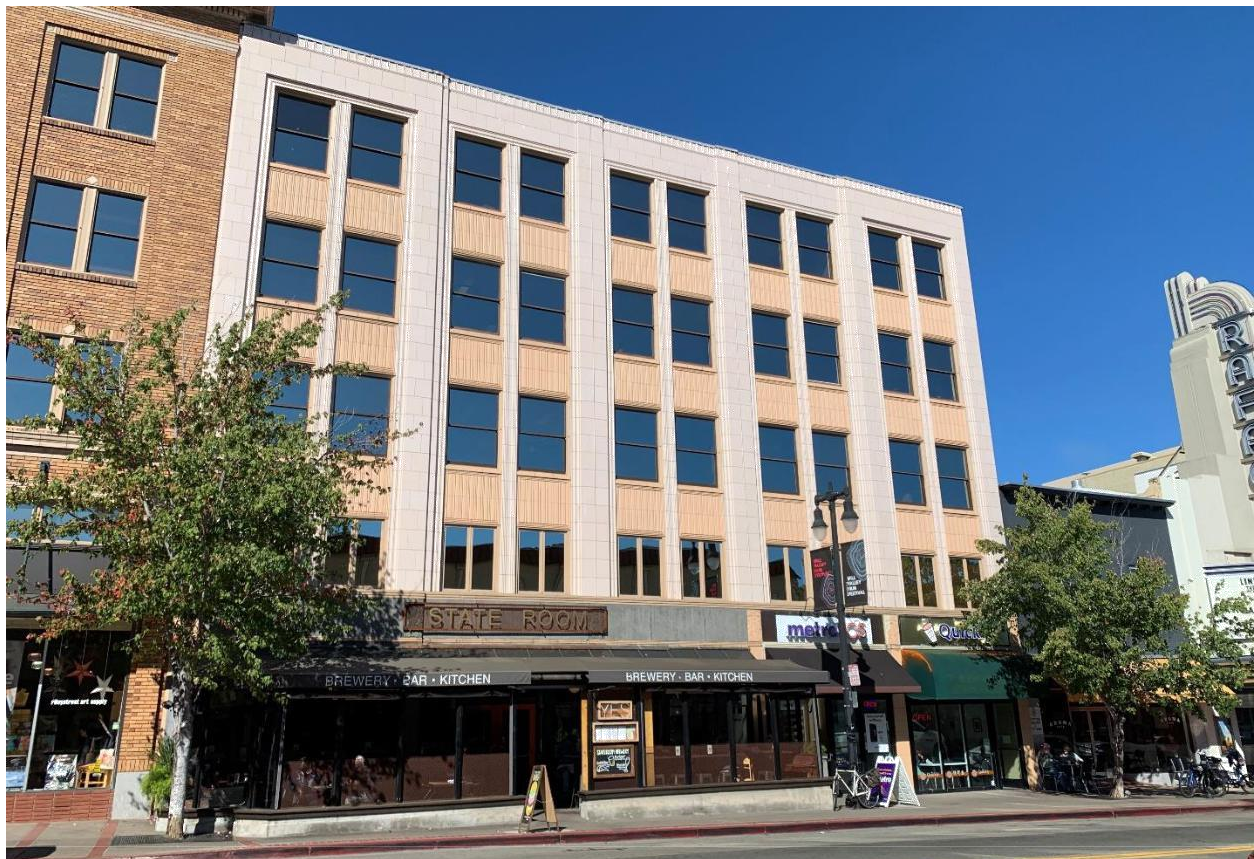
Address/code	1122-1132 Fourth St	EC
APN	011-215-02	
Building Name	Albert Building Annex	
Year Built	1916 (spreadsheet)	
Original Use	Storefront Commercial/apartments Offices above ground floor storefronts	
Architectural Style	Art Deco	
Architect/Builder		
Description	The five story building is rectangular in plan with a flat roof. Upper floor windows are paired and have been fitted with a combination of hung replacement windows and horizontal sliding sash. They are separated by restrained pilasters that reference Art Deco architecture, as does the minimalist decoration at the cornice. Panels between floors have grooved moulding. There are pilasters with stylized Corinthian capitals at the storefront level; other elements of the ground floor are unsympathetic replacements including a projecting storefront	
Integrity	Lacks integrity, windows, projecting storefront Building elements are sufficiently intact to convey the historical style and feel of the building.

Significance	Not eligible for listing Initially rated as "E" but modified to "C" through public comment. Warrants further evaluation.	
Notes	Closely related to Albert building next door at 1010 B Street (1138-1146 Fourth) NOT INCLUDED IN GROUP OF 160 BUT WAS LOOKED AT BECAUSE IT WAS PART OF PHOTO-SET Access to upper floors is through Albert Bldg on B Street

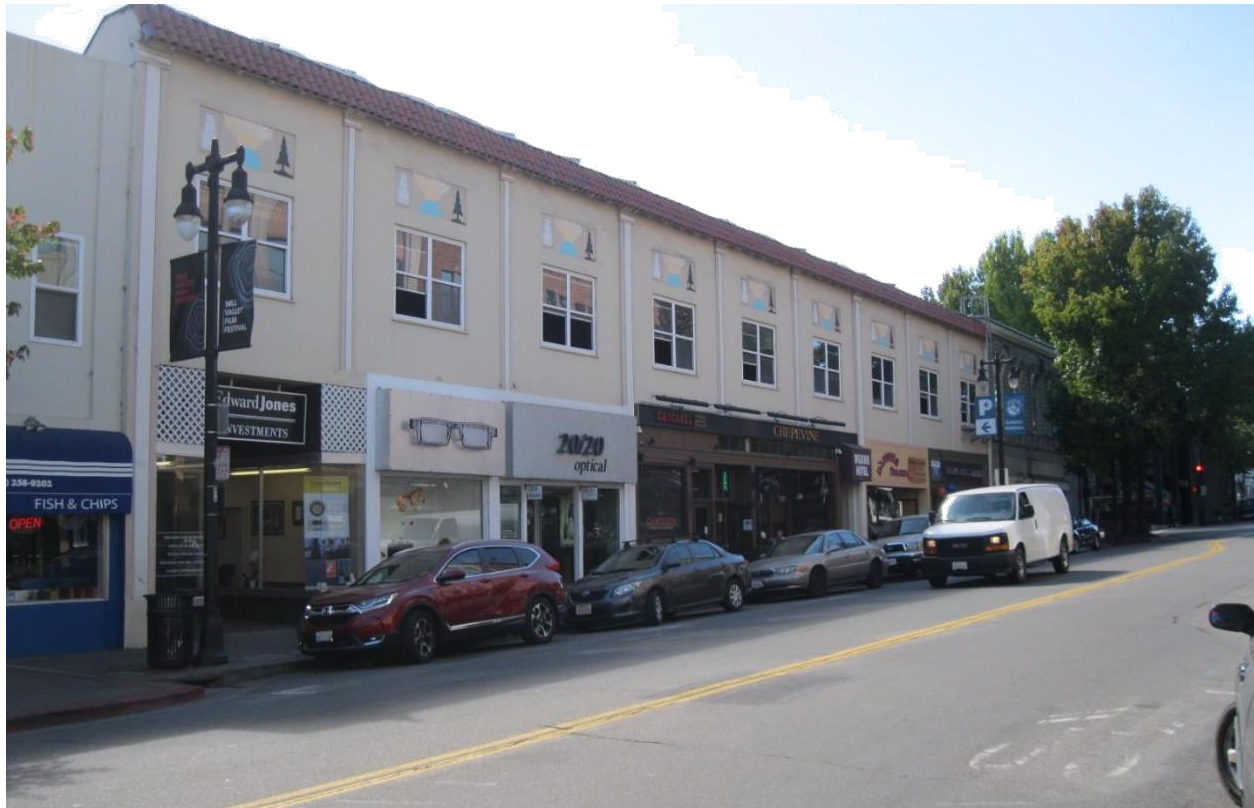
Address/code	1125-1139 Fourth St	C
APN	011-261-31	
Building Name		
Year Built	1892/1893/1920 (spreadsheet)	
Original Use	Storefront Commercial/ <u>offices (later converted to apartments)</u>	
Architectural Style		
Architect/Builder		
Description	The two story building is rectangular in plan with a flat roof and parapet with decorative tiled shed roof. It is clad in stucco with nine bays divided by stylized pilasters. Upper floor windows are paired and have been fitted with vinyl replacement windows. There is a decorative frieze with building/sunrise/tree motif (<u>representing City (San Francisco)/ Golden Gate/ Country (Marin)</u>) above each window. Historic storefronts at the center of the building have wooden doors and divided transoms. Storefronts at either end are contemporary	
Integrity	Probably retains integrity despite <u>extensive alteration, e.g.,</u> window/storefront replacement, more research needed

Significance	Appears eligible as landmark and district contributor, unusually detailed frieze	
Notes
