Downtown San Rafael Precise Plan Historic Resources Inventory Summary Report

December 2020

[Revised May 2021](#)

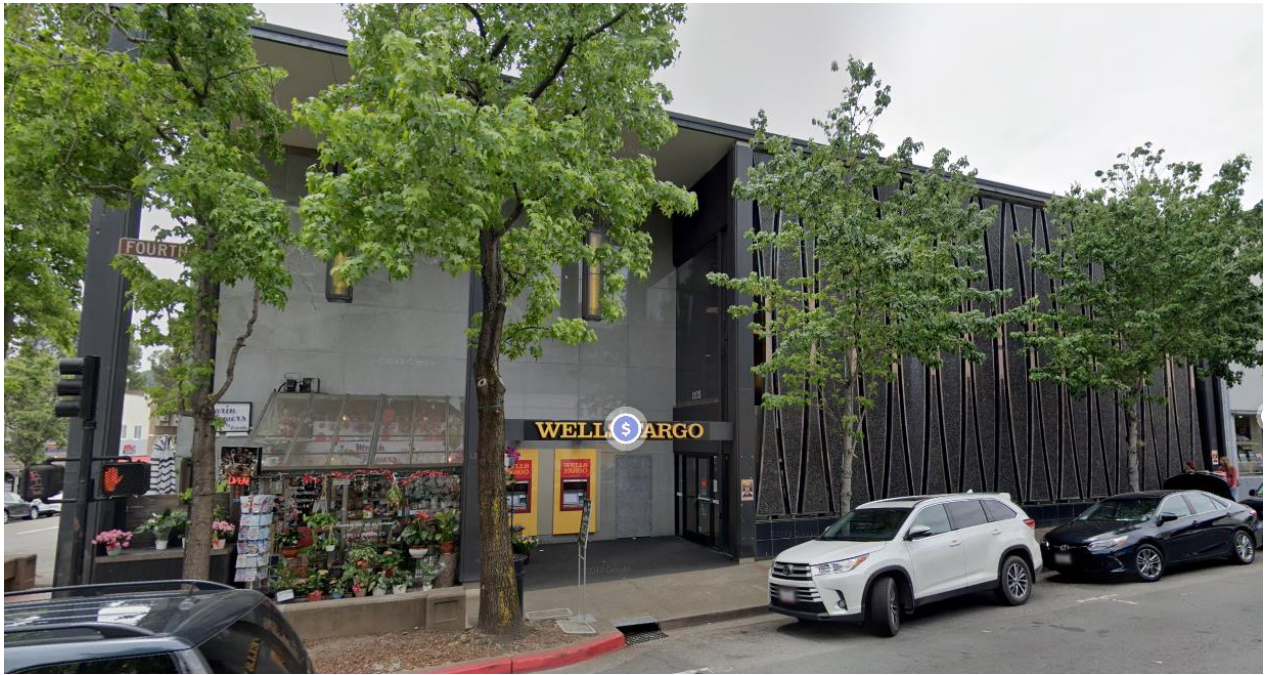
Address	1203 Fourth Street	CA
APN	011-255-23	
Building Name	Wells Fargo <u>(originally Crocker Bank)</u>	
Year Built		
Original Use	Commercial <u>(bank)</u>	
Architectural Style	Midcentury Modern	
Architect/Builder		
Description	The rectangular-plan building is located on a corner lot. It has a flat roof. It is clad in two kinds of tile and features large windows screened by pebbledash walls with decorative cutouts. The main entrance is located to the side of an integral full-height awning at the corner that also shelters ATMs and a shop under its own lower awning.	
Integrity	Appears to retain integrity, more study needed	
Significance	Appears eligible as landmark and contributor

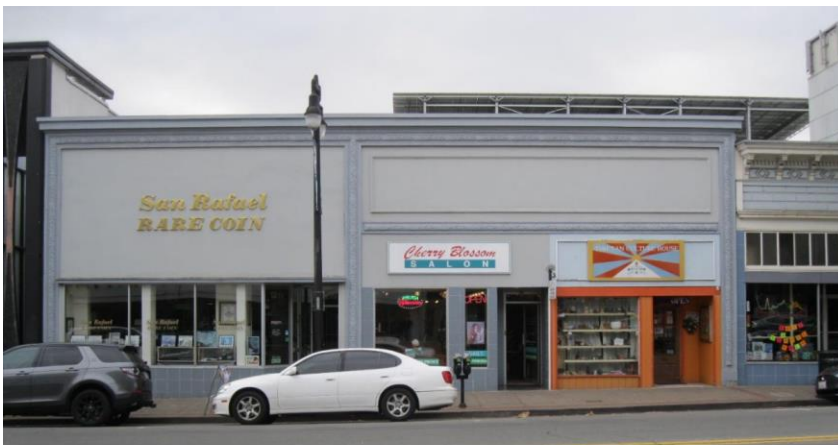
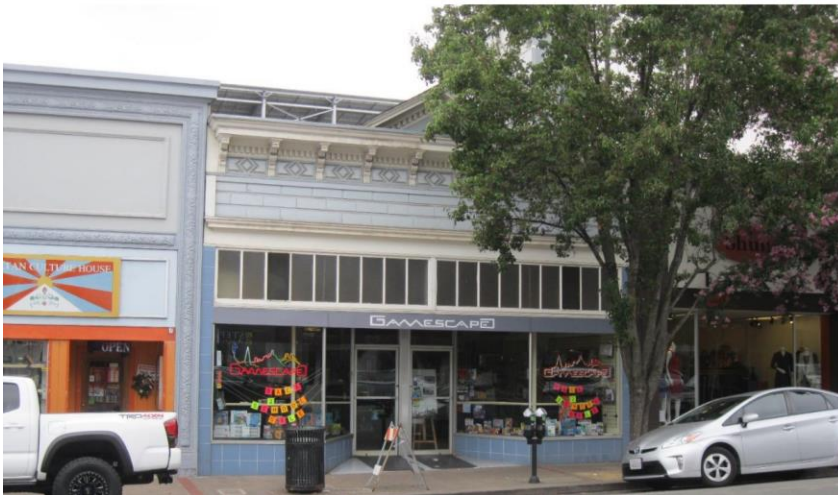
Address/code	1219-1223 Fourth St		<u>EC</u>
	1225 Fourth St	552	A
APN	011-255-28		
Building Name	Grosjean & Co.		
Year Built	Prior to 1887 (Sanborns) <i>(reported by SRH as 1872)</i>		
Original Use	Storefront Commercial <i>(incl. grocery lunch counter and furniture store)</i>		
Architectural Style			
Architect/Builder			
Description	The parcel has three single-story rectangular plan storefront commercial buildings. The two <u>storefronts buildings</u> at the east are clad in stucco and have terracotta ornament with large ceramic tile at the bulkhead. 1225 Fourth Street at the west end of the parcel has a wooden cornice elaborated with ornate brackets, paneled frieze, dentil moulding and decorative pediment above Wood siding on the upper façade is rusticated and there are divided light transoms above the storefront. Storefront is contemporary; <u>cornice lowered after fire.</u>		
Integrity	East end does not retain integrity (upper photo) <u>but merits further evaluation.</u> West end retains integrity (lower photo).

Significance	eligible as landmark and district contributor, unusual example of nineteenth century wood commercial facade		
Notes	<u>An earlier structure is located to the back. Also, 1225 was 2 stories prior to fire.</u>

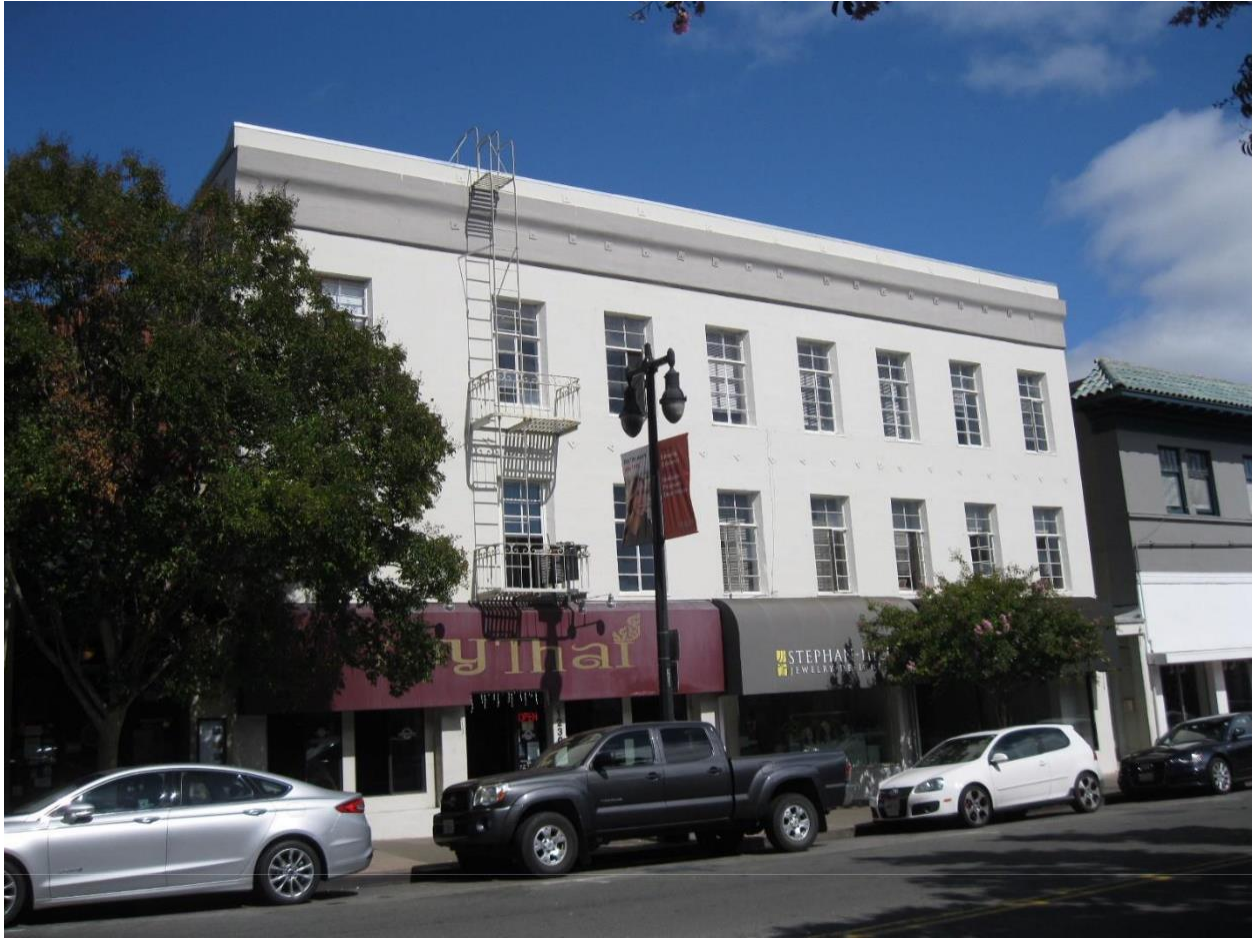
Address/code	1222-1230 Fourth St	5S2	E B
APN	011-212-06		
Building Name	Central Hotel <u>(first known as Hotel Marin)</u>		
Year Built	<u>1860</u> 1864 (spreadsheet)		
Original Use	Hotel		
Architectural Style			
Architect/Builder			
Description	The three story rectangular plan storefront commercial building has a flat roof with simple cornice. It is clad in smooth plaster stucco with steel casement windows. Storefronts are contemporary. <u>San Rafael Heritage notes this may be the oldest standing building in San Rafael and has high potential for restoration.</u>		
Integrity	Lacks integrity, building does not resemble historic Central Hotel		
Significance	Not eligible as landmark or district contributor, nothing is left of the Central Hotel building and its c1930 current appearance is undistinguished.		
Notes	<u>Building initially rated "E" but modified to "B" following public review.</u> <u>Assessment of alterations is warranted.</u>

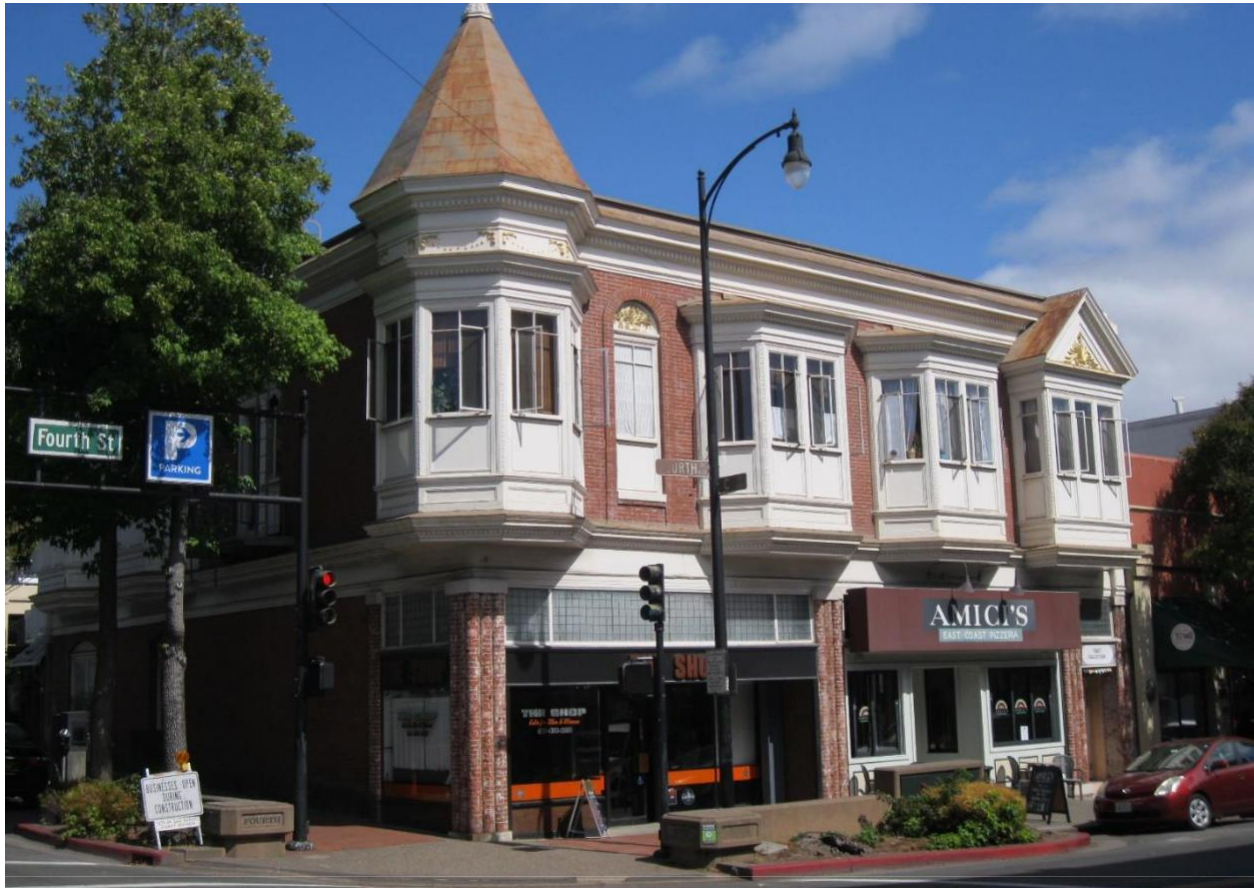
Address/code	12402-1244 Fourth Street / 1000 C St.		A
APN	011-212-14		
Building Name	Peter Building		
Year Built	1893 (spreadsheet)		
Original Use	Commercial / <u>offices</u>		
Architectural Style			
Architect/Builder			
Description	The two story rectangular plan storefront commercial building has a flat roof with decorative cornice and peaked roof on projecting corner bay. The building is brick with projecting bays on both C and Fourth Street facades executed in wood. Window openings are vertical and fitted with unsympathetic replacements. Window bays have their own cornices with dentil moulding and paneled frieze, and one is topped with an ornamental pediment. A single arched window near the west end of the south façade has a decorative blind transom. Storefronts are separated by round brick pilasters which appear originally to have been plastered and are topped with obscured glass transoms. Storefronts are contemporary.

Integrity	Retains integrity despite window replacement		
Significance	eligible as landmark and district contributor, excellent example of nineteenth

century commerical building
Notes	<u>The ornamental pediment to the east is over the original entrance to the 2nd floor.</u>

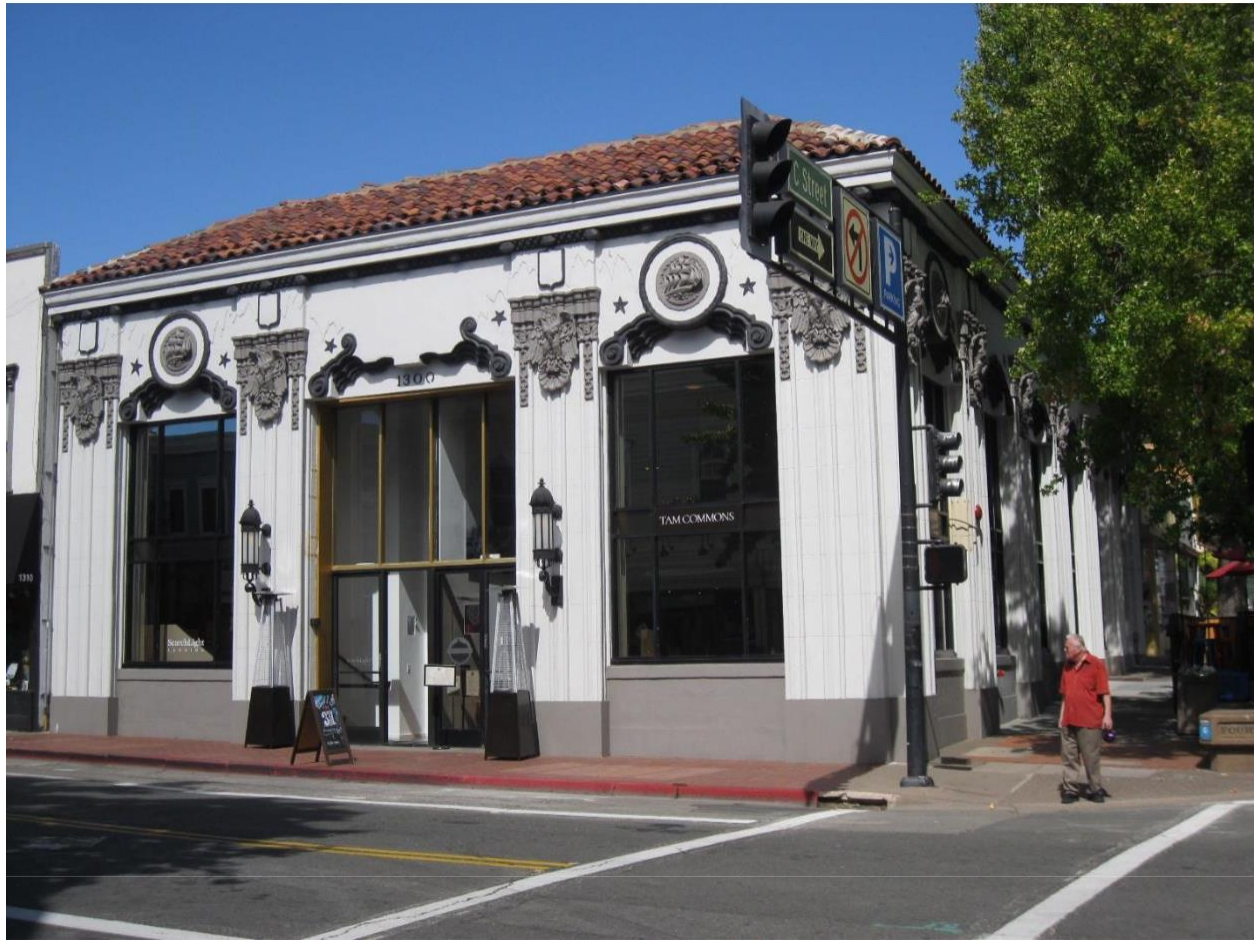
Address/code	1300 Fourth Street	3S	A
APN	011-205-08		
Building Name	Bank of Italy		
Year Built	1928 (spreadsheet)		
Original Use	Bank		
Architectural Style	<u>Art Deco/Spanish Revival/ Neoclassical</u>		
Architect/Builder			
Description	The tall single story building is rectangular in plan with a hipped tile roof. Its large window bays are separated by heavy stylized fluted pilasters topped with ornate capitals featuring an eagle motif. Shaped window openings have elaborately scrolled moulding. The main (Fourth Street) façade has medallions with the Bank of Italy's sailing ship emblem. The carved Bank of Italy name over the main entrance has been removed. Original sconces flank the main entrance. Windows and doors are contemporary.		
Integrity	Retains integrity despite window replacement		
Significance	Unique example of a bank building, eligible as landmark and contributor		
Notes

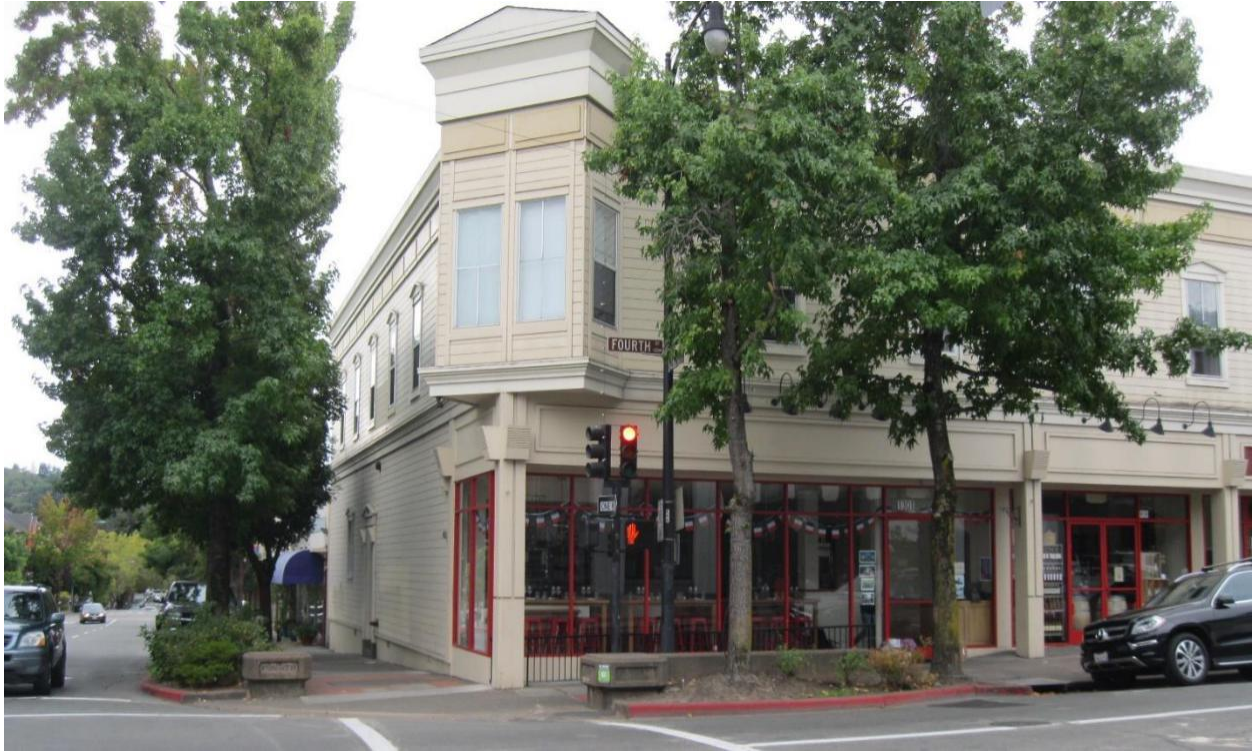
Address/code	1301 Fourth Street	5S2	<u>ED</u>
APN	011-253-10		
Building Name	Hayes		
Year Built	1987 (spreadsheet)		
Original Use			
Architectural Style			
Architect/Builder			
Description	Per spreadsheet 1987 replacement of nineteenth century building. Architecture displays nods to historic period building design but is not a replica of a historic building		
Integrity	Not historic		
Significance	Not historic		
Notes

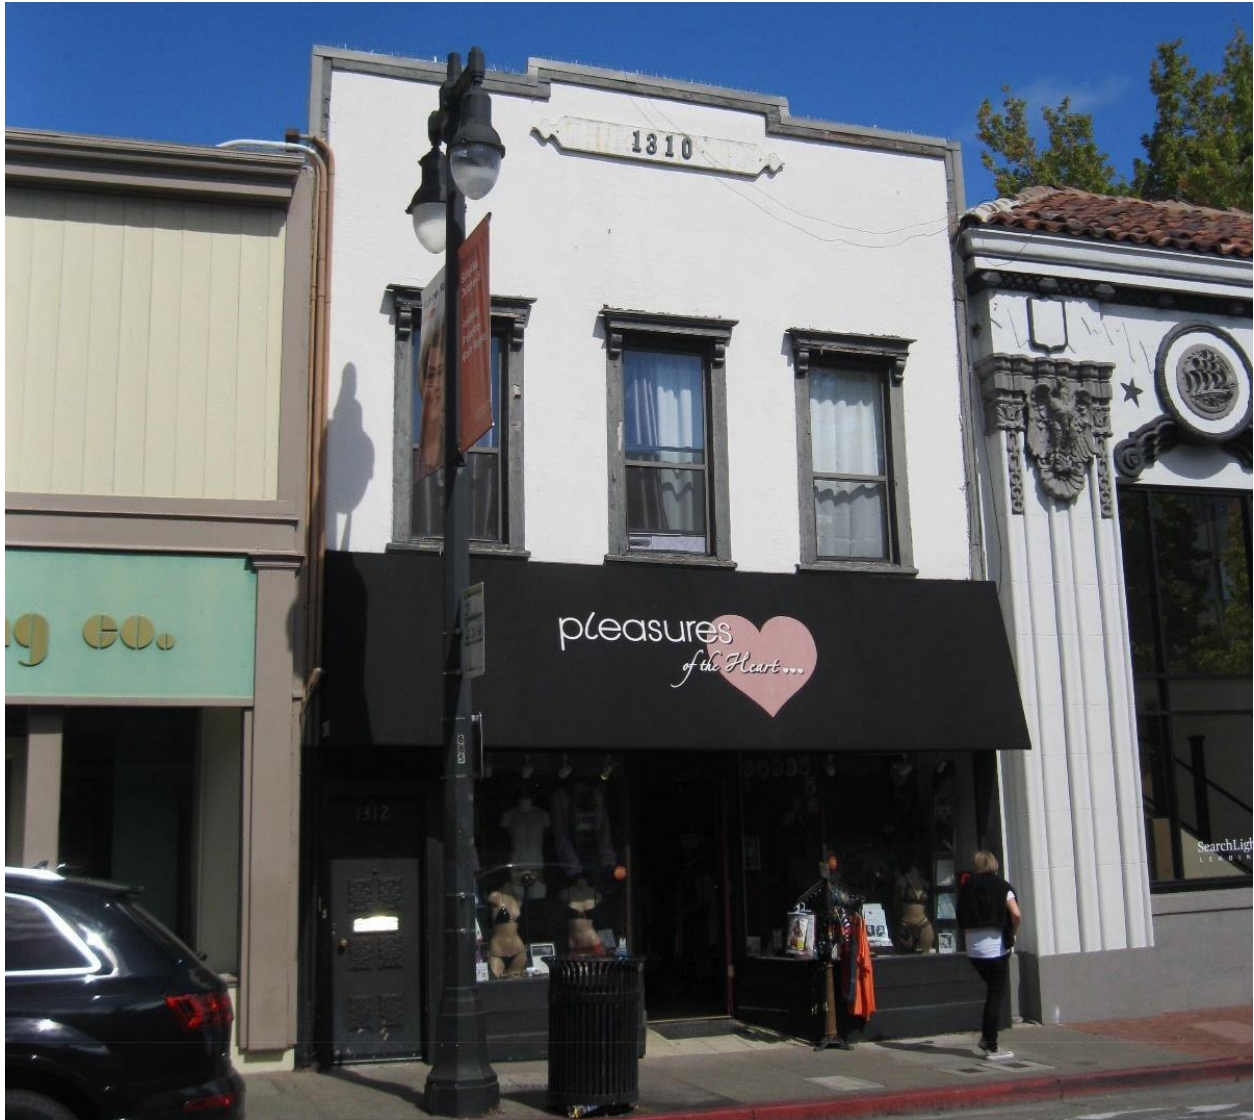
Address/code	1310 Fourth Street	7N	<u>E</u><u>D</u>
APN	011-205-09		
Building Name			
Year Built	before 1894 (Sanborns)		
Original Use	Commercial		
Architectural Style			
Architect/Builder			
Description	The single story building is rectangular in plan with a gabled roof hidden by a stepped parapet. Tall upper floor windows are fitted with replacement windows and have decorative crowns. The building is clad in stucco. The storefront and entrance are contemporary.		
Integrity	Lacks integrity, window replacement, stucco, storefront		
Significance	Not eligible, modest example lacking integrity		
Notes	<u>Request to improve rating from D to B was considered but both historians concluded building is ineligible in its current state.</u>

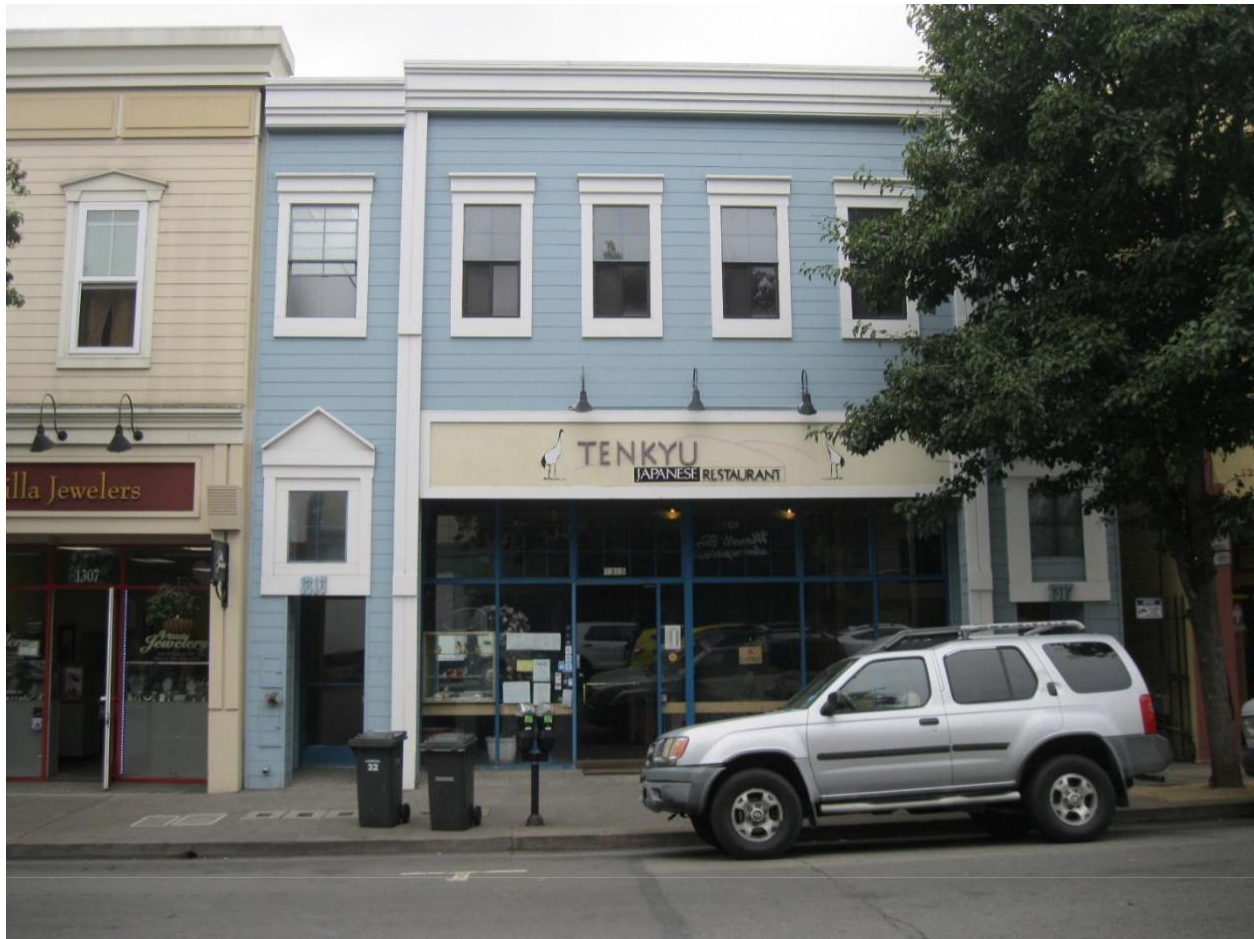
Address/code	1313-1317 Fourth Street	7N	<u>E</u> <u>D</u>
APN	011-253-04		
Building Name	Hayes		
Year Built	1987 (spreadsheet)		
Original Use			
Architectural Style			
Architect/Builder			
Description	Adjacent to 1301 Fourth St. Per spreadsheet 1987 replacement of nineteenth century building. Architecture displays nods to historic period building design but is not a replica of a historic building		
Integrity	Not historic		
Significance	Not historic		
Notes

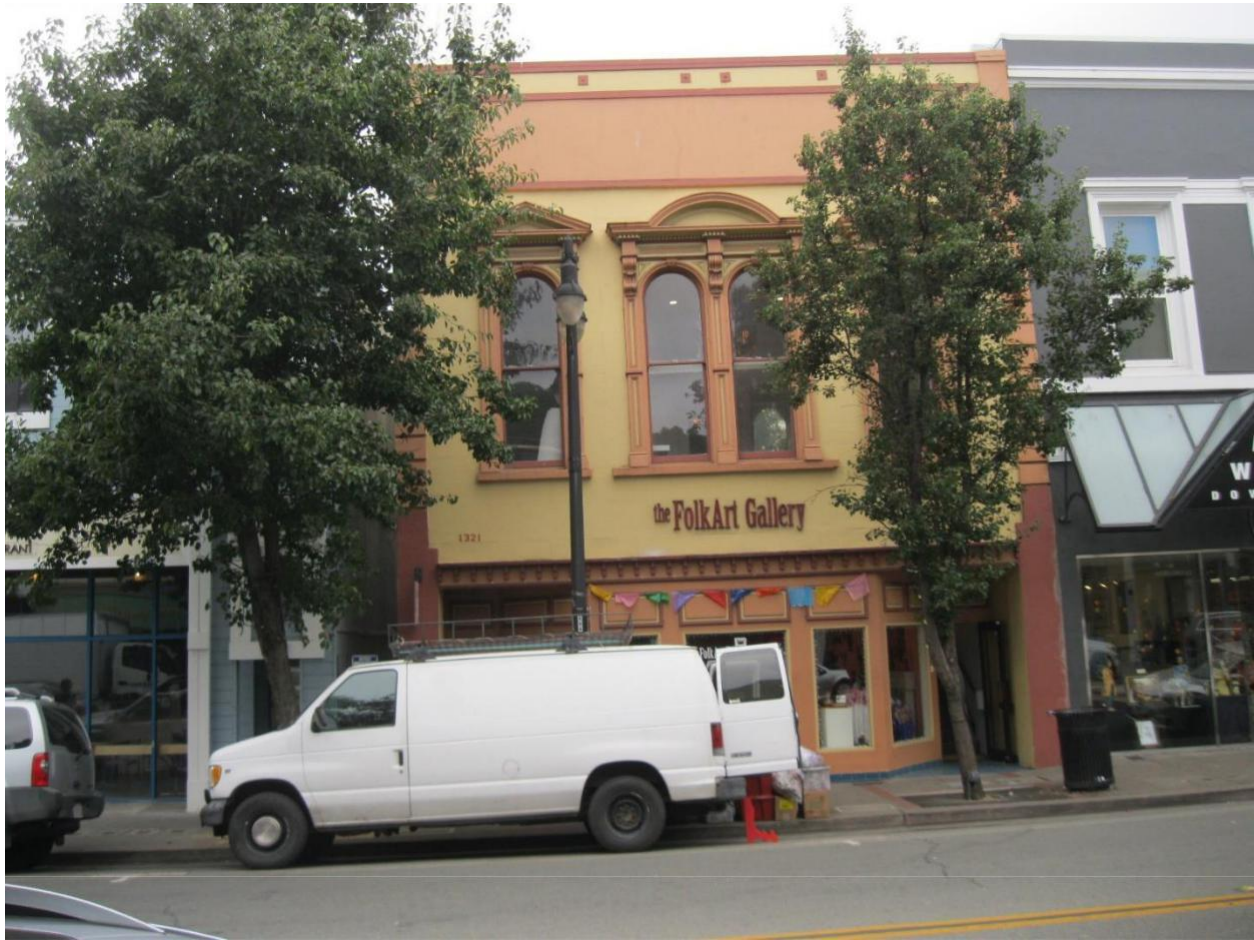
Address/code	1321-23 Fourth Street	7N	B
APN	011-253-03		
Building Name			
Year Built	c1871 (DPR)		
Original Use	Commercial		
Architectural Style	Italianate		
Architect/Builder			
Description	The two story building is rectangular in plan with a flat roof. Tall upper floor windows are fitted with double hung wood sash and feature highly decorative surrounds and crowns. The building is clad in rusticated smooth plaster stucco with decorative quoins at the corners. The contemporary storefront has a paneled frieze and is sympathetically designed.		
Integrity	Retains sufficient integrity for district despite loss of original cornice		
Significance	Eligible as district contributor, lacks integrity required for landmark status		
Notes

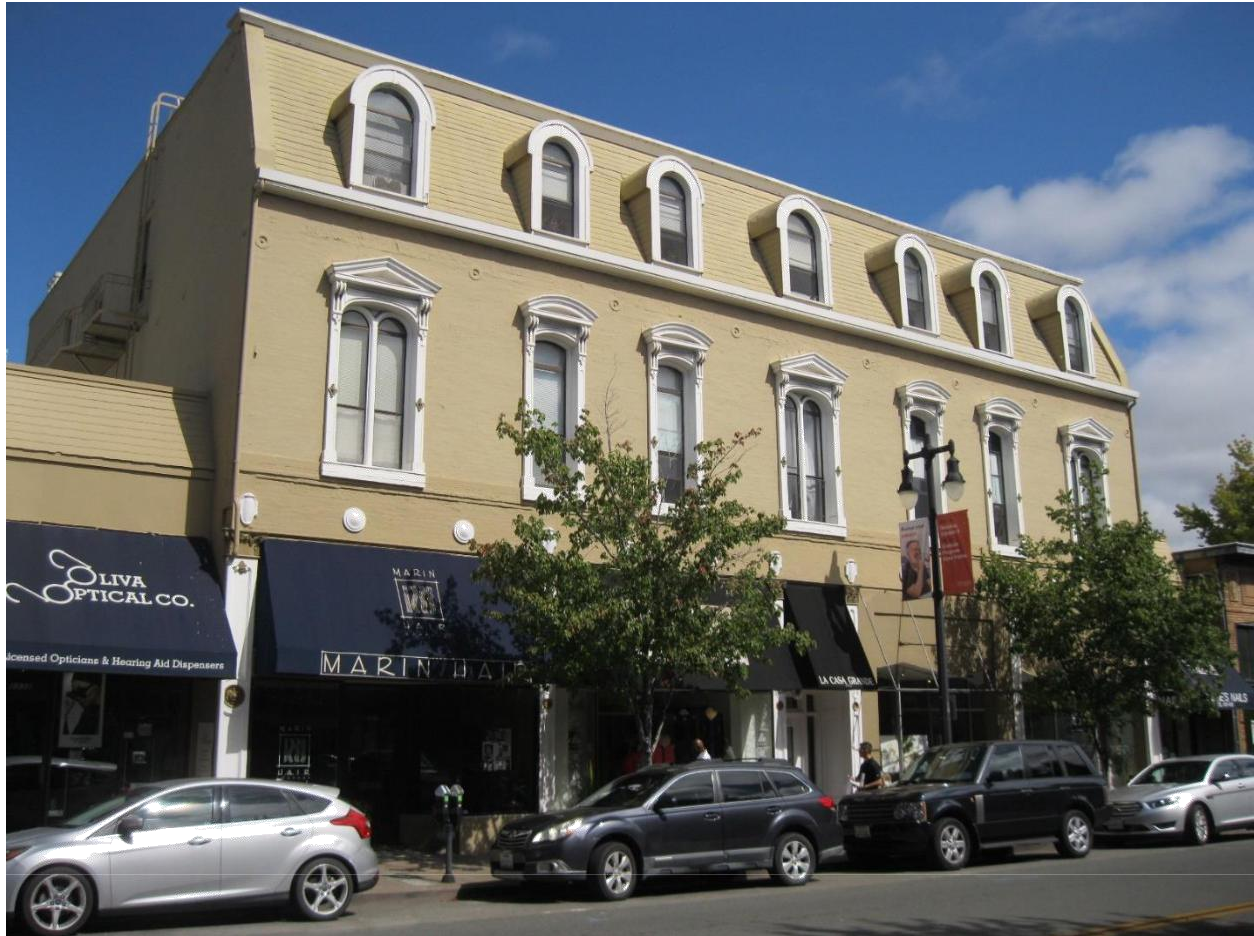
Address/code	1330 (1322-1336)28 Fourth St	3S	A
APN	011-205-11		
Building Name	Mahon House, Butchart Building		
Year Built	1869 (spreadsheet)		
Original Use	Storefront/Hotel		
Architectural Style	Second Empire		
Architect/Builder			
Description	The two story building is rectangular in plan with a mansard roof and arched roof dormers. Tall upper floor windows are fitted with vinyl replacement windows and have highly decorative surrounds and crowns. The building is brick. Storefront bays are separated by pilasters with Corinthian capitals. The centered entry to the second floor is fitted with fully glazed wood door, transom, and sidelights. Most storefront fabric is contemporary.		
Integrity	Retains integrity despite window and storefront replacement.		
Significance	Eligible as landmark and district contributor		
Notes

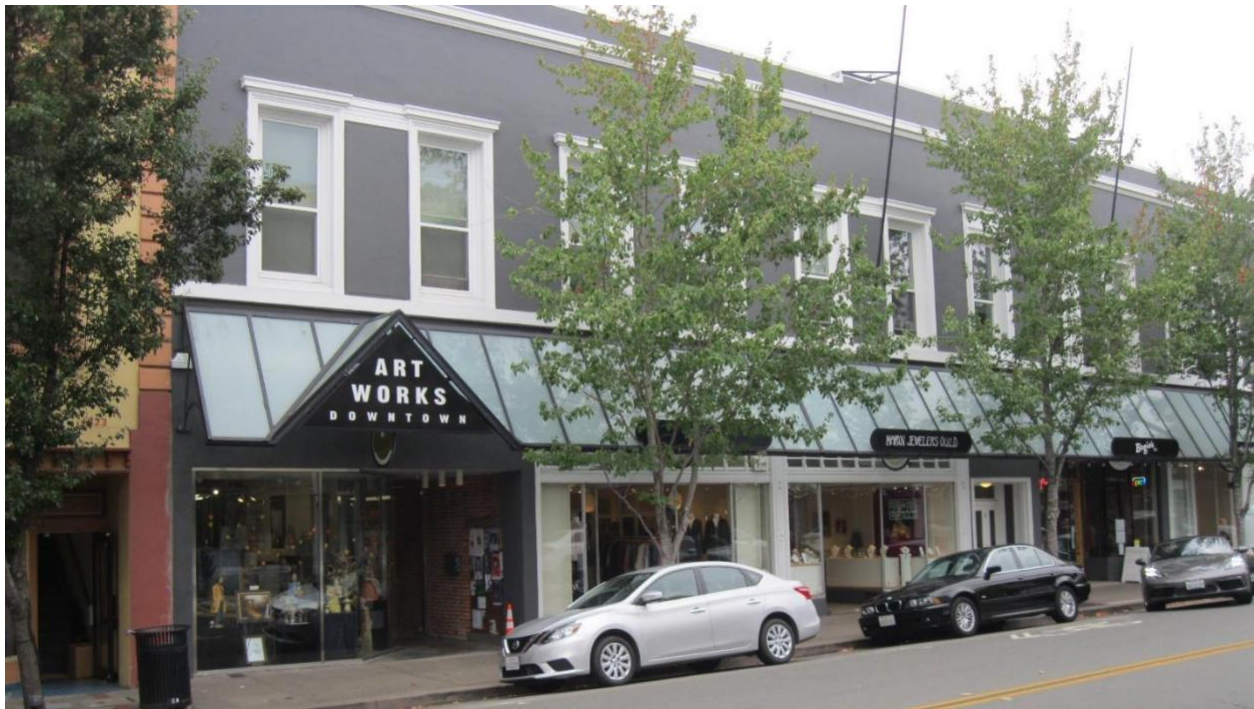
Address/code	<u>1333 (13257-1337)</u>		<u>D B</u>
APN	011-253-02		
Building Name	Gordon's Opera House		
Year Built	1989 (spreadsheet) but architecture reveals a historic period building		
Original Use			
Architectural Style			
Architect/Builder			
Description	The two story building is rectangular in plan with a flat roof and stepped parapet. Tall upper floor windows are fitted with vinyl replacement windows decorative surrounds and crowns. The building is clad in stucco and has minimal decorative features. Most storefront fabric is contemporary although two have original transoms under awning. <u>The original bays were removed many years ago.</u>		
Integrity	Lacks integrity		
Significance	May be historically significant but in its current form it is not a good example of a historic architectural style.		
Notes	<u>Initially given a D rating but modified to "B" after public review.</u>

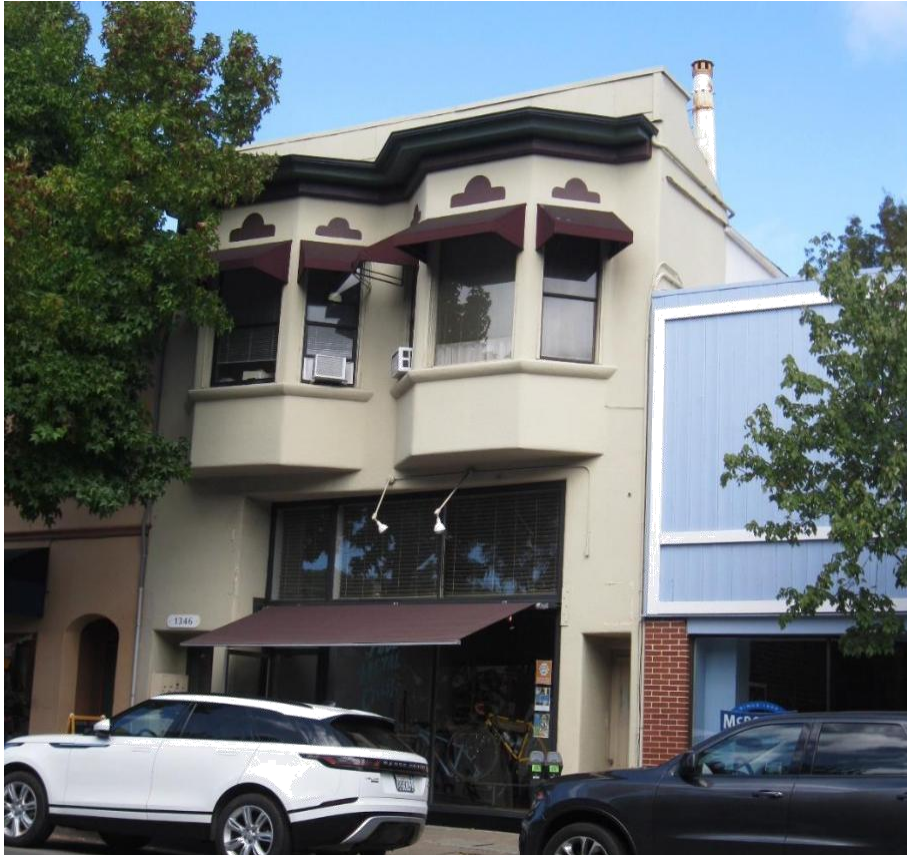
Address/code	1344-46 Fourth Street	ED
APN	011-205-13	
Building Name		
Year Built	1904/1967 (spreadsheet)	
Original Use	Storefront	
Architectural Style	Art Deco	
Architect/Builder		
Description	The single story building is rectangular in plan with a flat roof and parapet. Projecting upstairs window bays are topped by a cornice. The building is clad in stucco. Fluted columns and cornice exhibit typical Art Deco style. Storefront and door are contemporary	
Integrity	lacks integrity	
Significance	Not Eligible, lack of significance/integrity	
Notes

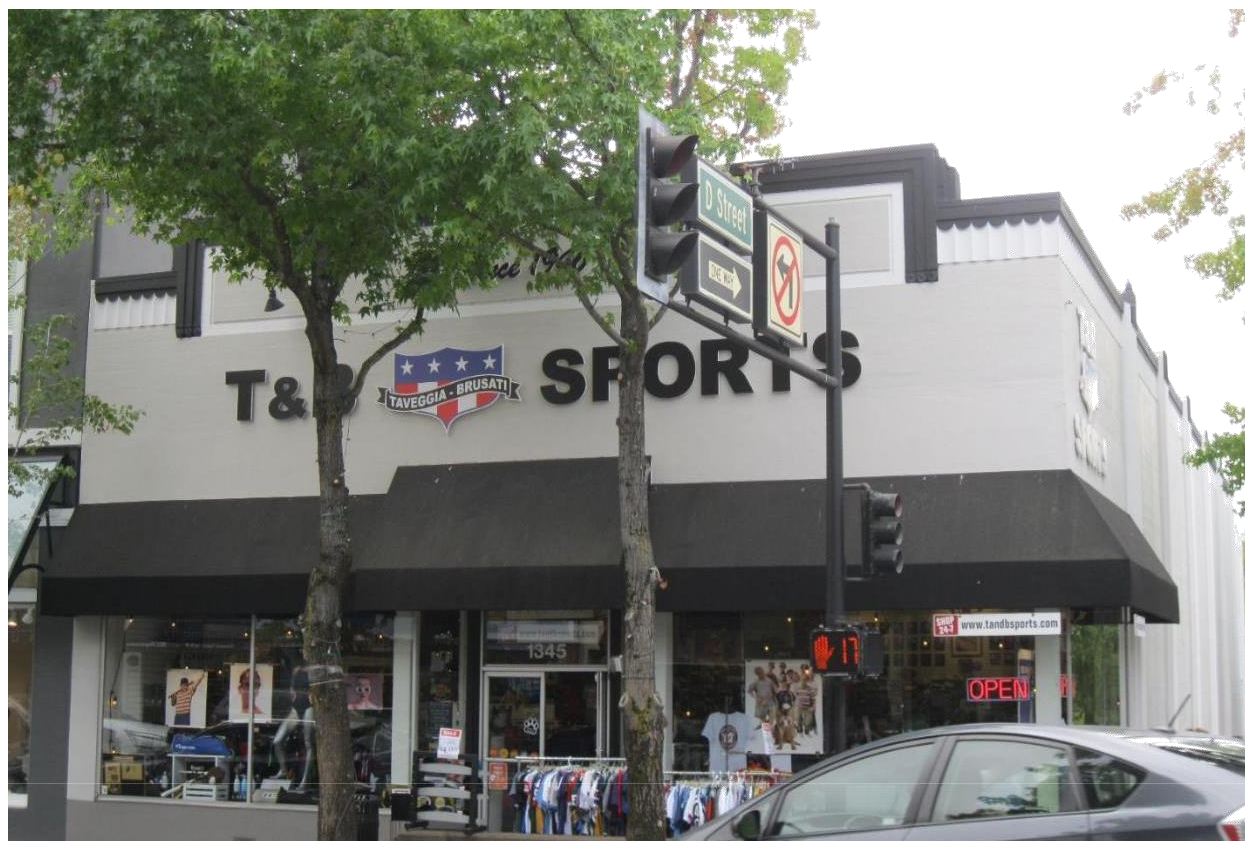
Address/code	1345 Fourth Street		B
APN	011-253-01		
Building Name			
Year Built	1930 (spreadsheet)		
Original Use	Storefront		
Architectural Style	Art Deco		
Architect/Builder			
Description	The single story building is rectangular in plan with a flat roof and stepped parapet. The building is clad in stucco. Fluted columns and cornice exhibit typical Art Deco style. Storefront and door are contemporary		
Integrity	Retains integrity despite storefront replacement.		
Significance	Eligible as district contributor, not sufficiently distinguished for landmark status		
Notes

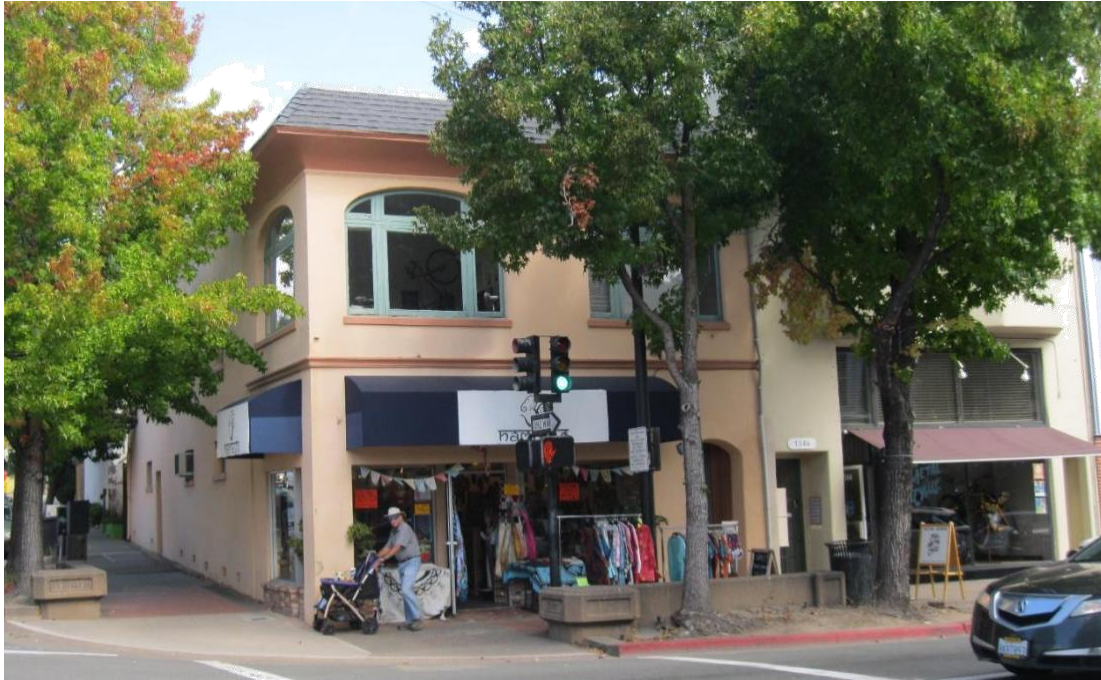
Address/code	1350 Fourth St (1040 D St)		D
APN	011-205-14		
Building Name			
Year Built	1903 (spreadsheet)		
Original Use	Storefront		
Architectural Style	Mission		
Architect/Builder			
Description	The two story building is rectangular in plan with a flat roof with decorative hipped roof at the south end of the building. Upper floor windows have divided lights in arched openings. The building is clad in stucco. Storefront and door are contemporary		
Integrity	Lacks integrity, roof appears to have lost tile and decorative features, bulkhead altered		
Significance	Appears ineligible, lack of significance/integrity		
Notes

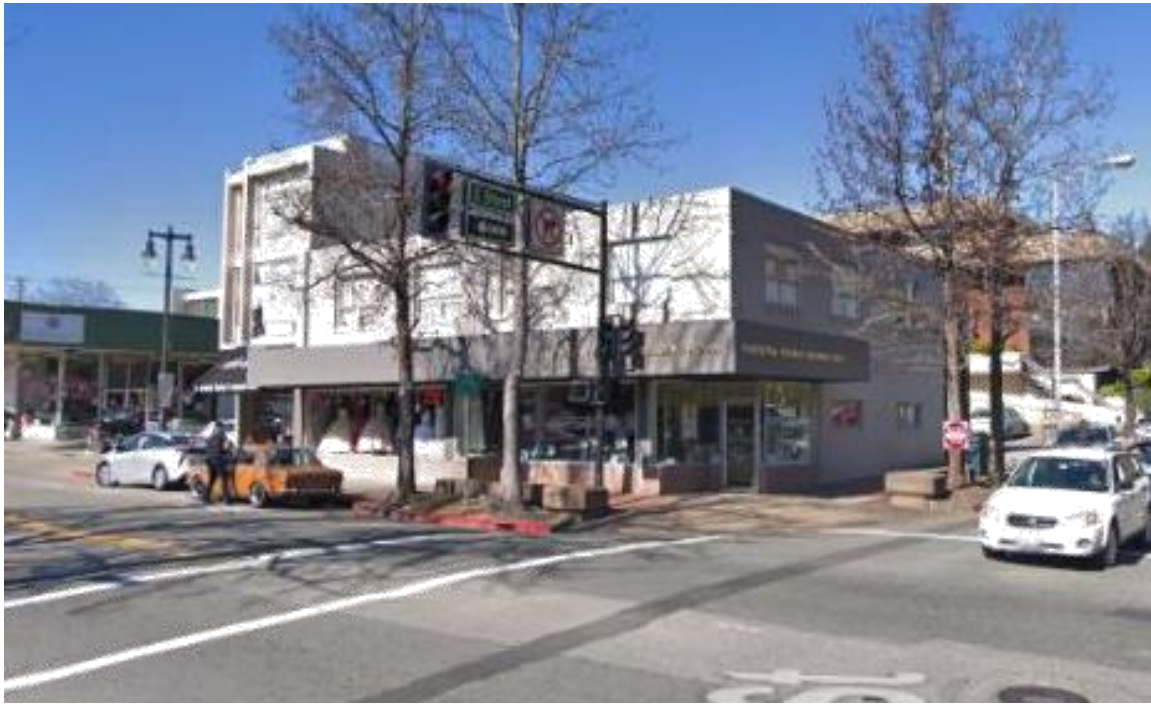
Address/code	1400 Fourth Street	<u>ED</u>
APN	011-204-08	
Building Name		
Year Built	1958 (spreadsheet)	
Original Use	Storefront	
Architectural Style	Midcentury Utilitarian	
Architect/Builder		
Description	The two story building is rectangular in plan with a flat roof. The building is constructed of concrete masonry units and lacks decorative features. Upper floor windows are square steel casement. Aluminum frame doors and storefronts appear original. A heavy soffit/awning has been installed above the storefronts.	
Integrity		
Significance	Undistinguished midcentury building, Not Eligible, lack of significance	
Notes	<i>This was subsequently dropped, and 1408 Fourth was added for consideration. It provides a better example of modernism than 1400 or 1414</i>

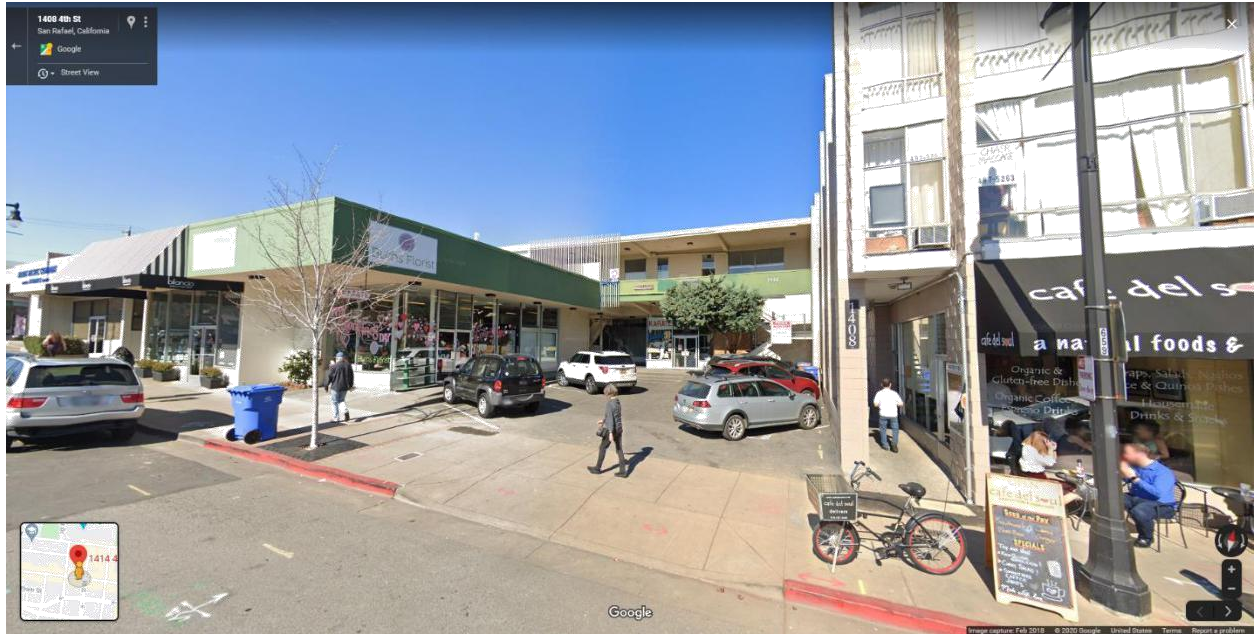
Address/code	1414 Fourth Street	ED
APN	011-204-17	
Building Name		
Year Built	1958 (spreadsheet)	
Original Use	Storefront/office	
Architectural Style	Midcentury Modern	
Architect/Builder		
Description	The building is L-shaped in plan in plan with a single story volume near the street and a two story volume recessed behind a parking lot. It has flat roof and is constructed of concrete masonry units. It lacks decorative features. Upper floor windows are rectangular. Aluminum frame doors and storefronts appear original. A heavy soffit/awning has been installed above one of the storefronts.	
Integrity		
Significance	Undistinguished midcentury building, Not Eligible, lack of significance	
Notes	<i>1408 Fourth not included, better example of modernism than 1400 or 1414</i>

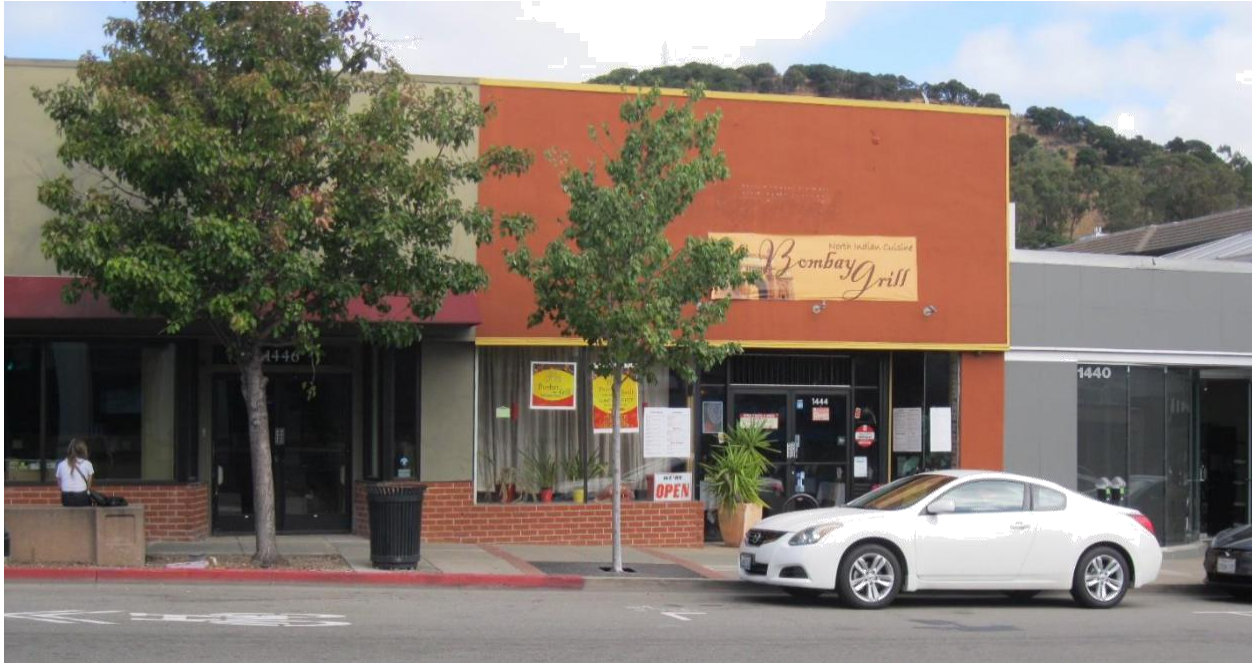
Address/code	1444- 1446 Fourth Street		<u>E</u> <u>D</u>
APN	011-204-15		
Building Name			
Year Built	1915/1965 (spreadsheet)		
Original Use	Storefront		
Architectural Style			
Architect/Builder			
Description	Two adjacent storefront buildings on the parcel are nearly identical in form, style and plan. They feature tall parapets, stucco cladding, brick bulkheads, and contemporary storefronts. They exhibit the typical plan and form of an early twentieth century storefront building but no architectural details associated with that era. Nor are they good examples of midcentury architecture.		
Integrity			
Significance	Undistinguished buildings not eligible as landmarks or contributors.		
Notes

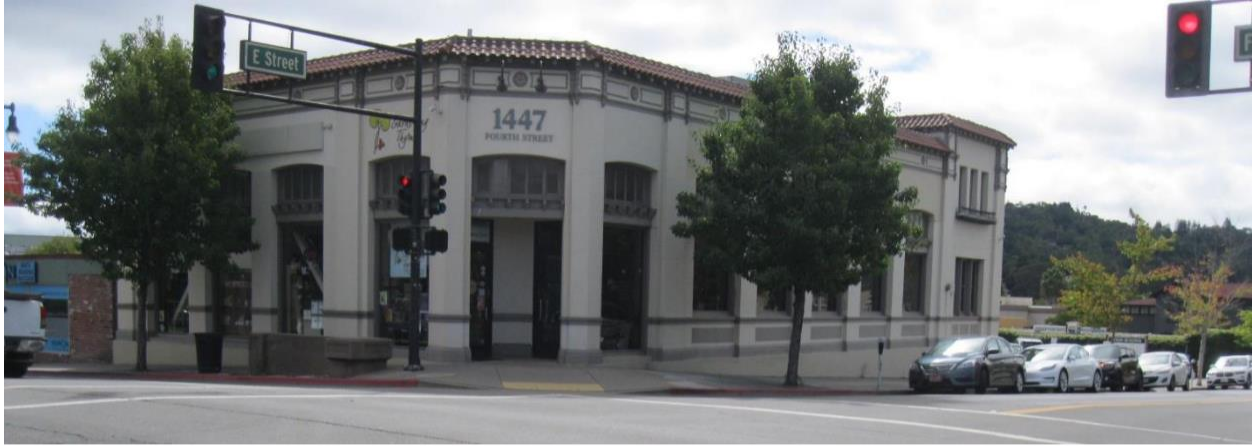
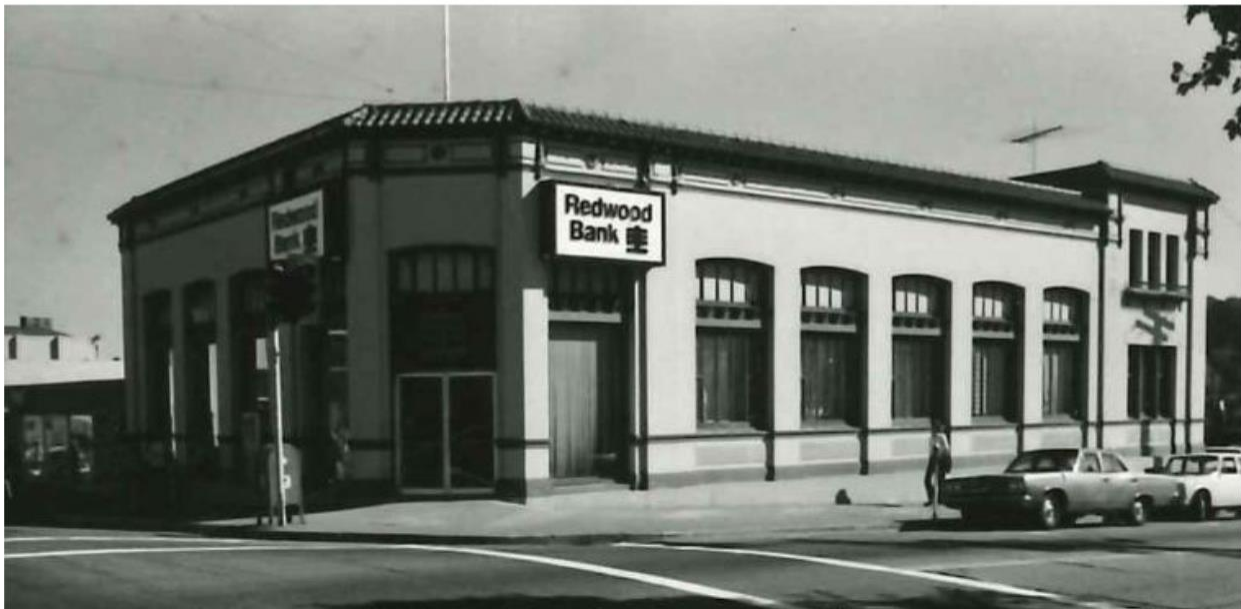
Address/code	1447 Fourth Street	7N	A
APN	011-251-01		
Building Name	<u>PG&E (later Redwood Bank)</u>		
Year Built	c1916 (DPR)		
Original Use	<u>Branch Headquarters (office)</u>		
Architectural Style	Spanish Revival		
Architect/Builder	<u>Frederick H Meyer, FAIA</u>		
Description	The tall single story building is rectangular in plan with a mansard tile roof and exposed rafter tails. It is clad in stucco with terracotta ornament including paneled frieze with floral motif and turned posts. Storefront bays are separated by wide pilasters with granite bases. Their tall rectangular windows are topped with arched transoms with wood frame divided lights and decorative brackets. Two recessed entrances have been created at the original corner entrance.		
Integrity	Retains integrity (see 1970s photo above)		
Significance	Excellent example of Spanish Revival Commercial architecture, eligible as landmark and contributor.
