Downtown San Rafael Precise Plan Historic Resources Inventory Summary Report

December 2020

[Revised May 2021](#)

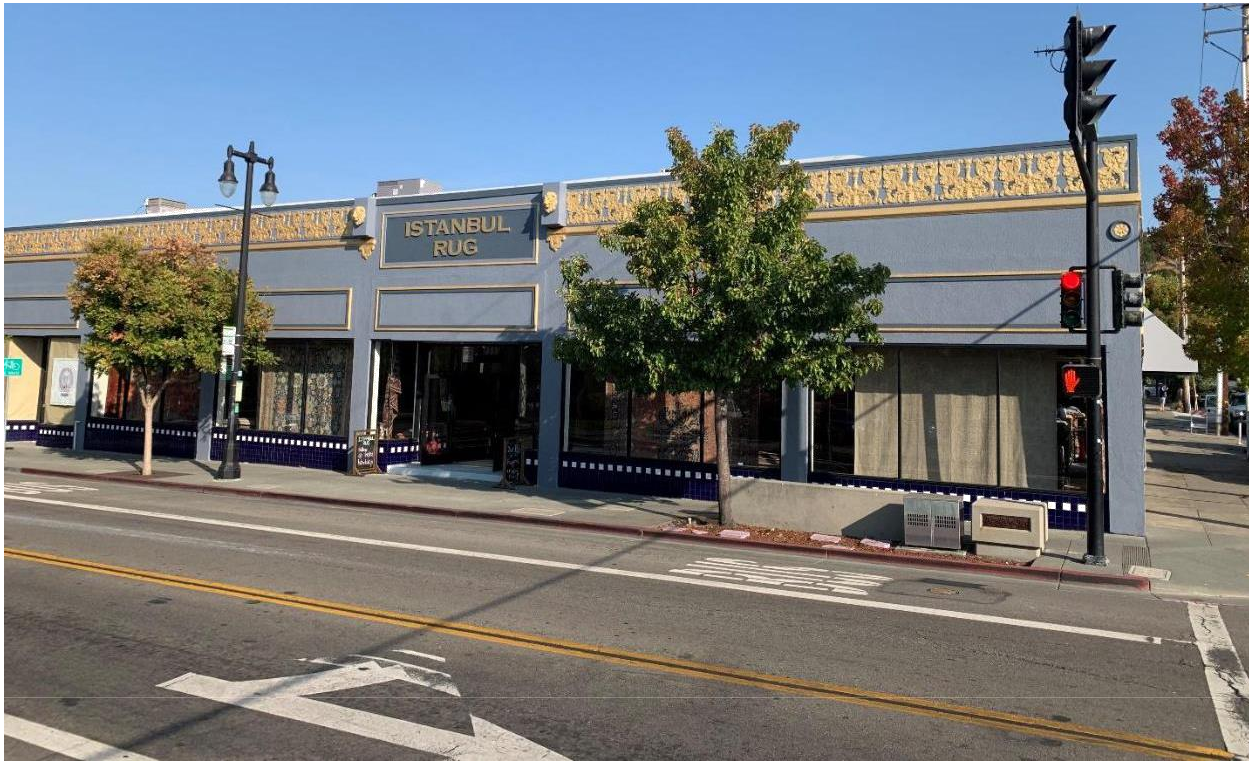
Address/code	1504-15102 Fourth St/ 1109 E St.		B
APN	011-202-14		
Building Name			
Year Built	1929 (spreadsheet)		
Original Use	<u>Auto Showroom</u>		
Architectural Style	Art Deco/Spanish Revival		
Architect/Builder			
Description	The large single story building is rectangular in plan with flat roof. It is clad in stucco with terracotta ornament including ornate floral frieze and lions' heads flanking the main entrance. Storefront bays are separated by minimalist pilasters with granite bases. Original transoms have been covered. Bulkhead is tile, and storefronts are contemporary.		
Integrity	Retains sufficient integrity for district contributor status because of well-preserved ornate frieze.		
Significance	<u>Potentially</u> eligible as contributor, lacks integrity required for landmark. <u>Requires further evaluation.</u>		
Notes	<u>Applies only to the corner building. The other building on the parcel (1512, or Bordenave's French Bakery) is not significant.</u>

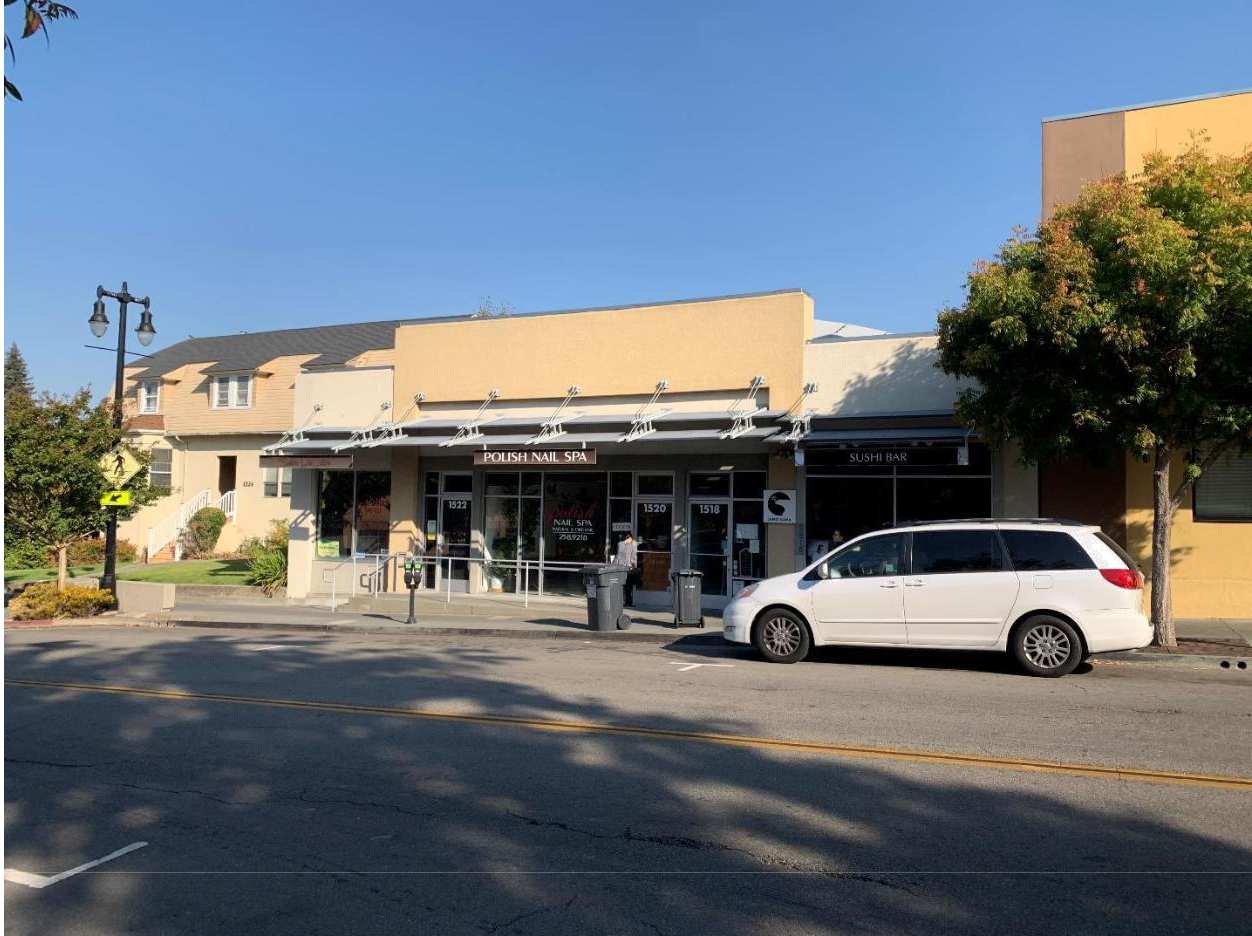
Address/code	151808-1522 Fourth Street		<u>E</u> <u>D</u>
APN	011-202-11		
Building Name			
Year Built	1928 (spreadsheet)		
Original Use			
Architectural Style			
Architect/Builder			
Description	The single story storefront commercial building is rectangular in plan with stepped parapet. It is clad in stucco and has aluminum frame storefronts and glazed doors. It exhibits no characteristics of historic architecture		
Integrity			
Significance	Not eligible as contributor or landmark		
Notes

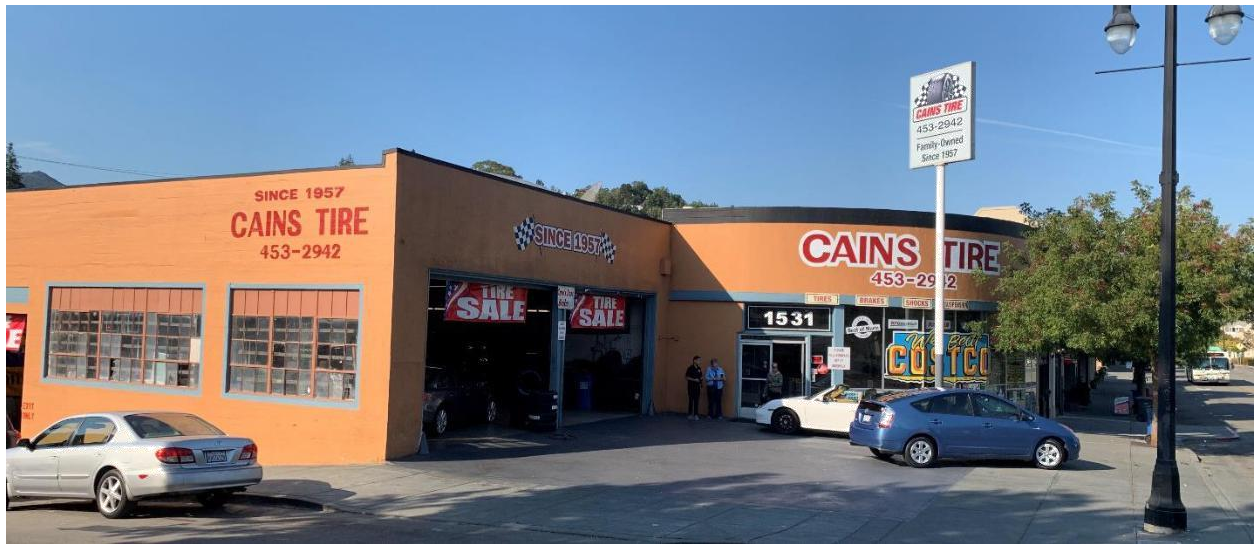
Address/code	1531 Fourth Street	B+
APN	011-242-11	
Building Name		
Year Built	1931 (spreadsheet)	
Original Use	<u>Tire sales and repair</u>	
Architectural Style		
Architect/Builder		
Description	The single story auto-oriented commercial building is rectangular in plan with a rounded volume projecting from its main (north) facade. It is clad in stucco and has industrial sash windows on its east elevation. There are three large vehicle openings at the north and east of the rectangular volume. The rounded volume is almost completely glazed, with a fully glazed double door near its junction with the main building.	
Integrity	Retains integrity	
Significance	Eligible as contributor and possibly landmark, good example of early auto-oriented building	
Notes

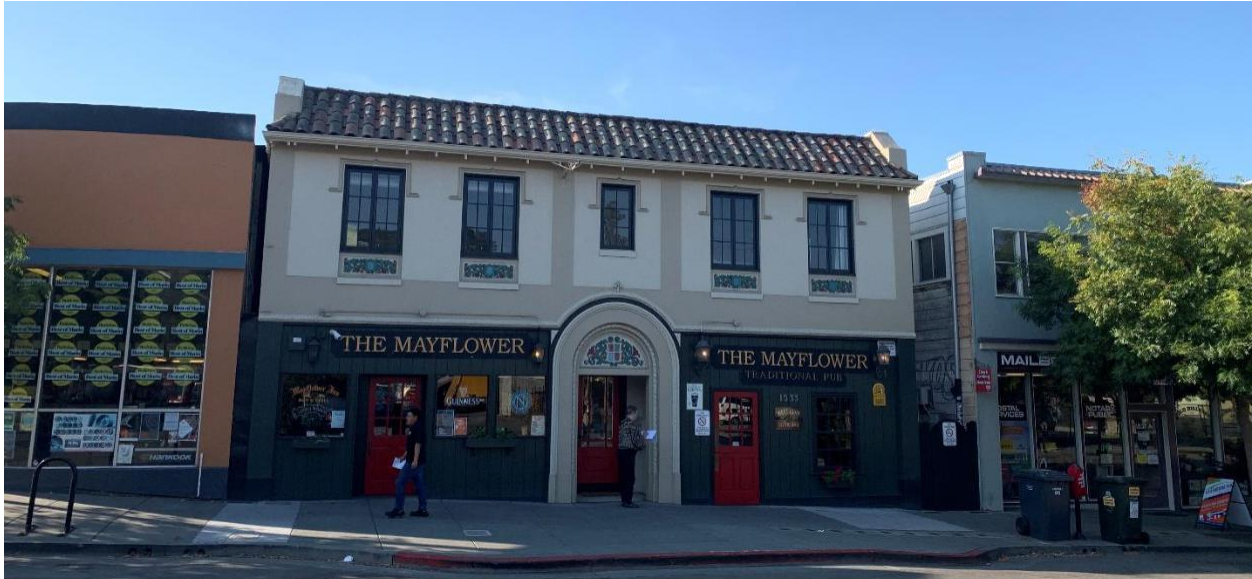
Address/code	1533 Fourth Street		B
APN	011-242-10		
Building Name			
Year Built	1925 (spreadsheet)		
Original Use			
Architectural Style	Spanish Revival		
Architect/Builder			
Description	The two story commercial building is rectangular in plan with decorative shed roof at the main (north) façade. The building is clad in stucco and has terracotta ornament with floral and shield motif. Upper story windows are fitted with multiple light wood sash and topped with ornamental hoods. The central entrance had a large arched surround with Romanesque moulding. Vertical wood cladding and small windows have replaced what were likely originally storefronts.		
Integrity	Retains integrity despite storefront alterations, highly decorative features have been retained.		
Significance	Eligible as contributor and possibly landmark, good example of Spanish/Mediterranean architecture		
Notes

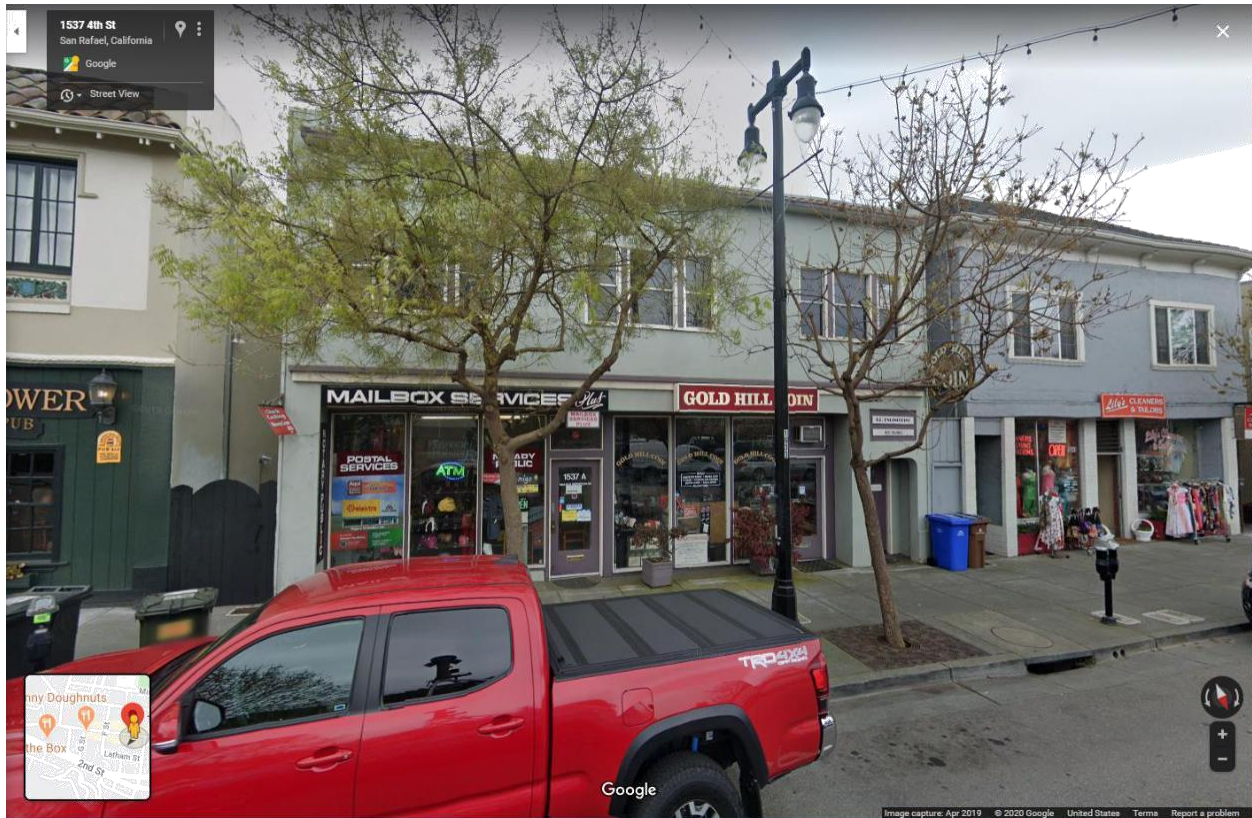
Address/code	1539 Fourth Street	ED
APN	011-242-09	
Building Name		
Year Built	1923/1961 (spreadsheet) probably older (drop siding with historic advertising side elevation)	
Original Use		
Architectural Style	Spanish Revival	
Architect/Builder		
Description	The two story commercial building is rectangular in plan with decorative shed roof at the main (north) façade. The building is clad in stucco tripartite upper story windows fitted with vinyl sash. Storefronts are contemporary.	
Integrity		
Significance	Lacks architectural significance, not eligible	
Notes

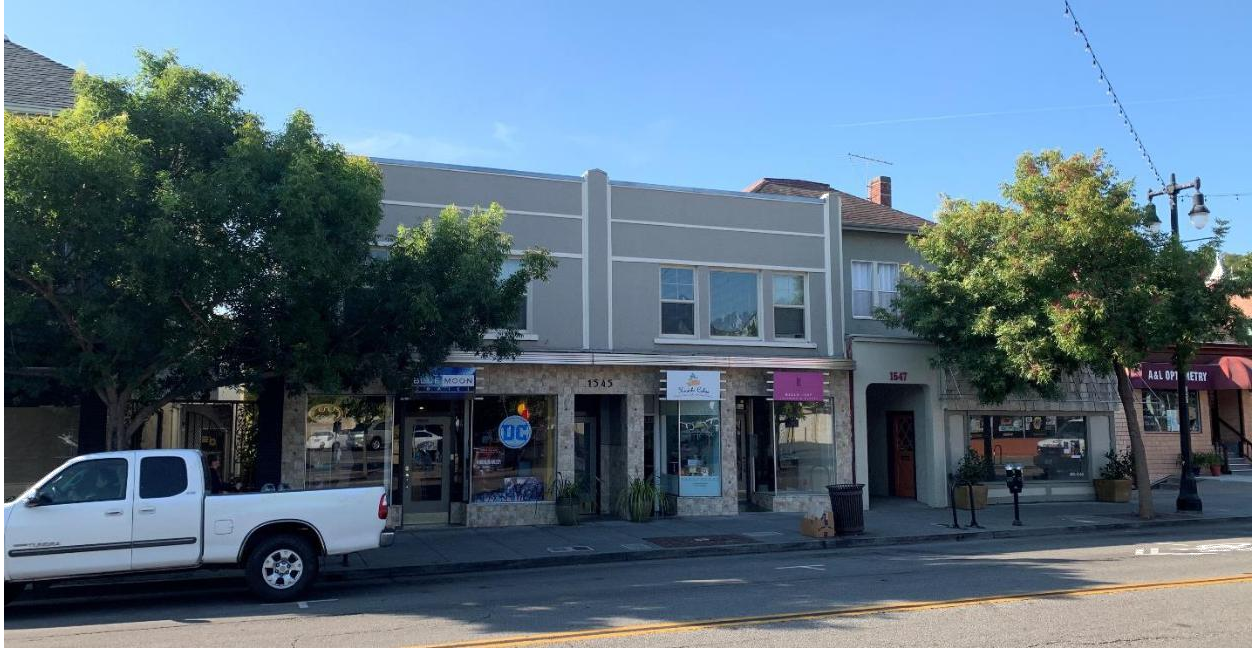
Address/code	1545 Fourth Street	ED
APN	011-242-07	
Building Name		
Year Built	1947 (spreadsheet)	
Original Use		
Architectural Style	Streamline Moderne	
Architect/Builder		
Description	The two story commercial building is rectangular in plan with flat roof. The building is clad in stucco tripartite upper story windows fitted with vinyl sash. Simple grooved columns adorn the corners and center of the building. There is a grooved metal awning over the storefront. Storefronts are contemporary with stone tile.	
Integrity	Lacks integrity, windows, stone tile	
Significance	Not eligible as landmark or contributor	
Notes

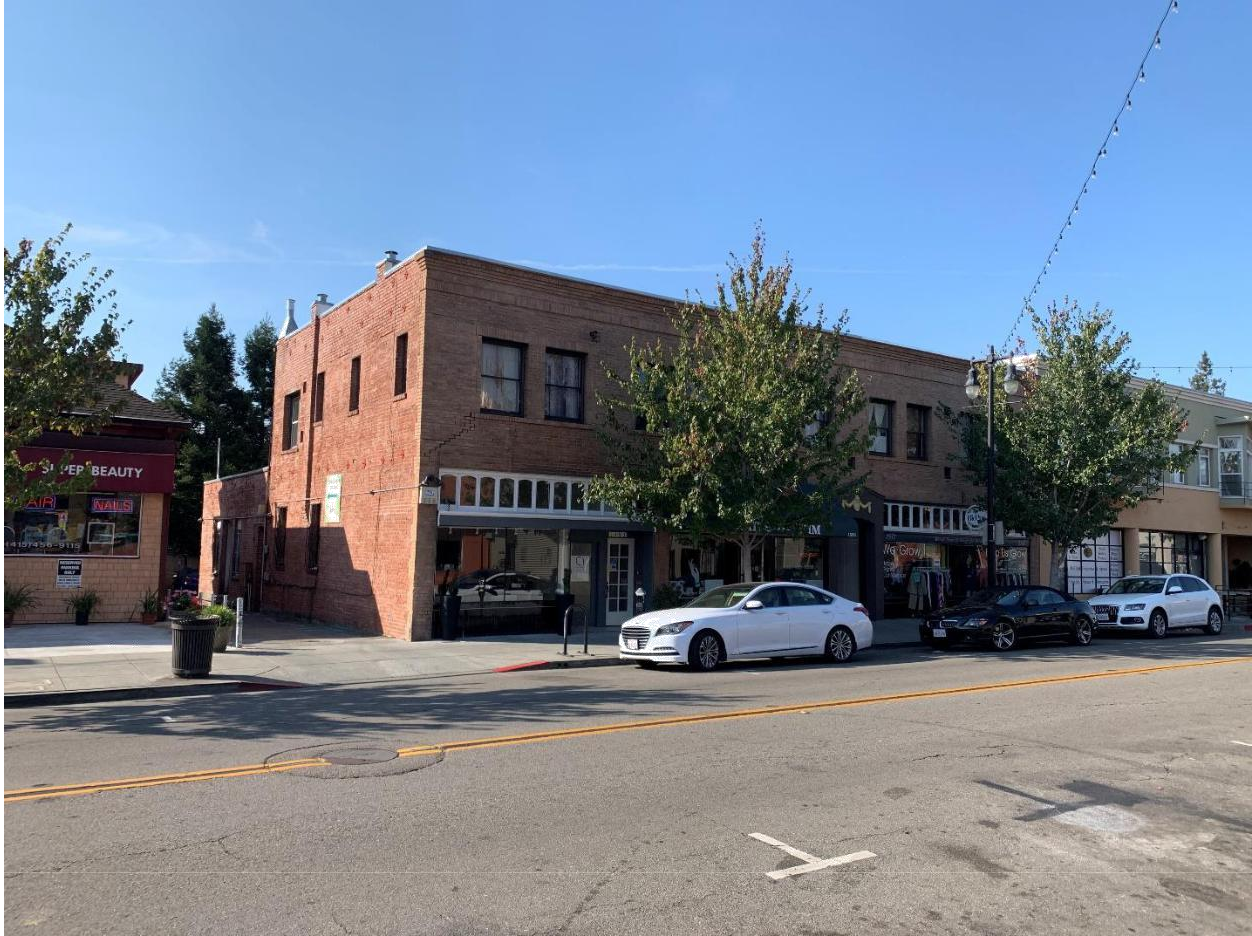
Address/code	1553-15575 Fourth St	7N	B
APN	011-242-04		
Building Name			
Year Built	1926 (spreadsheet)		
Original Use			
Architectural Style			
Architect/Builder			
Description	The two story commercial building is rectangular in plan with flat roof and brick cladding and cornice. Upper story windows fitted with double hung wood sash. A slightly projecting entrance has a gabled roof form with arched opening. It is stucco, with terracotta cartouche and swag. Decorative transoms are multiple light wood frame. Storefronts have tile bulkheads and contemporary doors.		
Integrity	Retains integrity		
Significance	eligible as contributor, lacks significance required for landmark status		
Notes

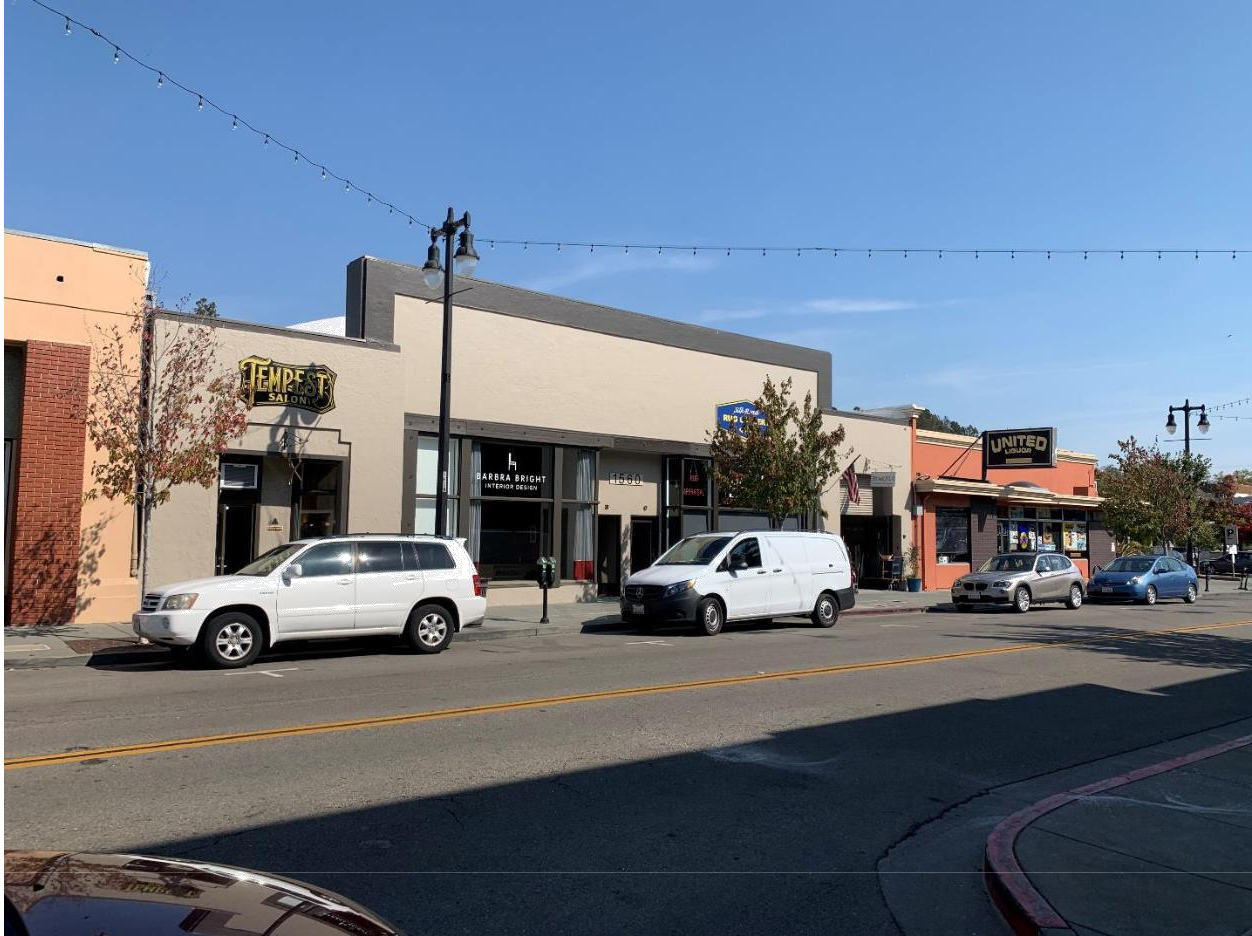
Address/code	1560 Fourth Street	ED
APN	011-196-11	
Building Name		
Year Built	1938 (spreadsheet)	
Original Use		
Architectural Style		
Architect/Builder		
Description	The single story commercial building is rectangular in plan with flat roof and stepped parapet. It clad is stucco, with shaped doorways at its east and west ends. Flush storefronts have multiple lights divided by heavy wood frames and doors at the center of the building	
Integrity		
Significance	Not eligible, lacks architectural significance	
Notes

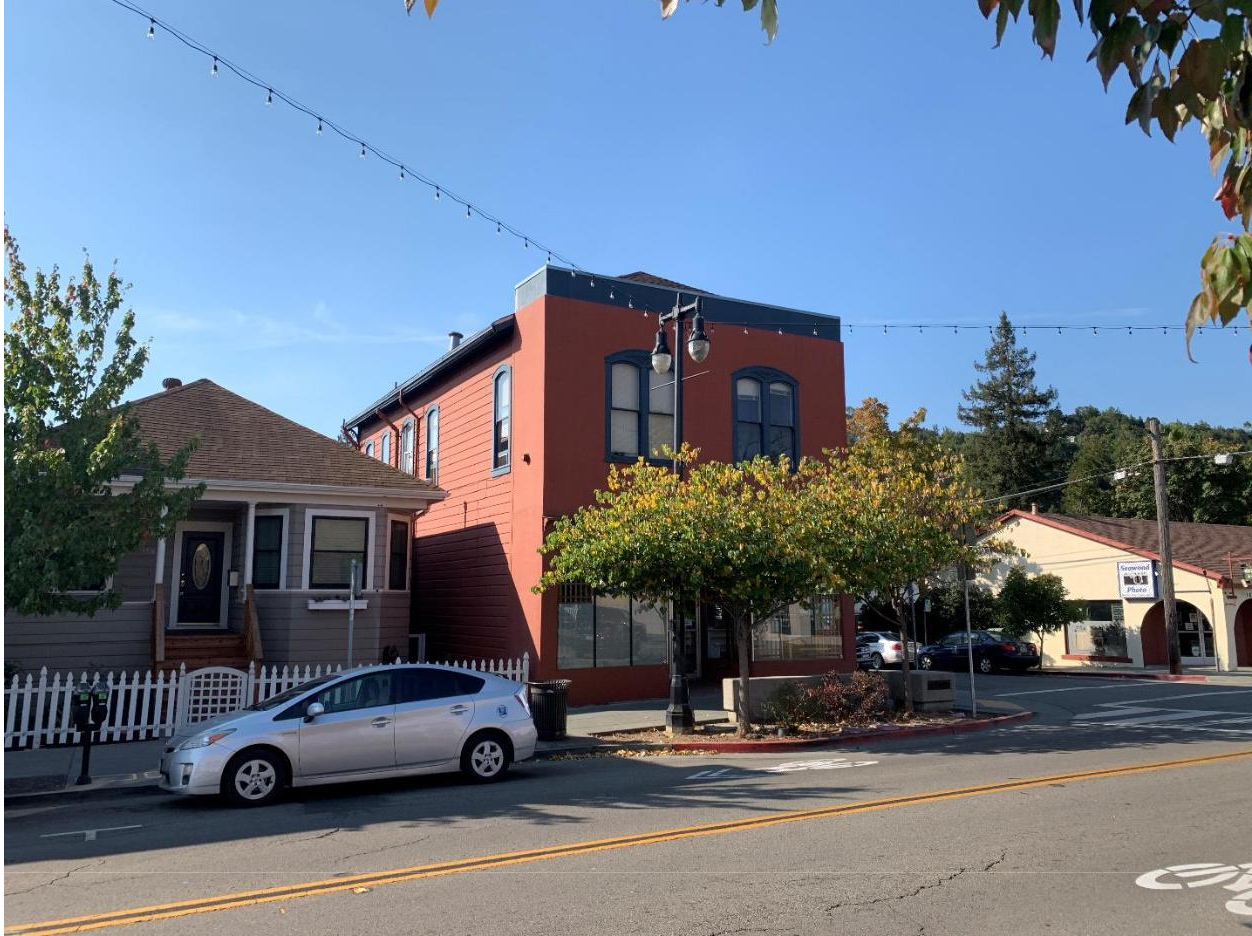
Address/code	1569 Fourth Street	ED
APN	011-242-01	
Building Name		
Year Built	1928 (spreadsheet), apparent nineteenth century building.	
Original Use		
Architectural Style		
Architect/Builder		
Description	The two story commercial-residential building is rectangular in plan with hipped roof and parapet. It clad is stucco, with drop wood siding at rear and side elevations. Double hung wood windows with arched tops and decorative surrounds and roof form indicate the building's probable origin as an Italianate house. Storefronts are contemporary.	
Integrity	Lacks integrity, stucco, parapet, storefronts	
Significance	Not eligible, lacks integrity	
Notes

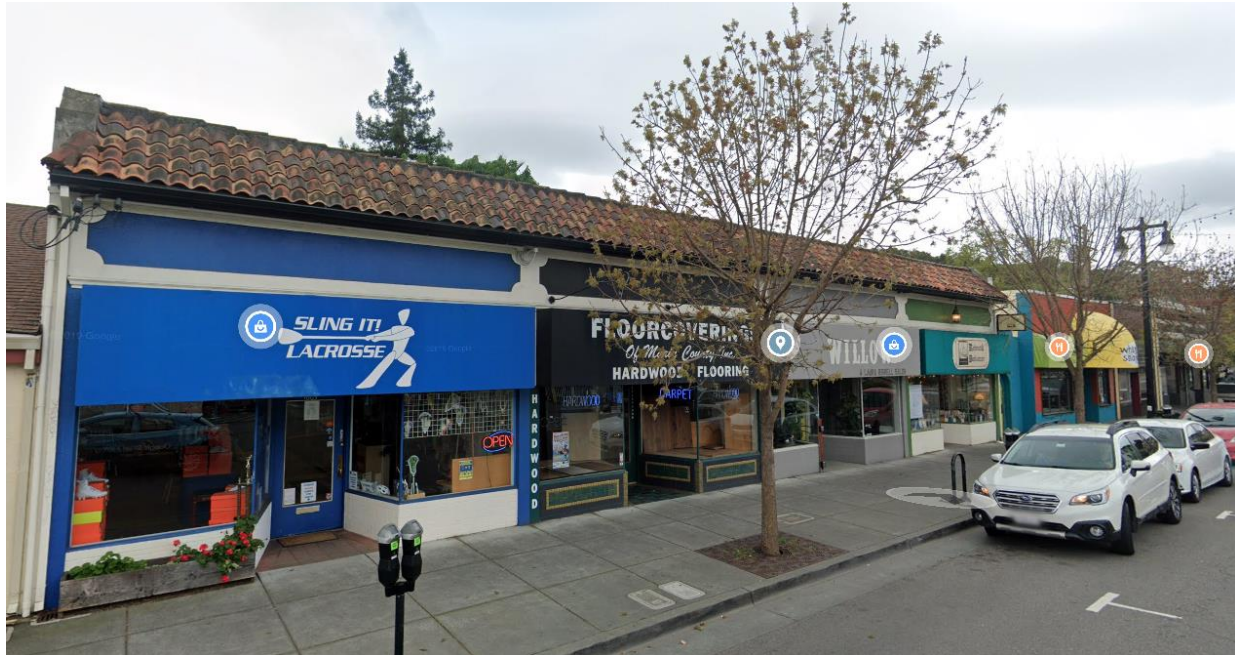
Address/code	1605-1611 Fourth St	B
APN	011-241-32	
Building Name		
Year Built	1927 (spreadsheet)	
Original Use		
Architectural Style	Spanish Revival	
Architect/Builder		
Description	The single story storefront building is irregular in plan with flat roof and decorative tiled shed roof on the main (north) facade. It clad is stucco, with drop wood siding at rear and side elevations. There is a simple paneled frieze above the four storefront bays. Large awnings cover the transom area. Slanted storefronts have original tile bulkheads (some of which have been painted) and fully glazed wood doors.	
Integrity	Retains integrity	
Significance	Simple but good example of Spanish Revival commercial architecture, eligible as district contributor, probably not distinguished enough for landmark status	
Notes

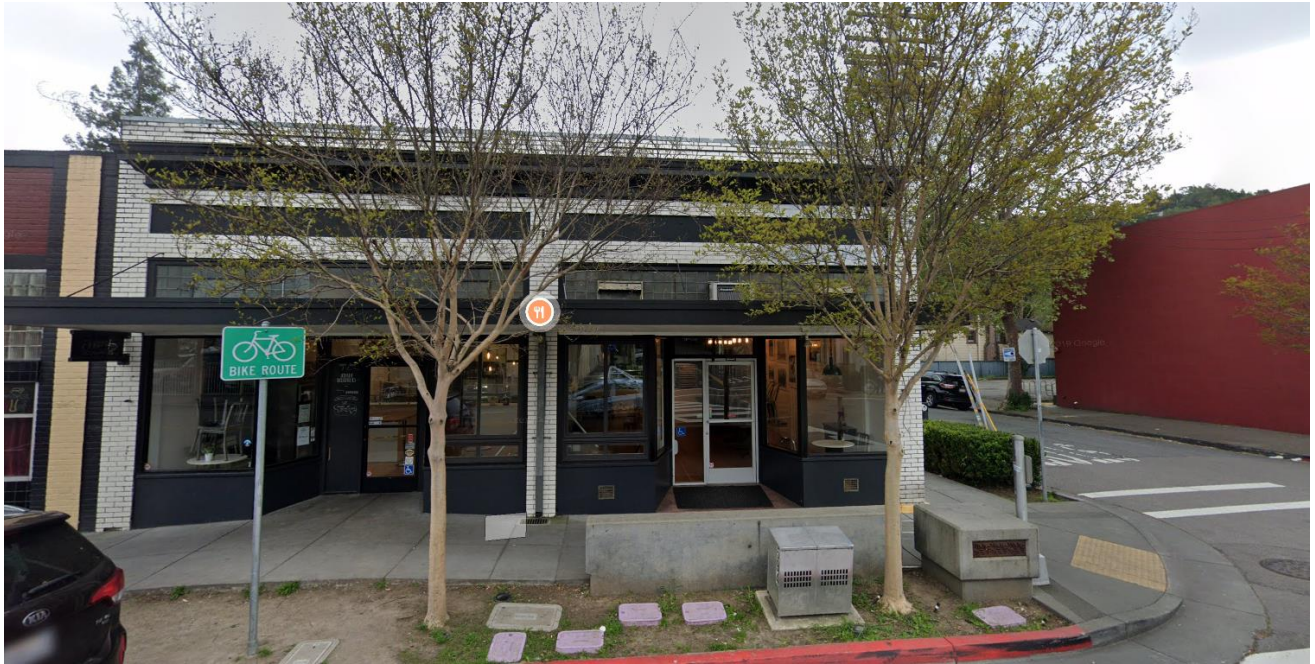
Address/code	1617 Fourth Street		B
APN	011-241-01		
Building Name			
Year Built	1920 (spreadsheet)		
Original Use			
Architectural Style	<u>Spanish Revival</u> <u>Neo-classical</u>		
Architect/Builder			
Description	The single story storefront building is rectangular in plan with flat roof and parapet with decorative cornice on the main (north) facade. The building is glazed brick, which is plastered at rear and side elevations. Original transoms have small square panes with obscured glass. A heavy awnings projects over the sidewalk below transoms. Slanted storefronts have original bulkheads and fully glazed aluminum replacement doors.		
Integrity	Retains integrity despite door replacement		
Significance	Simple but good example of commercial architecture, eligible as district contributor, probably not distinguished enough for landmark status		
Notes

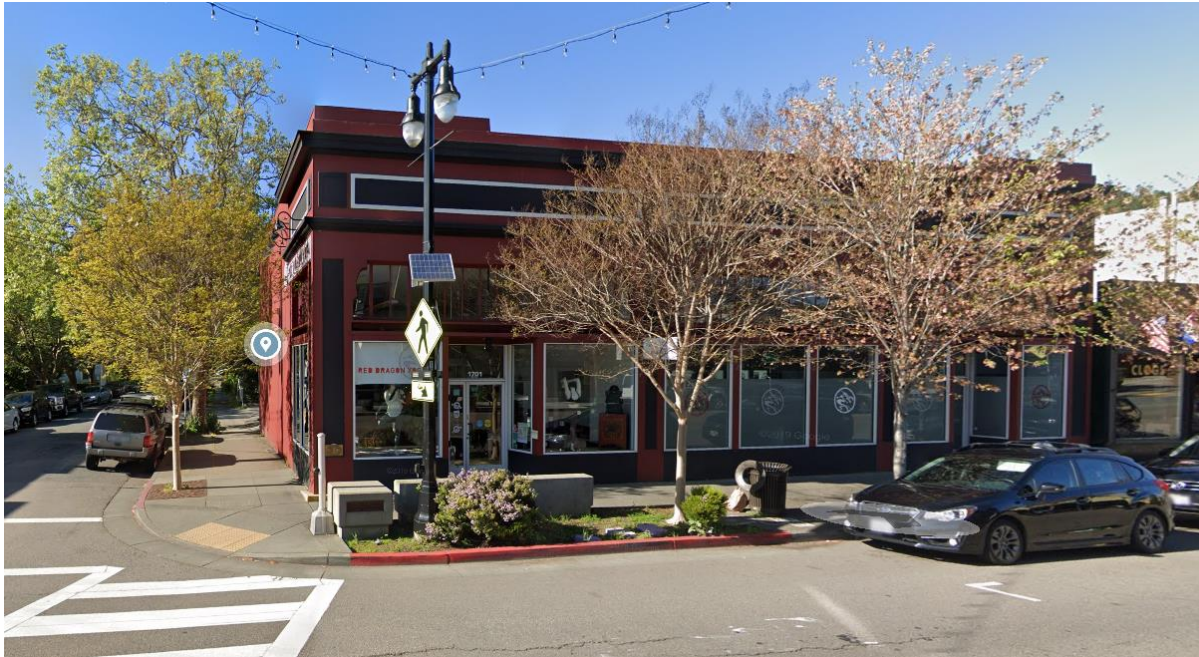
Address/code	1701 Fourth Street		C
APN	011-232-03		
Building Name			
Year Built	1925 (spreadsheet)		
Original Use	Grocery store		
Architectural Style	Neo-classical		
Architect/Builder			
Description	The single story storefront building is rectangular in plan with flat roof and stepped parapet with decorative cornice on the main (north) facade. It clad is stucco. There is a simple paneled frieze above the transoms, which have shaped openings and divided lights. The three storefront bays are contemporary		
Integrity	May retain integrity, more study needed, stucco may not be original		
Significance	Possibly eligible as district contributor, not distinguished enough for landmark status		
Notes

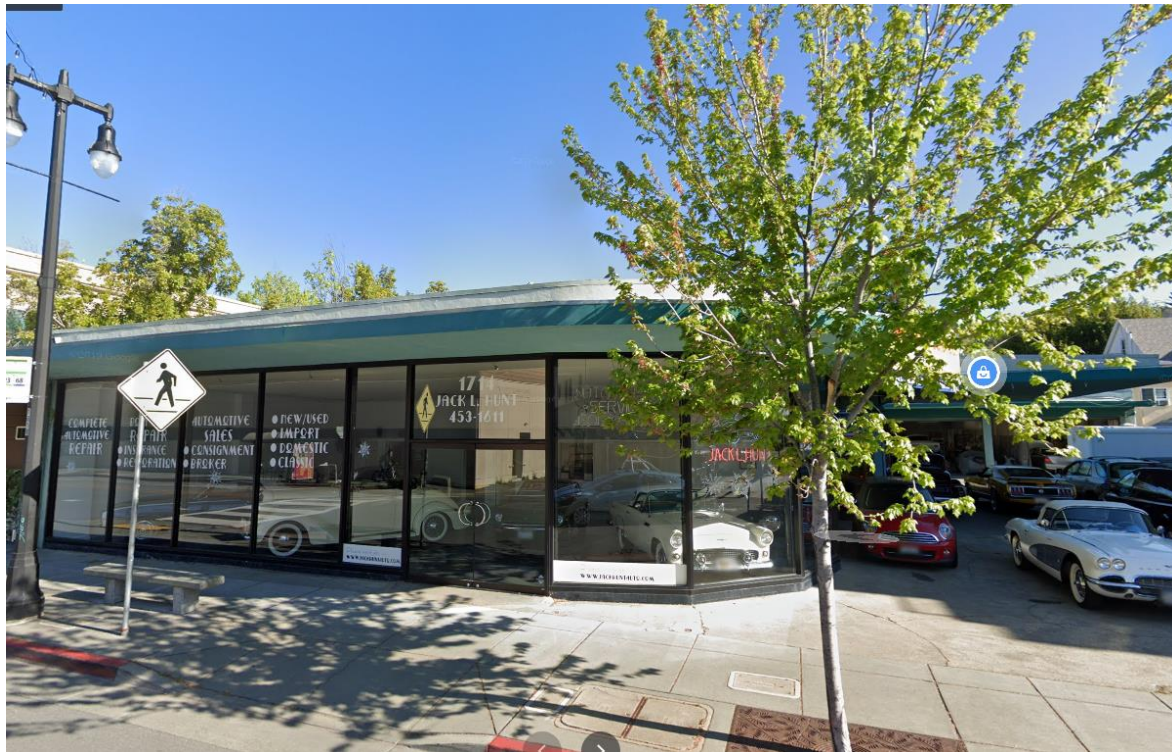
Address/code	1714 Fourth Street		C
APN	011-192-08		
Building Name			
Year Built	1951 (spreadsheet)		
Original Use	Service station Car showroom/ service bay		
Architectural Style	Midcentury Modern		
Architect/Builder			
Description	The single story storefront building has a roughly rectangular-plan front volume with flat roof and projecting porte cochere at the east. The front (south) end has a curved corner is fully glazed on the south and east. A heavy awning, also rounded at the corner, projects below the parapet. A second story adjacent to the porte cochere has flat roof and industrial sash windows. There is an L-shaped wing at the rear (north) with open bays for vehicles.		
Integrity	May retain integrity, more study needed, glass not original		
Significance	Possibly eligible as district contributor, not distinguished enough for landmark Status		
Notes	Original storefront was destroyed by an electrical fire, requiring its replacement

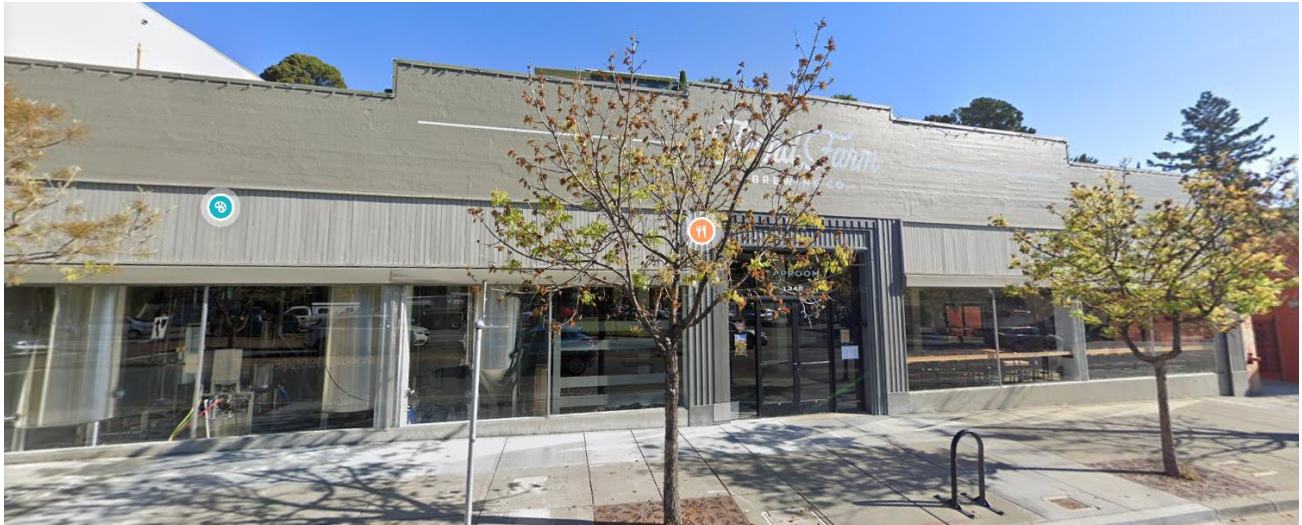
Address/code	1848 Fourth Street		B
APN	010-291-35		
Building Name			
Year Built	1947 (spreadsheet)		
Original Use	Commercial		
Architectural Style	Streamline Moderne/Stripped Classicism		
Architect/Builder			
Description	The single story storefront building has a rectangular plan and flat roof with stepped parapet. It is constructed of board form concrete with a decorative door surround featuring stylized fluted columns and dentil moulding. Transoms are covered with metal panels but may be extant. Storefronts and doors are contemporary		
Integrity	Retains integrity despite storefront and door replacement		
Significance	eligible as district contributor, rare example of stripped classical detailing, not distinguished enough for landmark status		
Notes

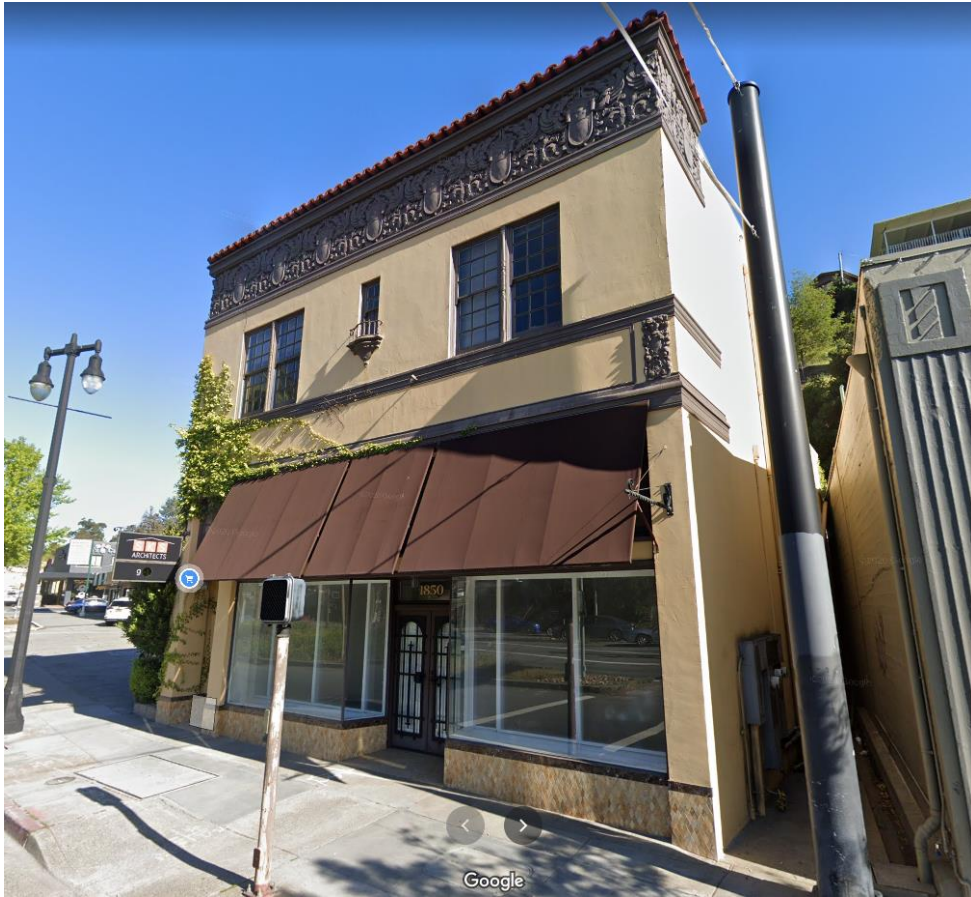
Address/code	1850-1852 Fourth St	7N	A
APN	010-291-57		
Building Name			
Year Built	1922 (spreadsheet)		
Original Use	Commercial		
Architectural Style	Art Deco /Spanish <u>Colonial</u> Revival		
Architect/Builder			
Description	The two story storefront building has a rectangular plan and flat roof with clay tile parapet. It is clad in stucco with terracotta ornament including an elaborate frieze at the cornice, diminutive balconet at the center of the upper façade, and detailing between stories. Paired upper story windows are fitted with double hung multiple light wood sash. Transoms are also multiple light wood. Original glazed wood doors are at the center and west end of the building. Storefronts and bulkheads are contemporary		
Integrity	Retains integrity despite storefront replacement		
Significance	eligible as district contributor and landmark		
Notes

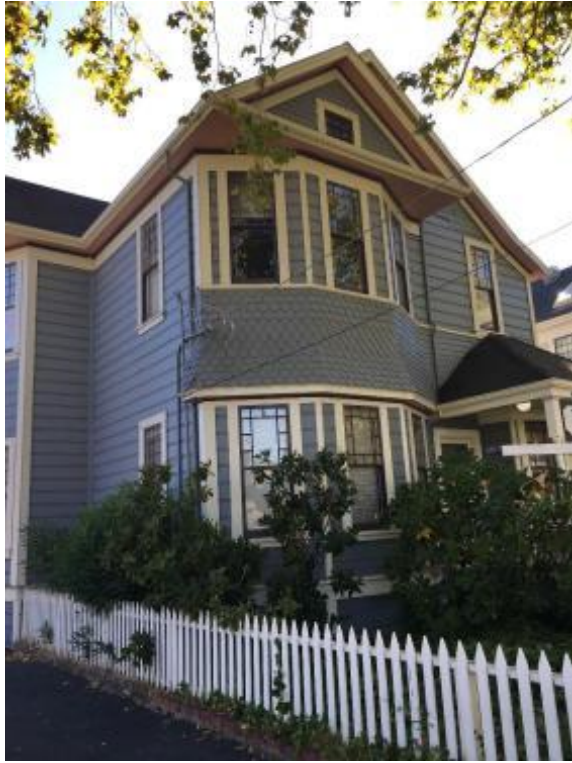
Address/code	633 Fifth Ave		A
APN	014-084-02		
Building Name			
Year Built	1898 (spreadsheet)		
Original Use	Residence		
Architectural Style	Queen Anne		
Architect/Builder			
Description	<p>The two story house is roughly rectangular in plan with a gable roof. There are projecting two-story bays at the main (north) and west elevations. They are topped with pedimented gables with multiple light windows and fishscale siding. Primary cladding is drop wood siding, with fishscale shingles separating upper and lower window bays. Multiple light windows are fitted into tall openings. The main entrance is roughly centered in the north façade and fitted with a partially glazed paneled wood door. It is sheltered by a partial-width porch with hipped roof and turned posts. A small area at the west end of the porch has been filled in and has a second entrance fitted with a paneled wood door.</p>		
Integrity	Retains integrity despite porch alterations

Significance	Eligible as district contributor and individual landmark		
Notes	<i>Pair with adjacent house at 637 Fifth</i>

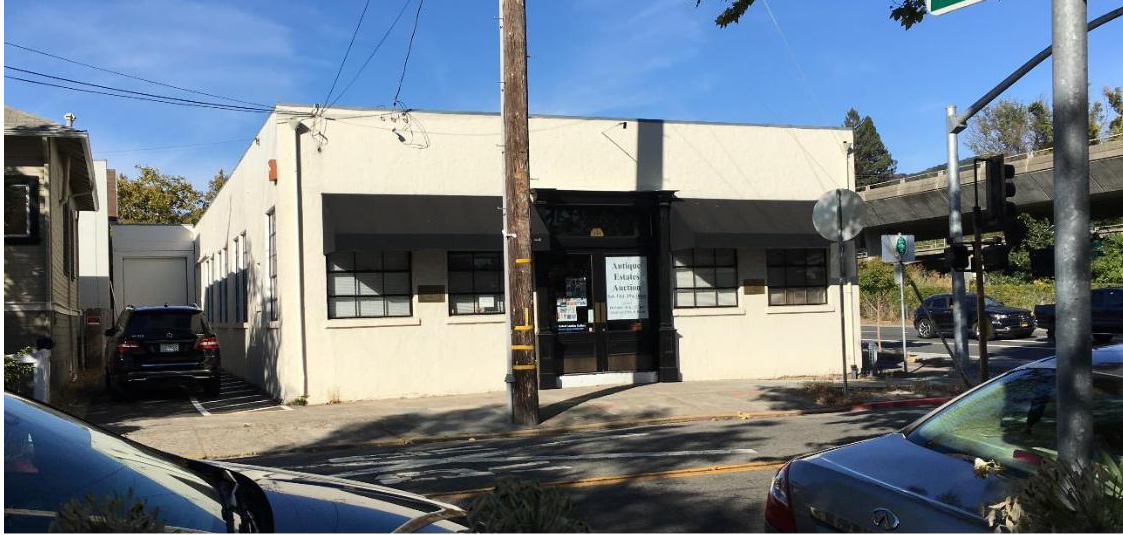
Address/code	634 Fifth Ave	ED
APN	014--081-08	
Building Name		
Year Built	1948 (spreadsheet)	
Original Use	Commercial	
Architectural Style	Utilitarian	
Architect/Builder		
Description	The single story commercial building is rectangular in plan with a flat roof. Windows are steel multiple light casement. The centered entrance has double partially glazed wood doors topped with a transom and flanked by wood pilasters. East and north elevations lack fenestration	
Integrity	Retains integrity	
Significance	Not eligible a landmark or contributor	
Notes

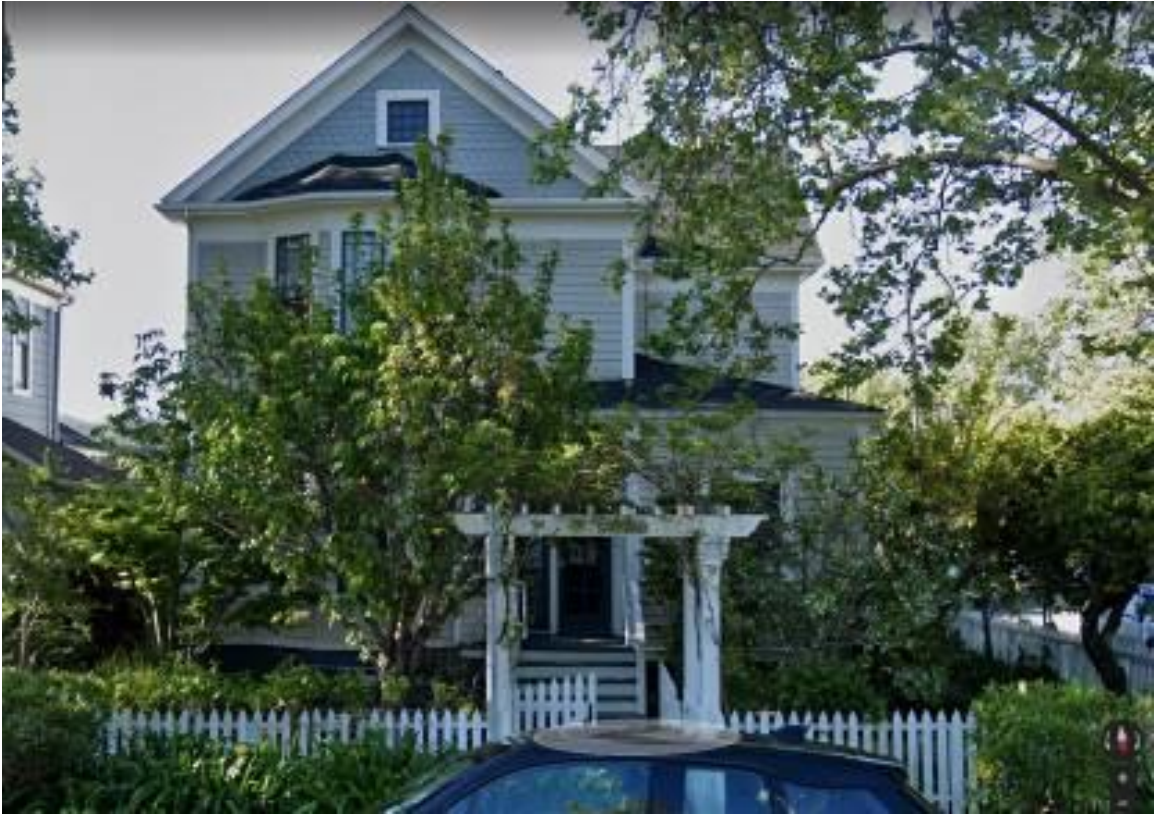
Address/code	637 Fifth Ave		A
APN	014--084-13		
Building Name			
Year Built	1954 (spreadsheet) c1895 plausible		
Original Use	Residence		
Architectural Style	Queen Anne		
Architect/Builder			
Description	<p>The two story house is roughly rectangular in plan with a gable roof. There are projecting two-story bays at the main (north) and east elevations. They are topped with pedimented gables with multiple light windows and fishscale siding. Primary cladding is drop wood siding, with fishscale shingles separating upper and lower window bays. Multiple light windows are fitted into tall openings. The main entrance is roughly centered in the north façade and fitted with a glazed wood door. It is sheltered by an integral porch with hipped roof and turned posts. There is an exterior staircase at the rear leading to upper floor entrance</p>		
Integrity	Retains integrity despite porch alterations		
Significance	Eligible as district contributor and individual landmark

Notes	<i>Pair with adjacent house at 633 Fifth</i>

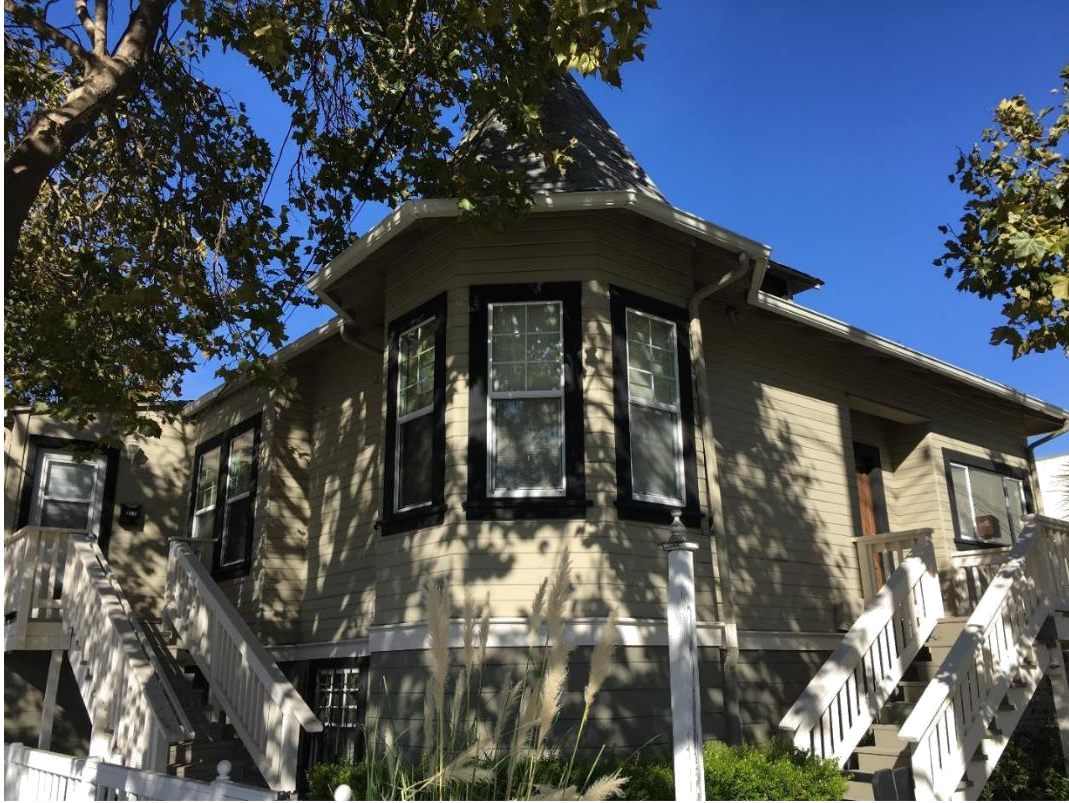
Address/code	638 Fifth Ave	ED
APN	014-081-09	
Building Name		
Year Built	1910 (spreadsheet)	
Original Use	Commercial	
Architectural Style	Hipped Roof Cottage with Queen Anne details	
Architect/Builder		
Description	The single story residential building is rectangular in plan with a hipped roof and hipped dormers. There is a bay with hexagonal roof at its southeast corner. The main floor is raised over a basement with a set of wooden steps from the side. Windows are various shapes and materials of replacement windows.	
Integrity	Lacks integrity, windows, porch, other alterations	
Significance	Not eligible as a landmark or contributor due to lack of integrity	
Notes

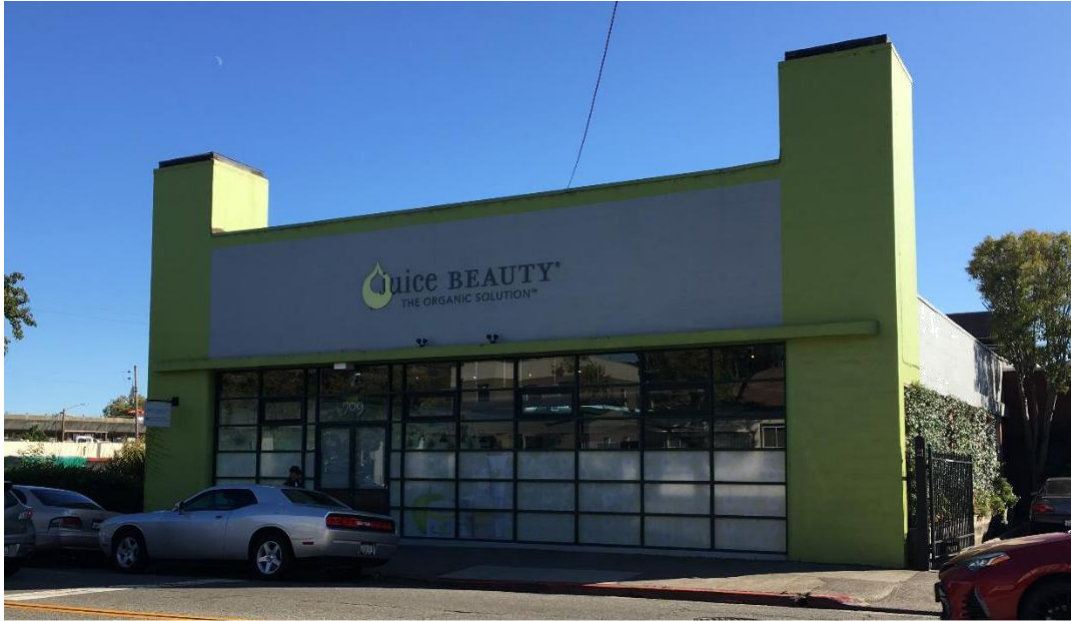
Address/code	709 Fifth Ave	ED
APN	011-227-02	
Building Name		
Year Built	1941 (spreadsheet)	
Original Use	Supermarket	
Architectural Style	Utilitarian	
Architect/Builder		
Description	The single story commercial building is rectangular in plan with a gabled roof hidden by a parapet. Windows are steel multiple light casement. The main (north) façade is occupied by large divided storefront windows and flanked by square pillars. Main façade cladding is stucco, the balance of the building is board form concrete. The off center entrance has double glazed doors.	
Integrity	Lacks integrity	
Significance	Not eligible as landmark or contributor due to lack of significance and integrity	
Notes

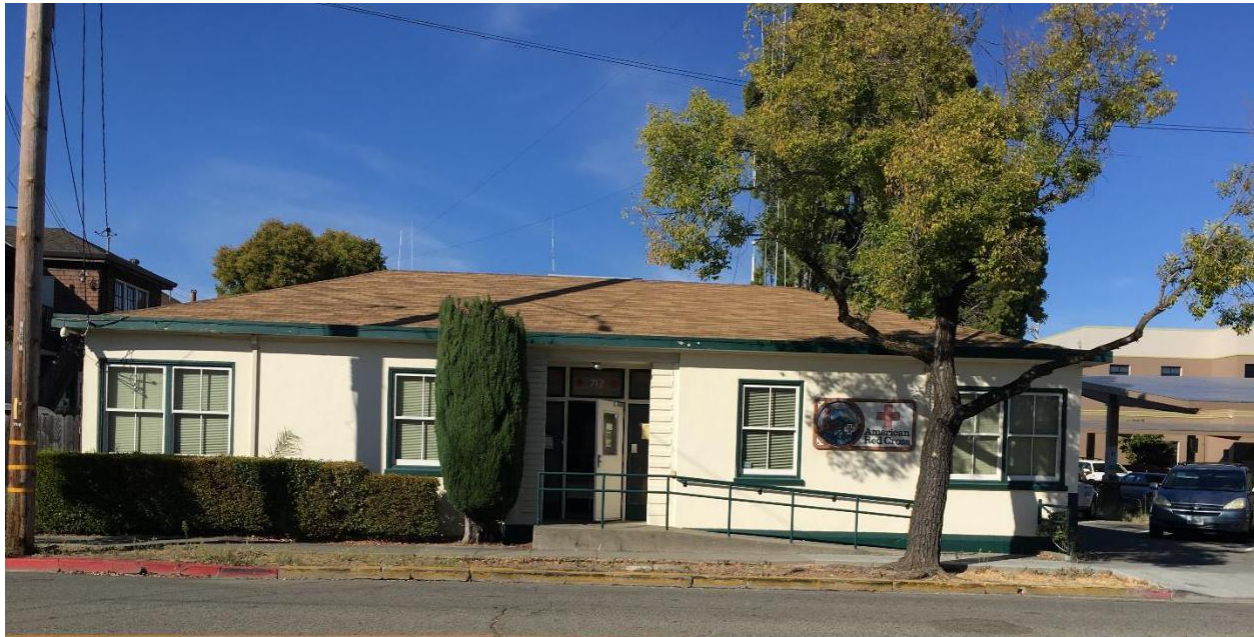
Address/code	712 Fifth Ave	ED
APN	011-226-06	
Building Name		
Year Built	1940/1970/1994 (spreadsheet)	
Original Use		
Architectural Style	Minimal Traditional	
Architect/Builder		
Description	The single story building has a T-shaped plan and low pitch hipped roof. It is clad in stucco with brick quoins around the recessed entry. The partially glazed metal replacement door has sidelights and transom and is accessed via an accessible ramp. Windows are double hung two over two wood sash.	
Integrity	Appears to retain integrity despite replacement door and ramp addition.	
Significance	Lacks architectural significance, not eligible as landmark or contributor	
Notes	Rear section of building includes former ship (ark)
