Downtown San Rafael Precise Plan Historic Resources Inventory Summary Report

December 2020

[Revised May 2021](#)

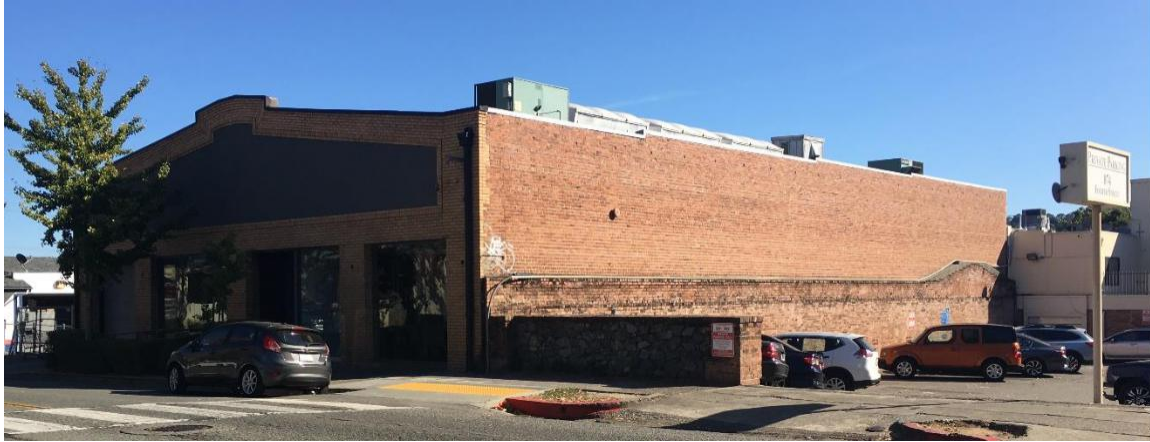
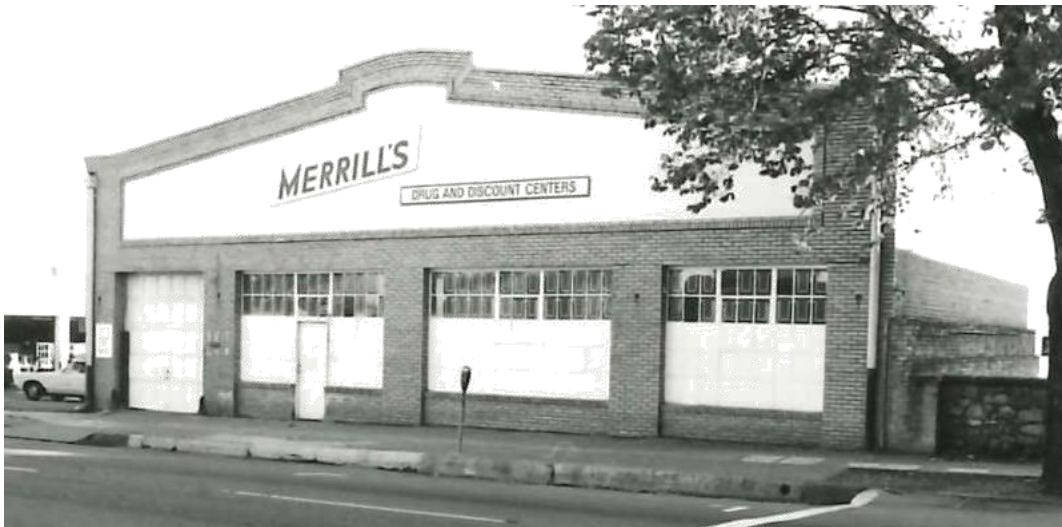
Address/code	835 Fifth Ave	<u>D</u> <u>B</u>
APN	011-224-21	
Building Name	Merrill's Drug and Discount	
Year Built	1921 (DPR)	
Original Use	Commercial (<u>Receiving</u>)	
Architectural Style	Mission	
Architect/Builder		
Description	The single story commercial building is rectangular in plan with a gabled roof hidden by a shaped parapet. The main (north) façade is occupied by large contemporary storefront windows with one roll up vehicle door. Cladding is brick with stuccoed areas. The off center entrance has a contemporary glazed door.	
Integrity	Lacks <u>sufficient</u> integrity <u>to be individual resource</u> (see 1970s photo above)	
Significance	Not eligible as landmark <u>or contributor</u> due to marginal significance and lack of Integrity— <u>4th Street frontage (#866) is ineligible</u>	
Notes	<i>Very similar to 819 Fifth/836 Fourth</i>

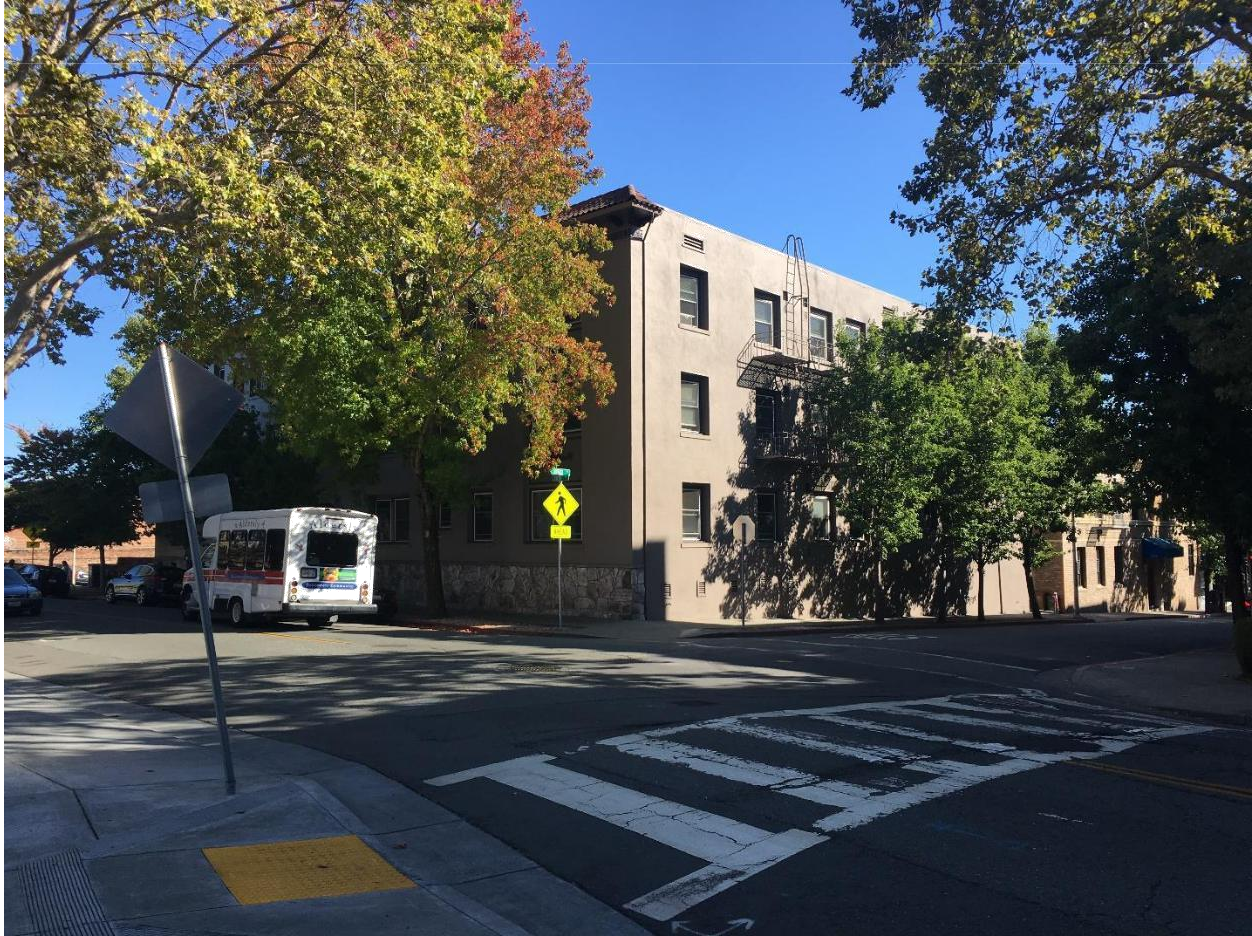
Address/code	845 Fifth Ave	D
APN	011-224-01	
Building Name	El Rey Apartments	
Year Built	1920 (spreadsheet)	
Original Use	Multi-family residential	
Architectural Style	Mediterranean Revival	
Architect/Builder		
Description	The three story apartment building is U-shaped in plan with a flat roof and hipped tile parapet with decorative cornice featuring shaped rafter tails. There is a floral frieze below the cornice and decorative swags on spandrel panels. The building is clad in stucco with decorative stone wainscoting and arched main entrance. The recessed door is wood frame and fully glazed with sidelights and decorative fanlights. Fenestration is vertical openings with replacement windows. There is a fire escape on the main (north) façade.	
Integrity	Apparently lacks integrity, replacement windows and wainscoting, more research needed	
Significance	Not likely to be eligible as landmark or contributor due to marginal significance and lack of integrity

Notes	Was considered a “high-end” development in its time

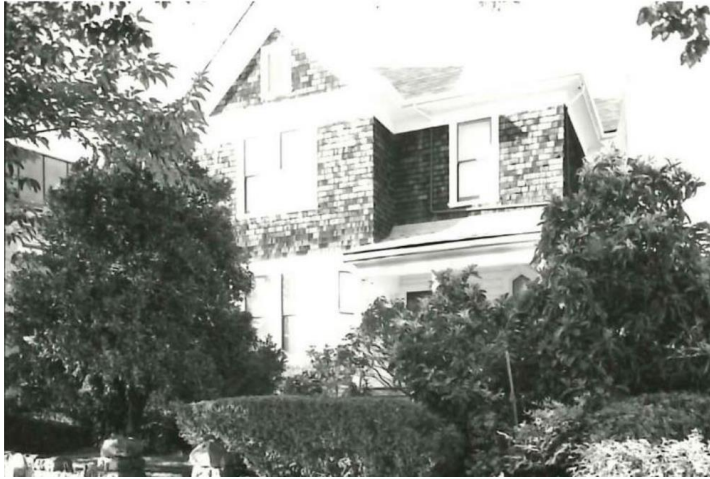
Address/code	918 Fifth Ave	7N	A
APN	011-221-08		
Building Name			
Year Built	c1900 (DPR)		
Original Use	Multi-family residential		
Architectural Style	Transitional Queen Anne		
Architect/Builder			
Description	<p>The 2.5 story house is roughly rectangular in plan with a gable on hip roof. It is clad in unpainted shingles with clapboard wood siding on the ground floor. Windows are double hung wood sash with a cutaway bay on the main (south) façade. A partial width porch adjacent to the window bay has a shed roof and solid balustrade with Tuscan columns. The wood door has a diamond shaped window and there is a lozenge shaped window adjacent to the door. The ground floor is set atop a raised basement and accessed via a set of wooden steps. A low stone wall encloses the front yard.</p>		
Integrity	Retains integrity (see 1970s photo above)		
Significance	Eligible as landmark and contributor		
Notes

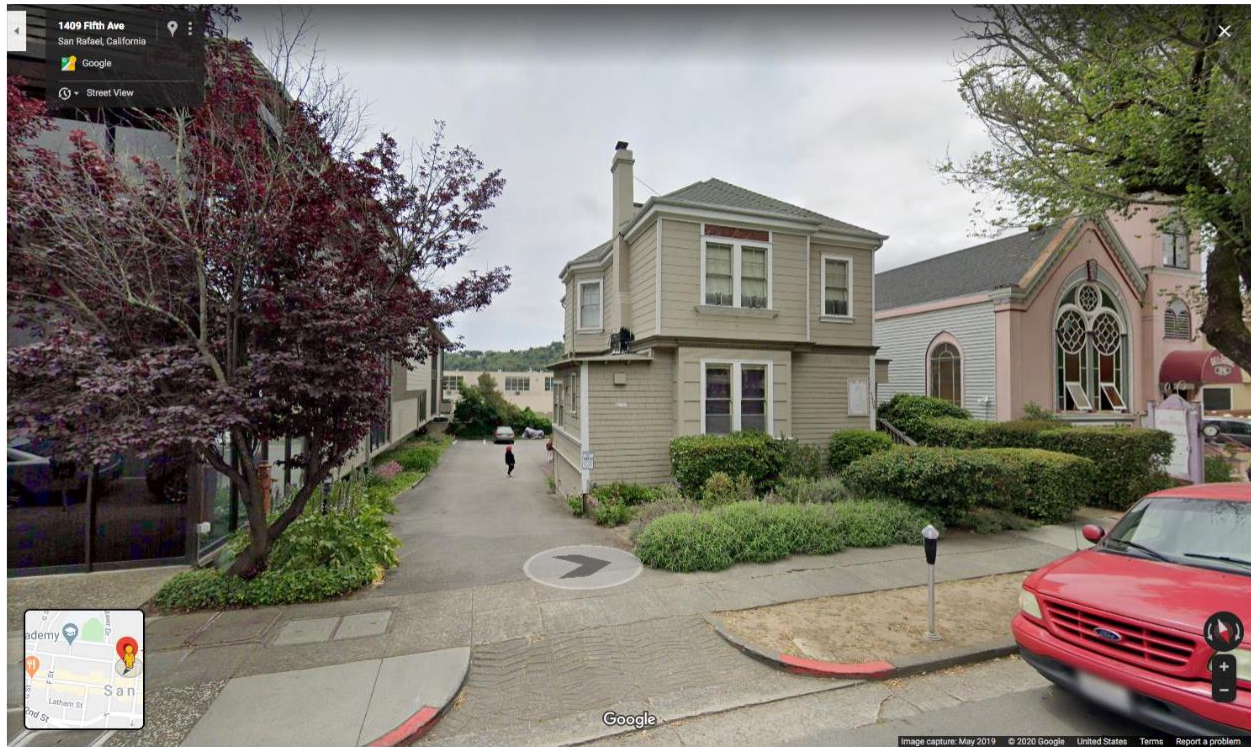
Address/code	1409 Fifth Ave	<u>E</u> <u>D</u>
APN	011-204-18	
Building Name		
Year Built	1888/1949 (spreadsheet)	
Original Use	Multi-family residential	
Architectural Style		
Architect/Builder		
Description	The two story house is roughly rectangular in plan with a hipped roof. It is clad in shingles and drop siding wood siding. Double hung wood sash windows and some decorative elements reveal nineteenth century origin of building, but its original style and form are unknown. Converted to 5 apartments 1949.	
Integrity	Lacks integrity, specific alterations unknown but not a good example of any historic residential style	
Significance	Not eligible as landmark or contributor due to lack of integrity	
Notes

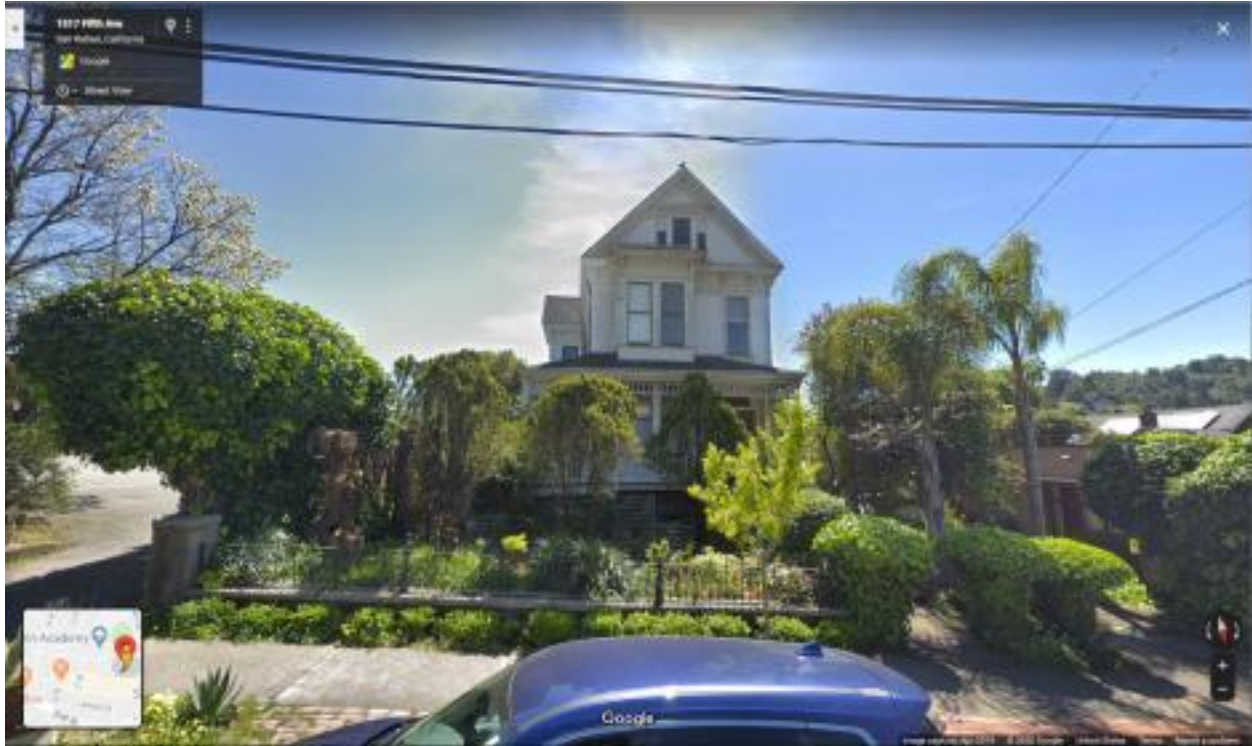
Address/code	1517 Fifth Ave	7N	A
APN	011-202-04		
Building Name	Chisolm House		
Year Built	1890/1920 (spreadsheet)		
Original Use	Residential		
Architectural Style	Queen Anne		
Architect/Builder			
Description	<p>The 2.5 story raised basement house is roughly rectangular in plan with a gabled roof. It is clad in narrow clapboard and wide horizontal wood siding. Windows are double hung wood sash. A full-width porch has a hipped roof projecting from the main (north) façade and its east end is enclosed in multiple-light wood windows. Ornamental details include decorative window assemblage with diminutive shed roof on the pedimented front gable, cornice with scrolled bracket and decorative frieze, turned posts and elaborate trim on the porch, and projecting second floor square window bay.</p>		
Integrity	Retains integrity		
Significance	Eligible as landmark and contributor		
Notes	Designated as local landmark in Dec 1979, but at wrong address (1505 Fifth)—correct address is shown.

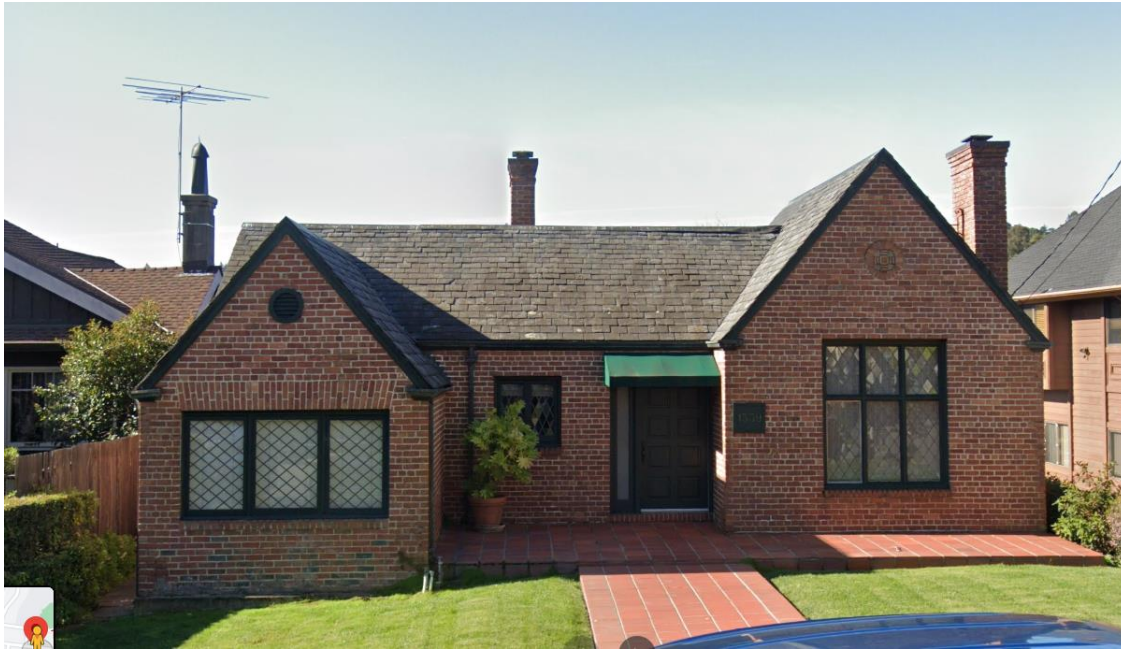
Address/code	1539 Fifth Ave		B+ C
APN	011-196-05		
Building Name			
Year Built	1935 (spreadsheet)		
Original Use	Residential		
Architectural Style	Tudor		
Architect/Builder			
Description	The single story raised basement house is U-shaped in plan with a steeply pitched cross-gabled roof. It is constructed of brick with a slate roof and has two decorative brick chimneys. Windows feature leaded diamond panes. The entrance is fitted with a wide paneled wood door.		
Integrity	Retains integrity		
Significance	Potentially Eligible as contributor, potentially eligible as landmark		
Notes

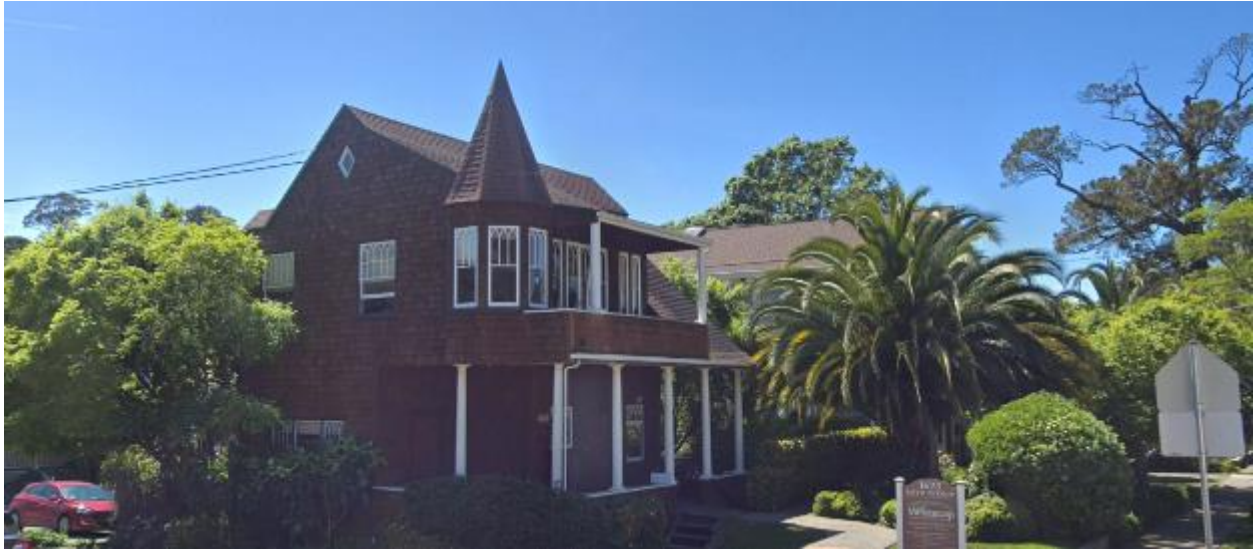
Address	1623 5th Avenue, Building A D	7N	B
APN	011-320-01		
Building Name	Kalliopeia Foundation <u>Victorian Village (Unit A)</u>		
Year Built			
Original Use	Residential		
Architectural Style	Victorian		
Architect/Builder			
Description	<u>Building A is shown here and is one of the original 1978 listed buildings. The other original building is the "little red schoolhouse" at 1623C. .</u>		
Integrity	Appears to retain integrity		
Significance	Potential local district contributor, not individually eligible at any level		
Notes

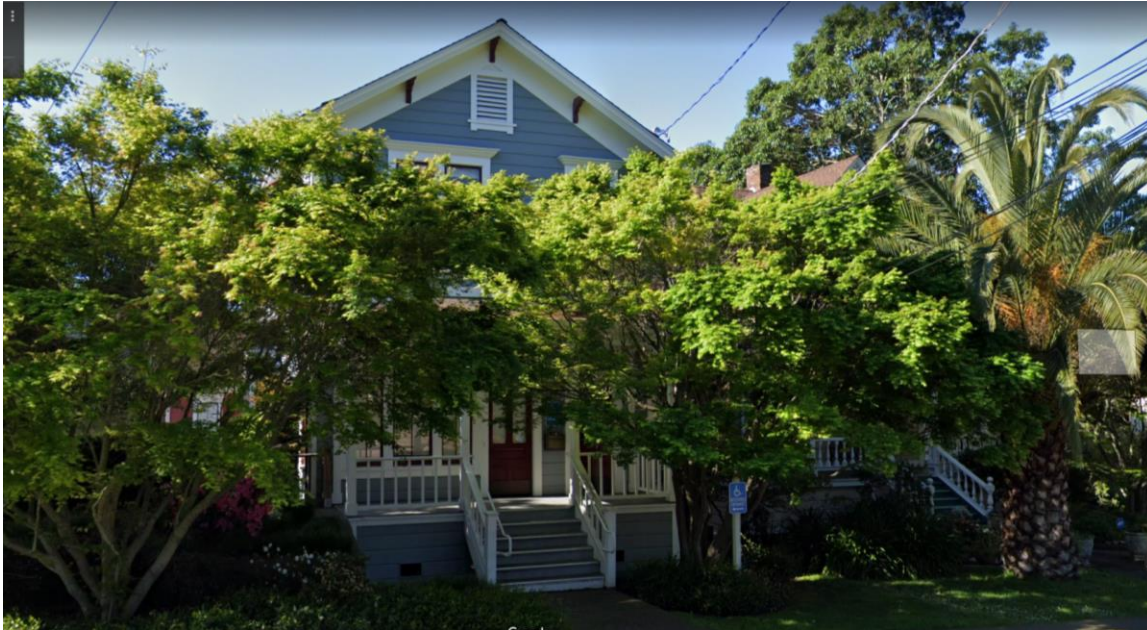
Address	1623 5th Avenue, Building B D	7N	B
APN	011-320-02		
Building Name	Kalliopeia Foundation <u>Victorian Village (Unit B)</u>		
Year Built			
Original Use	Residential		
Architectural Style	Victorian		
Architect/Builder			
Description	<u>Building B, which faces Fifth Avenue, is shown here. It was relocated to the site to make way for offices at 5th and D.</u>		
Integrity	Appears to retain integrity		
Significance	Potential local district contributor, not individually eligible at any level		
Notes

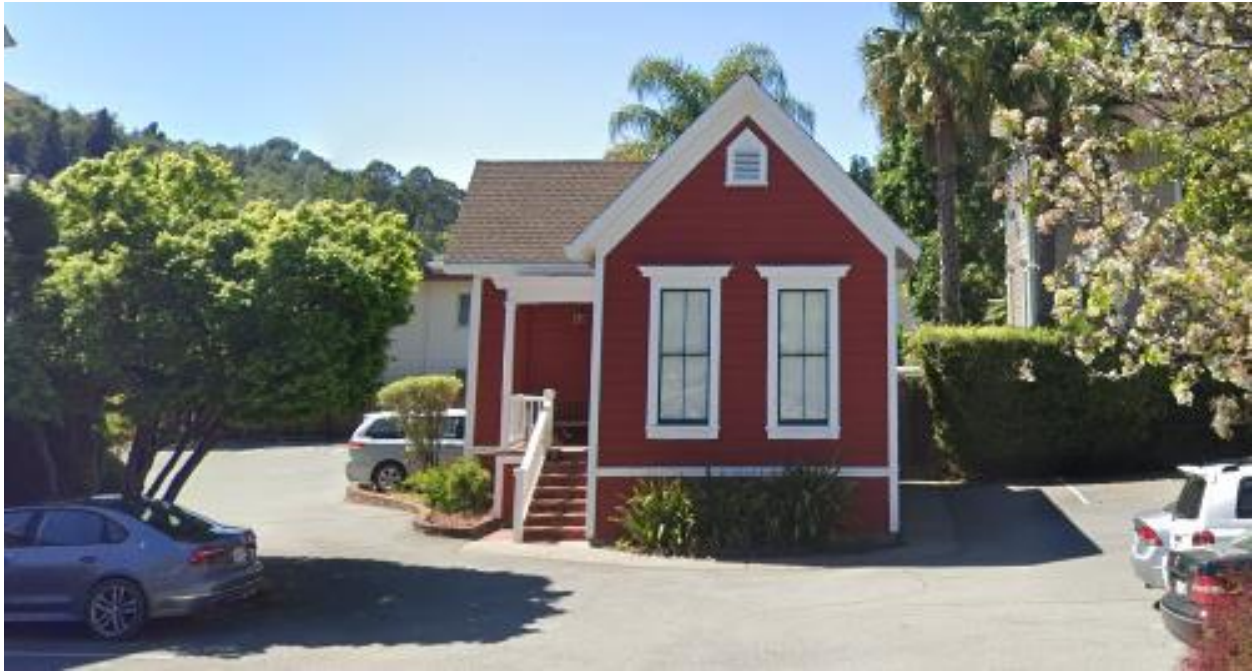
Address	1623 5th Avenue, Building C	7N	B
APN	011-320-03		
Building Name			
Year Built			
Original Use	Residential		
Architectural Style	Victorian		
Architect/Builder			
Description	The small one-story L-shaped building shares a parking lot with several other buildings and is set back from the street. It has a cross-gabled composition shingle roof. It is clad in horizontal channel board siding with fishscale shingle on the gable faces. A small integral porch on the main façade leads to the main entrance, which opens into the side of the projecting volume. Windows are tall, two-over-two light double-hung wood sash. <u>Was originally located close to C Street with a shed porch overhang.</u>		
Integrity	Appears to retain integrity		
Significance	Potential local district contributor, not individually eligible at any level		
Notes	<u>Colloquially called "little red schoolhouse"</u>

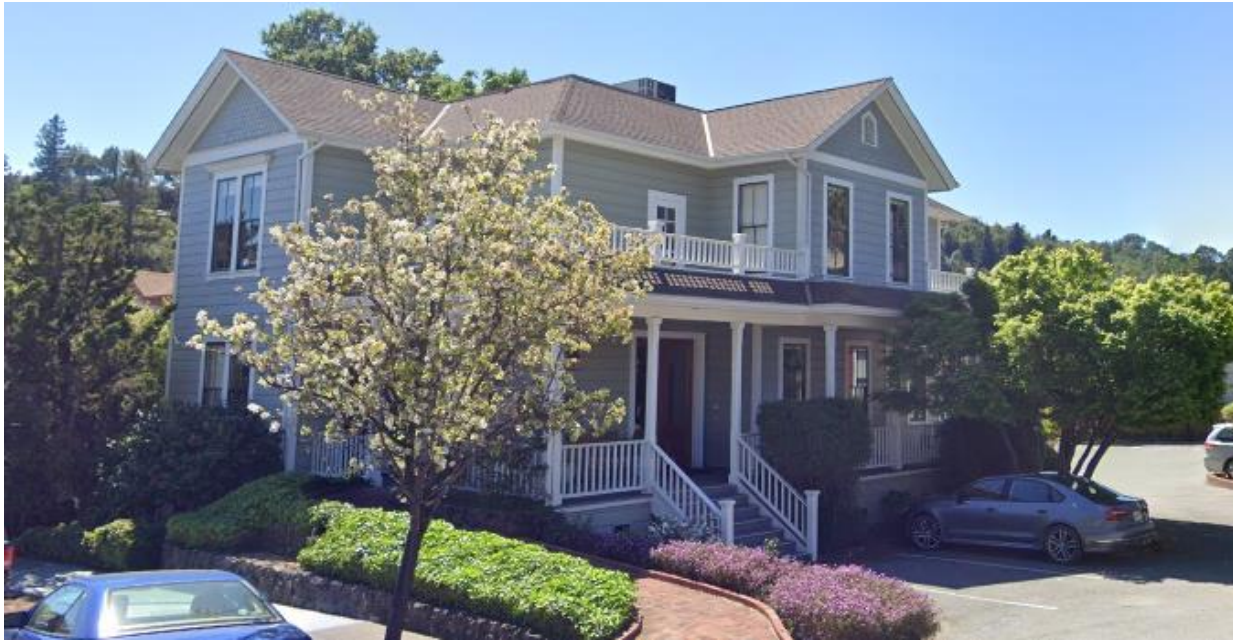
Address/code	1623-1627-1623 D Fifth Ave	7N	B
APN	011-320-04		
Building Name	<u>Victorian Village</u>		
Year Built	ND		
Original Use	Residential		
Architectural Style	Shingle, Folk Victorian		
Architect/Builder			
Description	<p><u>Building shown was relocated to this site from the corner of D and 5th to clear that corner for the office building currently on that site.</u> The two-story rectangular plan building shares a parking lot with several other buildings. It has a gable-on-hip composition shingle roof. The building features an integral wrap-around porch, with the main façade facing the parking lot rather than the street. It is clad in horizontal channel board siding with fishscale shingle on the gable faces. Windows are tall, two-over-two light double-hung wood sash. Multiple buildings, difficult to decipher Address/code /age etc.</p>		
Integrity	Retain integrity		
Significance	Buildings remains eligible as district contributors

Notes	<u>There were originally 3 buildings moved here, 1623B and 1623D are what remain</u>

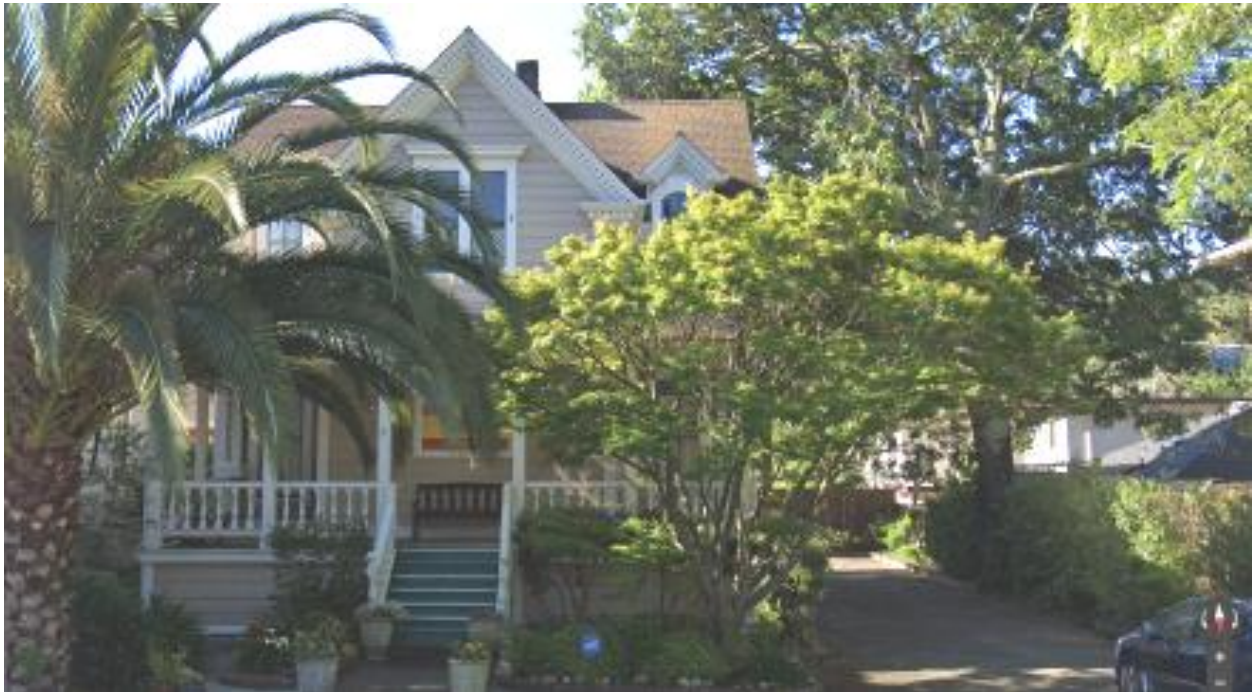
Address/code	1629 Fifth Ave	7N	A
APN	011-194-02		
Building Name	Thomas Morris House		
Year Built	1878 (spreadsheet)		
Original Use	Residential		
Architectural Style			
Architect/Builder	Queen Anne Cottage		
Description	The 1.5 story house is roughly rectangular in plan with steeply pitched cross-gabled roof and decorative gabled dormers. The house is clad in natural wood shingles. A full-width porch has its own hipped roof. The building is obscured by vegetation on available images and details are unclear.		
Integrity	Appears to retain integrity, field photography needed		
Significance	Eligible individually and as district contributor if field visit reveals integrity		
Notes	<u>Local landmark designation was requested by owner in 1976, but no official designation has been made.</u>

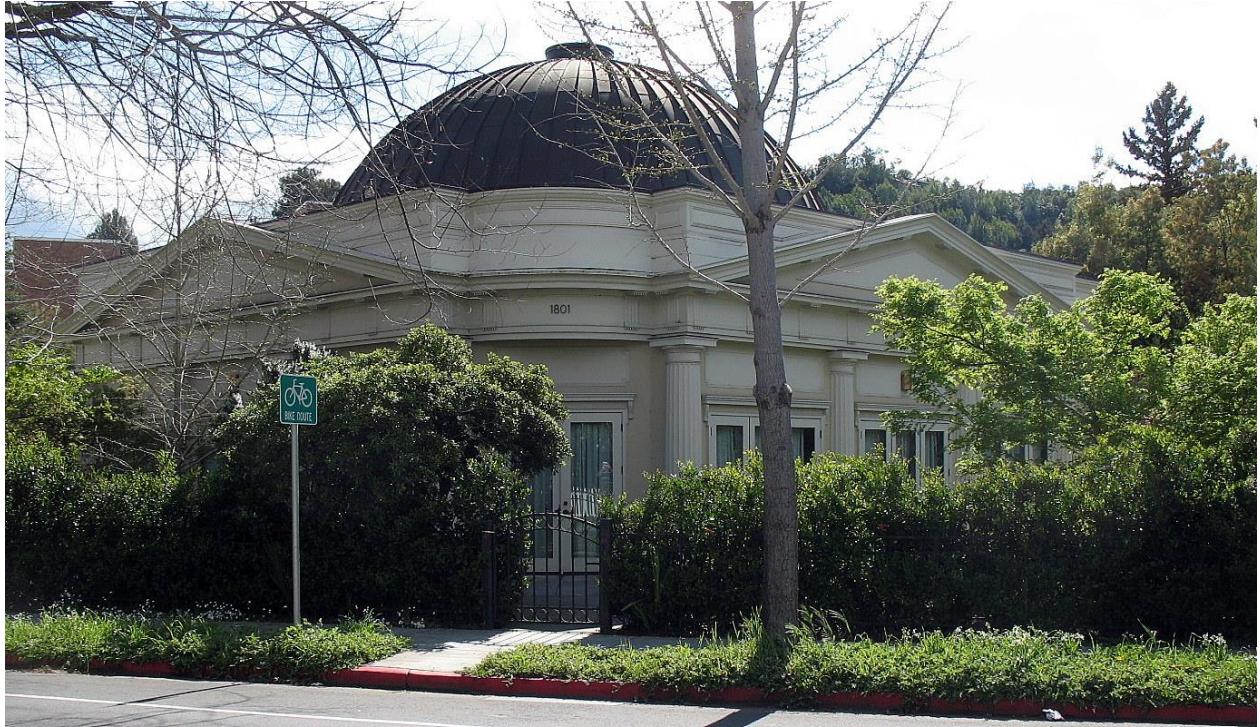
Address/code	1800 (1801) Fifth Ave	1S	A
APN	010-291-16		
Building Name	Victrola Pavilion/ San Rafael Improvement Club		
Year Built	1915/1916 (NRHP)		
Original Use	Panama-Pacific Exhibition Building/local clubhouse		
Architectural Style	Classical Revival		
Architect/Builder	William B. Faville		
Description	The single story building has a roughly square plan and flat/domed roof. Cladding is smooth plaster stucco or concrete. Classical revival ornament includes fluted plasters, cornice and frieze, and formal pediments. The building is obscured by vegetation on available images and details are unclear.		
Integrity	Appears to retain integrity, dome was added after 1983, field photography needed		
Significance	eligible as landmark and contributor		
Notes	<i>Listed on the NRHP 1984. Relocated after Panama Pacific Exhibition. Incorrectly addressed as 1800 Fifth Ave in some prior records.</i>

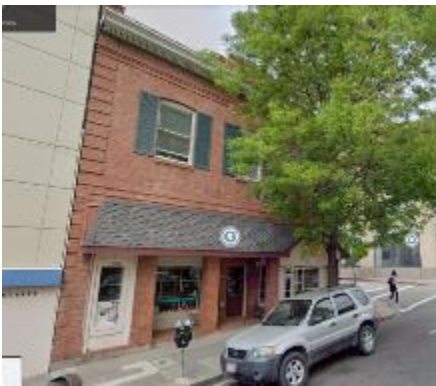
739 A Street (APN 013-011-09). Scout Headquarters, c.1943. The land and \$25,000 construction fund for this building was donated by Jacob Albert. It served as the meeting place for Boy, Girl, and Sea Scouts. The building is in excellent condition. It is given a C rating, meaning further evaluation is needed.

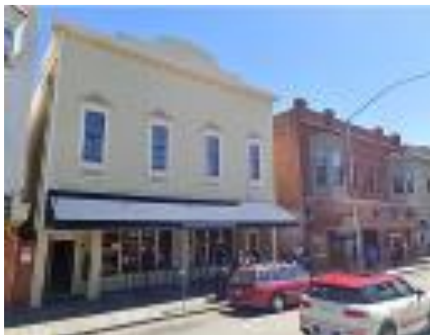
819-823 B Street (APN 011-256-09). Property was inventoried as a Contributor in the West Downtown Core district but a Fact Sheet was not prepared. Currently houses a Ramen restaurant. It is given a B rating.

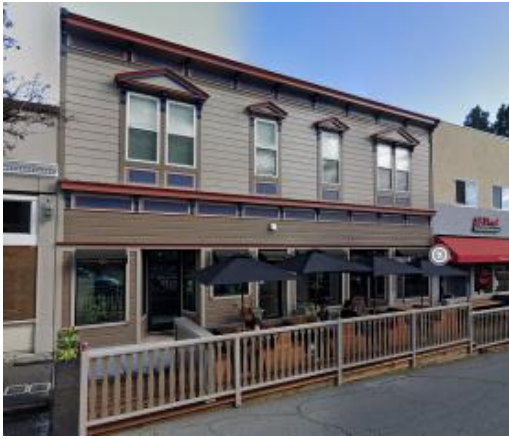
822 B Street (APN 011-262-15). St. Vincent de Paul. The initial survey identified this building as having minimal integrity due to modifications, and a Fact Sheet was not prepared. Upon public review and the secondary evaluation, the building was identified as meriting further study. Restoration has improved the façade relative to 1978 condition, and the building should be retained in the inventory. It is given an “B” rating.

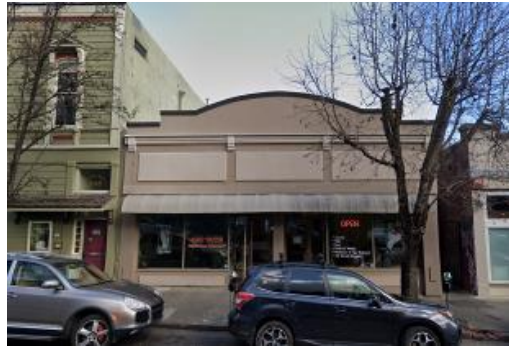
924 (920-926) B Street (APN: 011-261-12). Mash Building/ Butcher. M Herzog (now Libation Taproom). Contributing structure in the Eligible Downtown West historic district. Rated as B. Surveyors had questions about integrity of the recent remodel.

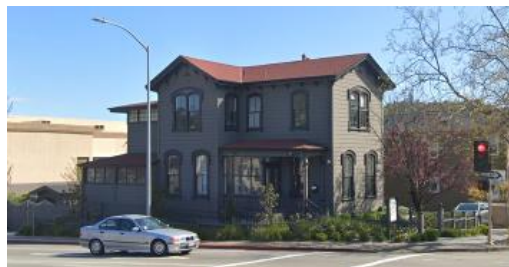
814 E Street (APN 011-252-27), Potential contributor, assign preliminary rating as B.

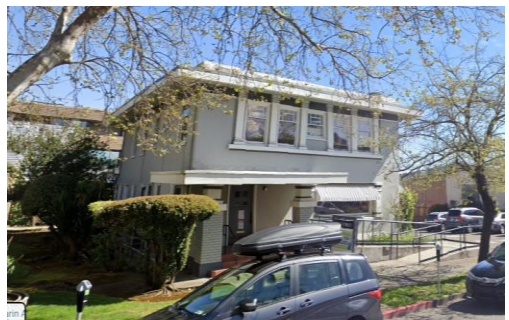
824 E Street (011-252-21). Residence converted to offices (Polaris/Greystone Financial Group). Future study recommended. No year of construction on record. Likely an "A" rated building.

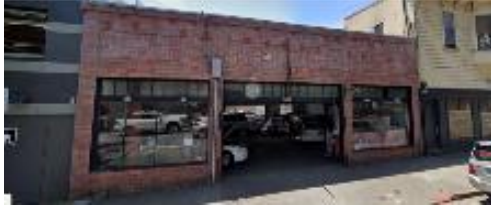
1016 (1018) E Street (011-204-16). Good example of Prairie Style architecture. Built in 1915. Retain as a C building, requiring further study.

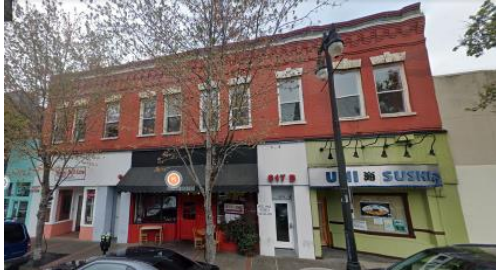
1117 3rd Street (APN 011-262-25). Milani Garage. Located within eligible west district. Retain as “C” for future evaluation. No year of construction provided by Assessor..R

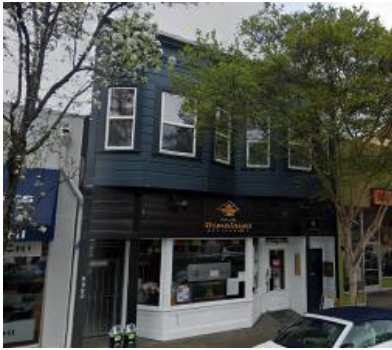
813-819 4th Street (APN 011-273-04). Mapped as a contributor—rated B. Apparently built in 1908 and is in good condition.

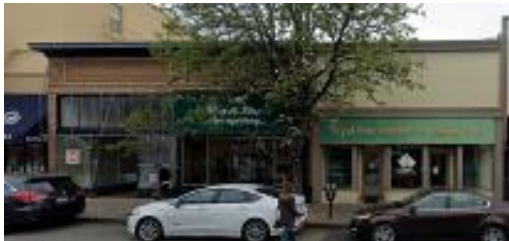
869 4th Street (APN 011-271-06). San Rafael Heritage recommended this building for further evaluation. Building dates to 1930 and appears to have an intact façade. Retain as “C” for future evaluation.

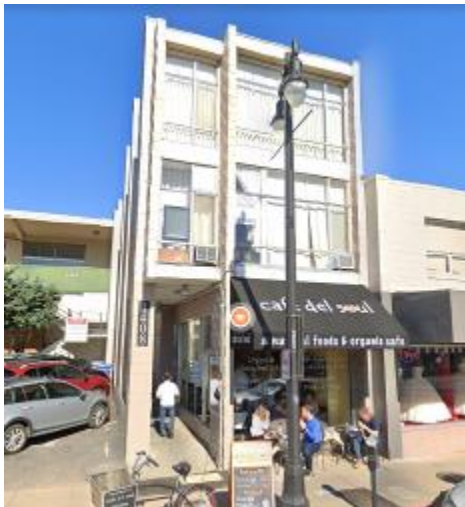
1318-1320 4th Street (APN 011-205-10). Marelli Bros. Shoe Repair. Likely a contributor to the West Downtown Core eligible district. Intact 1880 storefront and transoms. Adjacent building on same parcel may have resulted in Fact Sheet not being prepared. Retain as “B.”

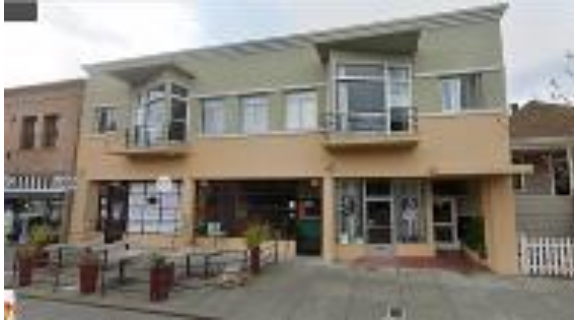
1408 Fourth St (APN 011-204-09). Mid-Century Modern, c. 1961. Rated C. Original storefront and windows

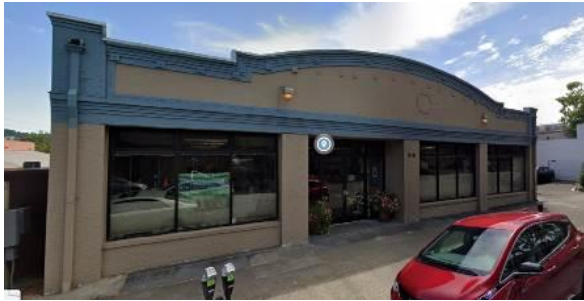
1559-1565 4th Street (APN 011-242-03). Good example of an international style storefront. Retain as “C” for future evaluation.
