Downtown San Rafael Precise Plan Historic Resources Inventory Summary Report

Originally Published December 2020

Revised and Re-released May 2021

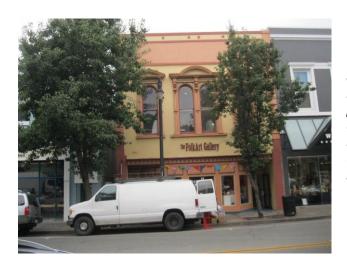
The oldest standing example of a commercial Italianate structure in San Rafael is at 1321 Fourth Street. Originally built in 1871 to house a business for local banker Upton Gordon, the building continued to be used for banking purposes through the early decades of the 20th century.28 The building has gone through several renovations but retains Italianate detailing in the pedimented arched windows and decorative quoins.

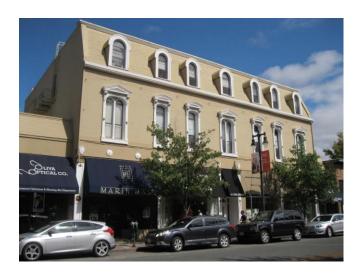
Originally known as the Mahon House, the building at 1330 Fourth Street first appears on the 1879 Sanborn Fire Insurance Map of San Rafael. The ground floor of the building has continuously been occupied with commercial space, with apartments or hotel rooms at the upper floor.³³

The identifying features of the Second Empire style include a mansard roof, dormer windows, molded cornices, and decorative brackets.³²

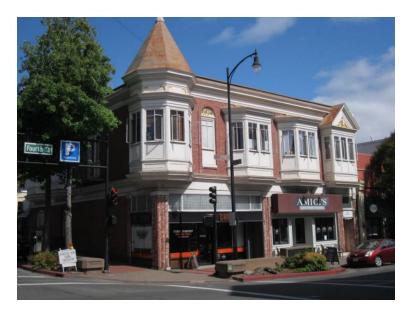
French-born tailor and local proprietor Louis Peter built 1240 Fourth Street to operate his dry goods business, opened in 1893. As a prominent commercial anchor on Fourth Street.

The most notable example of Queen Anne commercial style can be seen at 844-48 B Street (1890), and at 1240 Fourth Street (1893). Both buildings feature corner towers, cantilevered bay windows, and decorative cornices.

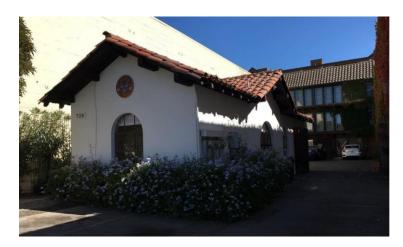
The station originally stood behind the Flatiron building at Second and B Street, but was moved to its current location in 1930 (720 [728] A Street).

While means of transportation were rapidly changing in the early 20th century, the need for rail stations persisted. The Spanish Colonial/Mission Revival "B Street Station" was constructed to replace an older structure in 1928. This era also saw the replacement of the 1884 railroad shed structure at Tamalpais Avenue with a Spanish Colonial/Mission Revival station in 1929. The station was designed by architect Frederick H. Meyer, who is credited with designing many "Mission Revival" stations throughout Marin County. The station has been significantly altered, but still stands in its original location.

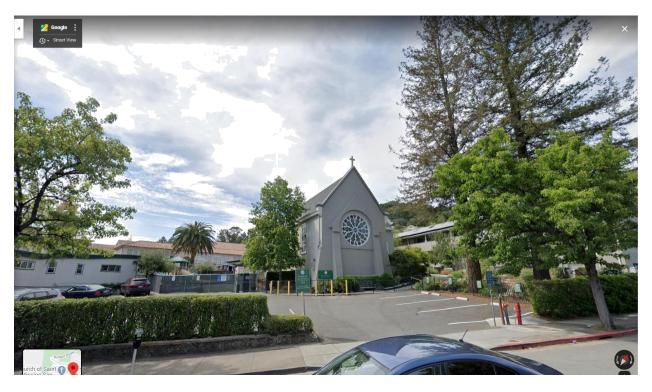
Address/code	1123 Court Street		В
APN	011-213-18		
Building Name	St Paul's Episcopal Church		
Year Built	1927 (church website), 1920 (DIJ 1949, Sanborn Maps)		
Original Use	Religious		
Architectural Style	Gothic Revival / Classical Revival		
Architect/Builder	WA Boyd, Contractor		
Description	The church sanctuary building is rectangular in plan with a steeply pitched gabled roof. It is connected to other church buildings to form a U-shaped compound building. The sanctuary has a rose window on the south elevation and pointed arch stained glass on the sides. It is clad in smooth stucco (may be reinforced concrete construction) with decorative buttresses. The main entrance is in a projecting volume near the east corner of the north elevation and features a pointed arch doorway under a pedimented gable.		
Integrity	Unknown. Building was moved from 4 th and E		
Significance	Probably not eligible for State or National listing, but eligible for local listing.

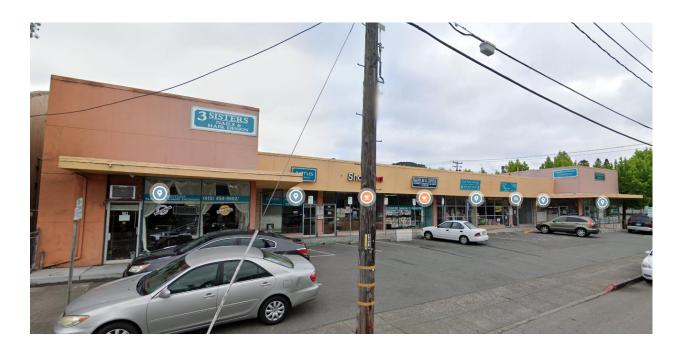
Address/code	963-977 Grand Av		D
APN	014-123-10		
Building Name			
Year Built	1956		
Original Use			
Architectural Style			
Architect/Builder			
Description	The one-story building has a flat roof and long, narrow U-shaped plan. The building is an early example of a strip shopping center with parking in front of the building. There is a slit-face rock bulkhead, as well as vertical strips at both ends of the long recessed volume. Elsewhere, the building is clad in smooth stucco. Large storefronts line the main façade. The projecting volumes at either end have higher roofs than the rest of the building and flat awnings above the storefront windows. Heavy soffits above storefronts on the recessed volume are canted.		
Integrity	Appears to retain integrity		
Significance	Lacks architectural distinction	, not eligible as landmark	or contributor
Notes

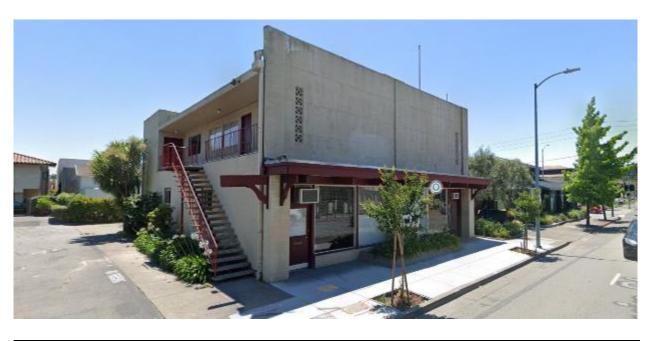
Address/code	914 Irwin Street		D
APN	014-123-21		
Building Name			
Year Built			
Original Use			
Architectural Style			
Architect/Builder			
Description	The two-story building has a rectangular plan and flat roof. There is brick at the corners, down the center, and at the main façade bulkhead, and the building is otherwise clad in textured stucco; the second-floor parapet of the main façade is concrete with a pattern of large squares. There are two storefronts with partially glazed doors and large windows. A small, flat wooden awning with exposed rafters and decorative knee braces shelters the first floor.		
Integrity	Integrity appears impaired		
Significance	Not significant at any level

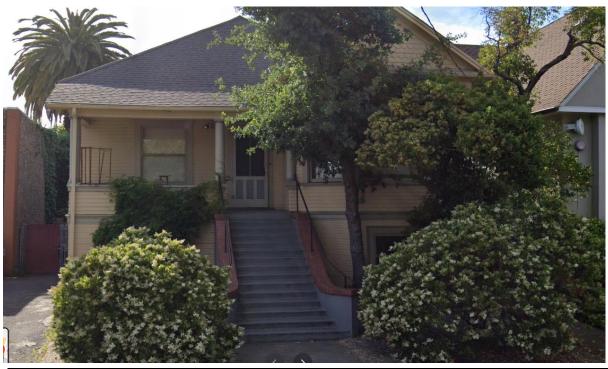
Address/code	1011 Irwin Street		В
APN	014-085-10		
Building Name			
Year Built	1907		
Original Use	Residential		
Architectural Style			
Architect/Builder			
Description	The two-story building has a rectangular plan and hipped roof with small gables on the main façade and one side. Under the gable on the front is a projecting volume with a second-floor bay window; next to the volume is the second-floor partial-width projecting porch. The building is clad in a wood clapboard and decorative shingles at gable ends.		
Integrity	Retains Integrity		
Significance	Good example of hipped roof	cottage, eligible as contri	butor
Notes		<u> </u>

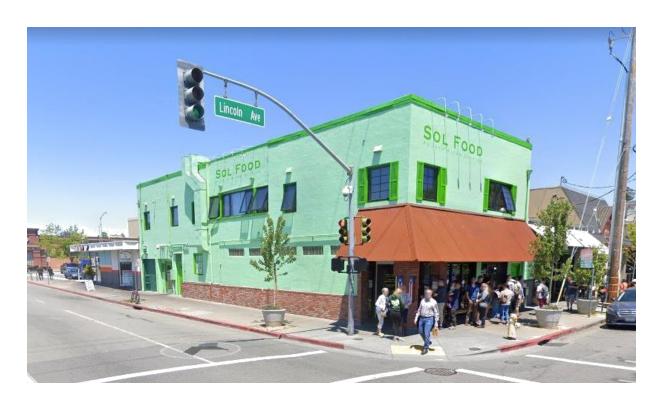
901 Lincoln Avenue/		
Address	806 3 rd St		D
APN	011-273-12		
Building Name			
Year Built	c1920		
Original Use			
Architectural Style			
Architect/Builder			
Description	The two-story building has a flat roof and a rectangular plan. There is a recessed entrance in the corner and floor-to-ceiling windows along most of the first story of one façade. Windows on the second floor have wooden shutters. The first floor also features a corrugated metal awning with a wide brick support above the façade with windows. The other street-facing façade has a low strip of brick at the bottom; otherwise, the building is clad in smooth stucco.		
Integrity	Appears to lack integrity, no visible 1920s fabric		
Significance	Not eligible		
Notes

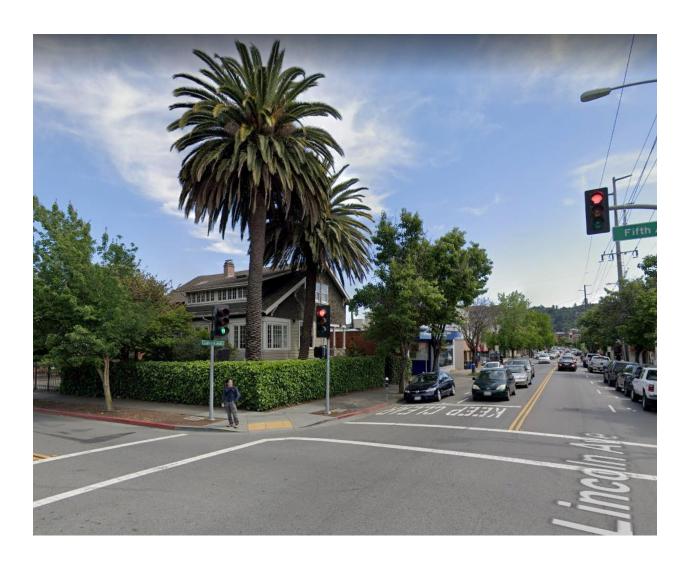
Address	1016 Lincoln Avenue	7N	В	
APN	011-227-01		•	
Building Name				
Year Built	c1889-1891			
Original Use				
Architectural Style				
Architect/Builder				
Description	The one-and-a-half story building has a roughly rectangular plan and a gabled roof. It is surrounded by a high, vine-covered fence. It has a raised foundation and a partial-width integral porch. There is a long dormer window on the side façade of the corner building. The first floor is clad in wide horizontal board siding and the second floor is clad in wood shingle.			
Integrity	Appears to retain integrity, more study needed			
Significance	Potential district contributor	, see note below		
Notes	Was the Grateful Dead head	quarters until the death of	Jerry Garcia.

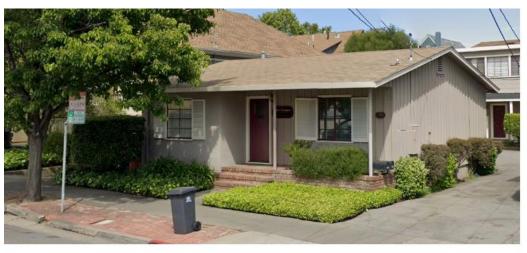
Address	1116 Lincoln Avenue		D
APN	011-226-13		
Building Name			
Year Built	1953		
Original Use	Residential		
Architectural Style			
Architect/Builder			
Description	The one-story building has a roughly square plan and gabled roof. The entrance is centered on the main façade at one end of a partial-width integral porch with a brick floor, steps, and planter. Windows are eight-light with large wooden shutters. The building is clad in board-and-batten.		
Integrity	Integrity appears impaired		
Significance	Not eligible, lacks significance	······································	
Notes

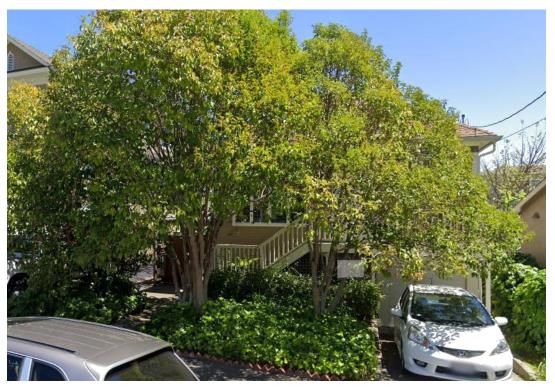
Address	1118 Lincoln Ave		С
APN	011-226-10		
Building Name			
Year Built	c1903		
Original Use	Residential		
Architectural Style			
Architect/Builder			
Description	The two-story building has a hipped composition shingle roof and rectangular plan. The second-floor main entrance is accessed by a side-facing staircase that runs along the length of the main façade. There is a metal roll-up garage door underneath the staircase on the first floor. The building is clad in both narrow and wide horizontal board siding.		
Integrity	Integrity appears impaired; v	isibility limited more study	needed
Significance	May be eligible as district cor	ntributor	
Notes		<u> </u>

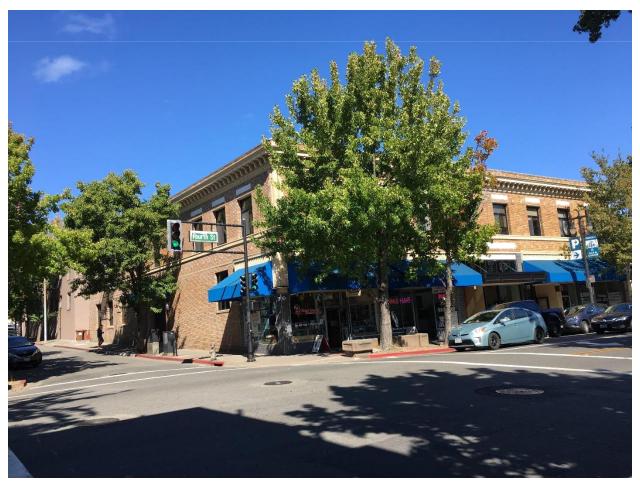
1010 Lootens/			
Address/code	882-884 Fourth Street	7N	Α	
APN	011-224-18			
Building Name	Masonic Building			
Year Built	1910 (spreadsheet)			
Original Use	Lodge/Storefront Commercial			
Architectural Style	Classical Revival			
Architect/Builder				
Description	The lodge/commercial building is two story and rectangular in plan with a flat roof. The building is clad in brick and has facades on Fourth and Lootens. The heavy cornice features decorative brackets and dentil moulding, there is also decorative moulding separating upper and lower floors. Storefronts and doors have been replaced, and original transoms are covered except over the recent central entrance on Fourth Street leading to the lodge rooms.			
Integrity	Retains sufficient integrity for listing as district contributor despite replacement windows and storefronts.			
Significance	Eligible as district contributor and potential local landmark

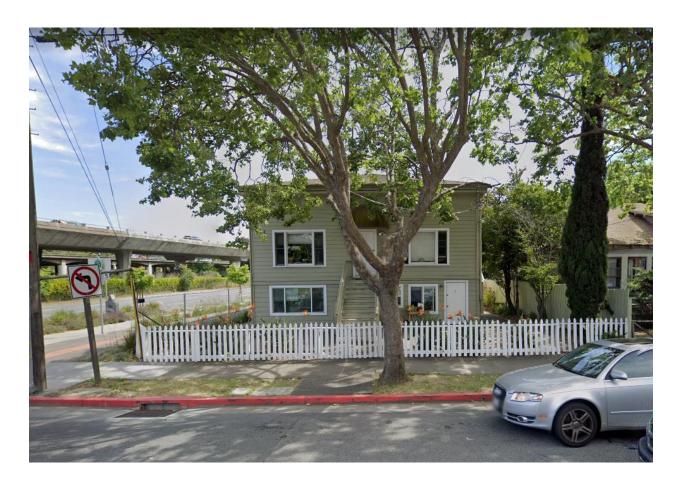
Address	633 Mission Avenue		D
APN	014-081-02		
Building Name			
Year Built	Pre-1894		
Original Use	Residential		
Architectural Style			
Architect/Builder			
Description	The two-story building has a rectangular plan and low-pitch hipped composition shingle roof. There are multiple entrances on the main façade, one on the first floor and one on the second floor, accessed by a wooden staircase and sheltered under an awning. The building is clad in horizontal board siding.		
Integrity	Appears to lack integrity		_
Significance	Not eligible		
Notes

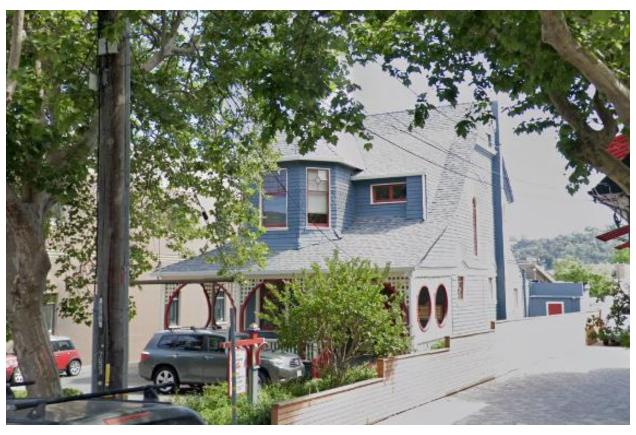
Address	705 Mission Avenue	7N	Α			
APN	011-226-03	011-226-03				
Building Name	NWP Station Master's House					
Year Built	c1900					
Original Use	Residential					
Architectural Style	Shingle	Shingle				
Architect/Builder						
Description	The one-and-a-half-story building has a roughly rectangular plan. It has a hip-on-dual-pitched-gable roof. It has a full-width integral porch with rounded openings on all sides. Double hung wood sash windows have various decorative configurations. It is clad in shingle, with several decorative strips of straight-lined fishscale on the second-floor projecting volume.					
Integrity	Appears to retain integrity					
Significance	Good example of rare style, Eligible as landmark and district contributor					
Notes		·	·

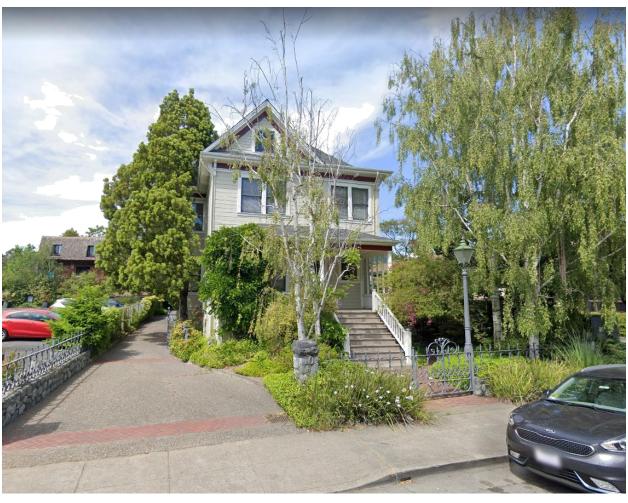
Address	710 Mission Avenue		Α	
APN	011-186-10			
Building Name				
Year Built	c1900			
Original Use	Residential			
Architectural Style	Queen Anne	Queen Anne		
Architect/Builder				
Description	The two-and-a-half story buil with decorative brackets at the raised elevation and a full-wind center that is screened on the The building is clad in horizor fishscale on the attic-floor gamany of them in pairs.	ne cornice and a roughly ro dth one-story projecting fr e sides. The entrance is ce atal board siding, with a co	ectangular plan. It has a ront porch with at the ntered and recessed.	
Integrity	Appears to retain integrity			
Significance	Eligible as individual landmar	k and district contributor		
Notes	Converted to offices

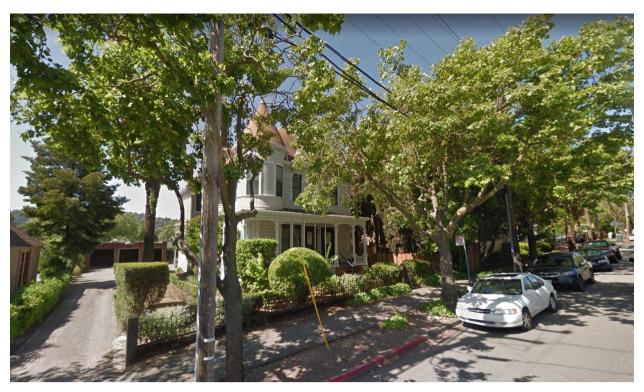
823-25 Mission		
Address	Avenue	3S	A
APN	011-223-02		•
Building Name			
Year Built	Pre-1887		
Original Use	Residential		
Architectural Style	Queen Anne		
Architect/Builder			
Description	The two-story building has a roughly rectangular plan and a gable-on-hip composition shingle roof with a round, pointed tower in one front corner. There is a projecting full-width porch on the first floor that extends wider than the house at one side. The building is clad in horizontal wood siding. Queen Anne decorative features include brackets at the tower cornice, ornate window casings, and square porch columns with capital and scrolled brackets.		
Integrity	retains integrity		
Significance	Excellent example of high style Queen Anne architecture, landmark and contributor		
Notes

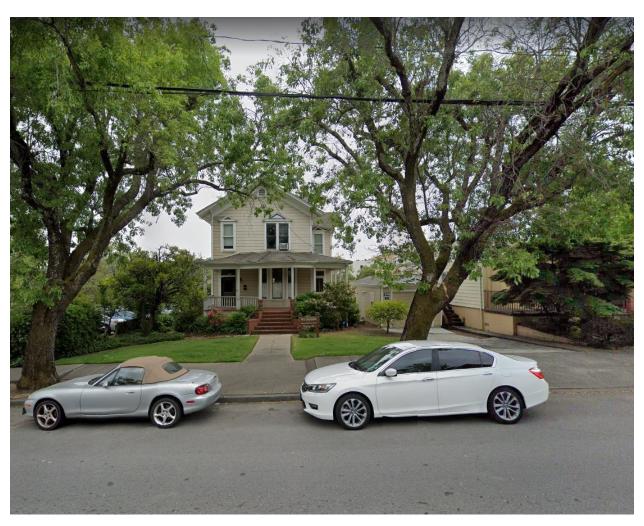
Address	907 Mission Avenue	7N	A-
APN	011-221-03		
Building Name	Cheda House		
Year Built	c1900 (moved here from the 0	Cheda Block (SE of 4 th and a	A)
Original Use	Residential		
Architectural Style	Folk Victorian		
Architect/Builder			
Description	The two-story building has a composition shingle roof feat corners. There is a projecting the main façade and side, wit accessed by a set of brick ste wood sash windows, and tho pediments. The building is cladetached garage next to the gabled roof with a gable truss	tures decorative triangular full-width wraparound poth entrances at either end ps. The building has tall, not se on the second floor feath in horizontal board sidir building with matching cla	knee braces at the orch on the first floor of and a bay window. It is arrow double-hung ture decorative wooding. There is a small
Integrity	Appears to retain integrity		
Significance	Eligible as landmark and cont	ributor

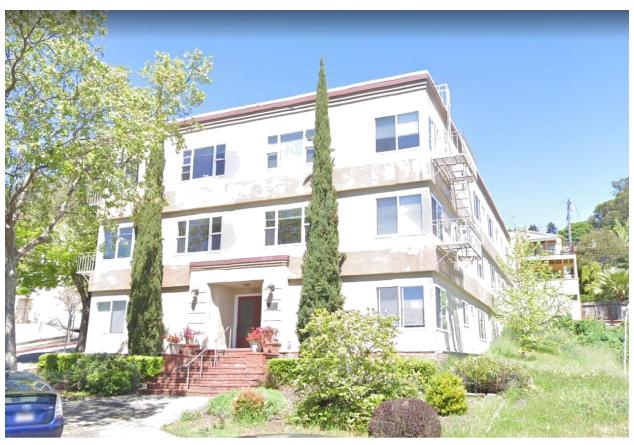
Address	1012 Mission Ave		D
APN	011-174-11		
Building Name			
Year Built	1949		
Original Use	Apartment Building		
Architectural Style	Streamline Moderne		
Architect/Builder			
Description	The three-story building has a rectangular plan with an open courtyard in the center and a flat roof. There is a large parking lot to one side of the building. Located on a slope, the building is only two stories at the back. The recessed front entrance is accessed by a set of brick steps at the center of the main façade. Windows are fitted with various types of replacement sash.		
Integrity	Appears to lack integrity		
Significance	Unlikely to be significant		
Notes

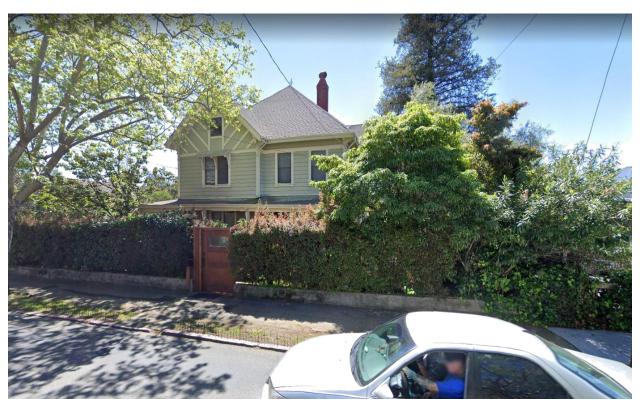
Address	1135 Mission Av		Α
APN	011-213-04		
Building Name	DeCourtieux House		
Year Built	1893		
Original Use	Residential		
Architectural Style	Stick		
Architect/Builder			
Description	The two-and-a-half-story building has a roughly rectangular plan and combination cross-gabled and hipped roof. While the first floor is mostly obscured behind a tall hedge, the building appears to have a full-width integral porch with a slightly projecting roof on the main façade. There is a variety of cladding, including horizontal channel board siding and half-timbering on the gable faces.		
Integrity	Appears to retain integrity		
Significance	Potential local district contribution changed to an individual resource.	•	, ,
Notes

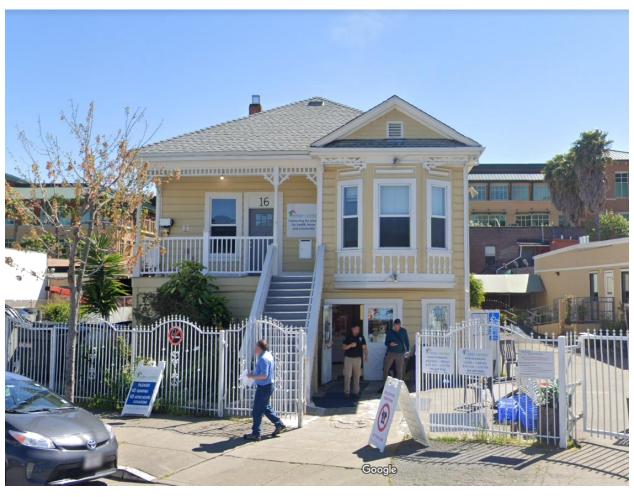
Address	16 Ritter Street		С
APN	011-272-04		
Building Name			
Year Built	1911 (spreadsheet)		
Original Use	Residential		
Architectural Style	Queen Anne Cottage		
Architect/Builder			
Description	The two-story building has a rectangular plan and a gable-on-hip composition shingle roof. There are two entrances on the main façade: a set of double doors on the first floor, and an entrance sheltered by a partial-width integral porch on the second floor. There is a bay window above the first-floor entrance. The building is clad in horizontal drop siding. The building has vinyl windows, a replacement door, replacement porch balustrade, and may have been raised.		
Integrity	Integrity appears impaired; windows replaced, door altered		
Significance	Initially rated poorly but r	nay require additional evalu	ation.
Notes	The last of a row of modes	t homes considered for inclu	usion in 1978.

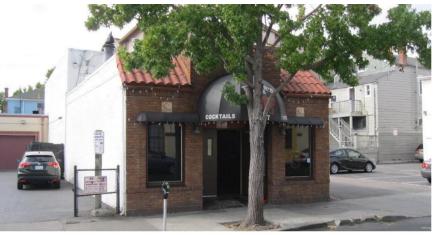
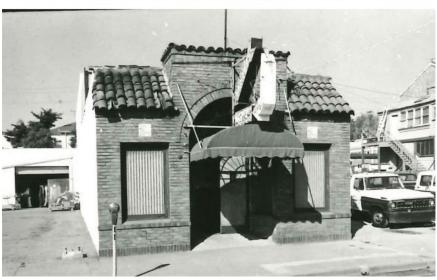
Address	927 Tamalpais Av	3S	В
APN	011-275-04		
Building Name	Barrel House		
Year Built	c1925 (spreadsheet)		
Original Use	Taxi office and/or ferry ticke	et office	
Architectural Style			-
Architect/Builder			
Description	The narrow rectangular building is one story at the front and two stories toward the back. It has a flat roof and is clad in brick with some vertical board siding on the second story. The brick is unpainted on the main façade. The main façade also features a slanted tile roof on either side of the partial-width parapet that shelters the arched main entrance. There are large decorative tiles over the small storefront windows. The façade and single story portion is the principal resource.		
Integrity	Retains integrity, see 1970s photo above		
Significance	Eligible as district contributor, lacks significance for landmark status		
Notes

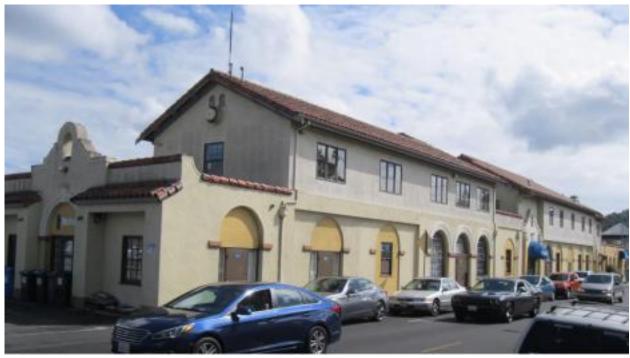
Address	930 Tamalpais Av	3S	С
APN	011-277-01		
Building Name	Northwestern Pacific Railroa	d Depot	
Year Built	c1929 (spreadsheet)		
Original Use	Railroad Depot		
Architectural Style	Mission Revival		
Architect/Builder	Frederick H Meyer, AIA		
Description	The two-story linear building runs along the railroad tracks next to Tamalpais Avenue. It is clad in smooth stucco and has a gabled tile roof. Windows are varied, but all have multiple small lights; most are wide vertical eight-over-eight light windows. A series of arches in shallow relief along the main façade have windows or doors in them. There are a number of entrances on the main façade, but the main entrance is located under a cloth awning and large decorative arch.		
Integrity	Appears to retain integrity, more study needed, 2 nd story addition		
Significance	Initially assigned "C" rating, but subsequently added to potential eastern historic district. Will require further evaluation.

- 930 Tamalpais (Northwestern Railroad Depot, aka "Whistlestop"). The Depot played a role in the development of transportation in Marin County and is regarded as a potential opportunity for adaptive reuse and restoration. The current owner (Vivalon) uses the building as a senior center but will be relocating to a new facility a few blocks away. Past studies of the building's historic importance have reached different conclusions; the 2019-2020 Precise Plan Historic Resources Survey found that the building's integrity had been compromised by prior alterations and additions, making it ineligible for landmark status.

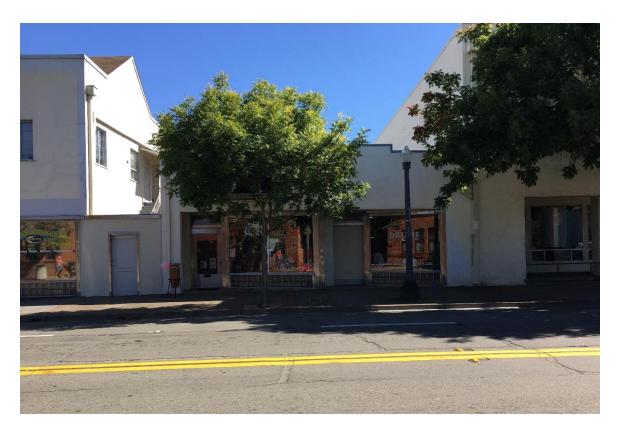
Address/code	740 A Street		D
APN	013-012-20		
Building Name	A Drummer's Tradition (dru	m store)	
Year Built	1948		
Original Use	Retail		
Architectural	Midcentury Modern		
Style			
Architect/Builder			
Description	The one-story commercial building is rectangular in plan with its main façade immediately adjacent to the sidewalk. It has a simple stepped parapet and two storefronts with entrances left of display windows. Storefronts slant outward from recessed doors creating a zig-zag façade. The building has glass block bulkheads and metal window and door trim. Cladding is stucco. There is a small wood-clad volume at the rear of the main building with a shed roof.		
Integrity	Appears to retain integrity, may have been altered 1950s		
Significance	Potential local district contributor if a sufficient concentration of postwar commercial resources is present, not individually eligible at any level. Initially rated "B" in the 2019 Survey. Because this structure is not in an eligible district and is not eligible as an individual resource, its final rating is D.

Notes	Bulkhead and trim match the adjacent building to the north (742-744 A), probably both were remodeled in the 1950s as other details differ. Both buildings should probably be included or not included in potential district

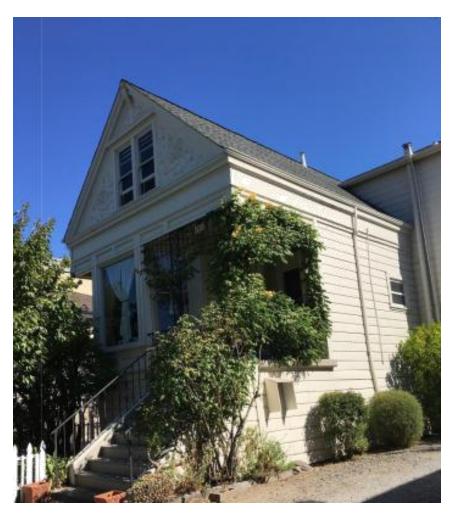
Address/code	808 A Street		В
APN	011-264-07		
Building Name			
Year Built	C1890 (Sanborn Maps)		
Original Use	Residence		
Architectural Style	Queen Anne Cottage		
Architect/Builder			
Description	The 1.5 story house has a roughly rectangular plan and a raised basement. It has a steeply pitched front-gabled roof. It is clad in drop wood siding and has a combination of double-hung wood sash and replacement windows. Decorative features include ornamental scrolls at the main façade gable end and a paneled frieze. Porch supports and balustrade are wrought iron.		
Integrity	Retains integrity despite replacement of some windows and original wood porch details		
Significance	Local district contributor, not individually eligible for architecture due to alterations		
Notes

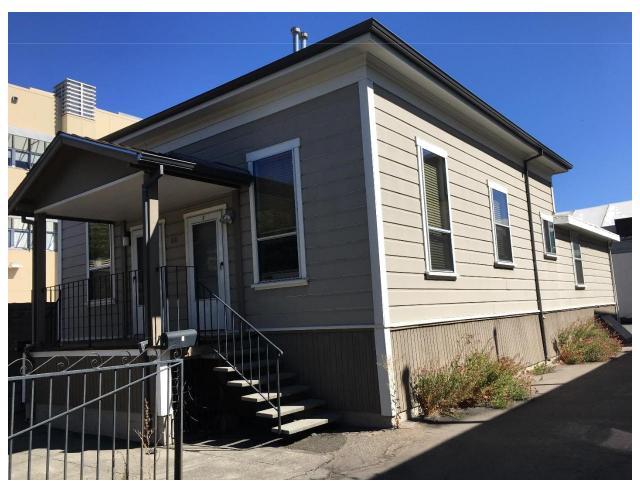
Address/code	812 A Street		D
APN	011-264-08		
Building Name			
Year Built	Before 1887 (Sanborn Maps)		
Original Use	Multi-family Residence		
Architectural Style	Folk Victorian Duplex		
Architect/Builder			
Description	The one story duplex has a rectangular plan and a slightly raised basement. Its front wing has a steeply pyramidal roof; the rear of the building has a lower shed roof. Front doors are side by side in the symmetrical main façade. The building is clad in drop wood siding with vertical groove plywood at the basement level and has vinyl replacement windows. A partial width projecting porch has a low pitch gabled roof, concrete steps with open risers, and a balustrade are wrought iron. The building lacks decorative features		
Integrity	Lacks integrity due to replacement of windows and original full-width porch, basement siding, and installation of inappropriate porch steps and balustrade

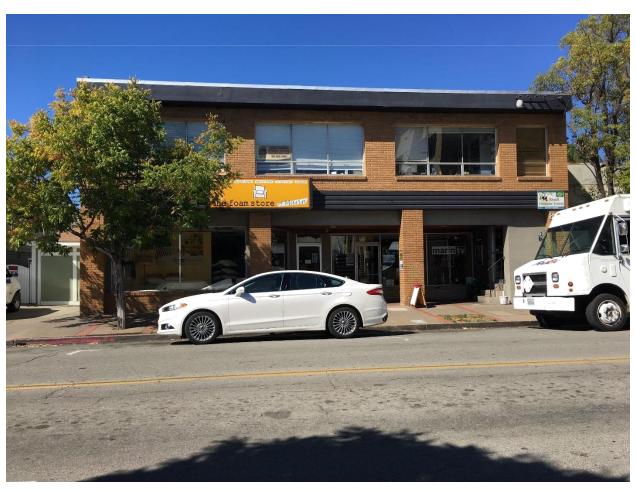
Address/code	813 A Street		С
APN	011-262-06		
Building Name	Foam Store		
Year Built	1951 (Sanborn Maps, aerials)		
Original Use	Commercial		
Architectural Style	Midcentury Modern		
Architect/Builder			
Description	The two story commercial building has a rectangular plan with storefronts on the ground floor and offices above. It has a flat roof with a heavy soffit on the upper floor. It is clad in brick with small areas of stucco. Upstairs windows are three-part steel casement. Decorative grooved moulding separates upper and lower stories. The storefront in the south third of the building is adjacent to the sidewalk, while the north end storefront and entrances are recessed behind heavy brick pillars and are fitted with contemporary replacement aluminum frame doors and windows.		
Integrity	Retains integrity despite storefront replacement.		
Significance	Potential local district contributor if a sufficient concentration of postwar commercial resources is present, not individually eligible at any level. Initially rated as "B" but requires further evaluation.

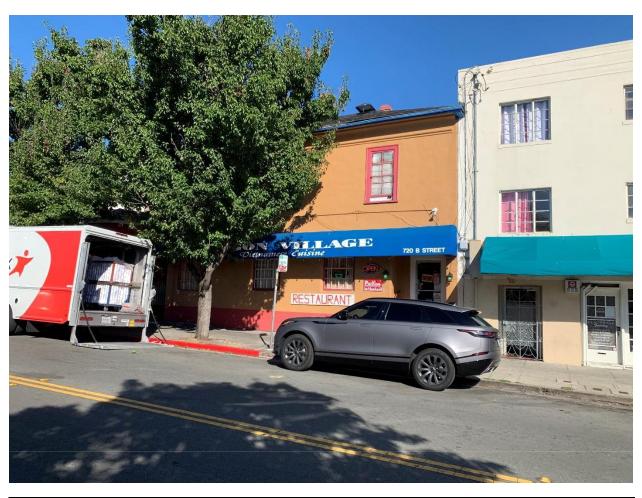
Address/code	720 B Street		Α
APN	013-011-02		
Building Name	San Rafael Hotel (now Saigo	n Village)	
Year Built	Before 1887 (Sanborn Maps)		
Original Use	Saloon/restaurant with rooms	for railroad workers upsta	nirs
Architectural Style	American Foursquare		
Architect/Builder			
Description	The two story residential-style building has a triangular plan to conform to the railroad tracks to its northeast. It features a medium pitch hipped roof in front with a flat-roofed addition at the rear. Cladding is stucco, windows are a combination of double-hung wood sash and fixed multi-light. The entrance is fitted with a fully-glazed aluminum frame commercial-style door. There are commercial buildings immediately adjacent to its side elevations.		
Integrity	Current appearance probably c1905, door modern, requires more study		
Significance	Potential local district contributor as extant nineteenth century restaurant/hotel. Conforms to former RR alignment. Not eligible for its architecture.

Notes	Good candidate for restoration	n incentives.

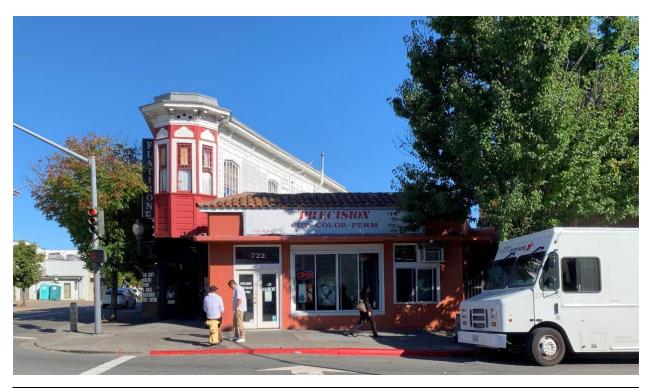
Address/code	724 B Street	7N	Α
APN	013-011-05		
Building Name	Flatiron Building		
Year Built	1883		
Original Use	Saloon/residential (rooms for	rent)	
Architectural Style	Queen Anne Commercial		
Architect/Builder			
Description	The two story commercial buthe ground floor and apartmed elaborated with ornamental land has double-hung wood schighly decorative projecting bedecorative spandrel panels along doorways on the north efitted with wood-frame Frence	ents above. It has a flat room or ackets and frieze. It is class windows. Its northwest asy above the main entrare pove multi-light stained-glevation feature pediments the doors, and there is a his	of and cornice ad in drop wood siding st corner features a nce which features ass windows. Windows ted hoods. Entrances are storic painted beer sign.
Integrity	Retains integrity, only doors appear to have been altered		
Significance	Individually NRHP eligible under C and potentially A, also local contributor

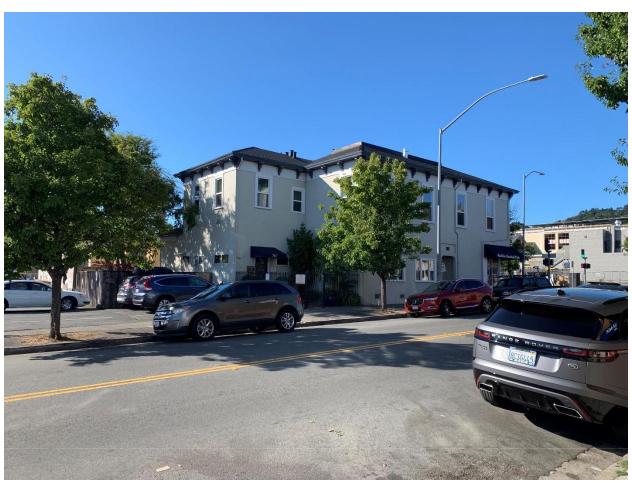
747 B Street/		
Address/code	1201 Second Street	N/A	C
APN	013-011-056		
Building Name	Cosmopolitan Hotel		
Year Built	Before 1887 (Sanborn Maps)		
Original Use	Hotel		
Architectural Style			
Architect/Builder			
Description	The two story hotel building has an irregular plan with moderate pitch hipped roof and ornamental brackets at the cornice. Cladding is stucco and the building has vinyl replacement windows. There is a small wood frame storefront at its northwest corner. The balance of the lower north elevation lacks fenestration.		
Integrity	Does not appear to retain integrity, storefront, blank wall all appear to be to "C" during public review	•	
Significance	Unlikely to be eligible, lack of integri	ty	
Notes	Property was mistakenly shown as 90	11 B in the 1978 Sur	rvey

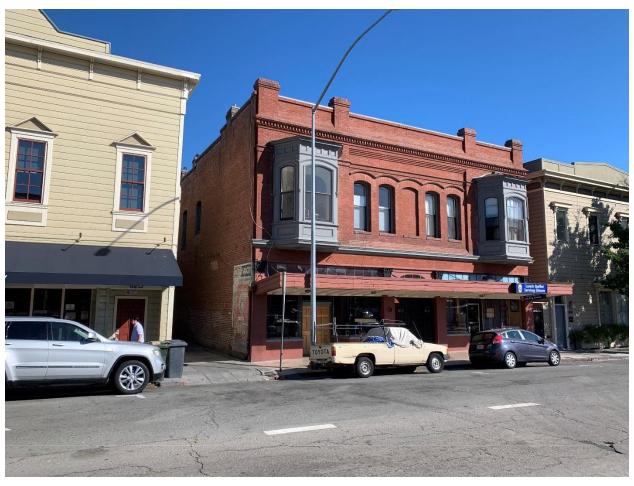
Address/code	810-814 B Street	3\$	Α
APN	01011-262-14		
Building Name	World Wide Antiques/Victory	Grocery	
Year Built	Before 1894 (Sanborn Maps)		
Original Use	Retail storefront		
Architectural Style			
Architect/Builder			
Description	The two story commercial building has a rectangular plan with flat roof and parapet. Cladding is brick with ornamental features including dentil moulding, upper floor pilasters, and window hoods also executed in brick. Two projecting wood upstairs bays have decorative frieze and window hoods. Window openings are arched and fitted with wood sash. Ground floor pilasters have Corinthian capitals flanking multiple light transoms above storefronts. A metal awning projects from the façade just below the capitals. Bulkheads and pilasters have been stuccoed below the awning. Ground floor doors are residential-type paneled wood doors on the north and a contemporary aluminum frame glazed door on the south.

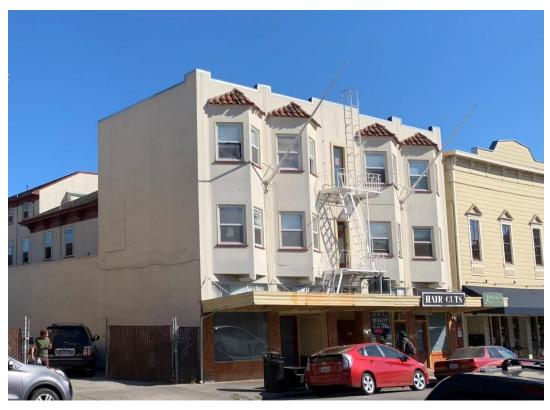
Address/code	826-832 B Street	5S2	С
APN	01011-262-16		
Building Name	Albion House, Hotel Carmel		
Year Built	1887 Albion Hotel, 2 story, sn		
	expanded footprint; 1907/19	24 unchanged; 1930 Hotel	Carmel current
	footprint (Sanborn Maps) c19	30 current façade (spread	sheet)
Original Use	Retail storefront/hotel		
Architectural Style			
Architect/Builder			
Description	The original 1887 building stands in the middle and the 1894 rear addition (probably the Cypress Villa Hotel) reflects the same style. The three story street-facing building is rectangular in plan with a lower-height volumes at the rear. Its main façade is immediately adjacent to the sidewalk. The roof is flat with a shaped parapet. Four slanted bays project from the upper stories; each is topped with a tile roof. Fenestration consists of vinyl replacement windows. There is a fire escape with exits at the center of the façade. A metal awning in front of multiple-light transoms shades the ground floor storefronts. Upper floors are stuccoed while the ground floor is clad in tile. Storefront entrances, one of which is recessed, are fitted with partially glazed paneled wood doors.

Integrity	May retain integrity to c1930 façade, more research needed		
Significance	Potential local contributor, not individually eligible		
Notes

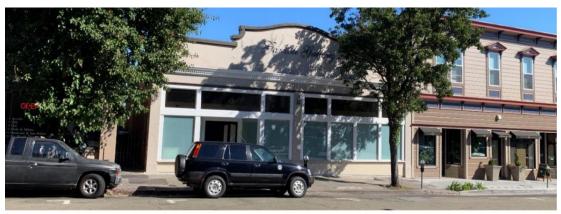
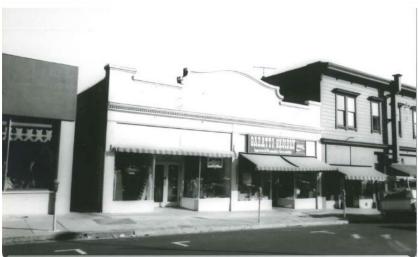
Address/code	926-930 B Street	7N	В
APN	011-261-13		
Building Name	Garatti Grocery		
Year Built	1914		
Original Use	Retail storefront grocery		
Architectural Style	Mission		
Architect/Builder			
Description	The one story commercial building is rectangular in plan with a decorative shaped parapet and entablature with dentil moulding above the storefront level. Replacement storefronts are divided by heavy wooden moulding. Cladding is stucco. The entrance is fitted with a paneled wooden door.		
Integrity	Lacks integrity, major alterations since 1970s survey (see above)		
Significance	not eligible, combination of modest architecture and integrity problems		
Notes	Originally rated as "D" but revised to "B"

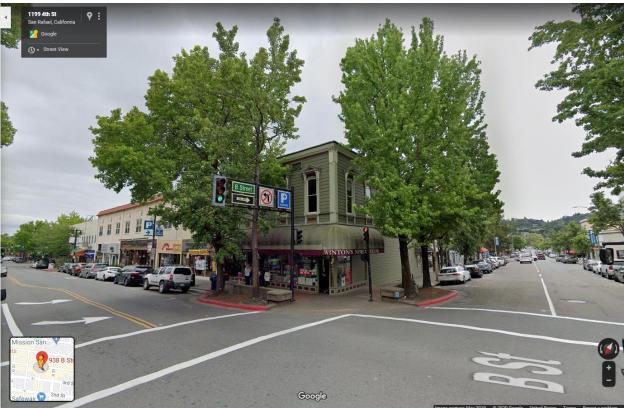
938 B Street/	Imana parturo N	Sau 2010 © 2020 Gronds - Histori States - Terme - Report a confilam
Address/code	1143-49 Fourth St	6X	Α
APN	011-261-01		
Building Name	McDermott Building/ Mulberry	House	
Year Built	Prior to 1887 (Sanborn Maps)		
Original Use	Retail storefront (grocery)/roor	ns for rent	
Architectural Style	Italianate/Mansard		
Architect/Builder			
Description	The two story commercial/mixed use building has a rectangular plan with a flat roof and minimal cornice. There are facades on B and Fourth streets. Cladding is drop wood siding. Upper floor windows are tall double-hung wood sash with decorative pedimented hoods elaborated with brackets and diamond shingles. The ground floor storefronts have paneled frieze bulkheads.		
Integrity	Appears to retain integrity despite some storefront alterations, spreadsheet says cornice removed		
Significance	Eligible as contributor and possibly as individual landmark. Property has been formally designated a local landmark.

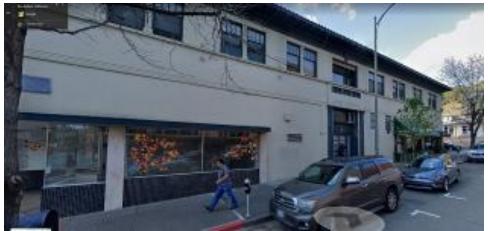
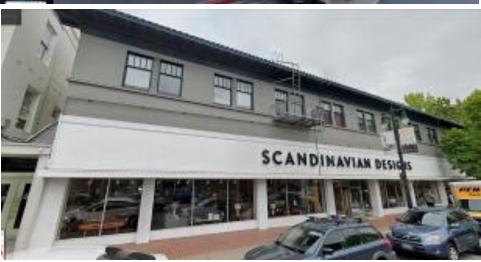
1009 B Street/		
Address/code	1200-1216 4 th	5S2	Α
APN	011-212-05		
Building Name	Aileen Apartments		
Year Built	1917 (architecture)		
Original Use	Apartments/ Commercial storefront	onts	
Architectural Style	Spanish Revival		
Architect/Builder			
Description	The two story commercial/apartment building is square in plan with a tiled mansard roof and cornice with decorative rafter tails, dentil moulding, cartouche, and floral frieze. There are facades on B and Fourth streets. Cladding is stucco. Upper floor windows are paired double-hung 4-over-1 wood sash separated by pilasters elaborated with floral motifs. An upstairs balcony feature decorative plaster in floral patterns. The ground floor apartment entrance is flanked by Corinthian columns, topped by a transom, and has double French doors with sidelights. Storefront windows on the ground floor have been somewhat altered		
Integrity	Retains integrity despite storefront replacement

Significance	Eligible as individual landmark and contributor		
Notes

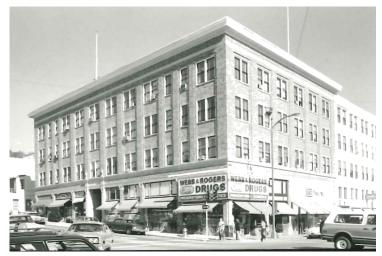
1010 B Street/		
Address/code	1138-1146 Fourth	1S	Α
APN	011-215-01		
Building Name	Albert Building		
Year Built	c1920 (DPR), 1930 (Annex)		
Original Use	Office/Retail storefronts		
Architectural Style	Neoclassical/Commercial		
Architect/Builder			
Description	The four story office/retail building decorative cornice. There are facad terra cotta decorative features and double-hung fitted with replaceme Corinthian pilasters elaborated with name. The door is deeply recessed door/sidelight/transom assemblage terra cotta capitals. Most have orig Contemporary awnings have been storefront facades intact.	es on B and Fourth s granite bulkheads. In the windows. The grant decorative urns an and fitted with an of e. Storefronts are se inal fully glazed woo	streets. Cladding is brick with Upper floor windows are paired bund floor entrance is flanked by d inscribed with the building riginal bronze parated by brick pilasters with d doors and transoms.

Integrity	Retains integrity despite window replacement and some storefront alterations		
Significance	Eligible as individual landmark and contributor		
Notes	The annex is treated as a separate Fact Sheet, at 1122-1132 4 th Street.

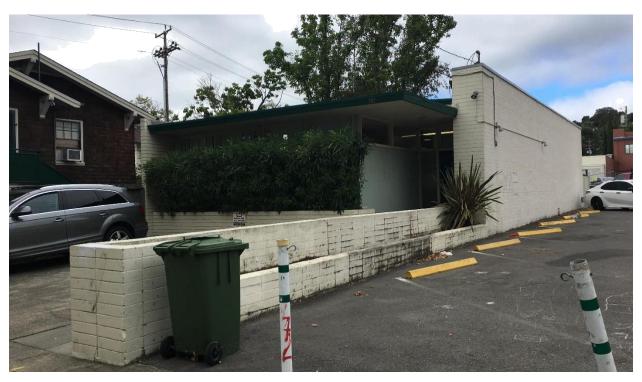
Address/code	707 C Street		A-
APN	012-073-11		
Building Name			
Year Built	1952 (spreadsheet)		
Original Use			
Architectural Style	Midcentury Modern		
Architect/Builder			
Description	The one story commercial building is recessed behind a parking area. It has a rectangular plan with a flat roof that projects over its deeply recessed entry, which is at the south end of its main (east) façade. The building is clad in brick with stucco accents and features clerestory windows on its main façade. There are built-in brick planters in front of the building and along the south property line.		
Integrity	Retains integrity, low visibility because of shrubbery		
Significance	Eligible as contributor and po architecture	ssibly as individual landma	ark for its Modern
Notes

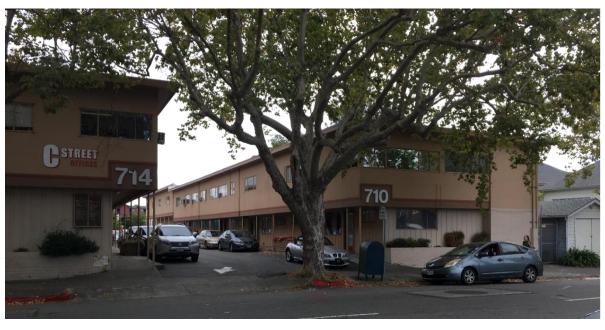
Address/code	710-714 C Street		D
APN	012-075-17		
Building Name			
Year Built	1954 (spreadsheet)		
Original Use	Apartment (now offices)		
Architectural Style	Midcentury Modern		
Architect/Builder			
Description	The two story apartment building (now used for offices) has two rectangular-plan flat-roofed buildings facing a central courtyard. Cladding is board and batten on the ground floor and stucco above. Windows are narrow frame metal casement. The overhanging second story on the courtyard-facing elevations is supported by plain metal poles and forms a sort of loggia sheltering apartment entrances. There are brick planters along the street-facing (west) elevations.		
Integrity	Retains integrity		
Significance	Not eligible individually or as district contributor		
Notes	Common example of inexpens	sive midcentury architectur	re

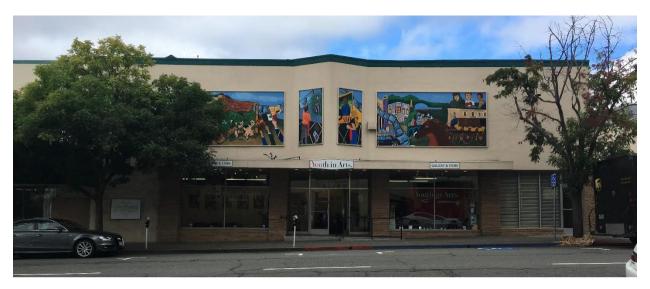
Address/code	917 C Street		D
APN	011-253-06		
Building Name	Youth in Arts		
Year Built	1880 (spreadsheet) /c1950		
Original Use			
Architectural Style			
Architect/Builder			
Description	The two story commercial budisguised by a parapet on the is stuccoed and lacks fenestration the main façade. The grouwindows and split-face rock of glazed aluminum frame double rear elevations have steel say of the 1880 building façade.	e main (east) façade. The mation. There is a projecting and floor has large aluminu columns and bulkheads. The doors with transom and sh windows in vertical oper	nain façade upper story v-shaped bay centered im frame storefront ie entrance has fully I sidelights. Sides and nings. There is nothing left
Integrity	Lacks integrity to 1880 constr	ruction, not a good exampl	e of a 1950s building
Significance	Not eligible individually or as district contributor		
Notes	19 th century industrial origins of buildings displayed by roof form and side/rear elevations. Partial c1950 façade remodel created an oddly hybrid building that is not a good example of either era. 901 C St (adjacent south) is a better example of a midcentury commercial building

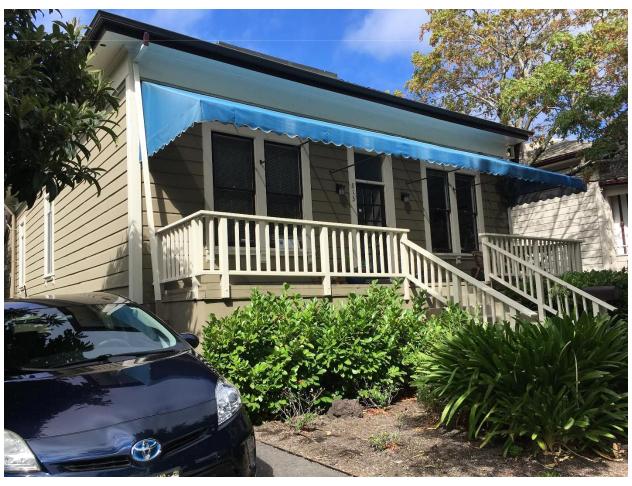
Address/code	813 D Street		С
APN	011-252-06		
Building Name			
Year Built	1882 (spreadsheet)		
Original Use	Residential		
Architectural Style	Folk Victorian		
Architect/Builder			
Description	The rectangular plan residence is single story with a hipped roof. It has a plain cornice with boxed eaves and full-width porch with simple balustrade. A canvas awning, likely a replacement for an original porch roof, shelters the porch. Windows are double hung wood sash and cladding is drop siding. The ground floor sits above a raised basement and is accessed via a wide set of wooden steps.		
Integrity	More research required, porch roof appears to have been removed and there may be additional alterations.		
Significance	Potentially eligible as contributor		
Notes	Good example of a folk house	e if integrity is present

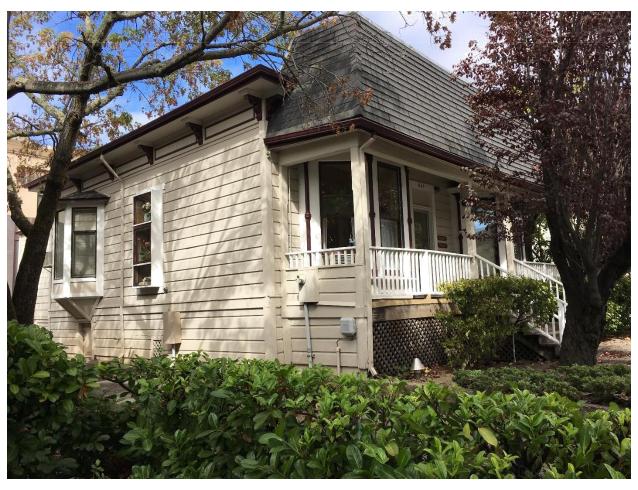
Address/code	817 D Street		С		
APN	011-252-05	011-252-05			
Building Name					
Year Built	1884 (spreadsheet)				
Original Use	Residential				
Architectural Style	Folk Victorian				
Architect/Builder					
Description	The rectangular plan residence with boxed eaves, ornamental has a replacement balustrade double hung wood sash with Cladding is drop siding. The gaccessed via a wide set of wood basement level is clad in lattice.	al brackets, and paneled fri e and an unusual mansard a projecting bay on the ma round floor sits above a ra oden steps. The front of th	ieze. Its full-width porch roof. Windows are ain (east) façade. ised basement and is		
Integrity	More research required, porc	ch appears altered, porch r	oof may not be original		
Significance	Potentially eligible as contributor				
Notes	Good example of a folk house	e, appears related to 813 D	next door

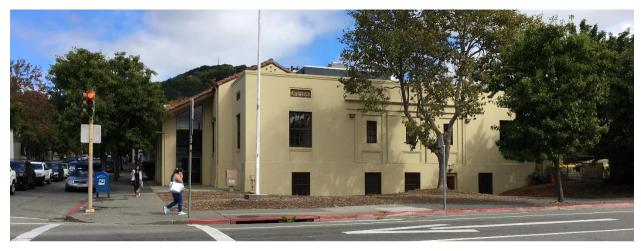
Address/code	910 D Street		С
APN	011-253-09		
Building Name	San Rafael Post Office "Mission	on Station"	
Year Built	1936		
Original Use	Post office		
Architectural Style			
Architect/Builder			
	First federal government building in Marin Co. In the early 1960s the entrance was		
Description	altered to provide ADA access. The sides and rear of the building remain intact		
Integrity	Requires further evaluation		
Significance	Not eligible		
Notes	Initially rated as E but upgraded to C in response to public comment. City should contact USPS, Tetra Tech looked at it in 2013 and concluded it lacked integrity due to Modernist addition. It has features of its original Spanish Colonial Revival elements. Could potentially brought back to original design.

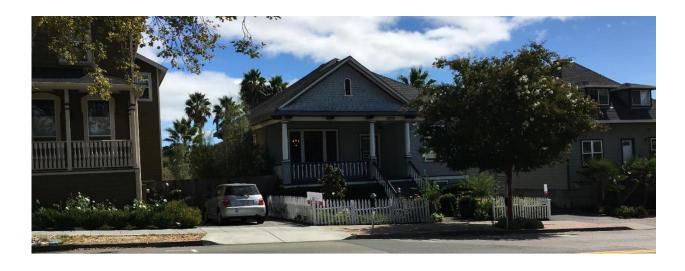
Address/code	810 E Street		Α
APN	011-252-14		
Building Name			
Year Built	1910 (spreadsheet)		
Original Use	Residence		
Architectural Style	Hipped roof cottage		
Architect/Builder			
Description	The rectangular plan residence is single story with a hipped roof from with a large gable over the partial-width porch. The gable end has a louvered vent in an arched opening and is clad in shingles. Boxed eaves have decorative shaped rafter tails. Porch supports are Tuscan columns a top a balustrade of narrowly spaced turned balusters. The front door is fitted with a paneled partially glazed wood door and accessed via a set of wooden steps. Windows are double-hung wood with at least one decorative cottage window on the main (east) façade. The main floor sits atop a raised basement		
Integrity	Retains integrity despite possible replacement of balustrade.		
Significance	Excellent example of vernacular hipped roof cottage, eligible landmark and contributor

Notes	Transitional Victorian/craftsn	nan features

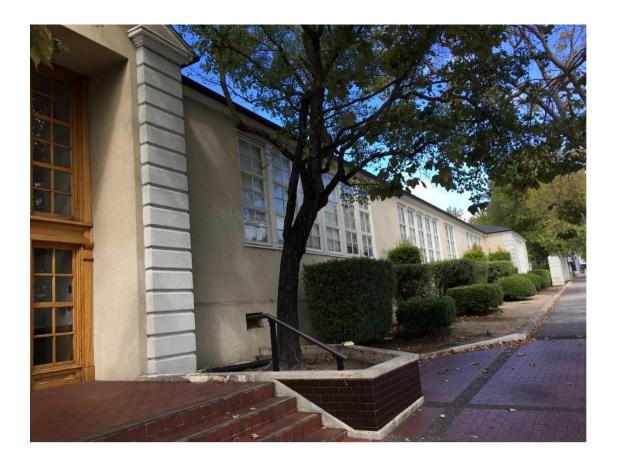
Address/code	901 E Street	С
APN	011-245-27	
Building Name	E Street Grammar School	
Year Built	1932-1946 (aerials)	
Original Use	School	
Architectural Style	Classical/Mediterranean Revi	<i>y</i> al
Architect/Builder		
Description	The single story building is roughly rectangular in plan with a hipped roof main volume and a smaller gable roof volume at the south. Large windows are fitted with multiple light windows. The main entrance on E Street has an assemblage of wood multiple light doors, sidelights and transoms. There are decorative quoins flanking the entrance. Cladding is spray-on stucco. There is a basement at the south end of the building. Recent remodel added wood entry element.	
Integrity	May retain integrity despite r	nodern stucco, more research needed.
Significance	Good example of a 1930s sch lacks the distinction of an arc	ool building, appears eligible as a contributor, nitectural landmark.

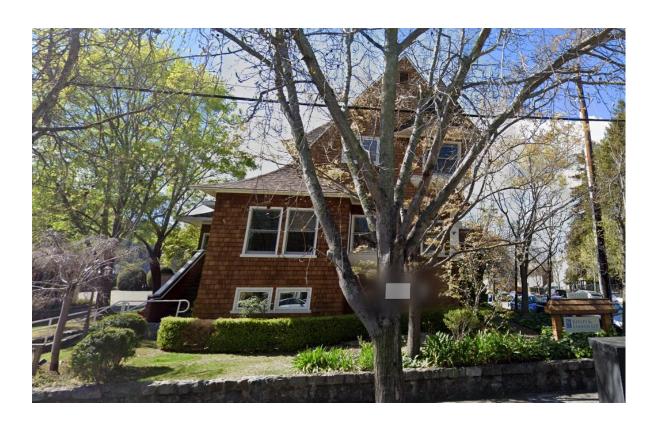
Address	1099 E Street		В
APN	011-202-06		
Building Name	Schlosser-Cole Residence		
Year Built	1895		
Original Use	Residential		
Architectural Style			
Architect/Builder			
Description	The three-story building has a composition shingle gable-or integral porch on the main fa building. The building has wid small tower with a pointed ro	-hip roof. It is clad in wood çade and several other end le double-hung wood sash	d shingle. There is an trances around the windows. There is a
Integrity	Appears to retain integrity		
Significance	Potential district contributor,	not individually eligible at	any level
Notes	Registered local landmark
