Downtown San Rafael Precise Plan Historic Resources Inventory Summary Report

Originally Published December 2020

Revised and Re-released May 2021

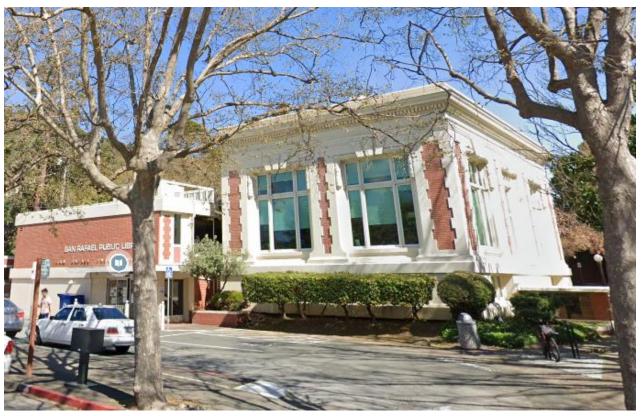
Address	1100 E Street	35	Α	
APN	011-203-01			
Building Name	San Rafael Public Library	San Rafael Public Library		
Year Built	1909			
Original Use	Library			
Architectural Style				
Architect/Builder				
Description	The large T-shaped building of surrounded by landscaping a The building is composed of taller older volume is clad in volume features a number of quoins flanking the windows the windows. The newer volubrick. On its main façade, the a corner; the upper half of the subtle dentil molding in a mofaçade is clad almost entirely alternate with brick-and-studies.	nd parking lots as well as multiple volumes of differ brick and stucco and has leaded as well as at the corners, ame is longer and shorter automatic sliding glass defaçade is clad in brick, are subdued echo of the of in brick. On the volume's co patterns that mimic the	streets on three sides. rent sizes and eras. The large windows. This ding dentil molding, and large keystones on . It is clad in stucco and oor entrance is located in and the lower features lder volume. The rear s other façades, windows he older volume's quoins.

Integrity	60s addition in notably differ and original building look to l		c and both the addition	
Significance				
Significance	Eligible as landmark and cont	וטטענוו		
Notes

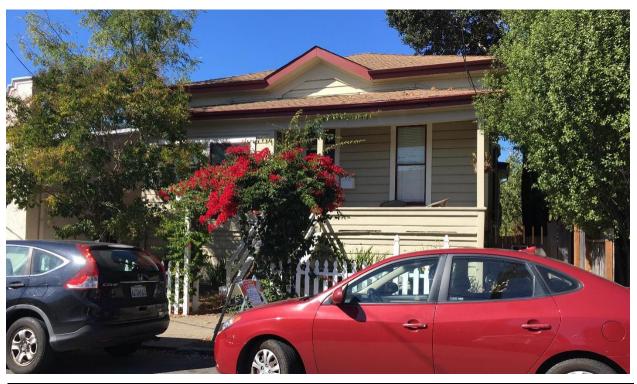
Address/code	105 F Street		D
APN	011-194-06		
Building Name			
Year Built	1893 (spreadsheet)		
Original Use	Residence		
Architectural Style	Folk Victorian		
Architect/ Builder			
Description	The single story house is roughly rectangular in plan with a gable on hip roof and full width porch under its own hipped roof. It is clad in drop siding and has tall window openings fitted with replacement windows. The south end of the porch has been enclosed.		
Integrity	Lacks integrity, odd roof form may be alteration, enclosed porch		
Significance	Not eligible		
Notes

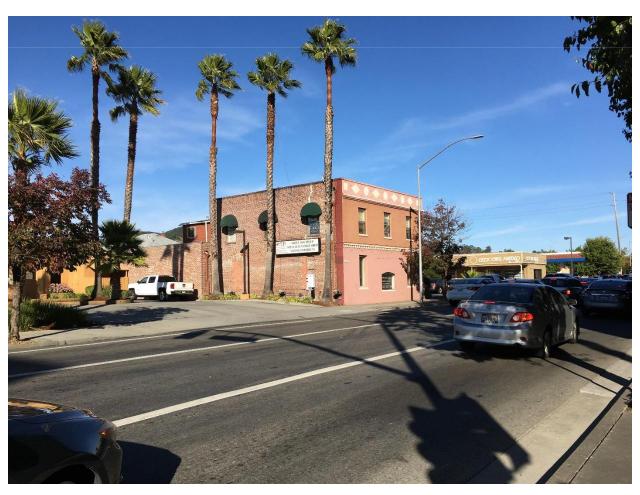
Address	826 Second Street		С
APN	011-272-10		
Building Name			
Year Built	1895-1905		
Original Use	Possibly the Lombard Hotel		
Architectural Style			
Architect/Builder			
Description	The building has a flat roof a front with a one-story portion clad in brick, with stucco on molding above the first floo roof of the two-story volum Windows are varied and fea building, as does a door into towards the back of the building.	on and a lower one-story and the main façade and addit r on the main façade. There e as well as brick sills on the ture rounded cloth awning o the lower volume. There a	ddition at the back. It is ion. There is dentil e is brick trim around the e second-floor windows. It is on the sides of the are also two garage doors
Integrity	Lacks Integrity		
Significance	Not eligible, nineteenth cen	tury commercial heavily alt	tered on main facade
Notes

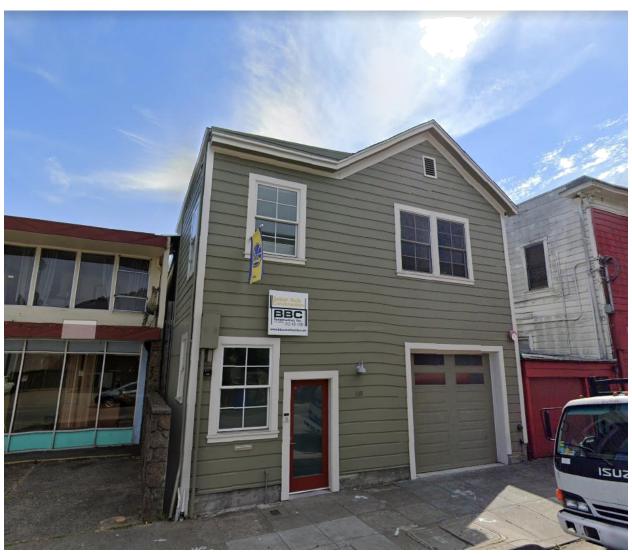
Address	1115 Second Street	7N	D
APN	013-011-06		_
Building Name	Mackey Frames		
Year Built	1875 (spreadsheet)		
Original Use	Residential		
Architectural Style			
Architect/Builder			
Description	The two-story building has a combination shed and gabled roof and a		
	rectangular plan. It is clad in horizontal drop siding. There is a glazed door and		
	a metal roll-up garage door	on the main façade. Wind	lows are hung vinyl sash
Integrity	Appears to lack integrity		
Significance	Not eligible, lack of significance and integrity		
	A request to change the rat	ing from D to C was consi	dered. The building was re-
Notes	evaluated and determined in	eligible.

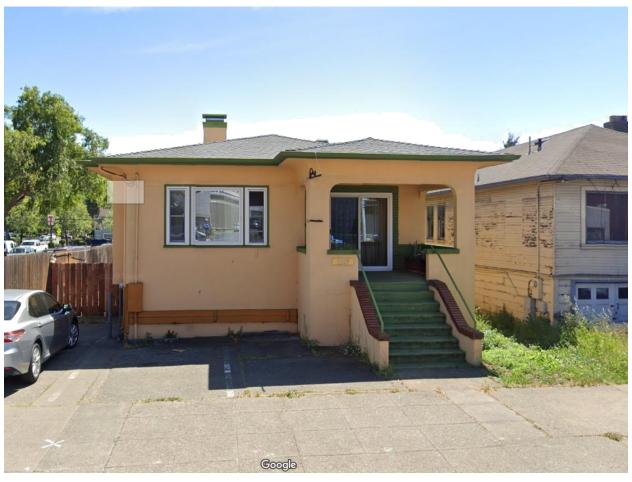
Address	1209 Second Street		D
APN	12-075-05		
Building Name			
Year Built	1924 (spreadsheet)		
Original Use	Residential		
Architectural Style	Craftsman		
Architect/Builder			
Description	The one-story building has a raised foundation and an L-shaped plan that includes a projecting partial-width porch. It has a hipped composition shingle roof. There are two doors accessed via the raised porch: one sliding double glass door that faces the street, and one partially glazed single wooden door that faces to the side. The building is clad in stucco with vertical board siding near the bottom on the side façades.		
Integrity	Appears to lack integrity, rep	acement windows, sliding	glass door
Significance	Not eligible, lacks significance	and integrity	
Notes

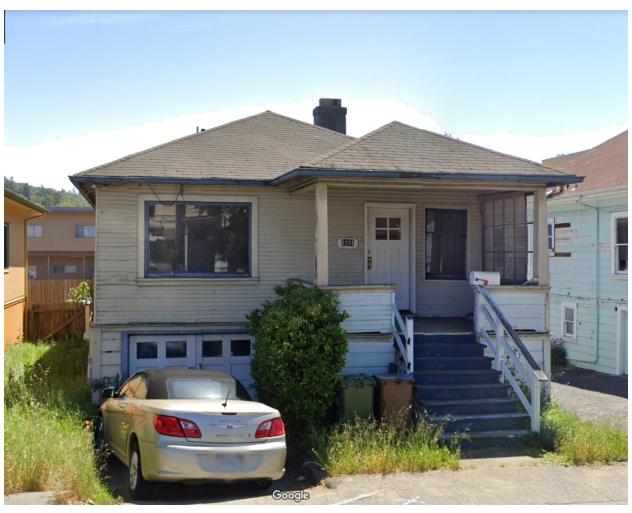
Address	1211 Second Street		С
APN	012-075-04		
Building Name			
Year Built	1920 (spreadsheet)		
Original Use	Residential		
Architectural Style	Hipped roof cottage		
Architect/Builder			
Description	The two-story building has ar width porch screened on one main entrance is on the secon siding in a variety of widths. Taçade.	side. It has a hipped comp nd floor. The building is cla	position shingle roof The d in a horizontal board
Integrity	Appears to retain integrity, m	ore study needed, conditi	on poor
Significance	Potential local district contrib	outor, not eligible as landm	ark
Notes

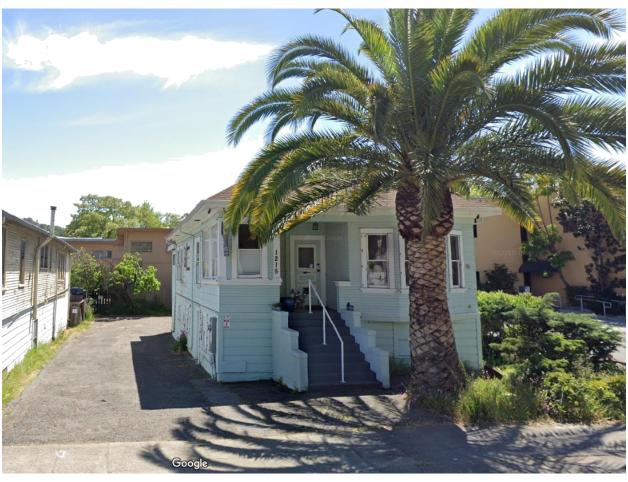
Address	1215 Second Street		В
APN	012-075-03		
Building Name			
Year Built	1916 (spreadsheet)		
Original Use	Residential		
Architectural Style	Hipped roof cottage		
Architect/Builder			
Description	The two-story building has rectangular plan and composition shingle hipped roof and has a parking lot behind it. The second-story main entrance is sheltered under a partial-width integral porch, with a bay window on one side. The building is clad in multiple widths of horizontal board siding. It has original double hung wood sash and partially glazed wood paneled door.		
Integrity	Retains Integrity		
Significance	Potential local district contrib	outor, not individually eligib	ole at any level
Notes

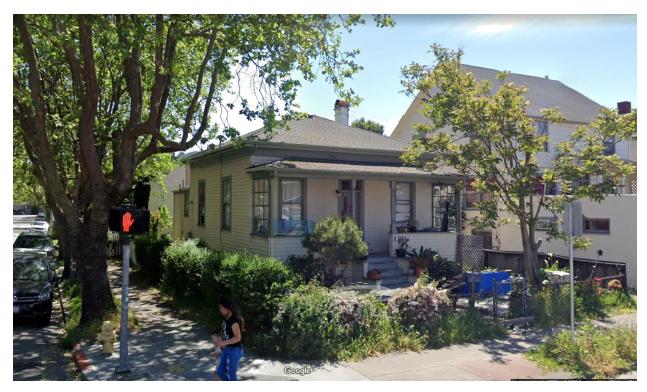
Address	1301 Second Street		B+
APN	012-073-07		
Building Name			
Year Built	1907 (spreadsheet)		
Original Use	Residential		
Architectural Style	Hipped roof cottage		
Architect/Builder			
Description	The one-story building has a a composition shingle hipped than the main roof. The main sheltered under a full-width process. The double hung wood sash and process.	roof. A volume at the real entrance is centered on the projecting porch, screened building is clad in wood sh	r of the building is lower he main façade and on both sides with iingle. It has original
Integrity	Appears to retain integrity		
Significance	Contributor and potentially la roof cottage with excellent in		d example of hipped
Notes

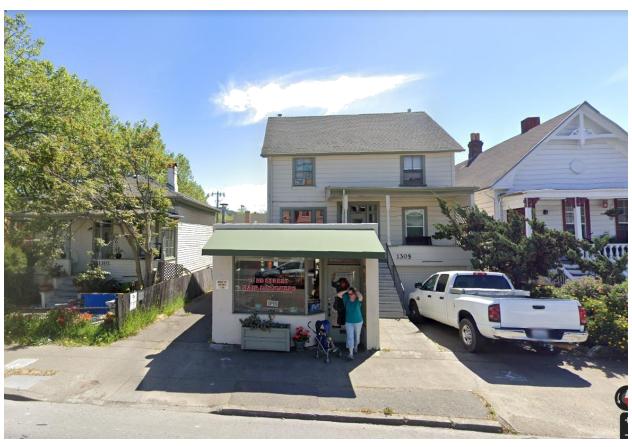
Address	1305 Second Street		D
APN	012-073-06		
Building Name			
Year Built	1887 (spreadsheet)		
Original Use	Residential		
Architectural Style	Folk Victorian		
Architect/Builder			
Description	The original building has a rouprojects forward on the main with a gabled composition sh partial-width projecting porchannel board siding. On the The addition is one story; it risecond floor, running next to supports, which is abbreviate original volume's main entrarplate glass window on its main	façade. The original voluningle roof. The main entran with a flat roof. The volunifirst floor is a vertical boarses to about halfway up the front staircase, under d to make space for it, and the original to the addition has its owner.	ne is three stories tall nce is sheltered under a me is clad in horizontal d wooden garage door. The original volume's one of the porch d up to one side of the wn entrance and large
Integrity	lacks integrity due to addition	1

Significance	Not eligible, lacks integrity		
Notes

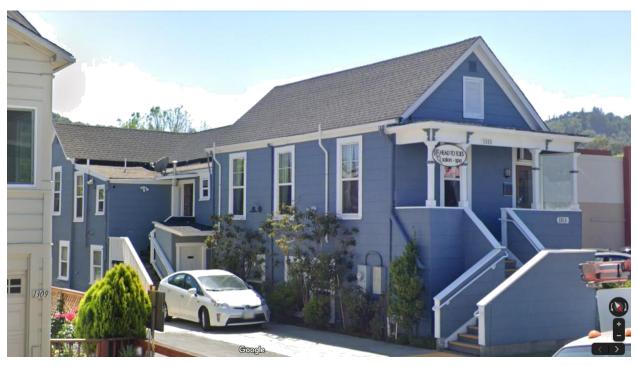
Address	1315 Second Street	D	
APN	012-073-03		
Building Name			
Year Built	c1900 (spreadsheet)		
Original Use	Residential		
Architectural Style	Folk Victorian		
Architect/Builder			
Description	The long, L-shaped two-story building has a gabled composition shingle roof. It is clad in horizontal board siding. The building has a second-floor entrance, sheltered under a projecting full-width porch accessed by a staircase on the main façade.		
Integrity	Lacks Integrity impaired, replacement windows, raised		
Significance	Ineligible, lack of integrity	·	·
Notes		<u> </u>

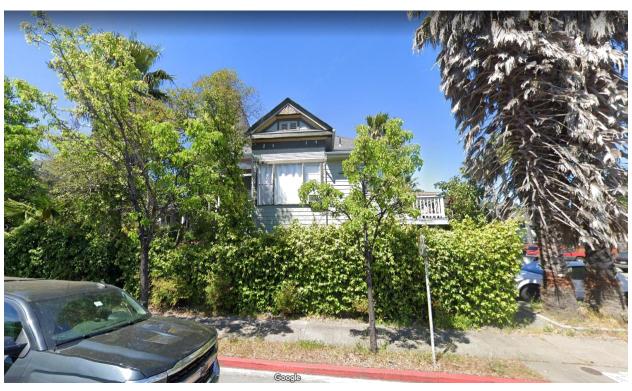
Address	1416-1420 Second St	7N	D
APN	011-252-11		
Building Name			
Year Built	1895 (spreadsheet)		
Original Use	Residential		
Architectural Style	Queen Anne		
Architect/Builder			
Description	The roughly rectangular two- overgrown with vines, and th is a parking lot to one side of deck are located near the bac parking lot rather than the fa composition shingle roof as v roof.	ere is considerable vegeta the building, and the seco ok of the building on the fa gade facing the street. The	ation on the parcel. There ond-story entrance and açade that faces the building has a gabled
Integrity	Lacks Integrity, replacement	windows and stairs/deck	
Significance	Not eligible, lacks integrity		
Notes	Presents opportunities for im	provement

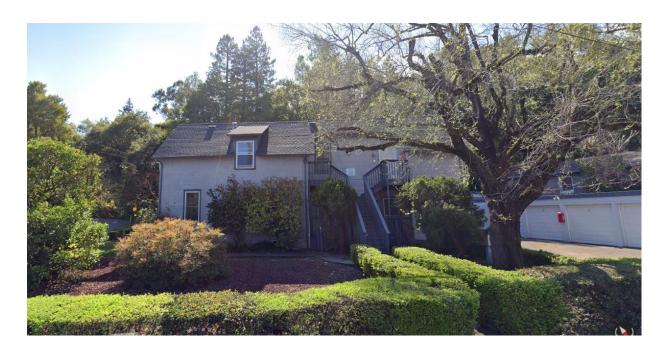
1621 Second St/		
Address/code	455 First St		D
APN	012-054-02		
Building Name			
Year Built	1950 (spreadsheet), appears to b	e c1900 house convert	ed to multi-unit
Original Use	Residential		
Architectural Style			
Architect/Builder			
Description	The single story building has a roughly rectangular plan and steeply pitched gabled roof with shed dormers. It is clad cement shingle and has replacement windows in vertical openings. The north elevation has been remodeled into apartments with an exterior staircase to the second floor		
Integrity	Lacks integrity		
Significance	Not eligible as landmark or contributor		
Notes

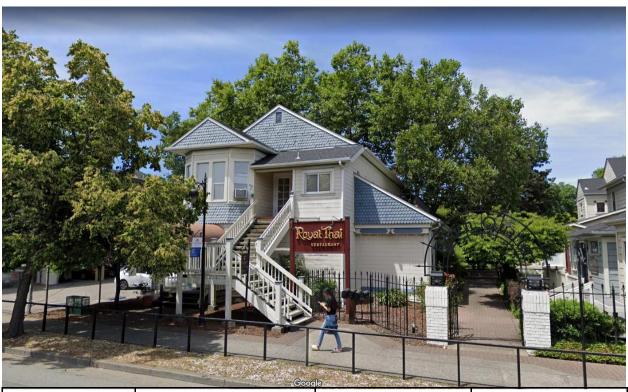
Address	610 Third Street		D
APN	014-122-14		
Building Name			
Year Built	Bldg shown was relocated to	the site c.1970.	
Original Use	Residential		
Architectural Style	Queen Anne		
Architect/Builder			
Description	The two-story rectangular bu are two entrances located on under a bay window is shelte on the second floor, is access partial-width integral porch. board and fishscale shingle si addition	the main façade. An entra red by a cloth awning. The ed by a wooden staircase a The building is clad in a cor	ance on the first floor other entrance, located and sheltered under a mbination of horizontal
Integrity	Integrity impaired by window	rs, staircase, enclosed porc	h, shed addition
Significance	Not eligible, lacks integrity		
_S Notes	Structure is located in the Fre includes 901, 903, 905, 907-9, more significant resources. A prepared.	and 911 Irwin, which are o	on their original sites and

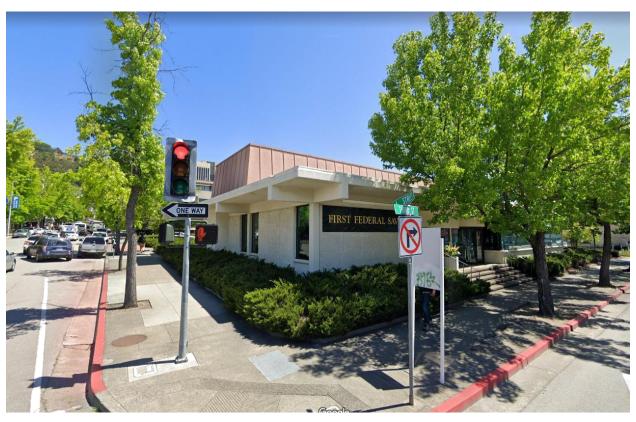
Address	1030 Third Street		Α
APN	011-263-21		
Building Name	Wells Fargo (now First Federa	al Savings and Loan)	
Year Built	1963 (spreadsheet)		
Original Use	Commercial (banking)		
Architectural Style	Modern		
Architect/Builder	John Carl Warnecke (DIJ 11/2	3/1962)	
Description	The one-story rectangular bu other two sides by a drivewar roof with wide eaves and a perough stucco, which are interlong horizontal stretches of warevolving door accessed by a other entrances.	y and parking lot. The build enthouse with slanted side spersed with tall vertical w vindow on multiple façade. set of wide, low concrete s	ling has a flat concrete is. It is clad in panels of vindows. There are also in the main entrance is a
Integrity	Appears to retain integrity, further study needed		
Significance	Probable eligible as landmark, designed by John Carl Warnecke		
Notes	Supplemental evaluation perfiction is eligible for the NRHP as an each the work of a Master.

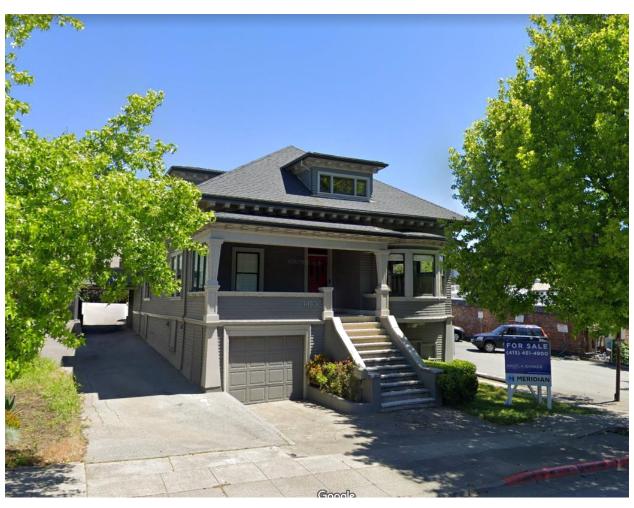
Address	1410 Third Street		Α
APN	011-251-09		
Building Name			
Year Built	1916 (spreadsheet)		
Original Use	Residential		
Architectural Style	Foursquare/Craftsman		
Architect/Builder			
Description	hipped dormers on three faça under a deep partial-width in Eaves around the roof as wel all feature decorative bracket	The two-story rectangular building has a hipped composition shingle roof with hipped dormers on three façades. The second-story main entrance is sheltered under a deep partial-width integral porch; next to it is a rounded bay window. Eaves around the roof as well as the porch, the bay window, and the dormers all feature decorative brackets. The building is clad in clapboard siding and has original double hung wood sash windows and partially glazed door. Porch	
Integrity	retains integrity		
Significance	Eligible as landmark and distr	ict contributor	
Notes

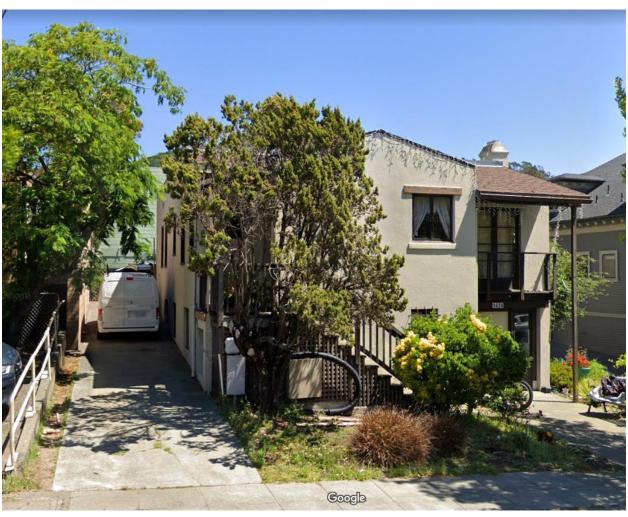
Address	1414 Third Street		D
APN	011-251-11		
Building Name			
Year Built	1930 (spreadsheet)		
Original Use	Residential		
Architectural Style			
Architect/Builder			
Description	The two-story rectangular-plan building has a cross gable near the main façade, but most of the roof is flat. The building is clad in stucco with varied fenestration. The main façade features a ground-floor entrance as well as a second-floor entrance accessed by a wooden staircase.		
Integrity	Appears to lack integrity		
Significance	Not likely to be significant		
Notes			•

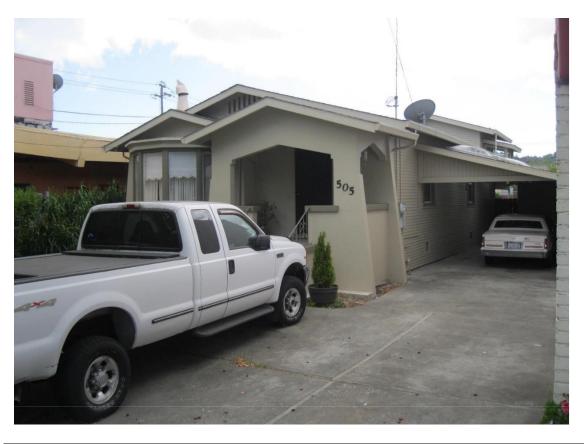
Address/Code	505 Fourth Street		D
APN	014-123-09		
Building Name	Residence		
Year Built	1924/1930 (spreadsheet),		
Original Use	residential		
Architectural Style	Craftsman		
Architect/Builder			
Description	The single story house has a roughly rectangular plan and medium pitched multi-gabled roof with shed dormers. It is wood clapboard with stucco on the main (north) façade. There is a projecting partial-width porch with battered supports and shaped opening adjacent to a projecting window bay. A shed roof carport projects from the west side of the house.		
Integrity	Lacks integrity, replacement windows, carport, probably stucco over original wood, large neighboring building affects setting		
Significance	Not eligible as landmark or integrity	contributor due to margina	Il significance and lack of
Notes

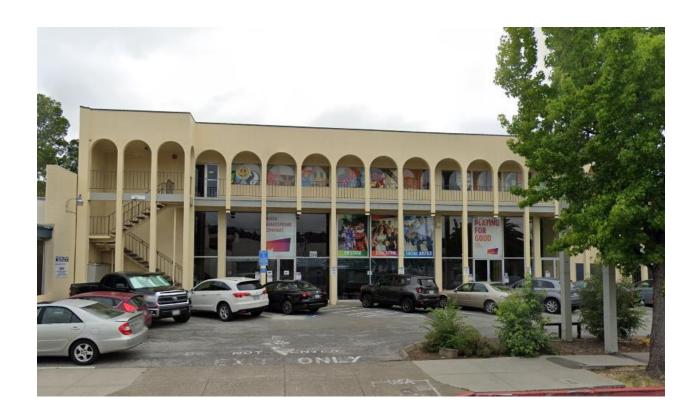
Address	514 Fourth Street		D
APN	014-086-15		
Building Name			
Year Built			
Original Use	Commercial		
Architectural Style	New Formalism		
Architect/Builder			
Description	The two-story rectangular-plate parking lot. The double-height aluminum frame storefronts forward slightly at one cornel along the second floor; both projecting roof with an arcad	t first floor features multip on the main façade. An ext of the main façade, and a the staircase and hallway a	ole entrances and large terior staircase projects in exterior hallway runs are sheltered under a
Integrity	Retains integrity		
Significance	Not eligible, not a significant	example of the style	
Notes

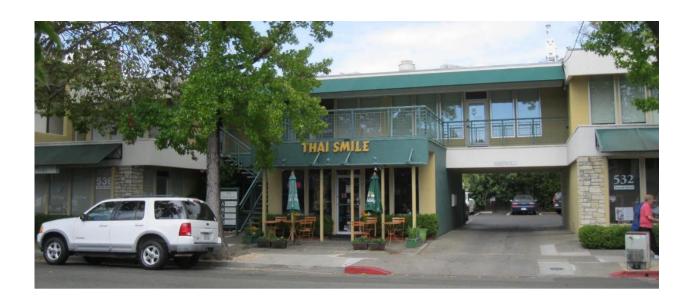
Address/code	532 Fourth Street		D		
APN	014-086-26				
Building Name					
Year Built	1965 (spreadsheet),				
Original Use					
Architectural Style	Midcentury Modern				
Architect/Builder					
Description	The two story storefront commercial building is rectangular in plan with flat roof, ground floor retail, and second floor office space. The two storefronts are separated by a driveway that leads under the second floor to the rear parking lot. Cladding is stucco with manufactured stone on the east storefront. Fixed windows are vertical with aluminum frames and doors are fully glazed aluminum frame.				
Integrity	Probably lacks integrity, ston- be replacements	e facing, upstairs balustrac	de, windows appear to		
Significance	Not eligible as landmark or cointegrity	ontributor due to marginal	significance and lack of		
Notes

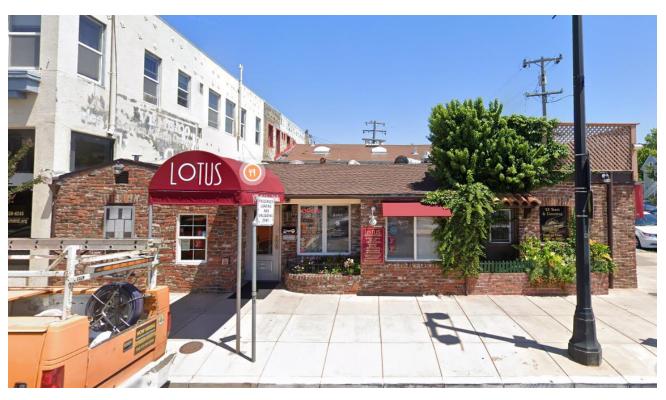
Address	704 Fourth Street		С	
APN	011-227-10			
Building Name	Lotus Restaurant (La Petit Aul	berge)		
Year Built	c.1920			
Original Use	Commercial			
Architectural Style	Storybook			
Architect/Builder				
Description	The rectangular-plan building is located on a corner lot. The roof type is unclear, but there is a front gable located to the side of the main entrance. The roof is composition shingle and there is a tile awning over one window, a cloth awning over another window, and a projecting cloth awning over the main entrance. The building is clad in irregular brick and the main façade features built-in brick planters. Windows are a variety of shapes and sizes.			
Integrity	Integrity appears impaired but consideration	the brick is a unique feato	ure that warrants further	
Significance	Not likely to be significant			
Notes

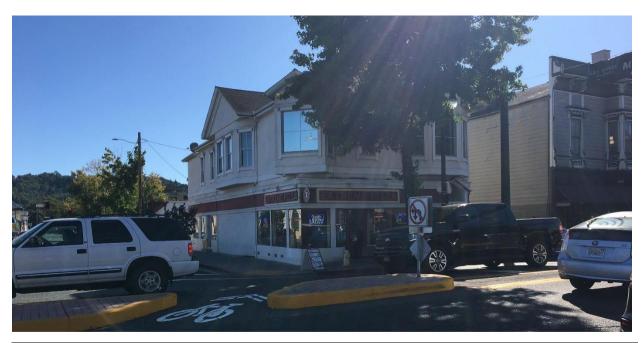
Address/code	705 Fourth Street		D	
APN	011-275-03			
Building Name	National Hotel			
Year Built	1898/1991/2008 (spreadshee	et)		
Original Use				
Architectural Style	Queen Anne			
Architect/Builder				
Description	The two story house is roughly rectangular in plan with a gable on hip roof and projecting bays at the north, east, and corner. It is clad in stucco and upper floor windows have been replaced. East and north elevations have been converted to storefront on the ground floor.			
Integrity	Lacks integrity, roof form and decorative window casings are drastically altered			
Significance	Not eligible as landmark or contributor due to lack of integrity			
Notes

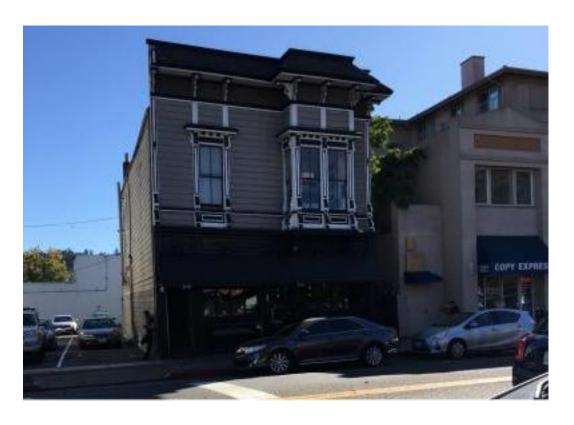
Address/code	709-711 Fourth Street	7N	Α
APN	011-275-02		
Building Name			
Year Built	1889 (spreadsheet)		
Original Use	Saloon/ Proprietor's residence	e above	
Architectural Style	Italianate		
Architect/Builder			
Description	The two story building is rectafloor residential. Its mansard upper floor windows are tall telaborated with decorative house Cladding is drop siding. A decoupper floor. An original partiamain (north) façade leads to a storefront entrance are conte	roof has a cornice with elactwo over two double hung bods and casings. There is brative frieze separates th Ily glazed wood panel doo a staircase to the second fl	borate shaped brackets. wood sash and a projecting square bay. e storefront from the ar at the east end of the
Integrity	Retains integrity despite mod	ernization of storefront	
Significance	Excellent example of Italianat landmark and contributor.	e commercial/residential a	architecture, eligible as

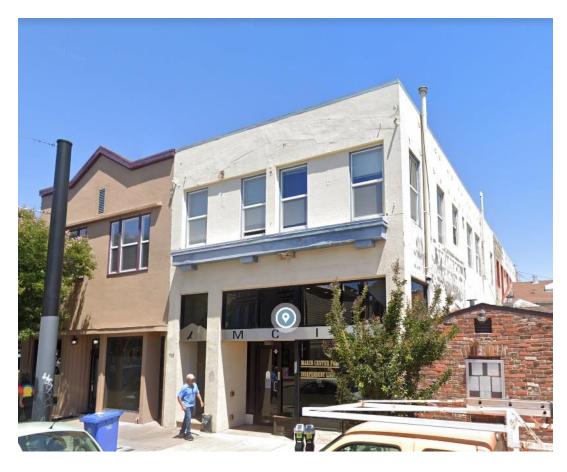
Address/code	710 Fourth Street		D		
APN	011-227-04				
Building Name	Marin Center for Independent	Living			
Year Built	1950s? (spreadsheet), c1930	(aerials)			
Original Use	residential				
Architectural Style	Minimal Traditional/Commer	cial			
Architect/Builder					
Description	Historic aerials suggest that the southwest portion of the building with cross-gabled roof was originally a small house constructed about 1930. Additions were constructed over the decades, resulting in a hybrid building with multiple roof forms and both horizontal and vertical window shapes. Brick cladding is unlikely to be original				
Integrity	Lacks integrity to 1930				
Significance	Not eligible as landmark or contributor, not a recognizable example of a historic style				
Notes

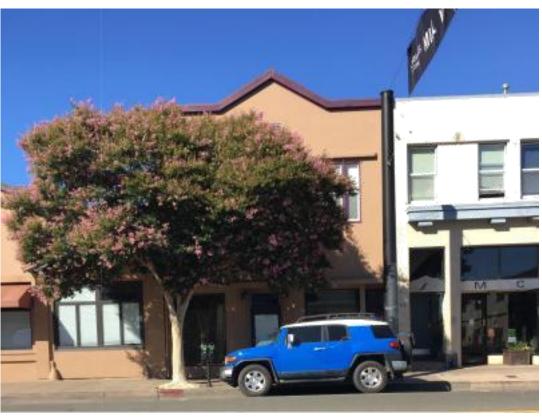
Address/code	716 Fourth Street		D
APN	011-227-05		
Building Name			
Year Built	1908/1949/1983 (spreadshee	et)	
Original Use	Storefront/residential		
Architectural Style			
Architect/Builder			
Description	The two story building is rectangular in plan with ground floor retail and upper floor residential or offices. It is clad in stucco and has a pointed parapet. Tall original window openings on the upper floor are fitted with replacement windows. The ground floor has storefront windows and a rounded streamline modern entrance and awning.		
Integrity	Lacks integrity		
Significance	Hybrid architecture from various eras, not a good example of any historic style, not eligible		
Notes

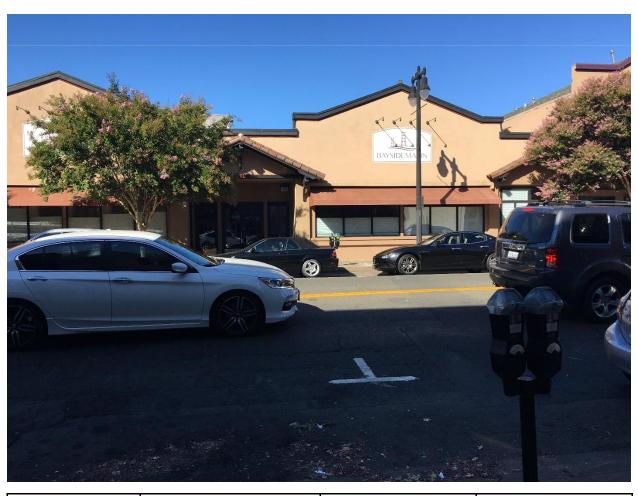
Address/code	718-24 Fourth Street		С
APN	011-227-06		
Building Name	Bayside Marin		
Year Built	1918 (spreadsheet)		
Original Use	Storefront		
Architectural Style			
Architect/Builder			
Description	The large single story building is rectangular in plan with a tall shaped parapet and divided storefront windows. The projecting entrance has a gabled roof with plastic tile and shaped knee braces. The building is clad in stucco.		
Integrity	Appears to lack sufficient inte	grity to be eligible	
Significance	Not a good example of any hi	storic style	
	Originally noted as ineligible.	May warrant further stud	y. Used for auto repair
Notes	until 1970s

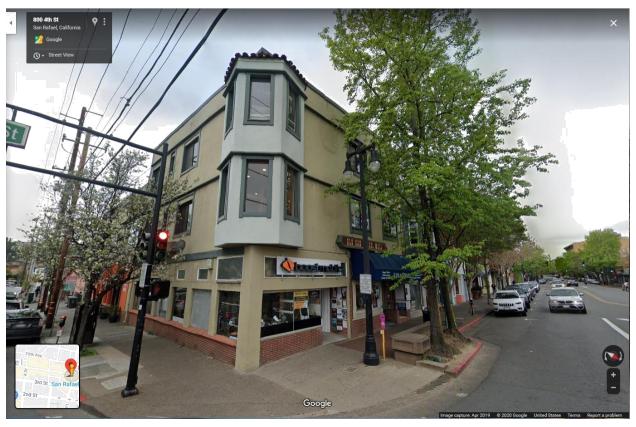
Address/code	801-805 Fourth Street	5S2	D
APN	011-273-06		
	Old San Rafael Mall		
Building Name	(California/ Union Hotel)		
Year Built	1878 (spreadsheet)		
Original Use	Hotel		
Architectural Style			
Architect/Builder			
Description	The three story corner comm Fourth St and Lincoln Ave fac stucco with Roman brick bulk window openings altered. A p is the only recognizable elem	ades with apartments abo heads. Windows have bee projecting second and thir	ve. The building is clad in en replaced and most d floor bay at the corner
Integrity	Lacks integrity		
Significance	Not a good example of any hi	storic style, not eligible	
Notes

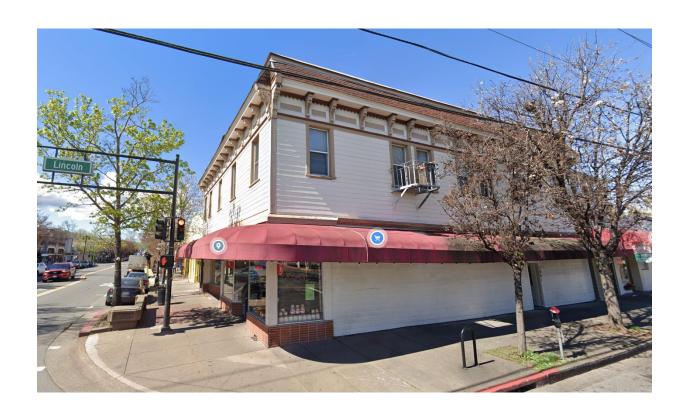
802-06 4 th Street/		
Address	1001 Lincoln Avenue		В
APN	011-224-10		
Building Name			
Year Built			
Original Use	Commercial		
Architectural Style			
Architect/Builder			
Description	The two-story building has a rectangular plan. The roof consists of two side-by-side composition shingle gables, hidden on both the street-facing sides of the corner lot by a slanted parapet supported by decorative molding and brackets. The main façade contains two first-floor storefronts consisting primarily of large plate-glass windows, with brick bulkheads and narrow vertical board siding between the windows. On the second floor and other façades, the building is clad in horizontal board siding. Upstairs windows have been replaced.		
Integrity	Appears to retain integrity despite window replacements		
Significance	Eligible as district contributor, lacks integrity required for landmark		
Notes	806 is the original entrance to the upper floor, now accessed from Lincoln, a later alteration.

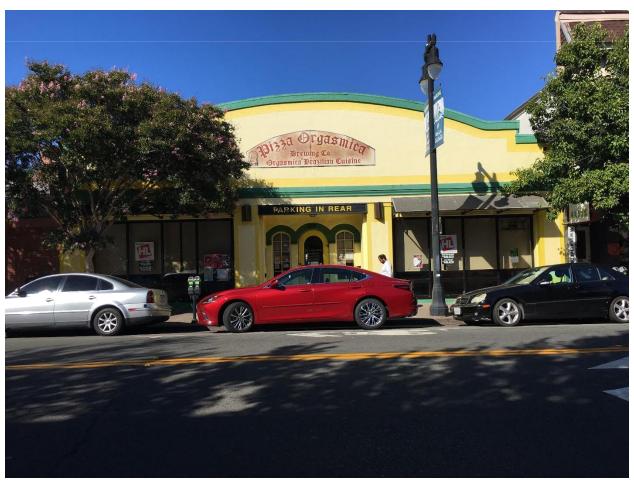
Address/code	812 Fourth Street	5S2	В
APN	011-224-11		
Building Name	Redhill Imports		
Year Built	1920/1950/1971 (spreadsh	eet)	
Original Use	Auto repair		
Architectural Style	Mission		
Architect/Builder			
Description	The one story storefront commercial building is rectangular in plan with arched roof and shaped parapet. Its recessed main entrance has an arched door flanked by arched multiple light wood windows. Divided storefront windows are contemporary.		
Integrity	Appears to retain integrity, more research needed		
Significance	Good if modest example of Mission commercial architecture, not a landmark, potentially a district contributor		
Notes

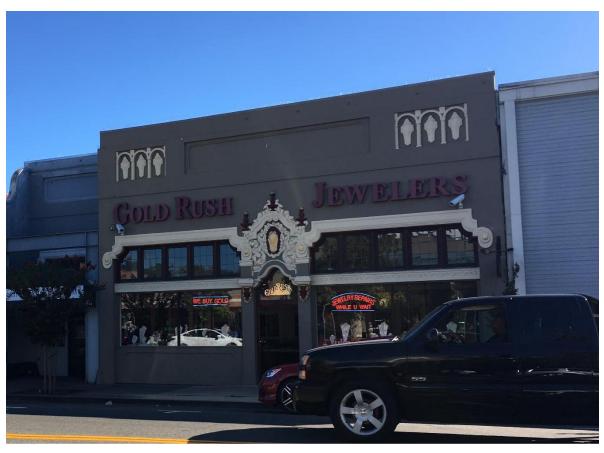
Address/code	827-831 Fourth Street	3 S	Α
APN	011-273-02		
Building Name	Rafael Florist/Gold Rush Jewe	elers	
Year Built	Before 1924 (Sanborn Maps)		
Original Use	Commercial (auto showroom		
Architectural Style	Mission		
Architect/Builder			
Description	The one story storefront com roof concealed by a parapet. including cartouche and arch topped by floral frieze and lar posts and scrolled moulding. transom and set in an elabora and candle motifs tops the doleading to a repair area behind and parapet that matches the	The building is stucco with motif at parapet corners. Sige multiple light transoms The partially glazed wood ately shaped arch. A cartoupor. 827 Fourth originally hid the showroom and retain	sterracotta ornament Storefront windows are with decorative turned door is topped by a uche with ornate floral and a vehicle door
Integrity	Retains integrity		
Significance	Excellent example of Mission architecture, eligible as landmark and district contributor

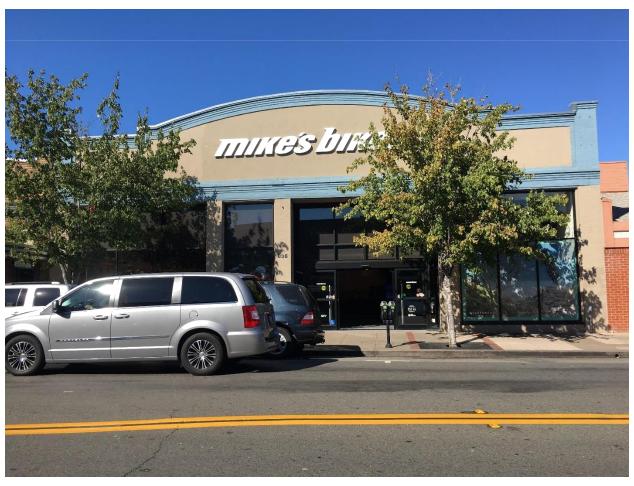
Address/code	836 Fourth Street		В
APN	011-224-13		
Building Name			
Year Built	1924 (spreadsheet, Sanborns)	
Original Use	Commercial, auto showroom	l	
Architectural Style	Mission		
Architect/Builder			
Description	The single story commercial building is rectangular in plan with a gabled roof hidden by a shaped parapet. The main (south) façade is occupied by large contemporary storefront windows and centered entrance. Cladding is brick with stuccoed areas. Decorative corbelling is also executed in brick.		
Integrity	Retains integrity		
Significance	Good simple example of Mission architecture, potential district contributor		
Notes	Similar to 831 Fifth but better	example of the style

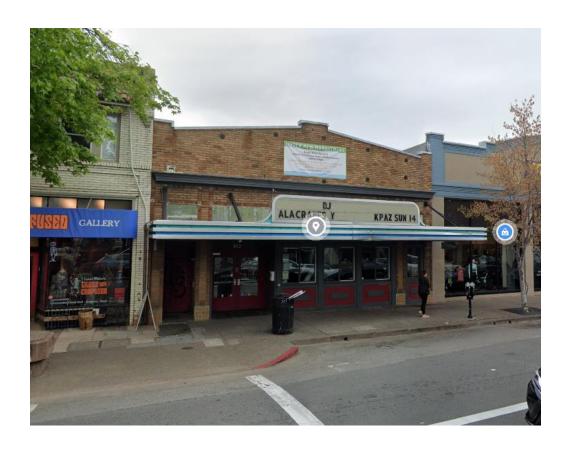
Address/code	842 Fourth Street		В
APN	011-224-14		
Building Name	George's San Rafael Recreation	n and Pool Hall	
Year Built	1929 (spreadsheet)		
Original Use	Commercial		
Architectural Style	Mission		
Architect/Builder			
Description	The single story commercial building is L-shaped in plan with a flat roof and stepped parapet. The main (south) façade is occupied by small windows above a paneled bulkhead and two entrances at its west end. A metal awning with a small marquee projects from the façade above the storefront level. Transoms above the awning appear to have been partially covered. There is a cornice between transoms and parapet. The building is clad in brick with columns articulated in contrasting color brick and tile column bases		
Integrity	Retains integrity, probable alterations to storefront level are sympathetic		
Significance	Good example of Mission architecture, potential district contributor

Notes	Same parcel as 846 Fourth

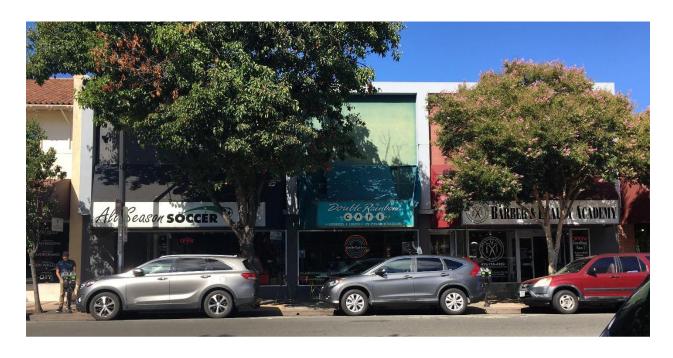
Address/code	866 Fourth Street	5S2	D
APN	011-224-20		
Building Name			
Year Built	1953 (spreadsheet)		
Original Use	Commercial		
Architectural Style			
Architect/Builder			
Description	The single story commercial building is rectangular in plan with arched roof and flat parapet. Three storefront bays are divided by concrete beams. The building is clad in stucco. Storefront windows and doors are contemporary.		
Integrity	Integrity unknown		
Significance	Not eligible, not a good exan	nple of any historic archite	ctural style
Notes	Rear of building is 835 Fifth A integrity.	we and is a contributor, bu	it 4 th Street frontage lacks

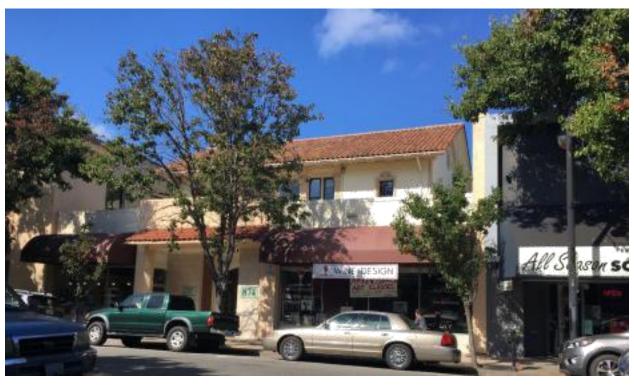
Address/code	874 Fourth Street		С	
APN	011-224-17			
Building Name	Marin Municipal Water Depa	rtment		
Year Built	1903 (spreadsheet)			
Original Use	Water Department			
Architectural Style	Spanish Revival			
Architect/Builder				
Description	The municipal/commercial building has a two story 1903 municipal building set back on the lot with a single story storefront addition adjacent to the sidewalk. The original building has a side-gabled roof and stucco cladding with highly decorative terra cotta ornament. The storefront is also stucco and has a shed tile roof at the center entrance, but it is contemporary in character.			
Integrity	Lacks Integrity, intrusive main façade addition 1951-1964.			
Significance	Architecturally significant original building ineligible, lack of integrity			
Notes	Although heavily altered, this The building's original attracti additions. If restored, it could	ve façade has been maske	d by the storefront

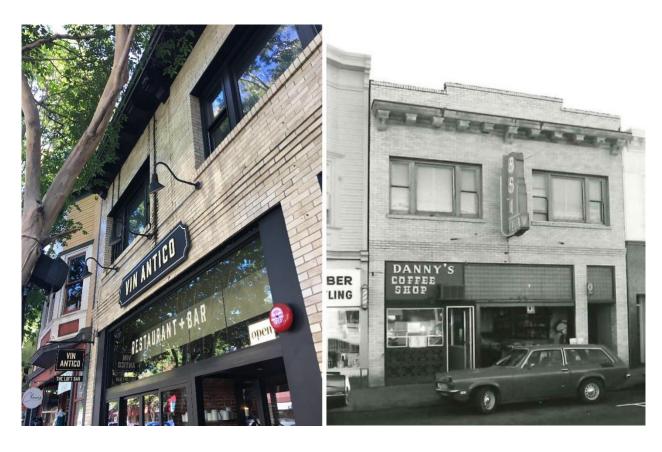
Address/code	881-883 Fourth Street		Α
APN	011-271-03		
Building Name			
Year Built	1905/1975 (spreadsheet)		
Original Use	Storefront Commercial		
Architectural Style	Neo-classical		
Architect/Builder			
Description	The commercial building is tw has a stepped parapet and he Tripartite upstairs windows has replacement windows. The busills also executed in brick. Or the door to the upstairs. Replacement.	avy wood cornice with de ave been fitted with fairly uilding is clad in brick with iginal obscure transom ha	corative rafter tails. sympathetic mouldings and windows s been retained above
Integrity	Retains integrity despite repla similar to 1970s photo	scement window and store	efront, appearance
Significance	Eligible as landmark and conti	ributor	
Notes

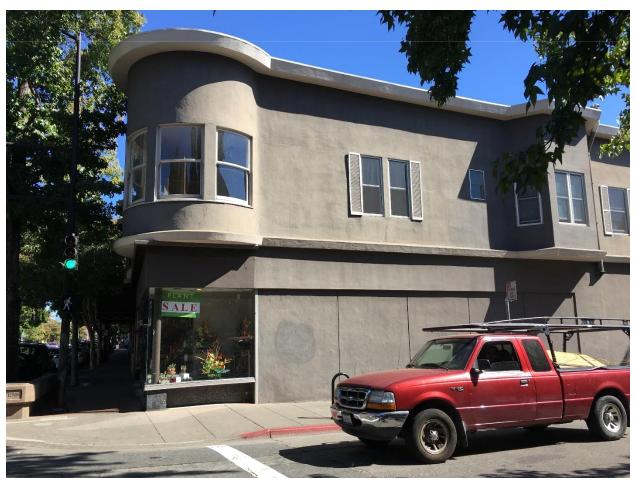
Address/code	889-891 Fourth Street		D
APN	011-271-01		
Building Name			
Year Built	1908/1956 (spreadsheet)		
Original Use	Storefront Commercial		
Architectural Style			
Architect/Builder			
Description	The commercial building is two story and rectangular in plan with a flat roof and heavy plain cornice. There is a rounded upper bay at the corner and a slanted bay on Lootens. Cladding is stucco. Some upper windows have been replaced and some are double hung wood sash. Terrazzo flooring and storefront configuration suggest it was installed in 1956		
Integrity	Lacks integrity		
Significance	Not a good example of any hi	storic building type, not el	igible for listing
Notes

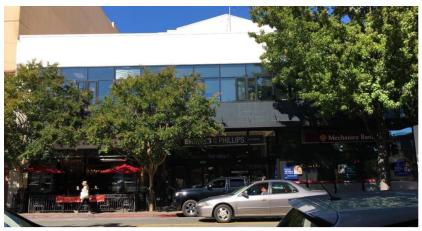
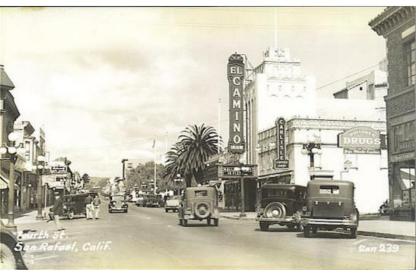
Address/code	900 Fourth Street		D
APN	011-222-05		
Building Name	El Camino Theatre		
Year Built	1925-30 (Sanborns/aerials)		
Original Use	Cinema		
Architectural Style	High Spanish Colonial		
Architect/Builder			
Description	The large commercial building is two story and rectangular in plan with a flat roof. It is clad in stucco with continuous windows along upper and ground floors on Fourth Street. Some remnants of Art Deco details can be discerned at sides and rear but building is missing ornate tower, marquee, and other character-defining elements		
Integrity	Lacks integrity, does not conv	ey significance	
Significance	Not eligible because of lack o	f integrity	
Notes

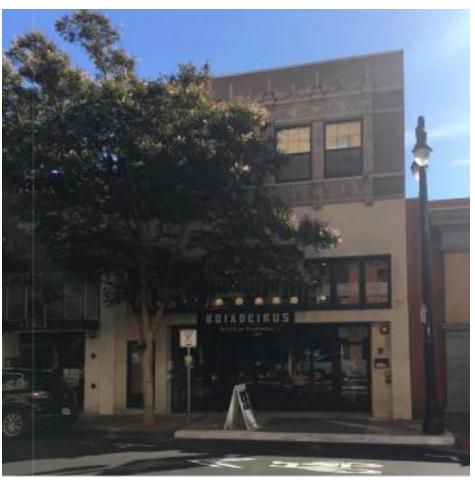
Address/code	925 Fourth Street		В
APN	011-263-07		
Building Name			
Year Built	1928 (spreadsheet)		
Original Use	Storefront Commercial		
Architectural Style			
Architect/Builder			
Description	The commercial building is two story and rectangular in plan with a flat roof. It is clad in stucco and has ornate terracotta decorative surrounds on vertical upstairs windows, which are fitted with vinyl replacement sash. A decorative balconet at the mezzanine level has a shaped opening and is flanked by transom divided by diminutive turned posts. The storefront is contemporary		
Integrity	Retains sufficient integrity to	qualify as district contribu	tor but not as landmark
Significance	Good example of 1920s com	mercial architecture, eligib	le as district contributor
Notes		·	·

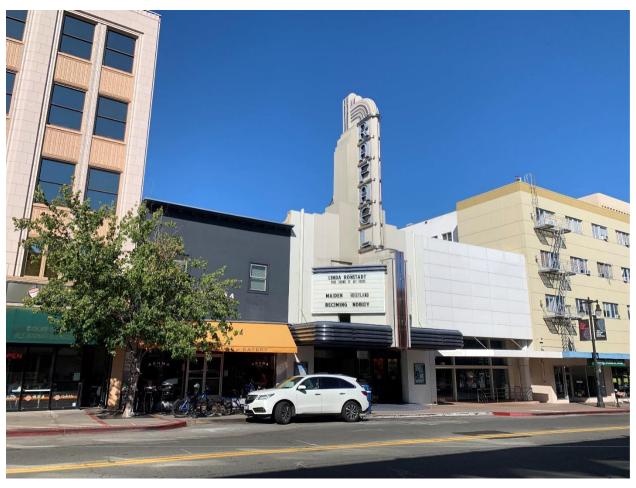
Address/code	1118 Fourth Street	3S	Α
APN	011-215-04		
Building Name	Orpheus/Rafael Theatre		
Year Built	1920/1938 (spreadsheet/Cin	ema Treasures)	
Original Use	Cinema		
Architectural Style	Streamline Moderne		
Architect/Builder			
Description	The small theater building octall pylon marquee with neor motif that characterizes Street parapet is stepped up to the neon atop a curved awning wicket booth have been remoentrance. Original terrazzo si sidewalks.	n letters spelling "Rafael" a amline Moderne architecto pylon sign. There is a marc with the same motif. The or wed and replaced with a re	and the curved horizontal ure. The building's quee with streamline riginal entrance and ecessed contemporary
Integrity	Retains integrity despite entrance replacement		
Significance	Good example of 1930s ciner contributor	ma architecture, eligible as	s landmark and district
Notes	Adj. bldg. to west (now Arom	a Café) was an early movie	e house (the Lyric)

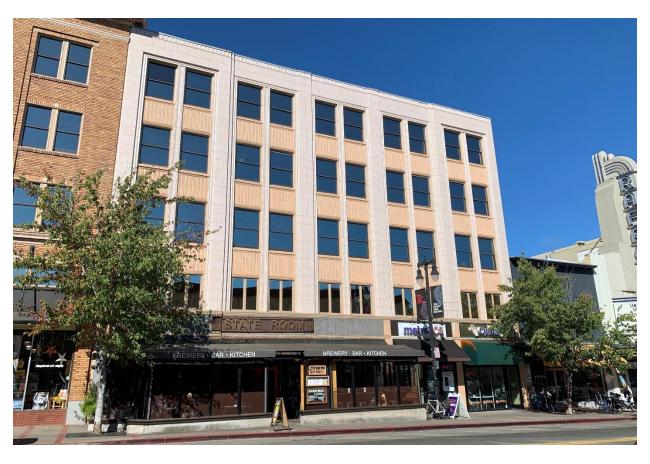
Address/code	1122-1132 Fourth St		С	
APN	011-215-02			
Building Name	Albert Building Annex			
Year Built	1916 (spreadsheet)			
Original Use	Offices above ground floor sto	refronts		
Architectural Style	Art Deco			
Architect/Builder				
Description	The five story building is recta			
	windows are paired and have been fitted with a combination of hung			
	replacement windows and horizontal sliding sash. They are separated by			
	restrained pilasters that reference Art Deco architecture, as does the minimalist			
	decoration at the cornice. Panels between floors have grooved moulding.			
	There are pilasters with stylized Corinthian capitals at the storefront level; other			
	elements of the ground floor are unsympathetic replacements including a			
	projecting storefront			
	Building elements are sufficie	ntly intact to convey the h	istorical style and feel of	
Integrity	the building.			
	Initially rated as "E" but modif	ied to "C" through public o	comment. Warrants

Significance	further evaluation.			
Notes				
	Closely related to Albert building next door at 1010 B Street (1138-1146 Fourth)			
	Access to upper floors is thro	ugh Albert Bldg on B Street	t

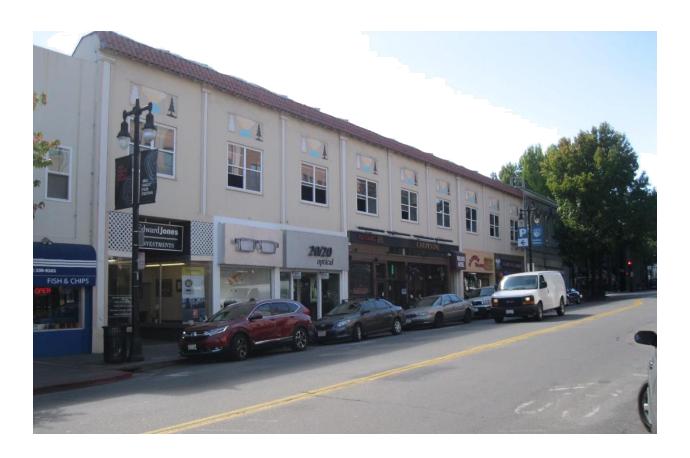
Address/code	1125-1139 Fourth St		С
APN	011-261-31		
Building Name			
Year Built	1892/1893/1920 (spreadshee	et)	
Original Use	Storefront Commercial/offices	(later converted to apartr	ments)
Architectural Style			
Architect/Builder			
Description	The two story building is rectangular in plan with a flat roof and parapet with decorative tiled shed roof. It is clad in stucco with nine bays divided by stylized pilasters. Upper floor windows are paired and have been fitted with vinyl replacement windows. There is a decorative frieze with building/sunrise/tree motif (representing City (San Francisco)/ Golden Gate/ Country (Marin)) above each window. Historic storefronts at the center of the building have wooden doors and divided transoms. Storefronts at either end are contemporary		
Integrity	Probably retains integrity despite extensive alteration, e.g., window/storefront replacement, more research needed

Significance	Appears eligible as landmark and district contributor, unusually detailed frieze		
Notes			_

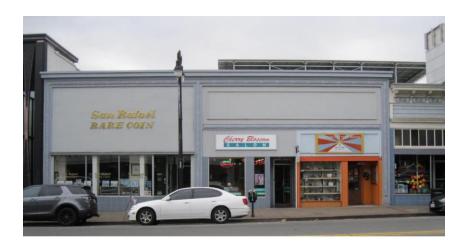
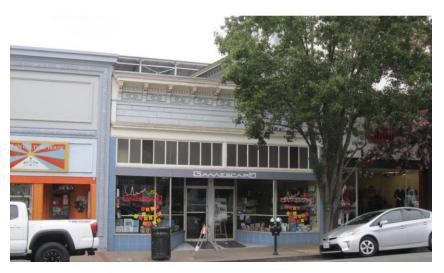
Address/code	1219-1223 Fourth St		С
	1225 Fourth St	5S2	Α
APN	011-255-28		
Building Name	Grosjean & Co.		
Year Built	Prior to 1887 (Sanborns) (repo	orted by SRH as 1872)	
Original Use	Storefront Commercial (incl. g	rocery lunch counter and	furniture store)
Architectural Style			
Architect/Builder			
Description	The parcel has three single-story rectangular plan storefront commercial buildings. The two storefronts at the east are clad in stucco and have terracotta ornament with large ceramic tile at the bulkhead. 1225 Fourth Street at the west end of the parcel has a wooden cornice elaborated with ornate brackets, paneled frieze, dentil moulding and decorative pediment above Wood siding on the upper façade is rusticated and there are divided light transoms above the storefront. Storefront is contemporary; cornice lowered after fire.		
Integrity	East end does not retain integrity (upper photo) but merits further evaluation. West end retains integrity (lower photo).

Significance	eligible as landmark and disticentury wood commercial fa		cample of nineteenth
Notes	An earlier structure is located	to the back. Also, 1225 v	vas 2 stories prior to fire.

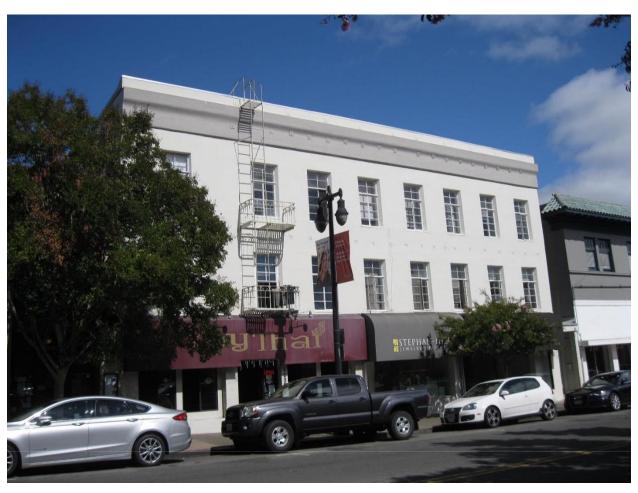
Address/code	1222-1230 Fourth St	5S2	В
APN	011-212-06		
Building Name	Central Hotel (first known as	Hotel Marin)	
Year Built	1860 (spreadsheet)		
Original Use	Hotel		
Architectural Style			
Architect/Builder			
Description	The three story rectangular p with simple cornice. It is clad windows. Storefronts are cor the oldest standing building i	in smooth plaster stucco v ntemporary. San Rafael He	with steel casement ritage notes this may be
Integrity	Lacks integrity, building does	not resemble historic Cen	tral Hotel
Significance	Not eligible as landmark or district contributor, nothing is left of the Central		
	Hotel building and its c1930	current appearance is undi	istinguished.
	Building initially rated "E" but	_	g public review.
Notes	Assessment of alterations is w	varranted.

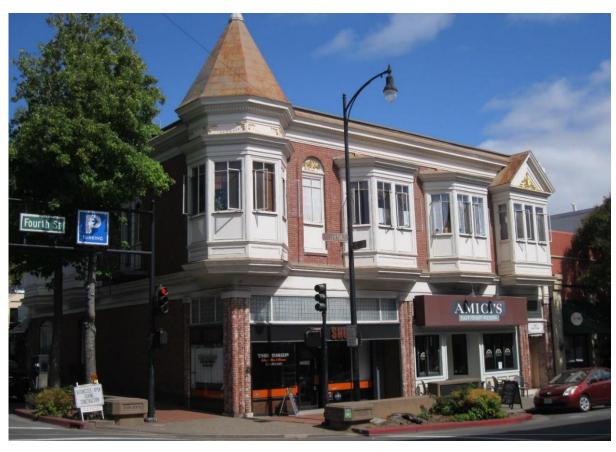
1240-1244 Fourth Street/		
Address/code	1000 C St.		Α
APN	011-212-14		
Building Name	Peter Building		
Year Built	1893 (spreadsheet)		
Original Use	Commercial/ offices		
Architectural Style			
Architect/Builder			
Description	The two story rectangular plan stowith decorative cornice and peaker is brick with projecting bays on bowood. Window openings are vertirellacements. Window bays have paneled frieze, and one is topped arched window near the west end transom. Storefronts are separate originally to have been plastered a Storefronts are contemporary.	ed roof on projecting of th C and Fourth Street cal and fitted with un- their own cornices w with an ornamental p of the south façade h d by round brick pilas and are topped with o	corner bay. The building et facades executed in sympathetic ith dentil moulding and bediment. A single has a decorative blind eters which appear
Integrity	Retains integrity despite window replacement

Significance	eligible as landmark and district co	ontributor, excellent e	example of nineteenth
	century commerical building		
Notes	The ornamental pediment to the ea	ast is over the origina	l entrance to the 2 nd floor.

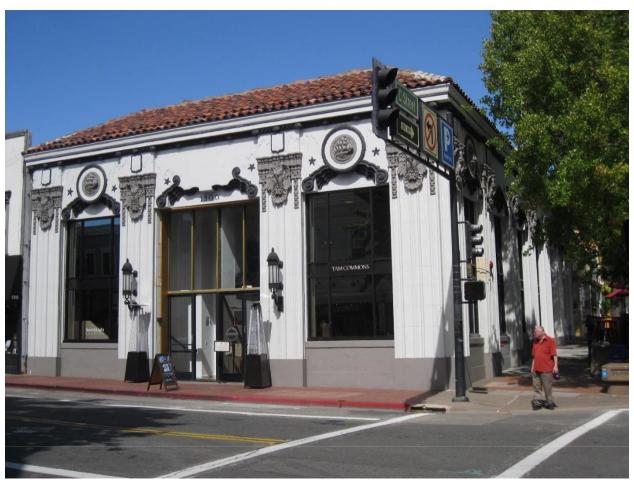
Address/code	1300 Fourth Street	3S	Α		
APN	011-205-08	011-205-08			
Building Name	Bank of Italy				
Year Built	1928 (spreadsheet)				
Original Use	Bank				
Architectural Style	Spanish Revival/ Neoclassica				
Architect/Builder					
Description	The tall single story building is rectangular in plan with a hipped tile roof. Its large window bays are separated by heavy stylized fluted pilasters topped with ornate capitals featuring an eagle motif. Shaped window openings have elaborately scrolled moulding. The main (Fourth Street) façade has medallions with the Bank of Italy's sailing ship emblem. The carved Bank of Italy name over the main entrance has been removed. Original sconces flank the main entrance. Windows and doors are contemporary.				
Integrity	Retains integrity despite window replacement				
Significance	Unique example of a bank building, eligible as landmark and contributor				
Notes
