Downtown San Rafael Precise Plan Historic Resources Inventory Summary Report

Originally Published December 2020

Revised and Re-released May 2021

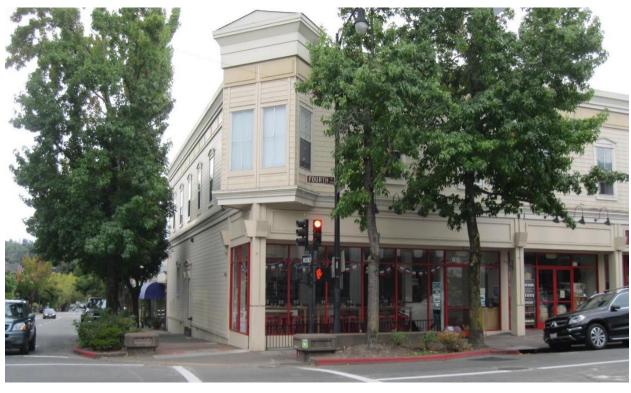
Address/code	1301 Fourth Street	5S2	D		
APN	011-253-10	011-253-10			
Building Name	Hayes				
Year Built	1987 (spreadsheet)				
Original Use					
Architectural Style					
Architect/Builder					
Description			eenth century building. Architecture ign but is not a replica of a historic		
Integrity	Not historic				
Significance	Not historic				
Notes		·

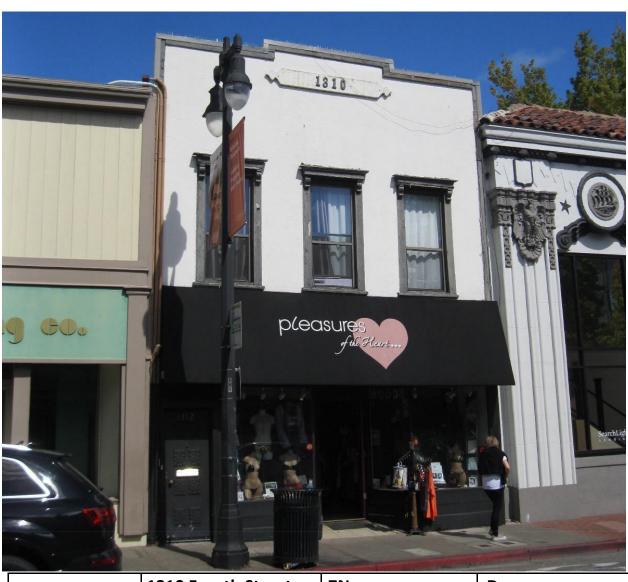
Address/code	1310 Fourth Street	7N	D
APN	011-205-09		
Building Name			
Year Built	before 1894 (Sanborns)		
Original Use	Commercial		
Architectural Style			
Architect/Builder			
Description	The single story building is restepped parapet. Tall upper fand have decorative crowns. entrance are contemporary.	loor windows are fitted wi	th replacement windows
Integrity	Lacks integrity, window repla	cement, stucco, storefron	t
Significance	Not eligible, modest example lacking integrity		
	Request to improve rating fro	om D to B was considered b	out both historians
Notes	concluded building is ineligible	e in its current state.

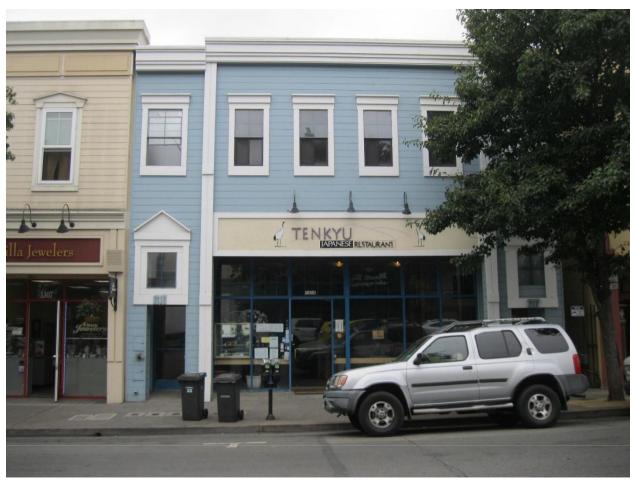
1313-1317 Fourth			
Address/code	Street	7N	D	
APN	011-253-04			
Building Name	Hayes			
Year Built	1987 (spreadsheet)			
Original Use				
Architectural Style				
Architect/Builder				
Description	Adjacent to 1301 Fourth St. Per spreadsheet 1987 replacement of nineteenth century building. Architecture displays nods to historic period building design but is not a replica of a historic building			
Integrity	Not historic			
Significance	Not historic			
Notes

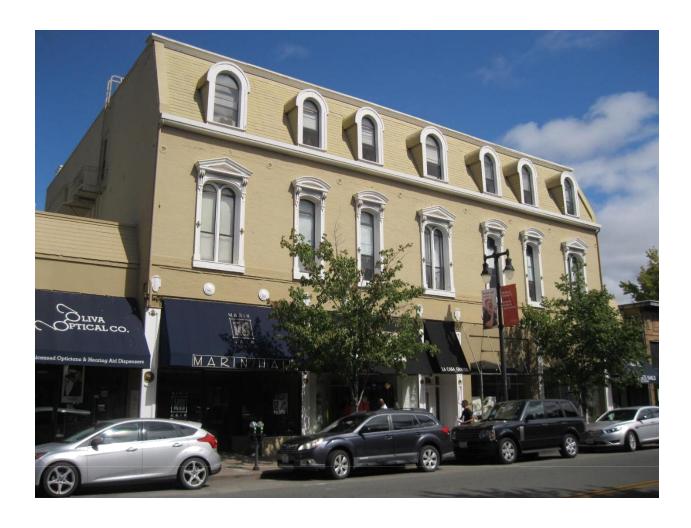
1330 (1322-1336)		
Address/code	Fourth St	3S	A
APN	011-205-11		•
Building Name	Mahon House, Butchart Bu	ilding	
Year Built	1869 (spreadsheet)		
Original Use	Storefront/Hotel		
Architectural Style	Second Empire		
Architect/Builder			
Description	The two story building is rectangular in plan with a mansard roof and arched roof dormers. Tall upper floor windows are fitted with vinyl replacement windows and have highly decorative surrounds and crowns. The building is brick. Storefront bays are separated by pilasters with Corinthian capitals. The centered entry to the second floor is fitted with fully glazed wood door, transom, and sidelights. Most storefront fabric is contemporary.		
Integrity	Retains integrity despite window and storefront replacement.		
Significance	Eligible as landmark and district contributor		
Notes

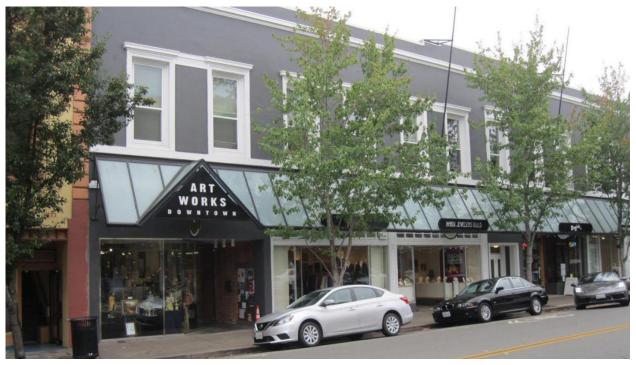
1333 (1325-1337)		
Address/code	Fourth Street		В
APN	011-253-02		
Building Name	Gordon's Opera House		
Year Built	1989 (spreadsheet) but archi	tecture reveals a historic p	eriod building
Original Use			
Architectural Style			
Architect/Builder			
Description	The two story building is rectangular in plan with a flat roof and stepped parapet. Tall upper floor windows are fitted with vinyl replacement windows decorative surrounds and crowns. The building is clad in stucco and has minimal decorative features. Most storefront fabric is contemporary although two have original transoms under awning. The original bays were removed many years ago.		
Integrity	Lacks integrity		
Significance	May be historically significant a historic architectural style.		
Notes	Initially given a D rating but m	nodified to "B" after public	review.

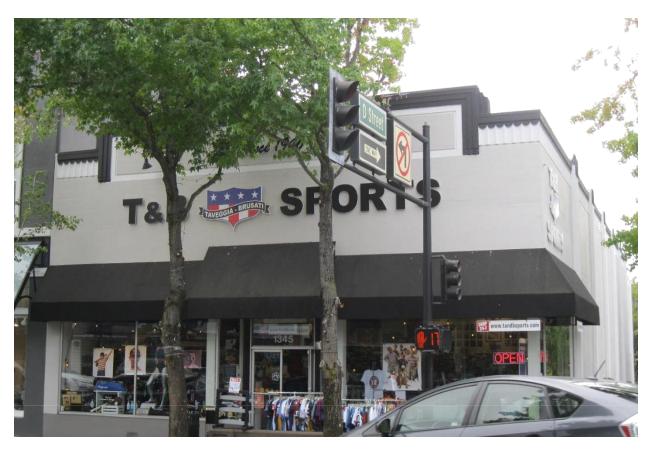
Address/code	1345 Fourth Street		В
APN	011-253-01		
Building Name			
Year Built	1930 (spreadsheet)		
Original Use	Storefront		
Architectural Style	Art Deco		
Architect/Builder			
Description	The single story building is rectangular in plan with a flat roof and stepped parapet. The building is clad in stucco. Fluted columns and cornice exhibit typical Art Deco style. Storefront and door are contemporary		
Integrity	Retains integrity despite stor	efront replacement.	
Significance	Eligible as district contributor, not sufficiently distinguished for landmark status		
Notes

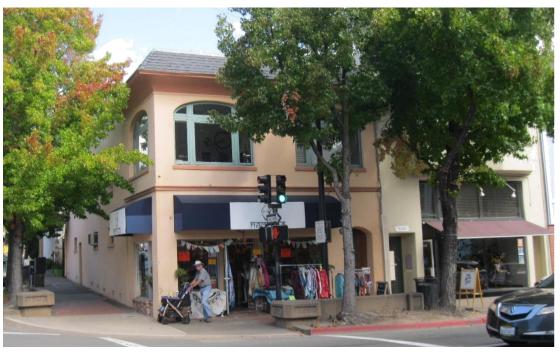
1350 Fourth St/		
Address/code	1040 D St		D
APN	011-205-14		
Building Name			
Year Built	1903 (spreadsheet)		
Original Use	Storefront		
Architectural Style	Mission		
Architect/Builder			
Description	The two story building is rectangular in plan with a flat roof with decorative hipped roof at the south end of the building. Upper floor windows have divided lights in arched openings. The building is clad in stucco. Storefront and door are contemporary		
Integrity	Lacks integrity, roof appears to have lost tile and decorative features, bulkhead altered		
Significance	Appears ineligible, lack of significance/integrity		
Notes

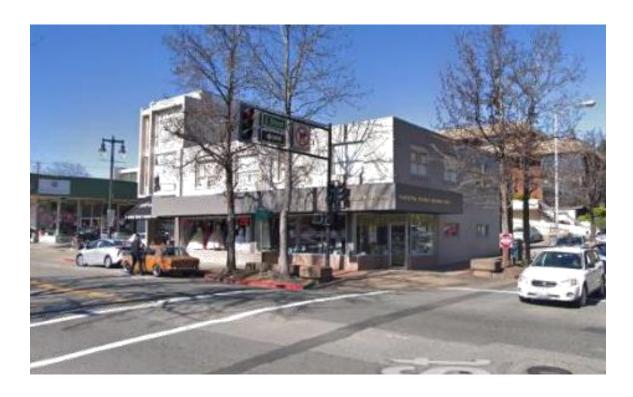
Address/code	1400 Fourth Street		D
APN	011-204-08		
Building Name			
Year Built	1958 (spreadsheet)		
Original Use	Storefront		
Architectural Style	Midcentury Utilitarian		
Architect/Builder			
Description	The two story building is rectangular in plan with a flat roof. The building is constructed of concrete masonry units and lacks decorative features. Upper floor windows are square steel casement. Aluminum frame doors and storefronts appear original. A heavy soffit/awning has been installed above the storefronts.		
Integrity			
Significance	Undistinguished midcentury building, Not Eligible, lack of significance		
Notes	This was subsequently dropp consideration. It provides a be 1414.

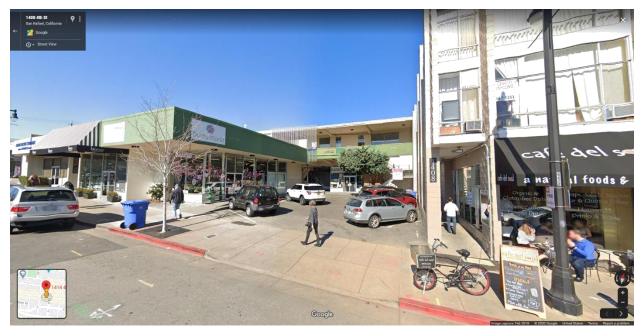
Address/code	1414 Fourth Street		D
APN	011-204-17		
Building Name			
Year Built	1958 (spreadsheet)		
Original Use	Storefront/office		
Architectural Style	Midcentury Modern		
Architect/Builder			
Description	The building is L-shaped in plan in plan with a single story volume near the street and a two story volume recessed behind a parking lot. It has flat roof and is constructed of concrete masonry units. It lacks decorative features. Upper floor windows are rectangular. Aluminum frame doors and storefronts appear original. A heavy soffit/awning has been installed above one of the storefronts.		
Integrity			
Significance	Undistinguished midcentury	building, Not Eligible, lack	of significance
Notes	This was subsequently dropp provides a better example of

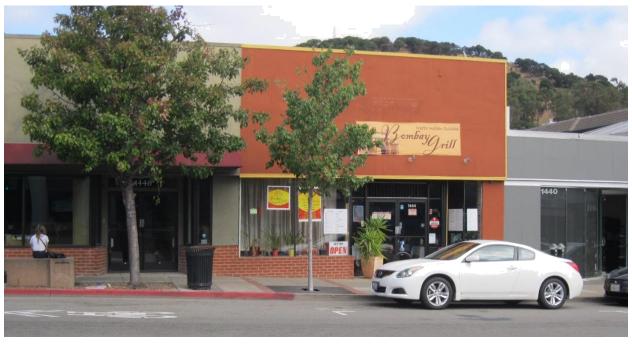
1444- 1446 Fourth		
Address/code	Street		D
APN	011-204-15		
Building Name			
Year Built	1915/1965 (spreadsheet)		
Original Use	Storefront		
Architectural Style			
Architect/Builder			
Description	Two adjacent storefront buildings on the parcel are nearly identical in form, style and plan. They feature tall parapets, stucco cladding, brick bulkheads, and contemporary storefronts. They exhibit the typical plan and form of an early twentieth century storefront building but no architectural details associated with that era. Nor are they good examples of midcentury architecture.		
Integrity			
Significance	Undistinguished buildings not eligible as landmarks or contributors.		
Notes

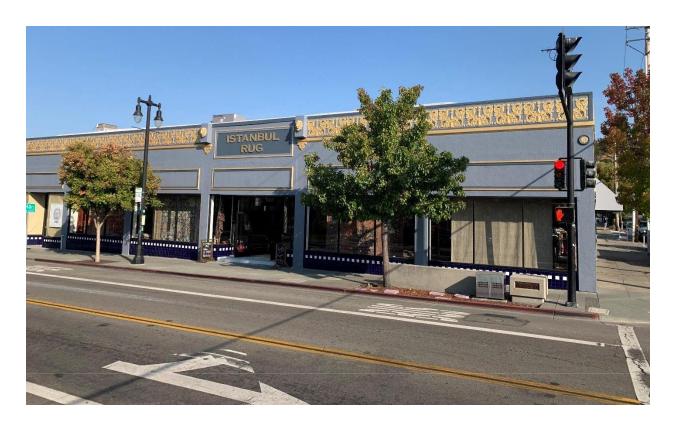
1504-1510 Fourth St/		
Address/code	1109 E St.		В
APN	011-202-14		
Building Name			
Year Built	1929 (spreadsheet)		
Original Use	Auto Showroom		
Architectural Style	Art Deco/Spanish Revival		
Architect/Builder			
Description	The large single story building is rectangular in plan with flat roof. It is clad in stucco with terracotta ornament including ornate floral frieze and lions' heads flanking the main entrance. Storefront bays are separated by minimalist pilasters with granite bases. Original transoms have been covered. Bulkhead is tile, and storefronts are contemporary.		
Integrity	Retains sufficient integrity for district contributor status because of well-preserved ornate frieze.		
Significance	Potentially eligible as contributor, lacks integrity required for landmark. Requires further evaluation.		
Notes	Applies only to the corner building. The other building on the parcel (1512, or Bordenave's French Bakery) is not significant.

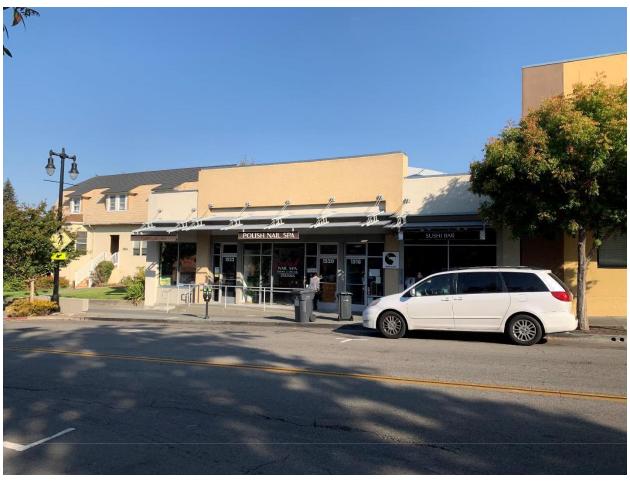
1518-1522 Fourth		
Address/code	Street		D
APN	011-202-11		
Building Name			
Year Built	1928 (spreadsheet)		
Original Use			
Architectural Style			
Architect/Builder			
Description	The single story storefront commercial building is rectangular in plan with stepped parapet. It is clad in stucco and has aluminum frame storefronts and glazed doors. It exhibits no characteristics of historic architecture		
Integrity			
Significance	Not eligible as contributor of	or landmark	
Notes		·	·

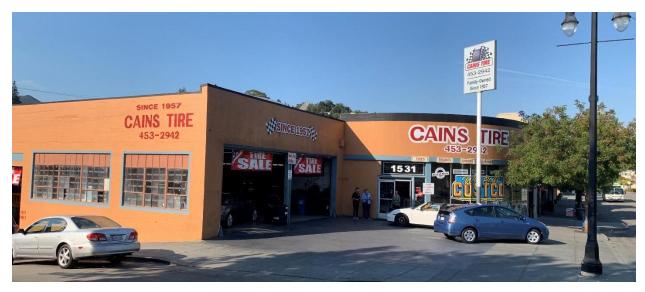
Address/code	1531 Fourth Street		B+
APN	011-242-11		
Building Name			
Year Built	1931 (spreadsheet)		
Original Use	Tire sales and repair		
Architectural Style			
Architect/Builder			
Description	The single story auto-orienterounded volume projecting from has industrial sash windows copenings at the north and ear is almost completely glazed, with the main building.	om its main (north) facade on its east elevation. There st of the rectangular volun	e. It is clad in stucco and are three large vehicle ne. The rounded volume
Integrity	Retains integrity		
Significance	Eligible as contributor and po oriented building	ssibly landmark, good exa	mple of early auto-
Notes

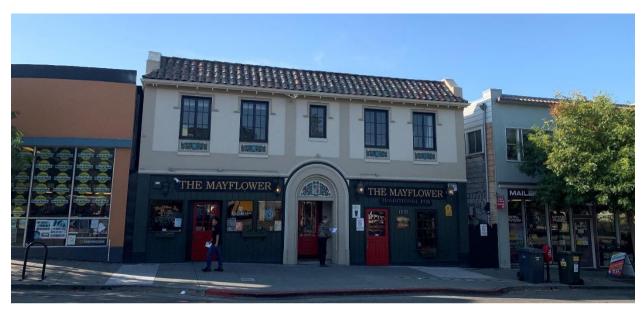
Address/code	1533 Fourth Street		В
APN	011-242-10		
Building Name			
Year Built	1925 (spreadsheet)		
Original Use			
Architectural Style	Spanish Revival		
Architect/Builder			
Description	The two story commercial bu roof at the main (north) façac ornament with floral and shie multiple light wood sash and entrance had a large arched swood cladding and small win storefronts.	de. The building is clad in sold in sold motif. Upper story wind topped with ornamental hour ound with Romanesque	tucco and has terracotta dows are fitted with noods. The central e moulding. Vertical
Integrity	Retains integrity despite stor- been retained.		
Significance	Eligible as contributor and po Spanish/Mediterranean archi		mple of
Notes

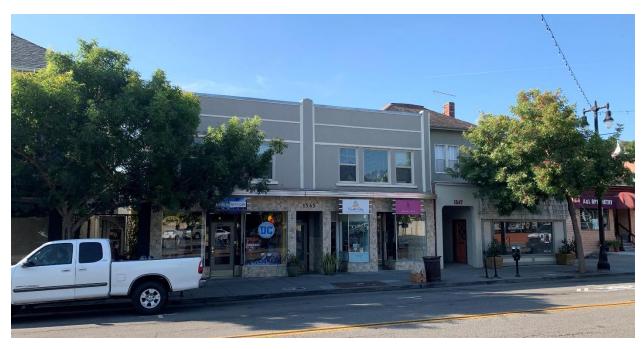
Address/code	1539 Fourth Street		D
APN	011-242-09		
Building Name			
Year Built	1923/1961 (spreadsheet) probably older (drop siding with historic advertising side elevation		
Original Use			
Architectural Style	Spanish Revival		
Architect/Builder			
Description	The two story commercial building is rectangular in plan with decorative shed roof at the main (north) façade. The building is clad in stucco tripartite upper story windows fitted with vinyl sash. Storefronts are contemporary.		
Integrity			
Significance	Lacks architectural significand	ce, not eligible	
Notes

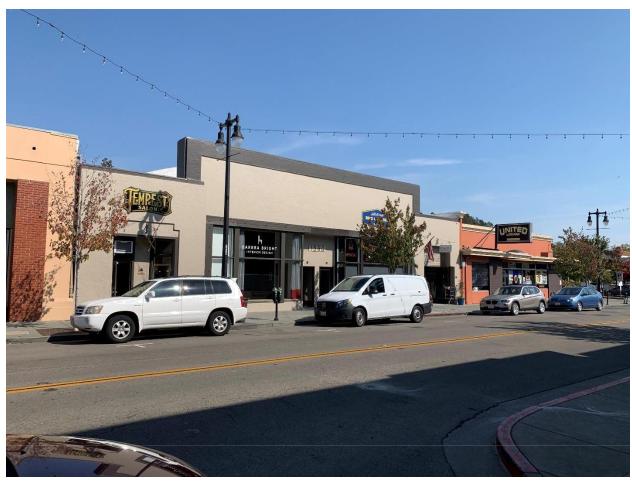
Address/code	1553-1557 Fourth St	7N	В
APN	011-242-04		•
Building Name			
Year Built	1926 (spreadsheet)		
Original Use			
Architectural Style			
Architect/Builder			
Description	cladding and cornice. Upper A slightly projecting entrance stucco, with terracotta carto	story windows fit has a gabled roo uche and swag. D	lar in plan with flat roof and brick ted with double hung wood sash. If form with arched opening. It is ecorative transoms are multiple ads and contemporary doors.
Integrity	Retains integrity		_
Significance	eligible as contributor, lacks	significance requi	red for landmark status
Notes

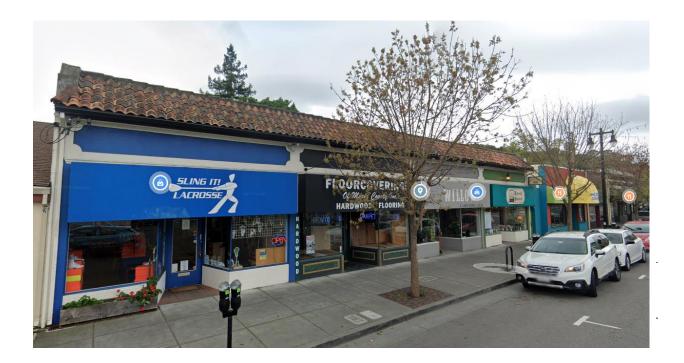
Address/code	1569 Fourth Street		D
APN	011-242-01		
Building Name			
Year Built	1928 (spreadsheet), apparen	t nineteenth century build	ing.
Original Use			
Architectural Style			
Architect/Builder			
Description	The two story commercial-residential building is rectangular in plan with hipped roof and parapet. It clad is stucco, with drop wood siding at rear and side elevations. Double hung wood windows with arched tops and decorative surrounds and roof form indicate the building's probable origin as an Italianate house. Storefronts are contemporary.		
Integrity	Lacks integrity, stucco, parap	et, storefronts	•
Significance	Not eligible, lacks integrity		
Notes

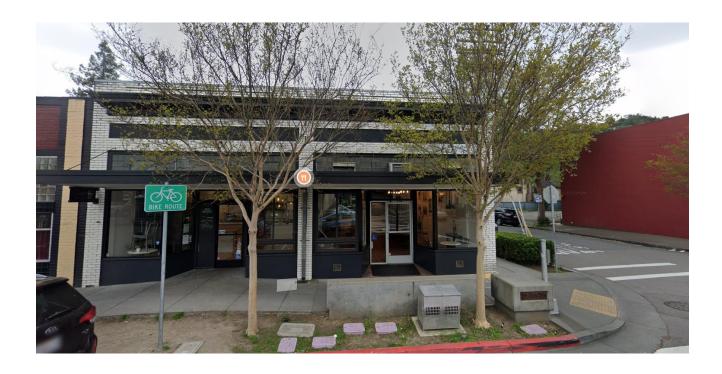
Address/code	1605-1611 Fourth St B
APN	011-241-32
Building Name	
Year Built	1927 (spreadsheet)
Original Use	
Architectural Style	Spanish Revival
Architect/Builder	
Description	The single story storefront building is irregular in plan with flat roof and decorative tiled shed roof on the main (north) facade. It clad is stucco, with drop wood siding at rear and side elevations. There is a simple paneled frieze above the four storefront bays. Large awnings cover the transom area. Slanted storefronts have original tile bulkheads (some of which have been painted) and fully glazed wood doors.
Integrity	Retains integrity
Significance	Simple but good example of Spanish Revival commercial architecture, eligible as district contributor, probably not distinguished enough for landmark status
Notes

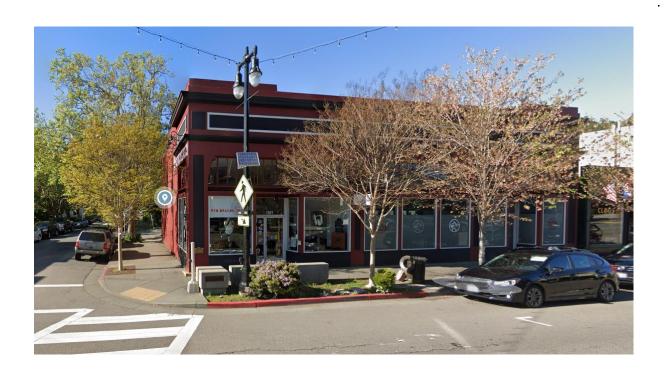
Address/code	1617 Fourth Street		В
APN	011-241-01		
Building Name			
Year Built	1920 (spreadsheet)		
Original Use			
Architectural Style	Neo-classical		
Architect/Builder			
Description	The single story storefront building is rectangular in plan with flat roof and parapet with decorative cornice on the main (north) facade. The building is glazed brick, which is plastered at rear and side elevations. Original transoms have small square panes with obscured glass. A heavy awnings projects over the sidewalk below transoms. Slanted storefronts have original bulkheads and fully glazed aluminum replacement doors.		
Integrity	Retains integrity despite door	replacement	
Significance	Simple but good example of contributor, probably not dis	•	•
Notes

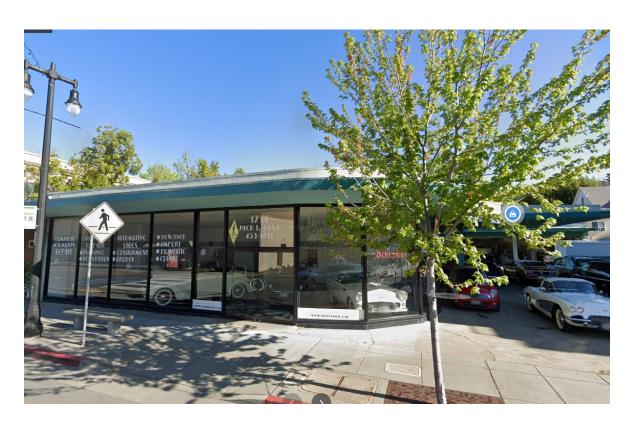
Address/code	1701 Fourth Street		C
APN	011-232-03		
Building Name			
Year Built	1925 (spreadsheet)		
Original Use	Grocery store		
Architectural Style	Neo-classical		
Architect/Builder			
Description	The single story storefront bustepped parapet with decorastucco. There is a simple pane openings and divided lights. The single paragraph is a simple paragraph.	tive cornice on the main (neled frieze above the trans	orth) facade. It clad is oms, which have shaped
Integrity	May retain integrity, more stu	udy needed, stucco may no	ot be original
Significance	Possibly eligible as district constatus	ntributor, not distinguished	d enough for landmark
Notes

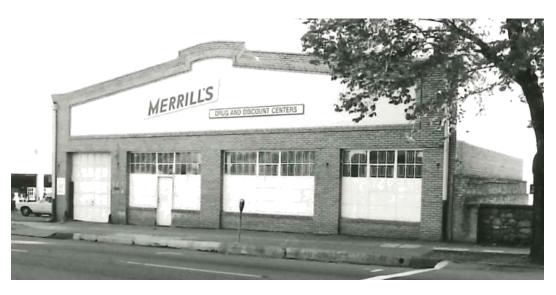
Address/code	835 Fifth Ave		В
APN	011-224-21		
Building Name	Merrill's Drug and Discount		
Year Built	1921 (DPR)		
Original Use	Commercial (Receiving)		
Architectural Style	Mission		
Architect/Builder			
Description	The single story commercial building is rectangular in plan with a gabled roof hidden by a shaped parapet. The main (north) façade is occupied by large contemporary storefront windows with one roll up vehicle door. Cladding is brick with stuccoed areas. The off center entrance has a contemporary glazed door.		
Integrity	Lacks sufficient integrity to be	individual resource (see 1	970s photo above)
Significance	Not eligible as landmark due	9	nd lack of
	Integrity—4 th Street frontage	(#866) is ineligible	
Notes	Very similar to 819 Fifth/836	Fourth

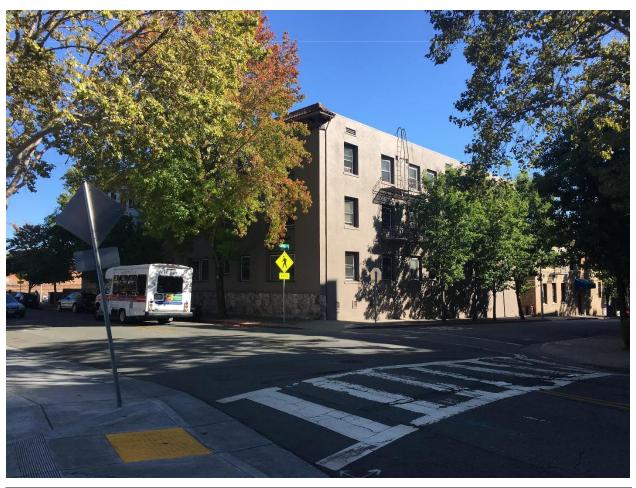
Address/code	845 Fifth Ave		D
APN	011-224-01		
Building Name	El Rey Apartments		
Year Built	1920 (spreadsheet)		
Original Use	Multi-family residential		
Architectural Style	Mediterranean Revival		
Architect/Builder			
Description	The three story apartment but hipped tile parapet with decors is a floral frieze below the conbuilding is clad in stucco with entrance. The recessed door decorative fanlights. Fenestra windows. There is a fire escape.	prative cornice featuring shad raice and decorative swags decorative stone wainscord is wood frame and fully glad ition is vertical openings water the corner was a strong the corner of	aped rafter tails. There on spandrel panels. The ting and arched main azed with sidelights and ith replacement
Integrity	Apparently lacks integrity, represearch needed	placement windows and w	ainscoting, more
Significance	Not likely to be eligible as lan and lack of integrity	dmark or contributor due	to marginal significance

Notes	Was considered a "high-end"	development in its time

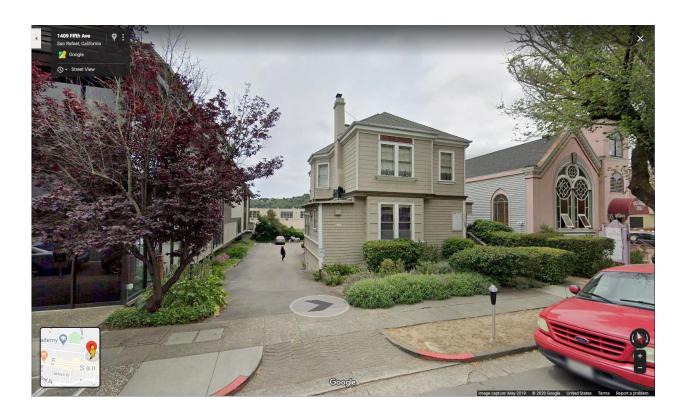
Address/code	1409 Fifth Ave		D
APN	011-204-18		
Building Name			
Year Built	1888/1949 (spreadsheet)		
Original Use	Multi-family residential		
Architectural Style			
Architect/Builder			
Description	The two story house is roughly rectangular in plan with a hipped roof. It is clad in shingles and drop siding wood siding. Double hung wood sash windows and some decorative elements reveal nineteenth century origin of building, but its original style and form are unknown. Converted to 5 apartments 1949.		
Integrity	Lacks integrity, specific alterations unknown but not a good example of any historic residential style		
Significance	Not eligible as landmark or co	ontributor due to lack of in	tegrity
Notes

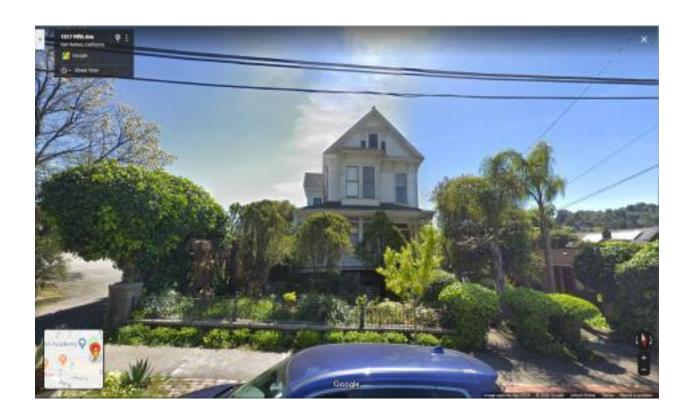
Address/code	1517 Fifth Ave	7N	Α
APN	011-202-04		
Building Name	Chisolm House		
Year Built	1890/1920 (spreadsheet)		
Original Use	Residential		
Architectural Style	Queen Anne		
Architect/Builder			
Description	The 2.5 story raised basemen gabled roof. It is clad in narro Windows are double hung we projecting from the main (no light wood windows. Orname assemblage with diminutive swith scrolled bracket and dectate porch, and projecting second	w clapboard and wide hore bood sash. A full-width porce orth) façade and its east en- ental details include decora shed roof on the pediment corative frieze, turned post	rizontal wood siding. The has a hipped roof It is enclosed in multipleative window The front gable, cornice The sand elaborate trim on
Integrity	Retains integrity		
Significance	Eligible as landmark and cont	ributor	
Notes	Designated as local landmark correct address is shown.	in Dec 1979, but at wrong	address (1505 Fifth)—

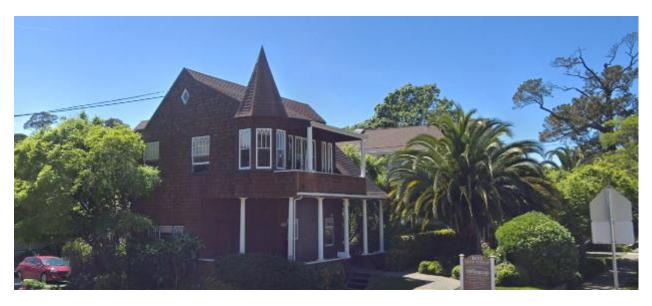
Address	1623 5 th Avenue, Building A	7N	В
APN	011-320-01		
Building Name	Victorian Village (Unit A)		
Year Built			
Original Use	Residential		
Architectural Style	Victorian		
Architect/Builder			
	Building A is shown here	and is one of the origina	al 1978 listed buildings.
Description	The other original buildin	g is the "little red schoo	lhouse" at 1623C
Integrity	Appears to retain integrity		
Significance	Potential local district c on	tributor, not individually e	eligible at any level
Notes

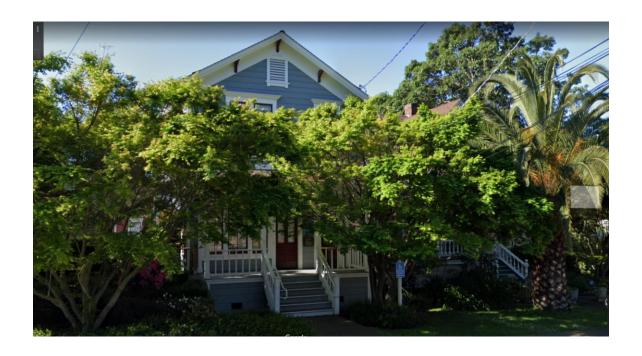
1623 5 th Avenue,		
Address	Building B	7N	В
APN	011-320-02		
Building Name	Victorian Village (Unit B)		
Year Built			
Original Use	Residential		
Architectural Style	Victorian		
Architect/Builder			
Description	Building B, which faces Fift	h Avenue, is shown here.	. It was relocated to the
	site to make way for offices	s at 5 th and D.	
Integrity	Appears to retain integrity		
Significance	Potential local district c ontri	butor	
Notes

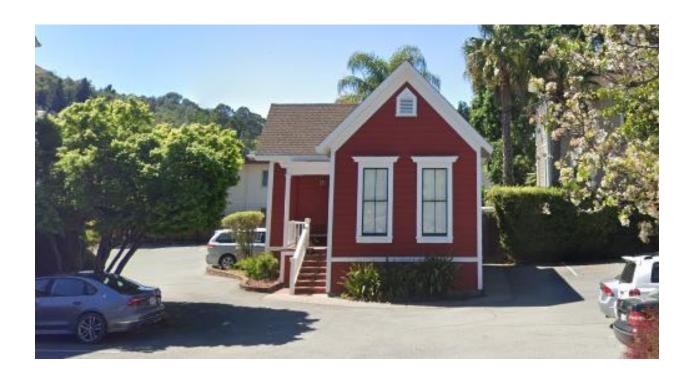
Address	1623 5 th Avenue, Building C	7N	В
APN	011-320-03		
Building Name			
Year Built			
Original Use	Residential		
Architectural Style	Victorian		
Architect/Builder			
Description	The small one-story L-shaped buildings and is set back from shingle roof. It is clad in horiz on the gable faces. A small in entrance, which opens into the two-over-two light double-hu Street with a shed porch over	n the street. It has a cross-a ontal channel board siding tegral porch on the main for the side of the projecting von the wood sash. Was origina	gabled composition g with fishscale shingle açade leads to the main olume. Windows are tall,
Integrity	Appears to retain integrity		
Significance	Potential local district contrib	outor, not individually eligil	ble at any level
Notes	Colloquially called "little red s	schoolhouse"

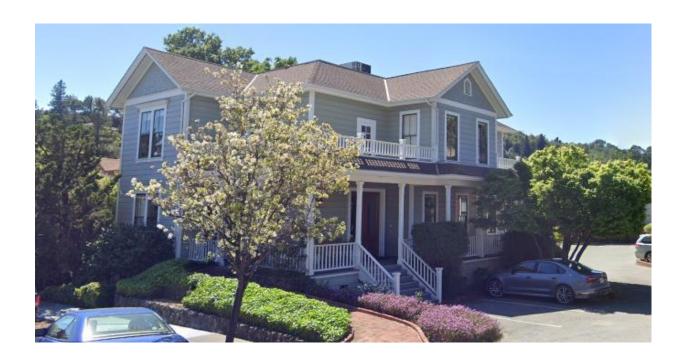
Address/code	1623 D Fifth Ave	7N	В
APN	011-320-04		
Building Name	Victorian Village		
Year Built	ND		
Original Use	Residential		
Architectural Style	Shingle, Folk Victorian		
Architect/Builder			
	Building shown was relocated that corner for the office buil rectangular plan building sha buildings. It has a gable-on-h an integral wrap-around porcrather than the street. It is clashingle on the gable faces. W	ding currently on that site res a parking lot with seve ip composition shingle rooth, with the main façade fand in horizontal channel bo	. The two-story ral other f. The building features scing the parking lot pard siding with fishscale
Description	wood sash		
Integrity	Retain integrity		
Significance	Building remains eligible as d	istrict contributor	
Notes	There were originally 3 buildir	ngs moved here, 1623B and	d 1623D are what remain

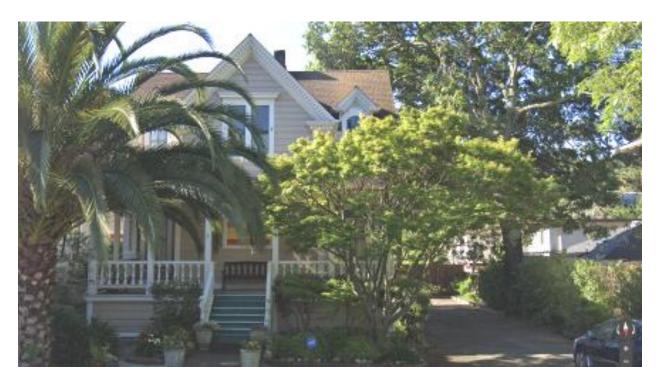
Address/code	1629 Fifth Ave	7N	Α
APN	011-194-02		
Building Name	Thomas Morris House		
Year Built	1878 (spreadsheet)		
Original Use	Residential		
Architectural Style			
Architect/Builder	Queen Anne Cottage		
Description	The 1.5 story house is roughly gabled roof and decorative gashingles. A full-width porch house transfer on available image	abled dormers. The house as its own hipped roof. The	is clad in natural wood
Integrity	Appears to retain integrity, fig	eld photography needed	
Significance	Eligible individually and as dis	trict contributor if field vis	sit reveals integrity
	Local landmark designation w	as requested by owner in	1976, but no official
Notes	designation has been made.

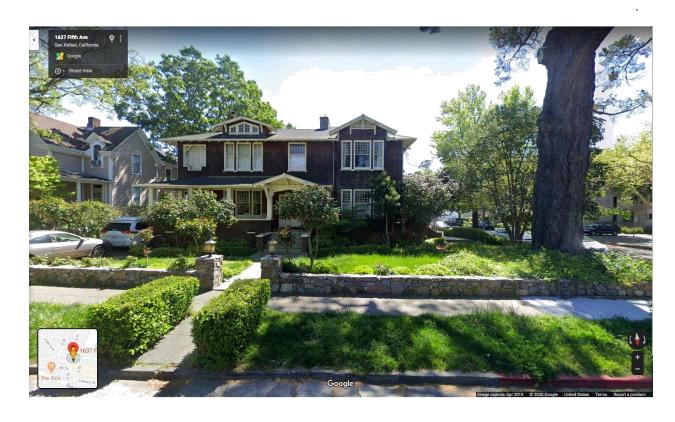
Address/code	1637 Fifth Ave	3S	Α
APN	011-194-01		
Building Name	Seitz-Knight House		
Year Built	1913/1990 (spreadsheet)		
Original Use	Residential		
Architectural Style	Craftsman		
Architect/Builder			
Description	The two story house is rectangabled dormers. The house is width porch has its own hippornament includes gable-endopenings, battered porch colofront yard is enclosed in a low improvements to match 5 th Av	clad in natural wood shin ed roof and solid parapet. vents, shaped knee brace umns, and multiple-light co stone wall. Recent side a	gles. A projecting partial Lavish craftsman-style s, arched porch ottage windows. The
Integrity	Retains integrity		
Significance	Excellent example of Craftsm contributor	an architecture. Eligible in	dividually and as district
Notes

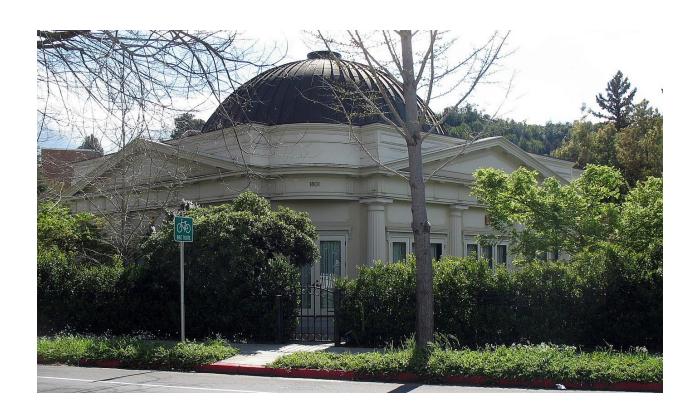
Address/code	1801 Fifth Ave	15	Α
APN	010-291-16		
Building Name	Victrola Pavilion/ San Rafae	el Improvement C	ub
Year Built	1915/1916 (NRHP)		
Original Use	Panama-Pacific Exhibition	Building/local club	phouse
Architectural Style	Classical Revival		
Architect/Builder	William B. Faville		
Description	Cladding is smooth plaster	stucco or concret ornice and frieze, a	e plan and flat/domed roof. e. Classical revival ornament and formal pediments. The building and details are unclear.
Integrity	Appears to retain integrity needed	, dome was added	l after 1983, field photography
Significance	eligible as landmark and co	ntributor	
	Listed on the NRHP 1984. R	elocated <mark>after Par</mark>	nama Pacific Exhibition. Incorrectly
Notes	addressed as 1800 Fifth Ave	e in some prior red	ords.
