Client Number: 020200025 Project ID: Seare 1528 9000 Northquie San Rafael, CA Work Order Number: C4-11-0454

Project ID (name): Sears/#1528/9000 Northgate Hall, San Rafael

Appendix B Photograph Log

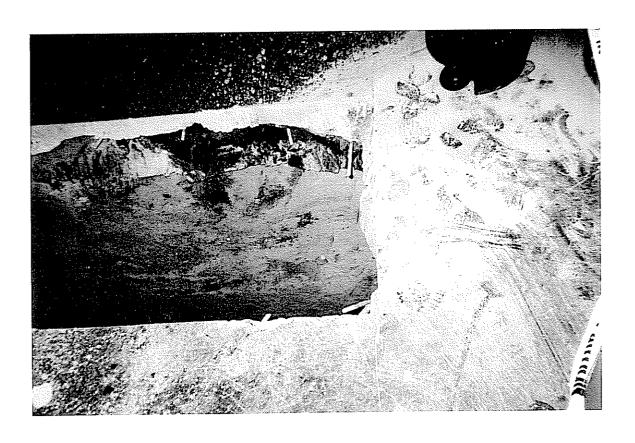
Photograph 1. Lift 3 after cylinder has been removed

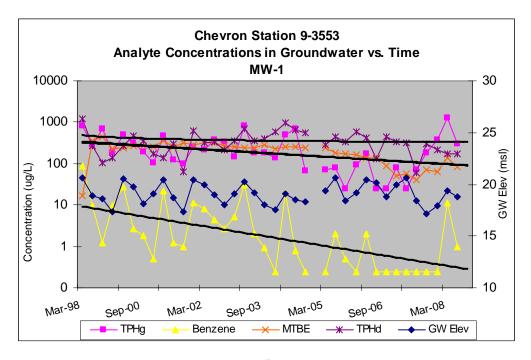
Concentrations in MW-1 show overall stable to decreasing trends. Fluctuations in concentrations are mainly attributed to seasonal changes in groundwater elevation. TPHg in MW-1 increased by one order of magnitude during the previous quarterly event; however, during this quarter, concentrations decreased to the normal range associated with fluctuating groundwater concentrations. Well MW-1 appears to be down-gradient of the adjacent Union 76 station.

Concentration Trends: Historical and current concentration trends for TPHd, TPHg, benzene and MTBE in groundwater versus time are shown for MW-1, MW-2, MW-3, and MW-4 on the graphs below. The trend graph for MW-3 also includes tertiary butyl alcohol (TBA), a degradation product of MTBE. Seasonal groundwater fluctuations continue to affect concentrations in groundwater on-site; however, overall a decreasing trend in each of these wells is evident.

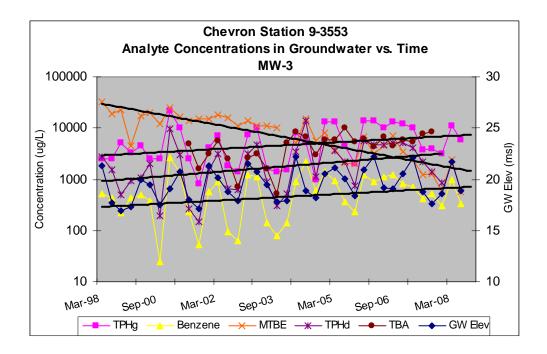
TPHg, benzene, TPHd and TBA concentrations are increasing slightly in well MW-3; however, are within historical ranges. MTBE concentrations are decreasing in MW-3. TBA/MTBE ratios have been useful in interpreting biodegradation of MTBE. Although more information is necessary to determine if this is occurring, trends suggest that a favourable environment for natural attenuation may exist in the subsurface. MW-7, located near the former used-oil tank, will help to further define on-site conditions as trends are established.

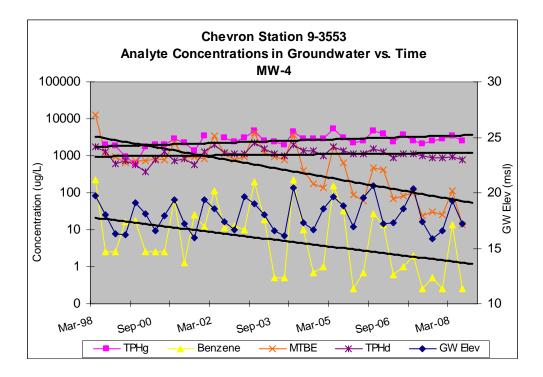
MTBE and benzene concentrations in MW-4 indicate decreasing trends. TPHg and TPHd concentrations are relatively stable, and correlation with seasonal changes in groundwater elevations is evident.

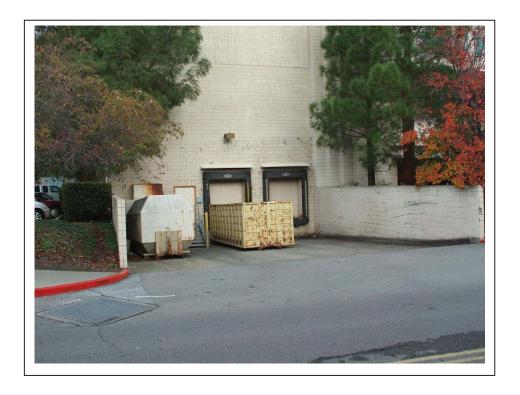
Project No.	Description	Loading dock with trash compactor (south side).	2
10008-008221.00	Name	Mervyn's Department Store, 5010 Northgate Mall, The Mall of Northgate, San Rafael, California 94903	Photo Date 12/18/2008

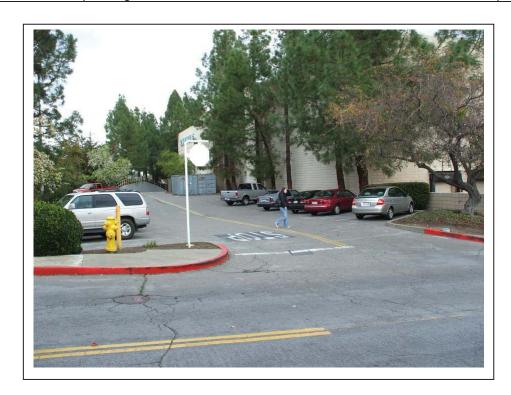
Project No.	Description	View along west side of Mervyn's. Emergency generator and transformer are behind grey storage boxes.	4
10008-008221.00	Name	Mervyn's Department Store, 5010 Northgate Mall, The Mall of Northgate, San Rafael, California 94903	Photo Date 12/18/2008

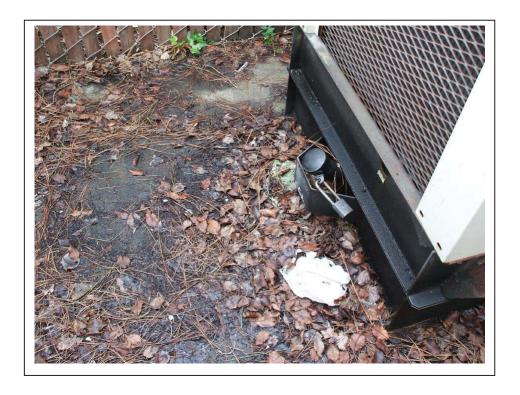
Project No.	Description	Fill port in generator belly tank, and de minimis diesel spillage on concrete pad.	6
10008-008221.00	Name	Mervyn's Department Store, 5010 Northgate Mall, The Mall of Northgate, San Rafael, California 94903	Photo Date 12/18/2008

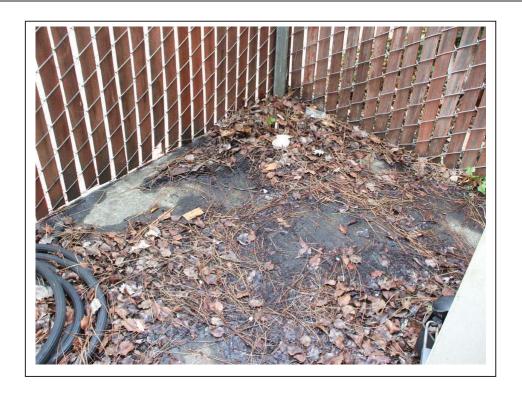
Project No.	Description	De minimis diesel staining on generator pad.	7
10008-008221.00	Name	Mervyn's Department Store, 5010 Northgate Mall, The Mall of Northgate, San Rafael, California 94903	Photo Date 12/18/2008

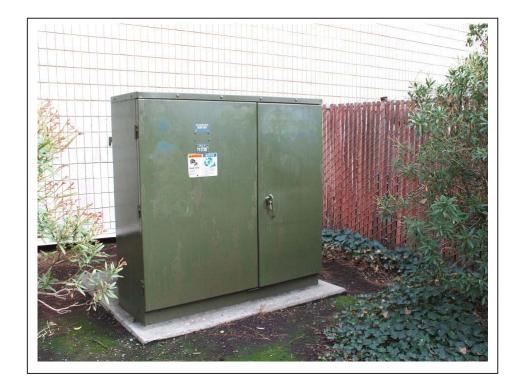
Project No.	Description	Utility-owned transformer adjacent to emergency generator enclosure.	8
10008-008221.00	Name	Mervyn's Department Store, 5010 Northgate Mall, The Mall of Northgate, San Rafael, California 94903	Photo Date 12/18/2008

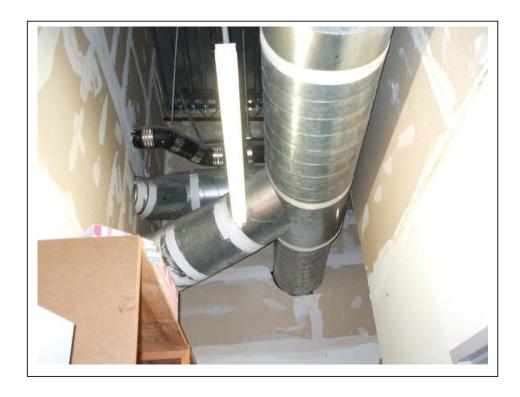
Project No.	Description	Typical HVAC ducts.	12
10008-008221.00	Name	Mervyn's Department Store, 5010 Northgate Mall, The Mall of Northgate, San Rafael, California 94903	Photo Date 12/18/2008

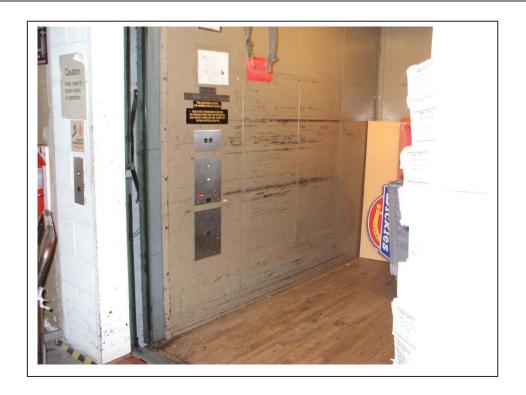
Project No.	Description	Freight elevator.	13
10008-008221.00	Name	Mervyn's Department Store, 5010 Northgate Mall, The Mall of Northgate, San Rafael, California 94903	Photo Date 12/18/2008

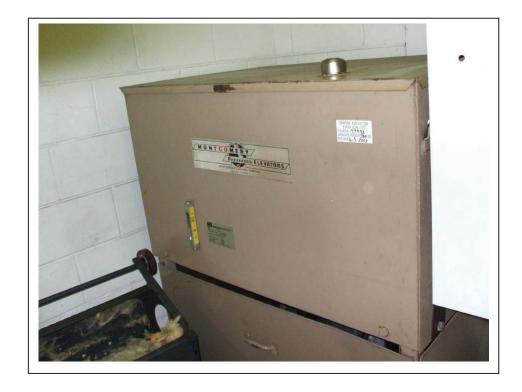
Project No.	Description	Equipment in elevator equipment room.	14
10008-008221.00	Name	Mervyn's Department Store, 5010 Northgate Mall, The Mall of Northgate, San Rafael, California 94903	Photo Date 12/18/2008

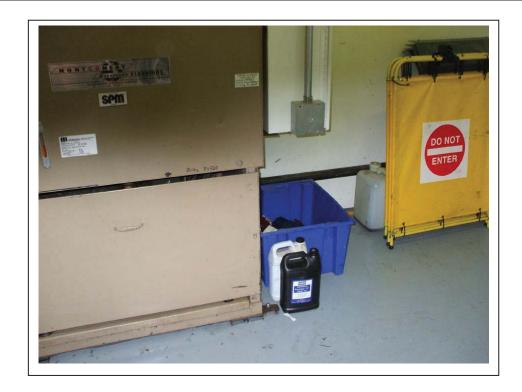
Project No.	Description	Equipment in elevator equipment room.	15
10008-008221.00	Name	Mervyn's Department Store, 5010 Northgate Mall, The Mall of Northgate, San Rafael, California 94903	Photo Date 12/18/2008

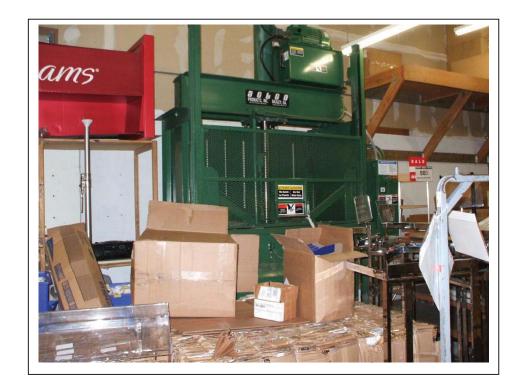
Project No.	Description	Cardboard bailer in warehouse area.	17
10008-008221.00	Name	Mervyn's Department Store, 5010 Northgate Mall, The Mall of Northgate, San Rafael, California 94903	Photo Date 12/18/2008

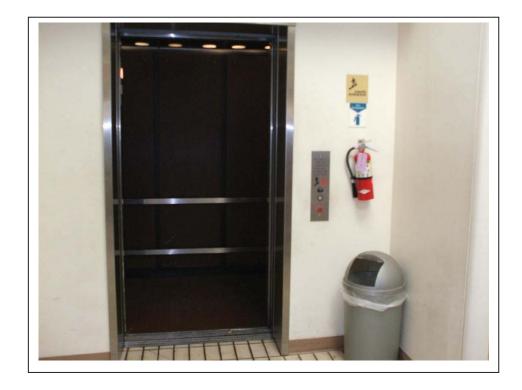
Project No.	Description	Passenger elevator.	
10008-008221.00	Name	Mervyn's Department Store, 5010 Northgate Mall, The Mall of Northgate, San Rafael, California 94903	Photo Date 12/18/2008

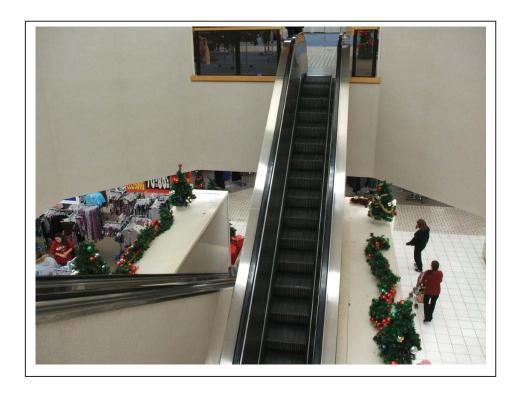
Description	Escalators	
Name	Mervyn's Department Store, 5010 Northgate Mall, The Mall of Northgate, San Rafael, California 94903	Photo Date 12/18/2008
