SITE: Northgate @ Las Galinas, San Rafael, CA

PROJECT#: SF075-050

Subject: Request for Closure
Sears, Roebuck and Co. Automotive Center No. 1528
9000 Northgate Mall
San Rafael, California

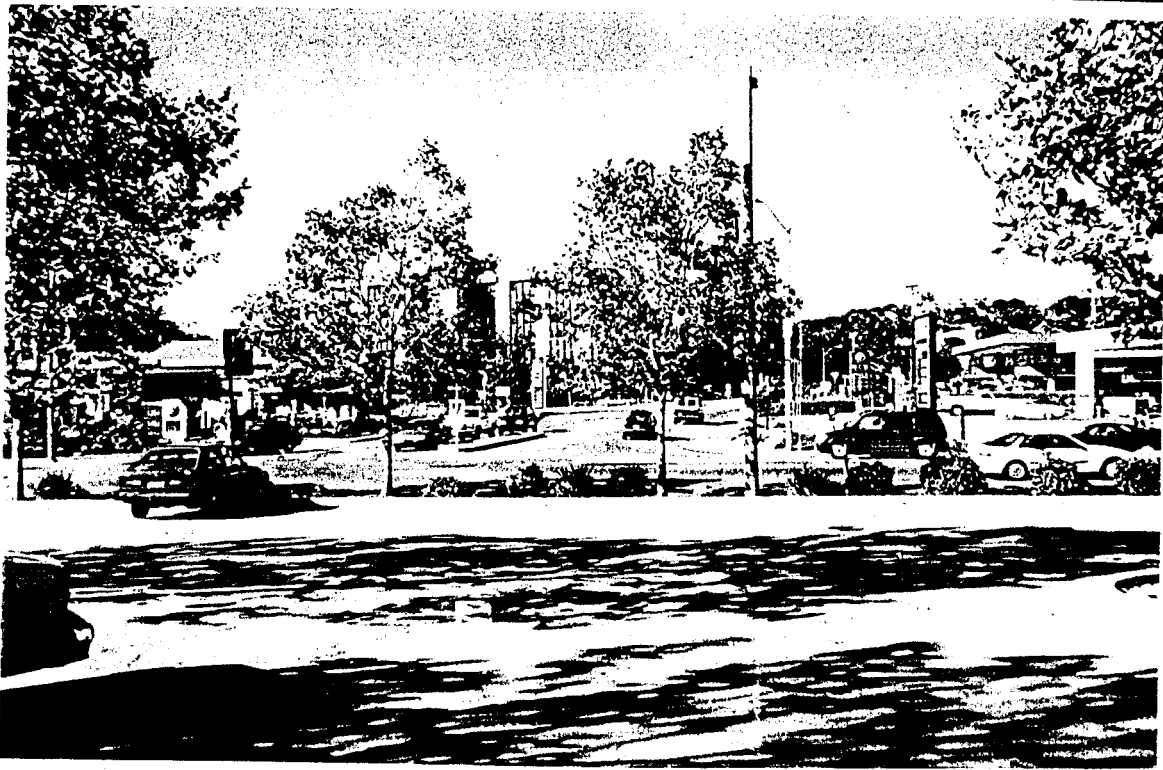
PHOTO #: 7

COMMENTS: Standing at front of the site looking north. Local neighboring active gas stations are visible in background.

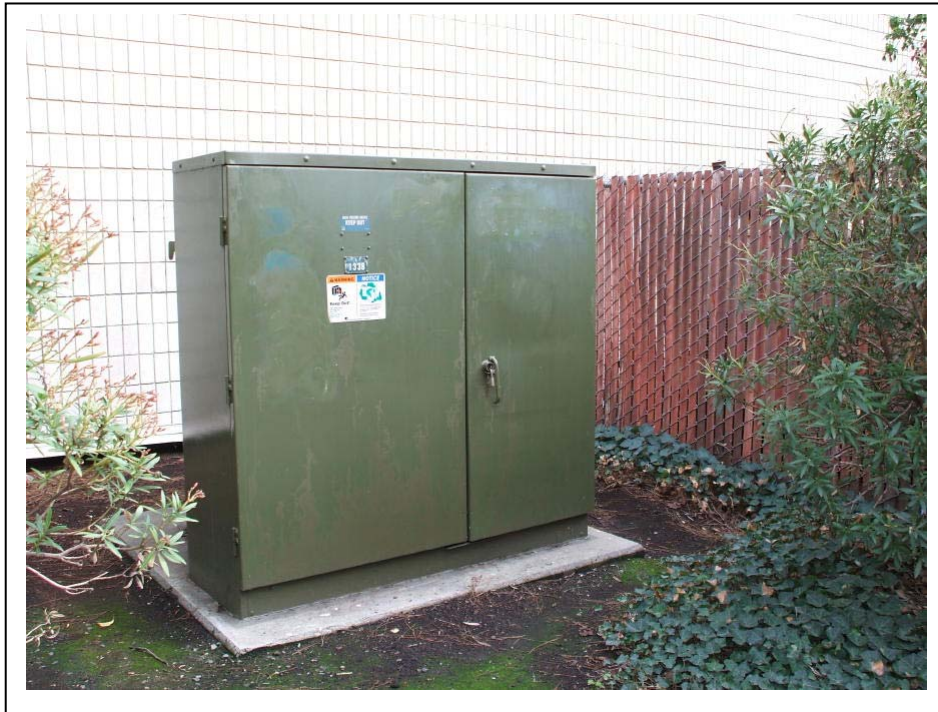
Project No. 10008-008221.00	Description	Utility-owned transformer adjacent to emergency generator enclosure.	8
	Name	Mervyn's Department Store, 5010 Northgate Mall, The Mall of Northgate, San Rafael, California 94903	Photo Date 12/18/2008

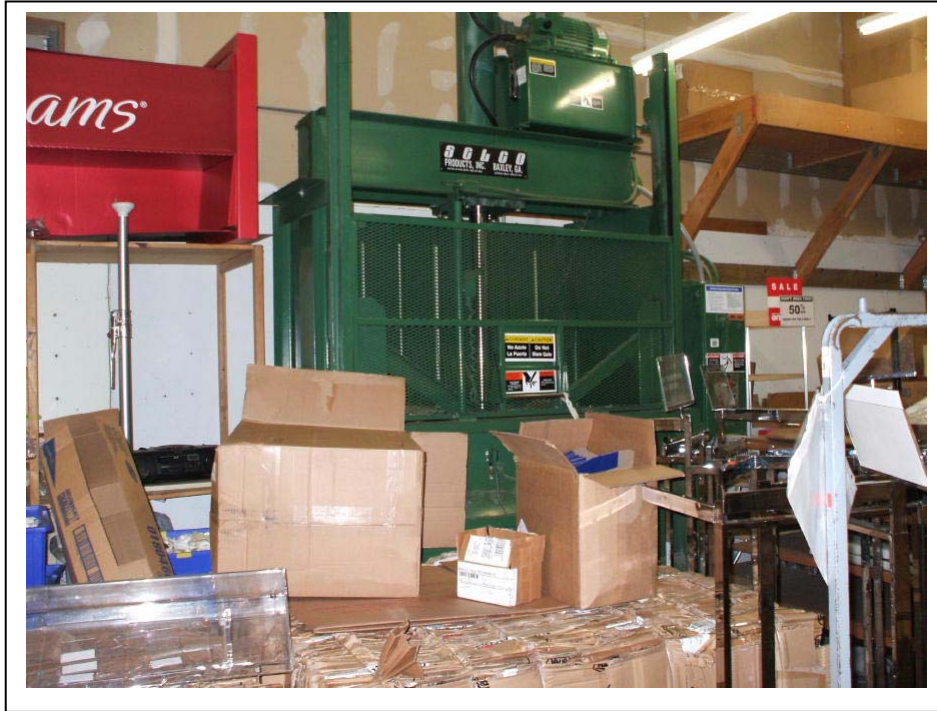
Project No. 10008-008221.00	Description	Cardboard bailer in warehouse area.	17
	Name	Mervyn's Department Store, 5010 Northgate Mall, The Mall of Northgate, San Rafael, California 94903	Photo Date 12/18/2008

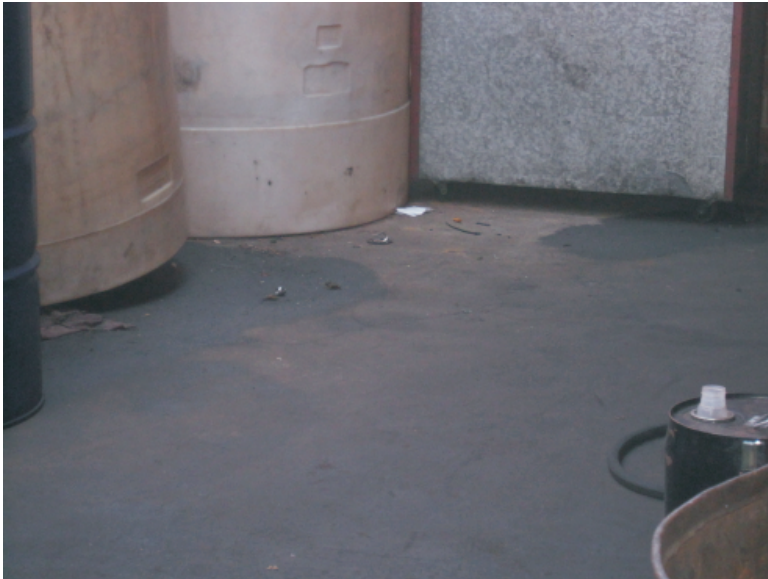
25. View of minor staining around hazardous materials.
