5800 Northgate Mall San Rafael, California 94903

Northgate Mall

TOR Environmental, Inc. (TOR) was retained by Glaser Weil Fink Howard Avchen & Shapiro LLP (Glaser Weil) on behalf of Merlone Geier Partners (MGP) to prepare a Phase I Environmental Site Assessment (Phase I ESA) for the Northgate Mall retail center, for the Northgate Mall retail center, located north and east of Northgate Drive and south and west of Las Gallinas Avenue in San Rafael, California 94903 (*Illustrations 1, 2 and 3*). For the purpose of this report the referenced retail parcels will be referred to as the "Subject Property". According to the Marin County Assessor's office, the current addresses associated with the Subject Property consist of 1000, 1500, 5010, 5800, 6000, and 9000 Northgate Drive. The Subject Property is identified by Marin County Assessor Parcel Numbers (APNs) 175-060-12, 175-060-40, 175-060-59, 175-060-61, 175-060-66 and 175-060-67. The Subject Property includes approximately 44.8 acres of land improved with commercial retail buildings.

This Phase I ESA was conducted on behalf of Glaser Weil and MGP as part of a property transfer. Glaser Weil and MGP will be the "User" of the resulting r

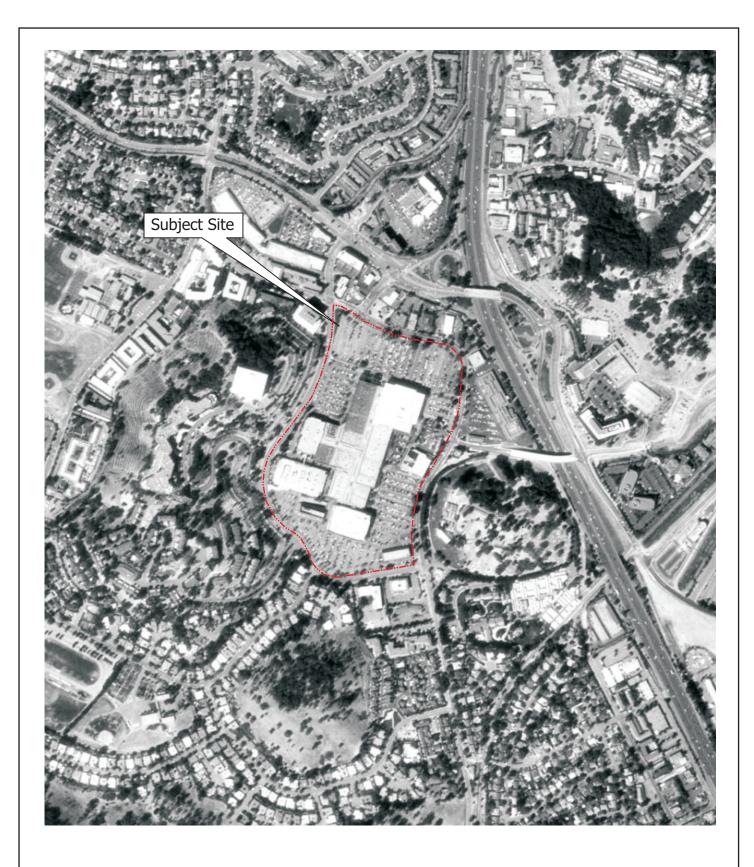
FIGURE 3Job No: 284110

Source: USGS Year: 1998

AERIAL PHOTOGRAPH

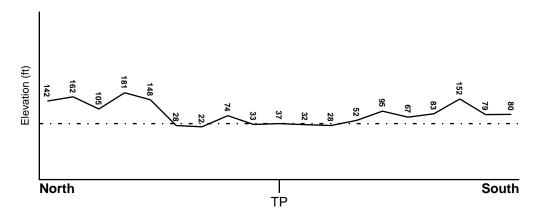
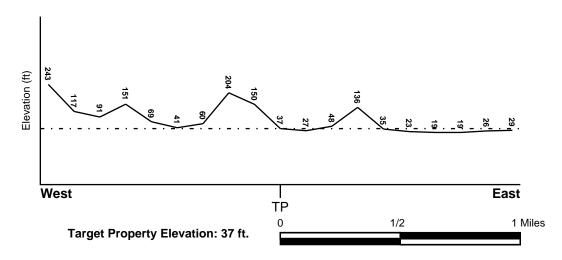
SURROUNDING TOPOGRAPHY: ELEVATION PROFILES

General Topographic Gradient: General SE

Source: Topography has been determined from the USGS 7.5' Digital Elevation Model and should be evaluated on a relative (not an absolute) basis. Relative elevation information between sites of close proximity should be field verified.

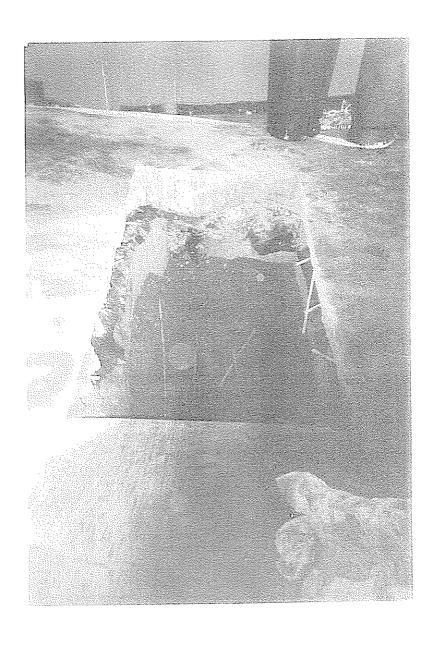
Photograph 2. Lift 2 after cylinder has been removed

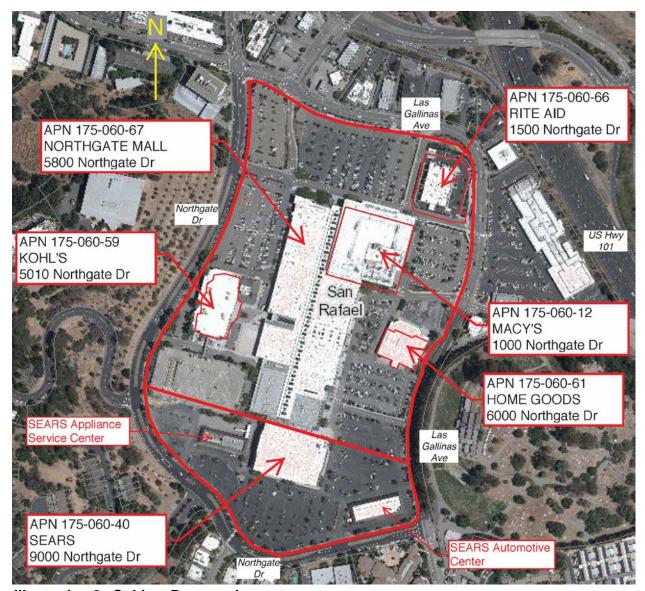
Illustration 3. Subject Property Layout

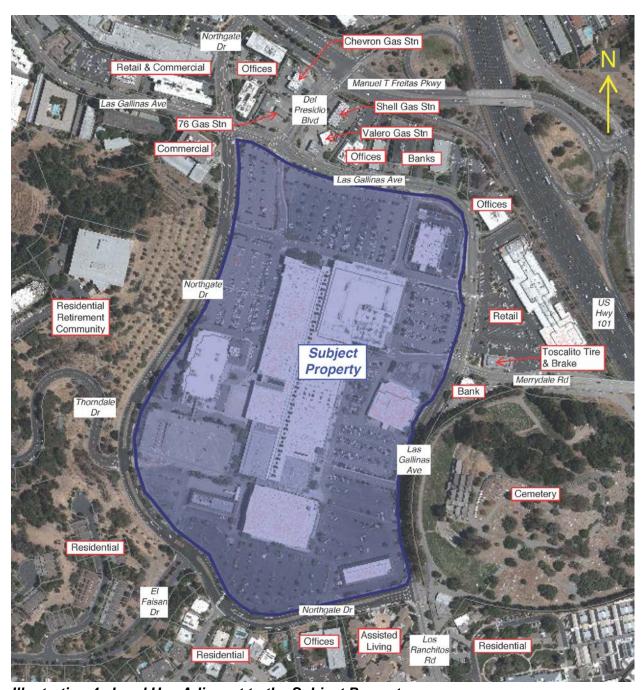
Illustration 4. Land Use Adjacent to the Subject Property

West: Northgate Drive, beyond which are office buildings and residential housing.

Illustration 4 shows adjacent land use.

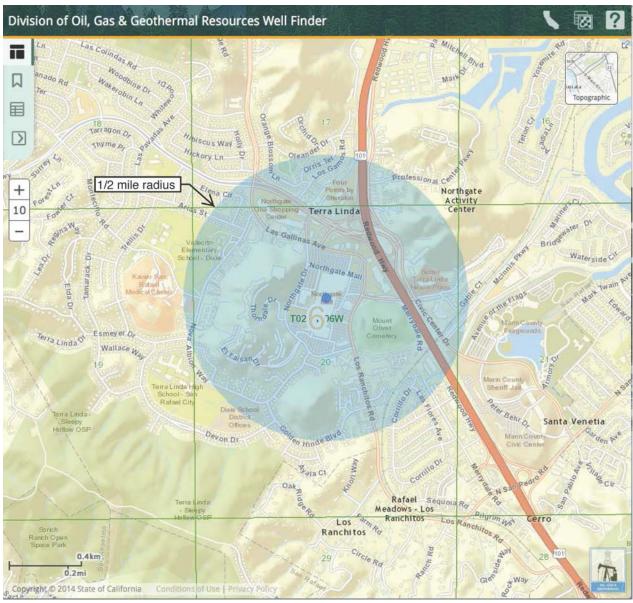
Illustration 5. California Division of Oil, Gas, and Geothermal Resource map showing no oil wells within 1/2 mile of the Subject Property.

TOR's review of the California Department of Conservation's Division of Oil, Gas & Geothermal Resources (DOGGR) Well Finder website indicates no permitted oil, gas or geothermal wells are located within a 1/2 mile radius of the Subject Property (*Illustration 5*).

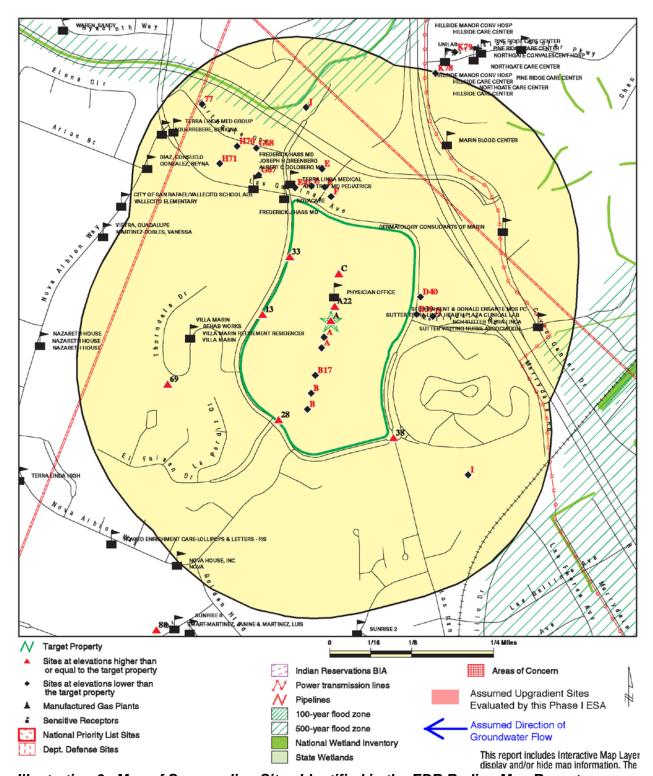
Illustration 6. Map of Surrounding Sites Identified in the EDR Radius Map Report

Site D39, Kerns & Walker Cleaners, 412 Las Gallinas Avenue, formerly located in the strip mall across the street from and downgradient of the Subject Property, is included on EDR's proprietary listing of Historical Cleaners (EDR HIST CLEANER). This listing describes Kerns & Walker Cleaners, Inc. occupying this facility in 2004. Based on its distance and down gradient location, this facility appears unlikely to have impacted the Subject Property.

Other sites identified in the EDR report, either due to distance, direction or nature of listing, appear unlikely to be sources of migrating constituents of potential concern to the Subject Property and therefore don't appear to represent *RECs*.

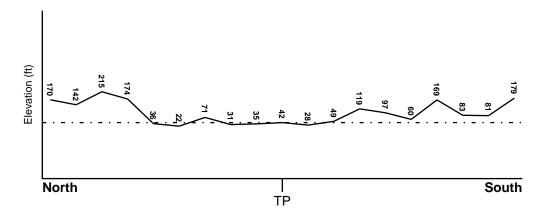
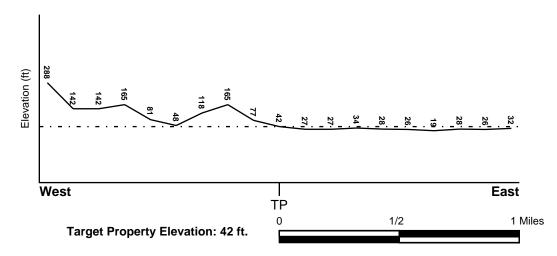
SURROUNDING TOPOGRAPHY: ELEVATION PROFILES

General Topographic Gradient: General East

Source: Topography has been determined from the USGS 7.5' Digital Elevation Model and should be evaluated on a relative (not an absolute) basis. Relative elevation information between sites of close proximity should be field verified.
