EXECUTIVE SUMMARY

At the request of The MaceRich Company, ATC/Diagnostic Environmental Incorporated (ATC/DEI) performed an Environmental Site Assessment of the Northgate Mall, located at 5800 Northgate Drive, San Rafael, California (Project Area/Site). Sears Department Store and its facilities, which also lie within the Site Boundary, are not part of the Project Area. ATC/DEI initiated its services on July 30, 1993. The purpose of the Environmental Site Assessment was to establish a preliminary evaluation of the past and/or present existence, use and/or release of environmentally regulated materials or wastes. The Environmental Site Assessment included a review of Project Area operations, a review of immediately adjacent and surrounding property use, a review of available historical site data and government records, aerial photo study and a review of geological/hydrogeological existing conditions.

ENVIRONMENTAL SITE ASSESSMENT
THE MACERICH COMPANY - THE MALL AT NORTHGATE - SAN RAFAEL, CALIFORNIA

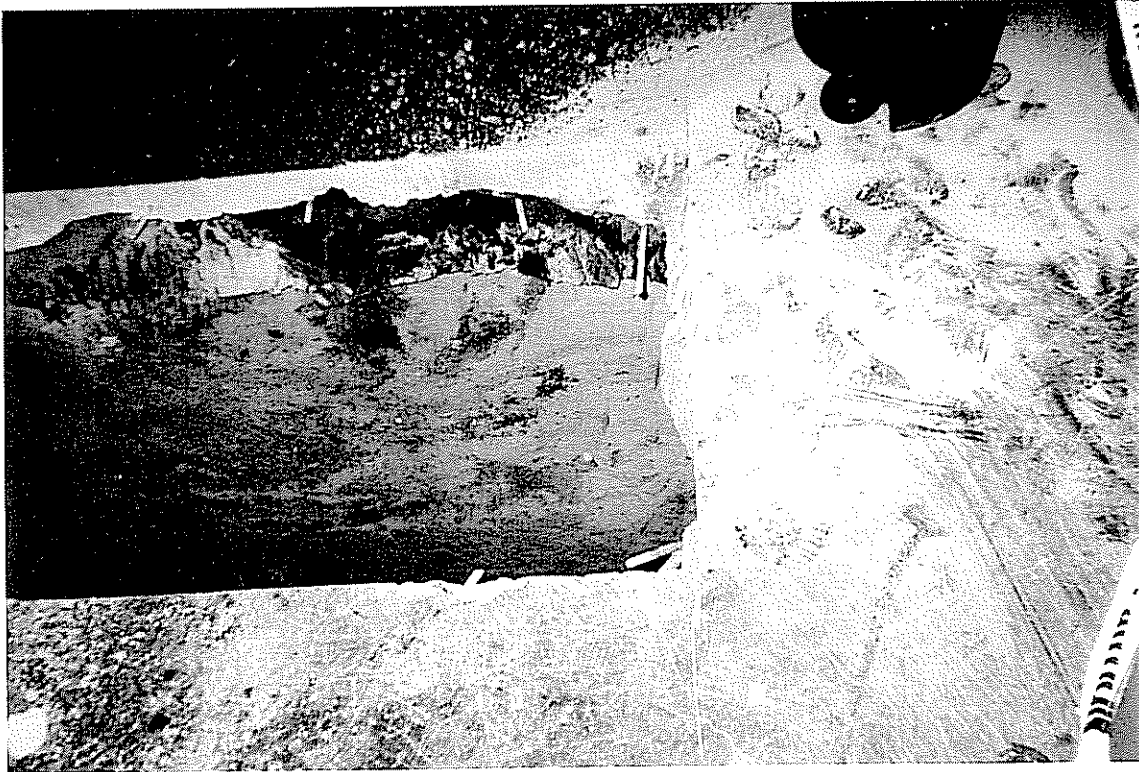
Photograph 1. Lift 3 after cylinder has been removed

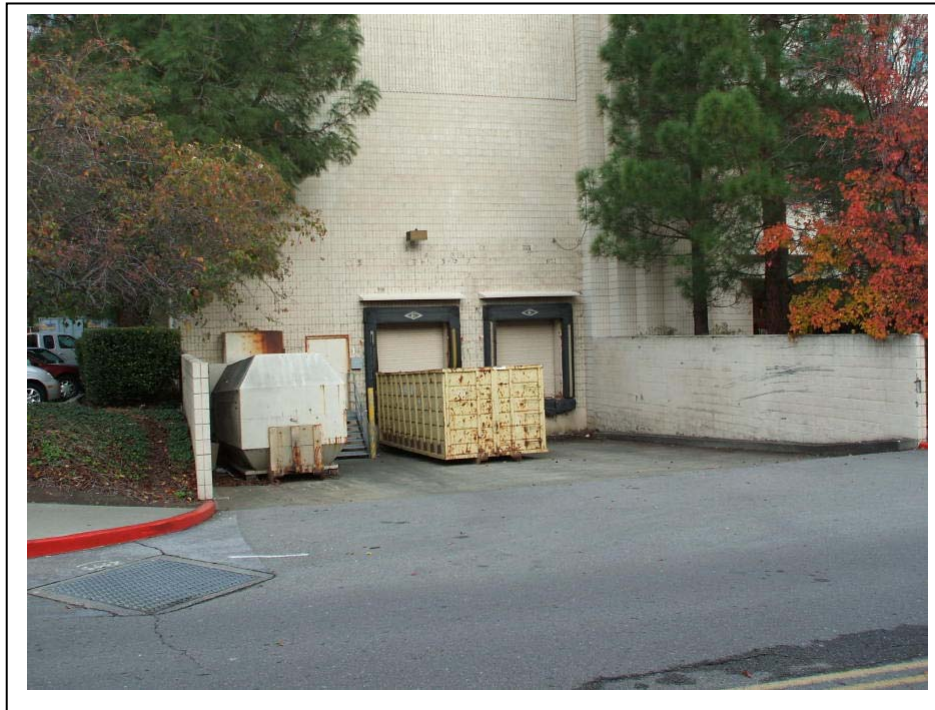
Project No. 10008-008221.00	Description	Loading dock with trash compactor (south side).	2
	Name	Mervyn's Department Store, 5010 Northgate Mall, The Mall of Northgate, San Rafael, California 94903	Photo Date 12/18/2008

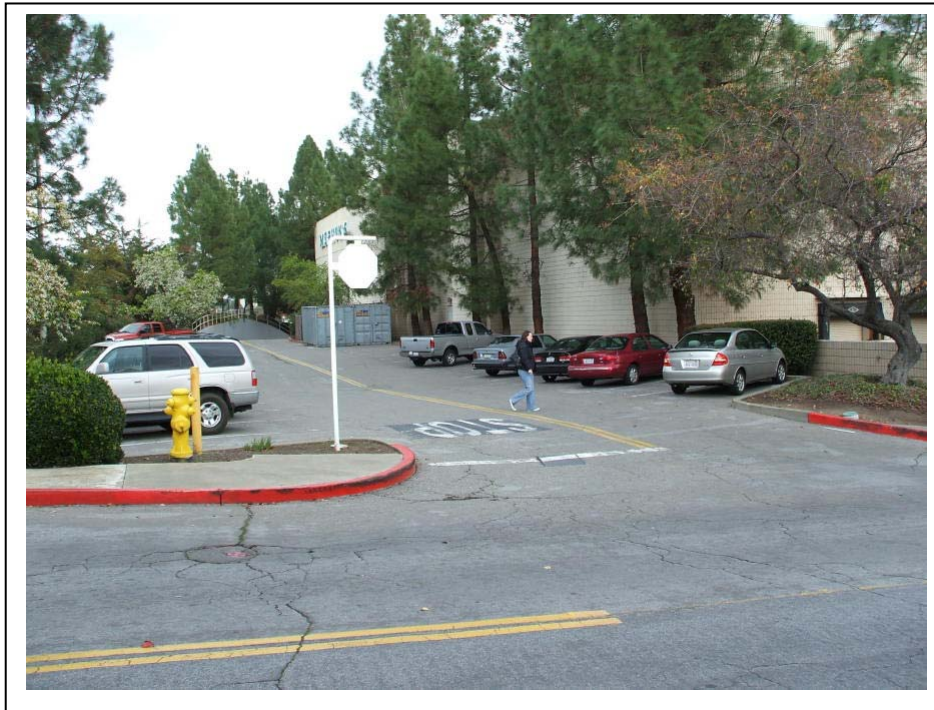
Project No. 10008-008221.00	Description	View along west side of Mervyn's. Emergency generator and transformer are behind grey storage boxes.	4
	Name	Mervyn's Department Store, 5010 Northgate Mall, The Mall of Northgate, San Rafael, California 94903	Photo Date 12/18/2008

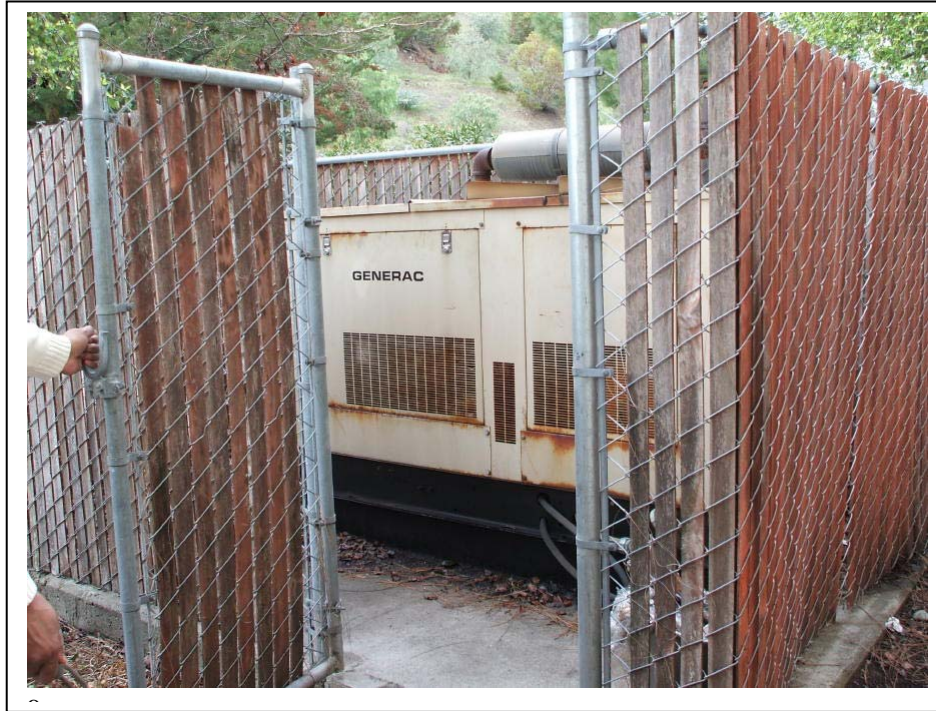
Project No. 10008-008221.00	Description	Emergency generator in enclosure.	5
	Name	Mervyn's Department Store, 5010 Northgate Mall, The Mall of Northgate, San Rafael, California 94903	Photo Date 12/18/2008

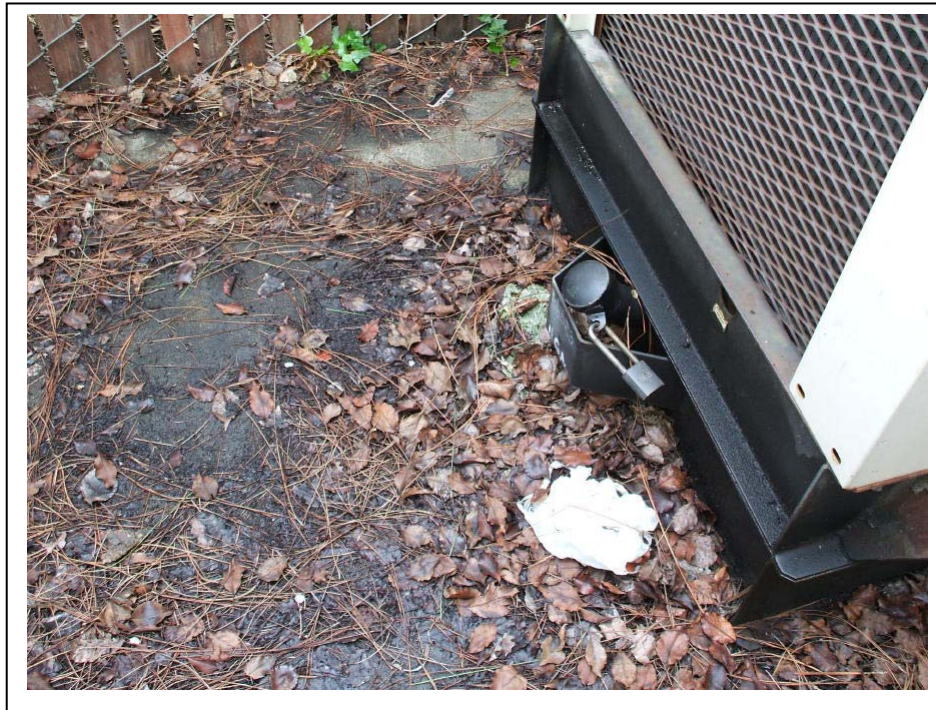
Project No. 10008-008221.00	Description	Fill port in generator belly tank, and de minimis diesel spillage on concrete pad.	6
	Name	Mervyn's Department Store, 5010 Northgate Mall, The Mall of Northgate, San Rafael, California 94903	Photo Date 12/18/2008

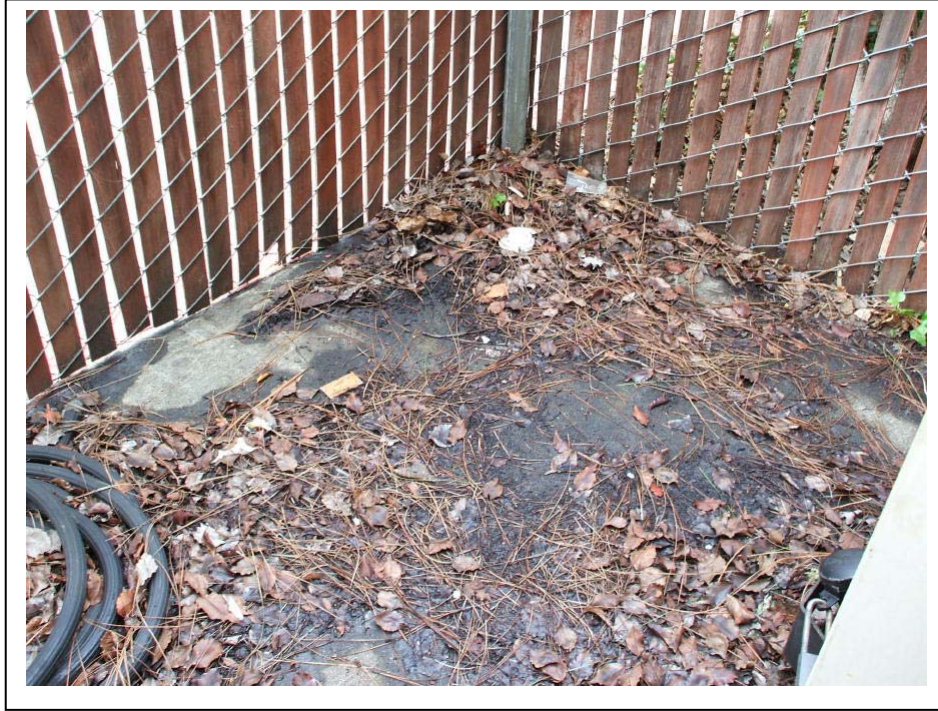
Project No. 10008-008221.00	Description	De minimis diesel staining on generator pad.	7
	Name	Mervyn's Department Store, 5010 Northgate Mall, The Mall of Northgate, San Rafael, California 94903	Photo Date 12/18/2008

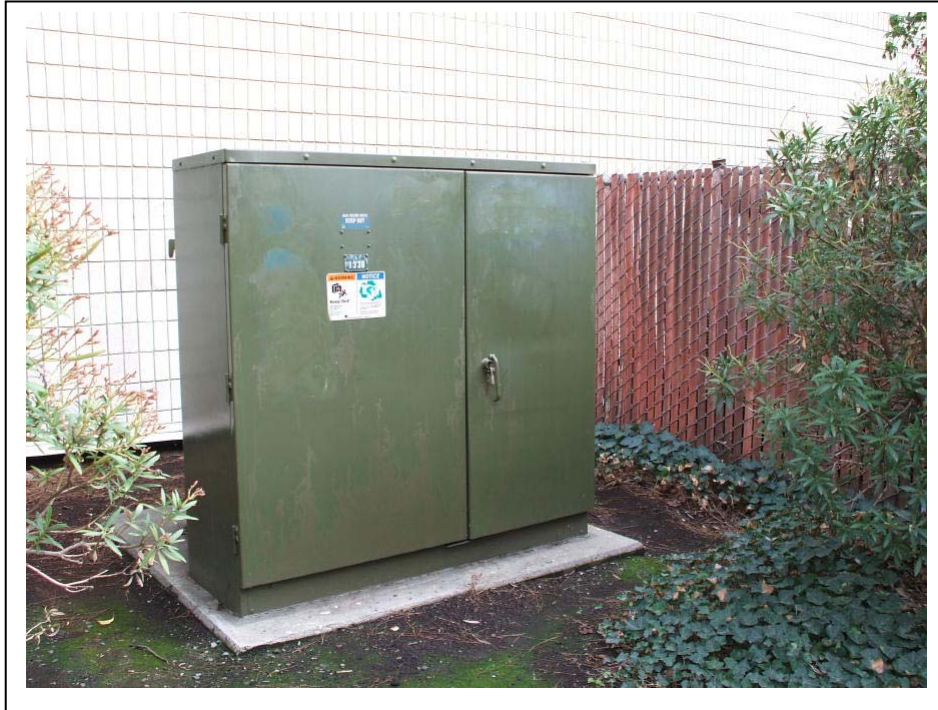
Project No. 10008-008221.00	Description	Utility-owned transformer adjacent to emergency generator enclosure.	8
	Name	Mervyn's Department Store, 5010 Northgate Mall, The Mall of Northgate, San Rafael, California 94903	Photo Date 12/18/2008

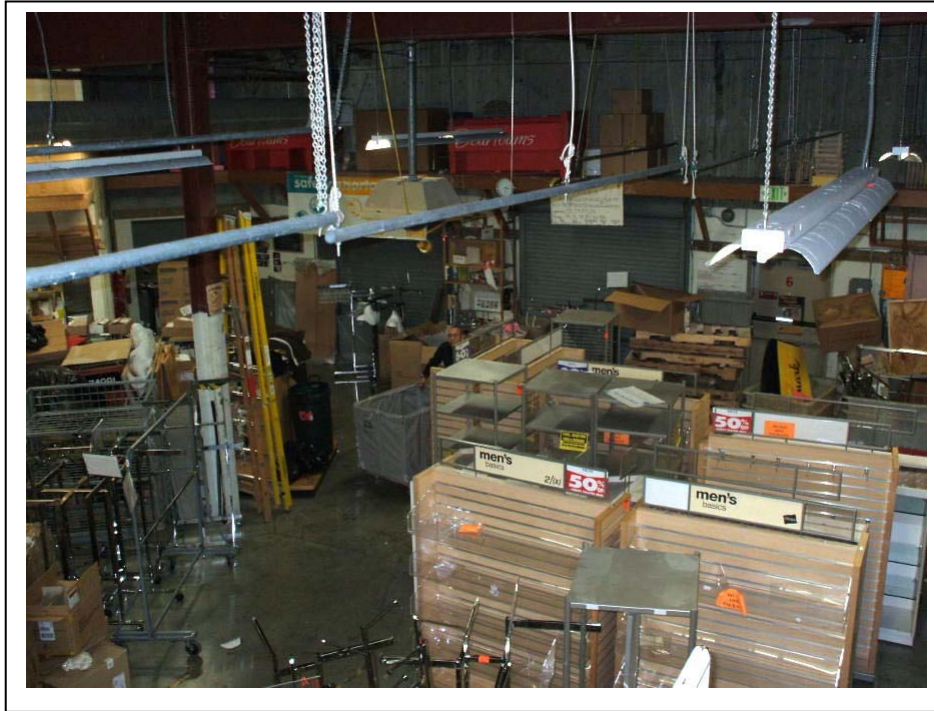
Project No. 10008-008221.00	Description	Lower warehouse area behind loading dock doors.	11
	Name	Mervyn's Department Store, 5010 Northgate Mall, The Mall of Northgate, San Rafael, California 94903	Photo Date 12/18/2008

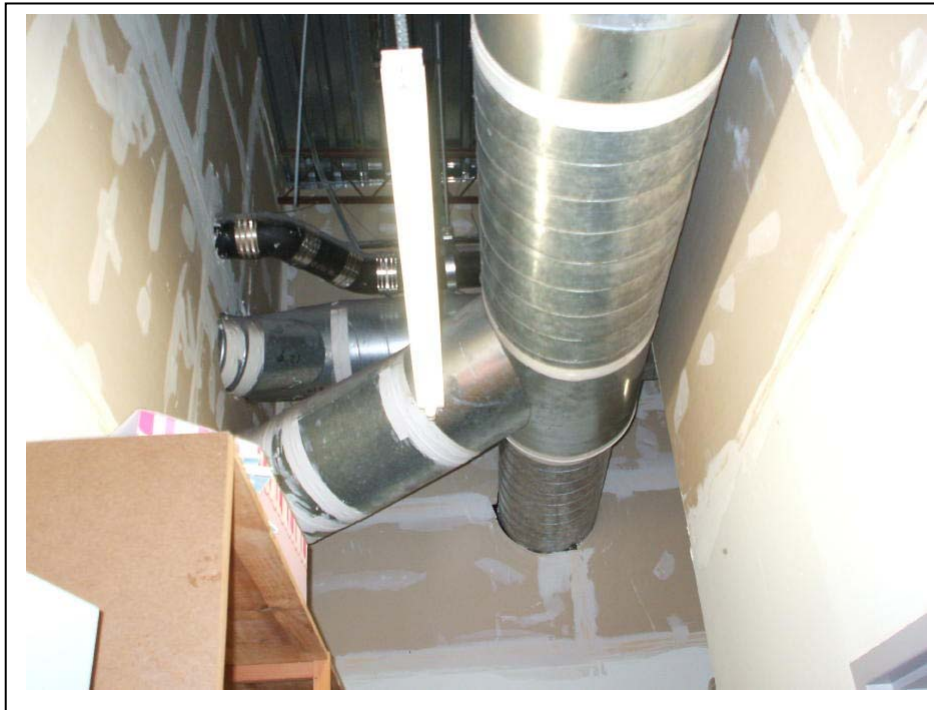
Project No. 10008-008221.00	Description	Typical HVAC ducts.	12
	Name	Mervyn's Department Store, 5010 Northgate Mall, The Mall of Northgate, San Rafael, California 94903	Photo Date 12/18/2008

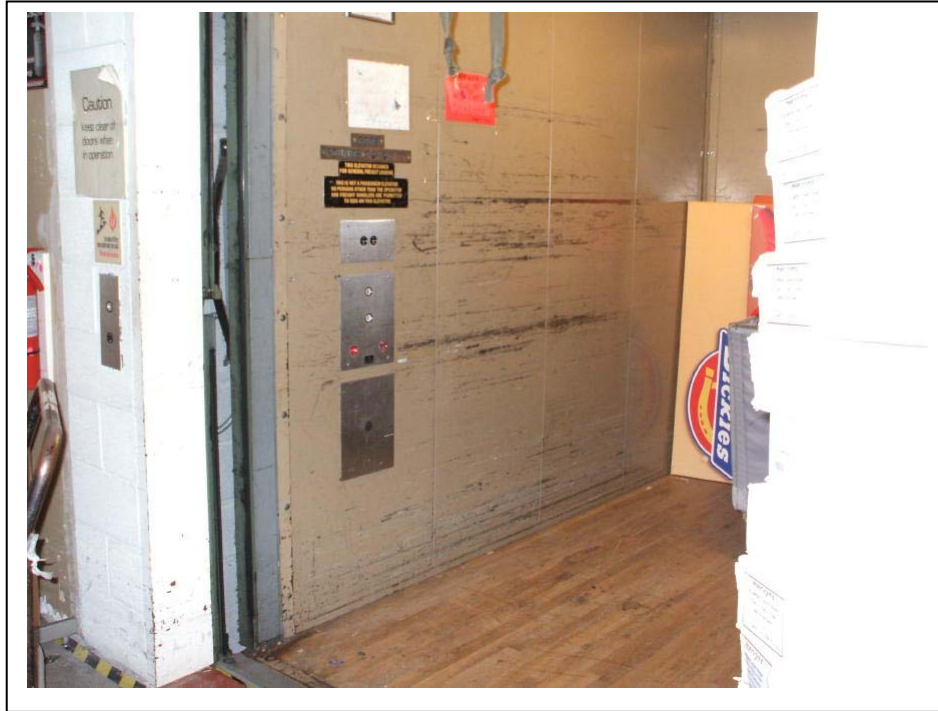
Project No. 10008-008221.00	Description	Freight elevator.	13
	Name	Mervyn's Department Store, 5010 Northgate Mall, The Mall of Northgate, San Rafael, California 94903	Photo Date 12/18/2008

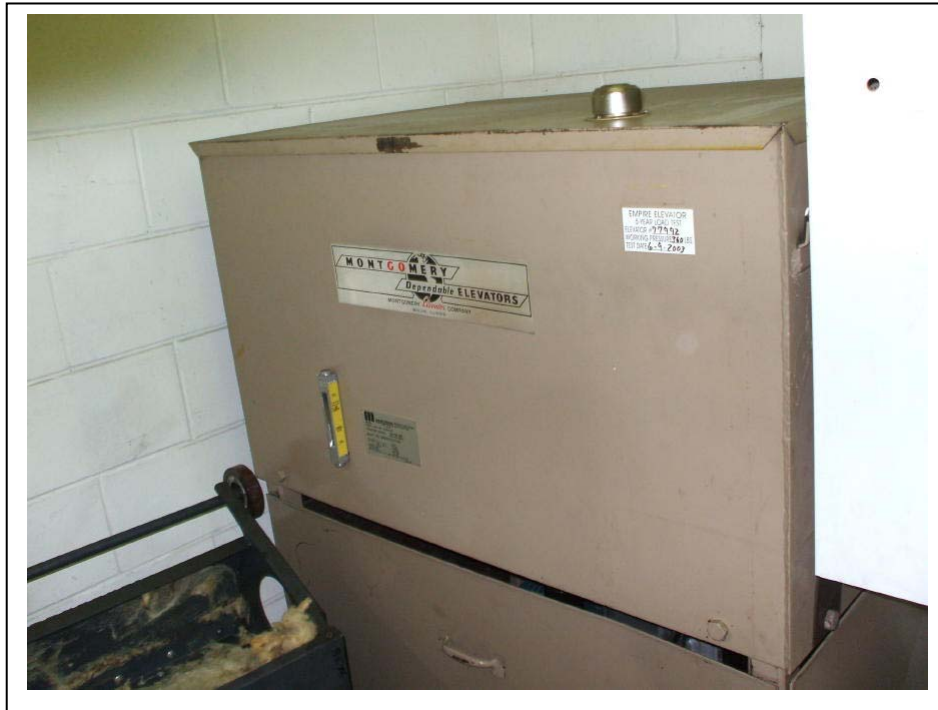
Project No. 10008-008221.00	Description	Equipment in elevator equipment room.	14
	Name	Mervyn's Department Store, 5010 Northgate Mall, The Mall of Northgate, San Rafael, California 94903	Photo Date 12/18/2008

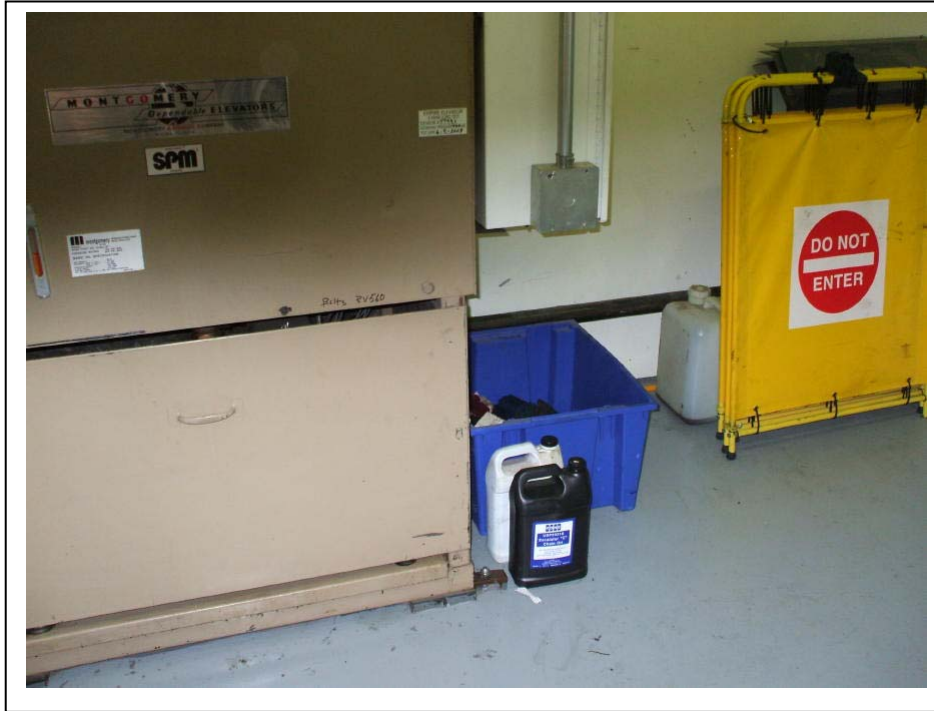
Project No. 10008-008221.00	Description	Equipment in elevator equipment room.	15
	Name	Mervyn's Department Store, 5010 Northgate Mall, The Mall of Northgate, San Rafael, California 94903	Photo Date 12/18/2008

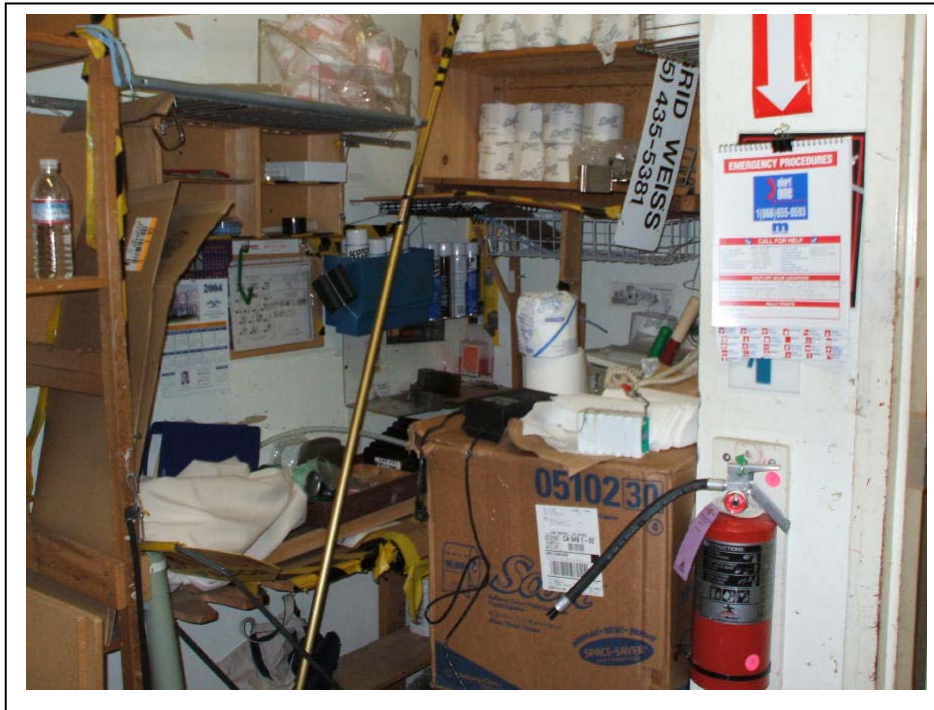
Project No. 10008-008221.00	Description	Cleaning supply storage area.	16
	Name	Mervyn's Department Store, 5010 Northgate Mall, The Mall of Northgate, San Rafael, California 94903	Photo Date 12/18/2008

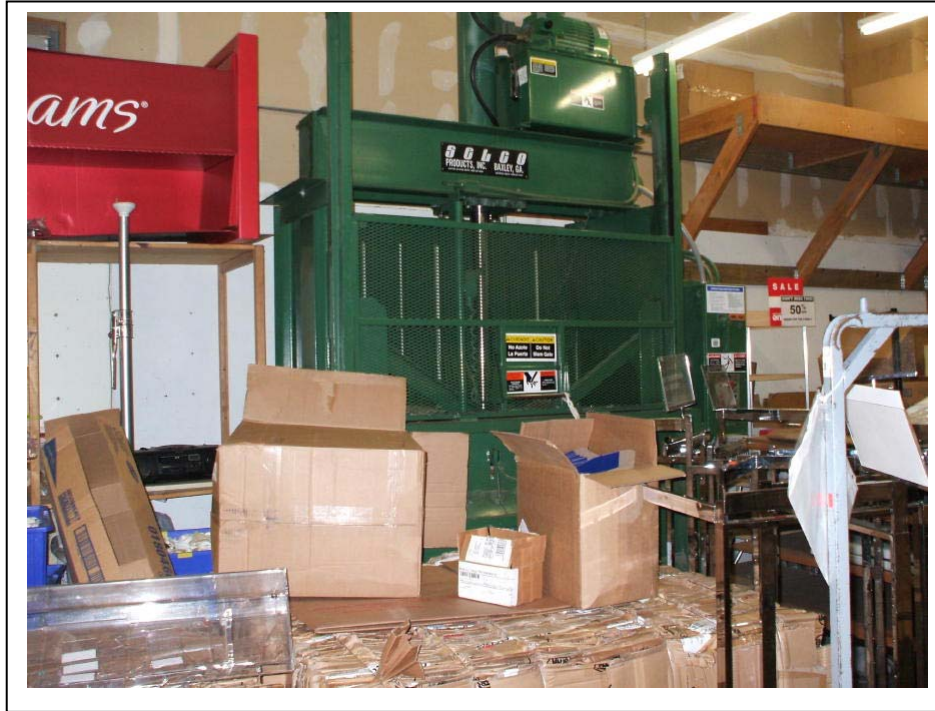
Project No. 10008-008221.00	Description	Cardboard bailer in warehouse area.	17
	Name	Mervyn's Department Store, 5010 Northgate Mall, The Mall of Northgate, San Rafael, California 94903	Photo Date 12/18/2008

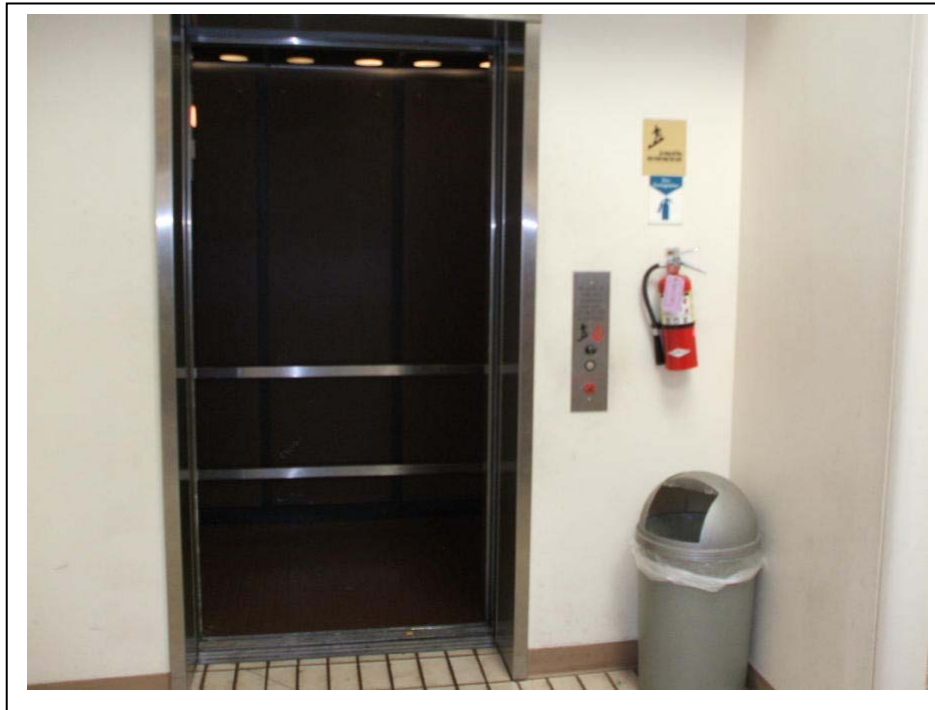
Project No. 10008-008221.00	Description	Passenger elevator.	Photo Date 12/18/2008
	Name	Mervyn's Department Store, 5010 Northgate Mall, The Mall of Northgate, San Rafael, California 94903

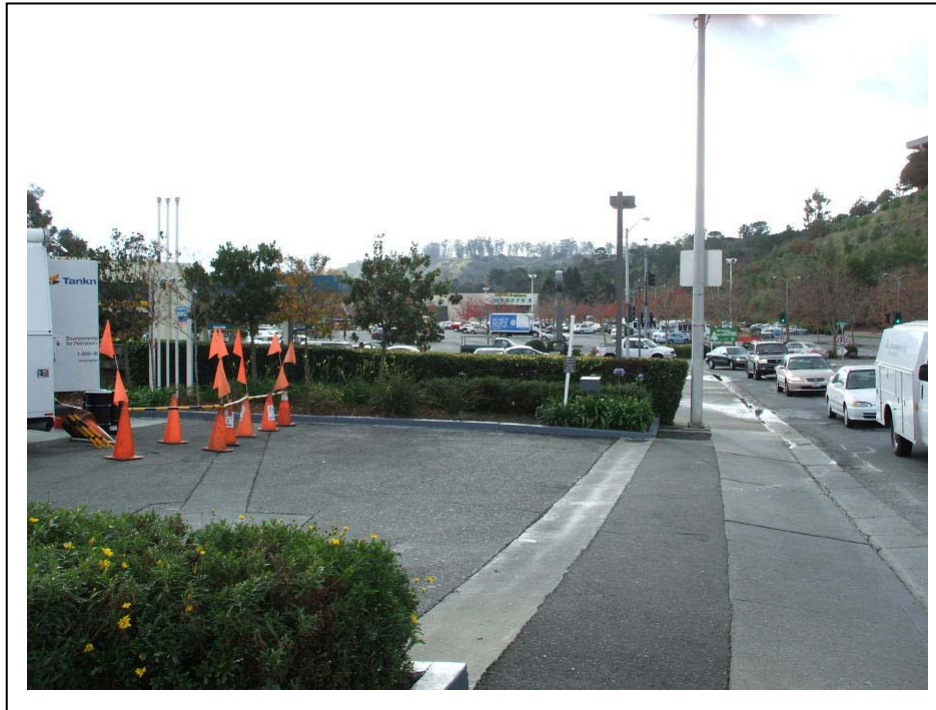
Project No. 10008-008221.00	Description	View south from offsite, Del Presidio Street (four gas stations). Mervyn's building is in center background.	Photo Date 12/18/2008
	Name	Mervyn's Department Store, 5010 Northgate Mall, The Mall of Northgate, San Rafael, California 94903
