**INITIAL SITE
ASSESSMENT
ADDENDUM**

**WARNER AVENUE
WIDENING FROM
MAIN STREET AND
GRAND AVENUE**

CITY OF SANTA ANA

MARCH 2013

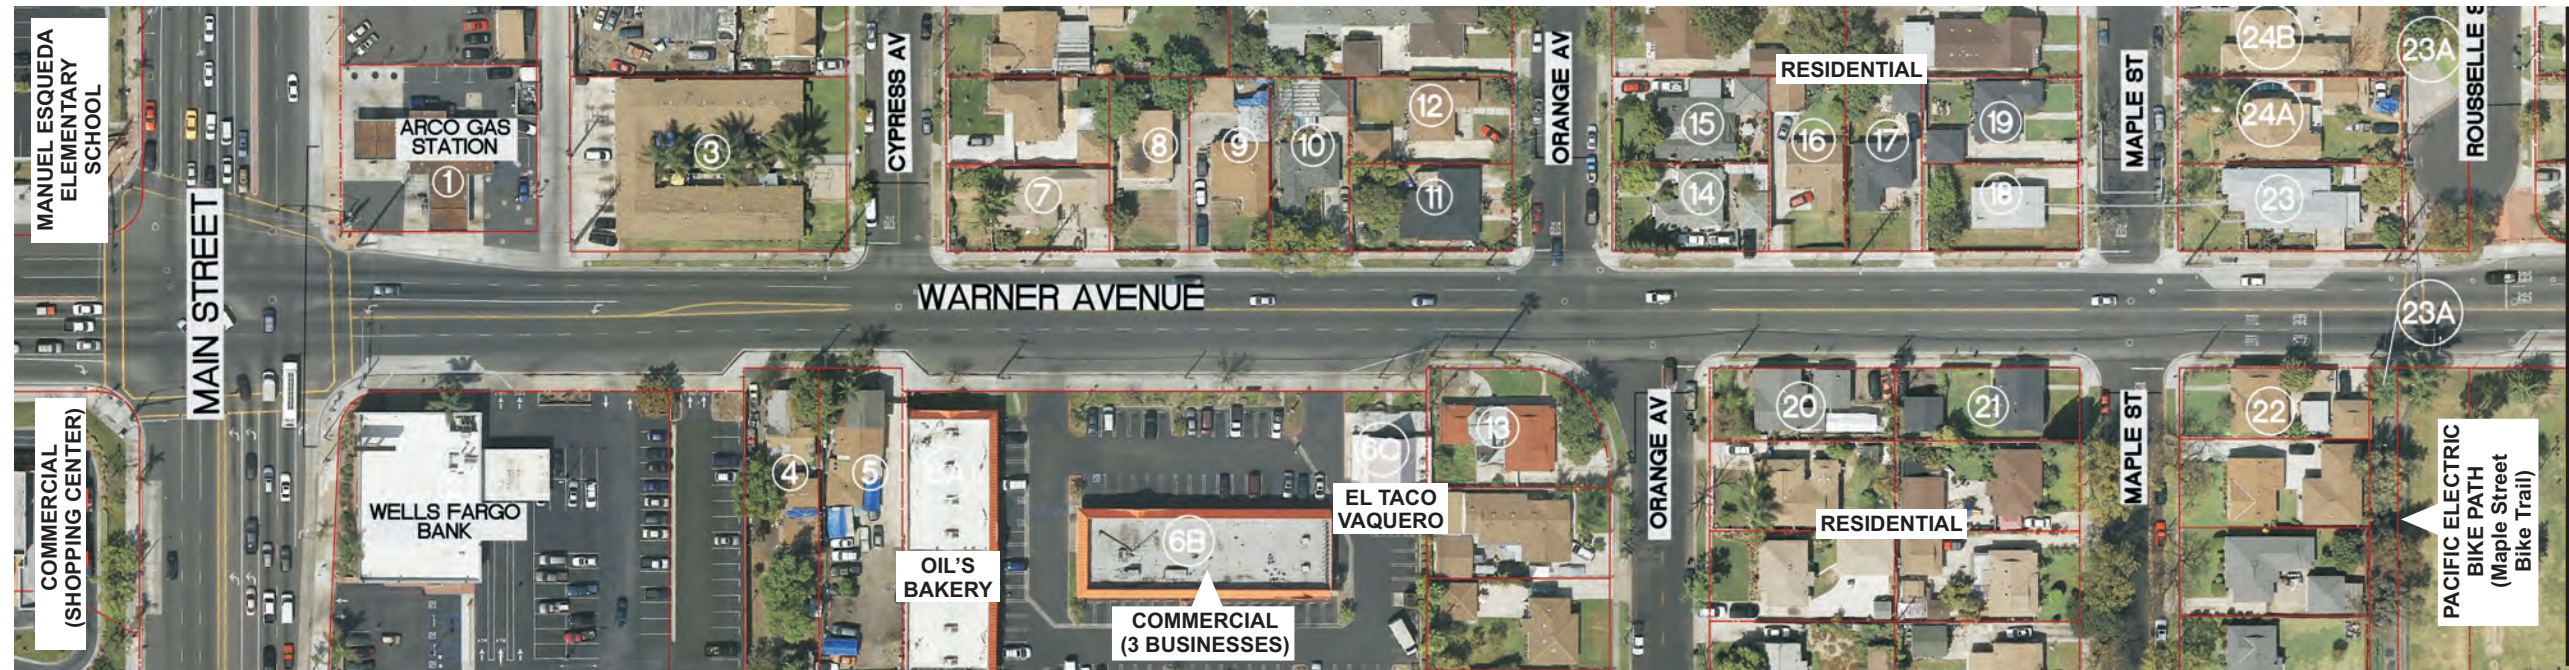
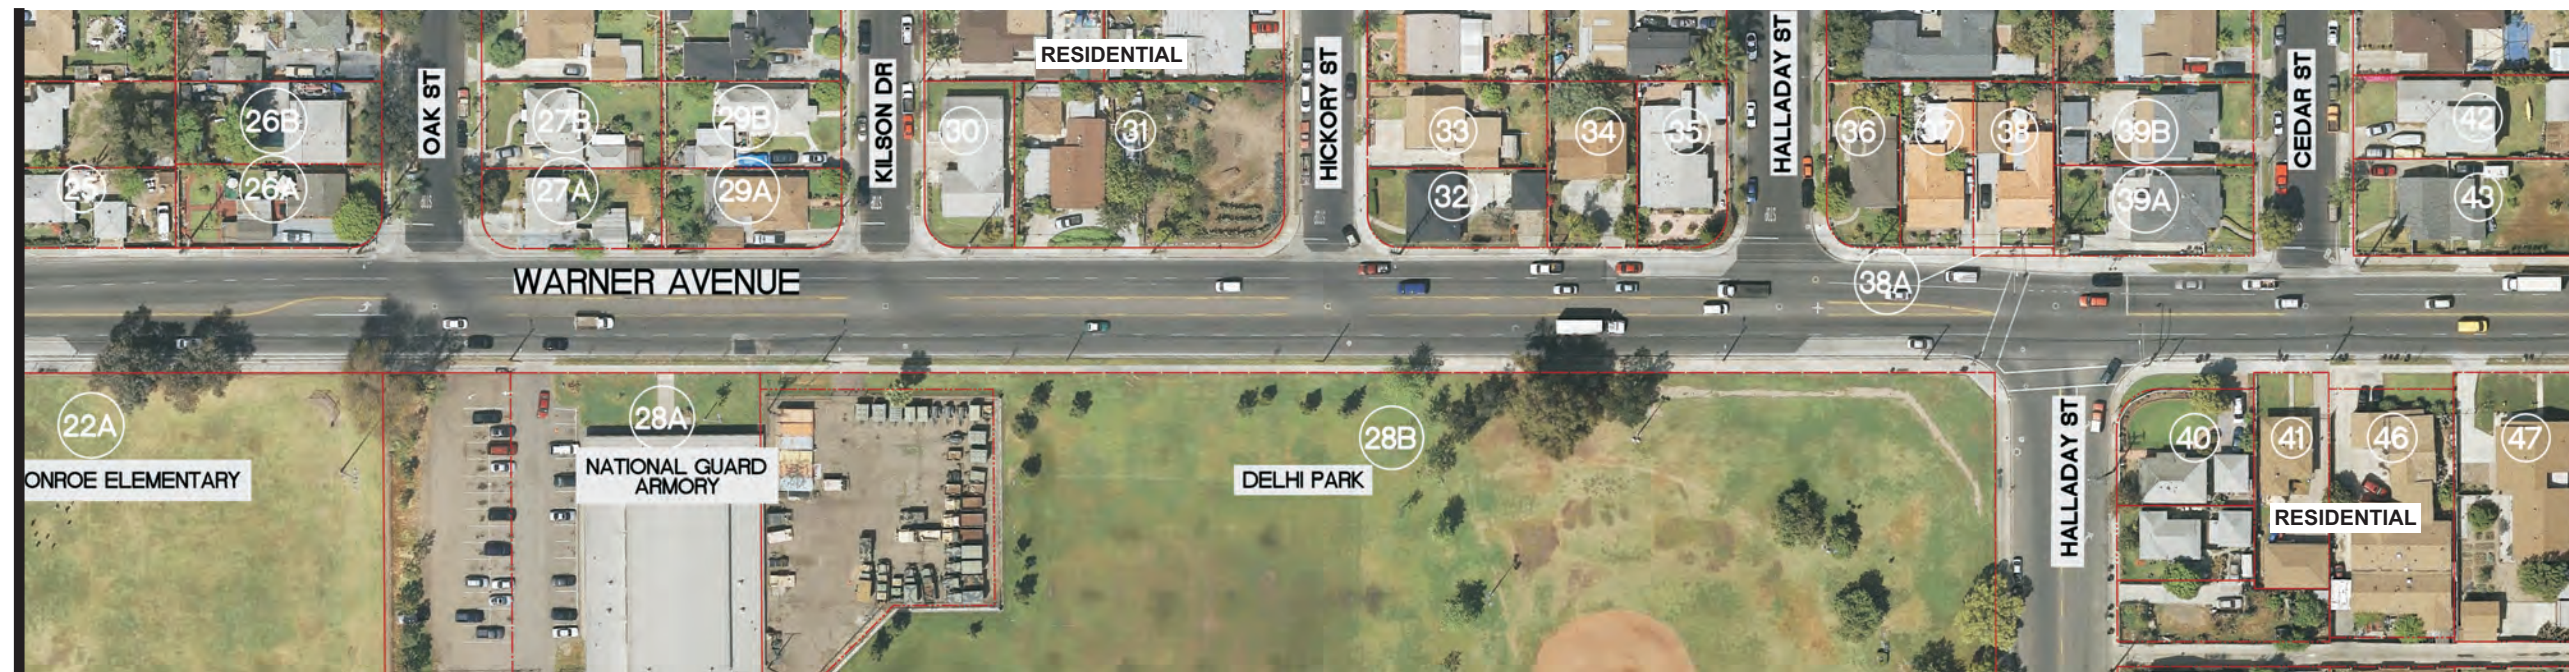
Existing Land Use

. This Addendum evaluates 6 full parcels and 17 partial parcels that were not within the project boundaries of the 2009 Initial Site Assessment. Figure 3a and 3b is an aerial photograph showing the project area with Main Street on the west to Grand Avenue on the east. The mile long project area has been divided into segments along Warner Avenue. For each segment the Assessor Parcel Numbers (APNs), site addresses, if the parcel is a full or partial parcel acquisition, and if the parcel is located on the north or south side of Warner Avenue are listed.

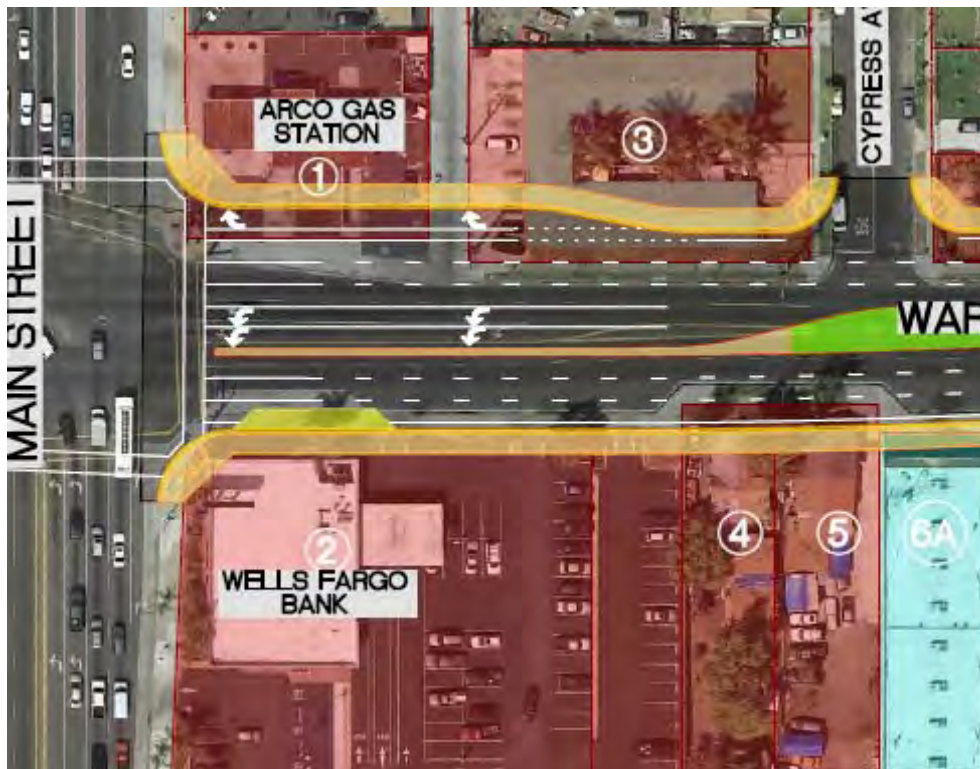
Warner Avenue from Main Street east to Cypress Avenue

The following table and figure identifies the parcels that are part of the widening project from Main Street to Cypress Avenue. Two additional parcels will be acquired from the south side of Warner Avenue, the Wells Fargo Bank property and adjacent parking lot to the east of the bank.

General Location	Acq No.	North or South	Property Impacted	Address	Partial or Full Take	Structures Impacted?	APN
Main Street to Cypress Avenue	2	S	Wells Fargo Bank	2301 S. Main St.	Full	Yes	016-031-54
	2	S	Wells Fargo Bank Parking	2301 S. Main St.	Full	No	016-031-38

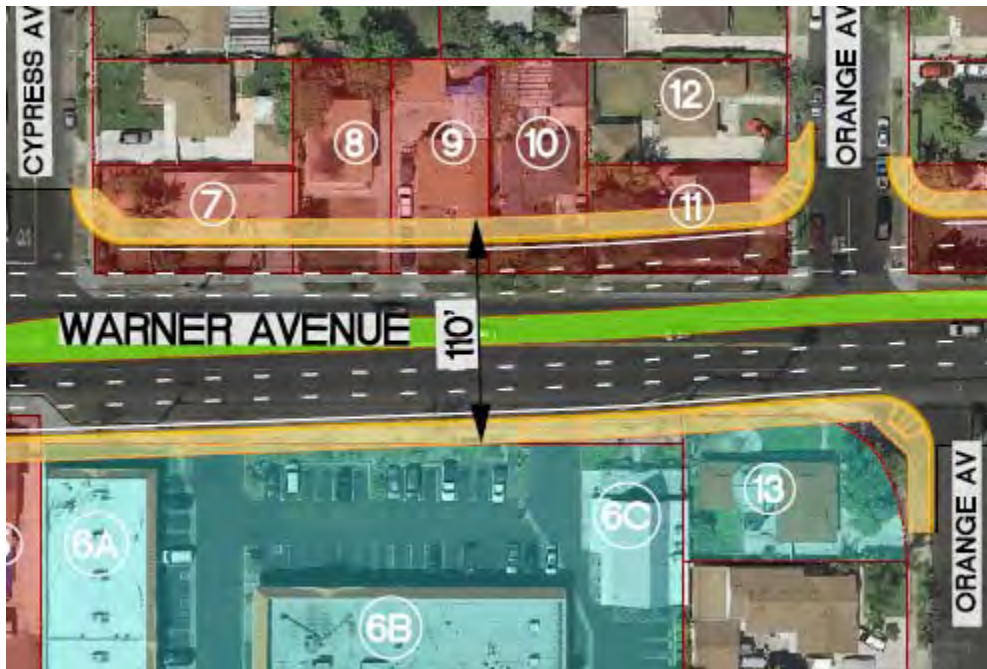
Warner Avenue from Cypress Avenue to Orange Avenue

The following table and figure identifies the additional parcels that are part of the widening project for Warner Avenue from Cypress Avenue to Orange Avenue. Three additional partial parcels (6A, 6B and 6C) would be acquired on the south side of Warner Avenue. No structures are included in the acquisition. A small strip in front of Oli's Panaderia, the adjacent parking lot, and El Taco Vaquero would be acquired.

General Location	Acq No.	North or South	Property Impacted	Address	Partial or Full Take	Structures Impacted?	APN
Cypress Avenue to Orange Avenue	6A	S	Oli's Panaderia	204 E. Warner Ave.	Partial	No	016-031-33
	6B	S	Shopping Center	216 E. Warner Ave.	Partial	No	016-031-50
	6C	S	El Taco Vaquero	222 E Warner Ave.	Partial	No	016-031-51

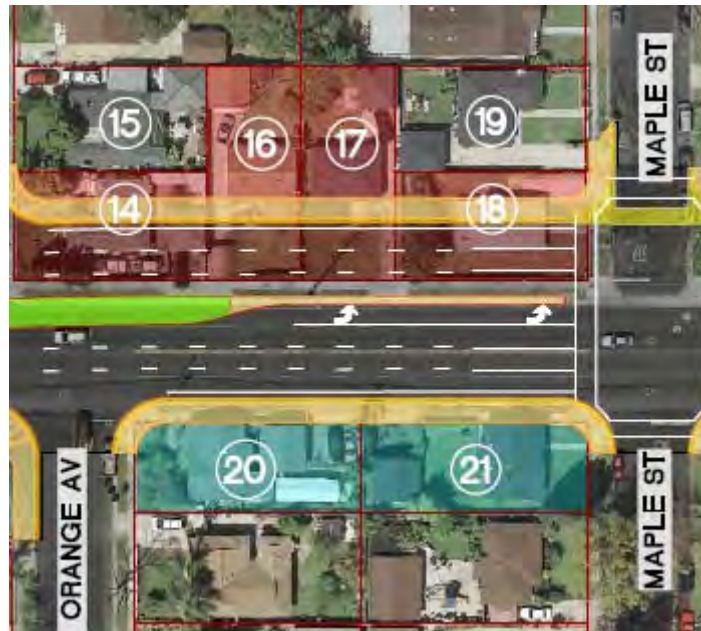
Warner Avenue from Orange Avenue to Maple Street

The following table and figure identifies the additional parcels that are part of the widening project for Warner Avenue from Orange Avenue to Maple Street. Two additional parcels (20 and 21) are acquisitions of partial residential parcels on the south side of Warner Avenue. Structures will not be impacted. Tips of the corners are being acquired at the intersection of Orange Avenue and Warner Avenue and at the intersection of Maple Street and Warner Avenue.

General Location	Acq No.	North or South	Property Impacted	Address	Partial or Full Take	Structures Impacted?	APN
Orange Avenue to Maple Street	20	S	Residential	302 E. Warner Ave.	Partial	No	016-034-01
	21	S	Residential	310 E. Warner Ave.	Partial	No	016-034-26

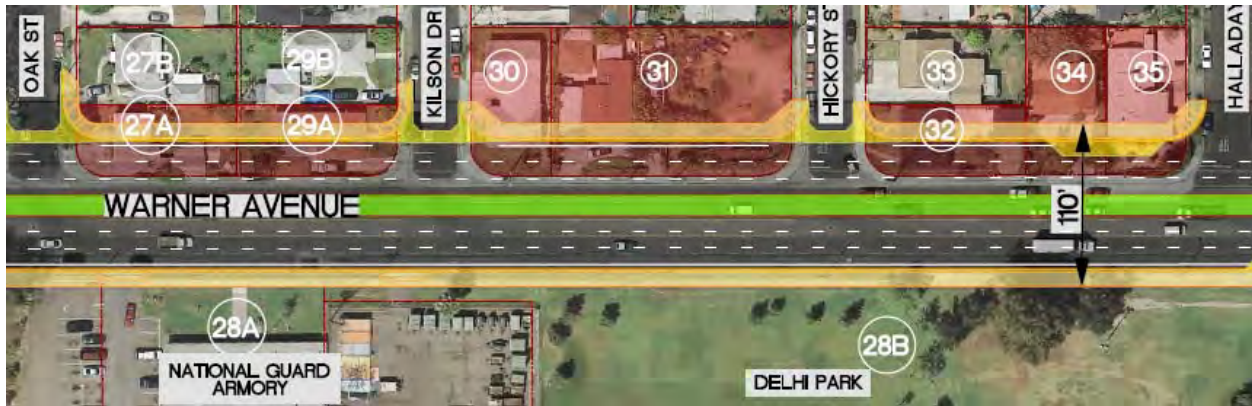
Warner Avenue from Oak Street to Halladay Street

General Location	Acq No.	North or South	Property Impacted	Address	Partial or Full Take	Structures Impacted?	APN
Oak Street to Halladay Street	31	N	Residential	705 E. Warner Ave.	Full	Yes	016-103-23
	34	N	Residential	809 E. Warner Ave.	Full	Yes	016-104-21

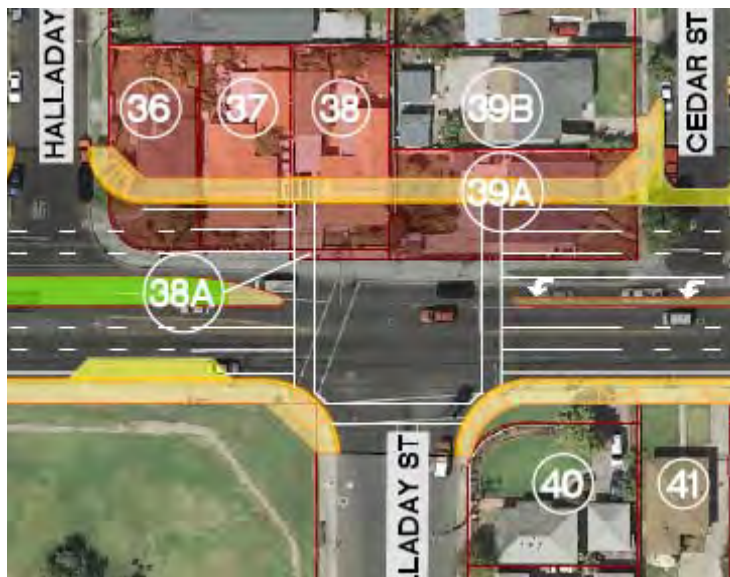
Warner Avenue from Halladay Street to Cedar Street

The following table and figure identifies the additional parcels that are part of the widening project for Warner Avenue from Halladay Street to Cedar Street. A small parcel with a separate APN 016-105-22 for the area located between the residence (APN 016-105-21, 909 E. Warner Avenue) and Warner Avenue and is identified as parcel 38A, traffic signal and utility pole. A small area at the intersection of Halladay Street and Warner Avenue would be acquired on the north side of Warner Avenue.

General Location	Acq No.	North or South	Property Impacted	Address	Partial or Full Take	Structures Impacted?	APN
Halladay Street to Cedar Street	38A	N	Traffic signal & utility pole	No Address	Full	No	016-105-22

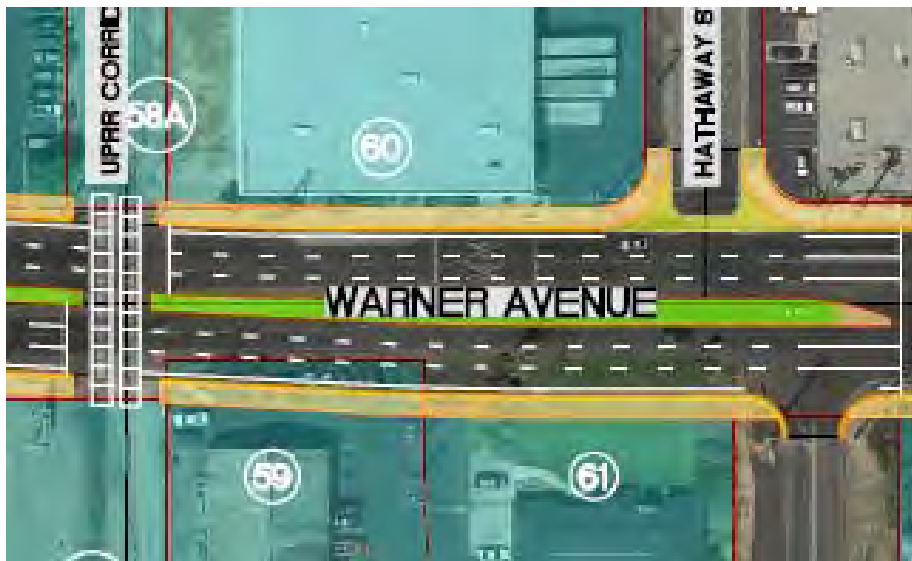
Warner Avenue from Railroad Tracks to Hathaway Street

The following table and figure identifies the additional parcel acquisition that is part of the widening project for Warner Avenue from the Union Pacific Railroad Corridor to Hathaway Street. Two partial parcels (60 and 61) would be acquired on the north and south side of Warner Avenue.

General Location	Acq No.	North or South	Property Impacted	Address	Partial or Full Take	Structures Impacted?	APN
RR Tracks to Hathaway Street	60	N	Montroy Supply Company	1301 E. Warner Ave.	Partial	No	014-281-19
RR Tracks to Hathaway Street	61	S	Hardy & Harper Asphalt Paving Contractor (former Sakioka Farms warehouse building)	1312 E. Warner Ave.	Partial	No	016-150-52

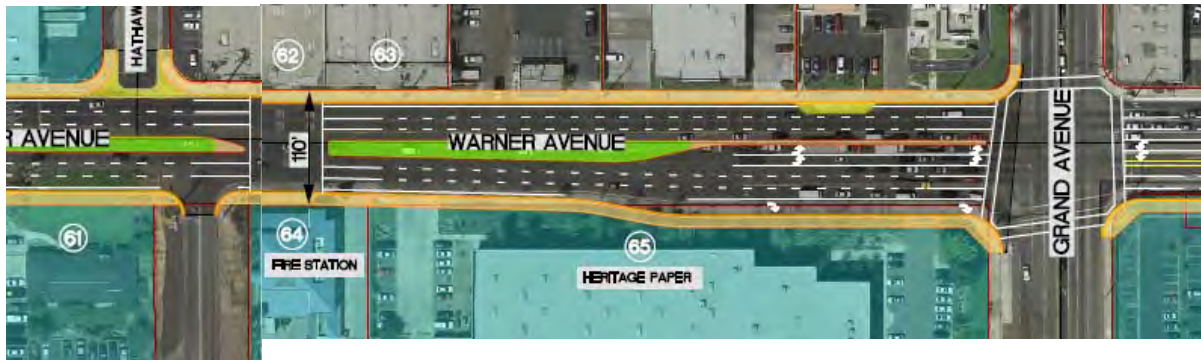
Warner Avenue from Hathaway Street to Grand Avenue

The following table and figure identifies the two additional parcels that are part of the widening project for Warner Avenue from Hathaway Street to Grand Avenue. A portion of parcel 64 and 65 will be acquired along this segment of Warner Avenue

General Location	Acq No.	North or South	Property Impacted	Address	Partial or Full Take	Structures Impacted?	APN
Hathaway Street to Grand Ave	64	S	City of Santa Ana Fire Station No. 9	1320 E. Warner Ave.	Partial	No	016-150-70
	65	S	Heritage Paper	2400 S. Grand Ave.	Partial	No	016-150-71
