Unoccupied Warehouse Property  
50 Kirby Avenue  
Somerville, Somerset County, NJ

SCALE: AS NOTED DATE: 11/2/2021  
DRAWN BY: KNG CHKD BY: RLG  
JOB: Figure 2  
DWG. NO.

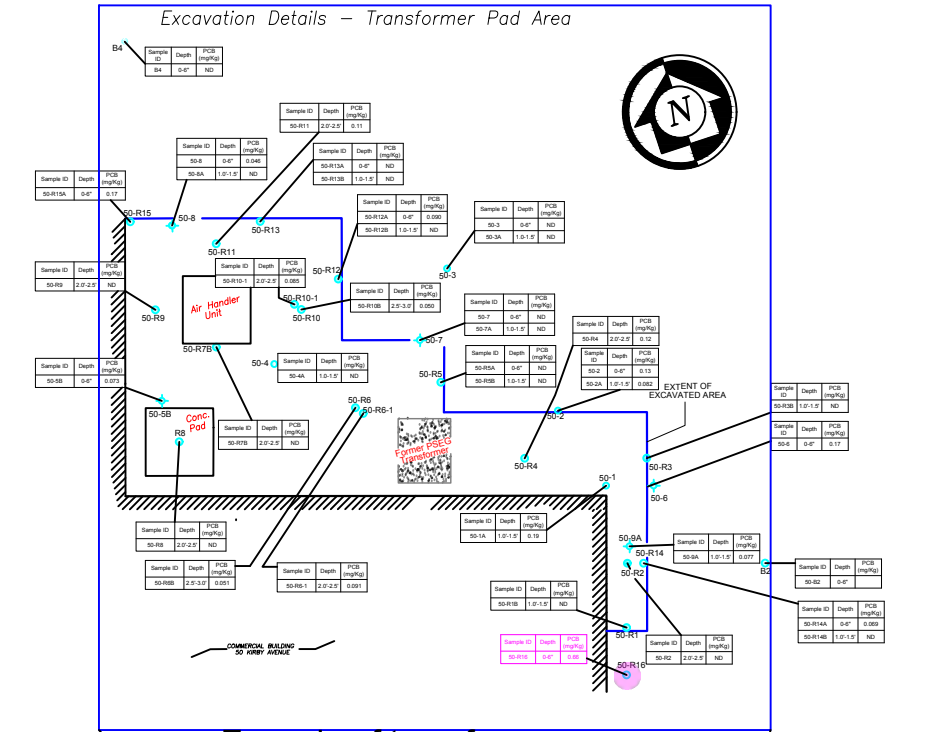
HISTORIC TEST PIT SAMPLE LOCATION
-

SOIL SAMPLE LOCATION

**PCB Conc. Above NJDEP NRSRS (1.0 mg/Kg)**

50-R17	3.0
50-B1	4.7
50-B3	7.1
50-B7	8.1
50-B14	1.2
50-B18	3.2

**PCB Conc. Above NJDEP RSRs/DIGWSSL (0.2 mg/Kg)**

50-R1A	0.24
50-R16	0.66
50-B5	0.29
50-B6	0.46
50-B8	1.0
50-B11	0.49
50-B12	0.21
50-B15	0.70

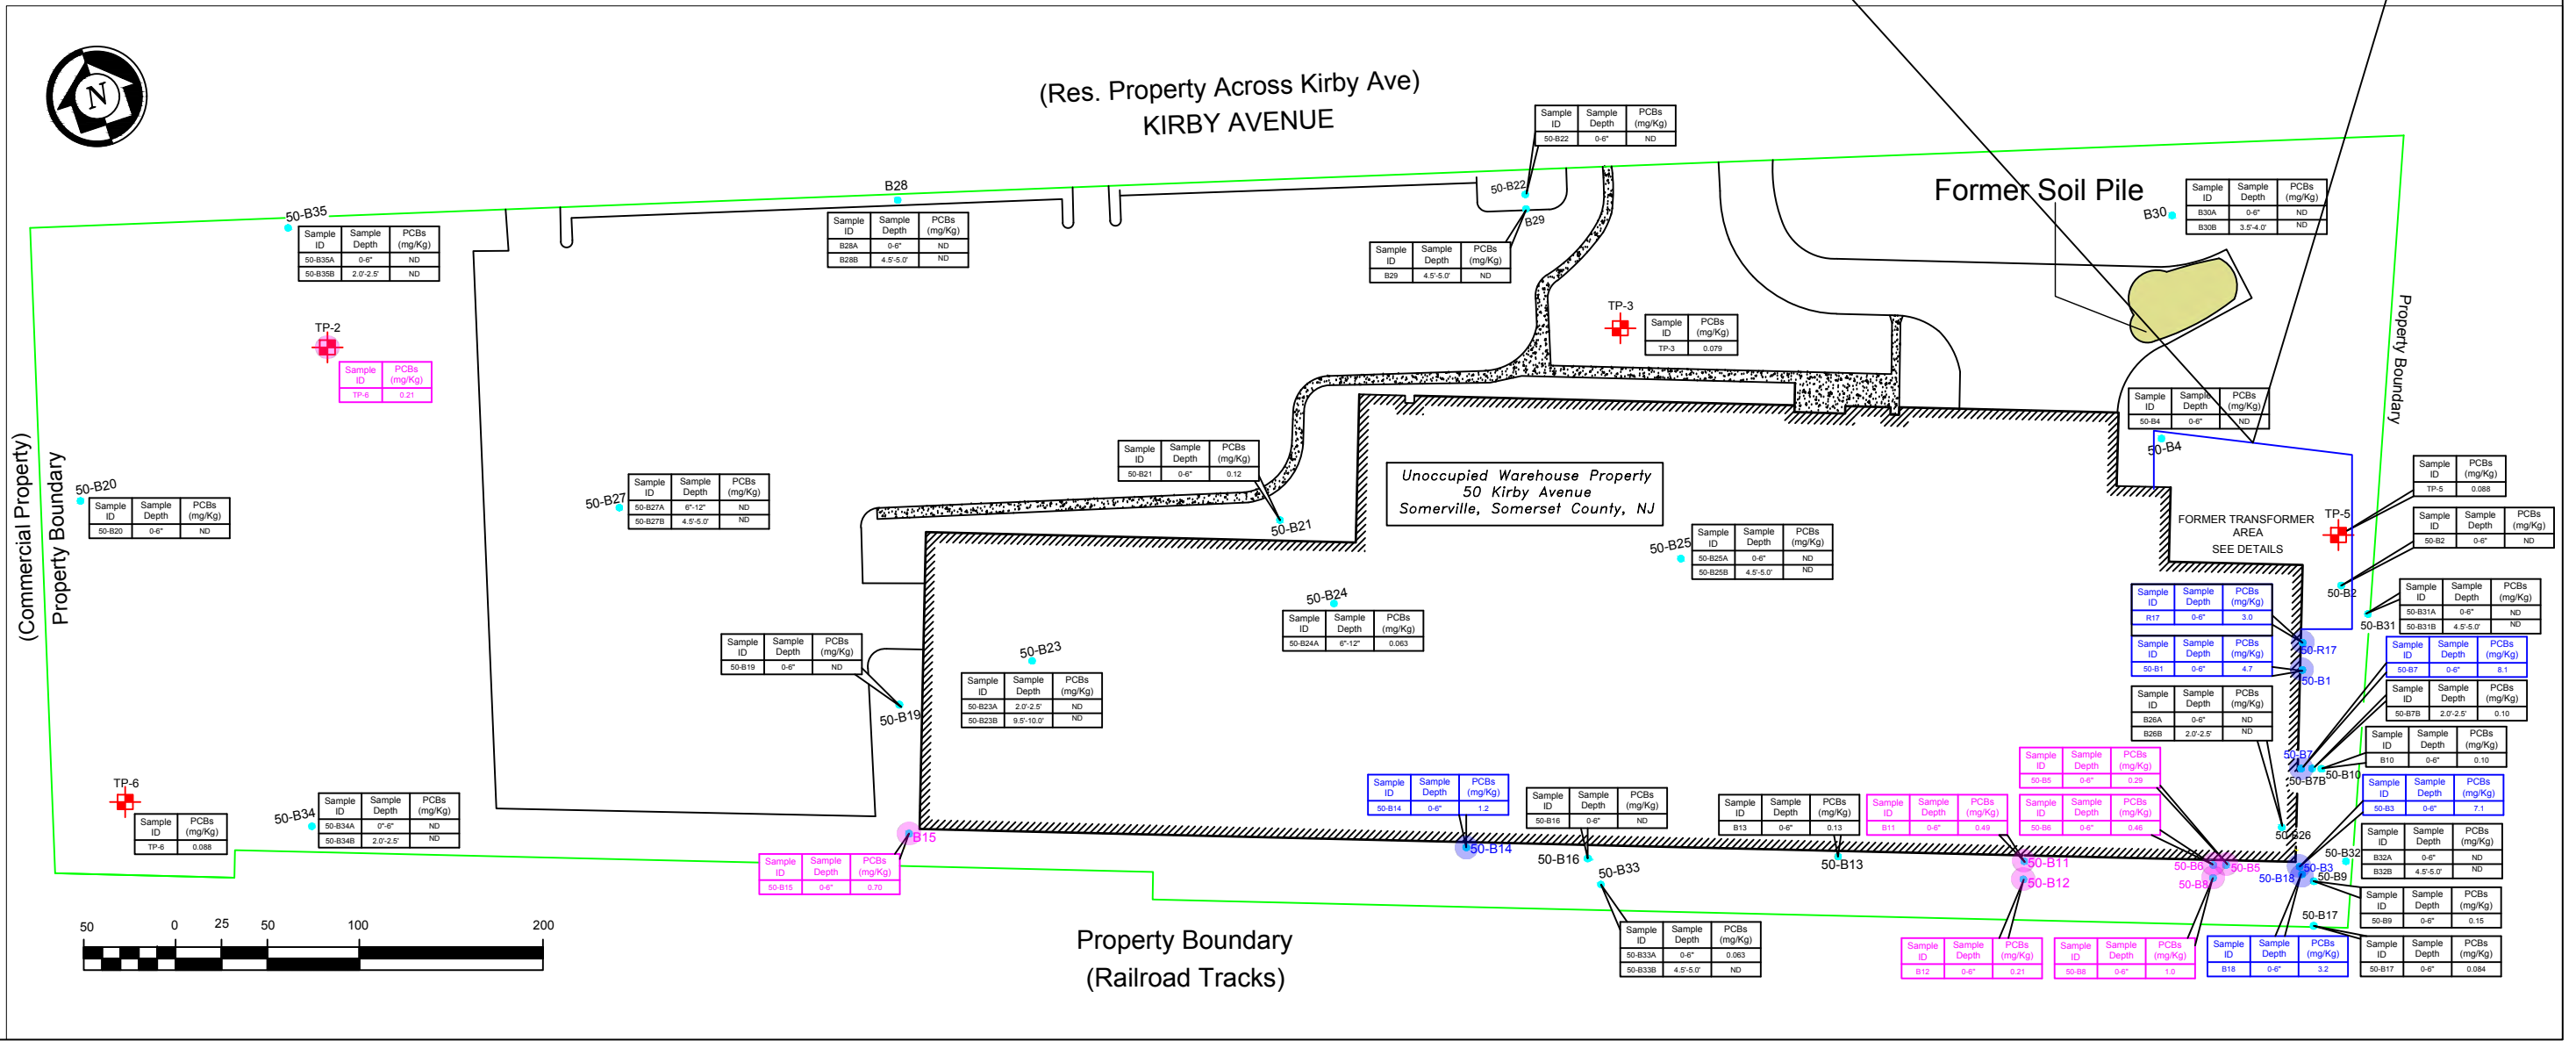
Zoom in of transformer area
