**SELF-IMPLEMENTING ON-SITE CLEANUP
AND DISPOSAL PLAN**

**50 KIRBY AVENUE
BLOCK 1, TAX LOT 4.01
BOROUGH OF SOMERVILLE
SOMERSET COUNTY, NEW JERSEY**

**DATE: DECEMBER 2021
EMG FILE: 16-125**

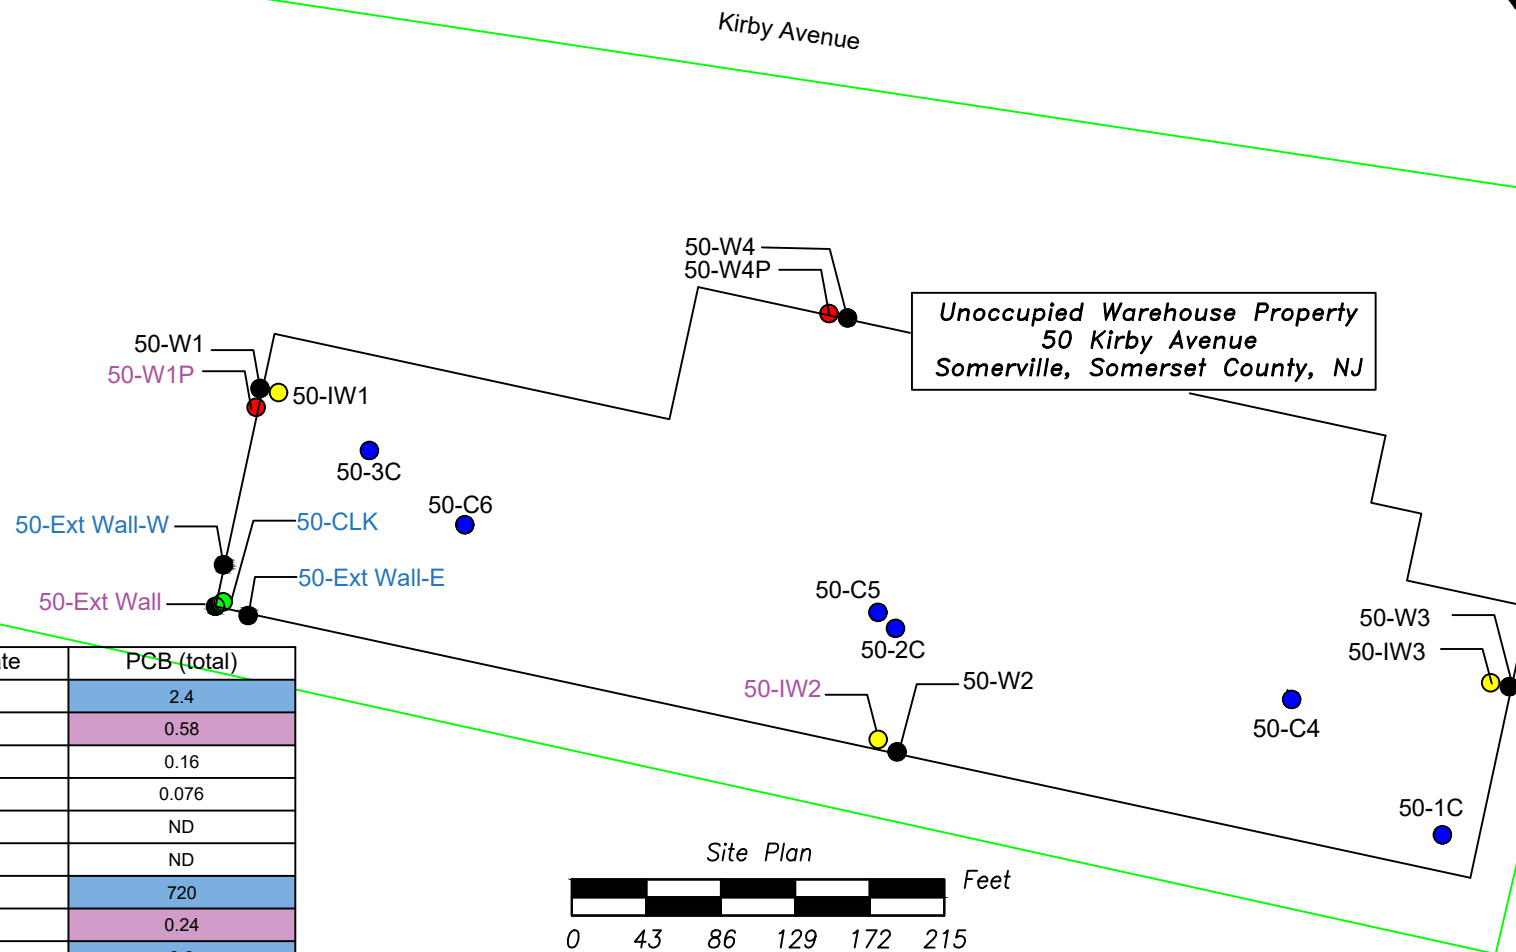
Figure 3

Sample Type	
●	Expansion Joint Caulking Sample
●	Interior Wall Sample
●	Exterior Paint Sample
●	Exterior Wall Sample
●	Interior Floor Sample

Sample ID	Sample Type	Sample Date	PCB (total)
50-1C	Interior floor conc. sample	12/10/2020	2.4
50-2C	Interior floor conc. sample	12/10/2020	0.58
50-3C	Interior floor conc. sample	12/10/2020	0.16
50-C4	Interior floor conc. sample	1/22/2021	0.076
50-C5	Interior floor conc. sample	1/22/2021	ND
50-C6	Interior floor conc. sample	1/22/2021	ND
50-CLK	Exterior Caulk	1/22/2021	720
50-Ext Wall	Exterior Conc. Wall	10/15/2021	0.24
50-Ext Wall-E	Exterior Conc. Wall	10/20/2021	9.9
50-Ext Wall-W	Exterior Conc. Wall	10/20/2020	16
50-W1	Exterior Conc. Wall	10/26/2021	ND
50-W2	Exterior Conc. Wall	10/26/2021	ND
50-W3	Exterior Conc. Wall	10/26/2021	ND
50-W4	Exterior Conc. Block Wall	10/26/2021	ND
50-W1P	Paint from 50-W1 location	10/26/2021	0.41
50-W4P	Paint from 50-W4 location	10/26/2021	0.058
50-IW1	Interior Wall conc. sample	10/26/2021	0.14
50-IW2	Interior Wall conc. sample	10/26/2021	0.47
50-IW3	Interior Wall conc. sample	10/26/2021	0.11

ENVIRONMENTAL MANAGEMENT GROUP		
1705 BAY AVENUE, POINT PLEASANT, NJ 08742		
<i>Site Plan & Building Material/Concrete PCB Sample Locations</i>		
Unoccupied Warehouse Property 50 Kirby Avenue Somerville, Somerset County, NJ	SCALE: AS NOTED	DATE: 11/1/2021
	DRAWN BY: KNG	CHKD BY: RLG
	JOB:	
	DWG. NO.

A summary of the analytical results is presented on Tables 1 through 8 and soil sample locations are shown on Figure 2 with building material samples shown on Figure 3.

The concrete floor samples (i.e., 50-C3, 50-C4, 50-C5, 50-C6), not in the area of concrete joints, were reported as non-detectable (ND) or below 0.25 ppm for PCBs. Concrete floor joint area/ exterior caulking material samples detected PCB concentrations above 1 ppm (i.e., 50-C1, 50-C2, 50-CLK). The exterior caulk sample, 50-CLK at 720 ppm was also above 50 ppm. The exterior building material samples adjacent to sample 50-CLK (i.e., 50-EXT WALL, 50-EXT WALL-W, 50-EXT WALL-E) also detected PCB concentrations above 1 ppm. Interior wall samples and other exterior wall samples collected on October 25, 2021 did not detect any PCB concentrations above 1 ppm.

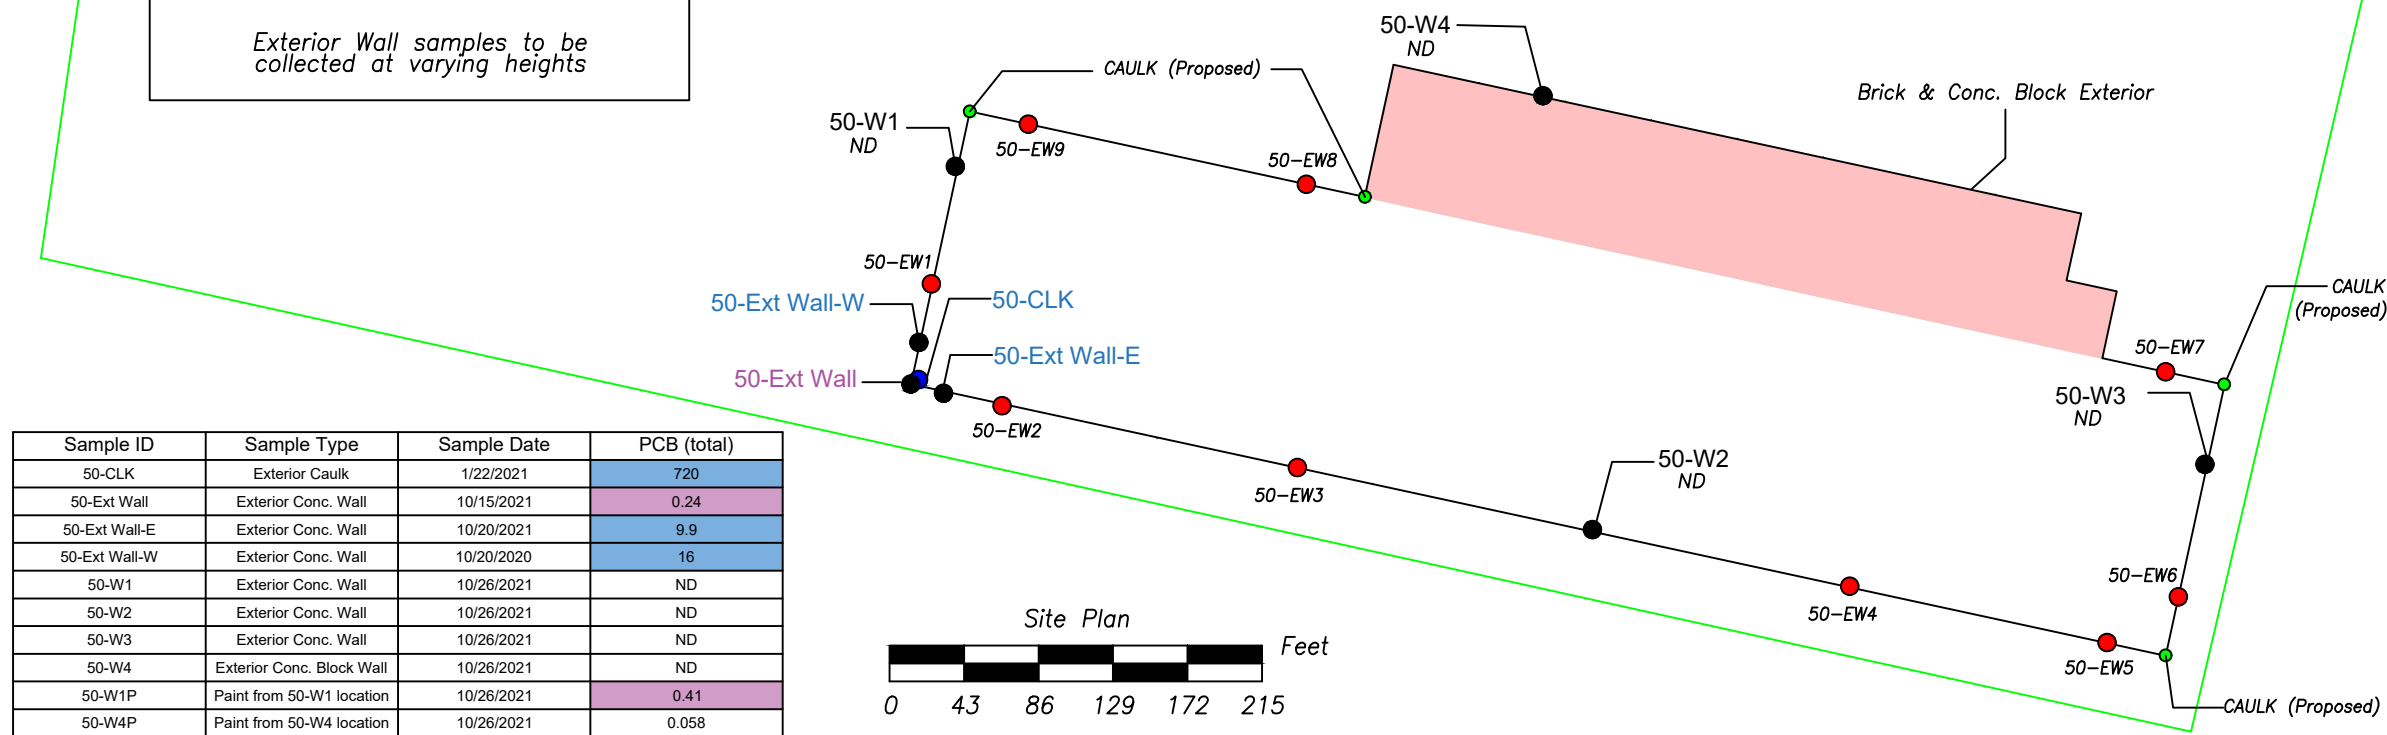
Figure 5A

- Previously Collected Ext. Wall Sample
- Previously Collected Caulk Sample
- Proposed Exterior Wall Delin. Sample
- Proposed Caulk Sample

Exterior Wall samples to be collected at varying heights

Sample ID	Sample Type	Sample Date	PCB (total)
50-CLK	Exterior Caulk	1/22/2021	720
50-Ext Wall	Exterior Conc. Wall	10/15/2021	0.24
50-Ext Wall-E	Exterior Conc. Wall	10/20/2021	9.9
50-Ext Wall-W	Exterior Conc. Wall	10/20/2020	16
50-W1	Exterior Conc. Wall	10/26/2021	ND
50-W2	Exterior Conc. Wall	10/26/2021	ND
50-W3	Exterior Conc. Wall	10/26/2021	ND
50-W4	Exterior Conc. Block Wall	10/26/2021	ND
50-W1P	Paint from 50-W1 location	10/26/2021	0.41
50-W4P	Paint from 50-W4 location	10/26/2021	0.058

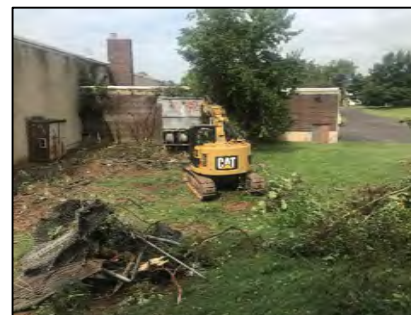
View of Brick & Conc. portion of the structure. Looking West from Eastern Site Boundary

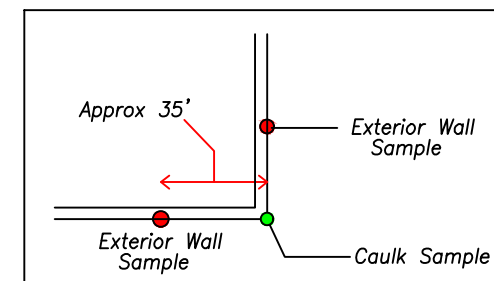
Typical "Corner" Sampling Plan
