Historic Resource Evaluation
20540 Broadway, Sonoma, 95476
Sonoma County, California
(APN 128-321-007-000)

Alice P. Duffee Healy
Historic Preservation Planner/Architectural Historian
APD Preservation LLC
March 2025

Main House ("House 1") (1911)

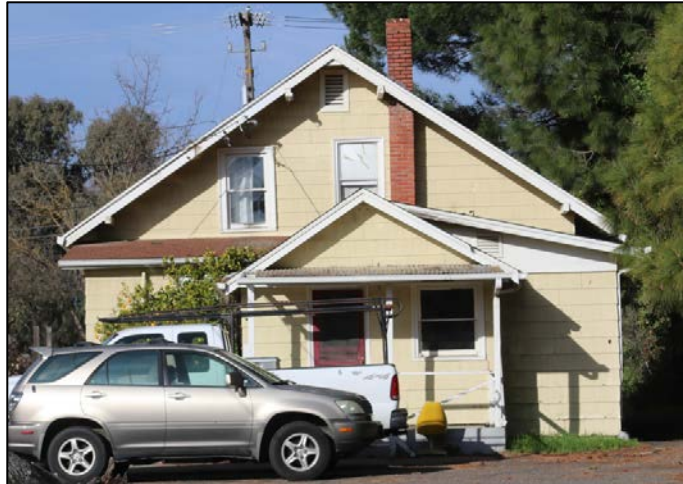
A running bond brick chimney extends through the eaves near the roof peak on the north slope. Two windows (one-over-one) are placed at irregular intervals on the upper level. An attic vent with wood louvers is in the gable peak (see Figure below).

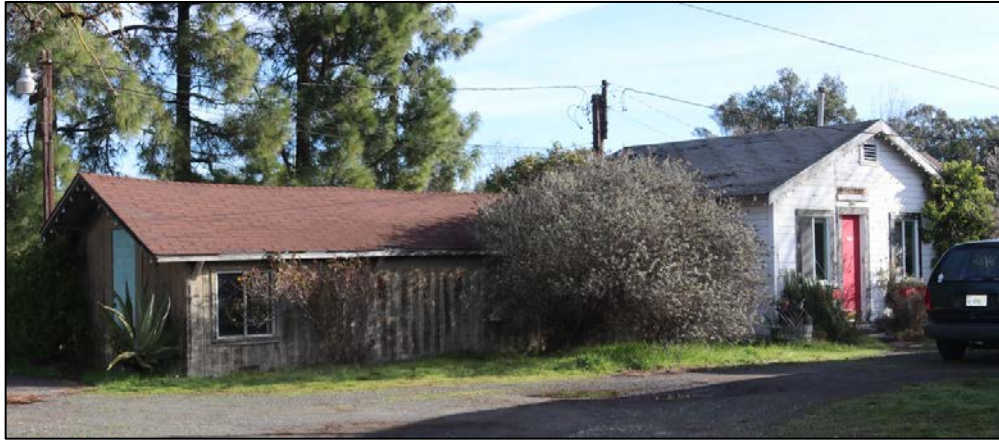
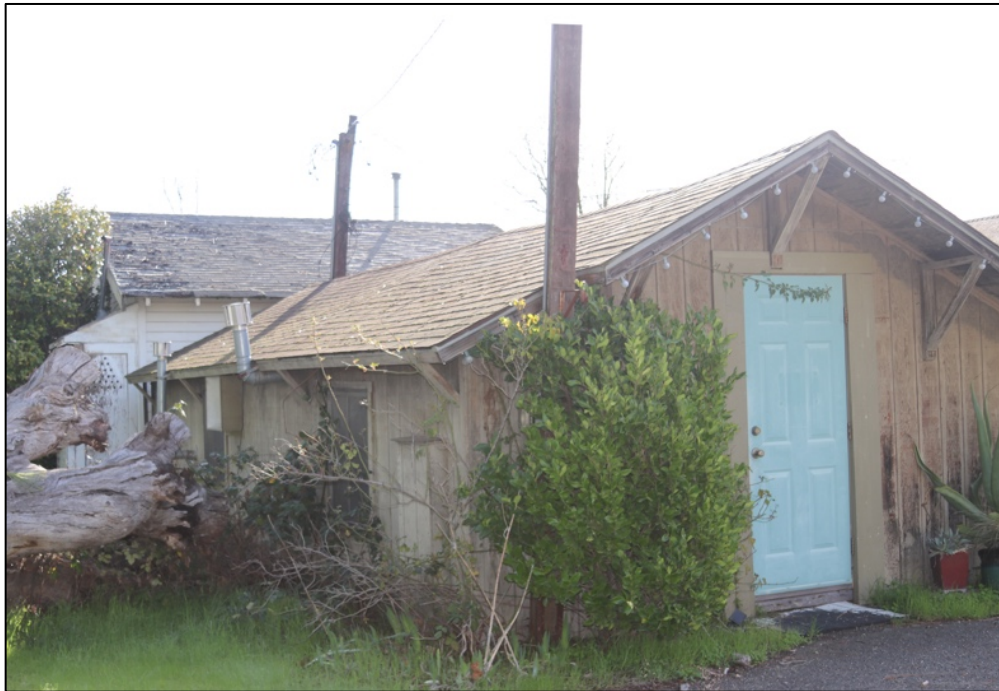
This auxiliary building is two adjacent structures that are in close proximity but do not abut (see Figure 31 in Appendix A). The front section appears to be newer than the rear section and is oriented east-west. It is very low and has a gabled roof with asbestos shingles and vertical T1-11 siding. The overhanging eaves are supported on plain brackets at the corners and gable peaks. A modern, six-paneled door with wood board trim is centered on the west gable. Both the north and south elevations have two modern sliding windows with aluminum sash (see photos below and Figures 35-36 in Appendix A).

well as at least one double-hung window (one-over-one). This elevation is overgrown with vegetation and is inaccessible. The north elevation is similarly overgrown, though a shed-roof wing is visible at the northwest corner (see photos below and Figures 32-35 in Appendix A).

The building is unoccupied and both sections are in poor condition. The older section has been heavily modified by the replacement or addition of windows and a door on the south side.

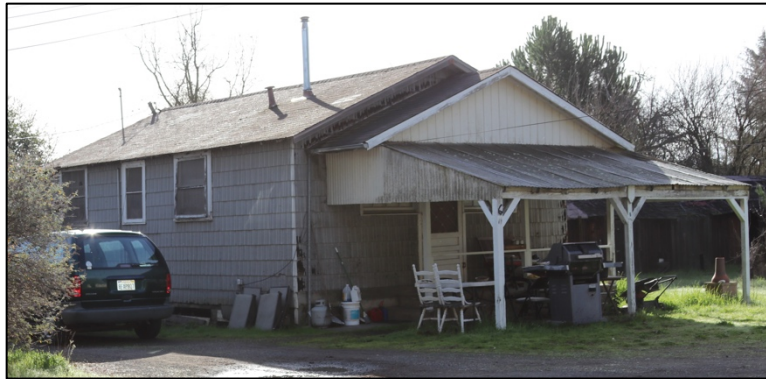
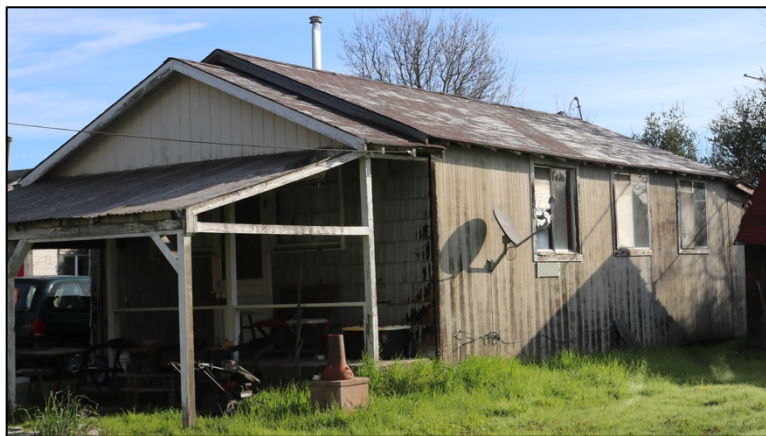
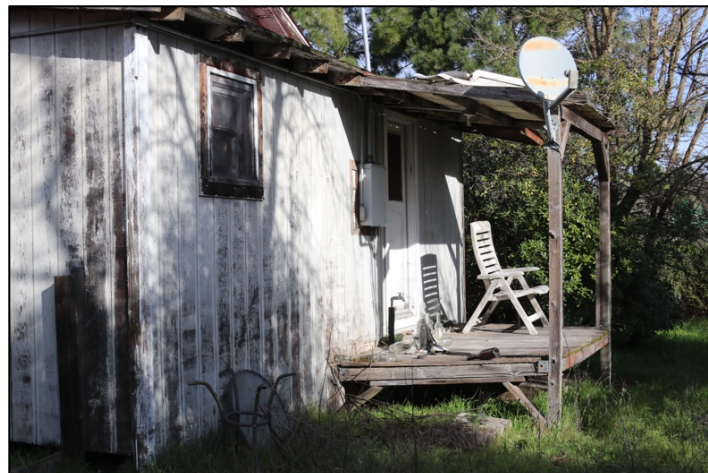
This one-story, gabled-roof house has an open, shed-roof porch projecting from a slightly recessed gable roof. Except for the projecting gable that has vertical board siding, the house is clad in asbestos shingles. The roof is composition shingles.

The porch has a corrugated metal roof supported by square posts with simple brackets. A concrete stoop extends the width of the gable and accesses the front door that is centered on the gable and flanked by two twelve-pane, fixed sash

picture windows. The south elevation has three modern sliding windows with aluminum sash. The north elevation has three one-over-one windows with wood, double-hung sash.

A shed-roofed wing extends across the east gable (rear). It has a small, one-over-one window with double-hung sash and a half glass door. A shed-roof porch with corrugated metal roof, wood floor and square posts projects from the northeast corner (see photos above and below and Figures 37-43 in Appendix A).

The building is occupied and is in poor condition. Modifications include addition of the front porch and possibly the rear porch and window replacement on the south elevation.

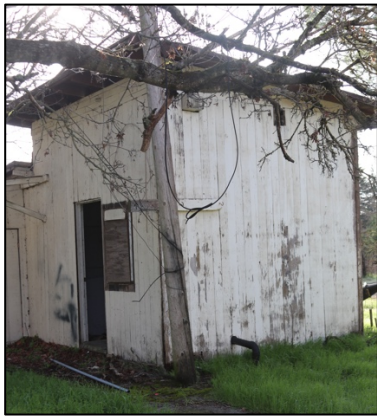
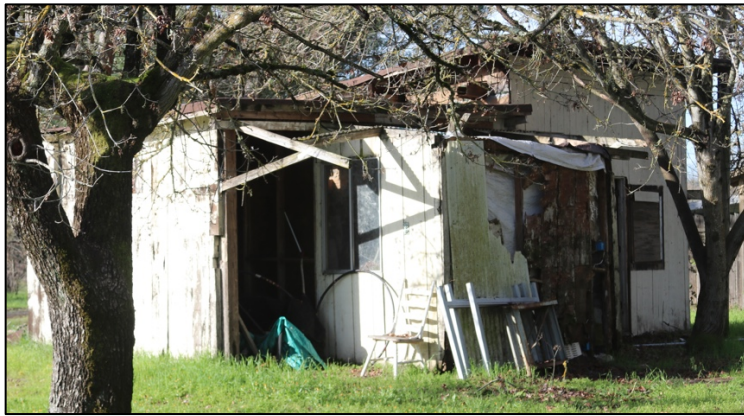
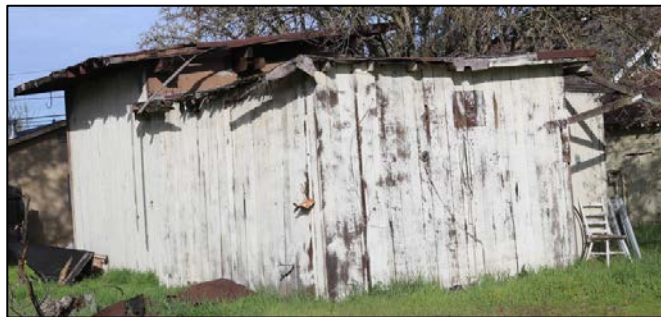
This utilitarian farm building has a shed roof, vertical wood siding and two shed-roof additions. The east, west and south elevations have no openings; the north elevation of the central block has a door opening and infilled window. The additions have a variety of windows and doors, some with sash and door units and some without (see photos below and Figures 44-49 in Appendix A).

The utilitarian building has been modified many times to suit the evolving uses and demands of the surrounding farm. It is in very poor condition.

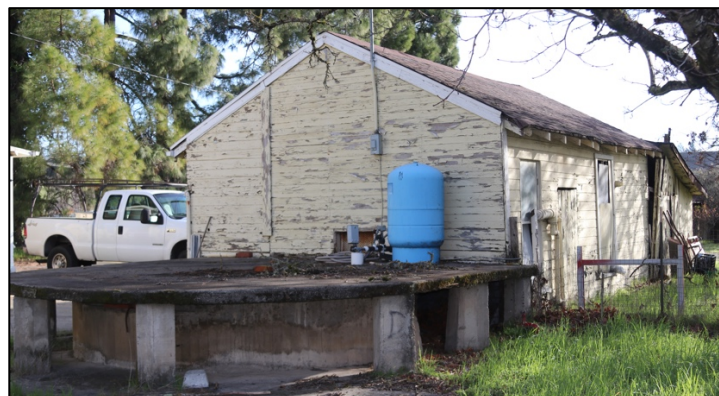
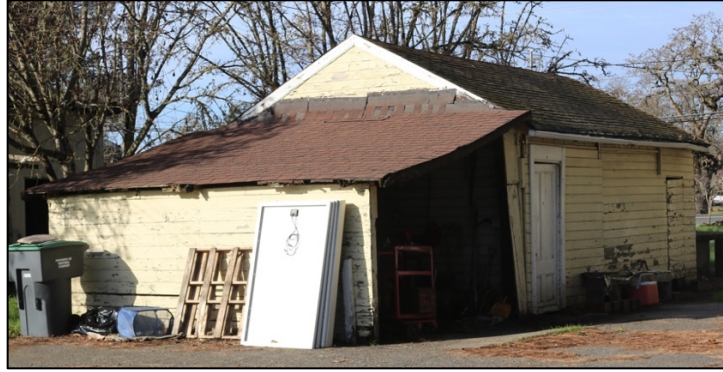
This one-story, gable-roofed structure has a shed-roof addition off the east gable and a round, concrete pad abutting the west gable. It has horizontal V-groove siding. The east and west elevations have no openings. The south elevation has two windows, including one two-over-two window (with narrow mullions) that appears to have been recycled from another building (see Figure 53 in Appendix A). Similarly, the four-paneled door on the north elevation at the northeast corner also appears to have been recycled (see Figure 55 in Appendix A). The north side of the shed addition is open as a vehicle bay (see photos below and Figures 50-55 in Appendix A).

The building is in very poor condition and appears to be used for storage.

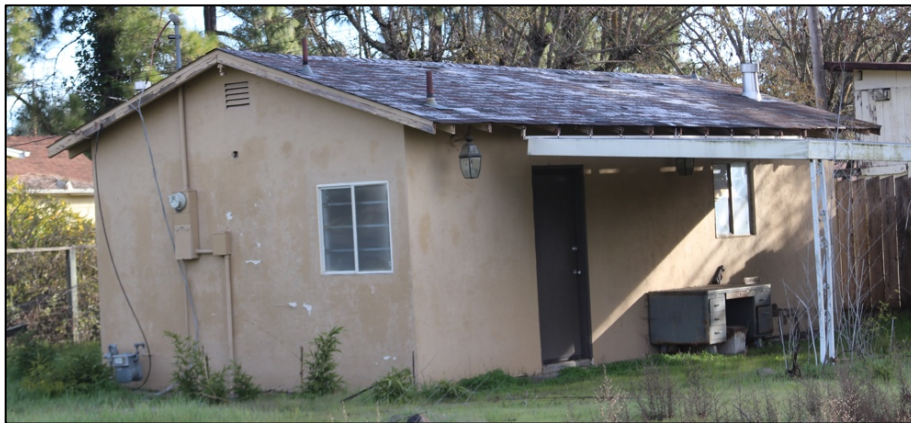
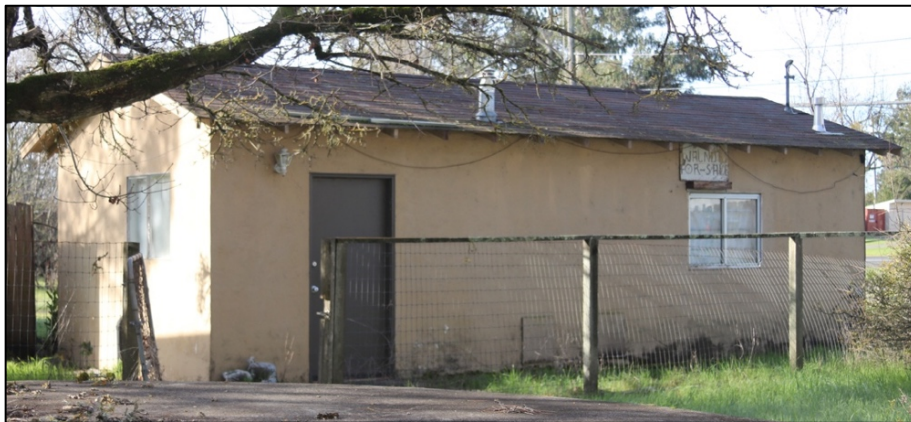
This modern, gable-roofed, one-story building is stuccoed and has a composition shingle roof. Each elevation has a single sliding window (aluminum sash) with interior security bars. A pedestrian door is under a shed roof porch on the south elevation, and another door is on the north elevation at the northeast corner. Metal trusses support the porch, that has a corrugated metal roof. A sign reading “Walnuts for Sale” is over the window on the north elevation (see photos below and Figures 56-60 in Appendix A). It was built as a catering kitchen in 1970.

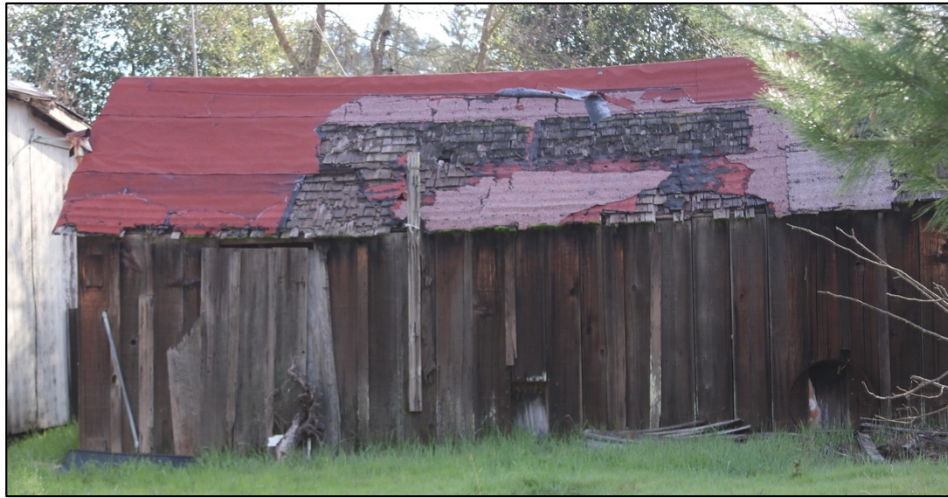
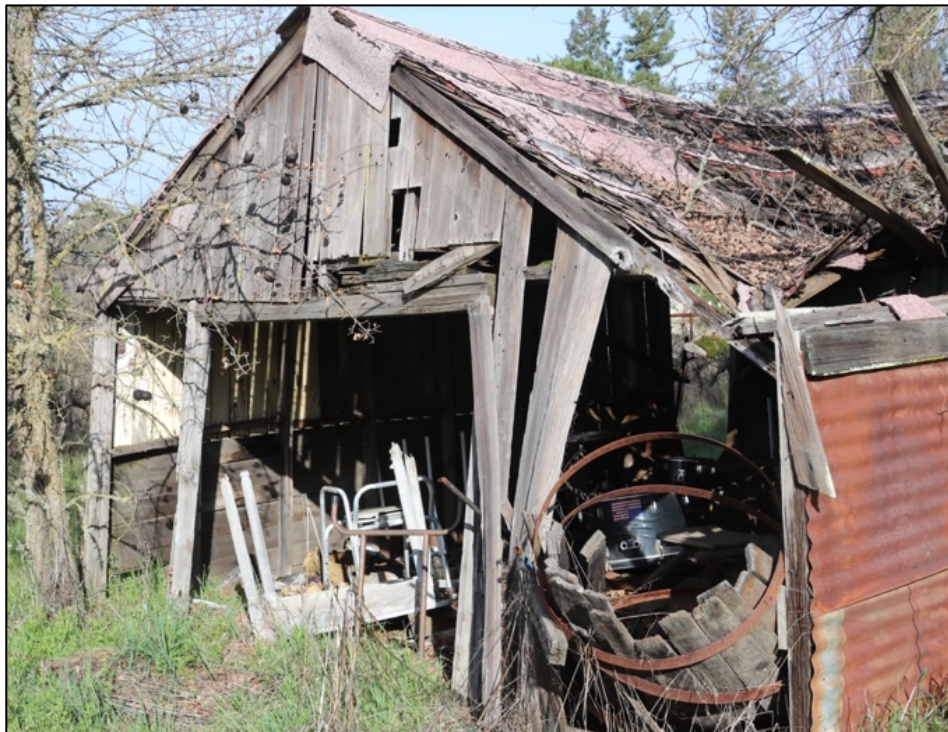
This one-story, gable-roofed structure is oriented north-south and has vertical wood board siding and a tar-paper roof over an older wood shake roof. The east and west elevations have a few openings (doors and windows), while the south gable has remnants of a vehicle bay. A pedestrian door with a concrete block stoop is on the north elevation (see photos below and Figures 61-70 in Appendix A).

The building is in very poor condition, with a significant portion of the structure collapsed.

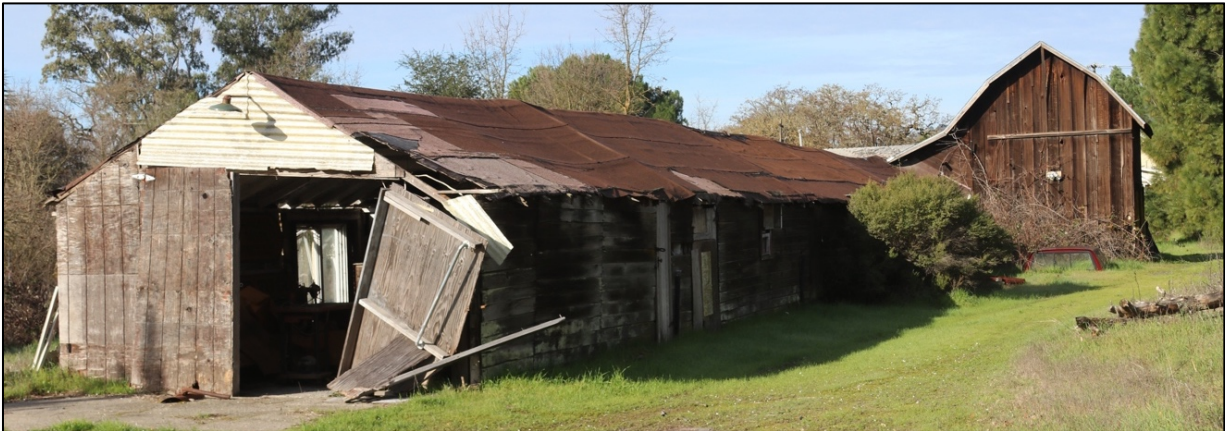
This second gable-roofed, one-story shed is oriented east-west and abuts the gambrel-roofed barn. Like the other poultry shed, it has a vehicle bay on the gable end and occasional openings on the north and south elevations. The tarpapered roof is near collapse in many sections, and the siding is a variety of vertical and wood boards as well as patches made of corrugated plastic and plywood (see photos below and Figures 71-76 in Appendix A).

The building is in very poor condition.

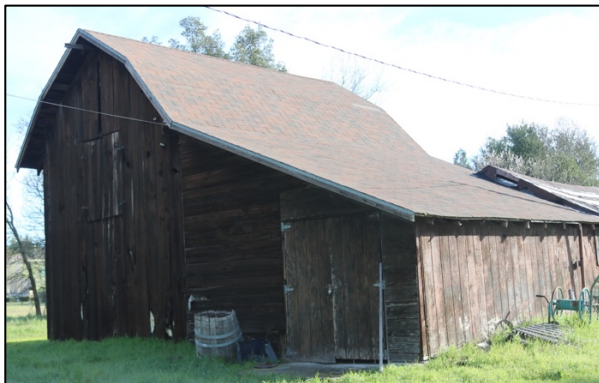
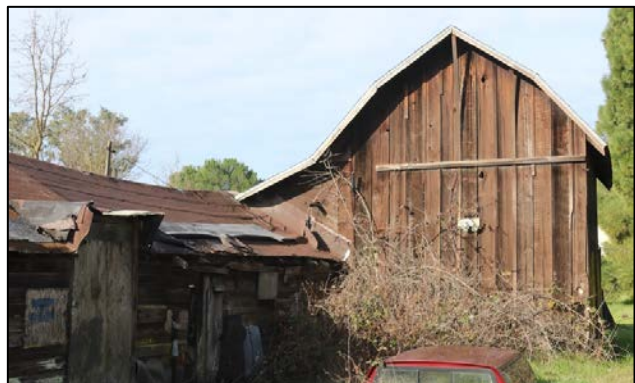
This two-story structure has a gambrel roof with overhanging eaves and a combination of vertical and horizontal board siding. A shed-roof addition extends along the south elevation and appears to have been built in two phases. The older section, closer to the gambrel roof section, has horizontal board siding while the newer section has a combination of horizontal wood siding and T1-11. The roof of all sections is composition shingles.

A pair of doors at the upper level of the west elevation accesses a hay loft, while a pair of doors at the southwest corner accesses the shed addition. On the north elevation, a pair of sliding and hinged doors fills the northwest corner. Where the barn abuts “Poultry Shed 2,” on the east elevation, the siding has been patched with diagonal wood boards and tar paper (see photos below and Figures 77-84 in Appendix A).

The barn is in poor condition and has been modified by the enlargement of the shed addition.

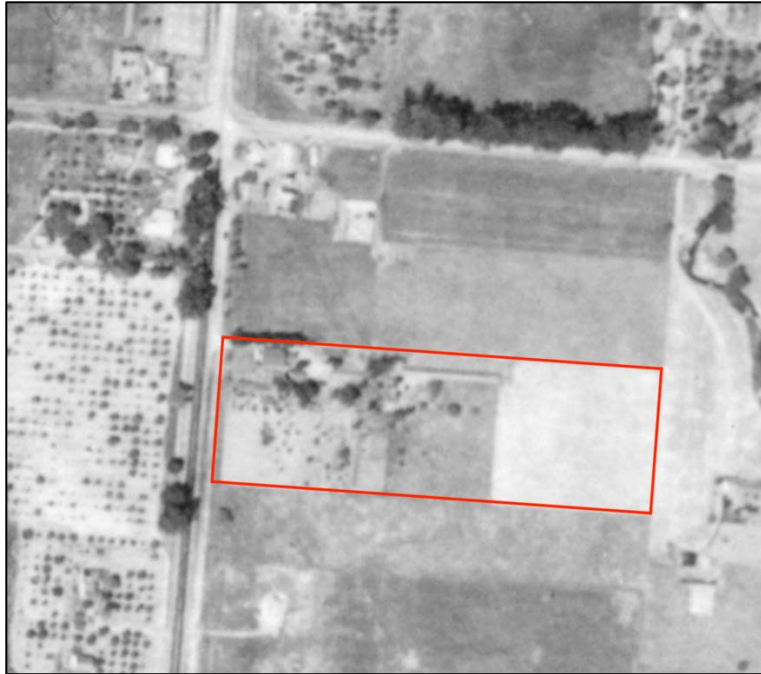
1942 aerial, project area indicated

A 1942 aerial photograph of the property shows the main house at the northwest corner, the barn and poultry shed along the north property line, the well house off the southeast corner of the house, the tank house south of the well house and the north-south poultry shed. Several other auxiliary buildings are apparent but difficult to discern (see Figure above).

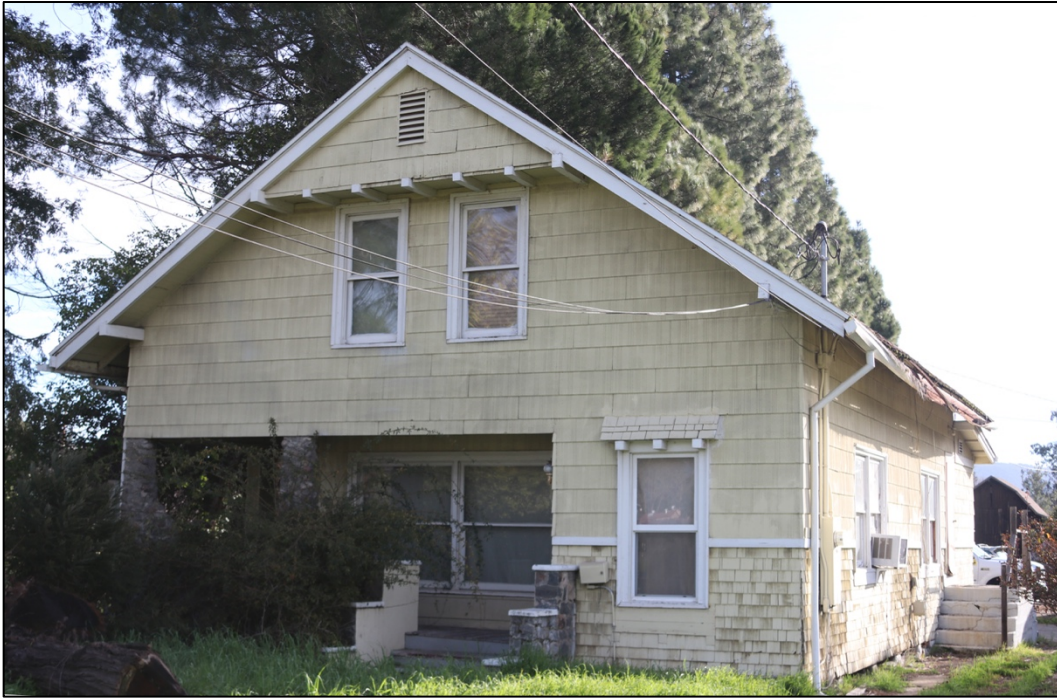
Figure 1: West elevation (front)

The remainder of the lower level has a single, one-over-one, double-hung window with modern vinyl sash set in a wood frame with a decorative shed hood with exposed rafter ends and shingles. The gable peak extends over the plane of the wall and is supported on decorative trusses. Decorative rafter ends punctuate the corners of the gable. A vent with wood louvers is at the gable peak. Two one-over-one, double-hung windows with modern vinyl sash set in wood frames are placed symmetrically at the upper level (see photo to right and Figures 1 and 5 in Appendix A).

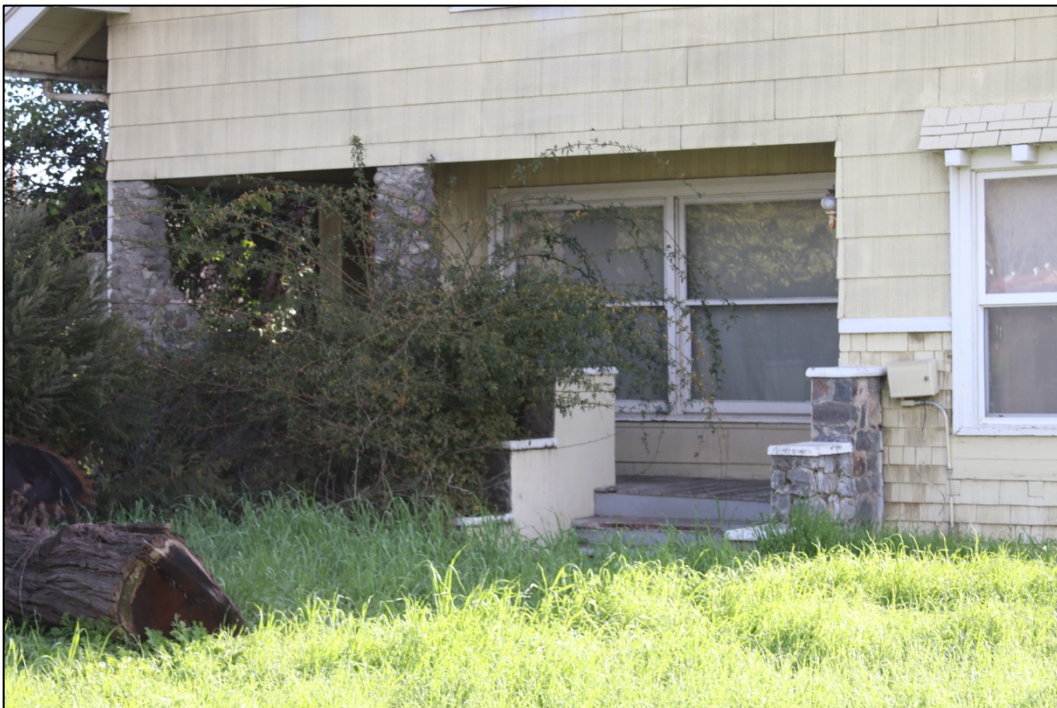
Figure 2: West elevation, porch

On the primary elevation (west), a porch is sheltered under the overhanging upper story and extends roughly two-thirds of the way across the elevation from the northwest corner. Three concrete steps lead to the wood floor of the porch. Half walls faced in a veneer of coursed polygonal and rubble masonry flank the stairs and have a square concrete cap. The interior of the wall is stuccoed (see Figures 6 and 7 in Appendix A). This stone veneer continues across the half wall of the porch and around the north corner. Rubble piers with thickly applied concrete mortar over small river rocks form the porch posts. The corner post flares out over the half wall in both directions. Given the crude workmanship of their stonework, these stone posts do not appear to be original to the house. A square pier on the north side of the porch does appear to be original, though it is currently faced with modern asbestos shingles (see Figures 3 and 4 in Appendix A).

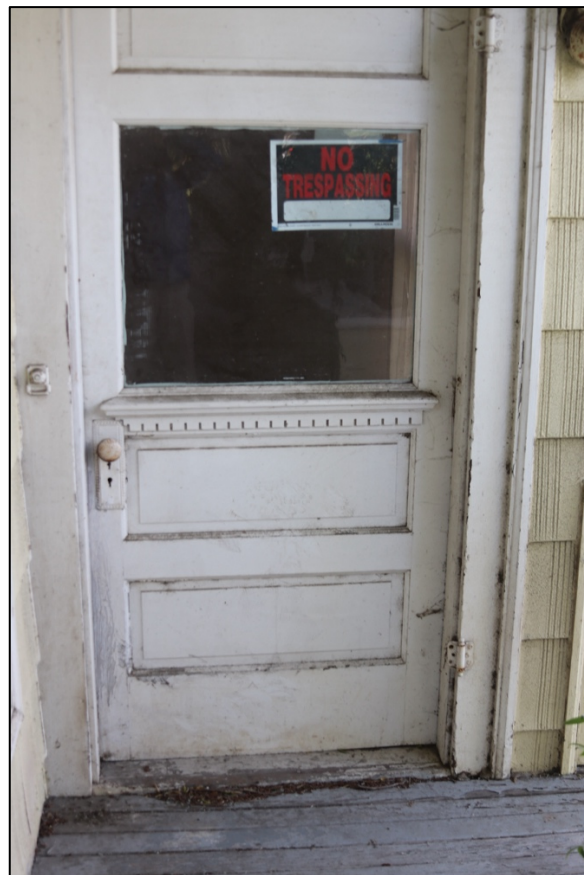
Figure 8: West elevation, front door (facing north)

Inside the porch, a pair of one-over-one, double-hung windows with modern wood sash are framed as a single unit in a wood frame. Two separate doors access the lower level from the porch. One door faces north and one door faces west; both have a single pane of glass over two raised panels separated by a decorative sill with dentils. Another raised panel is over the glass of each door (see Figures 8-10 in Appendix A).

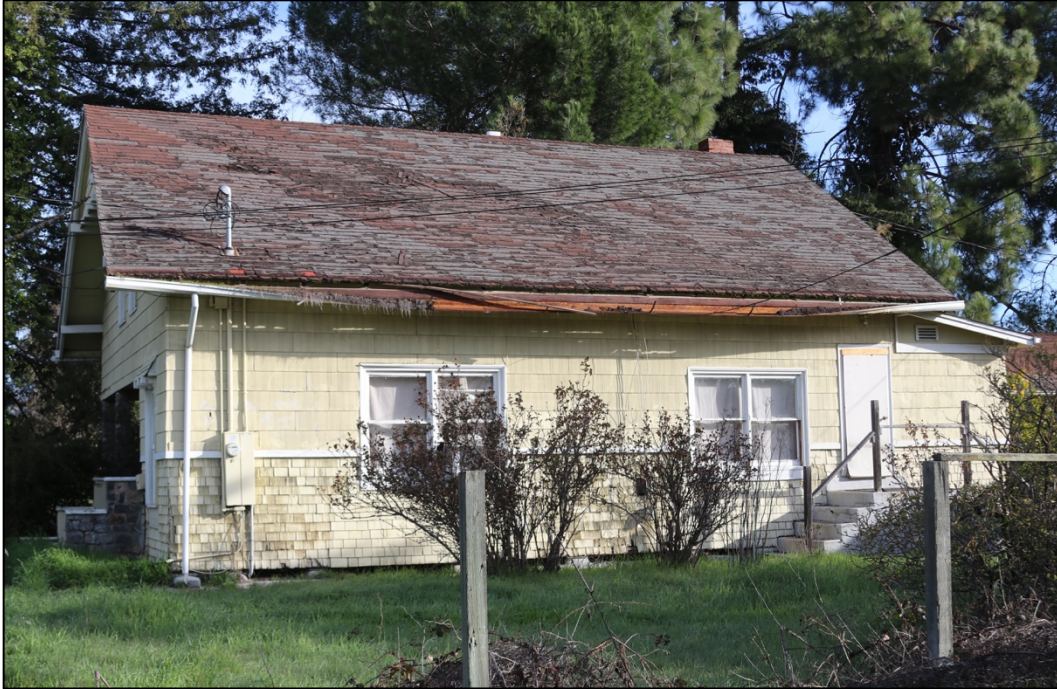
Figure 11: South elevation

The south elevation has two pairs of windows, a pedestrian door and a concrete stoop. The symmetrically placed windows are one-over-one, double-hung units with modern wood sash and molded wood frames. The wood door is modern, as is the poured concrete stoop. Five steps with a minimal board balustrade lead up the east and west sides of the stoop to a small landing (see photo below and Figures 11-15 in Appendix A). This porch appears on the 1979 League survey form and may date to the 1961 remodel of the house.

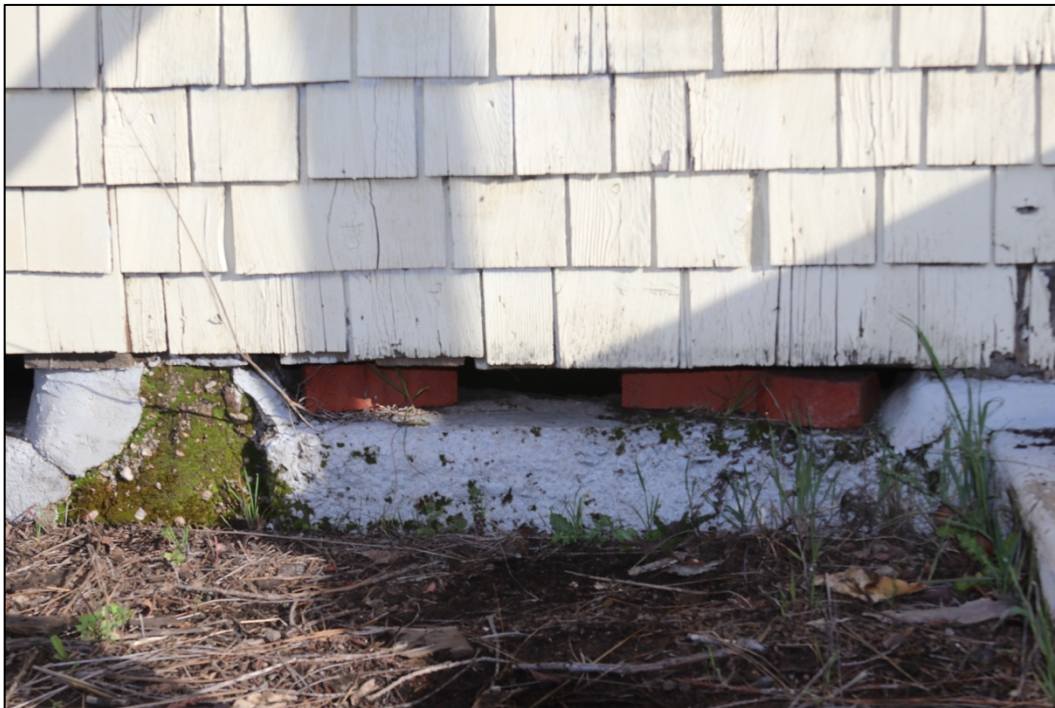
Figure 16: South elevation, foundation detail, random bricks

Changes made to the main house include replacing windows (date unknown), adding a side entrance on the south elevation (likely 1961), building an addition on the rear (1912-1939), expanding the rear addition (1961), applying asbestos shingles (likely 1961) and replacing the front porch piers (probably 1961). The house is in poor condition, with the roof showing evidence of failure and the gutters hanging off the eaves in multiple locations.

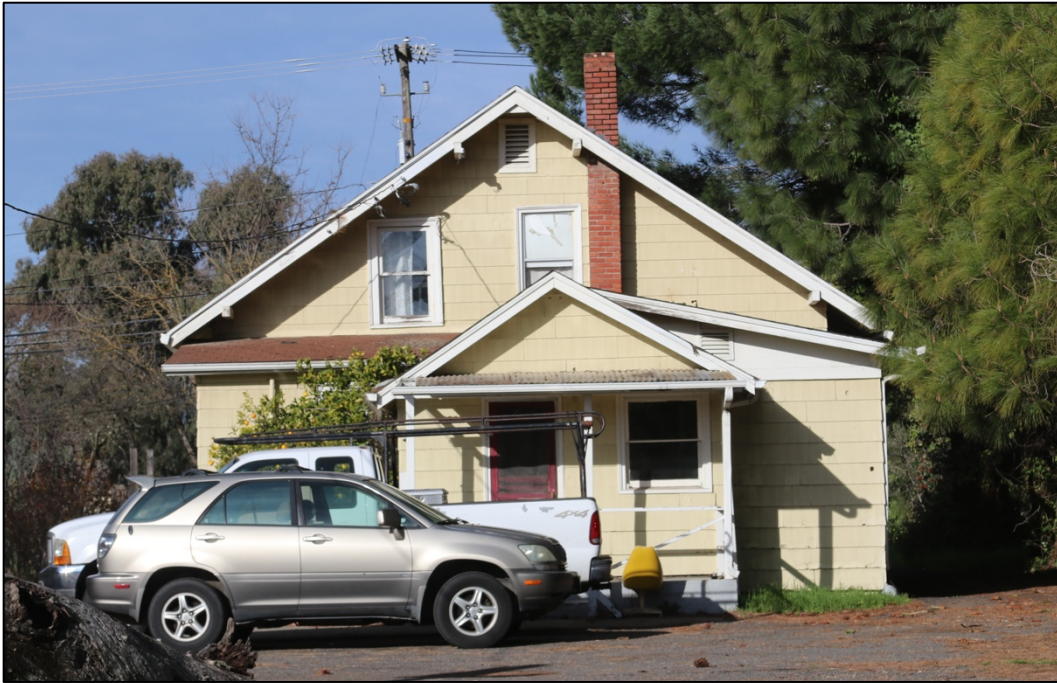
Figure 19: East elevation, rear

A one-story addition telescopes off the rear of the house from roughly the center of the elevation. This wing appears on the 1942 aerial and may date to 1912-1939. It abuts a one-story shed addition that extends the full width of the house and appears to be part of the original 1911 design, with a single window obscured by a lemon tree. The center section is gabled and has a simple, shed-roof porch that extends the width of the gable. This porch has a corrugated metal roof, square posts, a minimal board balustrade and poured concrete stoop and floor. A half-glass door is shielded behind a screen door at the back entrance, and a one-over-one, double-hung window with modern sash and frame is north of the door. The side of the gabled section has another one-over-one, double-hung window with modern sash and frame (see photo below and Figures 21-23 in Appendix A).

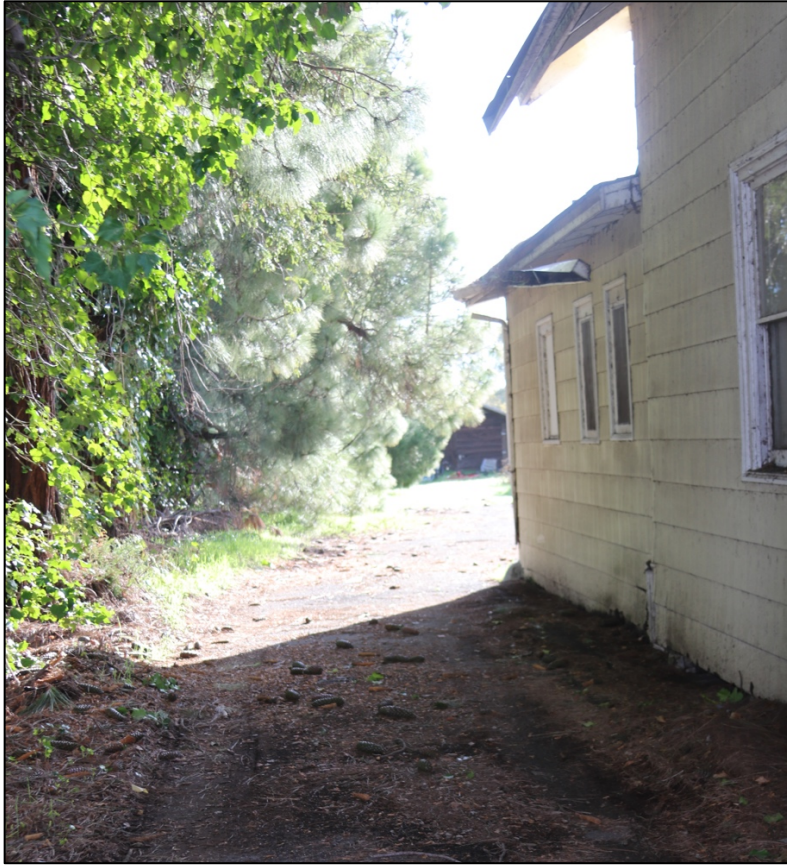
Figure 25: North elevation, rear wing, looking east

A shed-roof section extends from the north slope of the roof of the gabled addition and dates to 1961. It has an attic vent on the east side and three windows on the north (see Figure 25 in Appendix A).

The north elevation has the three previously mentioned windows on the rear addition (one of which has been infilled) and a pair of one-over-one, double-hung windows (modern sash) framed as a single unit (see Figures 25-29 in Appendix A).

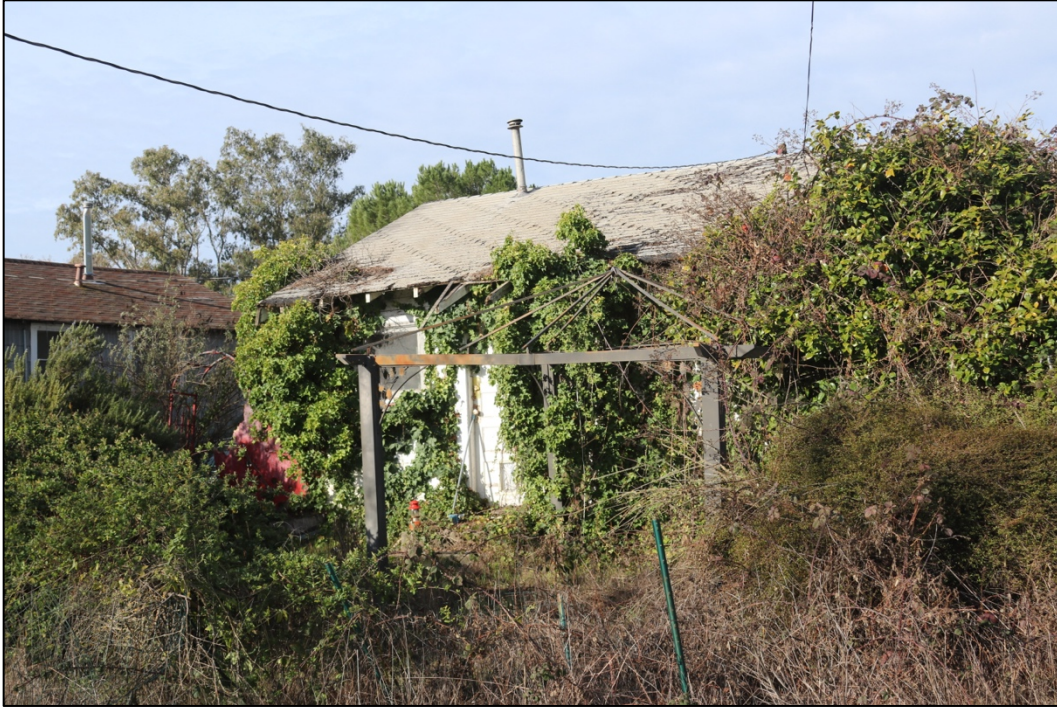
Figure 33: East elevation, rear wing (overgrown)

The rear section of the building is one story and has a north-south oriented gable roof with overhanging eaves, a composition shingle roof and V-groove wood siding. The primary entrance is off-center on the south gable and has a modern door set in a wood board frame. Two modern sliding windows with wood board frames flank the door and a wood louvered vent is in the gable peak. Another entrance with a five-paneled wood door is on the east elevation, as
