PRELIMINARY
GRADING AND DRAINAGE ANALYSIS

149 4th STREET RESIDENCE
LOT 227 RESIDENCE
LOT 228 RESIDENCE &
DRIVEWAY PROJECT

149 4th Street East, Sonoma, CA 95476
Brazil Street, Sonoma, CA 95476
APN 018-091-018 & 018-051-007

Date: May 25, 2017

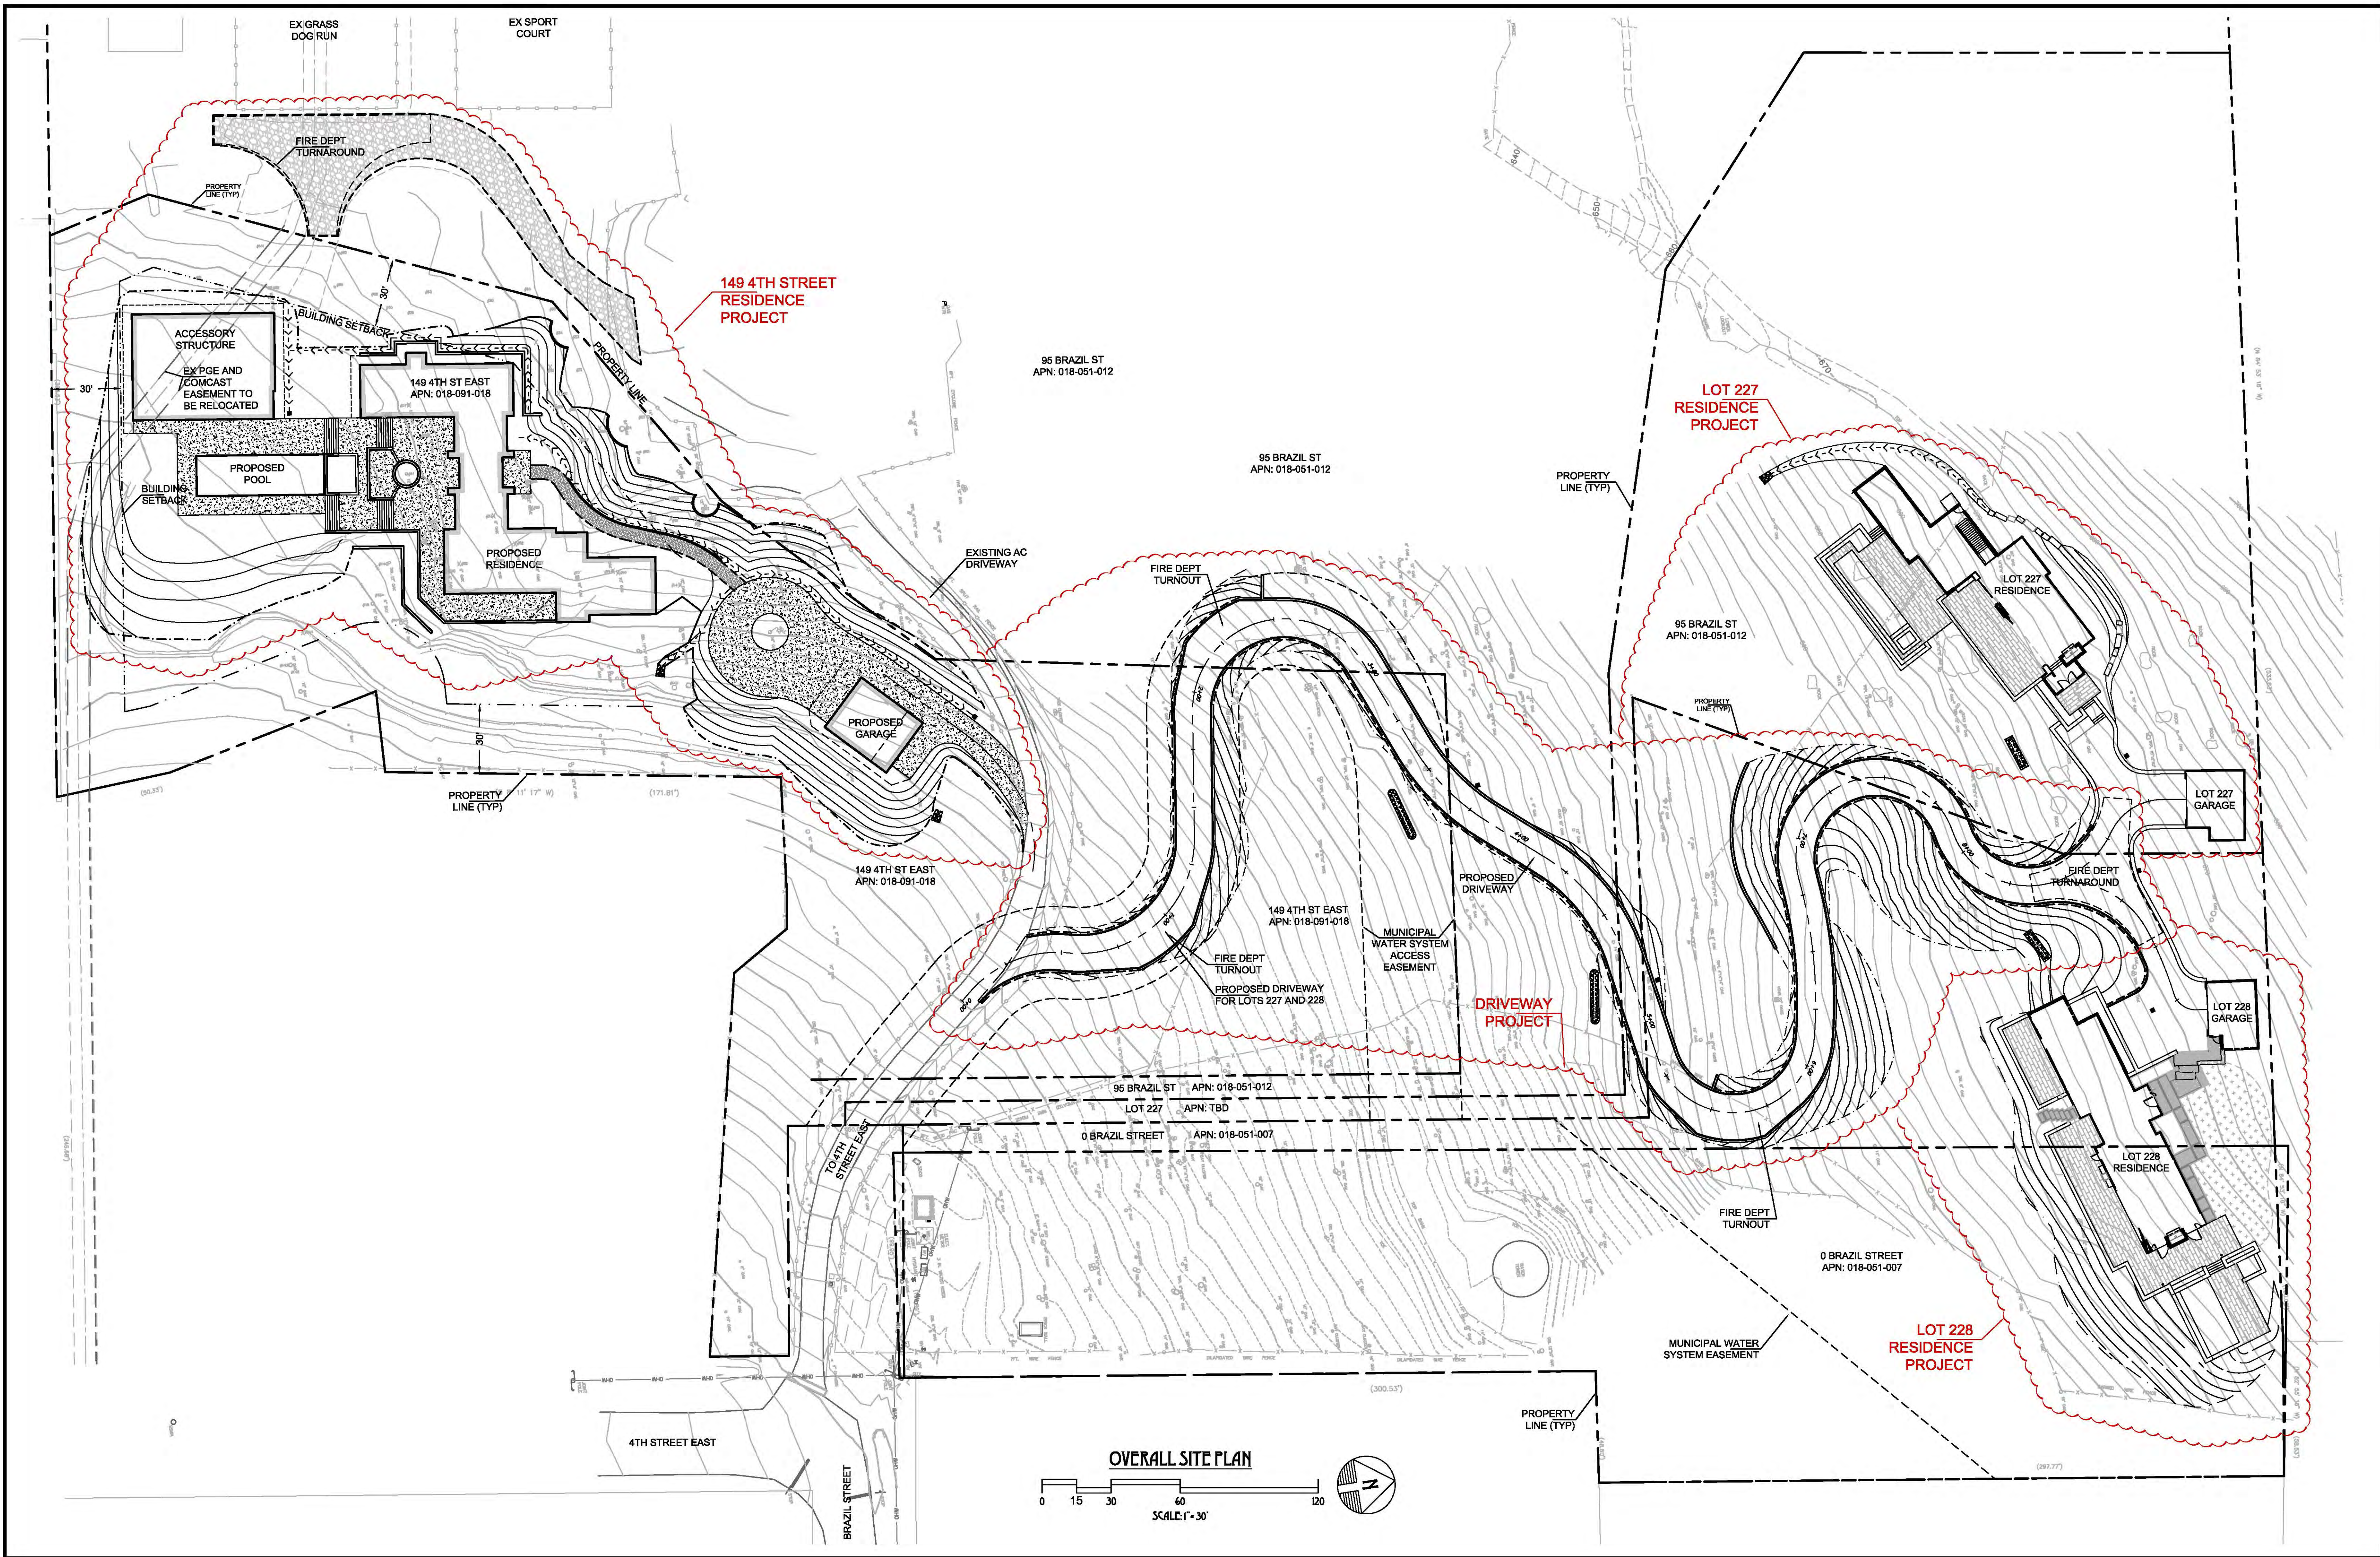
OVERALL SITE PLAN

149 4TH STREET
RESIDENCE
PROJECT

LOT 227
RESIDENCE
PROJECT

LOT 228
RESIDENCE
PROJECT

DRIVEWAY
PROJECT

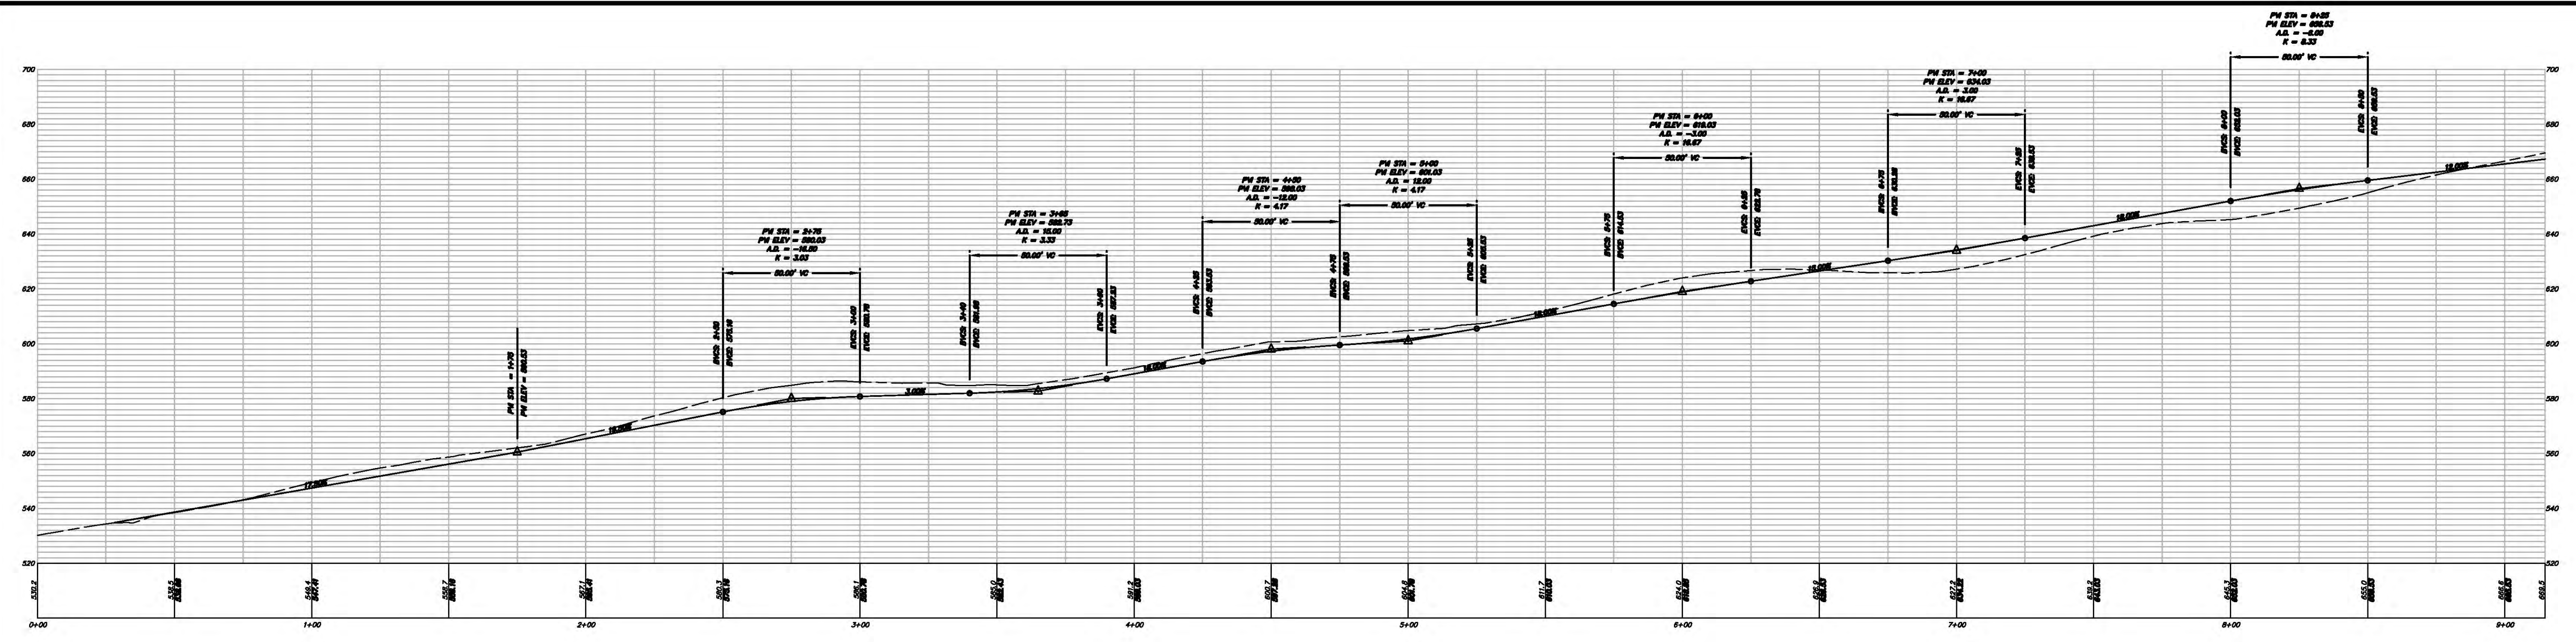
EARTHWORK CALCULATIONS

CUT: 3120 CUBIC YARD (CY)
FILL: 2890 CY
NET: 230 CY (EXPORT)*

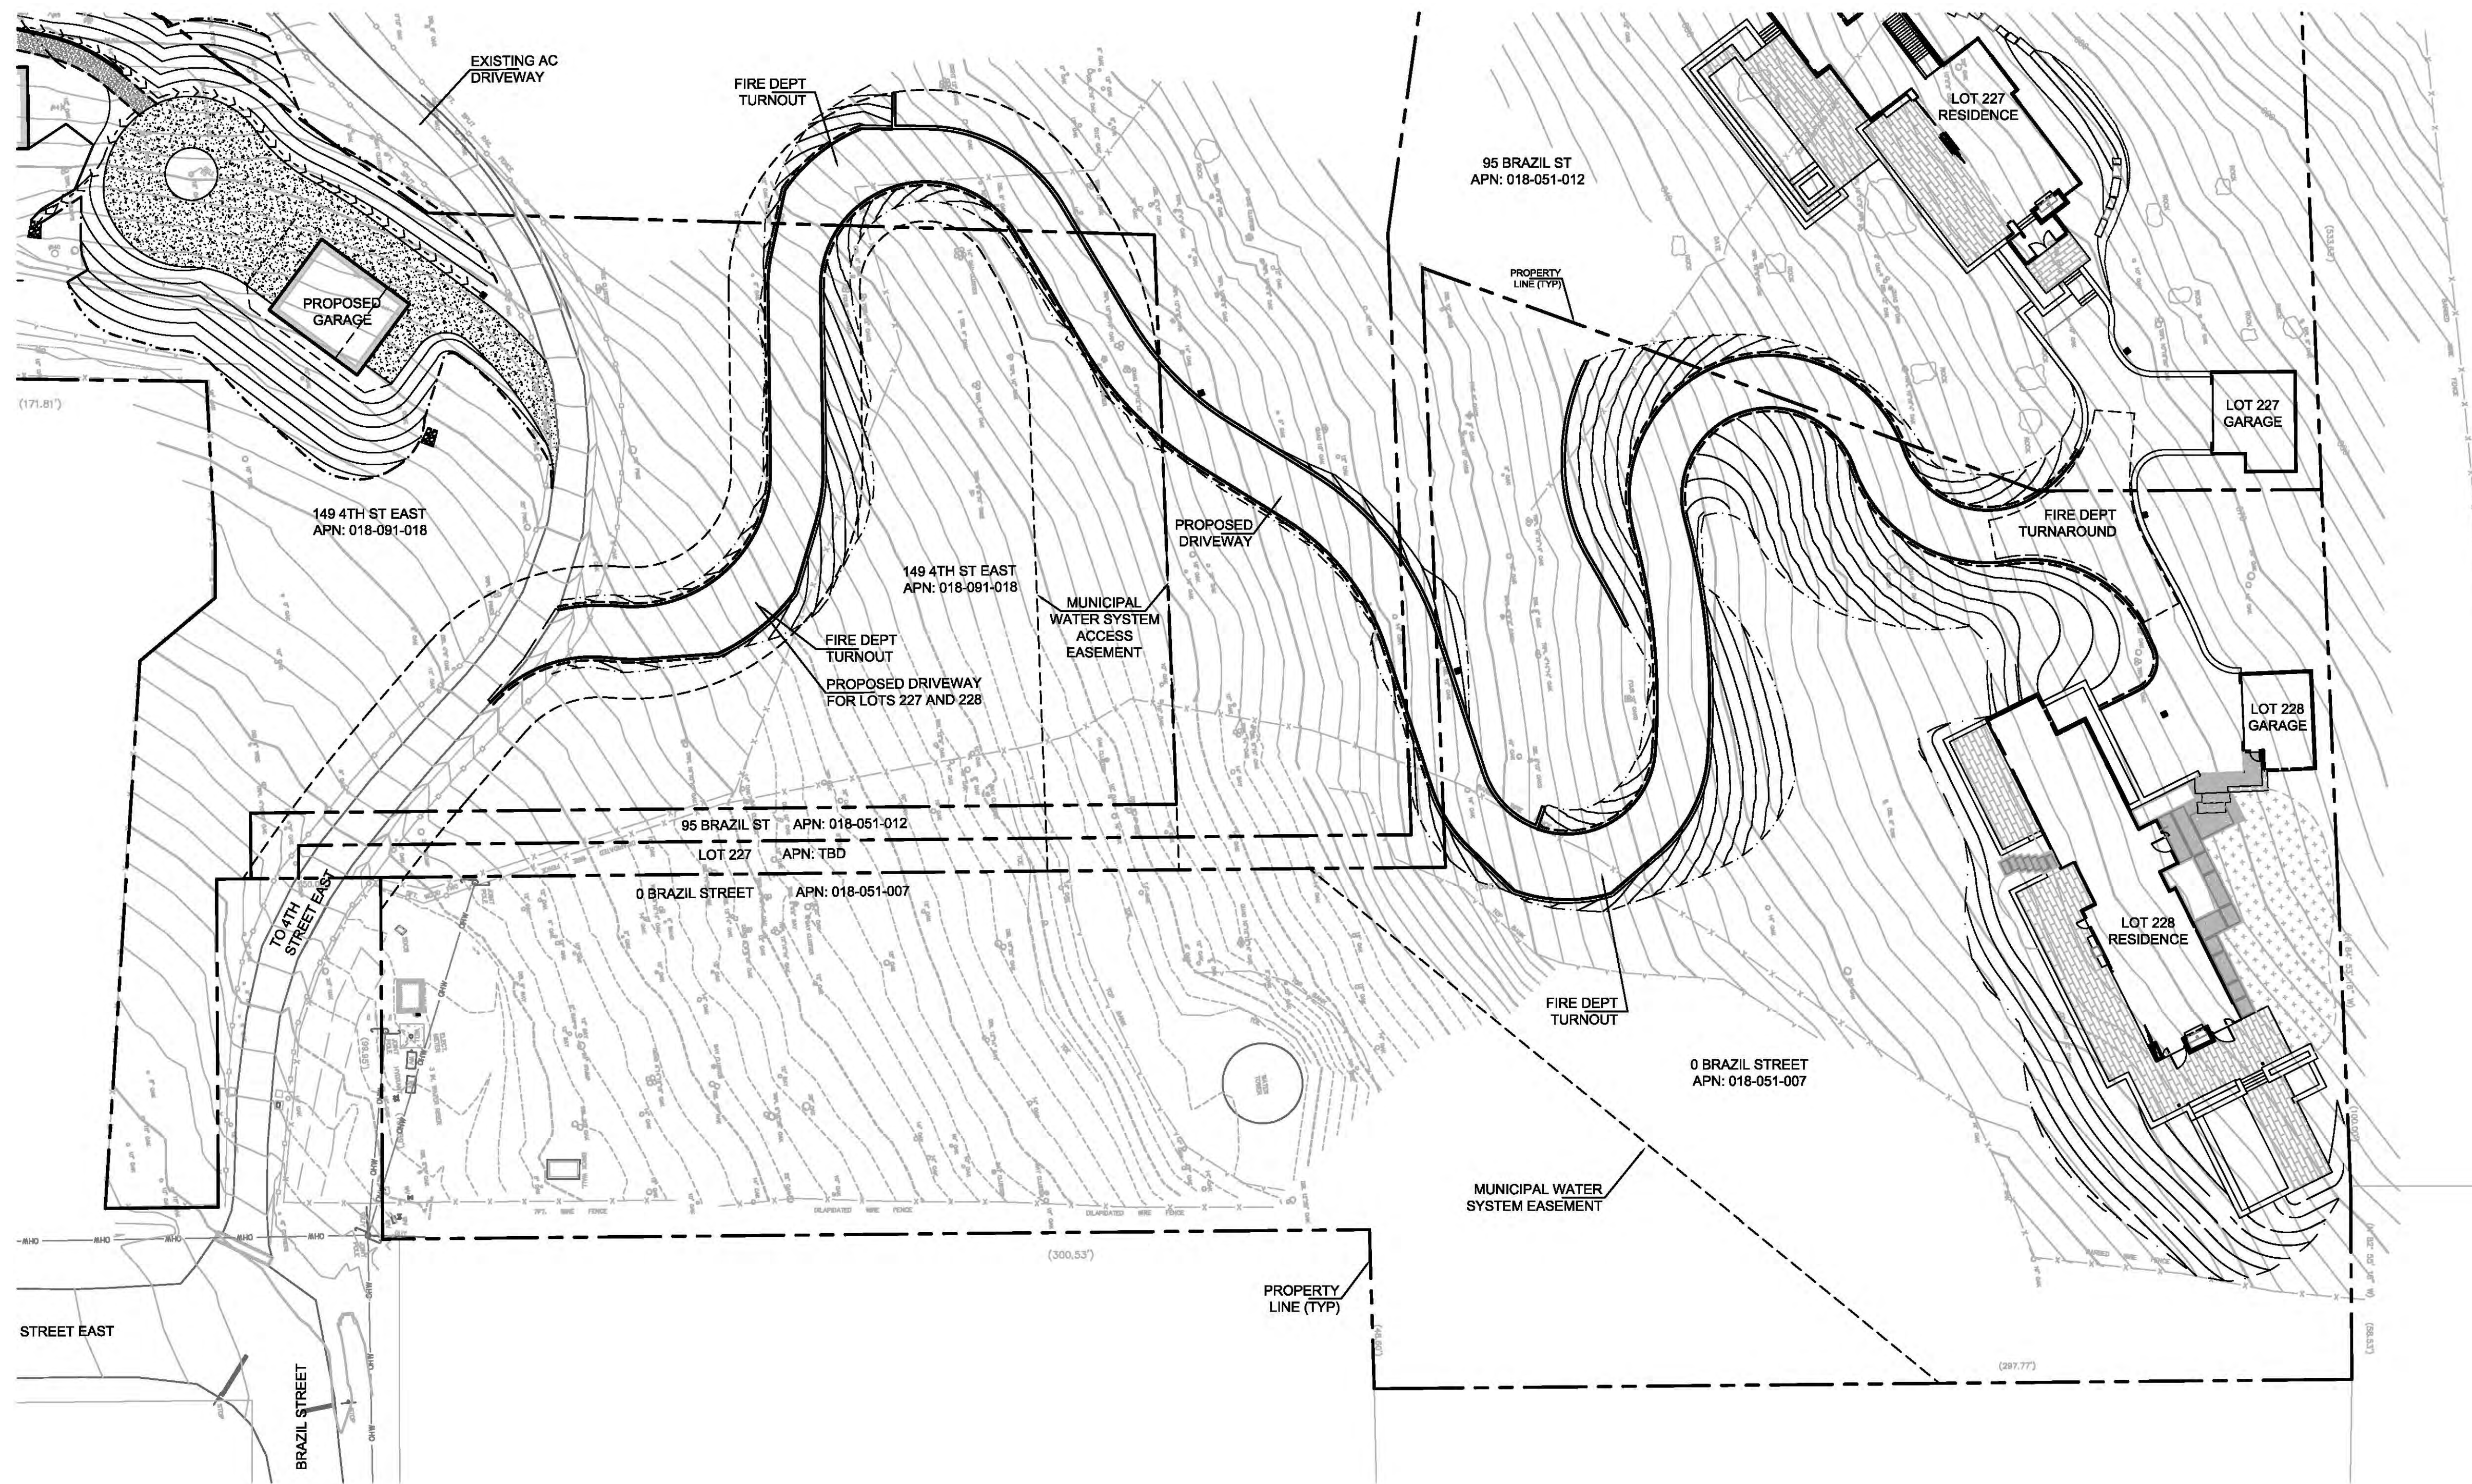
PRELIMINARY SITE PLAN - LOT 228

- Grading for the residence consists of cut and fill placement for foundation of the residence, and fill placement for the patio to the south. The backside of the garage is in cut. The building is stacked and terraced to reduce grading around the perimeter.

- Retaining walls have been designed on the downhill side of the pool and residence, which eliminates downslope fill placement. These walls have been designed to prevent damage to the existing trees.

- Roof and patio drainage will be conveyed to a bio-retention planter below the residence and pool. Runoff will be detained, infiltrated, and overflow will be spread out over 30-feet to maintain a sheet flow nature below the proposed improvements.

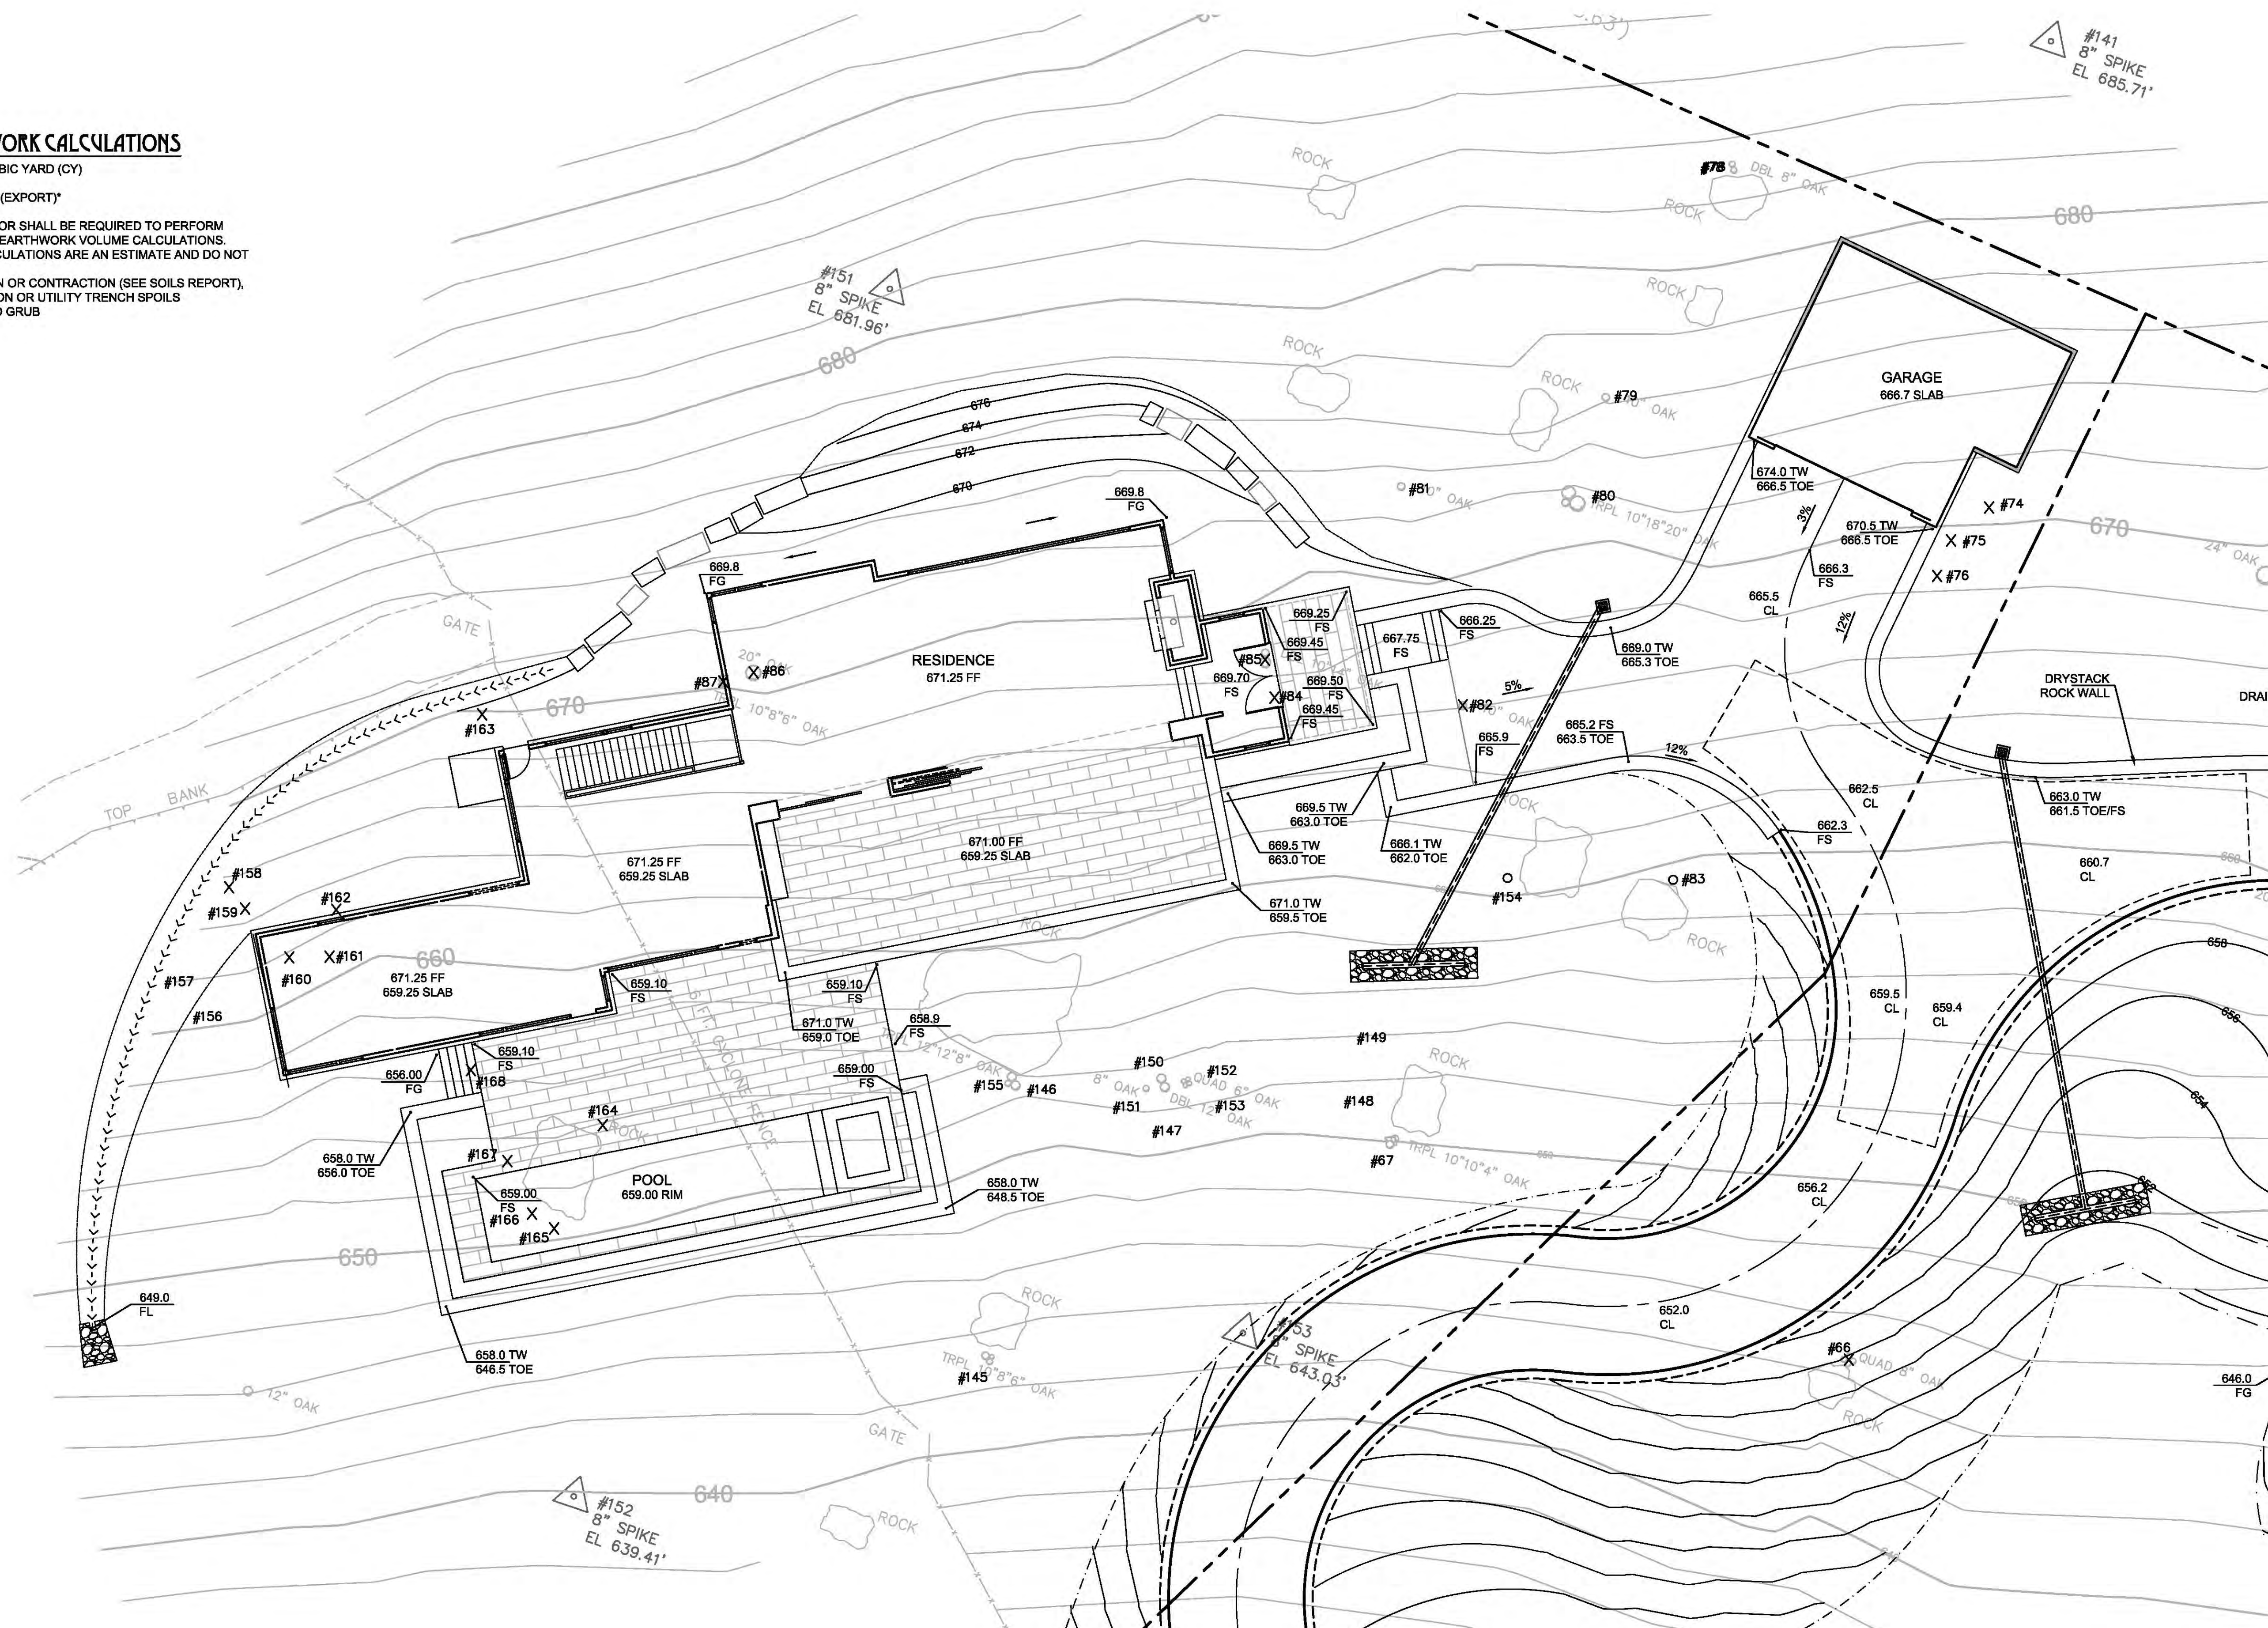
**LOT 227 RESIDENCE
PRELIMINARY GRADING PLAN**

PRELIMINARY GRADING PLAN
LOT 227 RESIDENCE
BRAZIL STREET, SONOMA, CA
APN: XXX-XXX-XXX

- Grading around the residence consists of cut and fill placement for foundation of the residence, and fill placement for the patio to the east. The main residence is stacked and terraced to reduce grading around the perimeter. The backside of the garage is in cut.

- Roof and patio drainage will be conveyed to two bio-retention planters below the residence. Runoff will be detained, infiltrated, and overflow will be spread out over 40-feet to maintain a sheet flow nature below the proposed improvements.

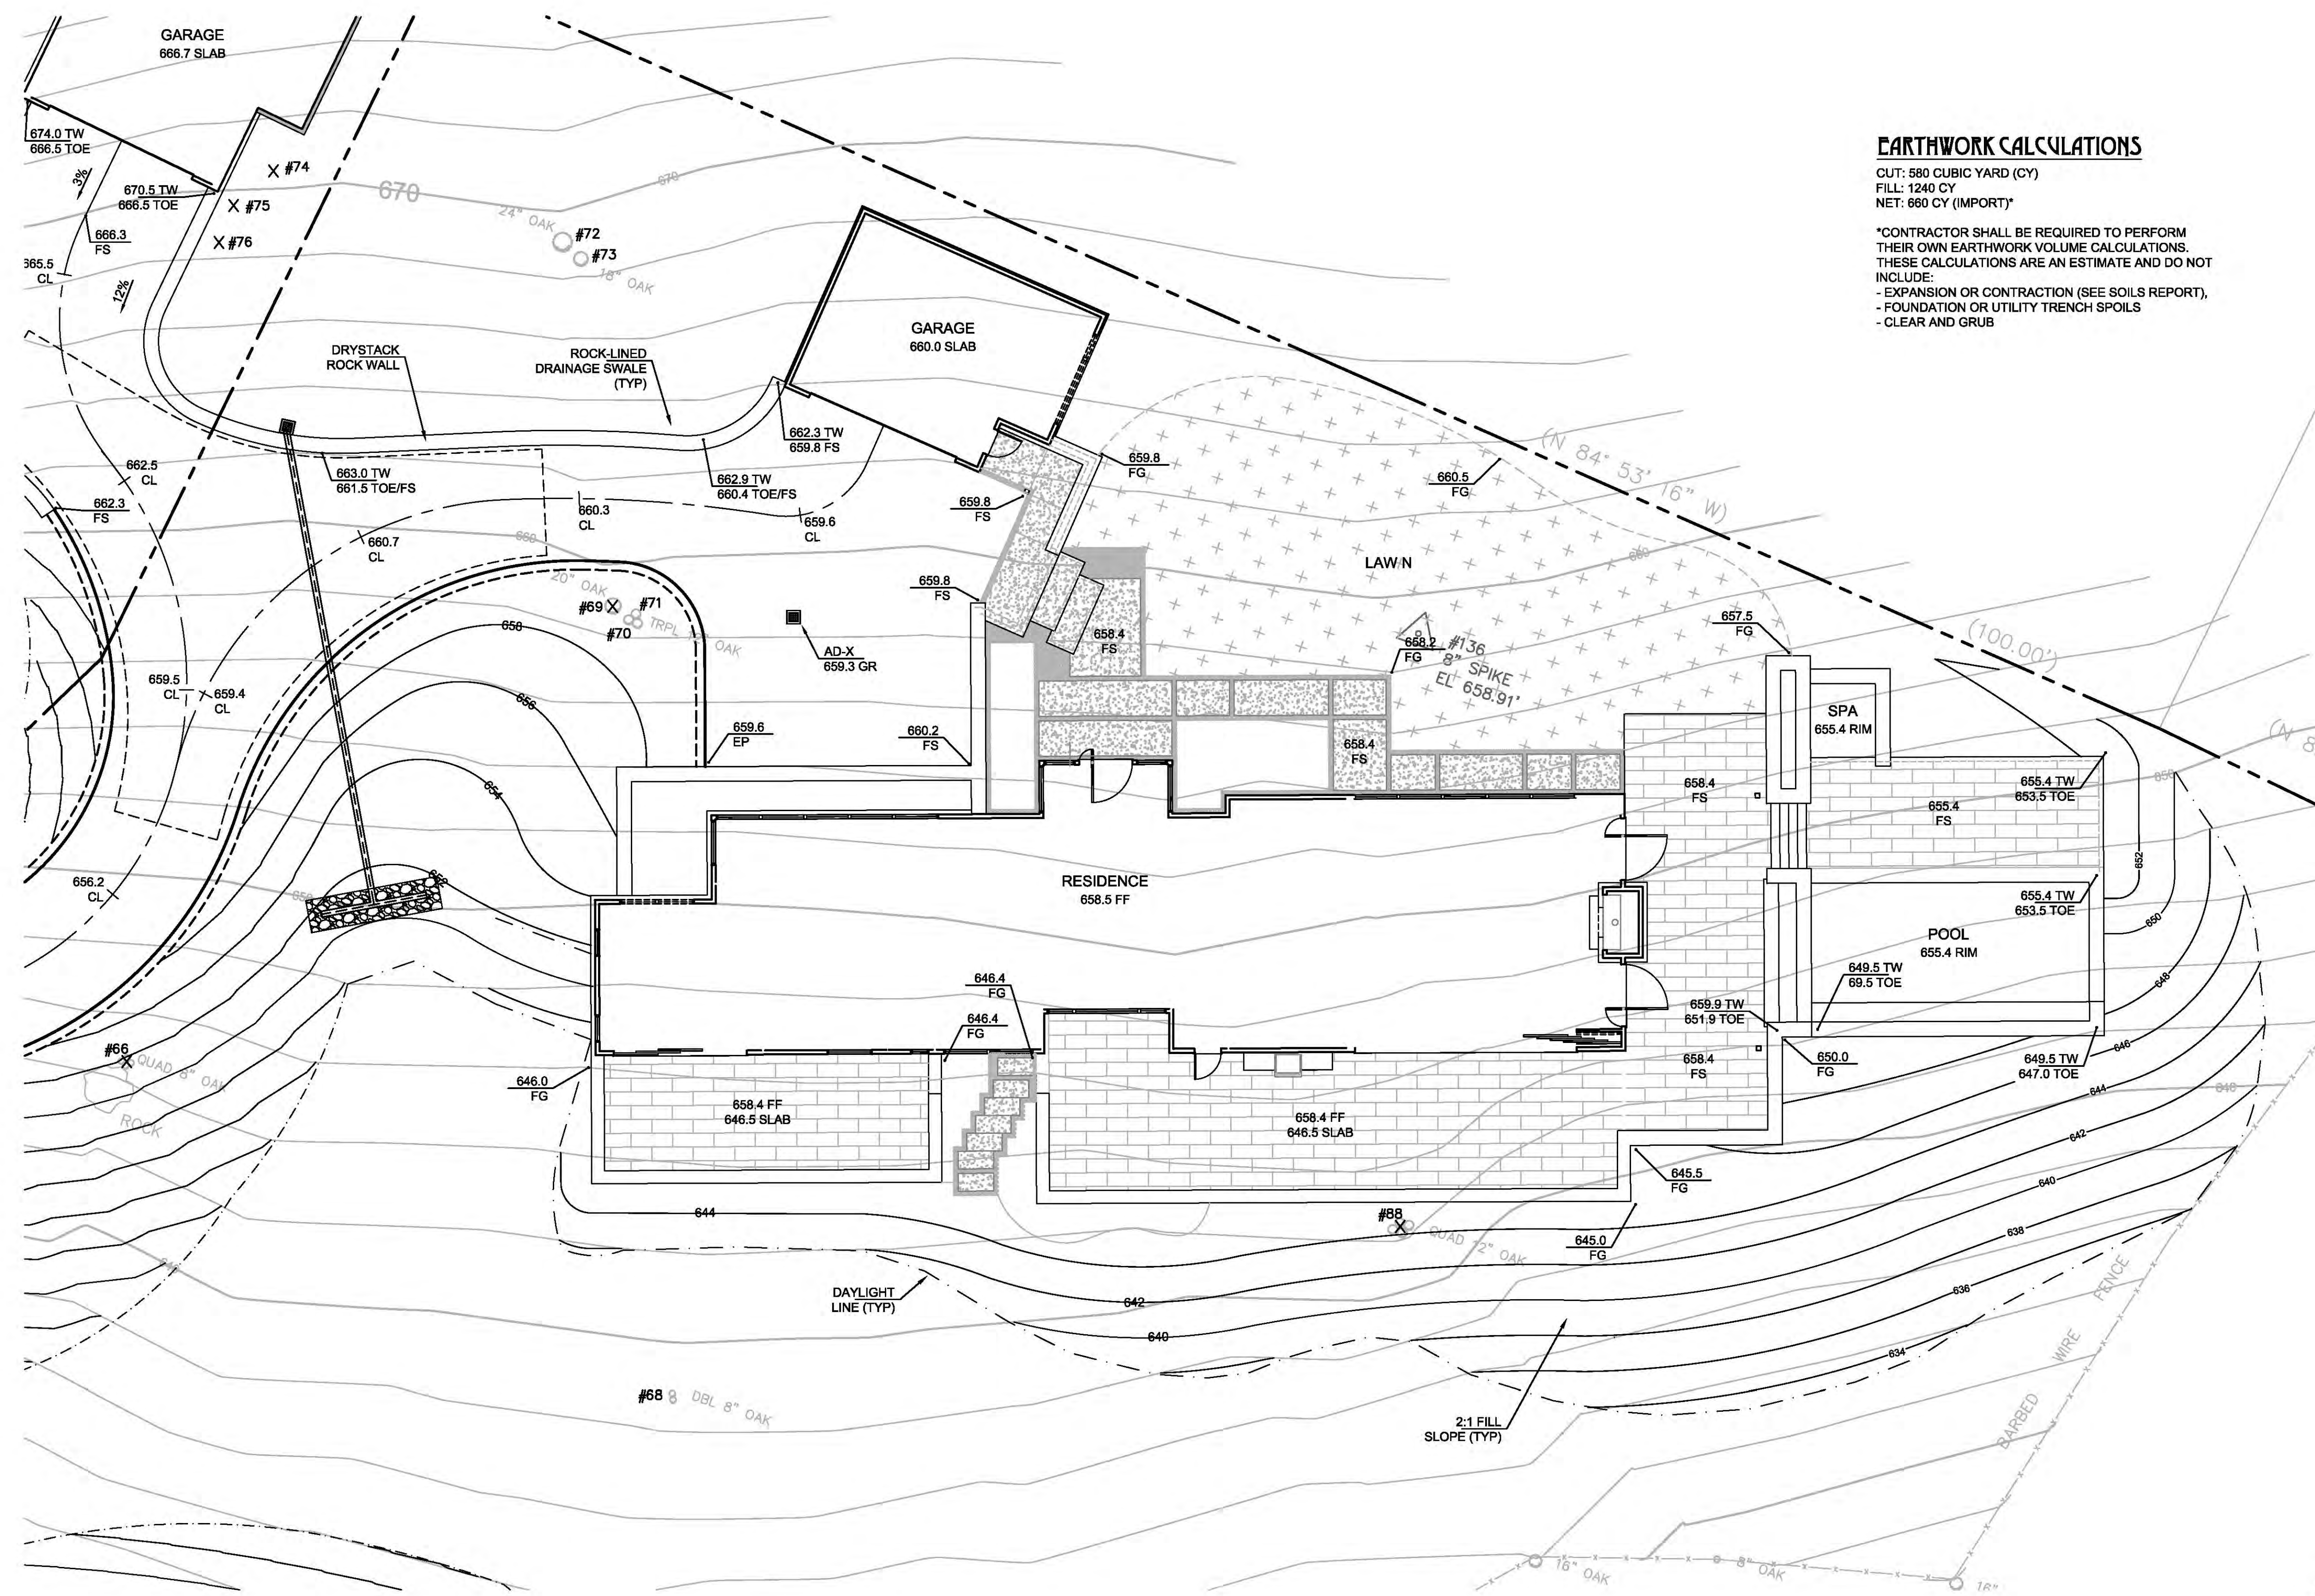
PRELIMINARY GRADING PLAN
LOT 228 RESIDENCE
BRAZIL STREET, SONOMA, CA
APN: 018-051-007

CUT: 580 CUBIC YARD (CY)
FILL: 1240 CY
NET: 660 CY (IMPORT)*

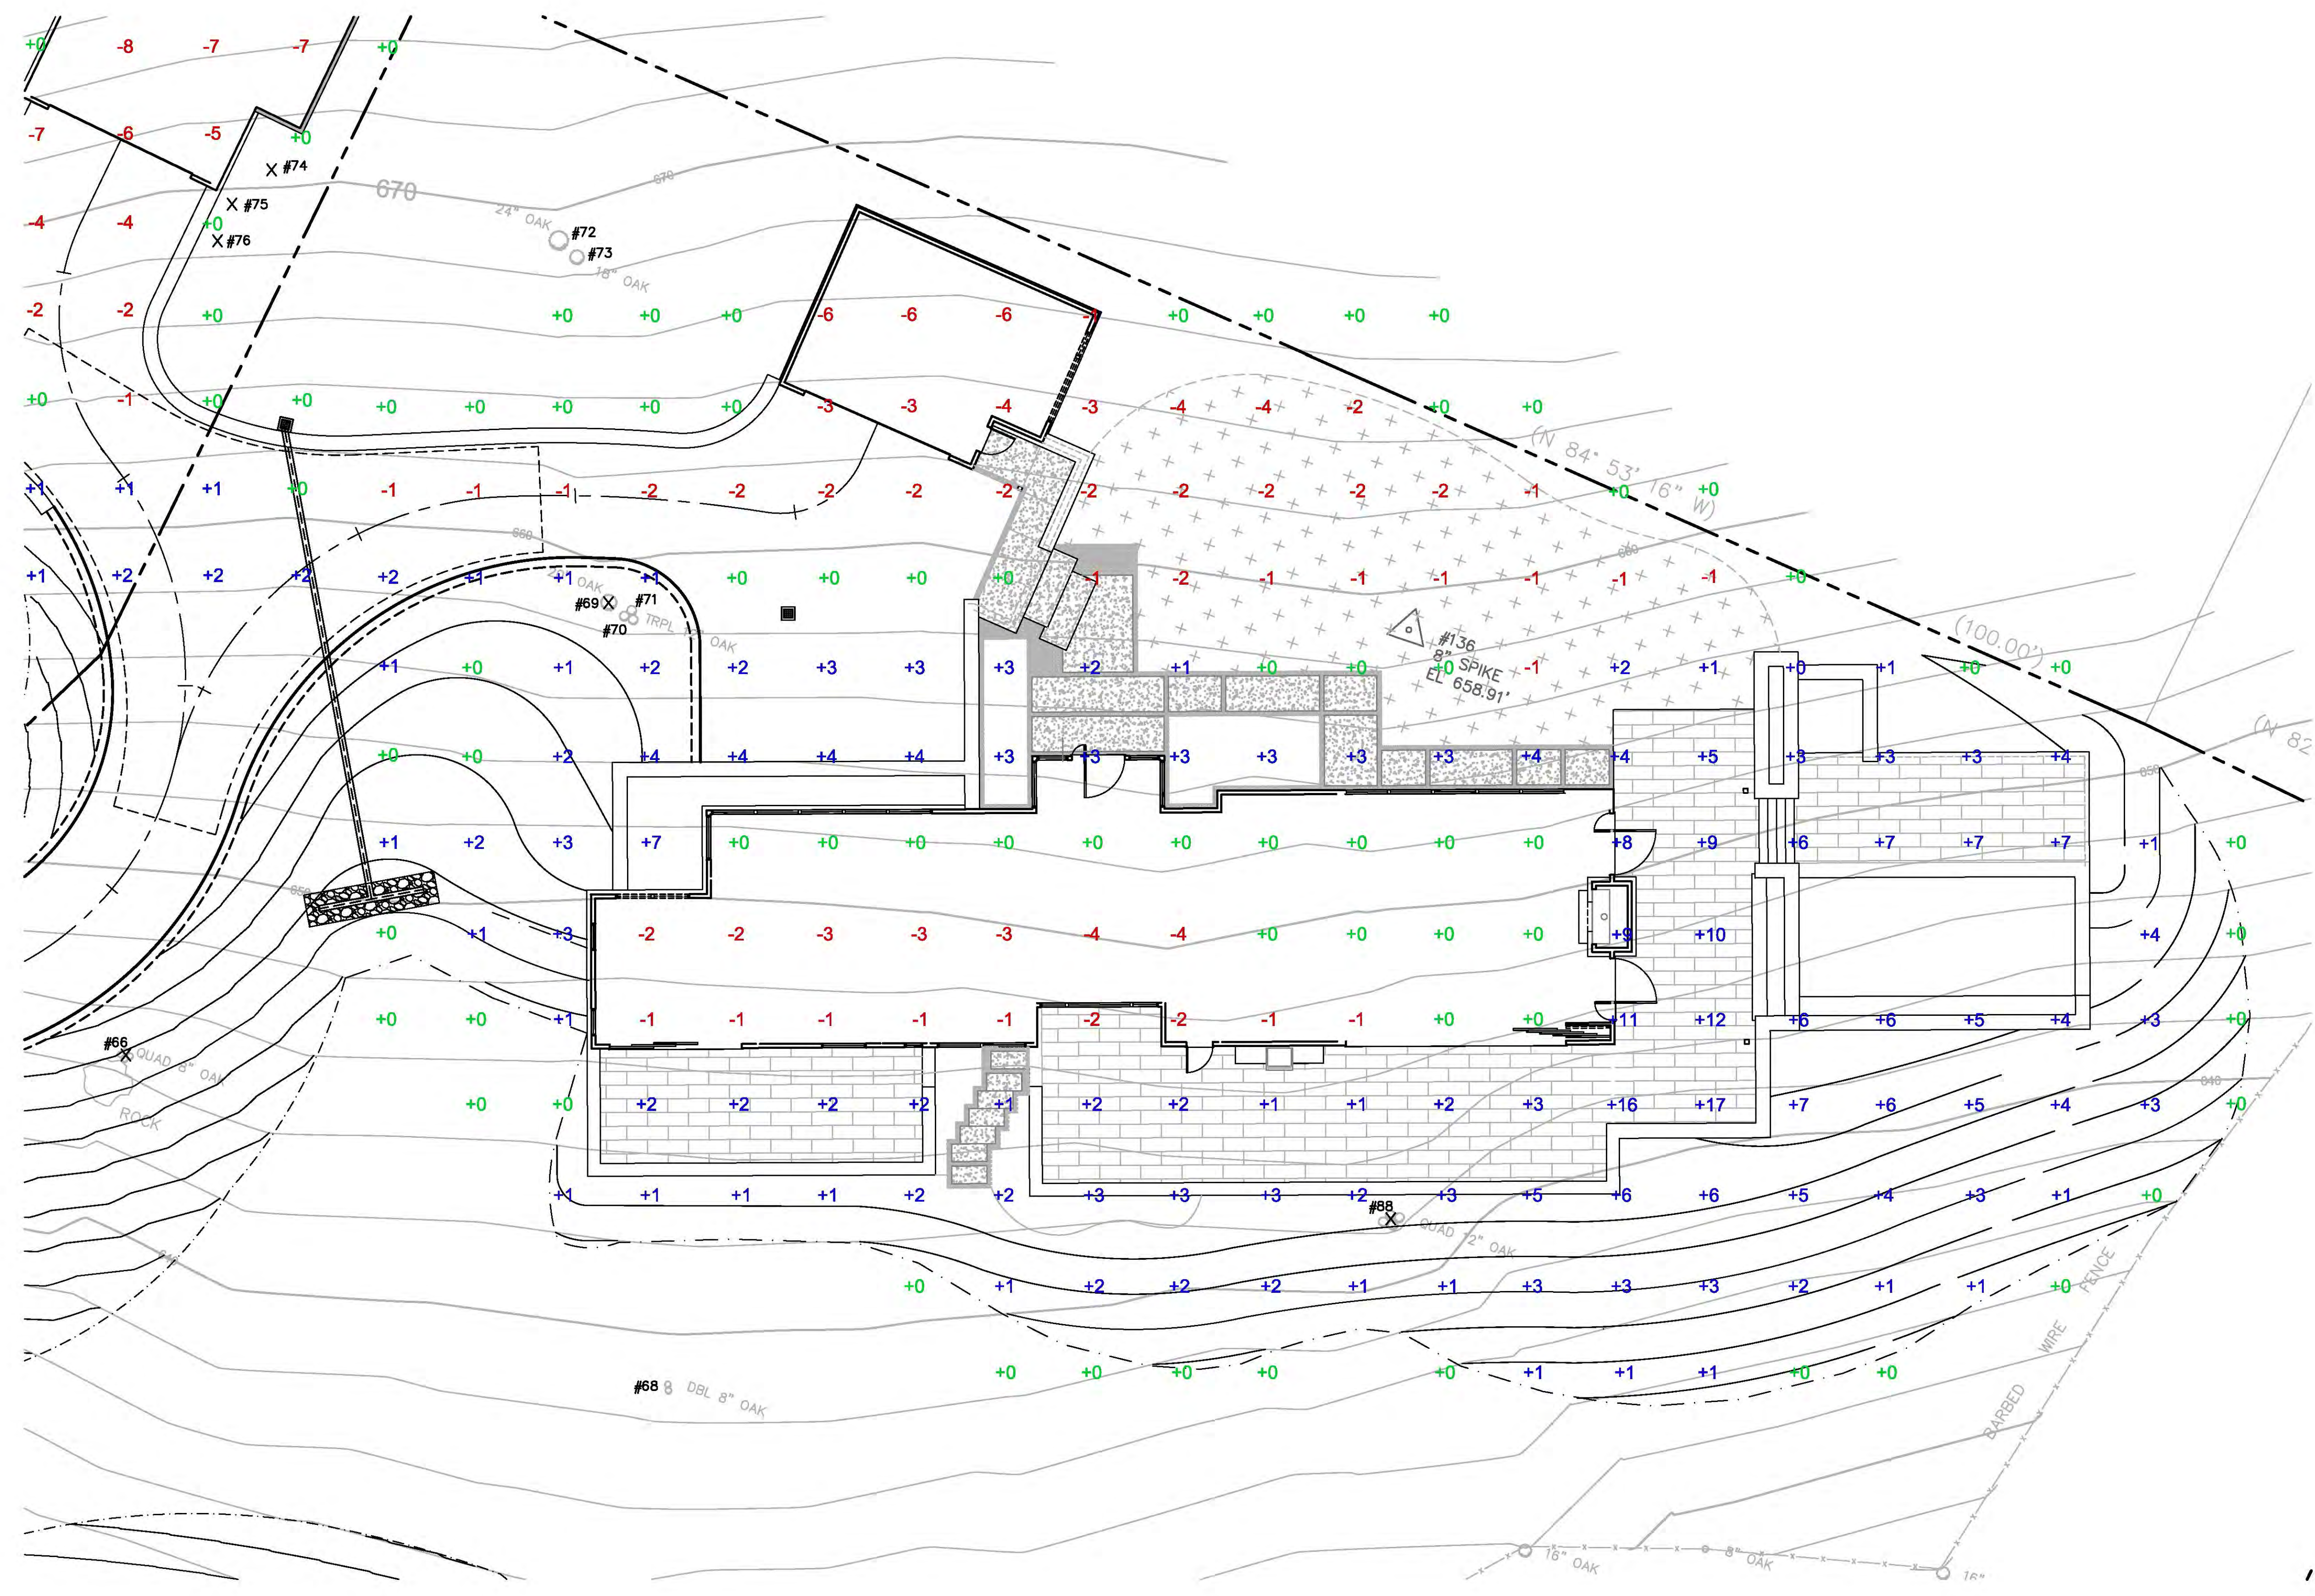
**LOT 228 RESIDENCE
CUT-FILL TICK EXHIBIT**

CUT-FILL TICK EXHIBIT
LOT 228 RESIDENCE
BRAZIL STREET, SONOMA, CA
APN: 018-051-007

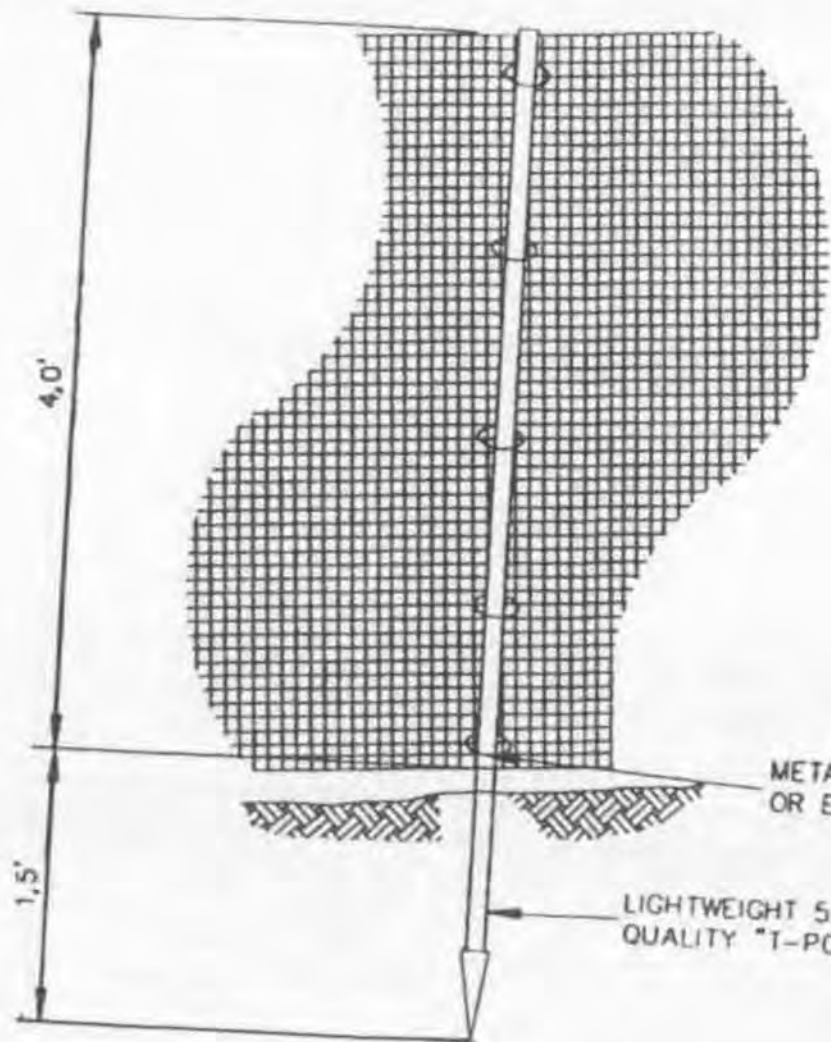
TREE FENCING DETAIL

NOTE:
TENSOR LIGHTWEIGHT SAFTY GRID, ORANGE
COLOR, BX226516, CUT OR FOLD AT POSTS
AS NEEDED TO CONFORM TO SLOPING TERRAIN.

METAL TIE WIRE, FLIP TIE
OR EQUIVALENT, 5 PER POST

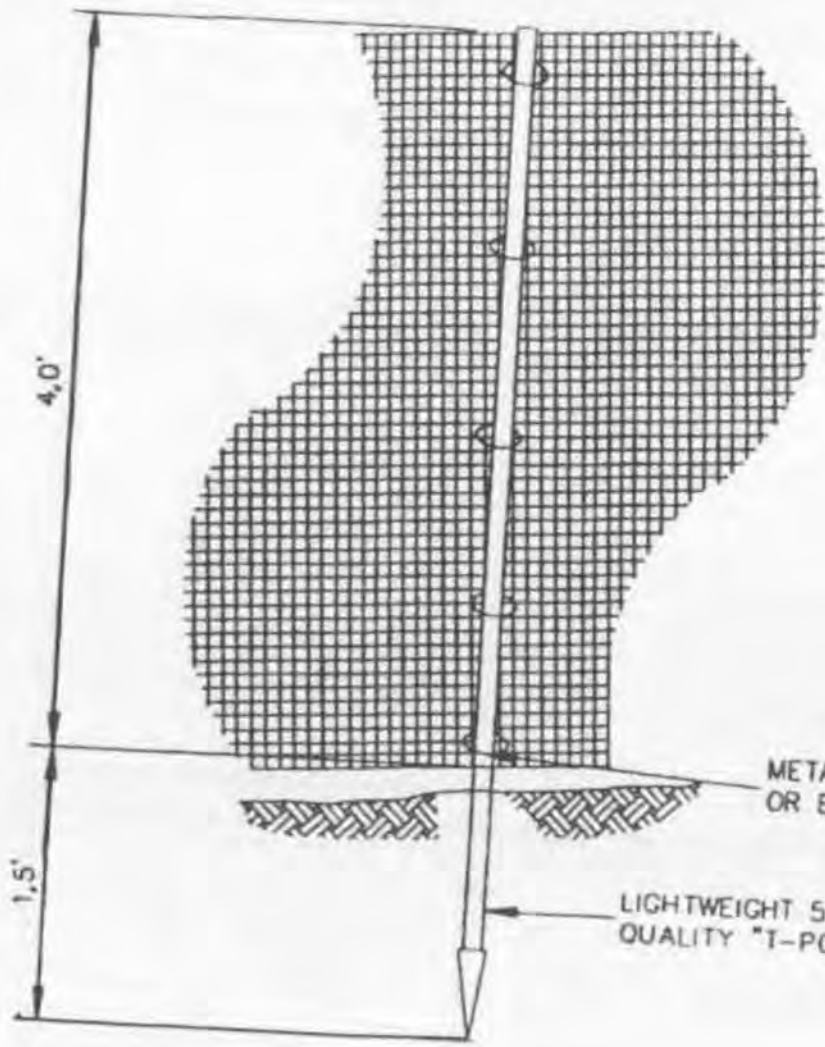
TREE FENCING DETAIL

NOTE:
 TENSOR LIGHTWEIGHT SAFTY GRID, ORANGE
 COLOR, BX226516, CUT OR FOLD AT POSTS
 AS NEEDED TO CONFORM TO SLOPING TERRAIN.

METAL TIE WIRE, FLIP TIE
 OR EQUIVALENT, 5 PER POST
