L'Auberge de Sonoma Hotel Rooms - Bay Area AQMD Air District, Annual

BIOLOGICAL RESOURCES ASSESSMENT
PROPOSED MACARTHUR HOTEL AND SPA REMODEL PROJECT
29 EAST MACARTHUR STREET
SONOMA, CALIFORNIA 95476

This Historic Resource Evaluation (HRE) has been prepared for the MacArthur Place Hotel and Spa at 29 E. MacArthur Street in Sonoma, California. The roughly five-acre property is situated on two parcels addressed 29 E. MacArthur Street (APN 1280-9100-500) and 20000 Broadway Street (APN 1280-8100-200) (**Figure 1**). For purposes of this report, the entire property will be referred to as 29 E. MacArthur Street. Across both parcels, the property contains a total of 20 buildings as well as a non-historic designed landscape. Of the existing buildings on the site, five buildings appear to be age-eligible (at least 50 years of age) for potential historic significance. The Burris House was evaluated for historic significance in 2001 and is currently an individual resource eligible for listing in the National Register of Historic Places.¹ Therefore, this HRE evaluates whether the Burris House retains sufficient historic integrity to remain eligible. Four additional age-eligible buildings hav

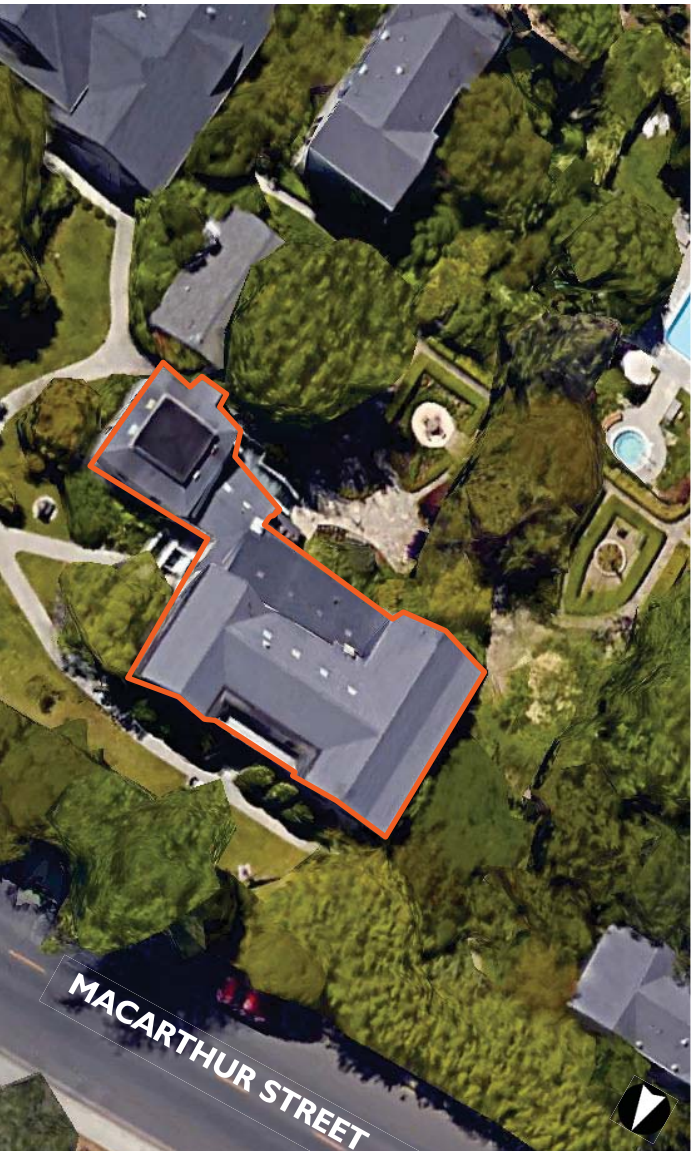
Figure 3: 3-D aerial imagery of Burris House. Orange outline indicates historic footprint of building ca. 1923 based upon Sanborn fire insurance maps. Source: Google Earth Pro, 2017. Edited by Page & Turnbull.

The Burris House is a two-story, wood frame residential building characteristic of the Italianate and Greek Revival architectural styles. The building has an estimated construction date of 1869 based upon previous historic evaluations. The building originally featured a H-shaped plan with a central gabled volume extending east-west and two cross-gabled end volumes extending north-south, with the west gabled volume extending slightly further southward than the east gabled volume (Figure 3). A two-story accessory building located southeast of the main residential building appears to have been used as a larder or other storage building originally, but was converted to residential use in 1999. This building appears to have been attached to the Burris House since at least 1923 according to available Sanborn fire insurance maps of the property. The Burris House is set back from the sidewalk adjacent to the south face of MacArthur Street approximately 33 feet and separated from the sidewalk by a wood picket fence and mature trees.⁷ A hedge row at the north façade substantially screens views of the historic resource from the street. The original designer of the building is not known, though the building appears to have been constructed by 1869 when David Burris and his family settled in Sonoma. During David Burris' ownership of the house, a one-story shed-roofed addition was added to the south to accommodate space for additional children in the family.⁸

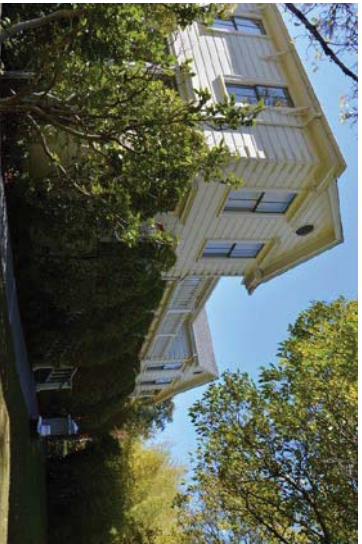
Figure 4: Primary (north) facade viewed from lawn to north of Burris House. Looking west.

The primary (north facade) is generally symmetrical in composition with a three-bay wide, recessed central volume flanked by two two-bay wide gabled volumes (**Figure 4**). The central three bays feature a balustraded porch at the first story, with a balustraded balcony directly above (**Figure 5** and **Figure 6**). A set of wood steps placed at the center of the primary facade is framed with wood posts and railings. The steps lead from ground level to the first story porch. The steps do not, however, center on the main entrance. Rather, the central three bays of the primary facade contain from east to west a standard window, standard window aligned with steps to the porch, and the main entrance. The main entrance features similar wood molding as the windows along the primary facade and contains a paneled wood door with a transom (**Figure 7**).

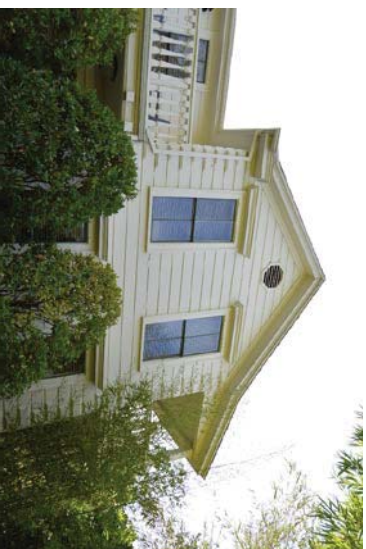
Figure 9: West gabled volume at primary (north) façade with stacked porch of west façade visible. Looking south.

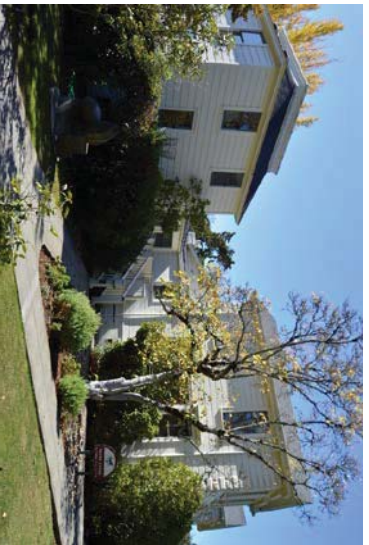
Figure 10: Main residential volume, one-story hyphen, and attached two-story converted larder building. Looking west.

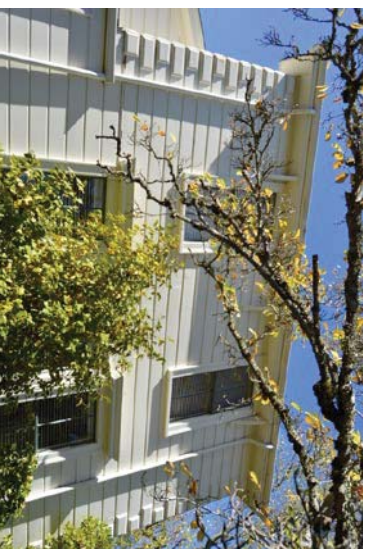
Figure 11: West façade at main residential volume. Rusticated quoins pictured at north and south end of façade. Looking west.

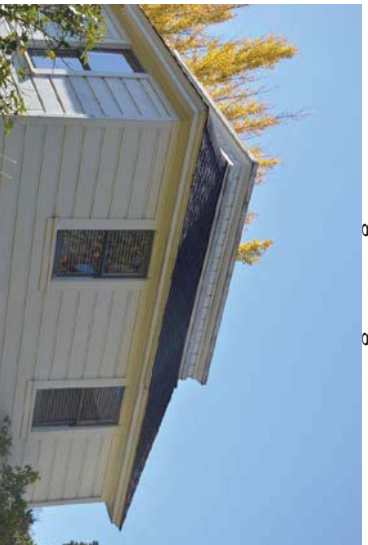
Figure 12: Central flat-roofed portion of converted larder building indicating former location of windmill. Looking southwest.

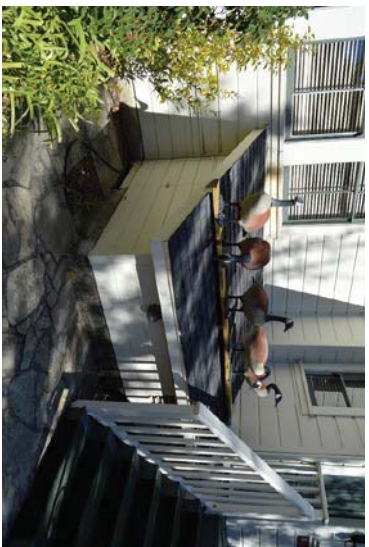
Figure 16: Rear cellar access with shed roof attached to rear facade. Looking northeast.

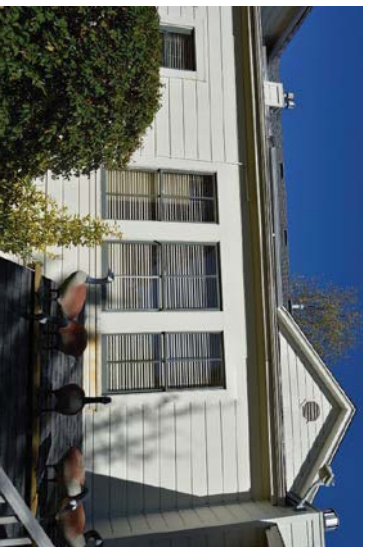
Figure 18: Rear, one-story addition added to Burris House to accommodate Burris' growing family in late 1800s. Looking north.

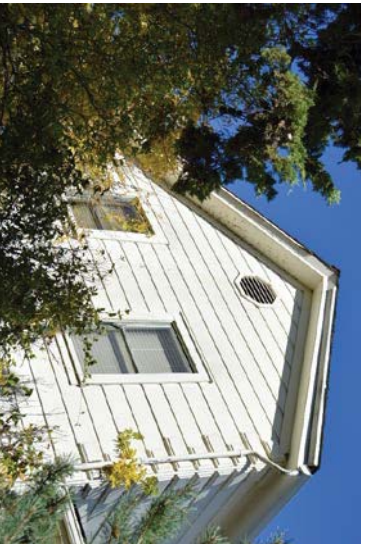
Figure 19: One-over-one double-hung windows at southwest gable end. Former location of brick chimney. Gable vent non-original. Looking northwest.

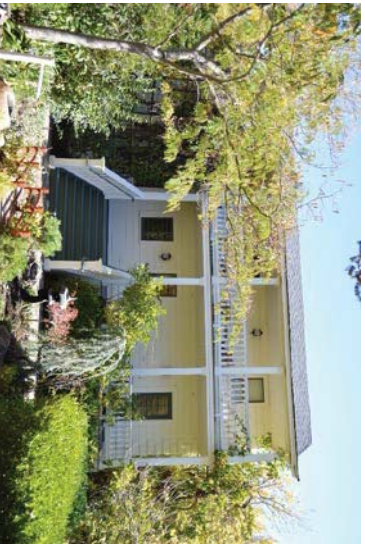
Figure 20: West façade with stacked porch. Wood balustrade at each story and wood stairs leading from ground level to first story. Looking east.

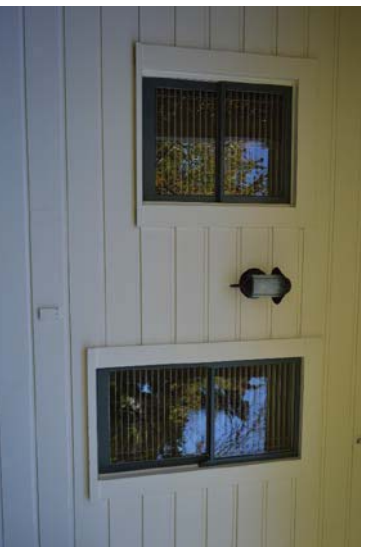
Figure 23: Typical one-over-one, wood-sash windows found at west and south façades (not visible from street) of Burris House. Looking east.

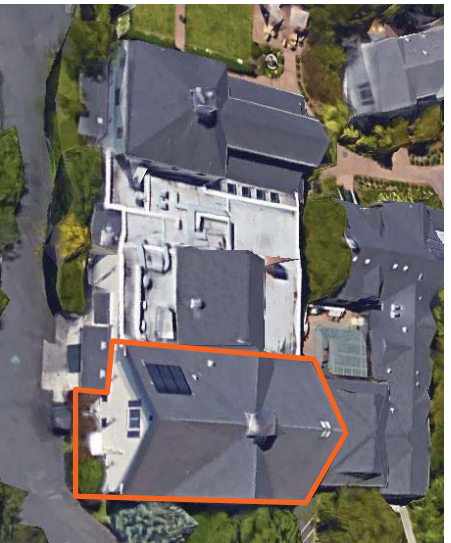
Figure 24: 3-D aerial imagery of former barn building. Original massing of building indicated with orange line. Source: Google Earth Pro, 2016.

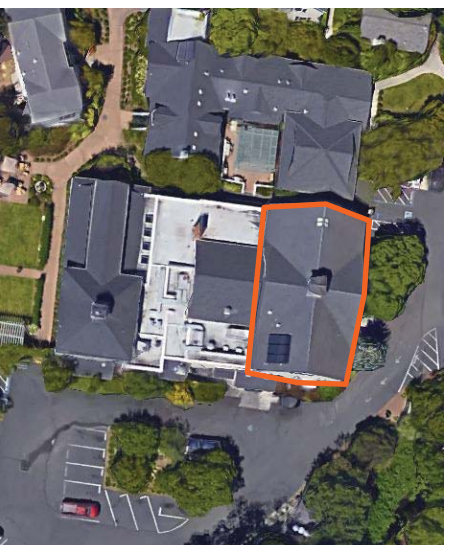
Figure 25: Additional 3-D aerial imagery of former barn building. Approximate footprint of original building indicated with orange line. Source: Google Earth Pro, 2016.

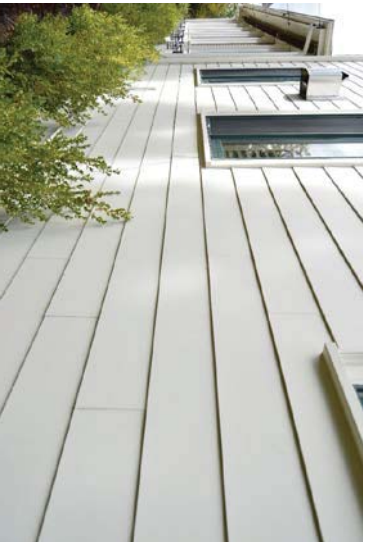
Figure 31: View of Masonite siding along south facade of barn. Typical cladding material found on non-original portions of barn. Looking west.

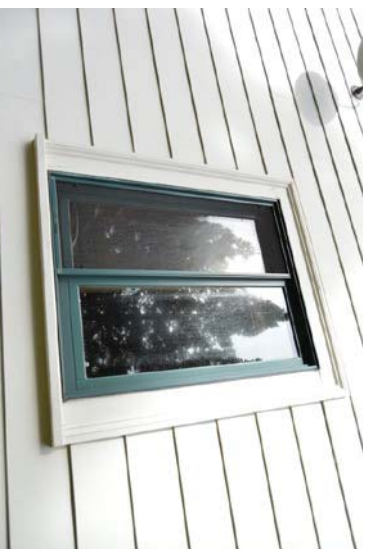
Figure 32: Typical siding, aluminum casement window located at several locations around barn.

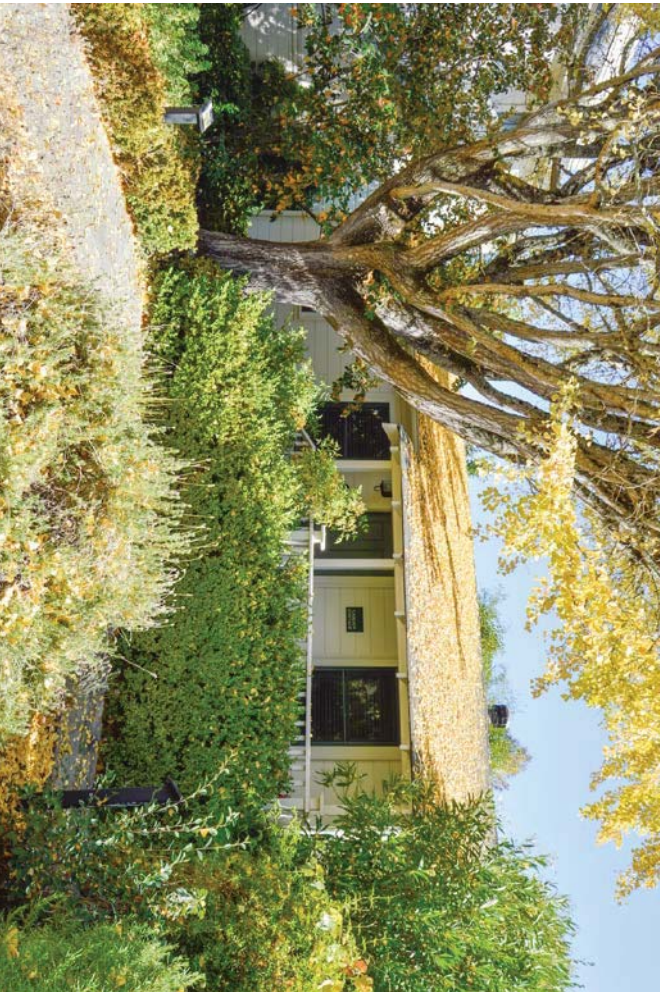
Figure 34: Primary (west) facade of former caretaker's cottage with cave extension over covered porch. Primary façade fenestrated with replacement one-over-one wood-sash windows. Looking east from central garden.

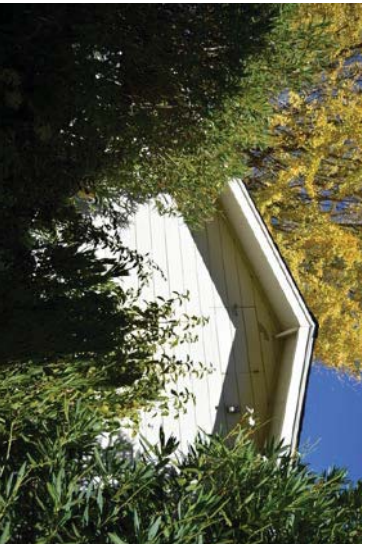
Figure 35: South gable-end with wood fascia and soffit. Looking north.

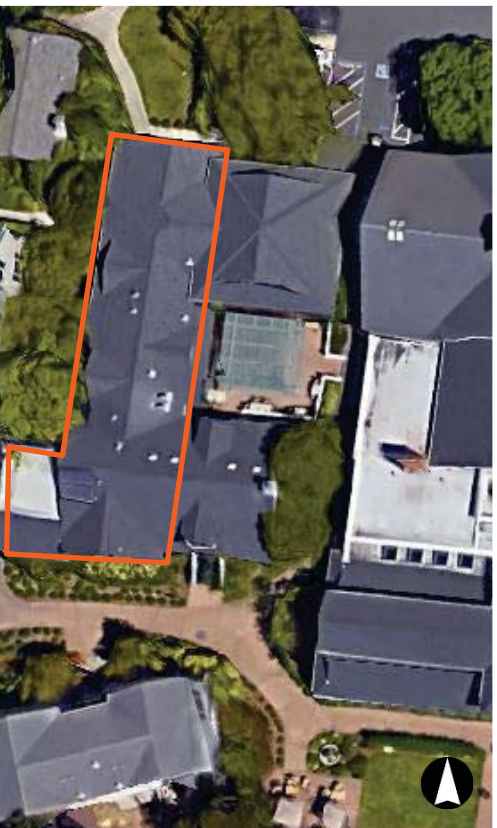
Figure 42: 3-D aerial imagery of former garage/carpport. Orange line indicates approximate footprint of original building. Source: Google Earth Pro, 2017.

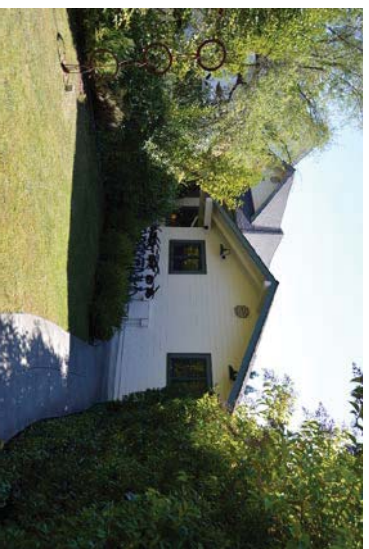
**Figure 44: Gable-roofed volume original to
former garage building. Looking south.**
