**PHASE I  
ENVIRONMENTAL SITE ASSESSMENT**

**200 ELEVATOR STREET  
WILLIAMSTON, MICHIGAN**

**SME Project Number LE48674  
December 20, 2004**

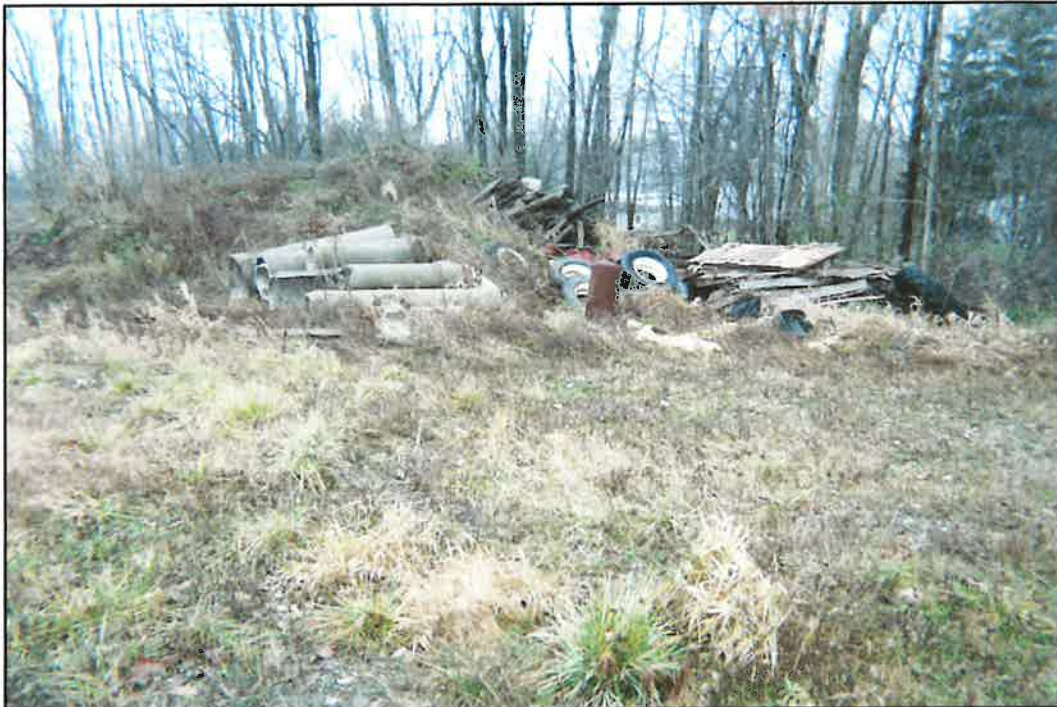
During SME's Property walkover, SME observed a soil pile containing miscellaneous debris, tires, concrete and pipes located on the southwest corner of the property. Piles of wood, stone, brick and tires were observed in the vicinity of the storage shed. SME observed no staining or stressed vegetation around the soil/debris piles. According to Mr. Howe the soil/debris piles, came from the Property, therefore in SME's opinion the soil/debris piles are not considered a REC in connection with the Property.

**PHOTO NO. 3: Soil/debris pile located on the southwest corner of the property.**

SME recommends the debris identified be removed and properly disposed from the Property and that if staining and/or odors are identified, we return to the site to scan the ground surface with a photoionization detector (PID) for evidence of volatile organic vapors, and perform a visual assessment for evidence of soil impact (i.e., soil staining or odors). With regard

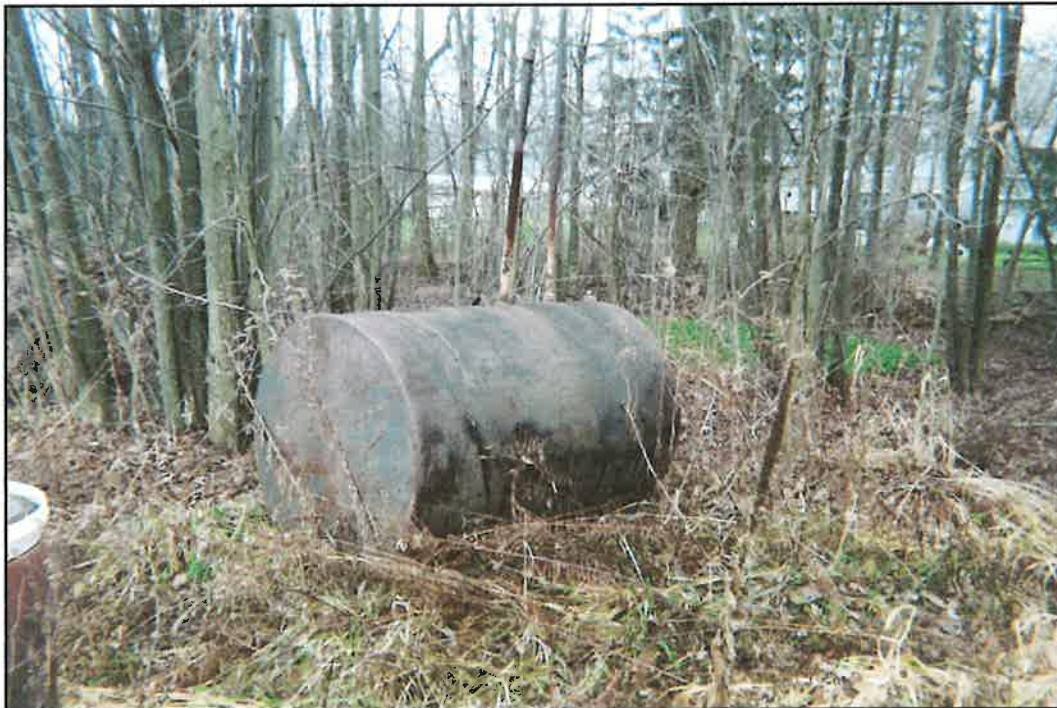
**PHOTO NO. 4: Former UST located on the southwest portion of the property.**

Due to the historical use of the Property as an elevator, it is possible that the concrete pads were used for silos to store grain. No staining was noted on or around the concrete pads. Therefore, in SME's opinion the concrete pads do not represent RECs in connection with the Property. SME also observed a former 500-gallon UST, setting on the ground surface, located on the southwest corner of the Property. SME observed no staining around the UST. According to Mr. Howe, the UST came from another site and is stored on the Property. In SME's opinion the UST is not a REC in connection with the Property since it came from another site. However, SME recommends proper removal and disposal of the UST prior to purchase of Property.

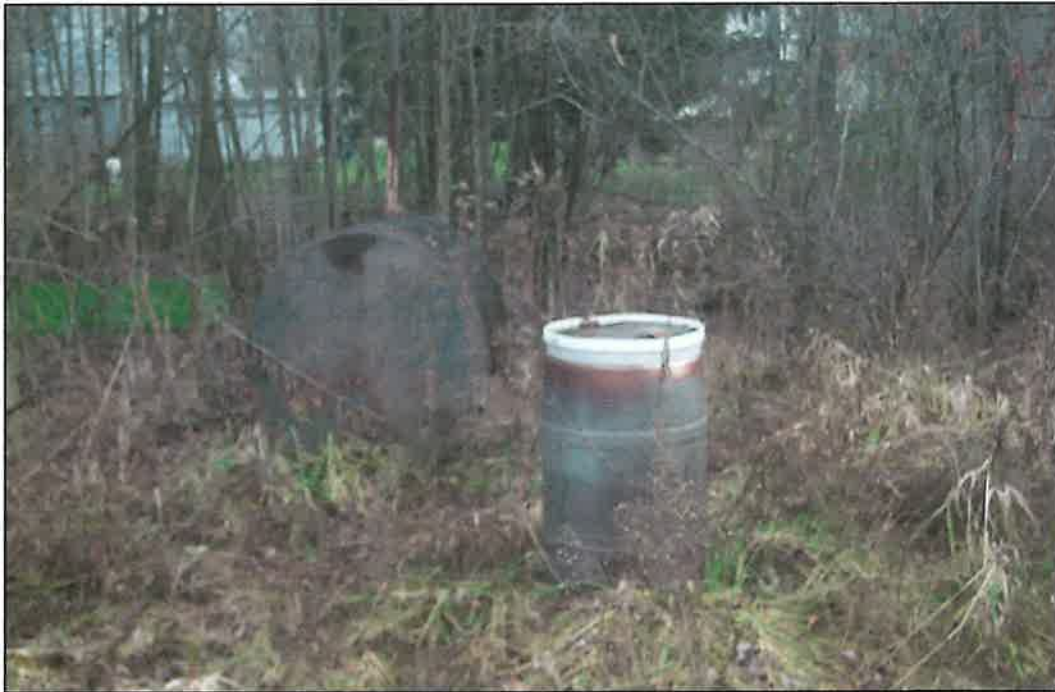
During the Property walkover, SME observed a 55-gallon drum, full of an unidentified substance, located on the southwest portion of the Property. SME observed no staining around the 55-gallon drum. According to Mr. Robert Howe, owner of the Property, the 55-gallon drum came from another site. SME observed two empty 55-gallon drums located on the northeast portion of the Property. According to Mr. Howe the 55-gallon drums were used for the haunted house located in the basement of the barn. SME also observed bottles of Hog Mange located on the second floor of the barn. According to Mr. Howe the hog mange was left over from when the barn was used as an elevator. In SME's opinion, the storage/presence of these materials is considered a *de minimis* condition and does not represent a REC in connection with the Property. However, SME recommends proper removal and disposal of these materials prior to the purchase of the Property.

**PHOTO NO. 5: A 55-gallon drum located on the southwest portion of the property.**

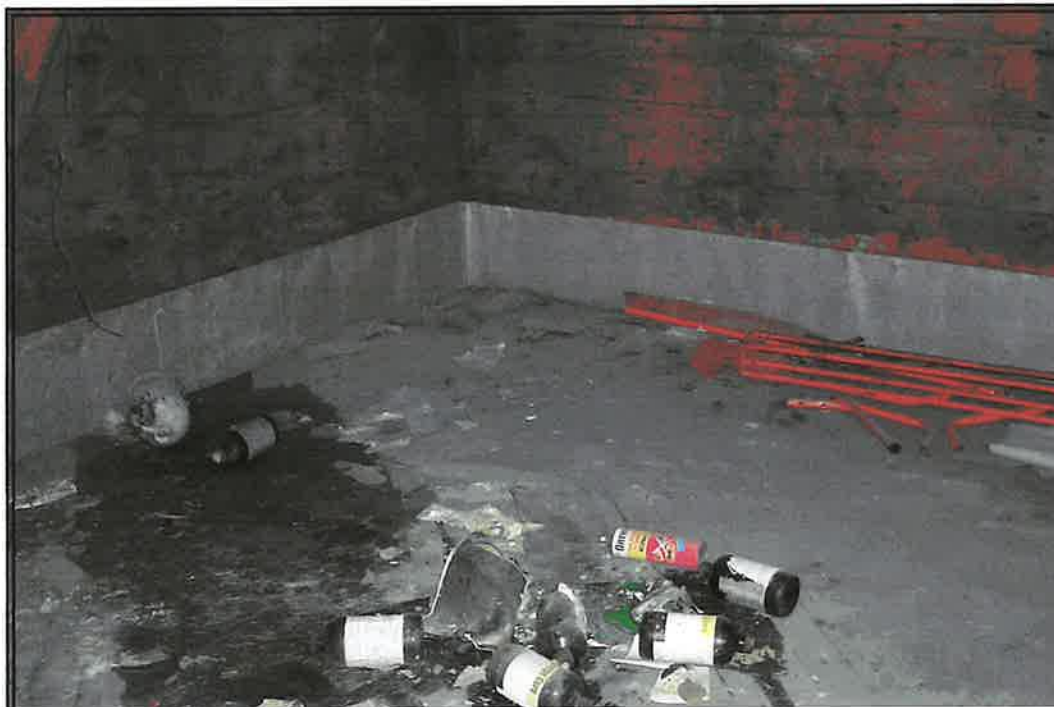
**PHOTO NO. 8: Bottles of hog mange located on the second floor of the Elevator building.**

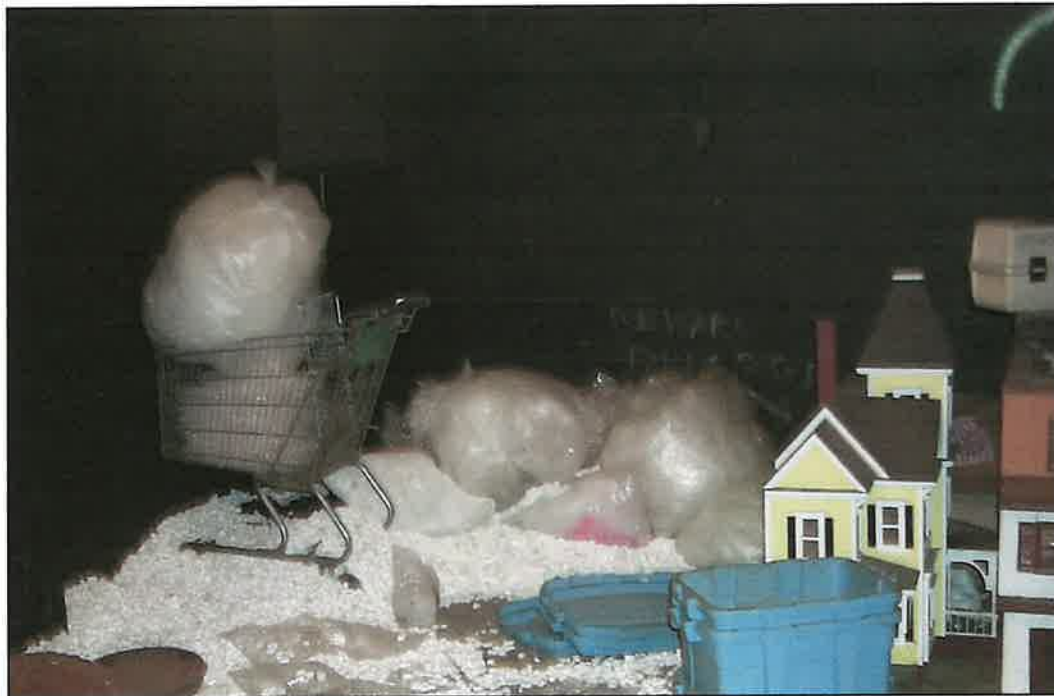
**PHOTO NO. 10: Garbage/debris located on the 1<sup>st</sup> floor of the Elevator building**

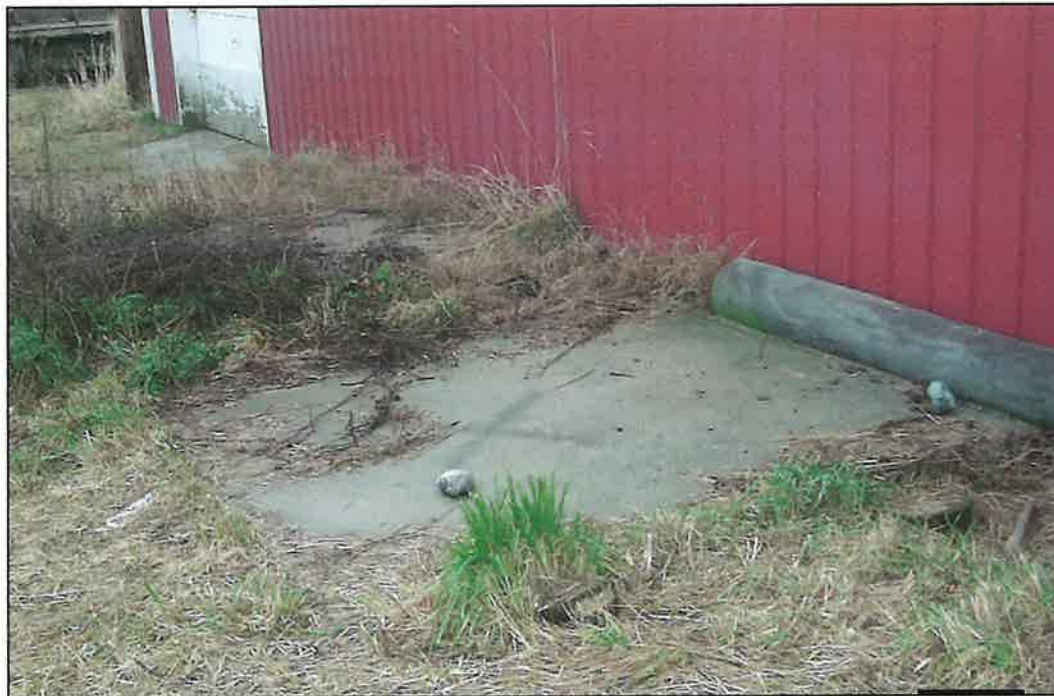
SME observed no visual evidence of underground storage tank systems (USTs) such as fill ports, vent pipes, dispensers, or areas of replaced pavement during the Property walkover. However, SME did observe three concrete pads for unknown purposes surrounding the barn.

**PHOTO NO. 14: Two concrete pads located on the east side of the Elevator building.**

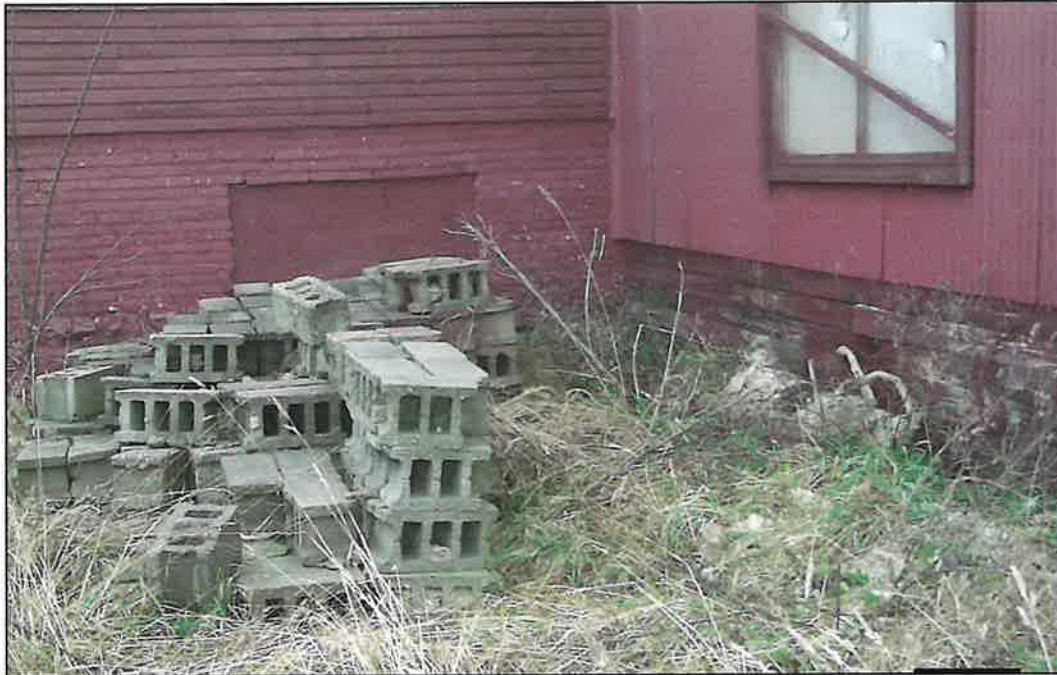
**PHOTO NO. 15: Pile of discarded bricks located on the south side of the Elevator building.**
