The First Campaign of Construction, Summer-Fall 1833

Source: *The First Mormon Temple: Design, Construction, and Historic Context of the Kirtland Temple*

The First Campaign of Construction, Summer–Fall 1833

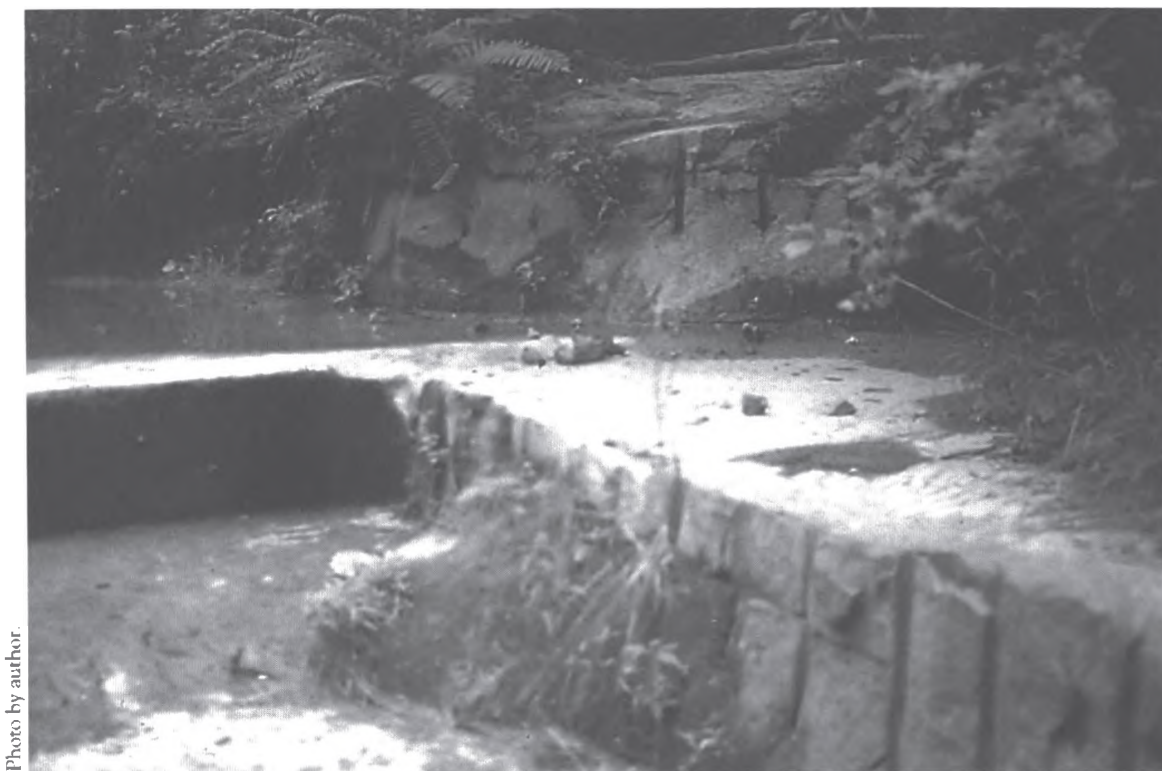
Fig 3-2. Stannard Quarry, Lake County Metroparks, Kirtland. The neat, regular excavation markings probably date from later quarrying activities.

miles south of the building site. Though not deep, this quarry consists of a sandstone bed exposed by the small stream running over it (fig. 3-2). The neat, regular drilling holes still visible in the quarry probably do not date from the Mormon excavations, for the majority of the stone in the temple walls is far more irregular in shape. Workers most likely used wedges to split out irregular blocks of stone along natural fissures.

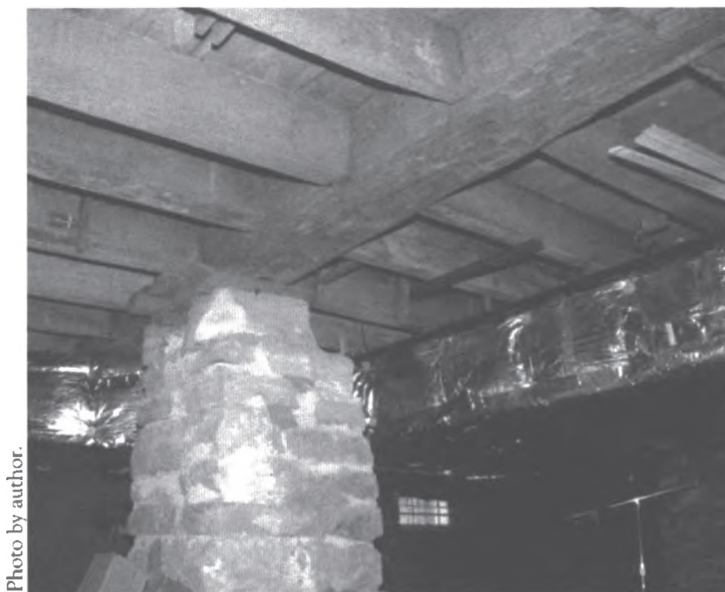
Fig 3-3. Detail of girder and pier supporting floor of lower court. Also visible are the masonry pier supporting the girder and joists framing into the girder. Modern additions include the insulated ductwork.

The orientation of the girders also reveals the workers' lack of experience constructing large buildings. The girders have a scantling, or cross section, of about nine inches by twelve inches oriented flatwise—that is, with

the twelve-inch dimension horizontal and the nine-inch dimension vertical. This orientation cuts the bending strength nearly in half compared to that of a vertically oriented girder.¹¹ This construction practice is typical of the eighteenth century, as builders preferred leaving substantial beam widths in order to accommodate mortises, or joist pockets, which were carved into the sides of the beam. This practice was also adequate for residences, which typically have smaller spans and floor loads than public assembly buildings.

However, with the building designed to house large public assemblies and with the span between support piers close to twenty-five feet, the horizontal orientation of support girders is woefully inadequate.

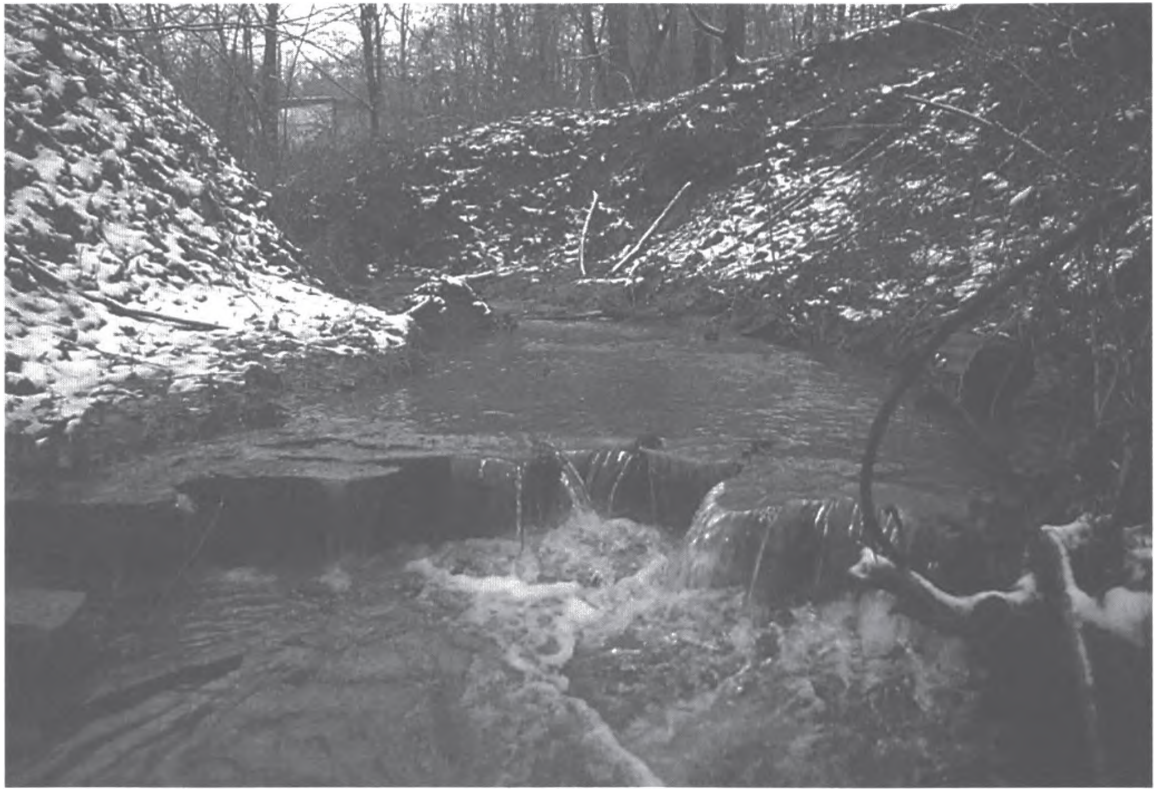
Fig 3-5. Russell Quarry in Kirtland. The regular bedding planes and exposed sandstone bed would have enabled roughly rectangular stones to be quarried with a minimum amount of effort. This site is one of several on the Russell property.

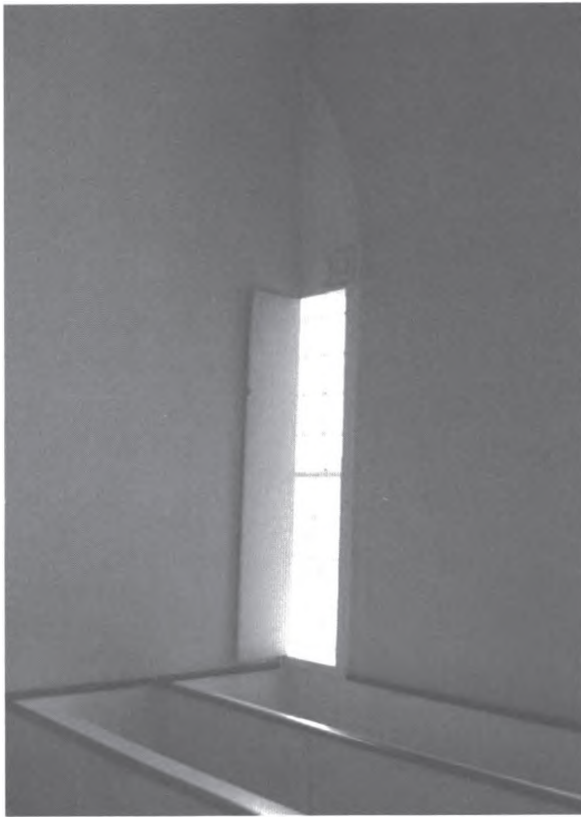
Fig 3-9 . Interior detail, upper court, showing the vestibule wall intersecting a window.

In addition to adding structural stress, this uneven bay spacing causes the vestibule wall that separates the stairs from the lower and upper courts to cut awkwardly through a window opening (fig. 3-9). On the lower floor, raised choir seats in the corner would have further interfered with the window opening in the eastern corners. Later restorers simply chose to cover the window, boxing it in so it lights only the vestries (the small rooms located under the stairs). However, early descriptions indicate that

the lower-court window was originally treated like that in the upper court, with an awkwardly shaped portion of the window peering into the corner of the room.²⁶
