Inspection Details	
Year	2007
Make	Bobcat
Model	S130
Date of Inspection	05/15/2024
Location of Inspection	15151 Airline Hwy, Baton Rouge, LA, 70817
VIN/Serial Number	529217179
Cylinders	See Notes
Engine Hours	2,865
EMS Warning Lights	No Active Warnings
Travel Control	See Notes
Operator's Seat	See Notes
Mirrors	N/A
Radio	No
A/C	No
Steering Wheel	N/A

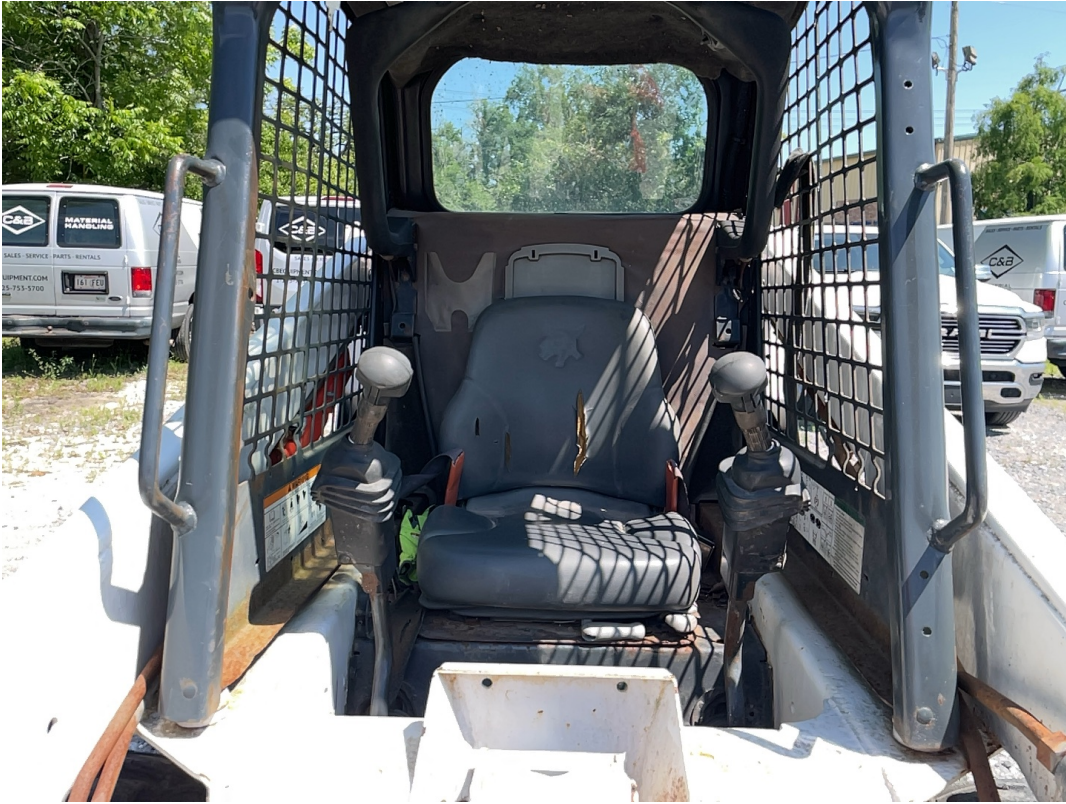
Cab Interior / 05-15-2024

cab entry lower metal is pitted and has some rust showing. The top window metal frame on the ceiling in the cab is rusty. There appears to be a switch missing on the front upper console. The front upper console plastic appears to be coming apart. The headliner is falling down in the cab. The right hand control rubber grip appears to be torn. The rooftop glass is scratched. The engine oil appears to be dark in color and above the full mark on the dipstick. The lift cylinders are leaking. The hydraulic metal lines on the boom arms are rusty. The auxiliary hydraulic fittings on the left boom arm are rusty. The front right of the cab is bent and dented by the work light. The rear door has paint worn off of it. The front left tire is cracking on the sidewall, and the treads are cut, gouged, and below 50%. The front left wheel has small dents in the lip. The rear left tire is cracking on the sidewall, and the treads are cut, gouged, and below 50%. The front right tire is cracking on the sidewall, and the treads are cut, gouged, and below 50%. The rear right tire is cracking on the sidewall, and the treads are cut, gouged, and below 50%. The rear right axle is oily, and the seal could possibly be leaking. The backup alarm is not operational. The bucket tilt pins sound like they need to be greased.

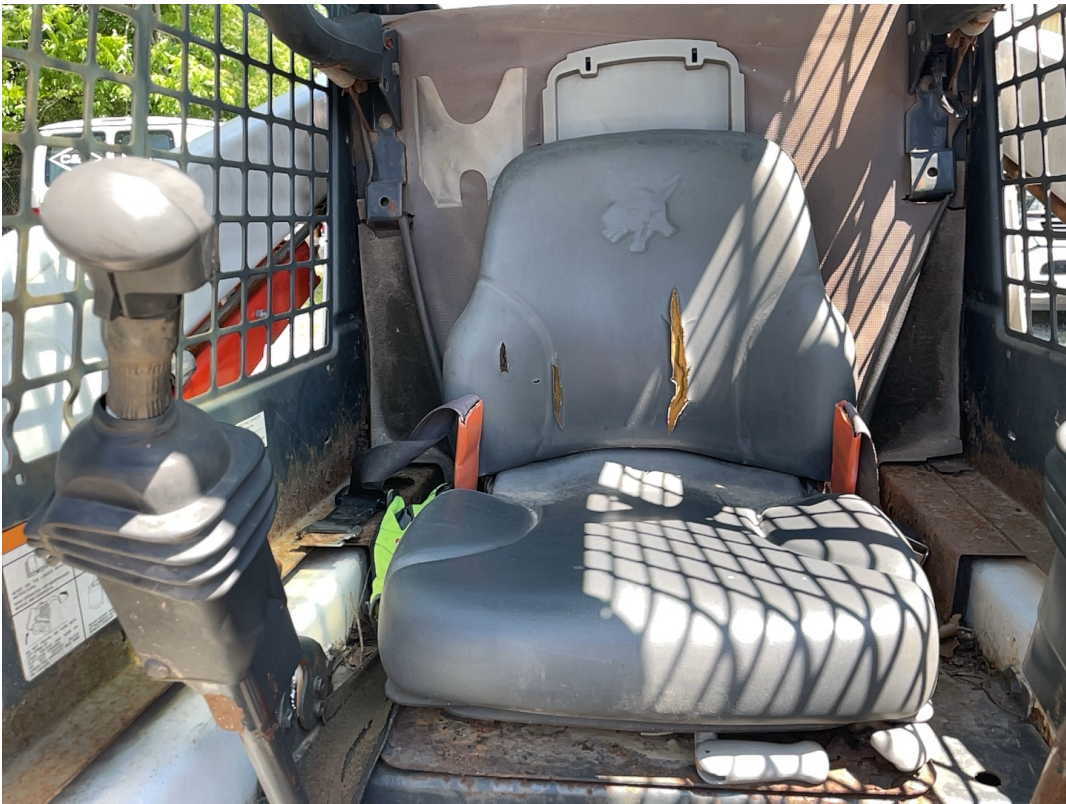
Operator's Seat / 05-15-2024

Rear Right Tire Size	10-16.5
Rear Right Tire Tread Depth Measurement	5/32"
Attachments - Bucket	See Notes
Cab Interior	See Notes
Comments	The horn is not operational. The front left and rear left wheels are missing lug bolts and nuts. The inside cab rails are rusty on both sides. The bottom seat base is rusty. The operator's manuals are missing. The operator's seat material is torn on the backrest. The material is coming off the wall behind the operator's seat. The lower rubber boots on the hand controls are torn. There are exposed wires crossing the center of the floorboard. The

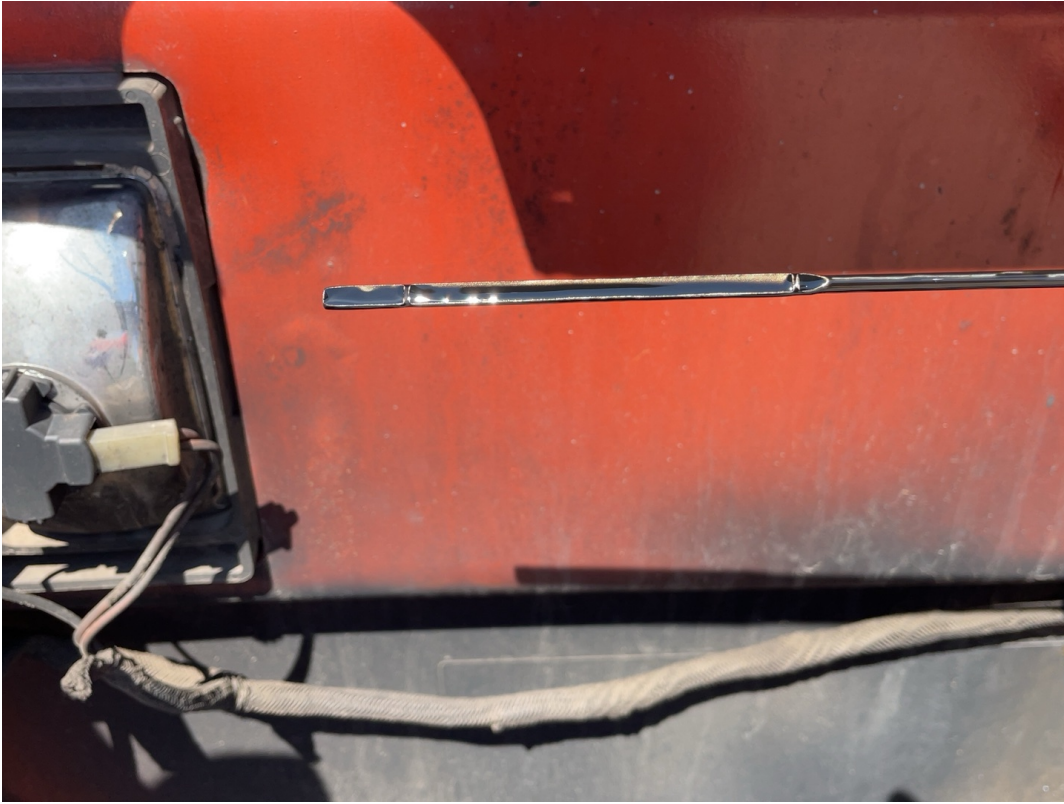
Oil Dipstick / 05-15-2024

Inspection Details Cont'd	
Pedals	No Damages Observed
Floorboard	See Notes
Power Mirrors	No
Heated Mirrors	No
Switches and Controls	See Notes
Steps	No Damages Observed
Handrails	No Damages Observed
Oil Dipstick	High Level / Dark Color
Engine Compartment	No Damages Observed
Exhaust	Single - No Damages Observed
Axles	No Damages Observed
Deluxe Instrumentation	No
Backup Camera	No
ROPS	No Damages Observed
Front Lights	No Damages Observed
Rear Lights	No Damages Observed
Front Left Tire Condition	See Notes
Front Left Tire Brand	Loadmax
Front Left Tire Size	10-16.5
Front Left Tire Tread Depth Measurement	2/32"
Rear Left Tire Condition	See Notes
Rear Left Tire Brand	Loadmax
Rear Left Tire Size	10-16.5
Rear Left Tire Tread Depth Measurement	2/32"
Front Right Tire Condition	See Notes
Front Right Tire Brand	Loadmax
Front Right Tire Size	10-16.5
Front Right Tire Tread Depth Measurement	4/32"
Rear Right Tire Condition	See Notes
Rear Right Tire Brand	Loadmax
