Inspection Details	
Year	2017
Make	Caterpillar
Model	239D
Date of Inspection	03/19/2024
Location of Inspection	7421 Highway 5, Nauvoo, AL, 35578
Serial Number	CAT0239DLBL901671
Cylinders	See Notes
Engine Hours	1,620
EMS Warning Lights	No Active Warnings
Travel Control	No Damages Observed
Operator's Seat	No Damages Observed
Mirrors	No Damages Observed
Radio	No
A/C	No
Steering Wheel	N/A

Aspen Field Services

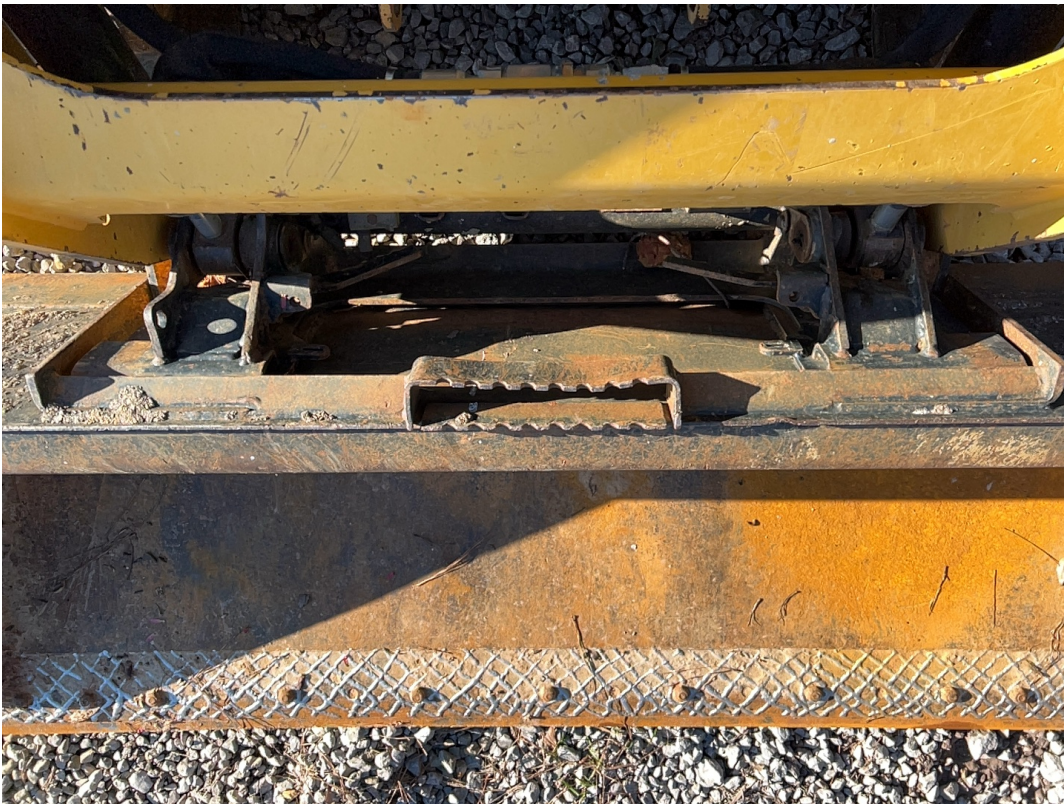
Steps / 03-19-2024

Inspection Details Cont'd	
Pedals	No Damages Observed
Floorboard	No Damages Observed
Power Mirrors	No
Heated Mirrors	No
Switches and Controls	No Damages Observed
Steps	See Notes
Handrails	See Notes
Oil Dipstick	Good Level / Good Color
Engine Compartment	See Notes
Exhaust	Single - See Notes
Axles	N/A
Deluxe Instrumentation	No
Backup Camera	No
ROPS	No Damages Observed
Front Lights	No Damages Observed
Rear Lights	No Damages Observed
Left Track Condition	No Damages Observed
Left Track Brand	Trek
Left Track Size	320X86BX49
Left Track Tread Depth Measurement	1"
Right Track Condition	See Notes
Right Track Brand	Trek
Right Track Size	320X86BX49
Right Track Tread Depth Measurement	1"
Attachments - Bucket	No Damages Observed
Cab Interior	See Notes
Comments	The rear door paint is scratched, and the door grille has dents in it. The exhaust tip is turned to the right. The upper top glass is faded. The bucket step is bent. The entry step is bent. The coolant level is low in the reservoir. The pins and bushings from the tilt cylinder rod ends to the coupler appear to be worn out and have gaps. The hydraulic hose on the bottom of the bucket has cracked rubber. The lift cylinders appear to be oily and possibly leaking. The front left grab handle is bent. The electrical plug on the left loader arm is missing its cover, and the retainer plate for the plug is bent. The front lower part of the cab has paint chipping. The headliner has some staining. The tilt cylinders have some paint chipping on them. The right track appears to have a cut in the tread lug.
