**USF NORTH PROPERTY**  
**TAMPA, FLORIDA**  
**ECOLOGICAL ASSESSMENT REPORT**

Prepared For:  
The University of South Florida

Prepared by:  
Timothy L Neldner, PWS  
Heidt Design, LLC

October 2021

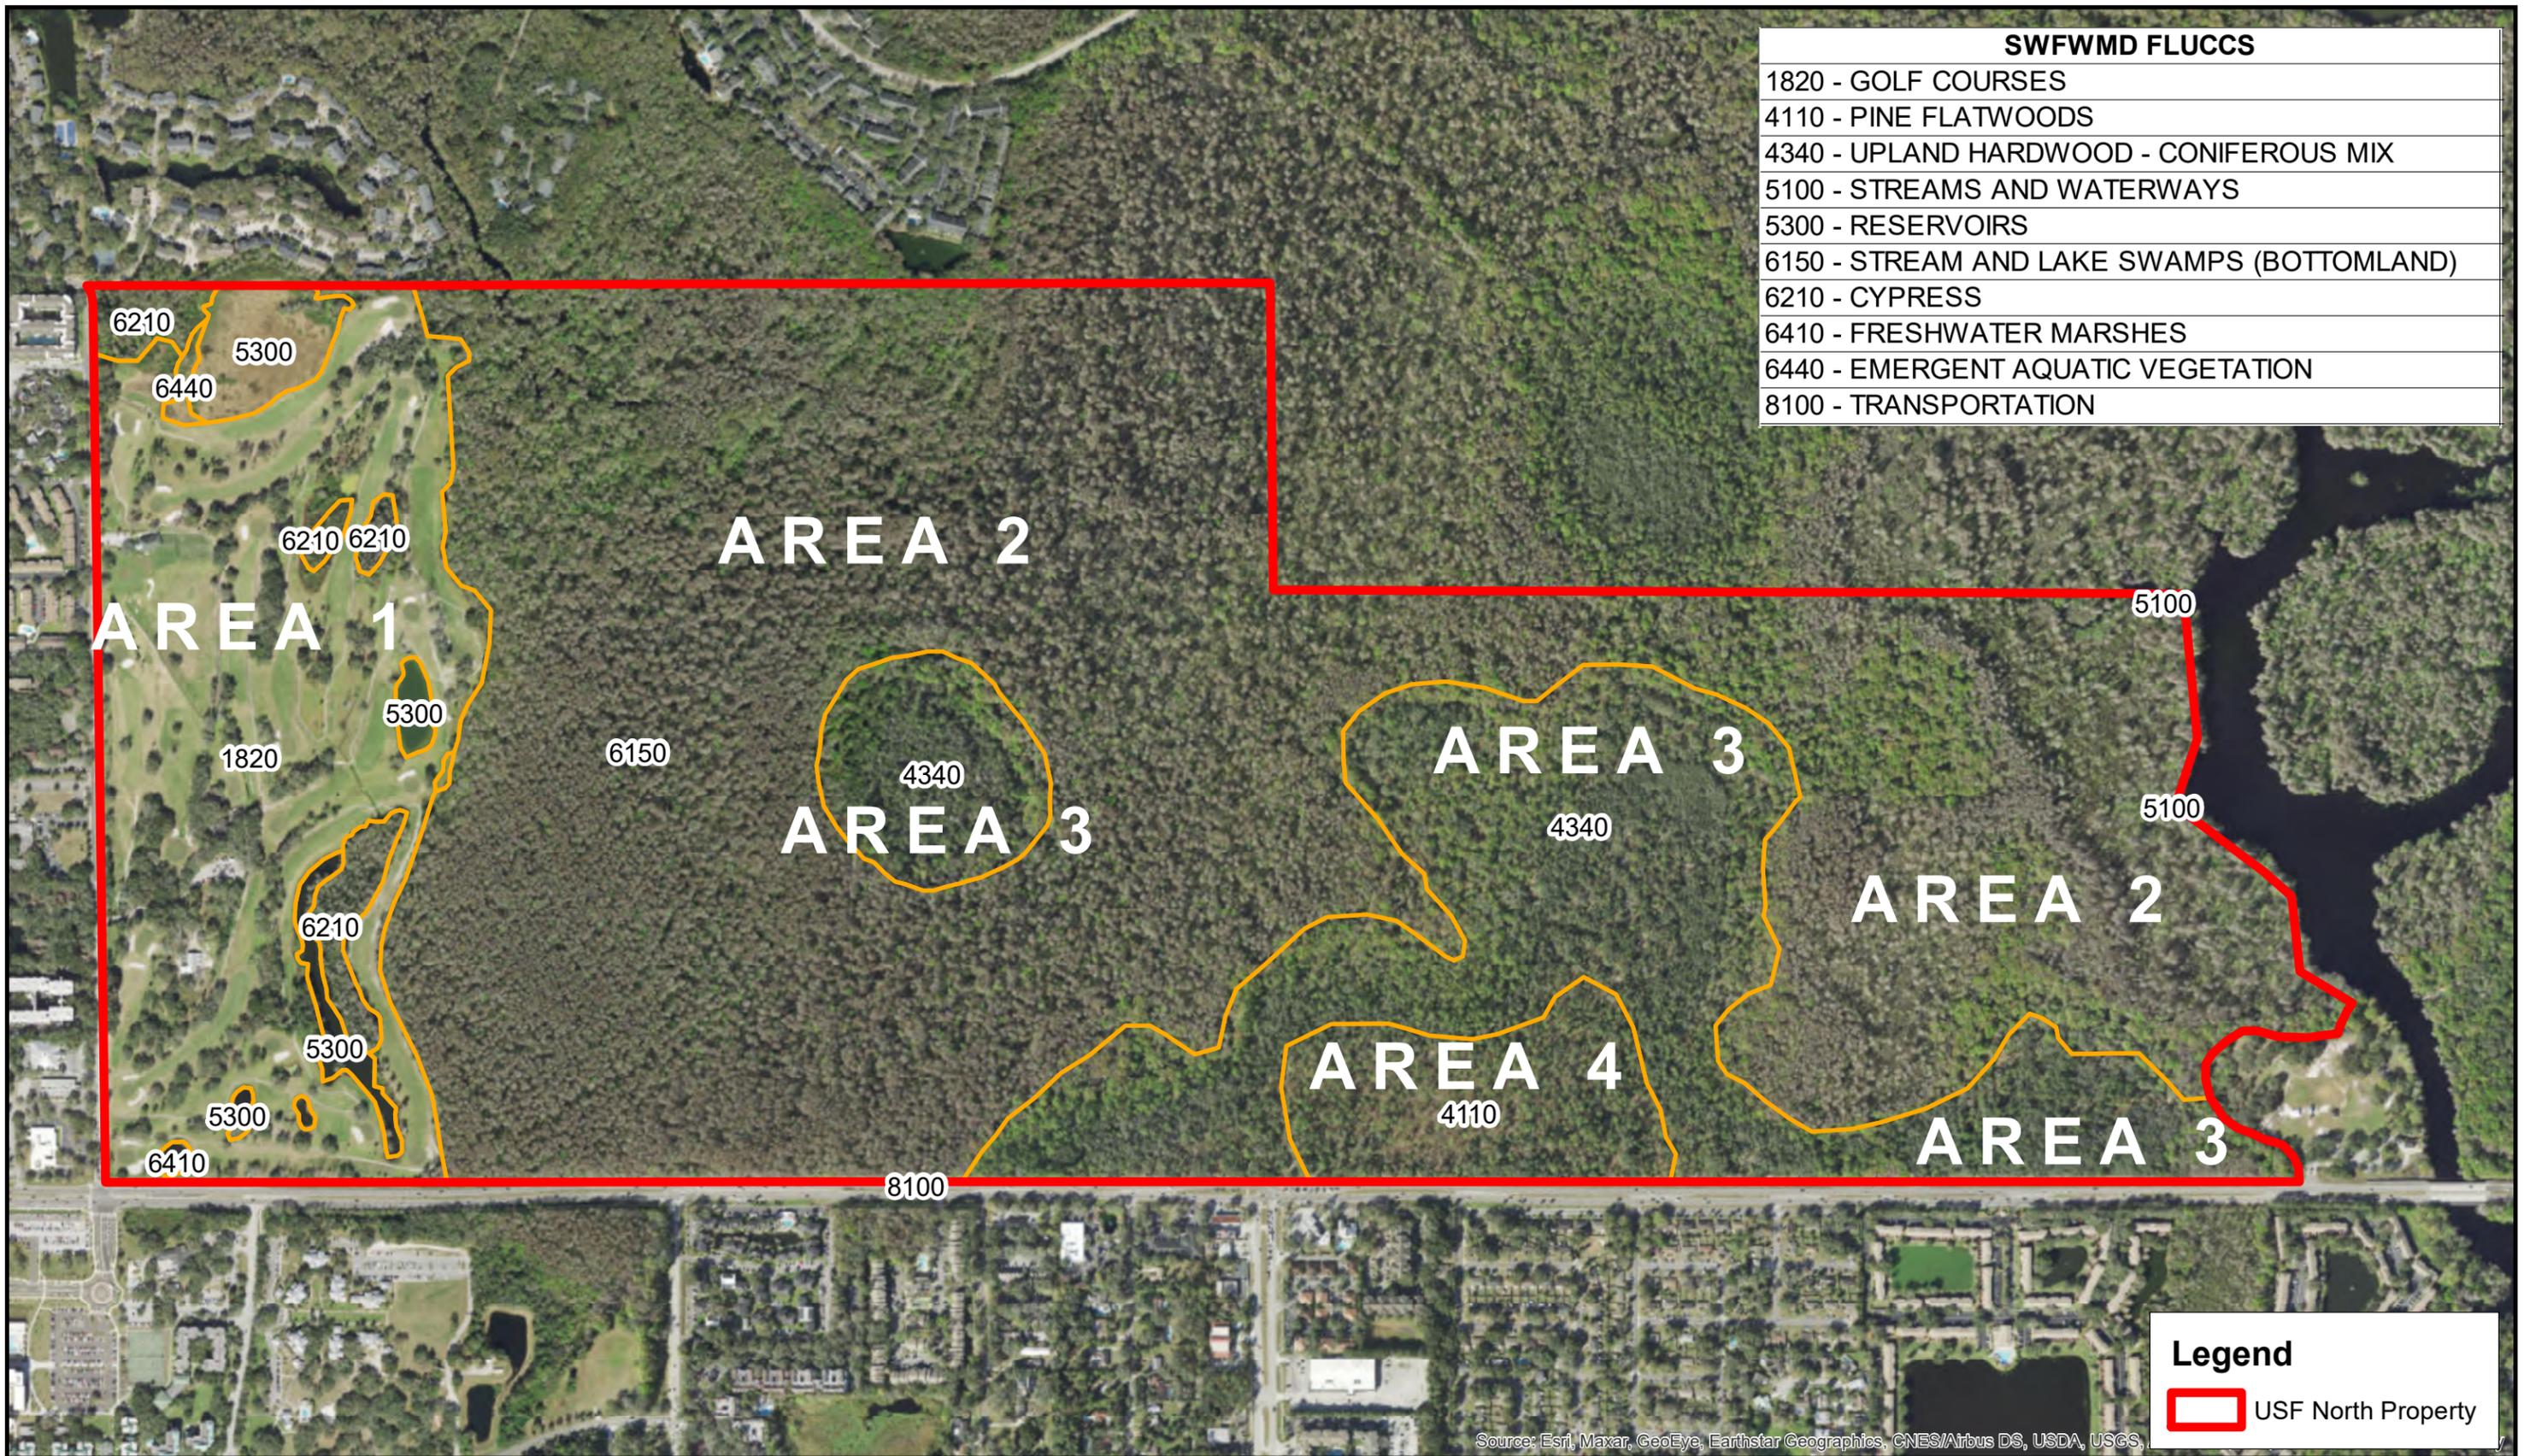
**USF North Property**  
 Potential Use Areas

SWFWMD FLUCCS	
1820	- GOLF COURSES
4110	- PINE FLATWOODS
4340	- UPLAND HARDWOOD - CONIFEROUS MIX
5100	- STREAMS AND WATERWAYS
5300	- RESERVOIRS
6150	- STREAM AND LAKE SWAMPS (BOTTOMLAND)
6210	- CYPRESS
6410	- FRESHWATER MARSHES
6440	- EMERGENT AQUATIC VEGETATION
8100	- TRANSPORTATION

The Property can be divided into four areas to discuss its potential use (Potential Area Use Map). These areas are assessed based on their differing ecological conditions and regulatory constraints. The Property is under the regulatory purview of the City of Tampa (City), Hillsborough County (County) and the Southwest Florida Water Management District (SWFWMD). Both the County and the City provide utility service to the Property. Wetland impacts are regulated by the Environmental Protection Commission of Hillsborough County (EPC) and the SWFWMD with the Florida Department of Environmental Protection (FDEP) having additional regulatory authority over impacts to Waters of the US. Impacts to listed species are regulated by the Florida Fish and Wildlife Conservation Commission (FWC) for State-listed species and by the US Fish and Wildlife Service (USFWS) for federally listed species.

Area 1, the golf course, is a likely parcel for development because of its past and current intensively managed land use and its proximity to the rest of the University campus and existing infrastructure including transportation corridors and utilities. The area could likely be properly entitled and permitted for residential, commercial and/or mixed-use development.

The existing ecological and physical conditions of Area 2 and the detailed regulatory review required for any proposed impacts to the existing habitats are significant constraints to any development within Area 2. The time and expenditures for pursuing authorizations from the regulatory agencies plus the cost of construction make the area unfeasible for improvements beyond minimally intrusive activities, such as elevated boardwalks and observation platforms. However, the ecological and physical conditions in Area 2 may be an opportunity for use as a wetland mitigation bank through a protective covenant or encumbrance such as a conservation easement, or as a desirable property for acquisition by a State or local conservation lands program.

Areas 3 and 4 are upland areas that abut a major roadway corridor. These uplands could likely be developed in a manner that is consistent with surrounding uses after appropriate entitlements are acquired and required permits are obtained.

Areas 3 and 4 are the forested upland habitat (represented by FLUCCS codes 4340 and 4110, respectively, on the Potential Area Use Map) immediately east of Area 2 along Fletcher Ave including the isolated hammock within Area 2. Area 4, the more well-drained and higher pine flatwoods habitat, is entirely surrounded by Area 3, the mesic oak/pine habitat. As Areas 3 and 4 are upland areas abutting a major roadway corridor, it is likely that typical development could be entitled on the parcels for uses that would be compatible with the surrounding areas. The appropriate regulatory agencies would review the drainage and construction design similarly as in Area 1, while other agencies would require the relocation of any gopher tortoises adversely affected by the proposed development. Similar to the potential wetland mitigation banking option in Area 2, Areas 3 and 4, whether all or in part, could be used as a conservation bank. Conservation banks are established to benefit upland wildlife and most specifically listed species that are impacted through development within their habitat. The State and federal wildlife agencies provide the authorization and establishment of credits through their regulatory processes for conservation banks. The conservation banks then sell these credits to permit applicants whose projects require this type of mitigation. The banker can establish the credit price as is deemed appropriate, certainly considering what the market will bear.

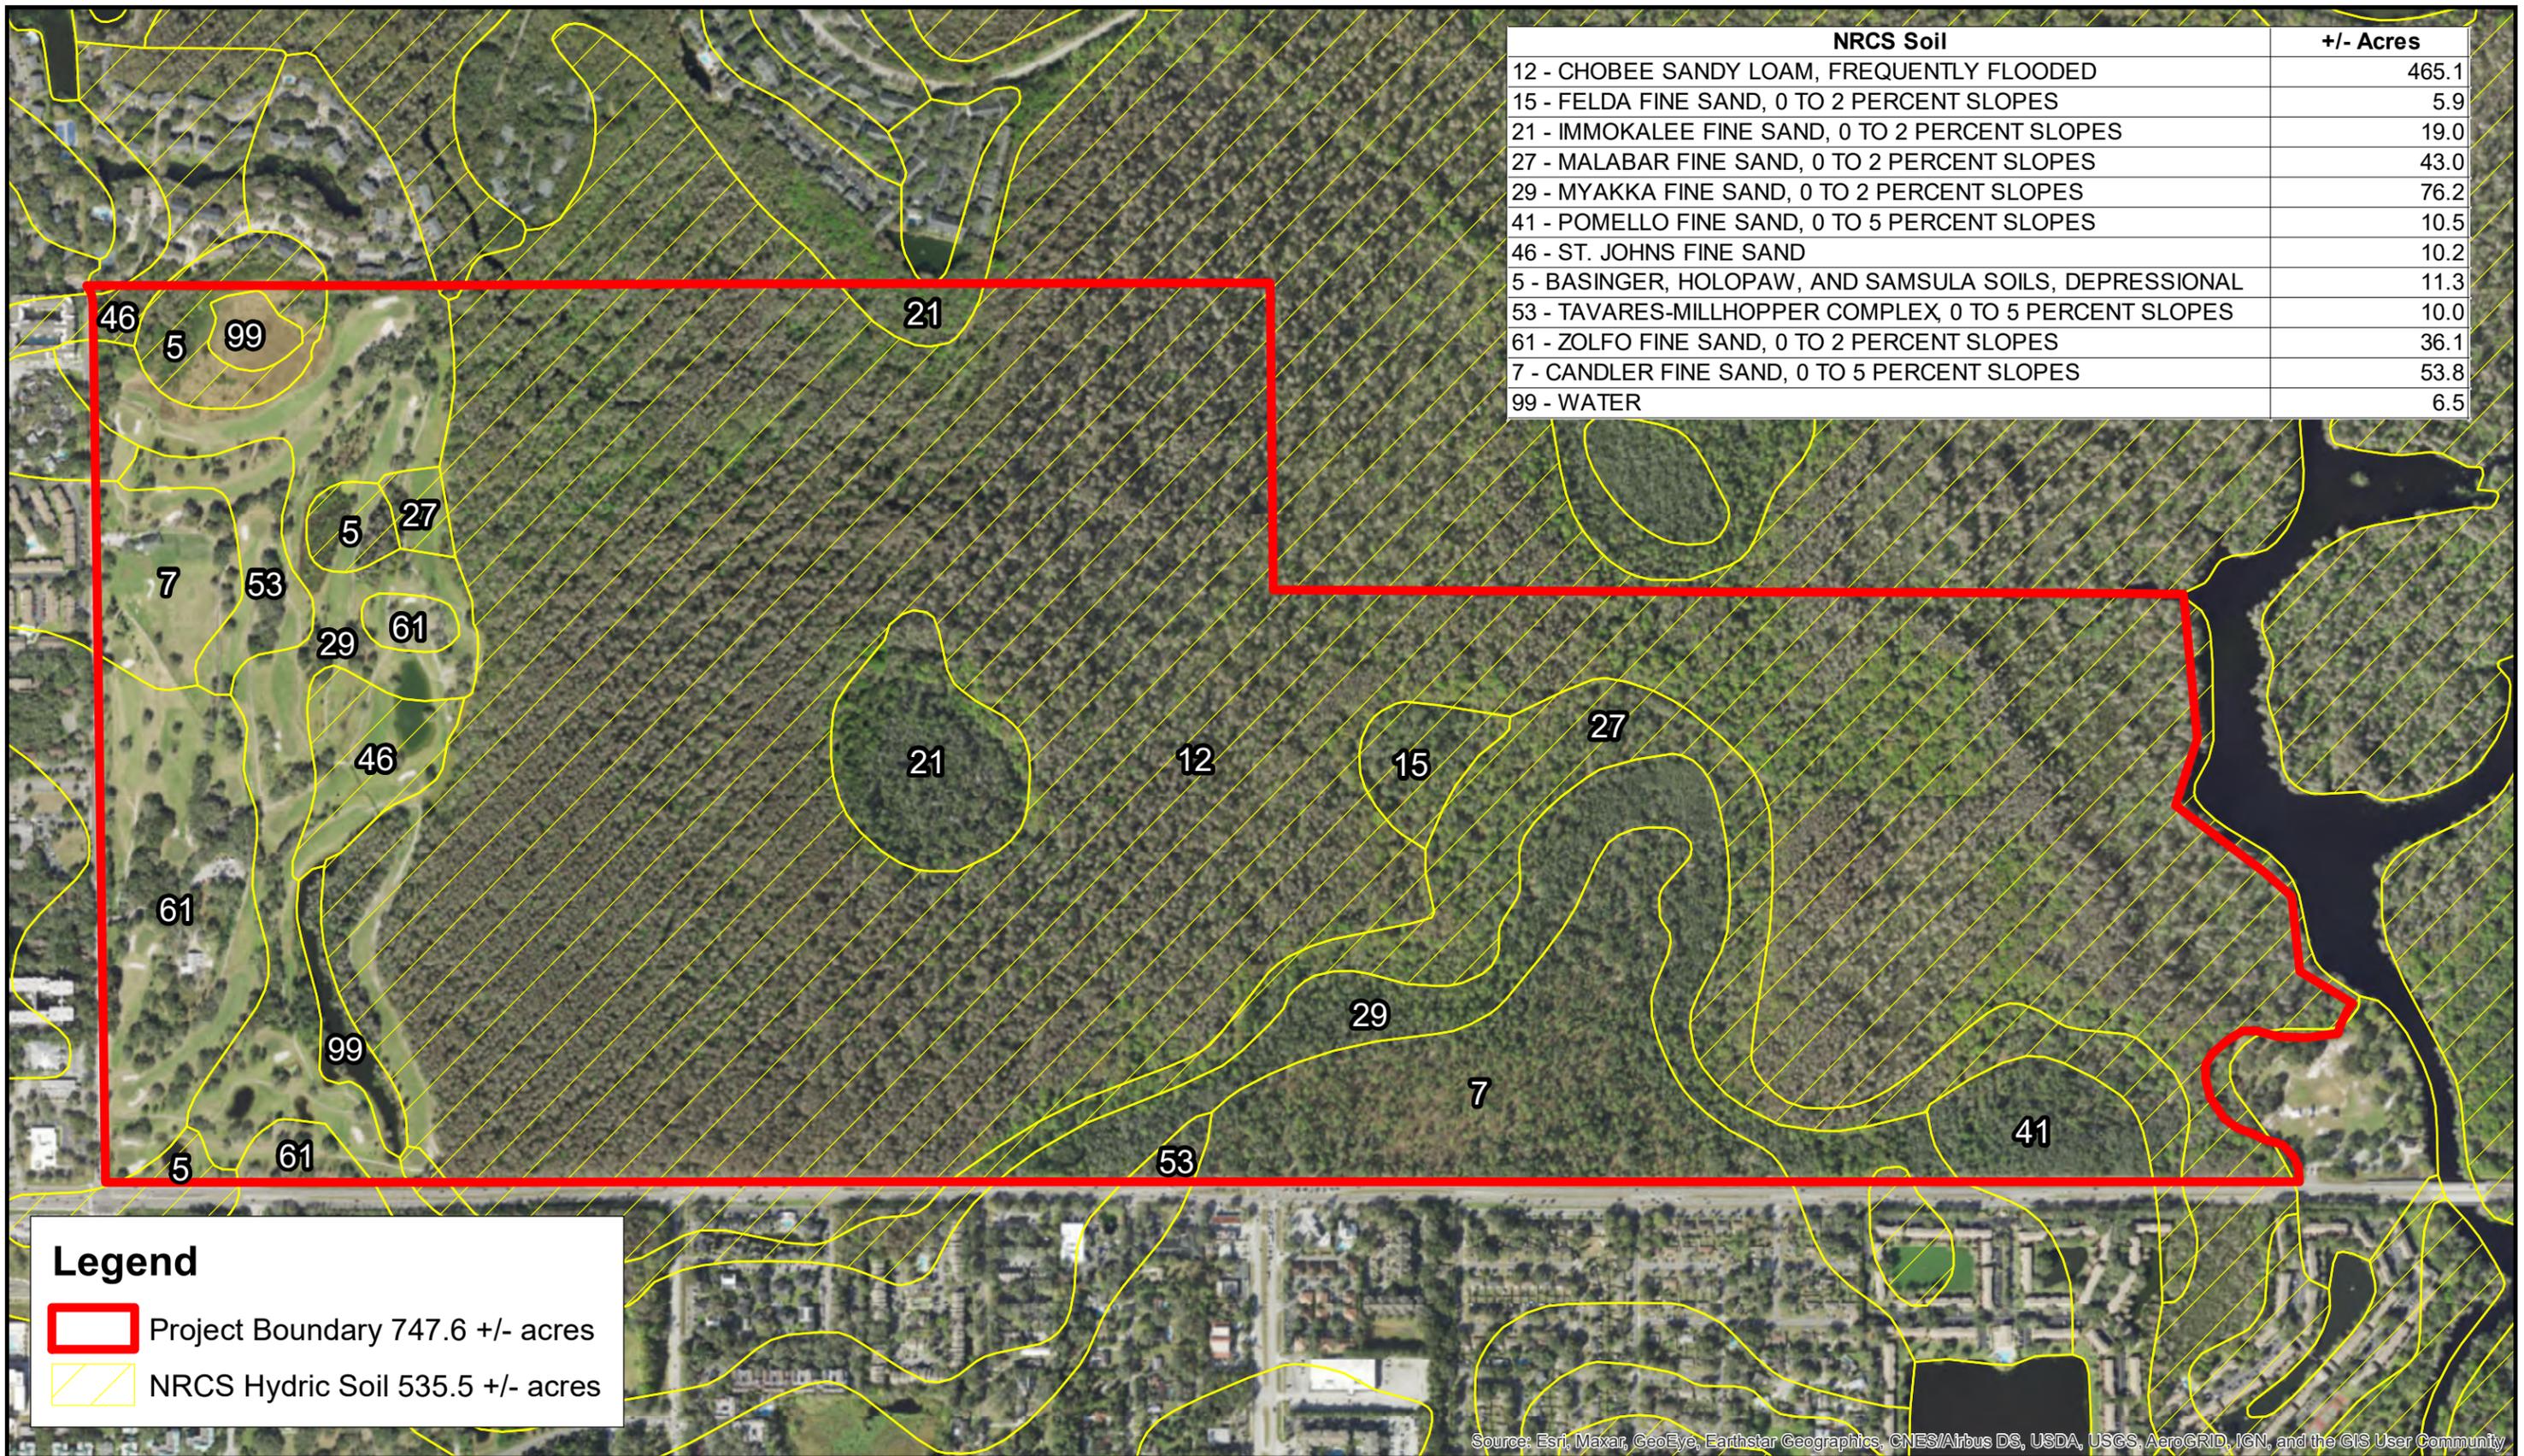
USF North Property  
NRCS General and Hydric Soils

NRCS Soil	+/- Acres
12 - CHOBEE SANDY LOAM, FREQUENTLY FLOODED	465.1
15 - FELDA FINE SAND, 0 TO 2 PERCENT SLOPES	5.9
21 - IMMOKALEE FINE SAND, 0 TO 2 PERCENT SLOPES	19.0
27 - MALABAR FINE SAND, 0 TO 2 PERCENT SLOPES	43.0
29 - MYAKKA FINE SAND, 0 TO 2 PERCENT SLOPES	76.2
41 - POMELLO FINE SAND, 0 TO 5 PERCENT SLOPES	10.5
46 - ST. JOHNS FINE SAND	10.2
5 - BASINGER, HOLOPAW, AND SAMSULA SOILS, DEPRESSIONAL	11.3
53 - TAVARES-MILLHOPPER COMPLEX, 0 TO 5 PERCENT SLOPES	10.0
61 - ZOLFO FINE SAND, 0 TO 2 PERCENT SLOPES	36.1
7 - CANDLER FINE SAND, 0 TO 5 PERCENT SLOPES	53.8
99 - WATER	6.5

- Project Boundary 747.6 +/- acres
- NRCS Hydric Soil 535.5 +/- acres

According to the Hillsborough County Soil Survey, 12 soil types occur on the Property (NRCS Hydric Soils Map). Five soil types are considered hydric and cover approximately 535 acres of the site. Additionally, there are approximately 6.5 acres of water (ponds on the golf course). The remaining soils on the Property include soil types that are poorly drained and somewhat poorly drained, but there are also areas of moderately well-drained and excessively drained soils.

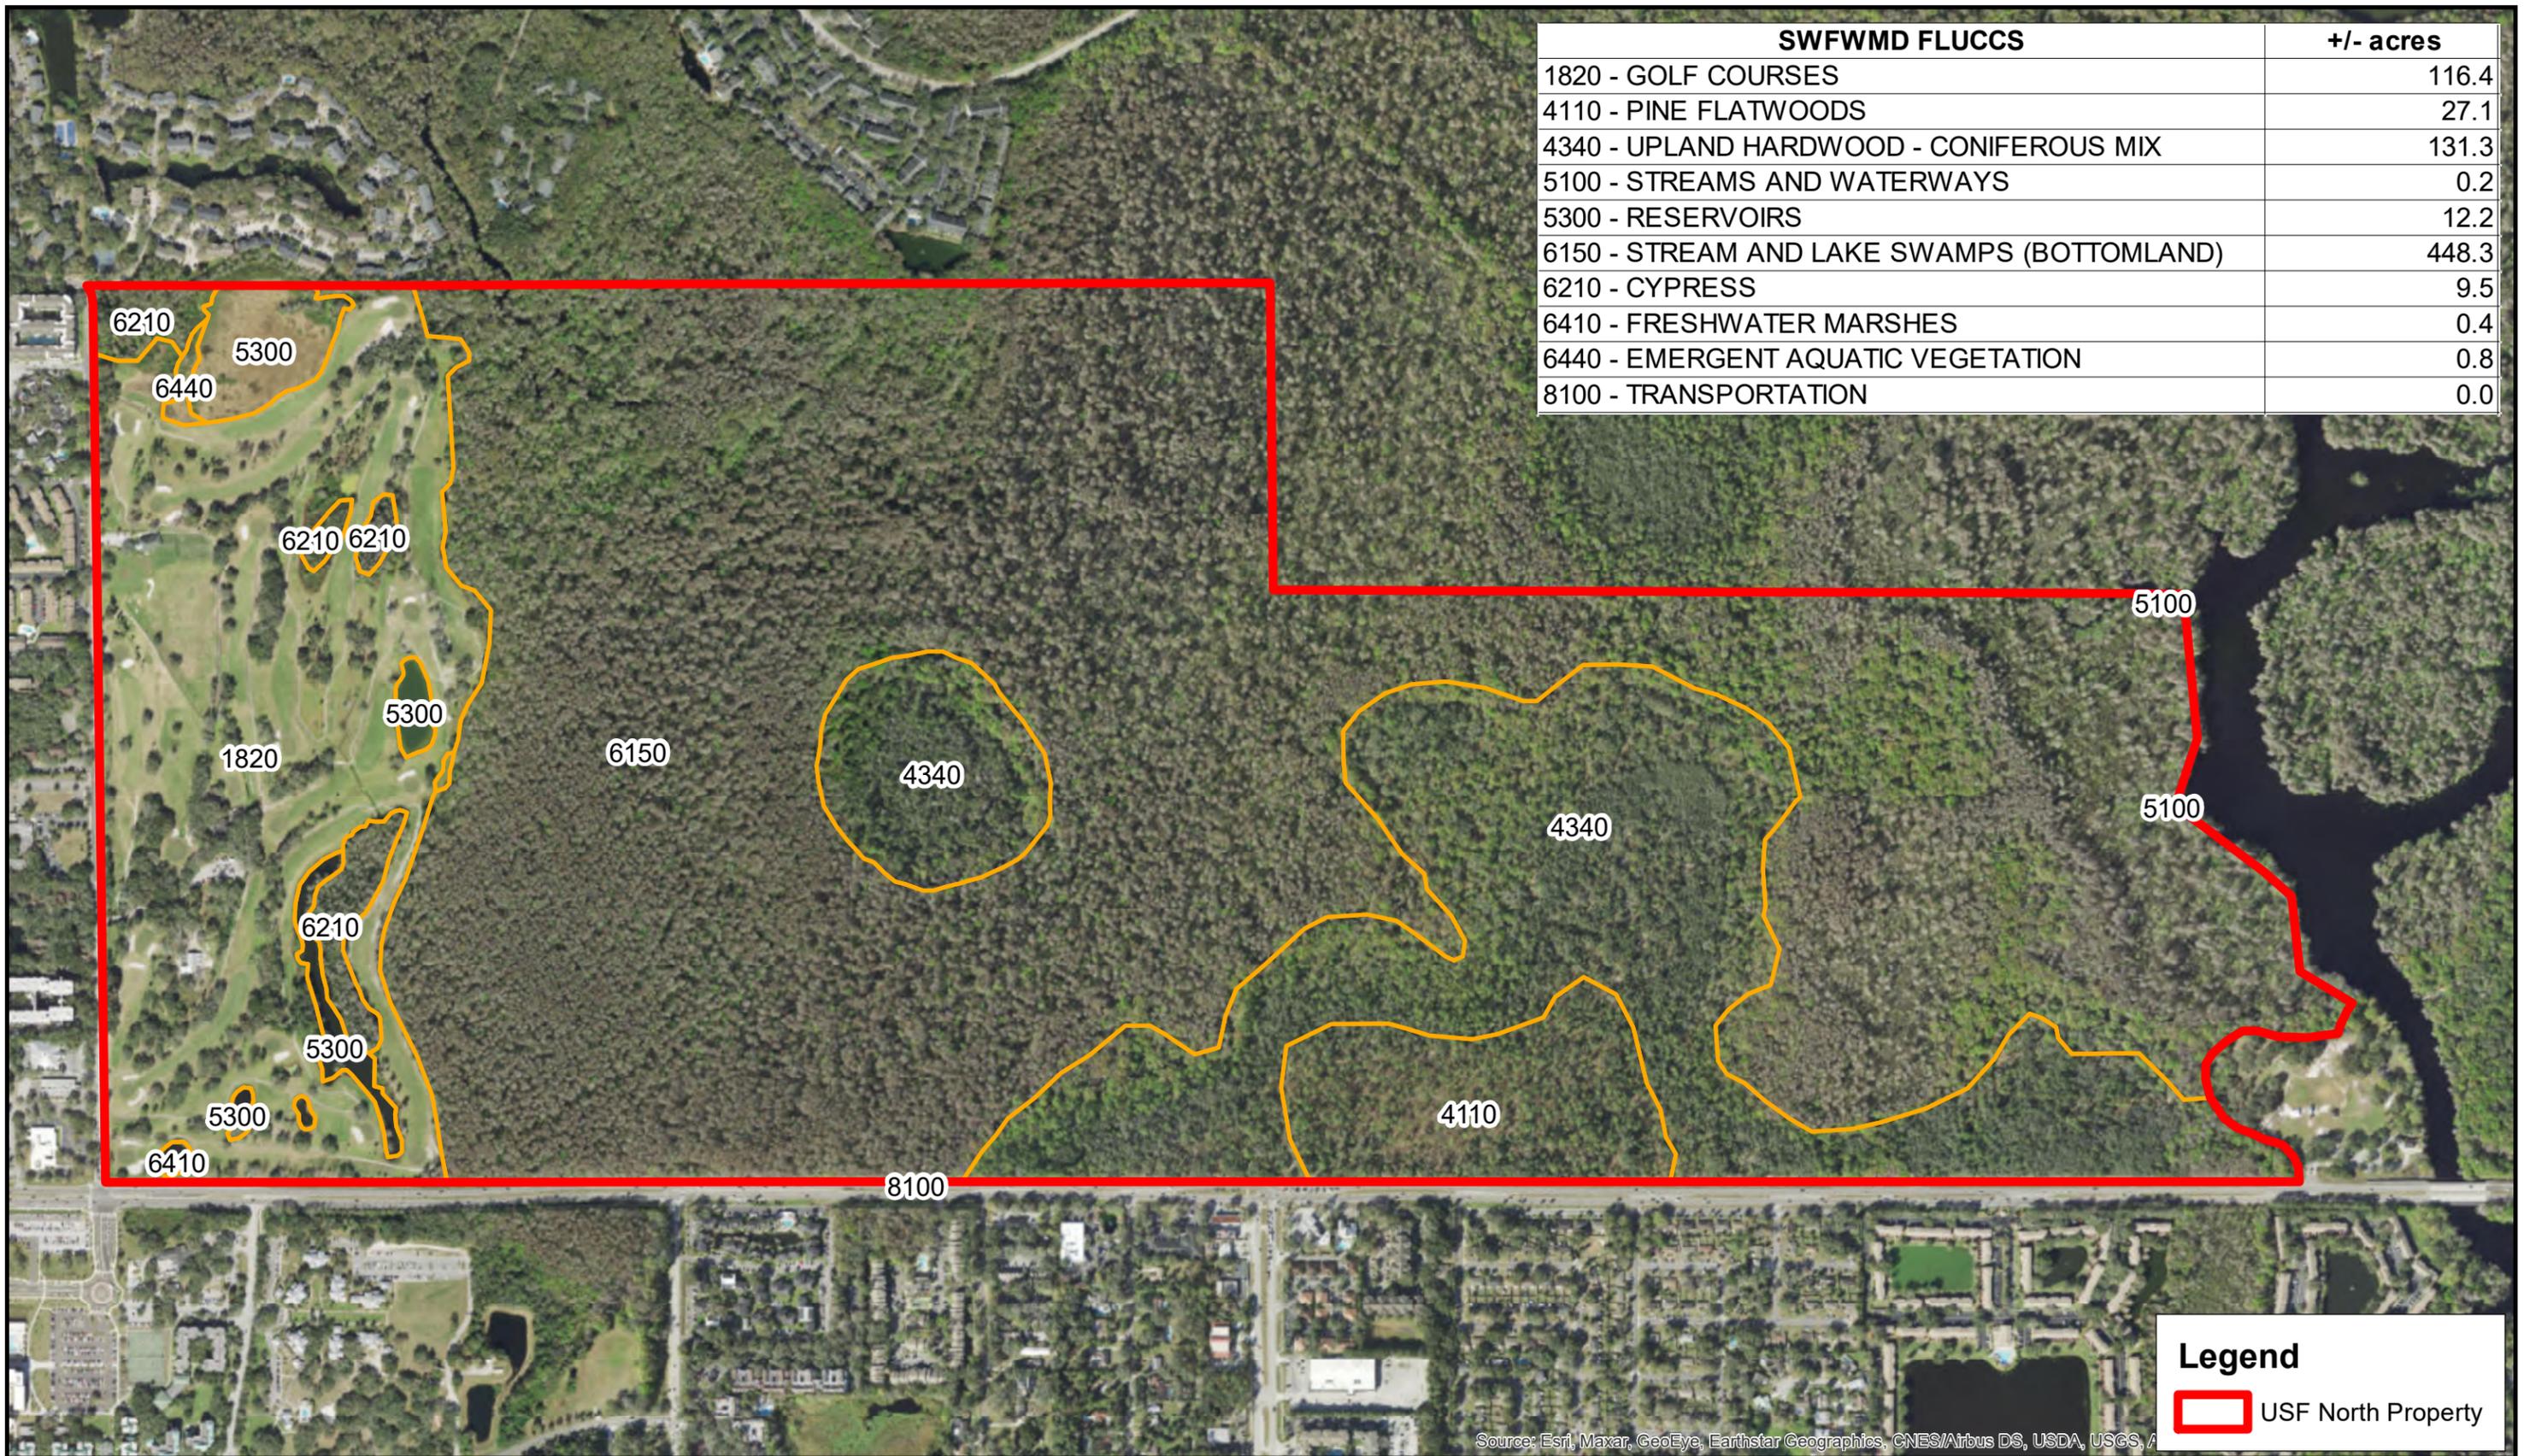
**USF North Property**  
SWFWMD FLUCCS

SWFWMD FLUCCS	+/- acres
1820 - GOLF COURSES	116.4
4110 - PINE FLATWOODS	27.1
4340 - UPLAND HARDWOOD - CONIFEROUS MIX	131.3
5100 - STREAMS AND WATERWAYS	0.2
5300 - RESERVOIRS	12.2
6150 - STREAM AND LAKE SWAMPS (BOTTOMLAND)	448.3
6210 - CYPRESS	9.5
6410 - FRESHWATER MARSHES	0.4
6440 - EMERGENT AQUATIC VEGETATION	0.8
8100 - TRANSPORTATION	0.0

The habitats on the Property have been given a land use/cover code based on the September 2021 site inspection using the Florida Land Use, Cover and Forms Classification System (FLUCCS) (SWFWMD FLUCCS Map). There are 10 total land use/cover types identified within the Property. The dominant habitat types are described below.

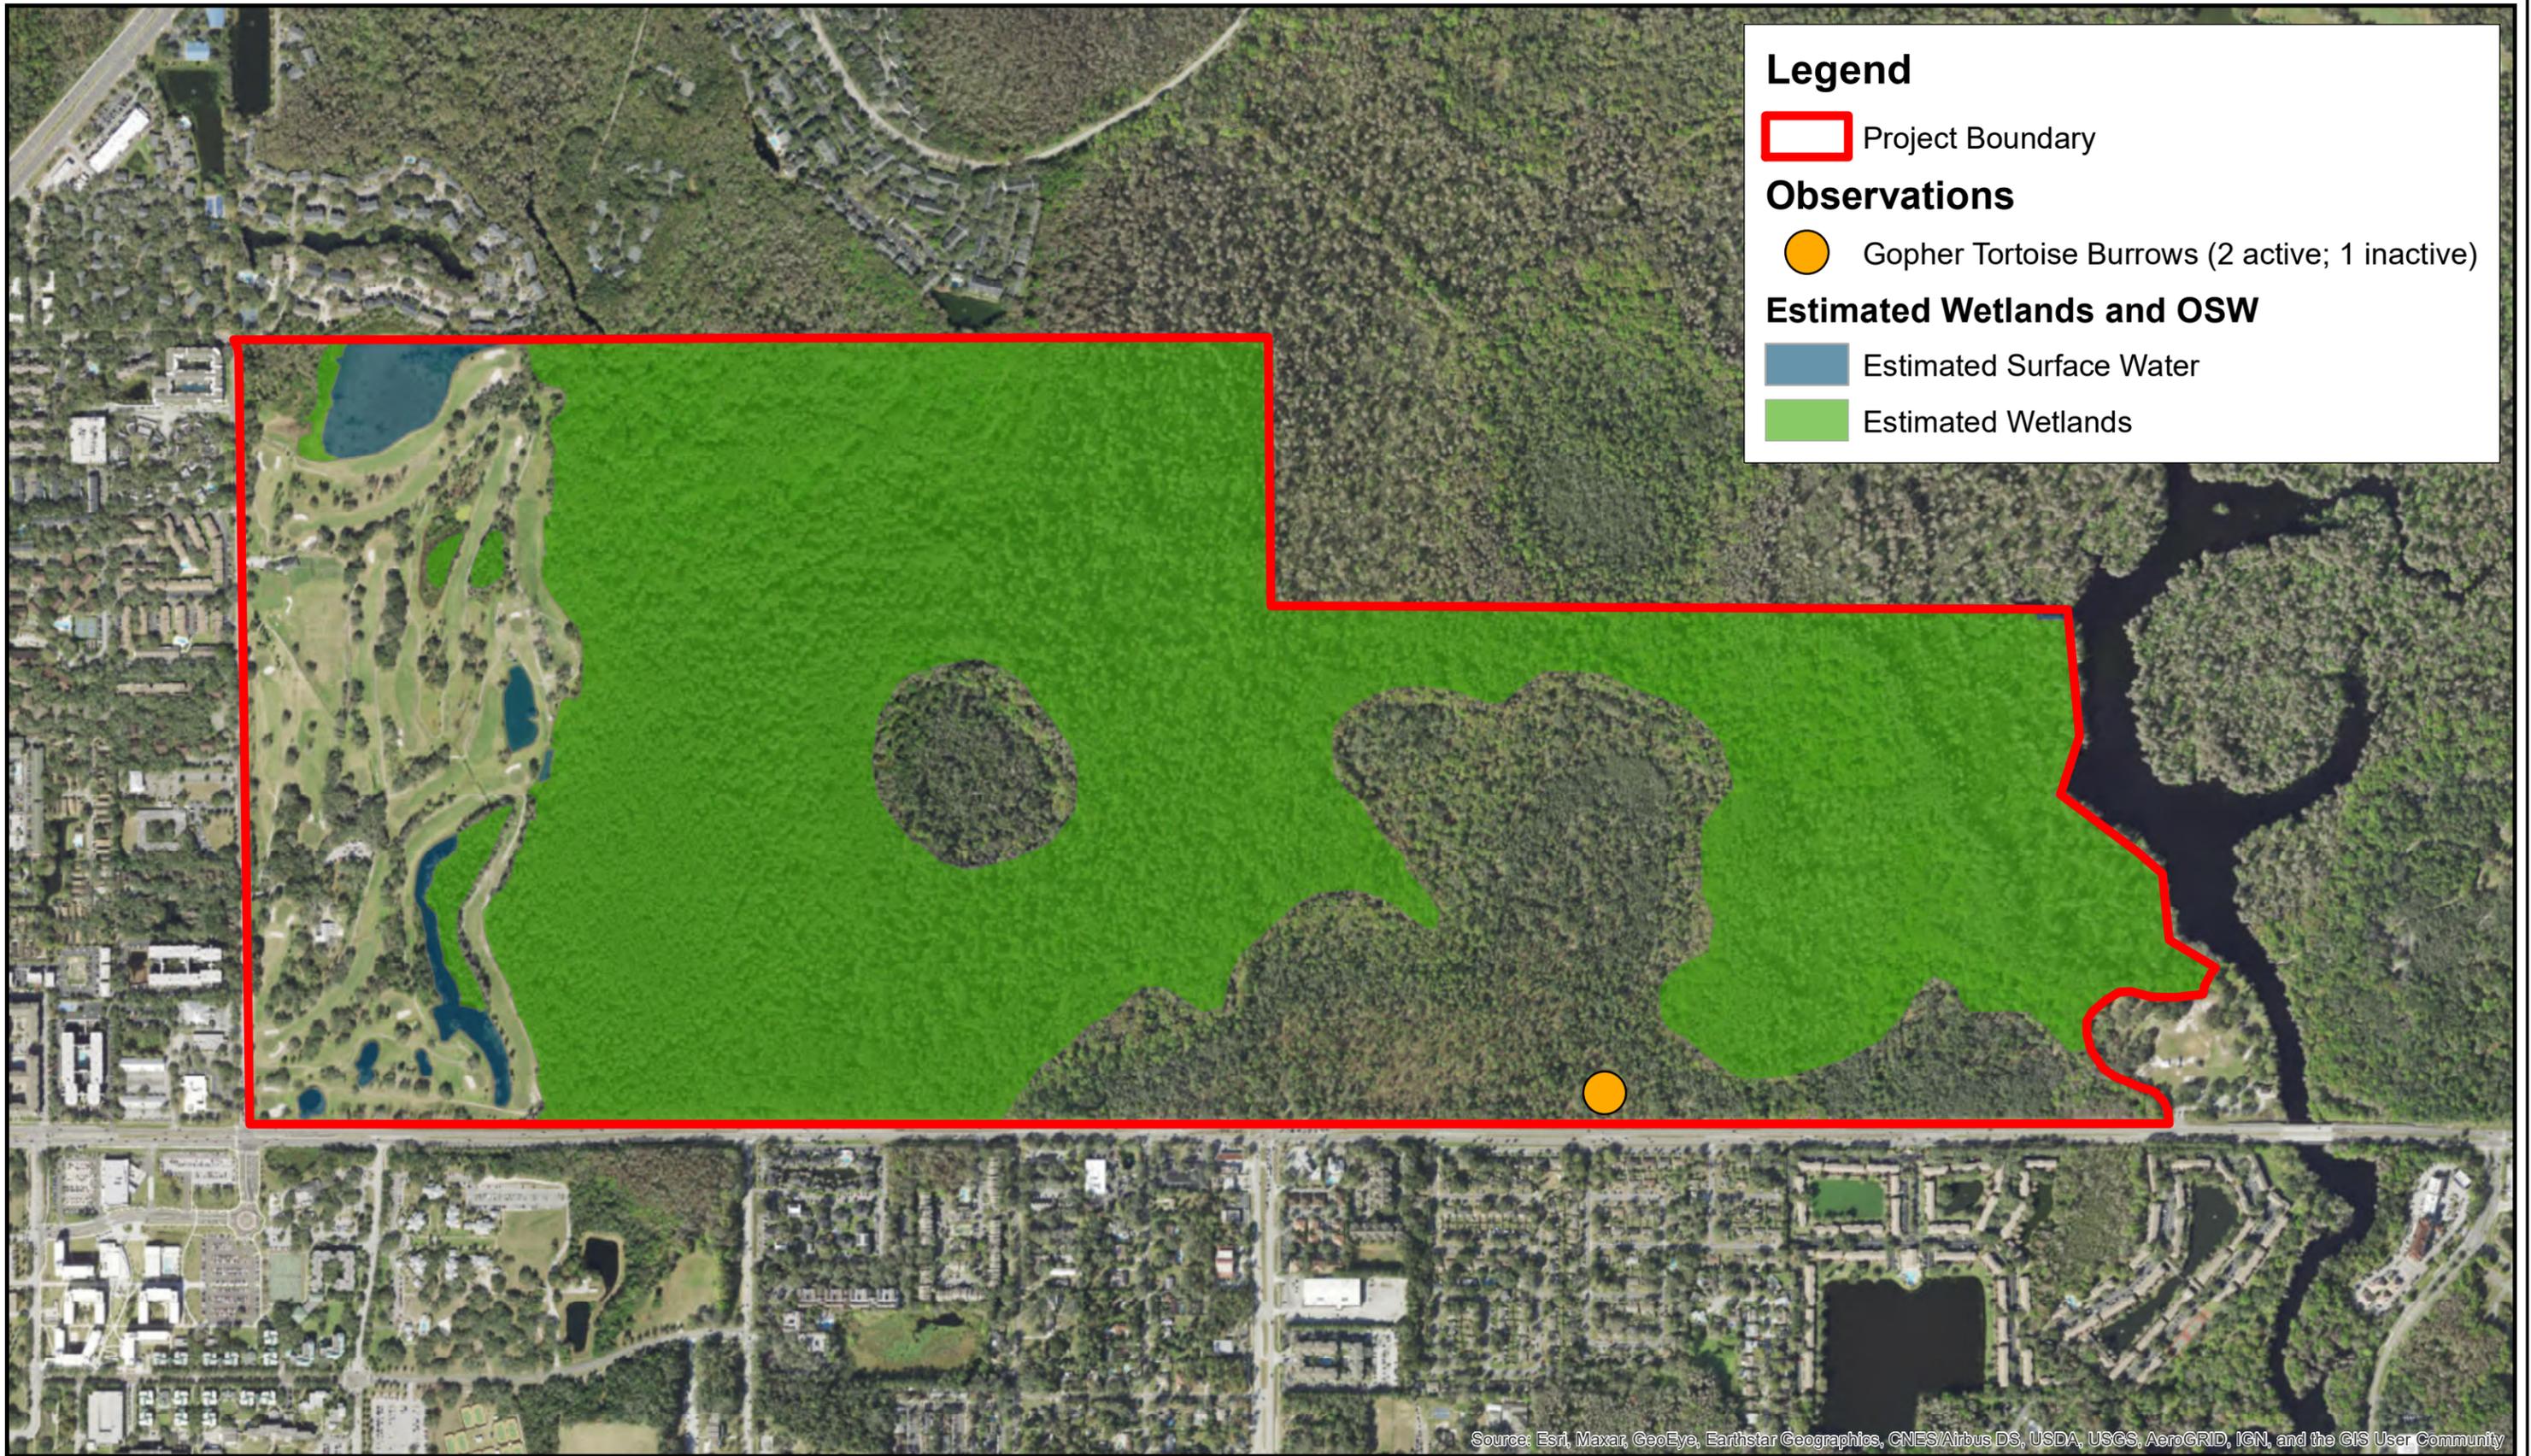
**USF North Property**  
 Wetlands and Listed Species Occurences

- Gopher Tortoise Burrows (2 active; 1 inactive)

- Estimated Surface Water
- Estimated Wetlands

During the September 2021 site review, Heidt Design ecologist performed pedestrian and vehicle transects to identify areas within the Property that might be utilized by listed species of wildlife and to observe evidence of listed species use. During the site review, evidence of only one listed species of wildlife was observed, the gopher tortoise (*Gopherus polyphemus*), listed as threatened under State of Florida regulations. Active and inactive tortoise burrows were found in the pine flatwoods habitat, but it is possible burrows could be found in the higher elevations of the upland hardwood habitat. Onsite observations/evidence of listed species are shown on the Wetlands and Wildlife Observations Map. Additionally, the Florida Natural Areas Inventory (FNAI) Biodiversity Matrix Map Server was reviewed to identify potential listed species of wildlife that may occur on or in the vicinity of the Property.
