# Monitoring Based Commissioning Program 2014 Higher Education/IOU Partnership

## Final Baseline Assessment Report Humboldt State University Gist Hall

Laurel Drive  
Arcata, CA 95521

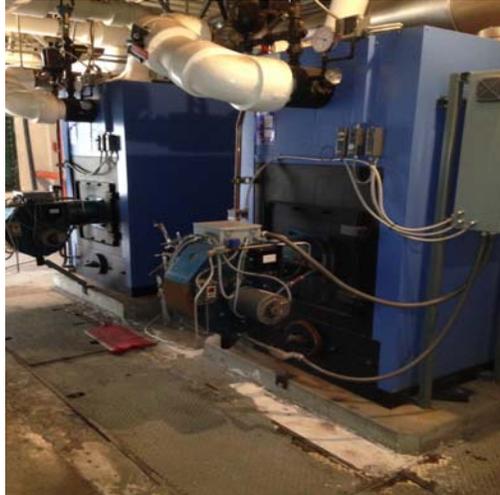
**Figure 3.1: Two Unilux Heating Hot Water Boilers**

The boilers are currently operated to supply 170°F heating hot water to Gist Hall, Jenkins Hall, and the east side and fifth floor west side of Science A. Although Gist hall closes at 6 PM, the boilers operate until 11 PM to provide heating for Science A labs. Only one class at Jenkins Hall is currently occupied. The kW team installed data loggers to monitor the boiler fans, hot water circulation pumps, and hot water supply/return temperature on the Jenkinings/Science A loop to better understand the heating hot water system.

We noted one boiler in operation and flow through both boilers during our site visit. Supply water temperature to the building was measured at 140 °F.

Measure Tag	Measure Name	System Affected	Description of Deficiencies	Date of Finding	Recommended Improvement/Possible Issues
RCx-9	Isolate flow to lag boiler when off.	B-1 and B-2	We noted one boiler in operation with constant temperature setpoint of 170 °F and flow through both boilers during our site visit. Supply water temperature to the building after mixing was measured at 140 °F.	4/8/2014	When lag boiler is not in operation
RCx-10	Reset pressure differential setpoint controlling hot water pumps.	P-1,2,3	During the site visit we noted that 3 HW pumps were in operation, The VFDs on the hot water pumps are controlled to maintain a 5 psi differential setpoint as measured in Science A.	4/8/2014	Investigate a control sequence that resets the differential pressure to maintain the worst case hot water valve at 95% open.
RCx-11	Optimized control of common area lighting		According to staff, common area lighting is turned off by facility staff at midnight.	4/8/2014	.We have installed current transducers on the lighting panels to determine if the lights are indeed turned off at night. Based on the data we may make a recommendation to automate the lighting control.
