LiDAR Quality Assessment Report

UT_GSLSouth_2011

This data set created using LiDAR points collected from airborne surveys completed between October 13, 2011 and October 18, 2011 and covers approximately 333 square miles contained in the following county(s): Salt Lake County, Utah; Davis County, Utah

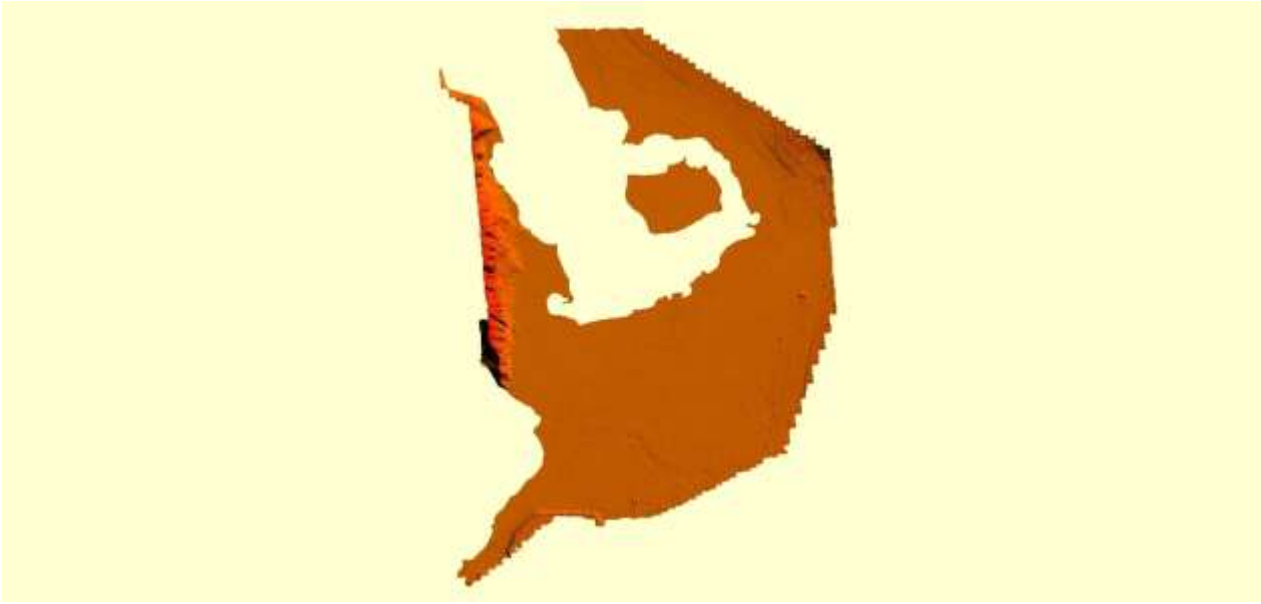
In order to make the DEM usable in the 1/9th NED the Water needed to have a value, A final mosaic was created by the USGS that coded each interior lake with a constant (flat) value of the lowest bordering pixel. The project boundary for the project was also determined to be the maximum swath extents and was buffered in by 100 Meters and cut out on the southern portion to ensure there were no gaps in the data due to the flight lines. The final product sent to the NED should be free of data voids and have adequate point density for gridded areas included in the final mosaicked DEM. This also has an accompanying DEM Project Footprint and is 221.72 SqMi.

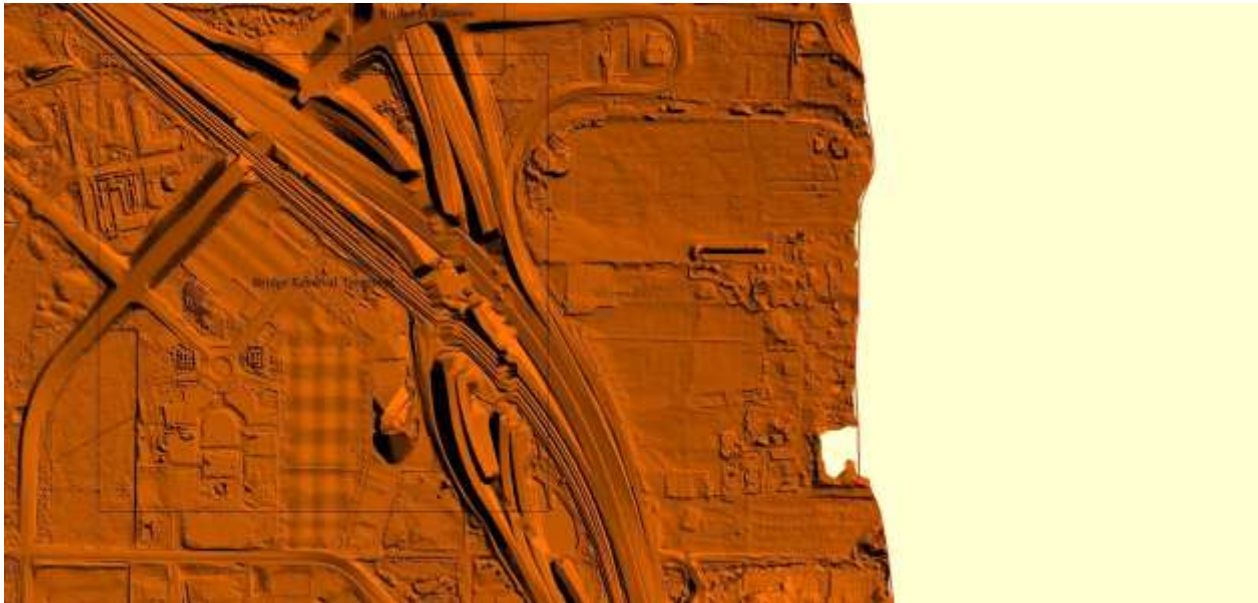
Several instances of bridge or overpass removal issues. Errors tagged as "Bridge" are highly suspect; whereas, errors tagged as "overpass" or "culvert" could not be determined if they needed to be removed or where culverts in the ground. The majority of these issues were corrected in the Final Mosaic DEM sent to the NED.
