# LIDAR MAPPING REPORT

## WASATCH EAST AERIAL SURVEY

WU\_Name: NV\_USFSR4\_2\_D23

**Submitted: May 13, 2024**

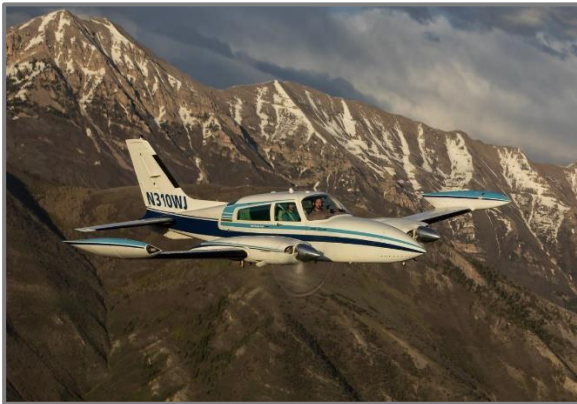
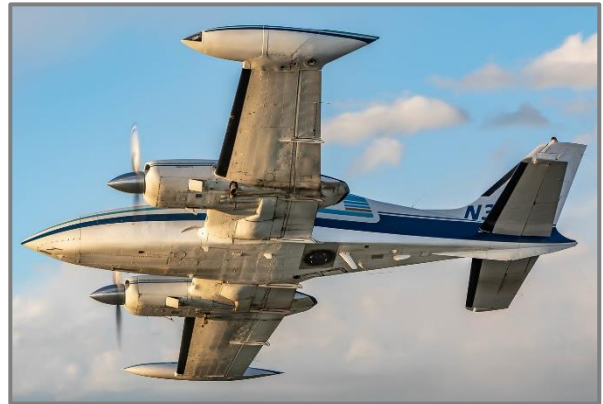
Aero-Graphics acquired LiDAR data from August 25, 2023 to September 9, 2023 with a turbocharged Cessna 310 (**Exhibit 3**). The stability of this platform is ideal for efficient data collection at high and low altitudes and at a variety of airspeeds. Additionally, our Cessna 310 has been customized to house a variety of airborne sensors, and the power system and avionics have been upgraded specifically to meet aerial survey needs.

**Exhibit 3:** A Cessna 310 was the acquisition platform for this project.

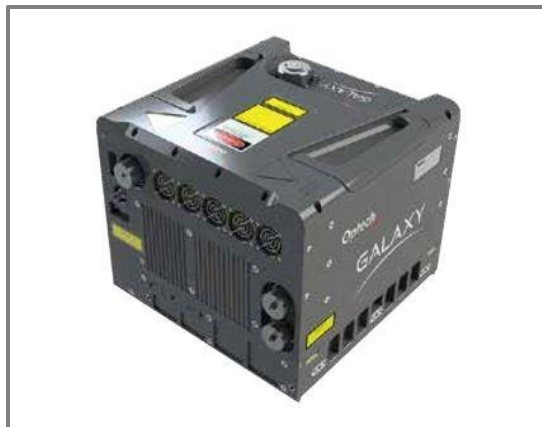
The Optech Galaxy T2000 was selected for this project on account of its high accuracy and efficiency (**Exhibit 4**). This sensor uses SwathTrak technology, which dynamically adjusts the scan field of view in real time to maintain a more consistent swath width over a variety of terrains. It also features up to 8 returns per pulse, which increases the vertical resolution of complex terrains. The sensor is complemented with the use of FMS Nav, which allows the system operator to monitor the point density and swath attributes of this project in real time, ensuring quality data and full coverage, as shown in **Exhibit 5**. More information about point density can be found in Section 4.4.

**Exhibit 4:** The Optech Galaxy T2000 was used for data acquisition.
