# HURRICANES AND SHORE-LINE CHANGES IN RHODE ISLAND

CHARLES W. BROWN

REPRINTED FROM  
THE GEOGRAPHICAL REVIEW

Vol. XXIX, No. 3, JULY, 1939

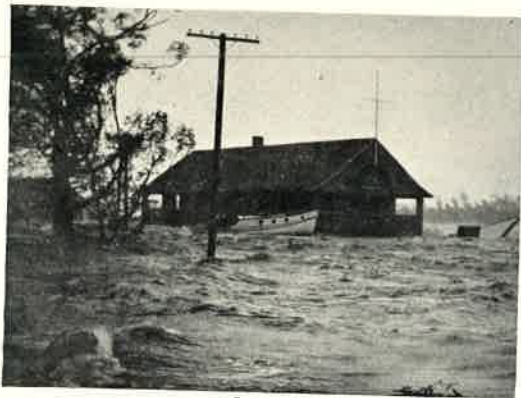
FIG. 3

FIG. 3—Brown University boat-clubhouse, Seekonk River, Providence, during height of gale, 5:45 p. m., Sept. 21, 1938.  
 FIG. 4—Brown University boat-clubhouse the morning after the gale, Sept. 22. Compare the foliage in Figure 3.  
 FIG. 5—Napatree Point and Watch Hill, 1936. Thirty-nine cottages on the low sandbar disappeared. This bar was breached but filled later; but the breach in the nearer bar still remains open. (Photograph by W. and M.)  
 FIG. 6—Watch Hill to Napatree Point, Dec. 4, 1938. Forty cottages were grouped here; useless groins still remain at the bathing beach.

STANDING at the sea wall at Ocean Drive, Narragansett Pier, at a little before three o'clock on that afternoon of September 21, 1938, the writer was aware that a whole gale was blowing. At that time, however, at the beginning of the flood tide, no spray came over the sea wall on the drive (Fig. 7). It is difficult to realize that within so short a period as three hours such desolation and change on a shore line could be wrought by wind and wave, which covered the drive several feet deep in an hour, even with wind velocities of about a hundred miles an hour and a resulting wind pressure of 40 pounds to a square foot (Fig. 8). From Figure 3 one gets an idea of the "atmosphere" of the storm and the low visibility.

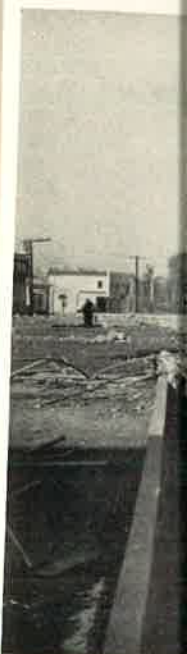
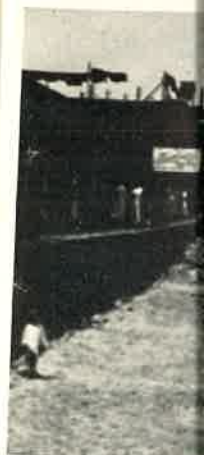
FIG. 7—Narragansett Pier Ocean Drive and retaining wall and jetty, 1911.

FIG. 8—Naragansett Pier Ocean Drive. Wreckage of wall and two-thirds of drive and transportation of two-ton fragments. Dec. 4, 1938.

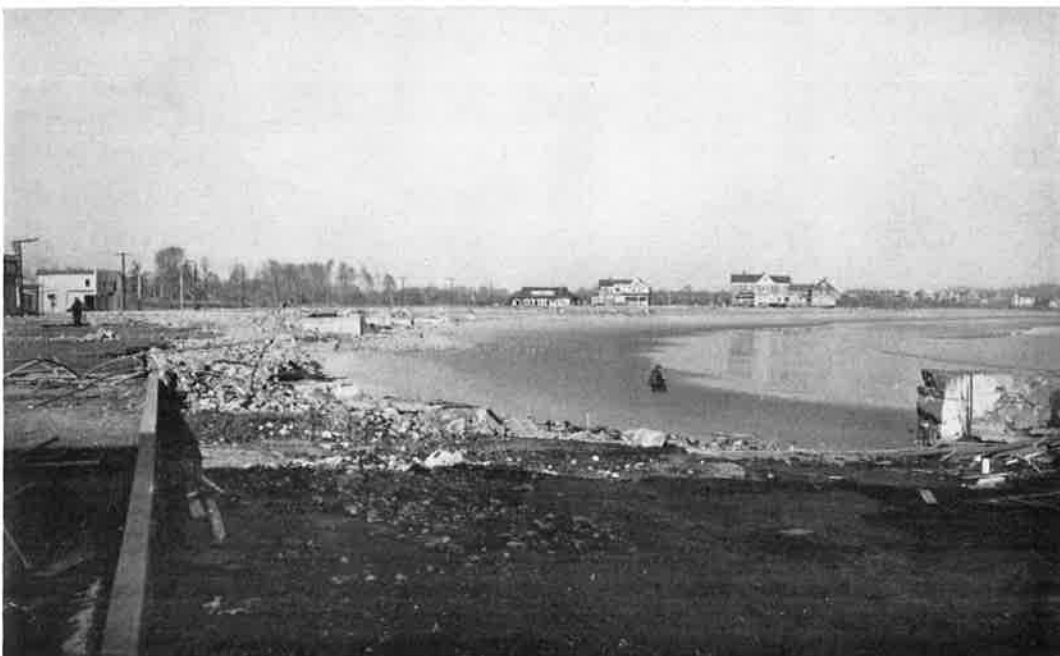
FIG. 9

FIG. 9—Naragansett Pier Beach showing character and extent of storm-wave destruction. Dec. 4, 1938. Compare with Figure 10.

and Bonnet Shores, all had a large number of pavilions, houses, and amusement structures built on them. These low-lying beaches were swept practically clean of buildings. In places erosion was concentrated at the center, the west or the east end of the beach according to the direction of the wave action (Figs. 9, 10, 24, 25, 26, and 27).

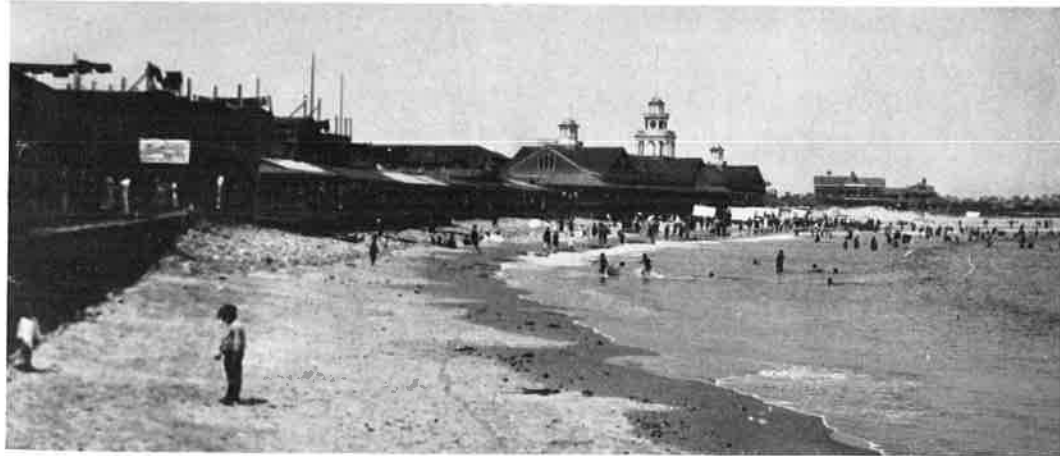
FIG. 10

FIG. 10—Naragansett Pier Beach with bathing pavilion and houses, 1925.

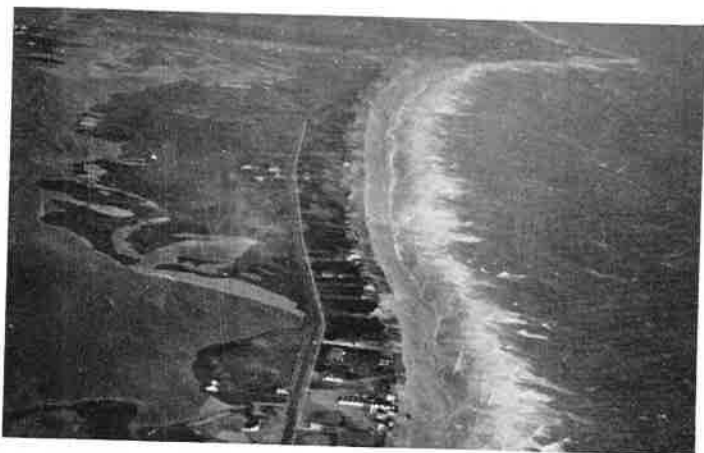
FIG. 12 (above)—Aerial view east over Winnepaug or Brightman Pond and beach, 1936, showing general plan of beach occupation: outward line of dunes with perched and nestling cottages; protected road with cottages either side between dunes and lagoons. (Photograph by W. and M.)

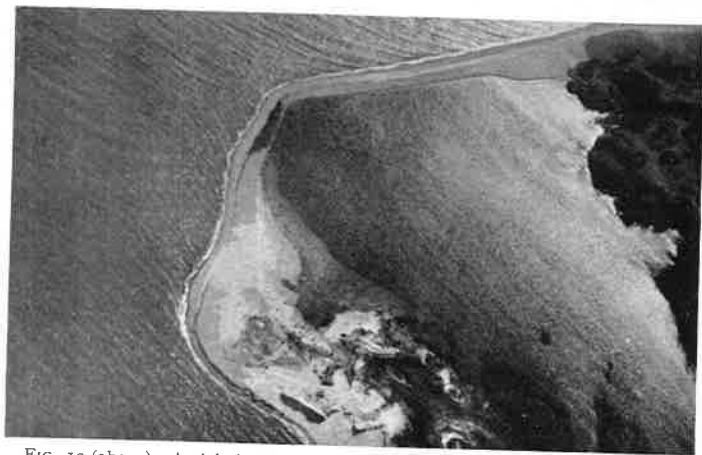
FIG. 13 (below)—Aerial view of Quick's Hole, Nashawena Island. Gale breach in bar filled by December 13, 1938. (Photograph by Dr. Alexander Forbes.)

Only two breaches in the beaches remain, one near Misquamicut (Fig. 14) and the other beyond Napatree Point. The latter will probably be kept open; but the former is being filled, to hasten nature's inevitable process. Quicks Hole, Nashawena Island, of the Elizabeth Islands group, Buzzards Bay, Massachusetts, shows the breaching of the bar by gale waves and its filling by December 13 at a lower level and farther seaward than the breach (Fig. 13).

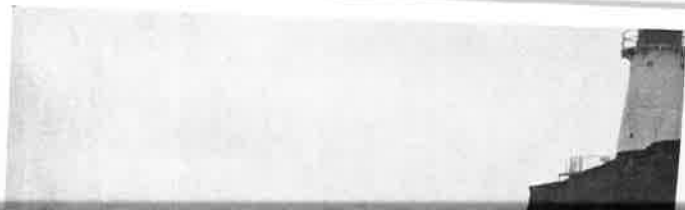
FIG. 13 (below)—Aerial view of Quick's Hole, Nashawena Island. Gale breach in bar filled by December 13, 1938. (Photograph by Dr. Alexander Forbes.)

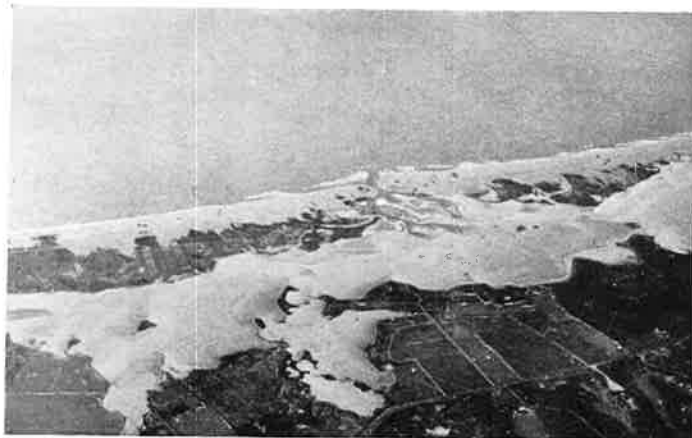
FIG. 14 (above)—Breach in Atlantic Beach and Winnepaug Pond, west of Noyes Point; one of the two gale breaches still remaining open. The beach, clean-swept of structures and debris, shows the erratic widening from flattening of sand dunes. Jan. 26, 1939. Compare Figures 11 and 12. (Photograph by Dr. Alexander Forbes.)

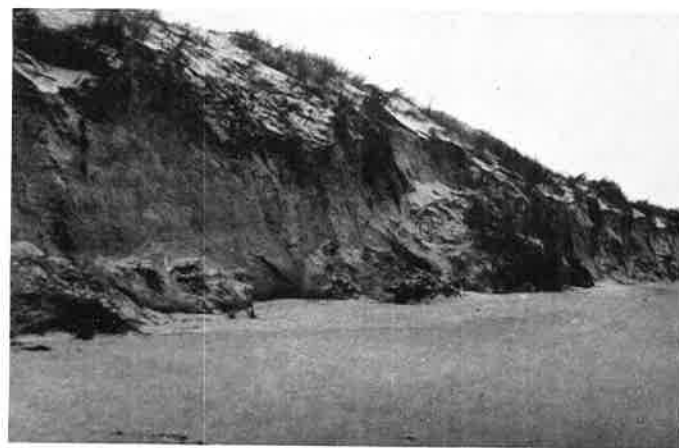
FIG. 15 (below)—Gale erosion of footing of Narragansett sand dunes by some six feet, 1931. These dunes were practically obliterated in the 1938 hurricane.

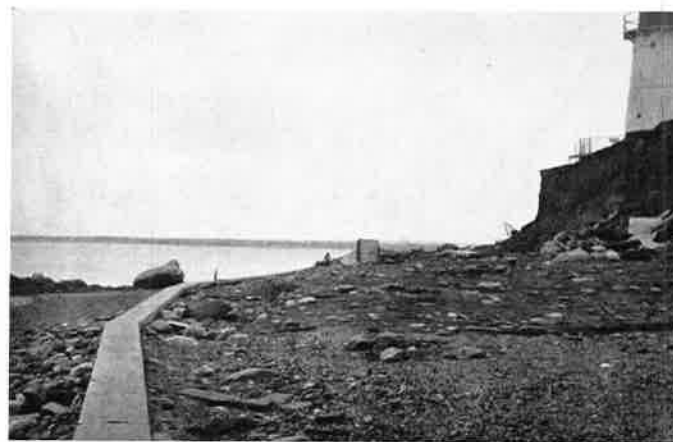
FIG. 16 (above)—Warwick Point Light, nearly undermined by 38-foot erosion of glacial debris and hard pan on a bench of graphitic shale flush with the five-foot bulkhead.

The high morainal cliff at Watch Hill lost about 35 feet; the 15-foot cliffs of glacial debris, Sakonnet, receded 25 to 30 feet (Fig. 17); No Mans Land is reported to have lost 25 feet and Cuttyhunk Island about the same; the 100-foot cliff at Block Island retreated about 30 feet; and the Warwick Point lighthouse, on a 20-foot cliff up Narragansett Bay, was nearly undermined by a 38-foot recession (Fig. 16).

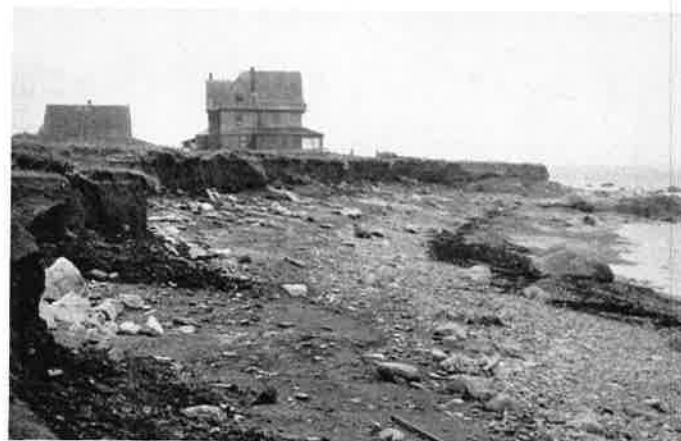
FIG. 17 (below)—Warren Point, Sakonnet. Fifteen-foot cliffs of glacial debris cut back by storm waves 30 feet from zone of lighter-colored shingle.

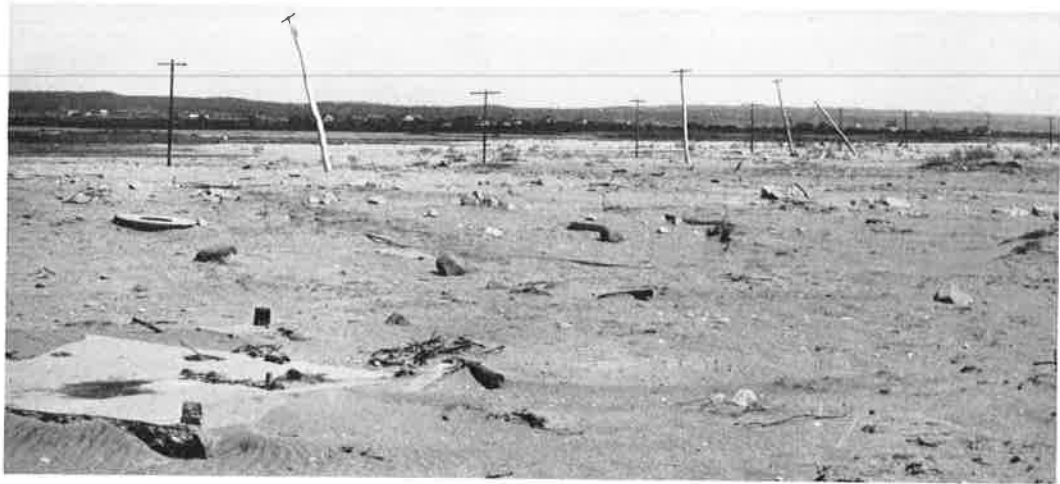
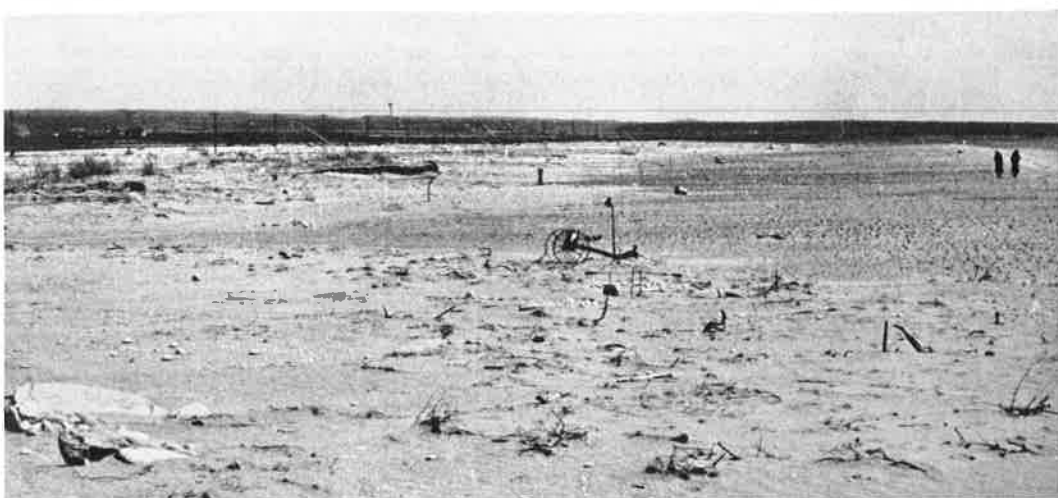
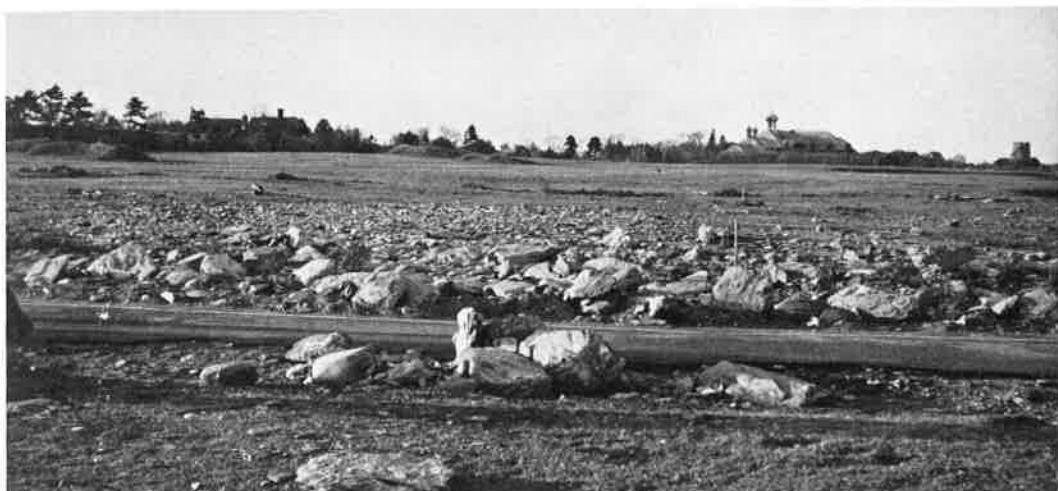
FIG. 18 (pp. 424 and 425)—Charlestown Beach, R. I. Ninety-odd cottages disappeared with the dunes just in front of the road and line of poles, where the storm swell swept all into the lagoon. Concrete garage floors and bent galvanized water and drain pipes are all that remain to show the site of the cottages. April 5, 1939.

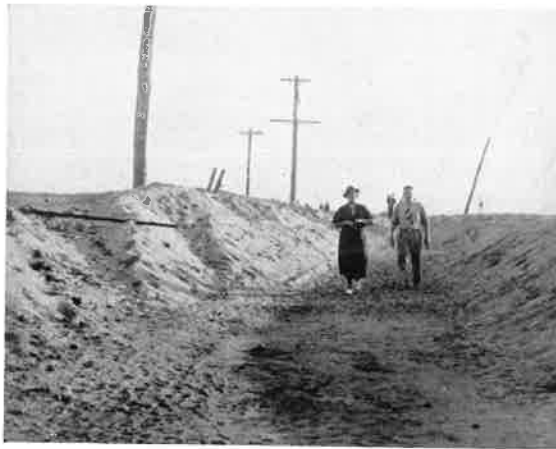
FIG. 19

FIG. 19—Buried road at Charlestown Beach excavated through sand wash on inner side of former dunes. The distant figures are not far from high-tide mark. Oct. 16, 1938.

Just as the natural healing processes tend to close the gale-made inlets, so dune building, which had been in progress since the great gale of 1815 and the minor one of 1869, is developing rapidly on the Charlestown beach (Figs. 19 and 20). With a three times wider sand area for westerly and northwesterly winds to draw from, dunes should build somewhat more rapidly than before the storm.

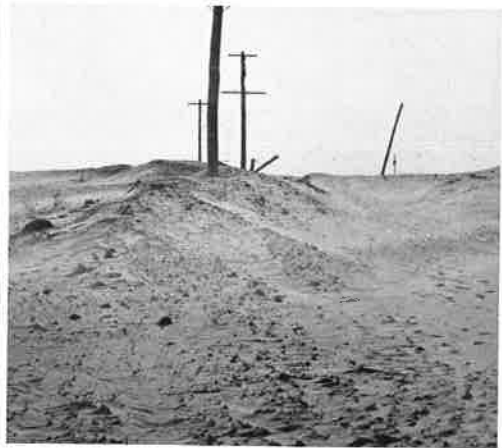
FIG. 20

FIG. 20—The road in Figure 19 was nearly filled in seven weeks by drifting sand. Dec. 7, 1938. Dune modeling evident.

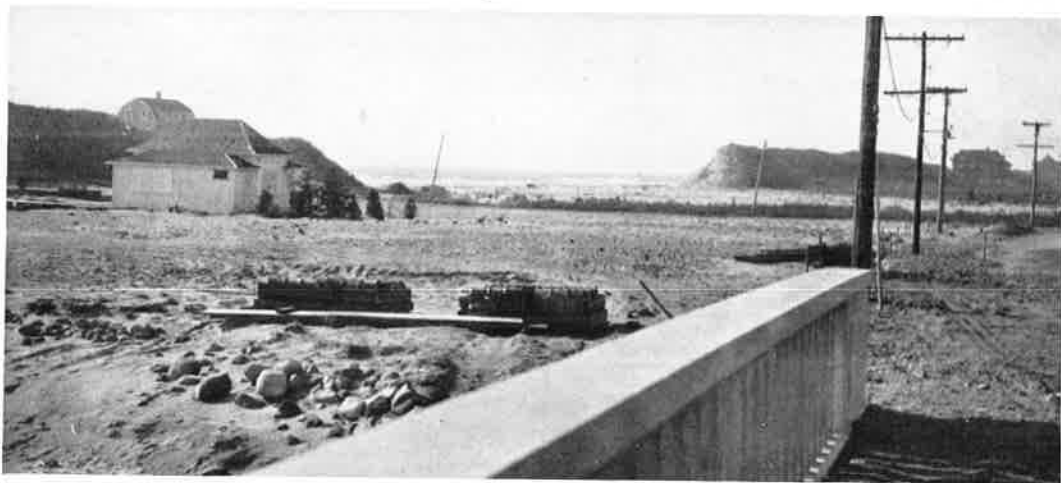
FIG. 21

FIG. 21—Misquamicut Beach bridge (repaired), breached dunes, and stranded cottage near outlet of Brightman or Winnepaug Pond. Dec. 4, 1938.

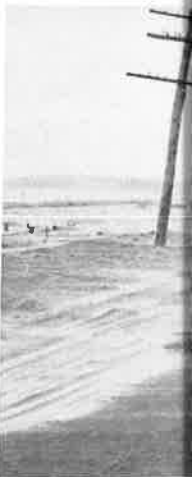
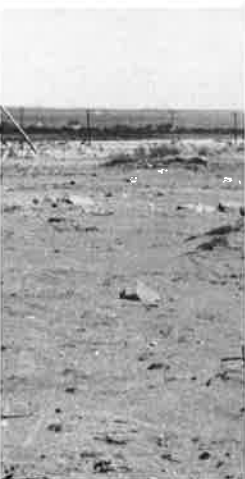
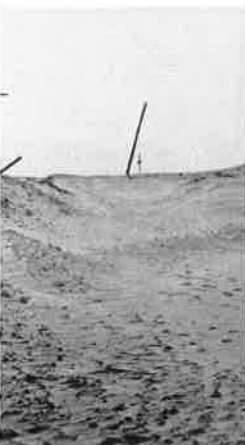
FIG. 18 (contd.)

FIG. 18 (contd.)—See opposite page for legend. The right and left halves of the panorama overlap.  
FIG. 22—Ocean drive at Brenton's Reef Point, Newport. Wave-borne boulders carried in nearly 100 yards, 12 feet above mean high water, simulating an elevated beach. Nov. 4, 1938.  
FIG. 23—Horse Neck Beach, Westport, Mass. The belt of dunes protecting the line of poles was destroyed and the road covered with dune and beach material to a depth of several feet. Erosion continued inland 125 feet into the major dune belt. Oct. 26, 1938.

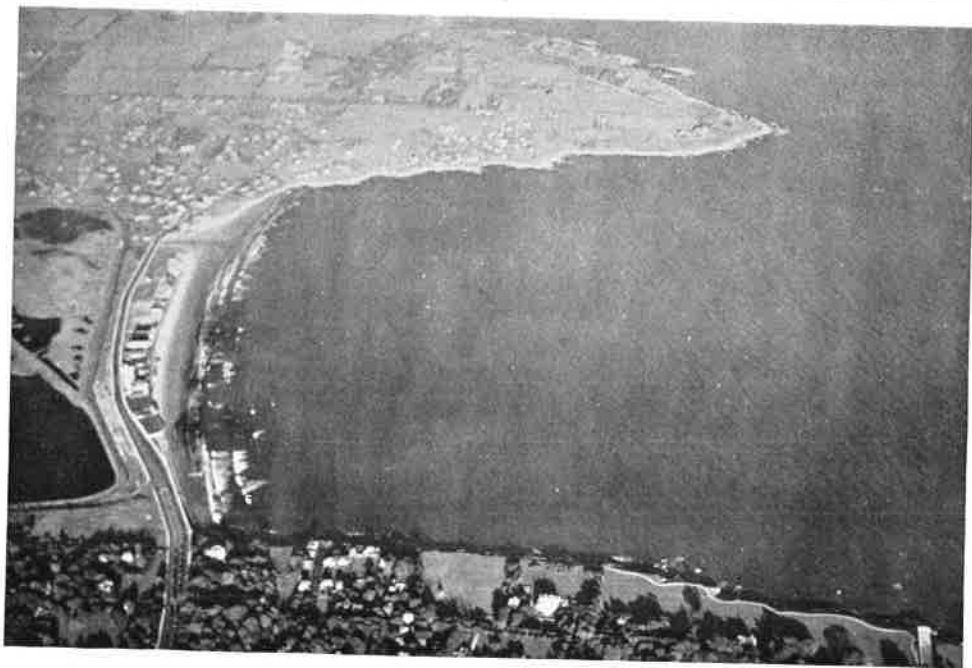
FIG. 24

FIG. 24—Newport Town (Easton's) Beach and amusement structures with lagoon in back and Easton's Point and Second Beach in distance in 1936. The famous "Cliff Walk" shows in lower right. (Photograph by W. and M.)

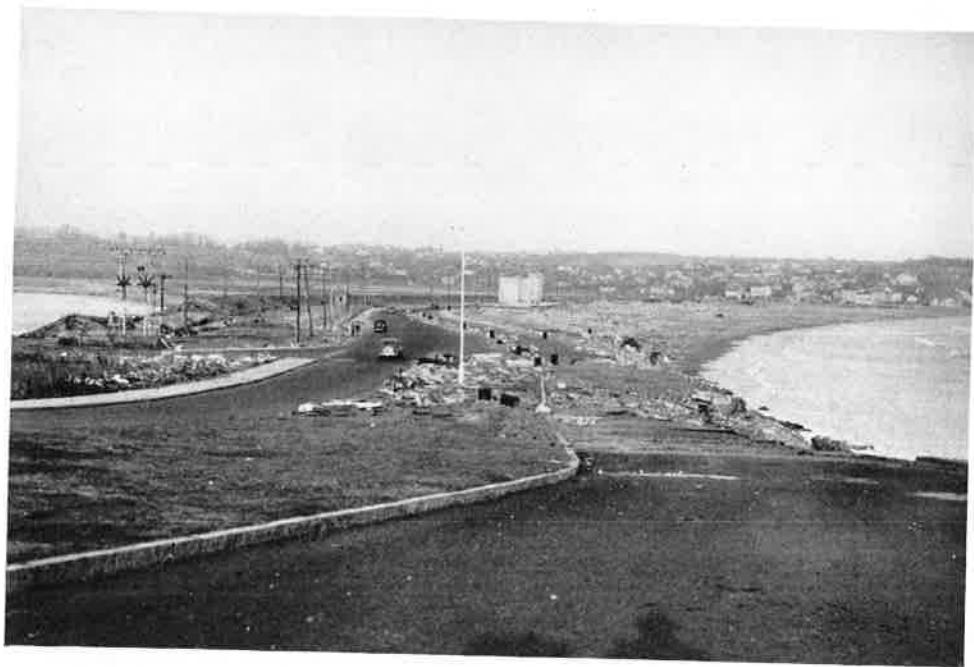
FIG. 25

FIG. 25—Newport Town (Easton's) Beach. Total destruction of all buildings save one concrete boxlike affair. Partial damage of road and wall with road cleared of three feet of debris. Waves swept salt water into city reservoir six feet above lagoon. Nov. 2, 1938.

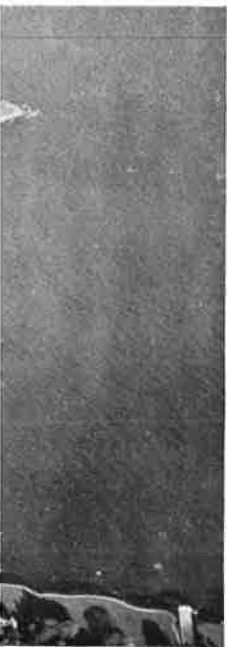
FIG. 26

FIG. 26—Westquage Beach (Bonnet Shores). Bay bar with bathing beach structures and sand-dune belt 20 feet high above high tide, 1936. (Photograph by W. and M.)

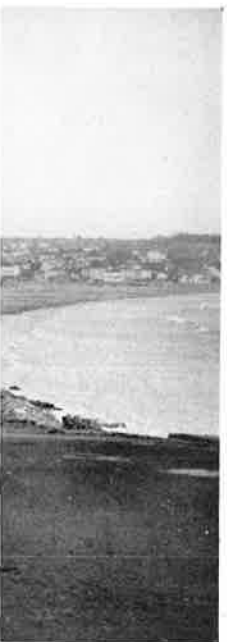
FIG. 27

FIG. 27—Westquage Beach (Bonnet Shores), from the west end showing distribution of dunes inland with entire destruction of buildings. Oct. 14, 1938.

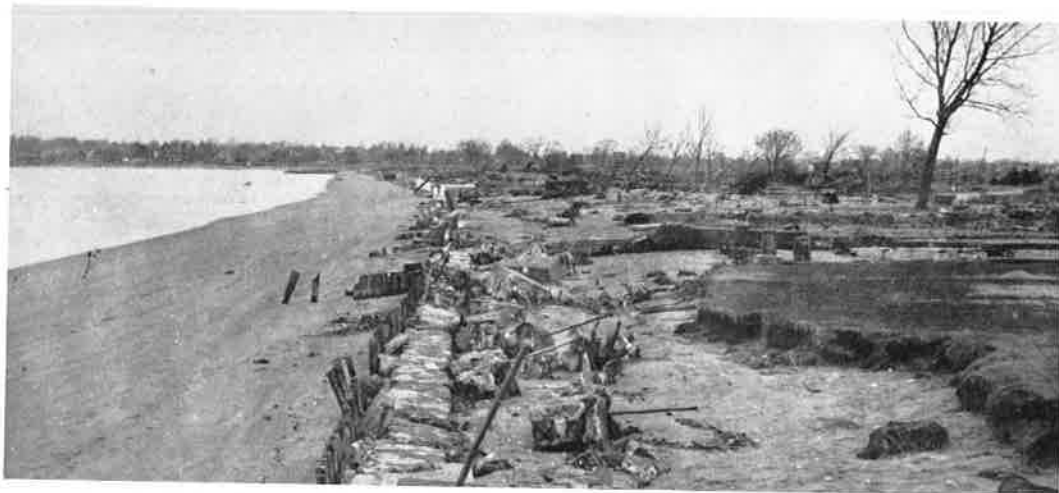
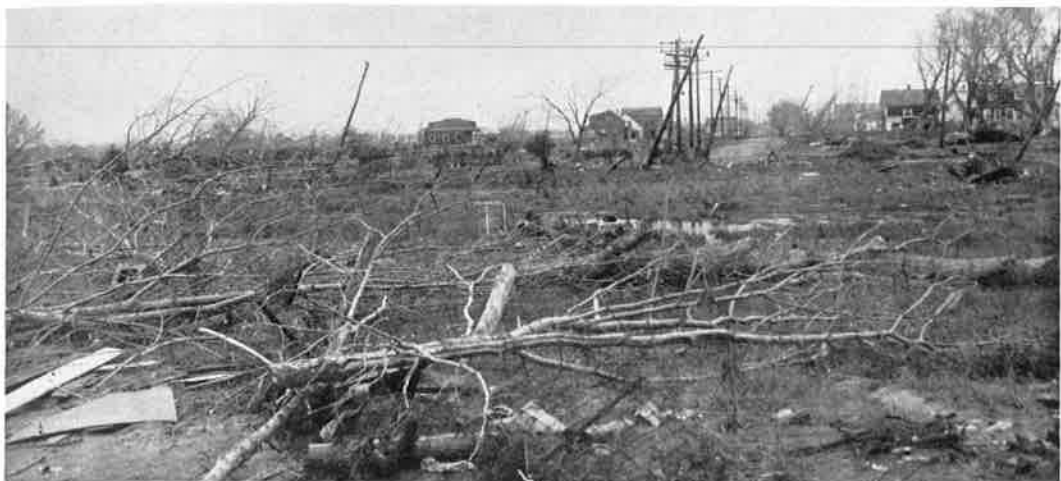
FIG. 28 (pp. 428 and 429)—Conimicut Point, Shawomet, R. I. Panorama illustrating damage to low jetties and bulkheads, erosion of soil and obliteration of about 100 cottages formerly on this low narrow sandspit four to six feet above tide. All the area shown in the panorama was covered with from 6 to 8 feet of storm-driven water. Nov. 20, 1938.

Ordinary barriers of bulkheads, breakwaters, and jetties were first battered by storm waves and rising waters, then weakened and buried by maximum high water, and finally undermined and destroyed by outrushing tides and the still furious waves at a lower level (Figs. 28, 30, 31, 34, and 35). It may be noted that the erosion level is determined by the height of resistant bulkheads.

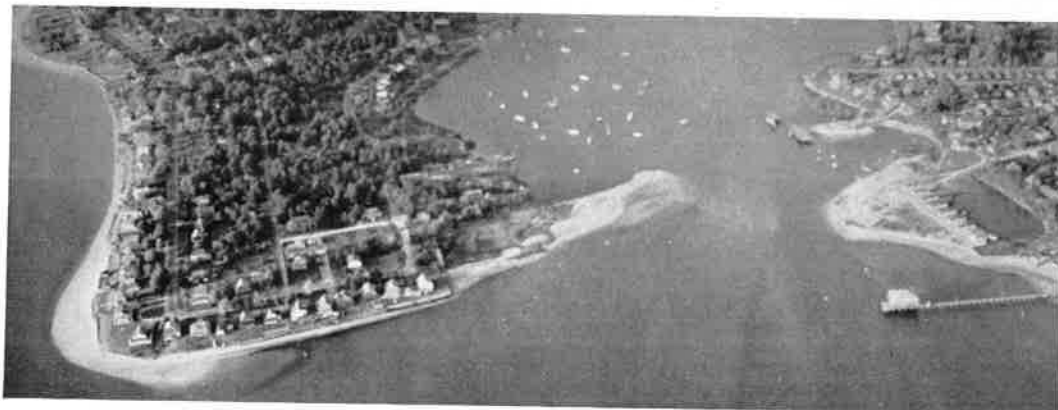
FIG. 29

FIG. 29—Bullocks Point, south of Riverside, R. I., 1936. Of the twelve south-facing cottages all but two (Fig. 31) disappeared. On the west (left) shore many cottages were partial losses by the undercutting of the fifteen-foot sand-plain cliffs in spite of supposedly protective 5-foot and 10-foot bulkheads. (Photograph by W. and M.)

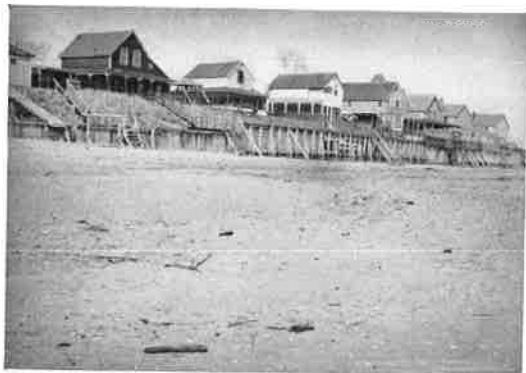
FIG. 30

FIG. 30—Bullocks Point cottages and bulkheads, 1936.

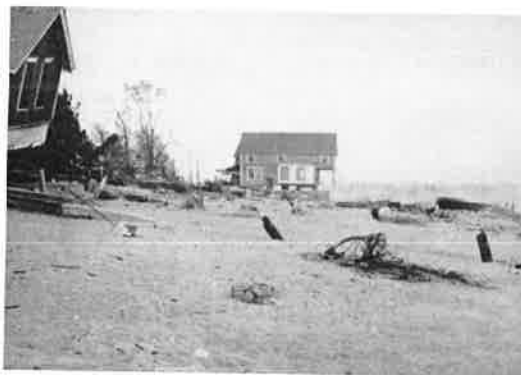
FIG. 31

FIG. 31—Bullocks Point, Oct. 7, 1938.

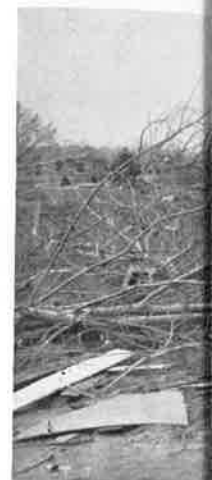
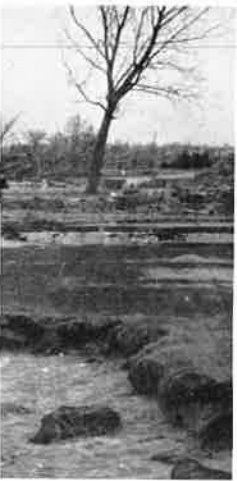
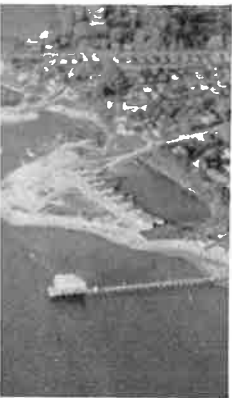
FIG. 28 (contd.)

FIG. 28 (contd.)—See opposite page for legend.

t; the 15-  
(Fig. 17);  
nk Island  
about 30  
up Narra-  
(Fig. 16).  
ties were  
tened and  
destroyed  
(Figs. 28,  
l is deter-

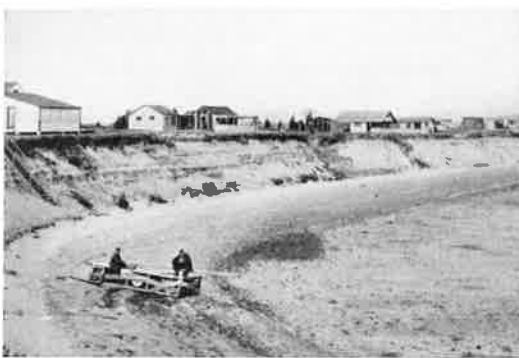
FIG. 32

FIG. 32—Gaspee Point (south), R. I. Beach profile at low tide before gale erosion, 1930.

The new high beach profile shows a tendency toward a gentler slope with possibly a slight convexity in places (Figs. 32 and 33). Beach material has changed in character and position. Directly after the gale it was reported that coarse or stony upper parts of beaches were covered with hard-packed sand; but unfortunately wave and rain only washed it lower down on the beach. In general, the change in the ordinary beach was slight, and that toward betterment of the high beach.

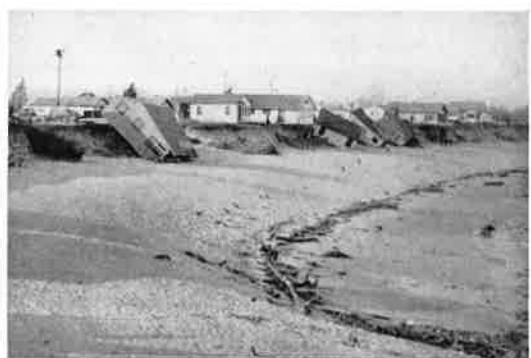
FIG. 33

FIG. 33—New upper beach profile at Gaspee Point. Note slight convexity of upper beach in erratic gale erosion of 15-foot cliffs of sand-plain material.

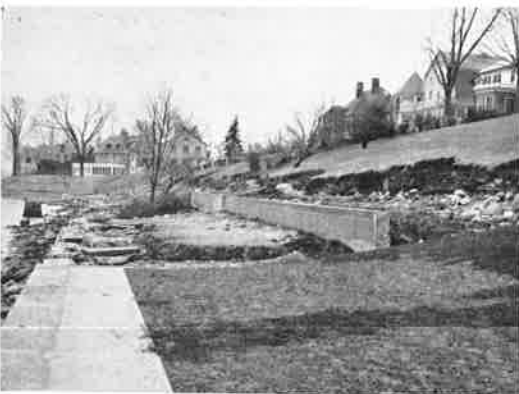
FIG. 34

FIG. 34—South of Rhode Island Yacht Club, Pawtuxet, showing erosion above bulkheads at two levels. For protection bulkheads must be as high as waves.

Some engineering lessons have been learned: more massive and solid and deeper foundations for shore structures are imperatively necessary in exposed places; protective devices such as bulkheads must be higher and stronger even in upper Narragansett Bay to serve their purpose; and certain provisions must be made to protect life on the beaches in late August and September.

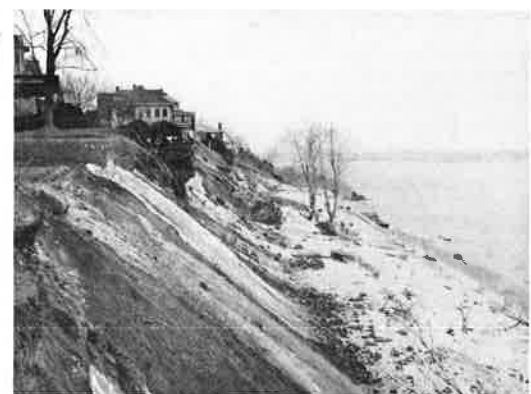
FIG. 35

FIG. 35—North of Rhode Island Yacht Club, Pawtuxet. Cliff erosion in sand and gravel sand plain, inland from trees and low 4-foot retaining walls by undercutting and slumping. Original slope may be seen in distance. April, 1939.
