Clinical Study

Late Removal of Titanium Hardware from the Elbow Is Problematic

Abdo Bachoura, Ruriko Yoshida, Christian Lattermann, and Srinath Kamineni

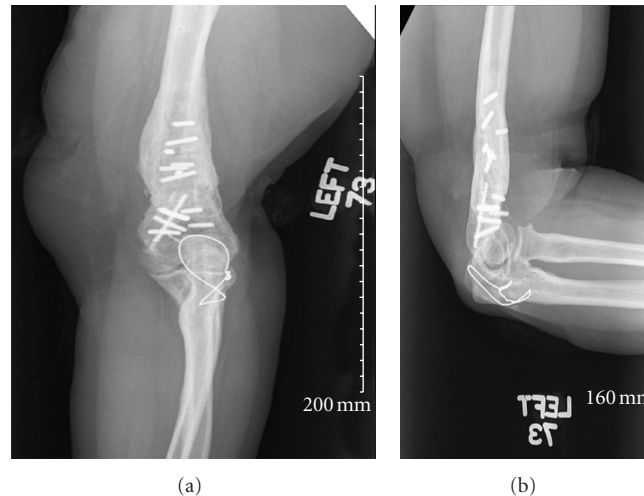
FIGURE 1: Broken hardware often poses a difficult problem and subsequent removal may increase surgical time and complexity of future surgeries. (a) shows an X-ray of an elbow (AP view) with broken and retained screws. (b) shows the same elbow in the lateral position.

Hardware removal is indicated for infection, nonunion, failure of fixation, pain, soft tissue irritation, and anticipated strenuous activity after fracture healing [1–4]. During removal cases however, hardware, especially screws, can break. Subsequent removal of broken hardware increases surgical time, and retained metalwork potentially complicates future surgeries (Figure 1) [5].

Hardware failure during removal cases is a commonly seen problem in orthopaedics [5] (Figure 1). Currently, there is

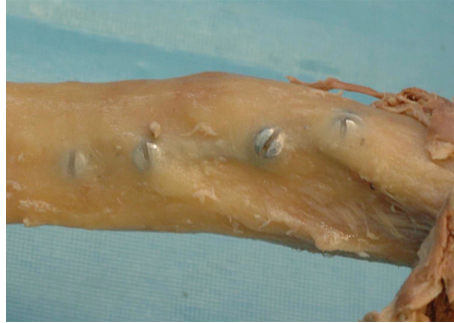
FIGURE 2: Bone ingrowth and on-growth onto metallic hardware in the humerus (cadaveric specimen). Due to a greater extent of osseointegration, greater removal torques will be necessary to extract the bone screws.

Osseointegration has been observed to occur within 3–10 months in titanium alloy [10, 11]. The degree of bone in-growth and on-growth, however, continues to increase for years after initial implantation (Figure 2) [15]. Although there have been studies showing evidence of stainless steel osseointegration, it is generally accepted that commercially pure titanium and titanium alloy are more biocompatible and more likely to osseointegrate than stainless steel [16]. In our series, it is likely that as osseointegration became

more complete, greater removal torques contributed to the failure of titanium alloy screws in this series [17]. Given these properties, we postulate that over longer periods and increased loading cycles, the development of microfractures and osseointegration contributed to screw breakage during implant removal.
