# WaterSmart Dams Surface Water Technical Report

Report by Jessie Ellis, Dr Bonny Stutsel & Associate Professor Nik Callow

UWA School of Agriculture and Environment  
Centre for Water and Spatial Science [cwss@uwa.edu.au](mailto:cwss@uwa.edu.au), Perth WA 6009 Australia

Report Number CWSS 2025/02

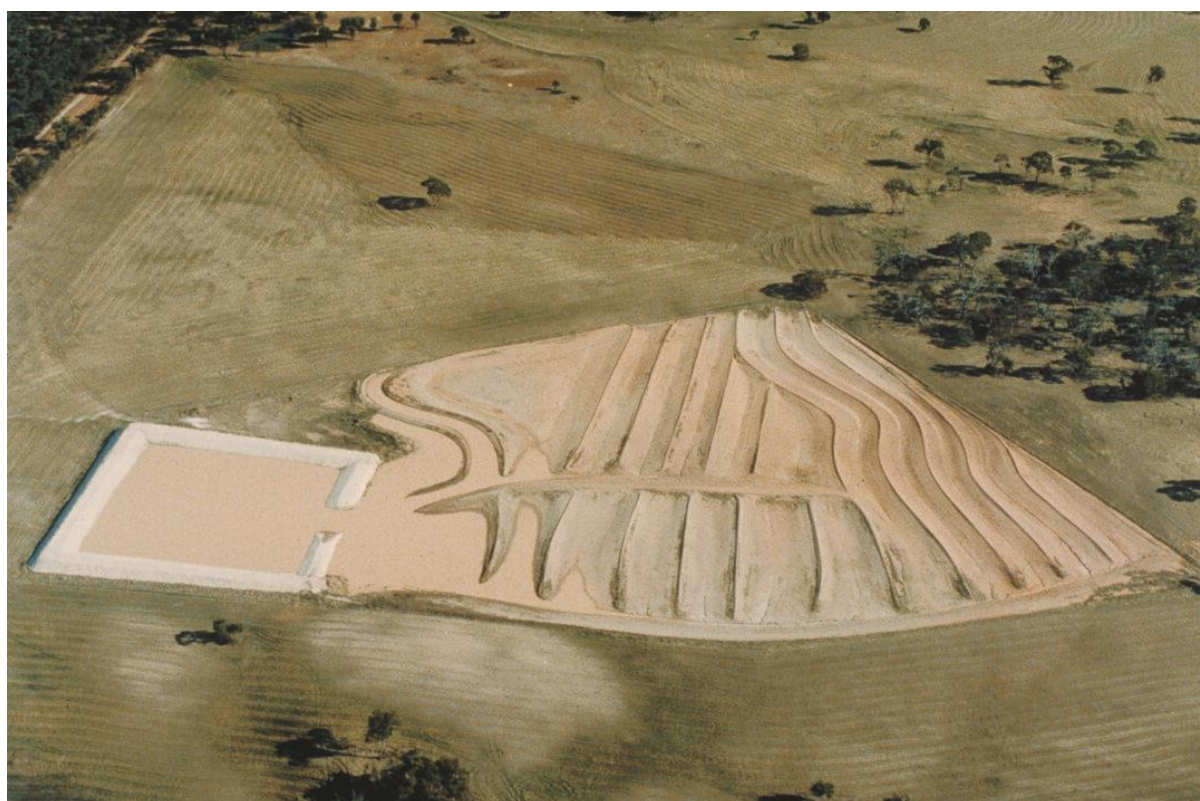
*Figure 1. An example of a roaded catchment (source Department of Primary Industries and Regional Development (DPIRD)).*

Typically, RCs consist of areas where sandy topsoil is not present or has been removed, with parallel ridges of compacted, bare clay soil with moderately steep side slopes (feeder slopes), designed to maximise runoff from relatively low-intensity rainfall - especially where natural catchments perform poorly (Laing, 1985, Figure 1). However, these catchments are often poorly maintained; without regular rolling to compact the surface and spraying to control weeds, their effectiveness declines. The condition of the surface directly influences the runoff threshold, or the minimum rainfall required to generate runoff, also known as the rainfall–runoff threshold (Baek & Coles 2013a; Li et al., 2004). Neglected RCs generally have a threshold between 10 and 12 mm (Baek & Coles, 2021; Baek & Coles 2013b), while well-maintained catchments can reduce this to around 8 mm (Davies & Denby, 1988).

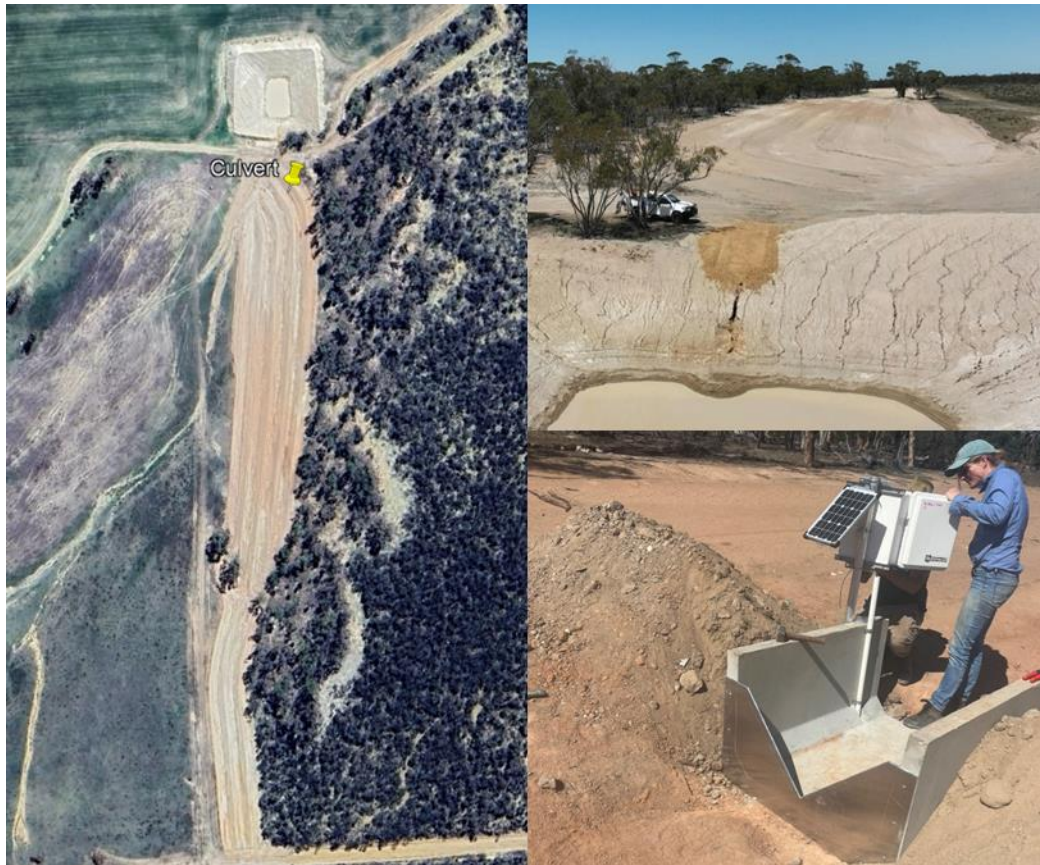
*Figure 5. Satellite image of Giles roaded catchment, culvert and dam system, 2025(left). Drone image looking up the roaded catchment (right-top) and the V-notch weir and logger box (right-bottom).*

This site lies within the Booran erosional land system, which is characterised by medium- to fine-textured soils with low permeability. Consequently, the area is prone to runoff and sheet flow, resulting in high volumes of loose sediment that interfere with the operation of water flow monitoring equipment (Bettenay et al., 1964). A V-notch weir was installed at the lower end of the rightmost trough (from a bird's-eye view) (Figure 5), which drains a 3,274 m<sup>2</sup> portion of the catchment. Total catchment discharge is therefore estimated by scaling measurements from this trough by a factor of 4.76.

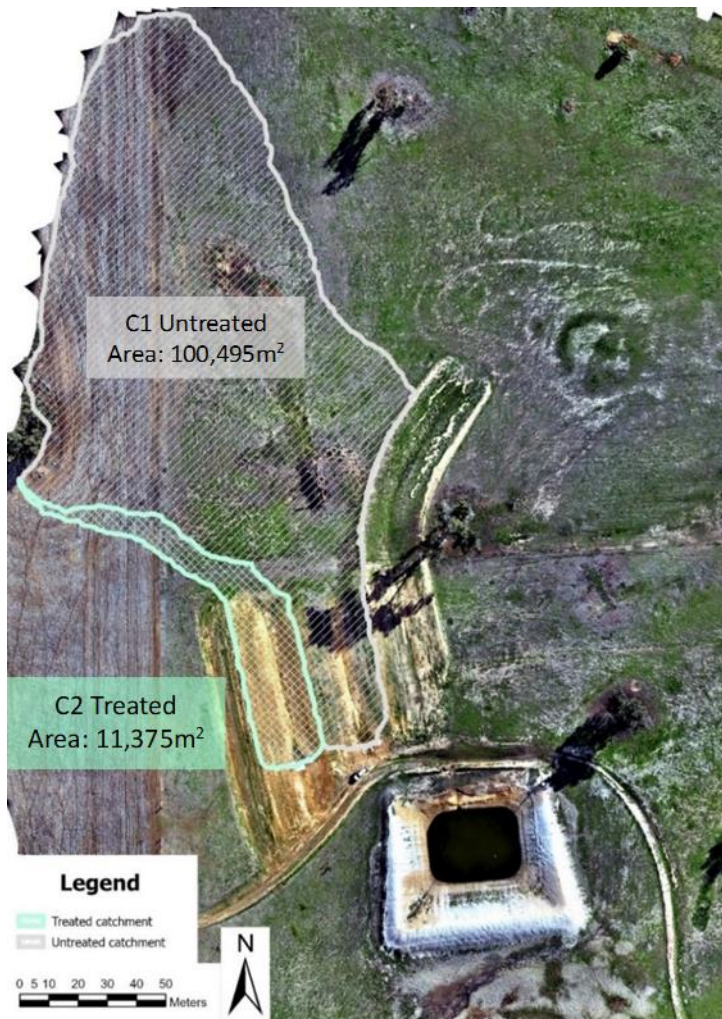
*Figure 6. Satellite image of the Goss dual catchment system, with the Digital Elevation Model (DEM) outlining calculated catchment size, C1 untreated (brown) and C2 treated (Green).*

Two catchments were delineated: Catchment 1 (C1), which remained untreated (‘do nothing’), and Catchment 2 (C2), representing best practice, was graded, rolled, and sprayed for weed control (Figure 6).

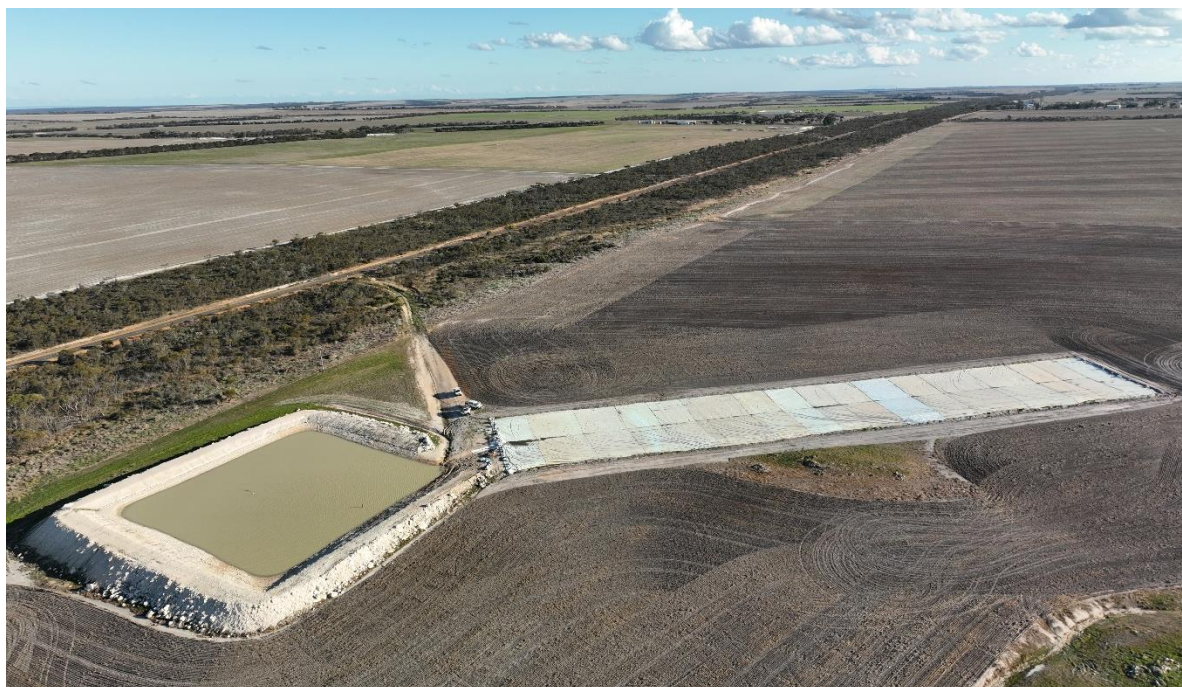
*Figure 7. Drone image of WSD Lester site tarped catchment system, May 2023*

Prior to installation, the roaded surface was graded and reshaped into a shallow V-profile before being smoothed. Eighteen tarps were stitched together by Elpha Contracting to cover the catchment, with an additional two tarps used to secure the ends. The tarp edges were anchored in trenches, backfilled, and weighted with rocks to prevent wind uplift. The perimeter was fenced to exclude livestock and prolong the lifespan of the tarps. Plastic and life cycle testing of the tarps was conducted at this site. Additionally, a V-notch weir and a rain gauge were installed at the catchment's accumulation point.

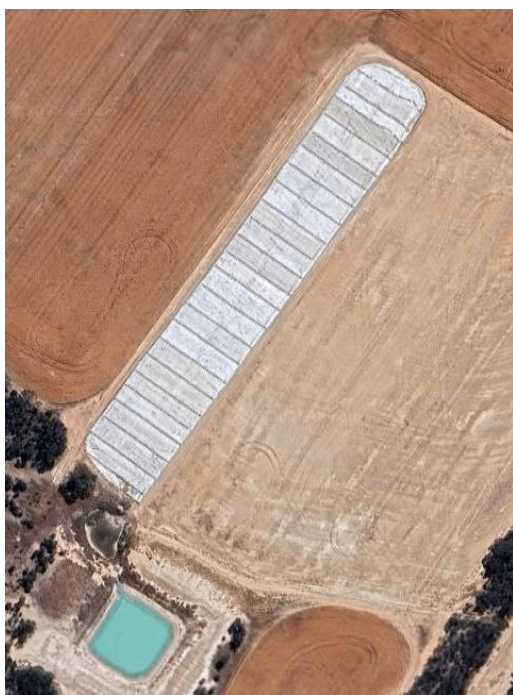
*Figure 8. Satellite image of Wandel site PVC tarped catchment system, 2025*

The Wandel site is situated near Grass Patch, within the Wheatbelt region of Western Australia. On 13 March 2024, an 8,360 m<sup>2</sup> paddock was cleared, and the surface was smoothed; no V-shaped contouring was applied. Twenty-five secondhand PVC grain tarps in good condition were laid and stitched together by Elpha Contracting to cover the catchment area (**Error! Reference source not found.**). The tarp edges were anchored in trenches, which were then backfilled to prevent wind uplift. Cut tyres were placed along the seams to aid in flattening and prevent lifting of the surface by wind. The perimeter was fenced to exclude livestock and extend the lifespan of the tarps. An 18-inch Parshall flume and a rain gauge were installed at the catchment's accumulation point. Runoff from the catchment is directed into a sump, which, once filled, overflows into a pre-existing dam.

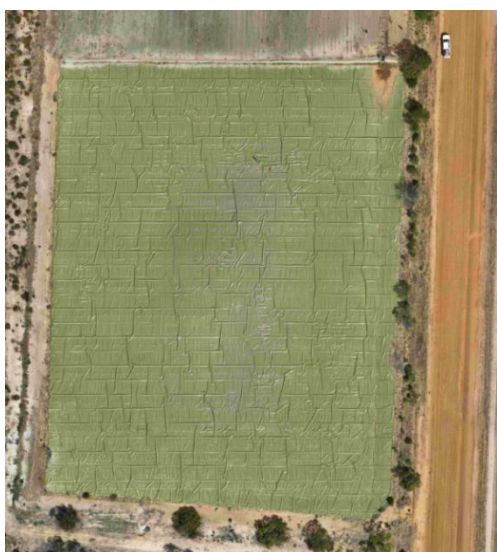
*Figure 9. Drone image of Borden High Density Polyethylene catchment, September 2024.*

A high density polyethylene (HDPE) catchment near the town of Borden was evaluated as by instrumenting a previous research site, with data from 13 September 2024. An 8,877 m<sup>2</sup> section of the bituminised catchment was overlaid with HDPE plastic material (Figure 9). The surface is flat, with no V-shaped contouring, and follows a natural, slight downslope in the landscape. HDPE “sausages” (effectively plastic-welded together HDPE sandbags) are placed on top of the HDPE surface to stop the impact from wind. The catchment edges were anchored in trenches and backfilled to prevent wind uplift. A V-notch weir and a rain gauge were installed at the catchment's accumulation point and re-instrumented for this study.

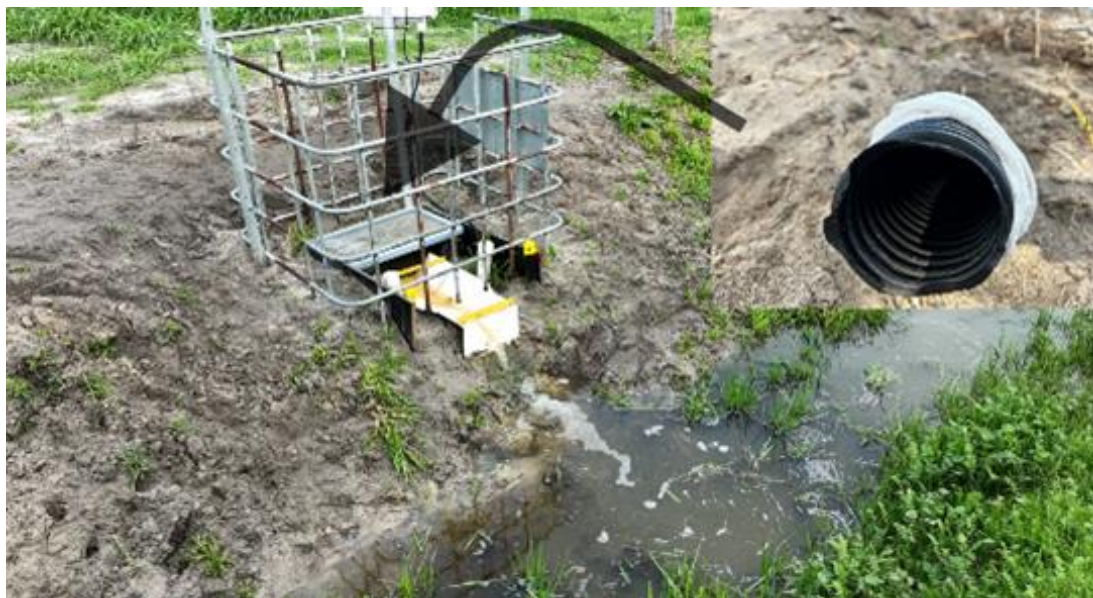
*Figure 10. Photograph of Ashton's site 11-inch Parshall flume outlet with the insert photo showing the style of agricultural pipe used*

The soil profile consists of loamy sand overlying a clay subsoil. To establish the system, they used a grader to excavate a single trench up the slope of the paddock. In the trench, they laid a socked agricultural pipe, then backfilled. The pipe terminates in a contour bank located at the base of the slope, which in turn drains into a key dam (see, WaterSmart Dams Evaporation Technical Report). An 11-inch Parshall flume was installed at the drainage system's outlet to measure discharge and electrical conductivity (salt load), and a rain gauge was located at the key dam to record rainfall (**Error! Reference source not found.**).

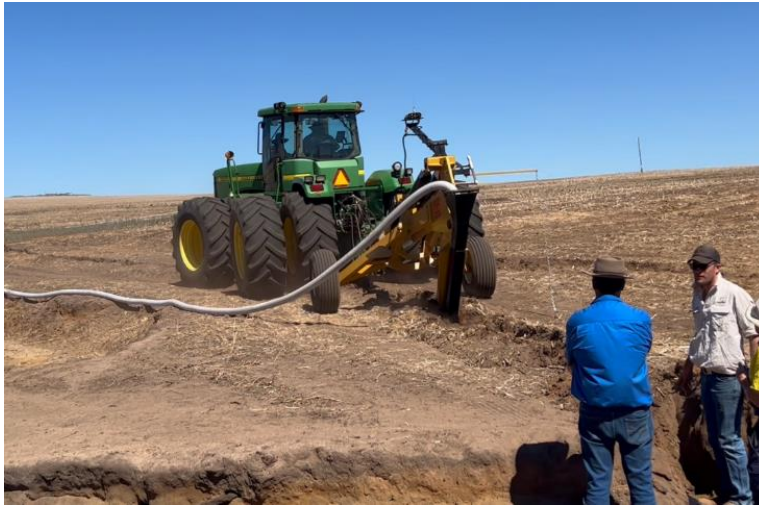
*Figure 11. Photograph of the “Soil Max” tile plough installing pipe behind a DGPS-guided tractor during a demonstration field day (note – photo is not at the Webb property, but from a field day).*

The tile drains were installed with a "SoilMax" tile plough. The tile plough excavates trenches at a predetermined depth to achieve the desired slope, simultaneously laying agricultural pipe as it progresses. Once laid, the trenches are backfilled to restore the paddock's trafficability (Figure 11). The pipe terminates at a sediment basin, which must fill before it flows through a 15-inch pipe to a V-notch weir (Figure 12). Discharge is measured at the weir before the water enters a dam, which is used for sheep drinking water. This site also had a rain gauge installed.

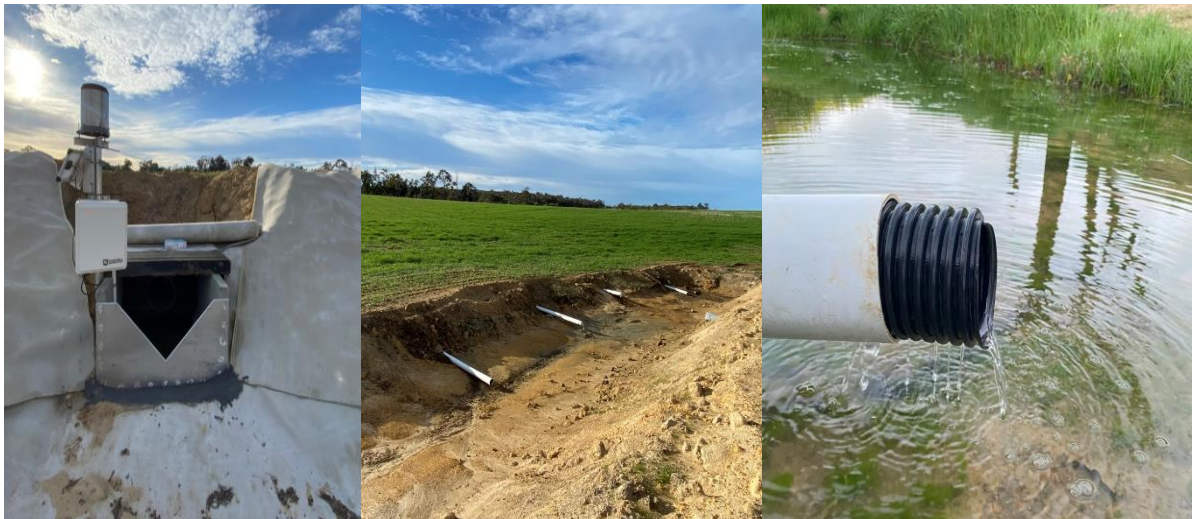
*Figure 12. V-notch weir setup at Webbs (left), Four tile drains ending at the sump above the dam (centre), Tile drain running on 20/8/2025 (right).*

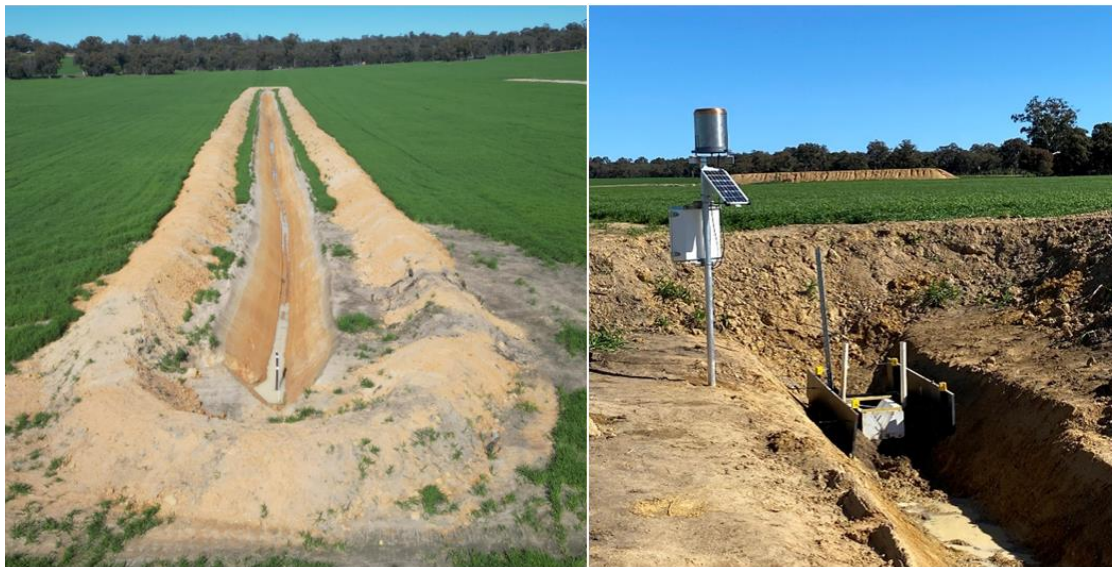
Figure 13. Left: South's site open V subsurface drainage system. Right: Ground-level image of the 11-inch Parshall flume and rain gauge monitoring equipment.

The South site is situated near Darkan, within the Wheatbelt region of Western Australia. The open V subsurface drainage system was installed on 12 July 2023, with data monitoring commencing on 1 August 2023. The system was designed to increase water capture in a key dam, including draining waterlogged areas and interception of throughflow and the perched seasonal aquifer on the duplex soils. The V drains end at a riser that connects to an agriculture pipe that directs flow to an outlet that is equipped with an 11-inch Parshall flume for measuring discharge and a rain gauge for recording rainfall (Figure 13). A contour bank channels flow from the discharge point to the nearby dam.
