North Valley Home Inspection

CONFIDENTIAL INSPECTION REPORT

Sample, Phoenix, AZ xxxxx

5/3/2016 12:30 pm to 3:00 pm

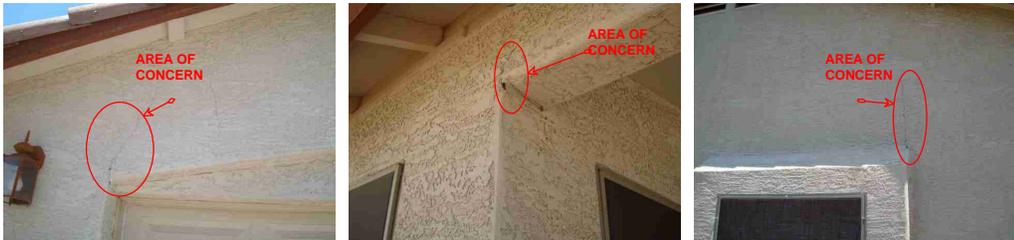
There are stress fractures in the stucco around the windows and doors that result from movement, and are quite common. Most people do not realize that structures move, but they do and sometimes more or less continuously. Therefore, stress fractures can reappear after they have been repaired, and particularly if they have not been repaired correctly.

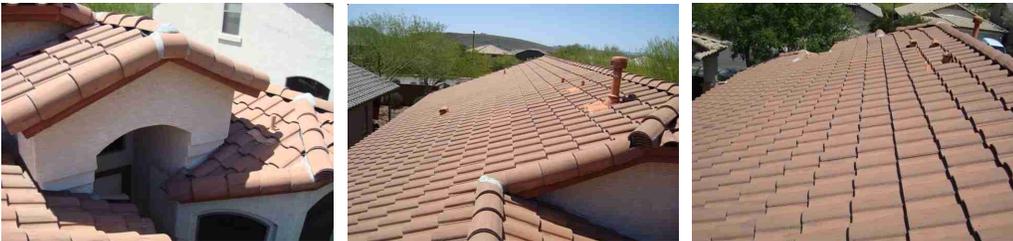
The roof appears to be in acceptable condition unless otherwise noted but this is not a guarantee. For a guarantee, you would need to have a roofing company perform a water-test and issue a roof certification.

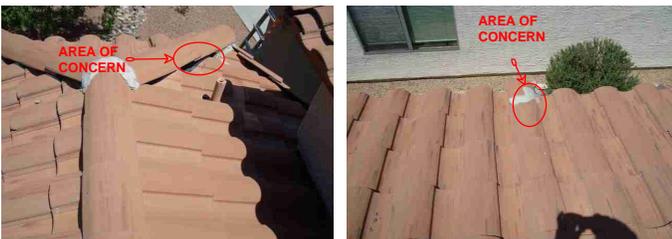
There are a number of cracked, broken, and or displaced tiles. Some of which have exposed the waterproof membrane, which should be repaired or the roof could leak. Recommend further evaluation by a roofing contractor and service as deemed necessary.

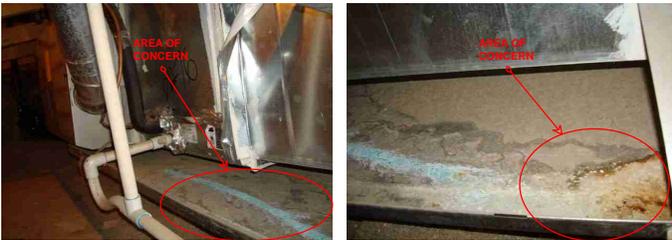
There is evidence of rust in the air handler drip pan which indicates a past blockage in the main condensation line. Recommend asking the sellers to explain.

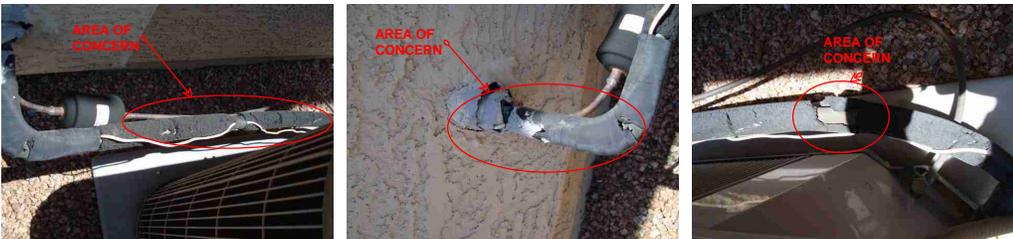
The insulation on the refrigerant lines is beginning to degrade which should be replaced.

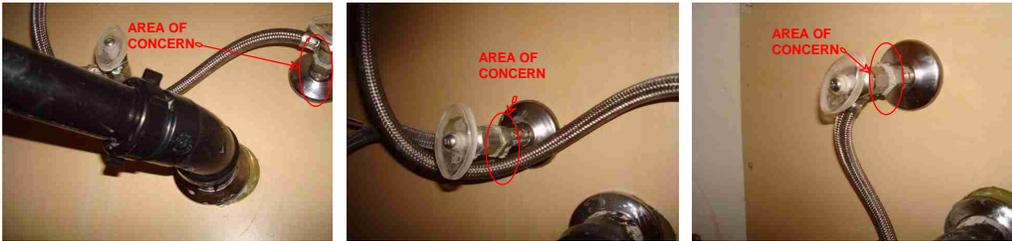
There are mineral deposits built up on one or more of the plumbing components under the sink which should be serviced. Recommend further evaluation by a licensed plumber.

(This condition is a past leak that has sealed itself with minerals and could potentially leak again in the future if the minerals are disturbed)

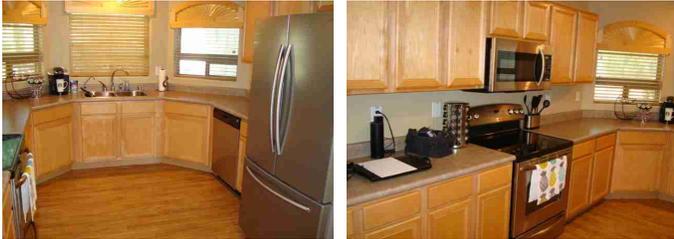
We have evaluated the kitchen, and found it to be in acceptable condition, unless otherwise noted.

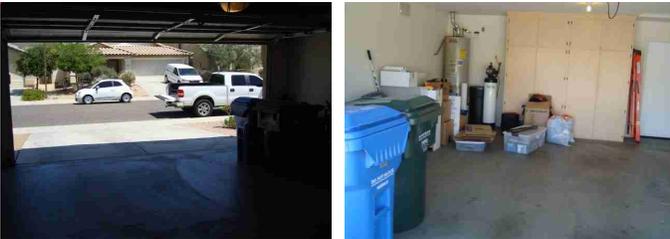
We have evaluated the garage, and found it to be in acceptable condition unless otherwise noted.

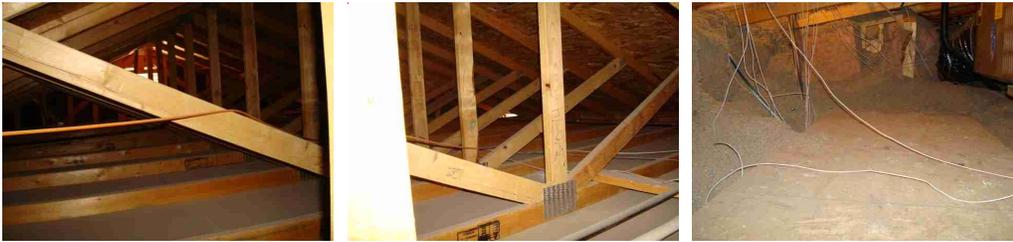
The visible portions of the roof framing consists of a factor- built truss system, comprised of components called chords, webs, and struts that are connected by wood or metal gussets nailed or glued in place. Each component of the truss is designed for a specific purpose, and cannot be removed or modified without compromising the integrity of the entire truss. The lowest component, which is called the chord and to which the ceiling is attached, can move by thermal expansion and contraction and cause creaking sounds, which are

more pronounced in the mornings and evenings along with temperature changes. Such movement has no structural significance, but can result in small cracks or divots in the drywall or plaster.
