North Valley Home Inspection

SUMMARY REPORT

Inspection Address: Sample, Phoenix, AZ xxxxx

Inspection Date: 5/3/2016 Start: 12:30 pm End: 3:00 pm

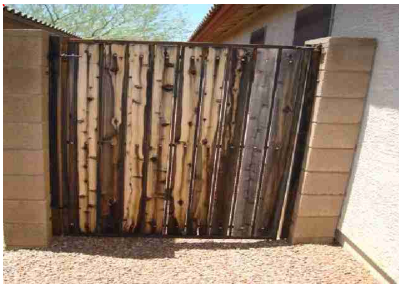
- 2.1 - The gate needs typical maintenance-type service, to open and close or latch properly. Recommend having a licensed general contractor adjust or repair.

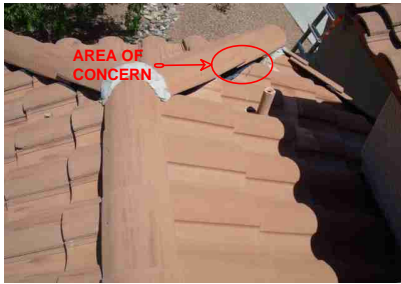
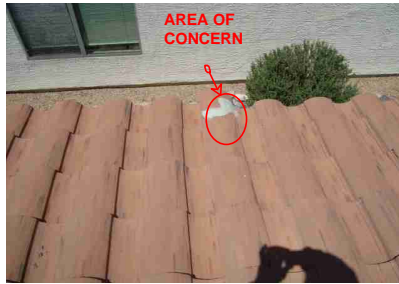
- 3.1 - There are a number of cracked, broken, and or displaced tiles. Some of which have exposed the waterproof membrane, which should be repaired or the roof could leak. Recommend further evaluation by a roofing contractor and service as deemed necessary.

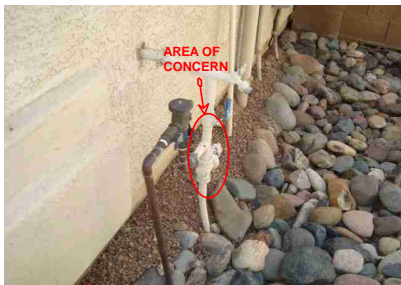
4.1 - The pressure at the distribution shut off is too high (90 psi) and will stress components of the system. A licensed plumber should reduce the pressure at the regulator to sixty pounds per square inch, which is optimum. However, the regulator may have failed and would need to be replaced.

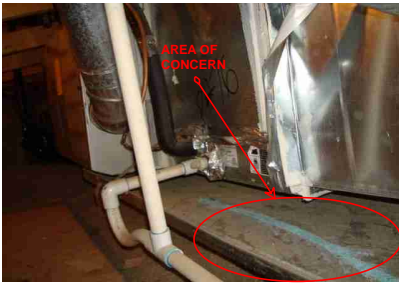
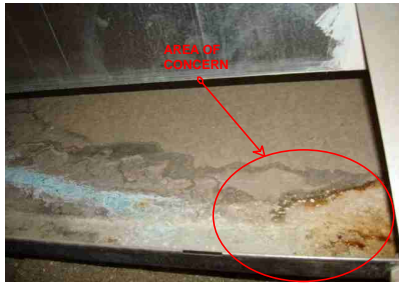
7.3 - There is evidence of rust in the air handler drip pan which indicates a past blockage in the main condensation line. Recommend asking the sellers to explain.

There is evidence of rust in the air handler drip pan which indicates a past blockage in the main condensation line - *Contir*

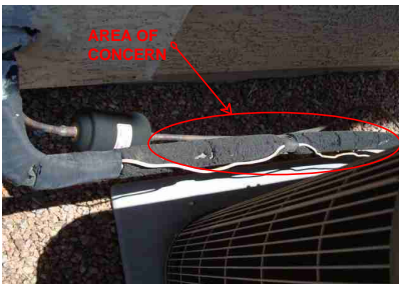
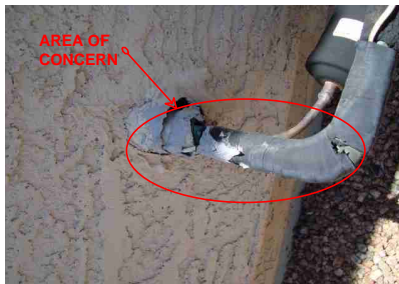
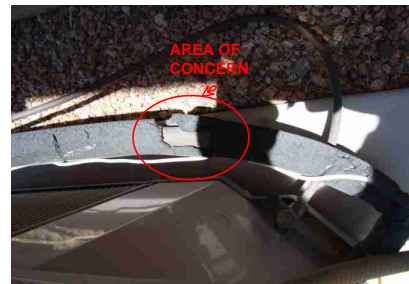
7.4 - The insulation on the refrigerant lines is beginning to degrade which should be replaced.

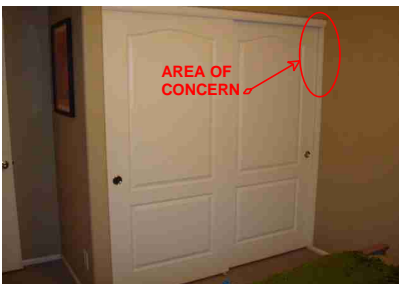
10.1 - The closet doors are out of level and will need to be adjusted to close properly. Recommend a handyman service the closet doors.

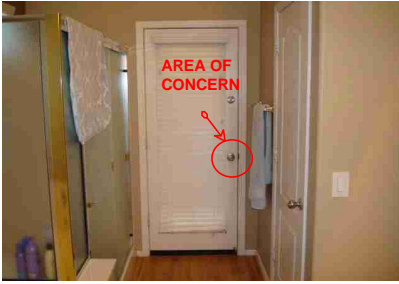
11.1 - The door striker plate needs to be adjusted for the striker pin to engage.

The door striker plate needs to be adjusted for the striker pin to engage - *Continued*

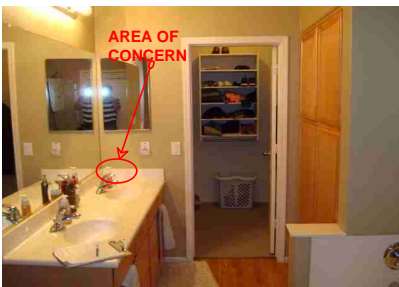
11.2 - The right hand sink faucet is loose, and should be tightened. Recommend having a licensed plumber remedy.

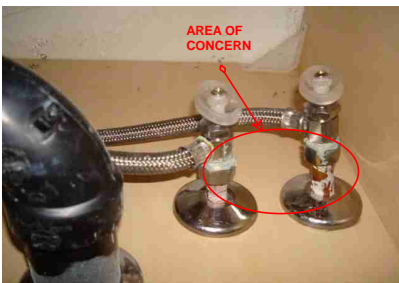
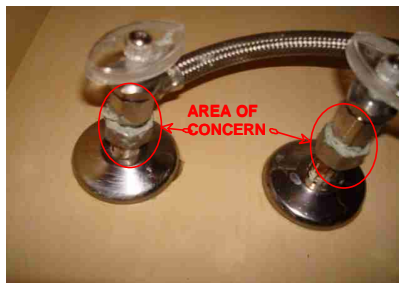
11.3 - There are mineral deposits built up on one or more of the plumbing components under the sink which should be serviced. Recommend further evaluation by a licensed plumber.
(This condition is a past leak that has sealed itself with minerals and could potentially leak again in the future if the minerals are disturbed)

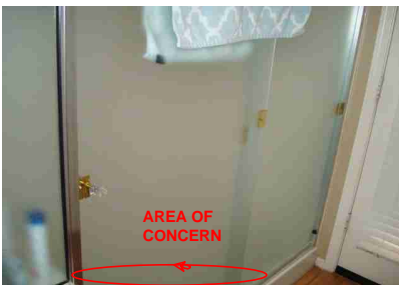
11.4 - The shower door bottom seal is missing or damaged, and should be replaced.

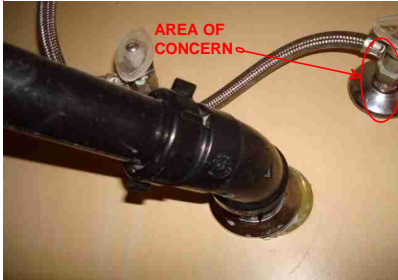
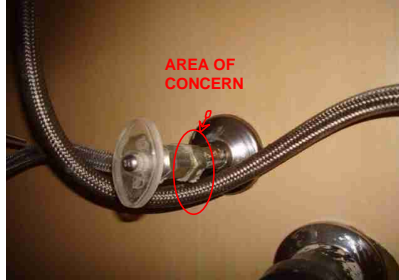
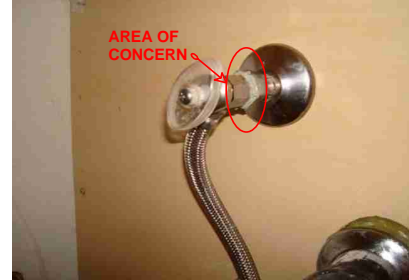
11.5 - The sink drain is slow or partially blocked and should be serviced.

11.6 - There are mineral deposits built up on one or more of the plumbing components under the sink which should be serviced. Recommend further evaluation by a licensed plumber.

(This condition is a past leak that has sealed itself with minerals and could potentially leak again in the future if the minerals are disturbed)

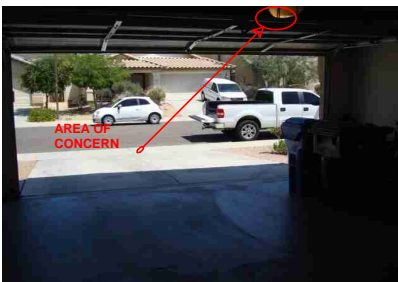
17.1 - The garage door opener is functional but noisy, and may need service, such as lubrication of components. Recommend having a garage door contractor evaluate.
