# Breast Care Leicester

## A case of capsular contracture requiring implant exchange

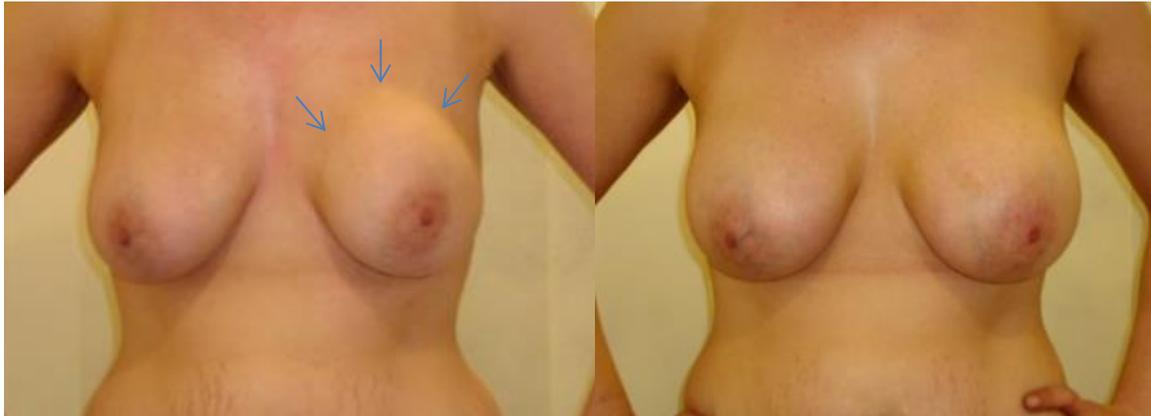
She has very kindly given us permission to publish this case report including her pre- and post-operative photographs on our website. The photograph on the left shows her before implant exchange with distortion particularly noticeable around the upper pole of her left breast (arrowed). The photograph on the right shows her after the implants were exchanged and the capsules removed.

This woman’s pain and distortion had been due to the contracture of the scar capsule around one of her implants. This is a common consequence after breast implant surgery and the solution is to replace the implants and remove the capsule surgically. As capsular contracture is a common reason for needing to replace implants, this lady is very sensibly making financial provision so she is prepared should her implants need to be replaced again in a few years’ time.
